UNITED STATES  
NUCLEAR REGULATORY COMMISSION  
WASHINGTON, D. C. 20555

SAFETY EVALUATION BY THE OFFICE OF NUCLEAR REGULATION

REACTOR INTERNALS BOLTING PROBLEMS

RANCHO SECO NUCLEAR GENERATING STATION

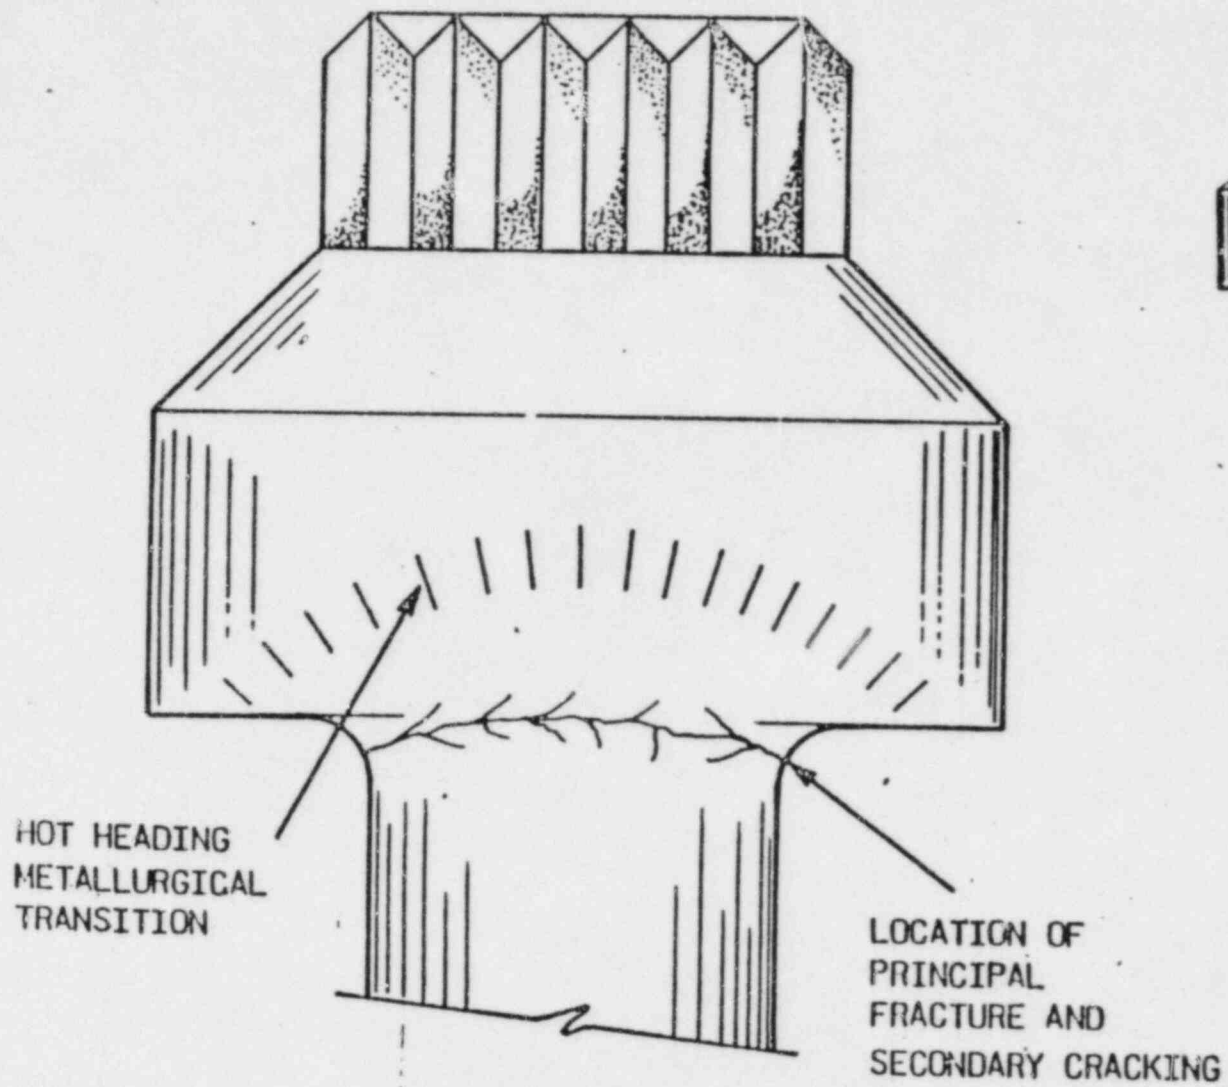
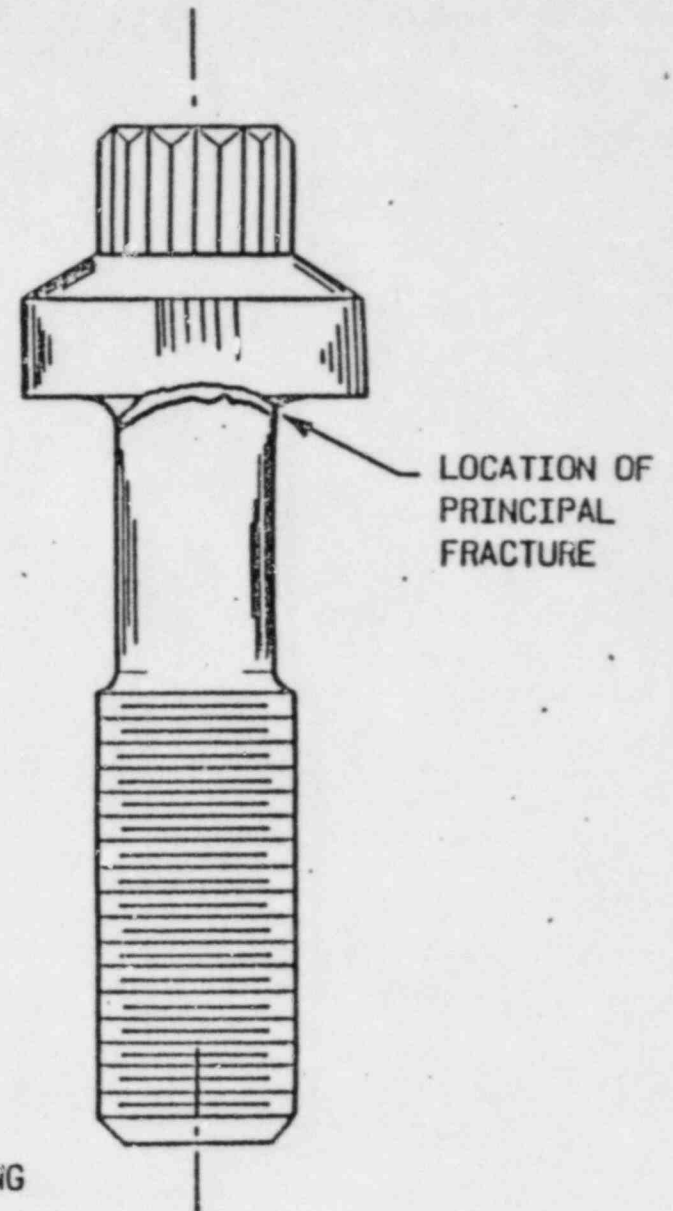
## LOCATION OF FRACTURE

Of these bolts, only the UCB and LCB bolts have core support significance. Cracked bolts have been randomly distributed around the joint without specific pattern with the location of cracks at the head-to-shank transition region of the bolt (see Enclosure 1). This area is a region of high stress concentration due to geometric discontinuity.

The tentative conclusion of the B&W Owners Group Task Force in regards to the failure mechanism involved is that all bolt failures to date are attributed to intergranular stress assisted cracking in the bolt head-to-shank transition region. Although the Task Force has stated that no evidence of corrosion has been observed, the staff has not been informed of any specific effort to determine if corrosion is a contributor to the failures. The licensee, as a member of the task force, supports this tentative conclusion regarding the bolt failures at Rancho Seco and has provided information to update the BAW-1784 information specific to Rancho Seco.

1. All 120 upper core barrel bolts were replaced with bolts fabricated from A-286 material which:
  - A. Were manufactured by machining the heads. No hot heading was allowed. This eliminated any potential problems in the heat effected zone which remains after hot heading.

- B. Manufactured using UNR thread tolerances to ensure rounded thread radii.
  - C. Peened under the head and in the head to shank transition region to minimize local stresses.

- D. Incorporated a locking device to ensure an isolated broken bolt does not become a loose part.
  - E. Were installed with torque values and pre-stress methods that resulted in a peak stress of 69,000 psi which is well below the measured yield stress of 100,000-134,000 psi for the A-286 material.

2. All 96 lower thermal shield bolts were replaced with bolts fabricated from A-286 material which:
- A. Were manufactured from 1 3/4" diameter forged bar stock without hot heading. This eliminates any potential problem in the heat effected zone which remains after hot heading.

- B. The design of the head to shank zone was improved by utilizing a composite under head radii to reduce the stress concentration factor.
  - C. The loading on the bolts was reduced by lowering the bolt torque from 305-335 ft-lbs to 235-265 ft-lbs.
