Subject: James A. FitzPatrick Nuclear Power Plant
Docket No. 50-333
Core Spray "A" Metallurgical Analysis

A METALLOGRAPHIC INVESTIGATION OF A
TYPE 304 STAINLESS STEEL SCHEDULE 80 PIPE

AN INVESTIGATION OF FLAWS ON THE
INSIDE SURFACE OF A TYPE 304 STAINLESS
STEEL SCHEDULE 80 PIPE

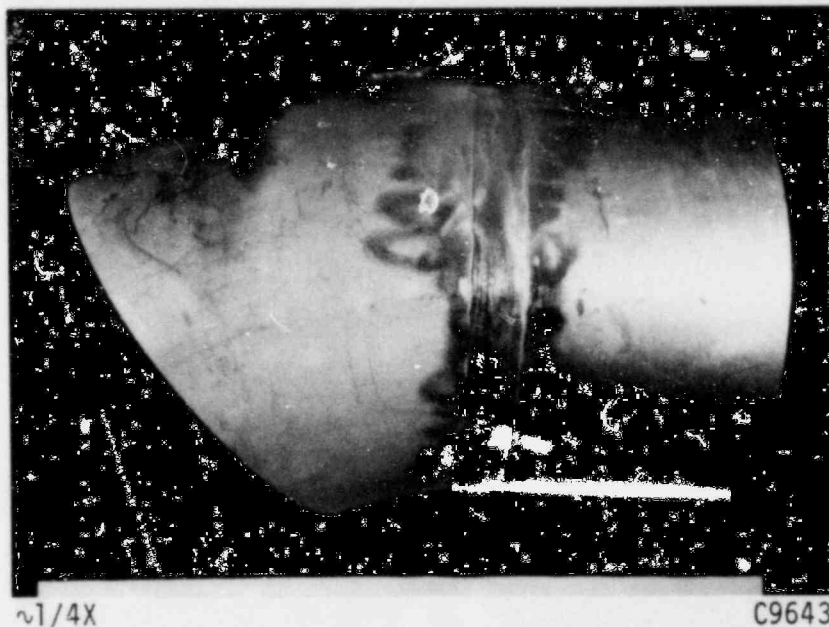
The photograph in Figure 1 shows a portion of the Type 304 stainless steel pipe that contained the linear indication detected by PASNY, that was submitted to BCL for the investigation. That portion of the pipe was approximately 15 inches long; it included about 7 inches of the straight-pipe section and about 7 inches of the elbow section that were joined together by the circumferential weld.

FIGURE 1. PORTION OF THE TYPE 304 STAINLESS STEEL PIPE FROM THE REACTOR CORE-SPRAY SYSTEM THAT CONTAINED THE LINEAR INDICATION DETECTED ULTRASONICALLY

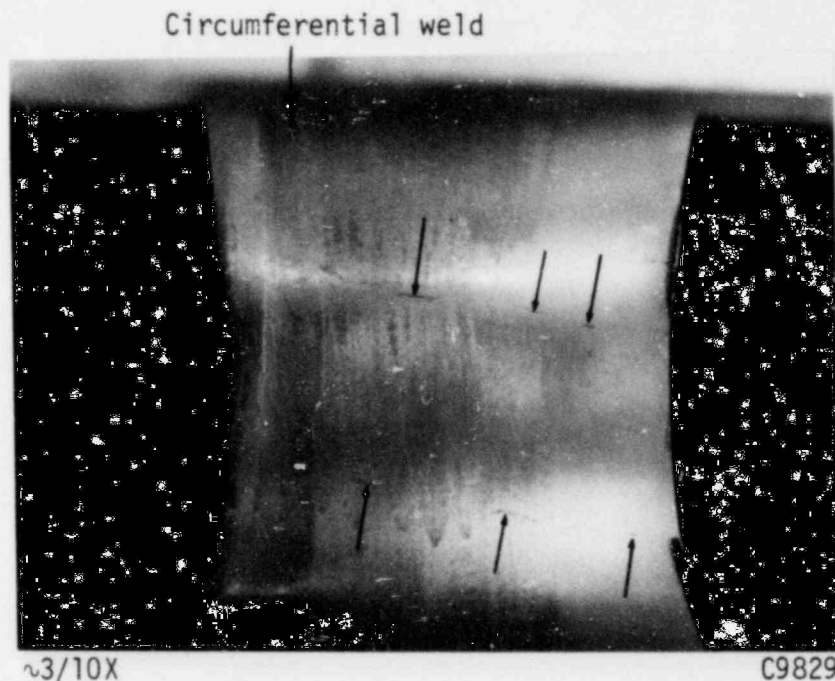
The photograph in Figure 2 reveals two regions on the inside surface of the pipe that contained linear surface defects. The defects are only faintly visible in Figure 2; a few of the defects are denoted by small arrows. Note that the two regions were essentially aligned parallel to each other, but were oriented at a small angle to the axial direction.

FIGURE 2. TWO REGIONS THAT CONTAINED LINEAR DEFECTS ON THE INSIDE SURFACE OF THE PIPE

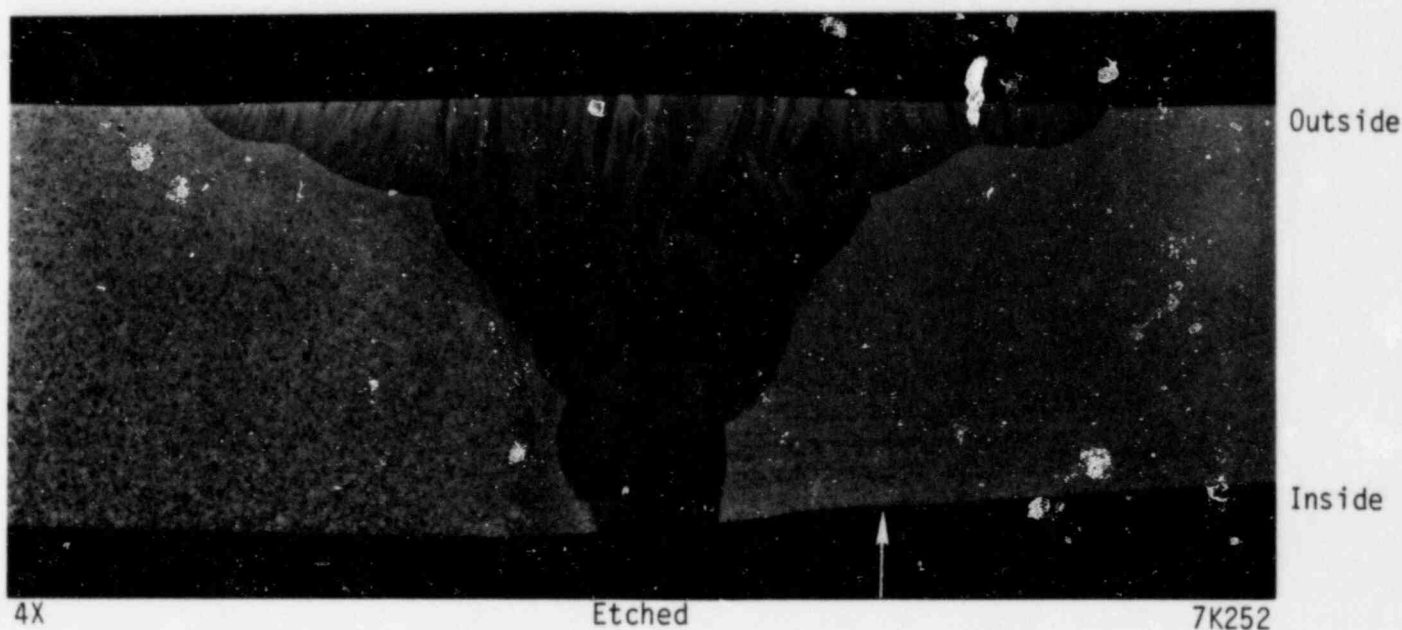
A photomicrograph of the cross section of the weld is presented in Figure 4. The root pass of the weld identifies the inside surface of the pipe. Microscopic examination revealed that sensitized material was present principally in the straight section in the heat-affected zone that was adjacent to the root pass. The degree of sensitization appeared to be

FIGURE 4. CIRCUMFERENTIAL WELD BETWEEN THE ELBOW SECTION (LEFT) AND THE STRAIGHT SECTION (RIGHT) OF THE TYPE 304 STAINLESS STEEL SCHEDULE 80 PIPE

mild based on the apparent size and concentration of the carbide precipitates in the austenite grain boundaries. The sensitization appeared to become considerably less severe towards the outside pipe surface. At the inside surface, the midregion of the sensitized zone was at the approximate location of the arrow in Figure 4. That location was translated to Section S-S (shown in Figure 3) across the linear defect marked by Arrow 1.

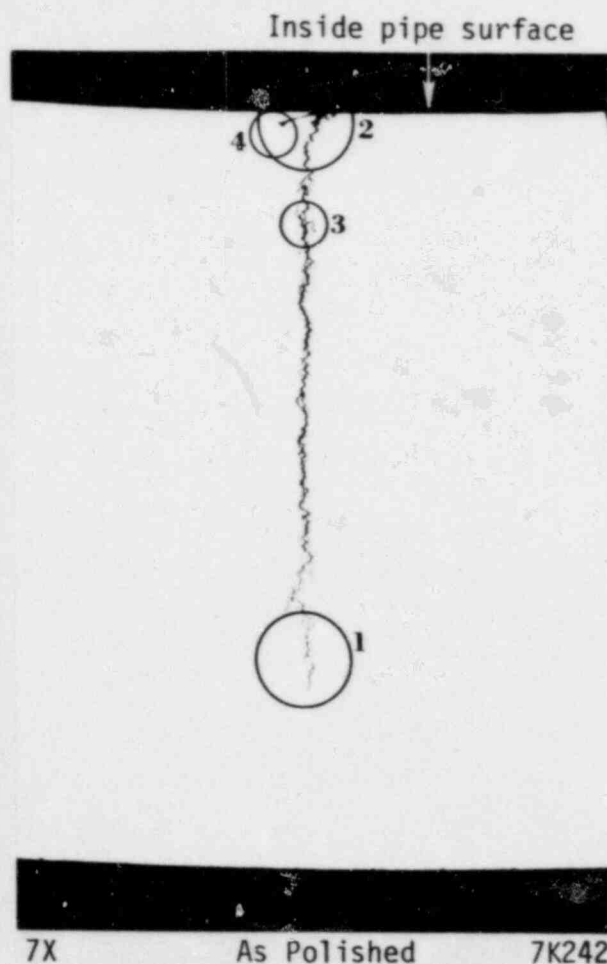
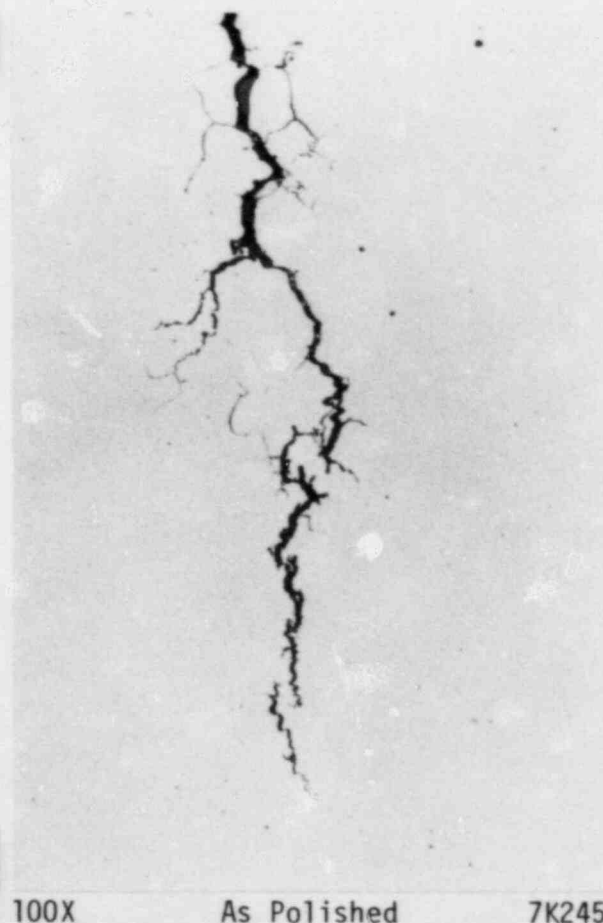
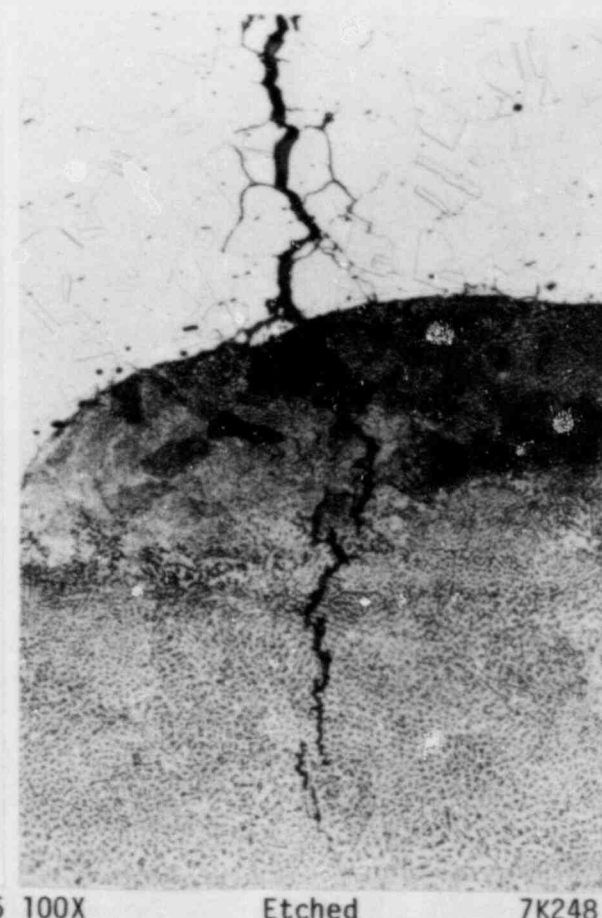
The metallographic cross section of the linear defect is shown in the as-polished condition in Figure 5a. The cross section revealed the presence of a crack that was perpendicular to the surface of the pipe. The crack extended from a location about 0.010 inch below the inside pipe surface for a distance through the pipe wall of about 0.41 inch. The wall thickness of the pipe at that cross section was about 0.53 inch; thus, the crack extended through approximately 77 percent of the pipe wall. As is shown in Figure 5c, the crack propagated into weld metal for a distance of about 0.027 inch and then terminated. In the weld heat-affected zone, crack propagation occurred entirely along the boundaries of equiaxed austenite grains; in the fusion zone, the crack continued to propagate along the austenite grain boundaries of the weld metal. Intergranular branching cracks were numerous along the entire length of the crack, although fewer branching cracks were observed within the weld metal. It appeared as though crack propagation may have been arrested by the weld metal.

a. Crack in the Pipe Wall

b. Circled Area 1 in (a) at a Higher Magnification

c. Same Field as (b) After Etching Electrolytically in 10% Oxalic Acid

FIGURE 5. CRACK OBSERVED IN THE CROSS SECTION THROUGH THE LINEAR SURFACE DEFECT MARKED BY ARROW 1 IN FIGURE 3

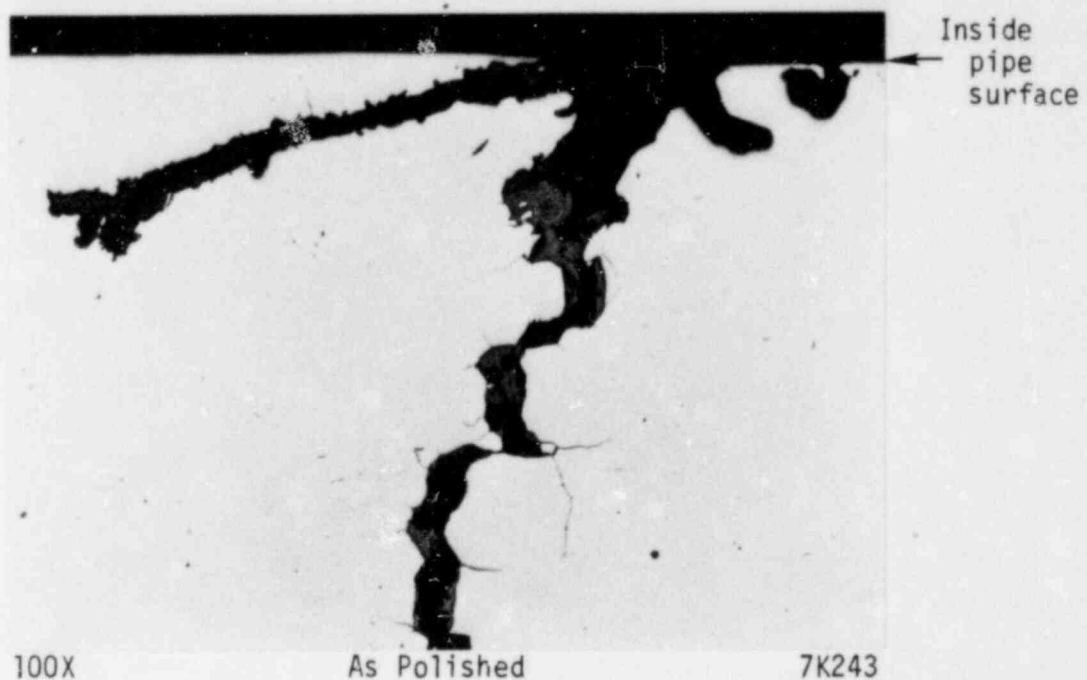
The as-polished appearance of the linear defect in the inside surface of the pipe in this cross section is shown in Figure 6, which is Circled Area 2 in Figure 5a at a higher magnification. The surface defect

FIGURE 6. CROSS SECTION OF THE LINEAR DEFECT
WITHIN CIRCLED AREA 2 IN FIGURE 5a

at which the crack initiated seemed to extend to a depth of about 0.010 inch below the surface and did not appear to be an intergranular crack. Rather than exhibiting characteristics of an intergranular crack, the defect exhibited characteristics similar to those generally observed for seams or laps in billet surfaces. For example, an apparent overlap, or fold, of surface metal that contained what appears to be oxide at the interface is evident in Figure 6 to the left of the part that showed on the pipe surface. The start of intergranular cracking was apparent only at a depth of about 0.010 inch (the depth of the lap and associated pit) below the surface.

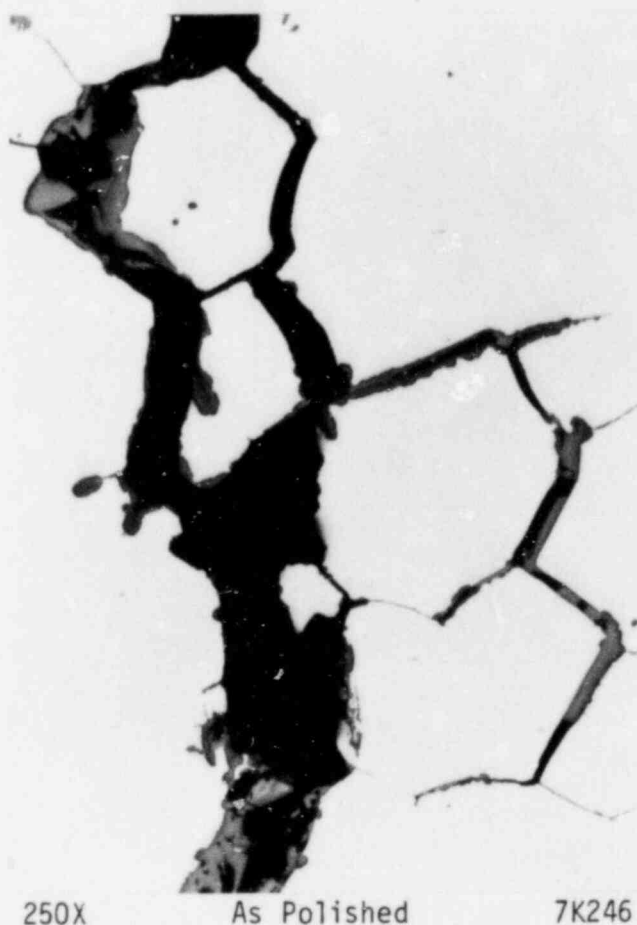
A typical region of the intergranular crack is shown in Figure 7. That region is within Circled Area 3 in Figure 5a. A dense nonmetallic corrosion product that can be seen in Figure 7 was observed on the principal crack surfaces and in adjacent grain boundaries where crack branching

FIGURE 7. TYPICAL REGION OF THE INTERGRANULAR CRACK THAT WAS LOCATED WITHIN CIRCLED AREA 3 IN FIGURE 5a

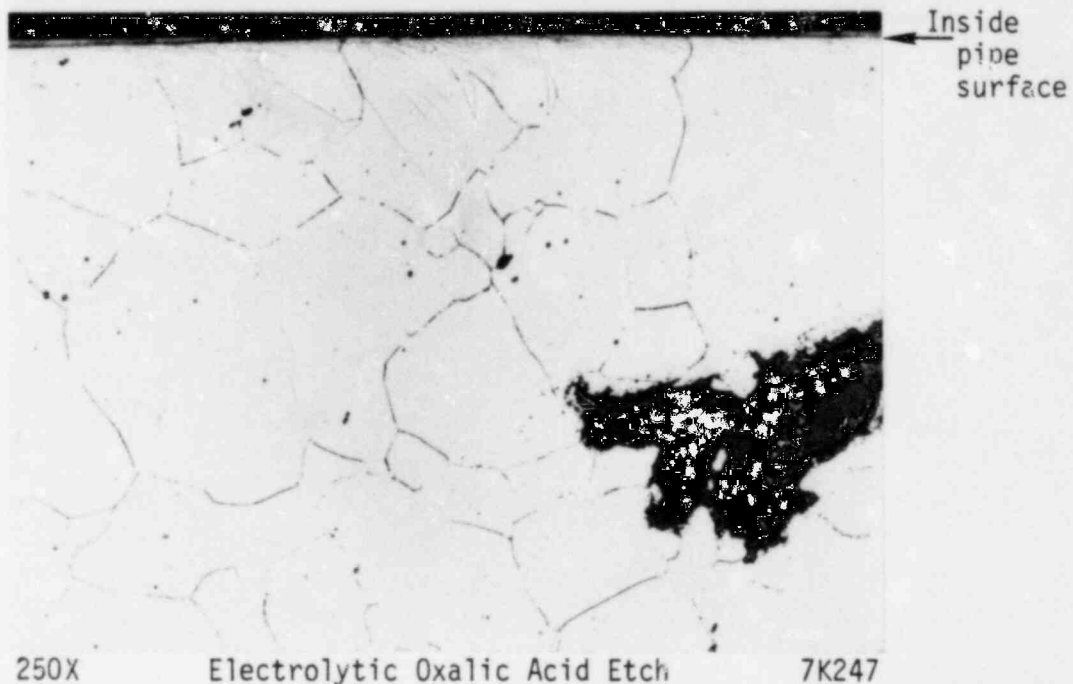
Sensitization was revealed in the cross section through the defect by electrolytic etching using an electrolyte that consisted of 10 percent by weight of oxalic acid in water. (This is an etch commonly used to reveal a sensitized microstructure in stainless steels.) Evidence of sensitization, the presence of fine carbide precipitates in the austenite grain boundaries, is presented in Figure 8. The area shown in Figure 8 was located within Circled Area 4 in Figure 5a. The presence of sensitized material was

FIGURE 8. SENSITIZATION (CARBIDE PRECIPITATE IN THE GRAIN BOUNDARIES) OBSERVED IN THE REGION OF THE LINEAR SURFACE DEFECT

revealed clearly by the etch to a depth of about 0.20 inch below the inside surface of the pipe. Beyond that depth, evidence of sensitization was observed in random grain boundaries.

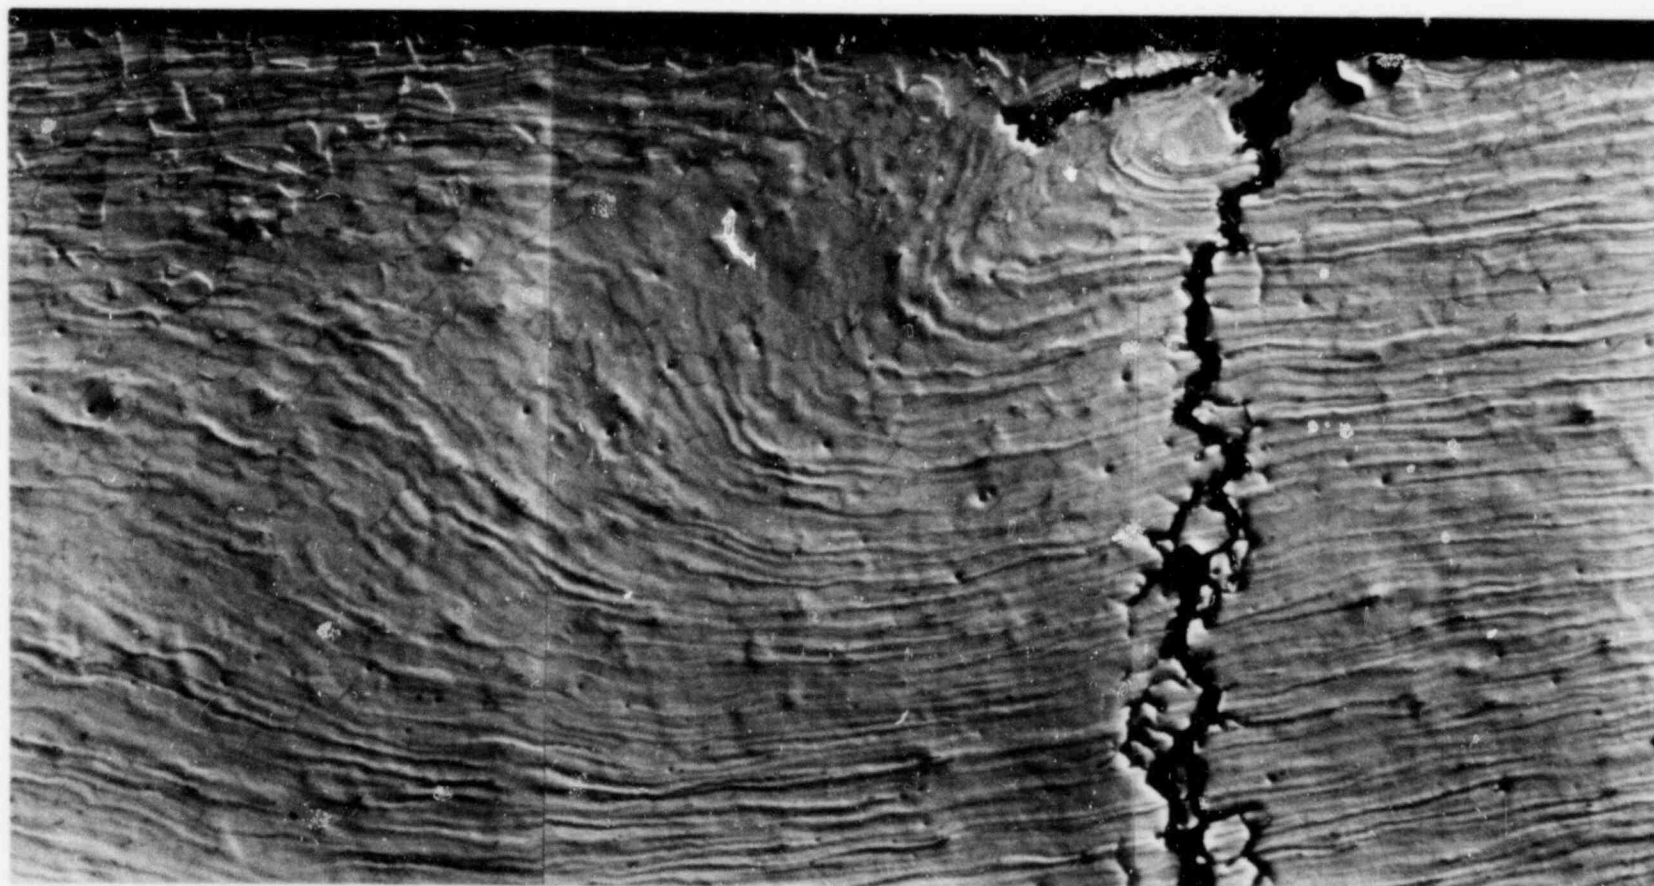
The coring pattern in Figure 9 shows that an interruption of the normal flow of metal occurred around the linear defect in the surface of the pipe during fabrication. The flow pattern around the linear defect was similar to that sometimes observed around seams or laps in billet surfaces. However, inasmuch as the linear defect was on the inside surface of seamless pipe, the origin of the linear defect must have been associated with the piercing or other operation in the process of producing the seamless pipe.

Note in Figure 9 that the cored regions were independent of the grains and the grain boundaries and that the coring had no noticeable effect on the initiation or propagation of the crack.

FIGURE 9. CORING THAT REVEALS THE FLOW PATTERN OF METAL AROUND THE LINEAR SURFACE DEFECT

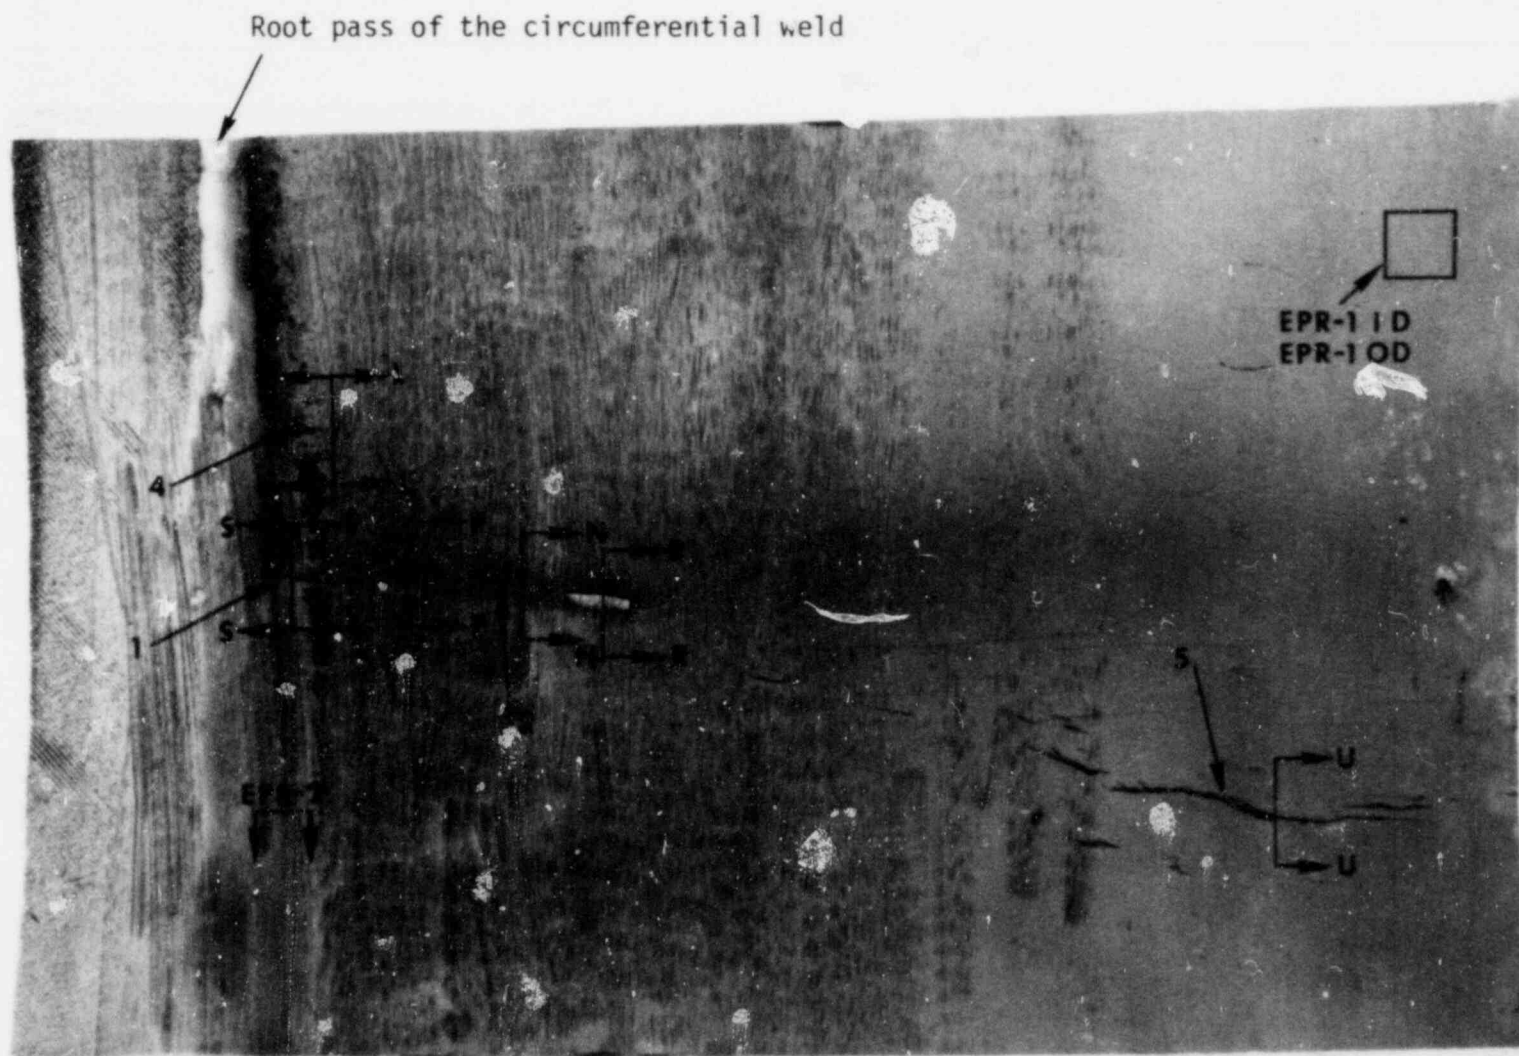
The photograph in Figure 1 shows the portion of the inside surface of the Schedule 80 pipe and the surface flaws that were observed during the previous investigation. (This photograph appeared as Figure 3 in the BCL report of the previous investigation and, also, as Figure 1 in BCL's proposal for this present investigation.) The surface flaws that were selected for further studies are identified in Figure 1 by the arrows numbered 1, 2, 4 and 5. Those flaws, as numbered, conform to the manner in which those flaws were identified in BCL's proposal for this investigation. The feature identified by the arrow that was numbered 3 in that proposal is actually a part of Flaw No. 2 and is now identified as Section R-R of Flaw No. 2 in Figure 1.

Metallographic cross sections through each of the four selected flaws and perpendicular to them, as shown in Figure 1, were prepared for microscopic examinations. The resulting metallographic specimens were identified as Specimen 1-S-S for Section S-S of Flaw No. 1, Specimen 1-T-T for

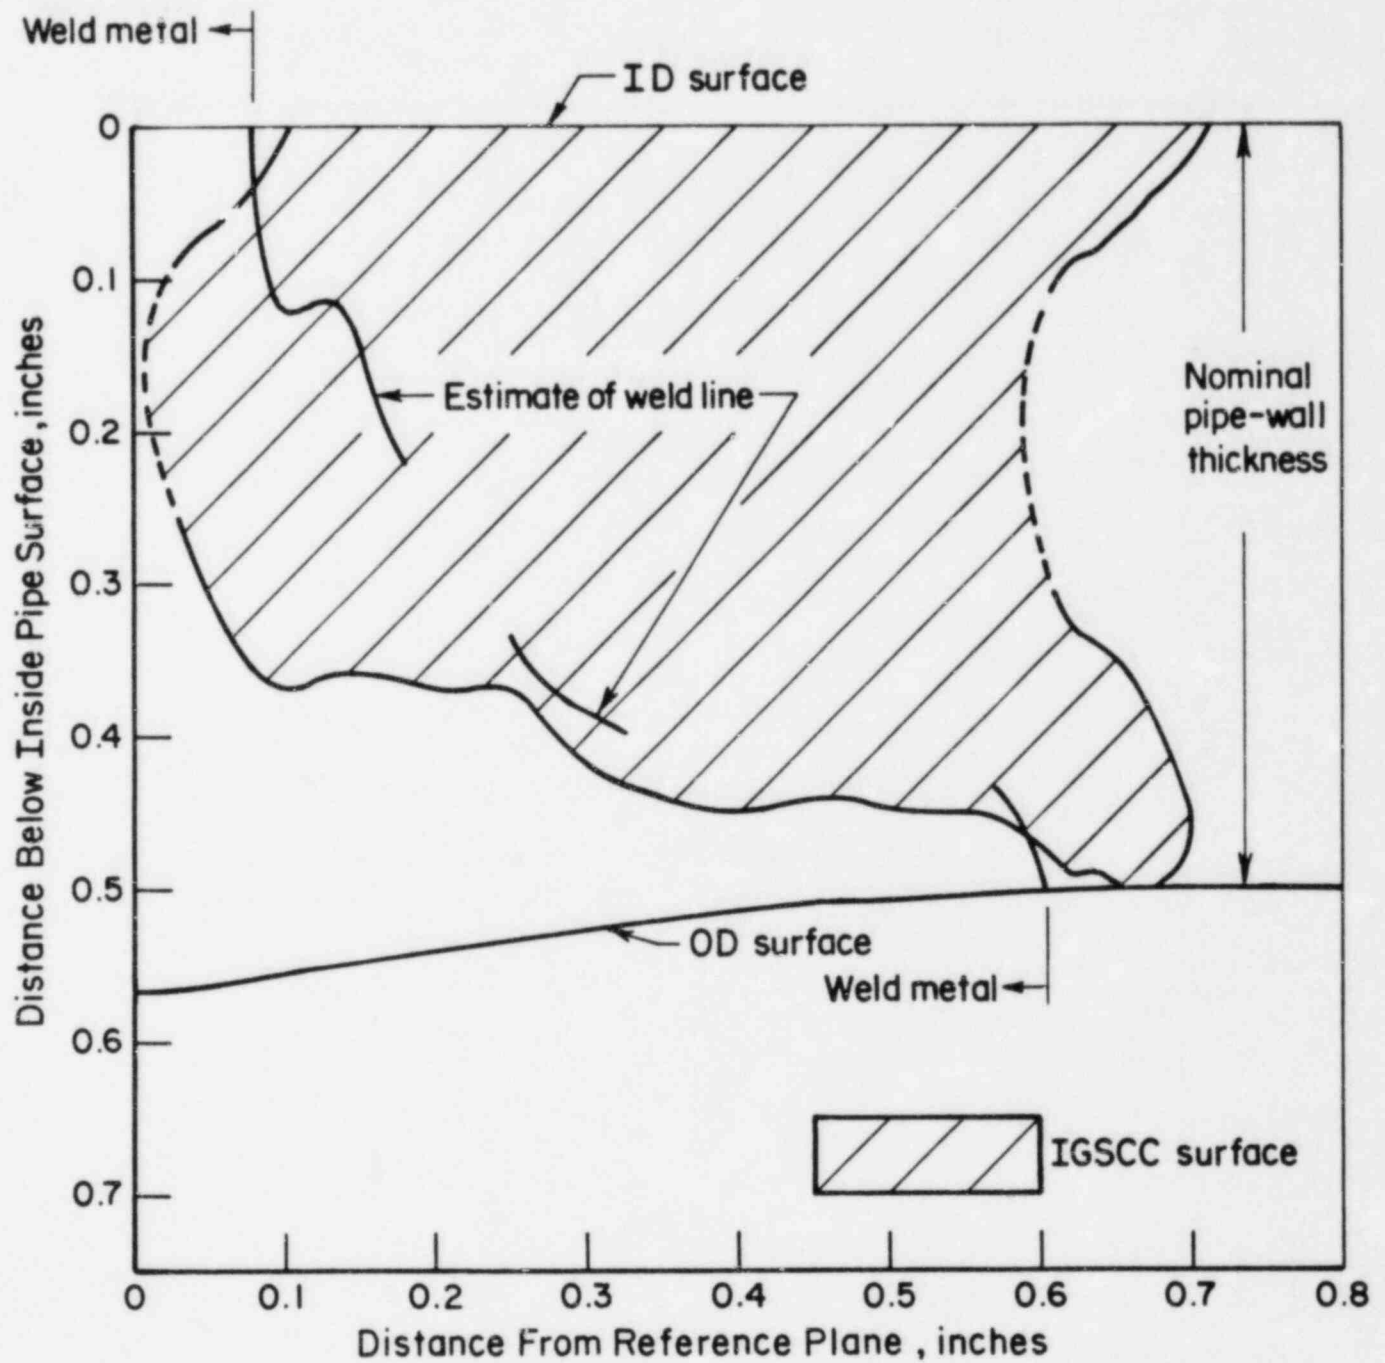
FIGURE 2. PROFILE OF INTERGRANULAR STRESS-CORROSION CRACK AT FLAW NO. 1

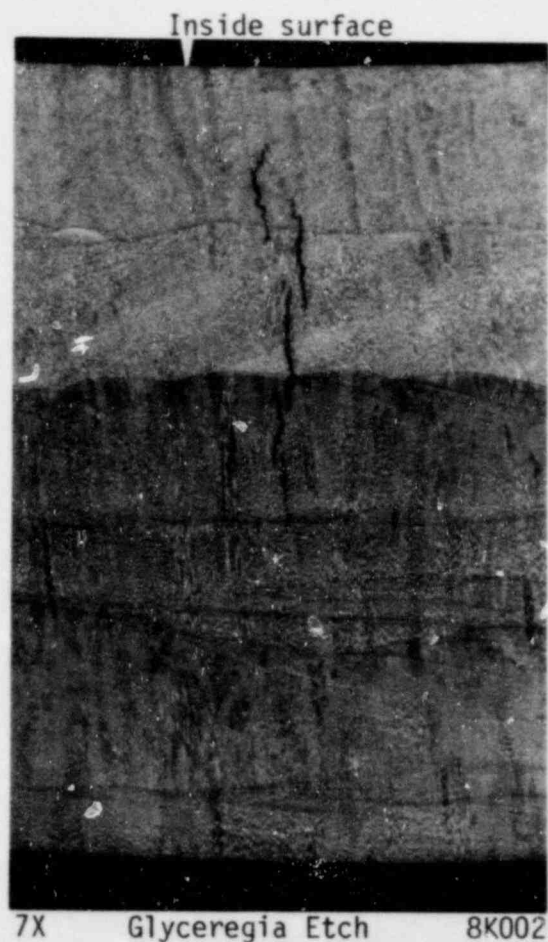
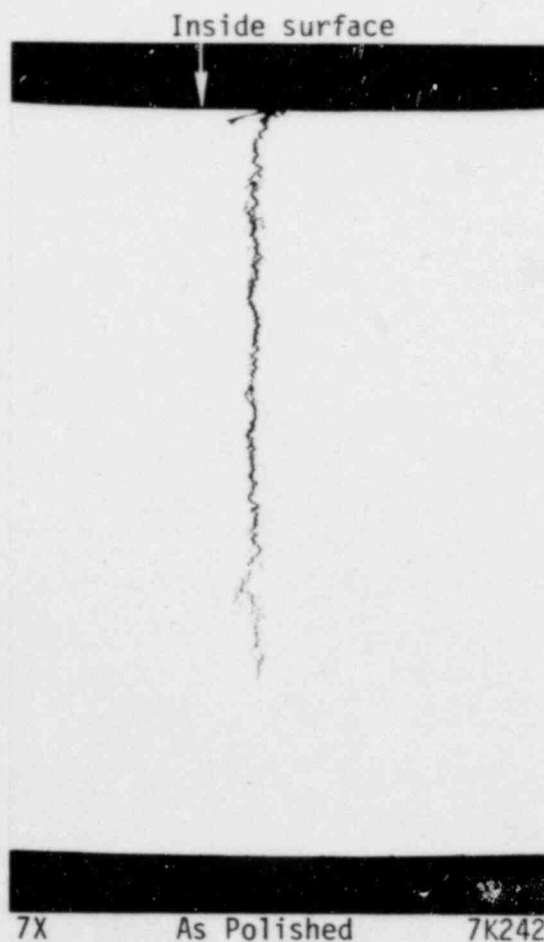
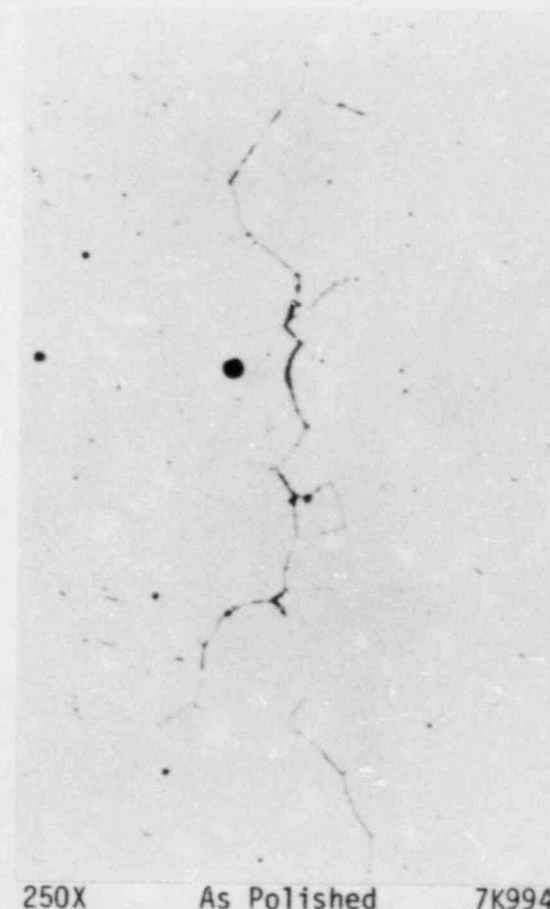
a. IGSCC at the 0.060-Inch Position

b. IGSCC at the 0.290-Inch Position

c. IGSCC Near the Outside Surface of the Pipe at the 0.70-Inch Position

FIGURE 3. THE IGSCC ASSOCIATED WITH FLAW NO. 1 AT SEVERAL LOCATIONS ALONG THE LENGTH OF THE CRACK

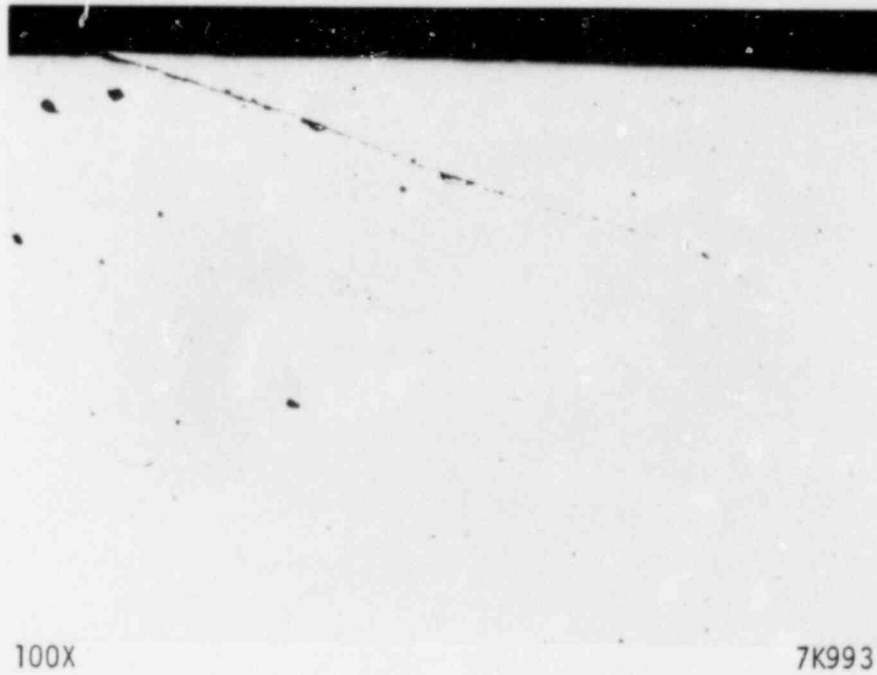
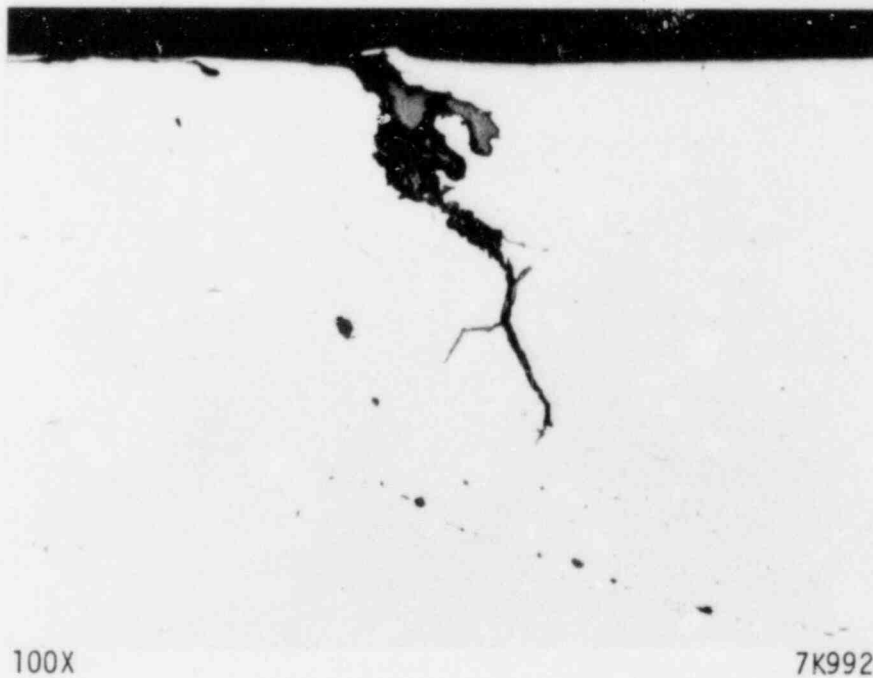
The appearance of the surface flaw at the 0.70-inch position is revealed in Figure 4. The flaw exhibited two surface imperfections that were approximately 0.1 inch apart; those two imperfections are shown in Figures 4a and 4b respectively. A little IGSCC was still evident at the flaw shown in Figure 4b.

a. Surface Imperfection Located About 0.1 Inch from the Imperfection Shown in (b) Below

b. Surface Imperfection and Some IGSCC at the 0.70-Inch Position

FIGURE 4. FLAW NO. 1 NEAR THE END OF THE IGSCC FARTEST FROM THE WELD

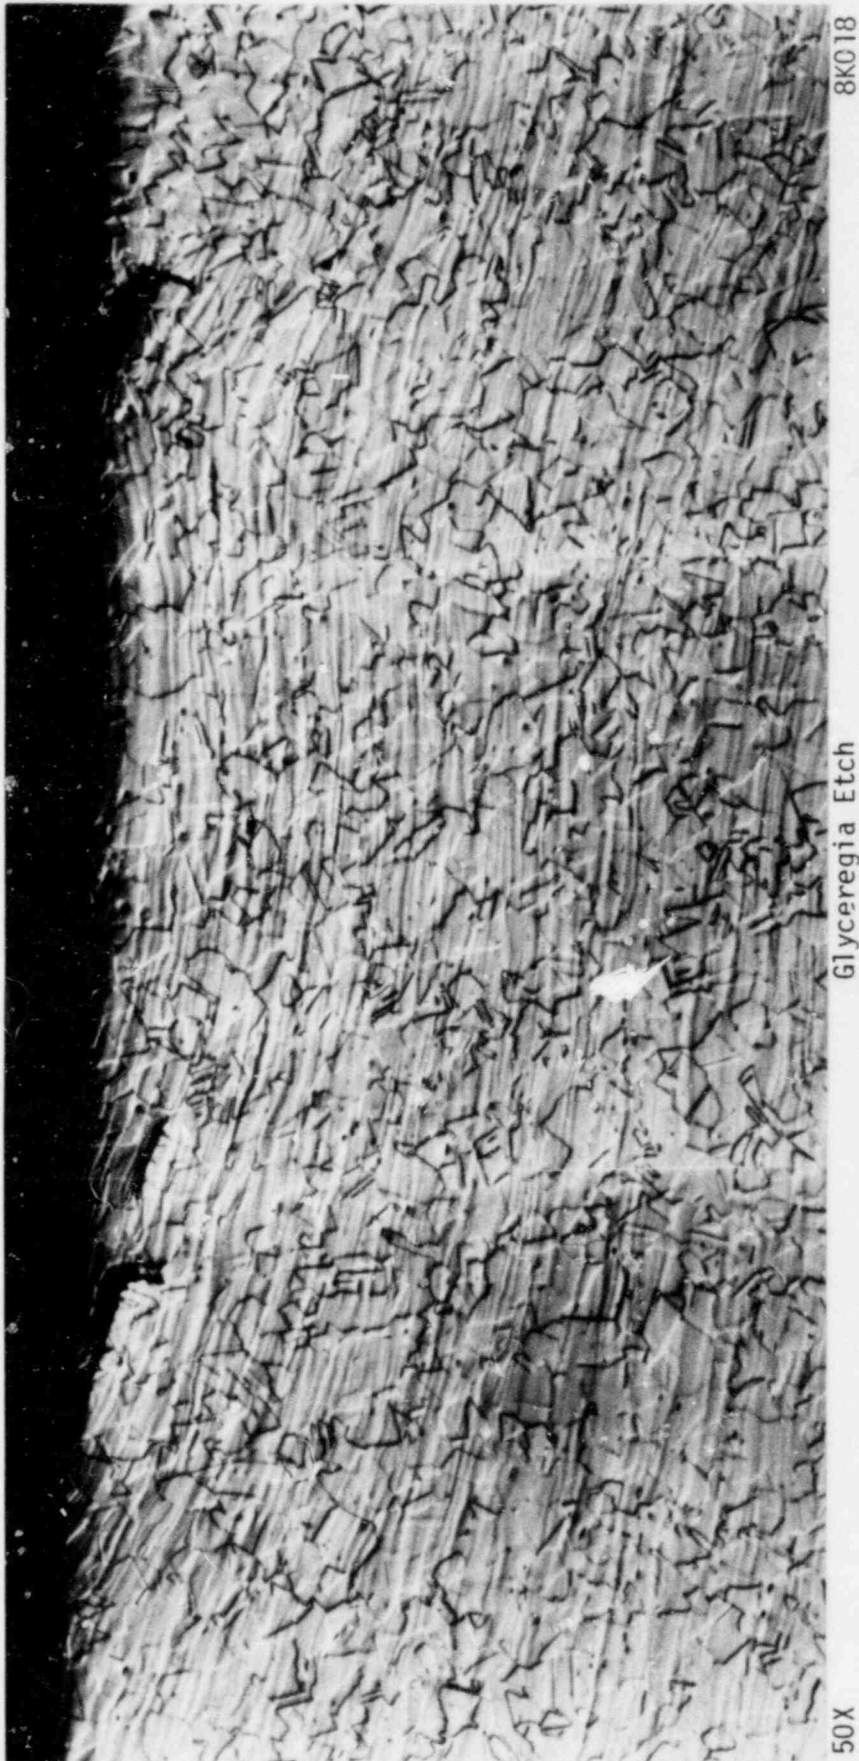
The flow pattern of the metal that developed around the flaw during the fabrication of the pipe was revealed by etching metallographically polished specimens, as is shown in Figure 5 at a magnification of 50X. At

FIGURE 5. THE FLOW PATTERN OF METAL AROUND FLAW NO. 1 AT THE 0.72-INCH LOCATION IN FIGURE 2

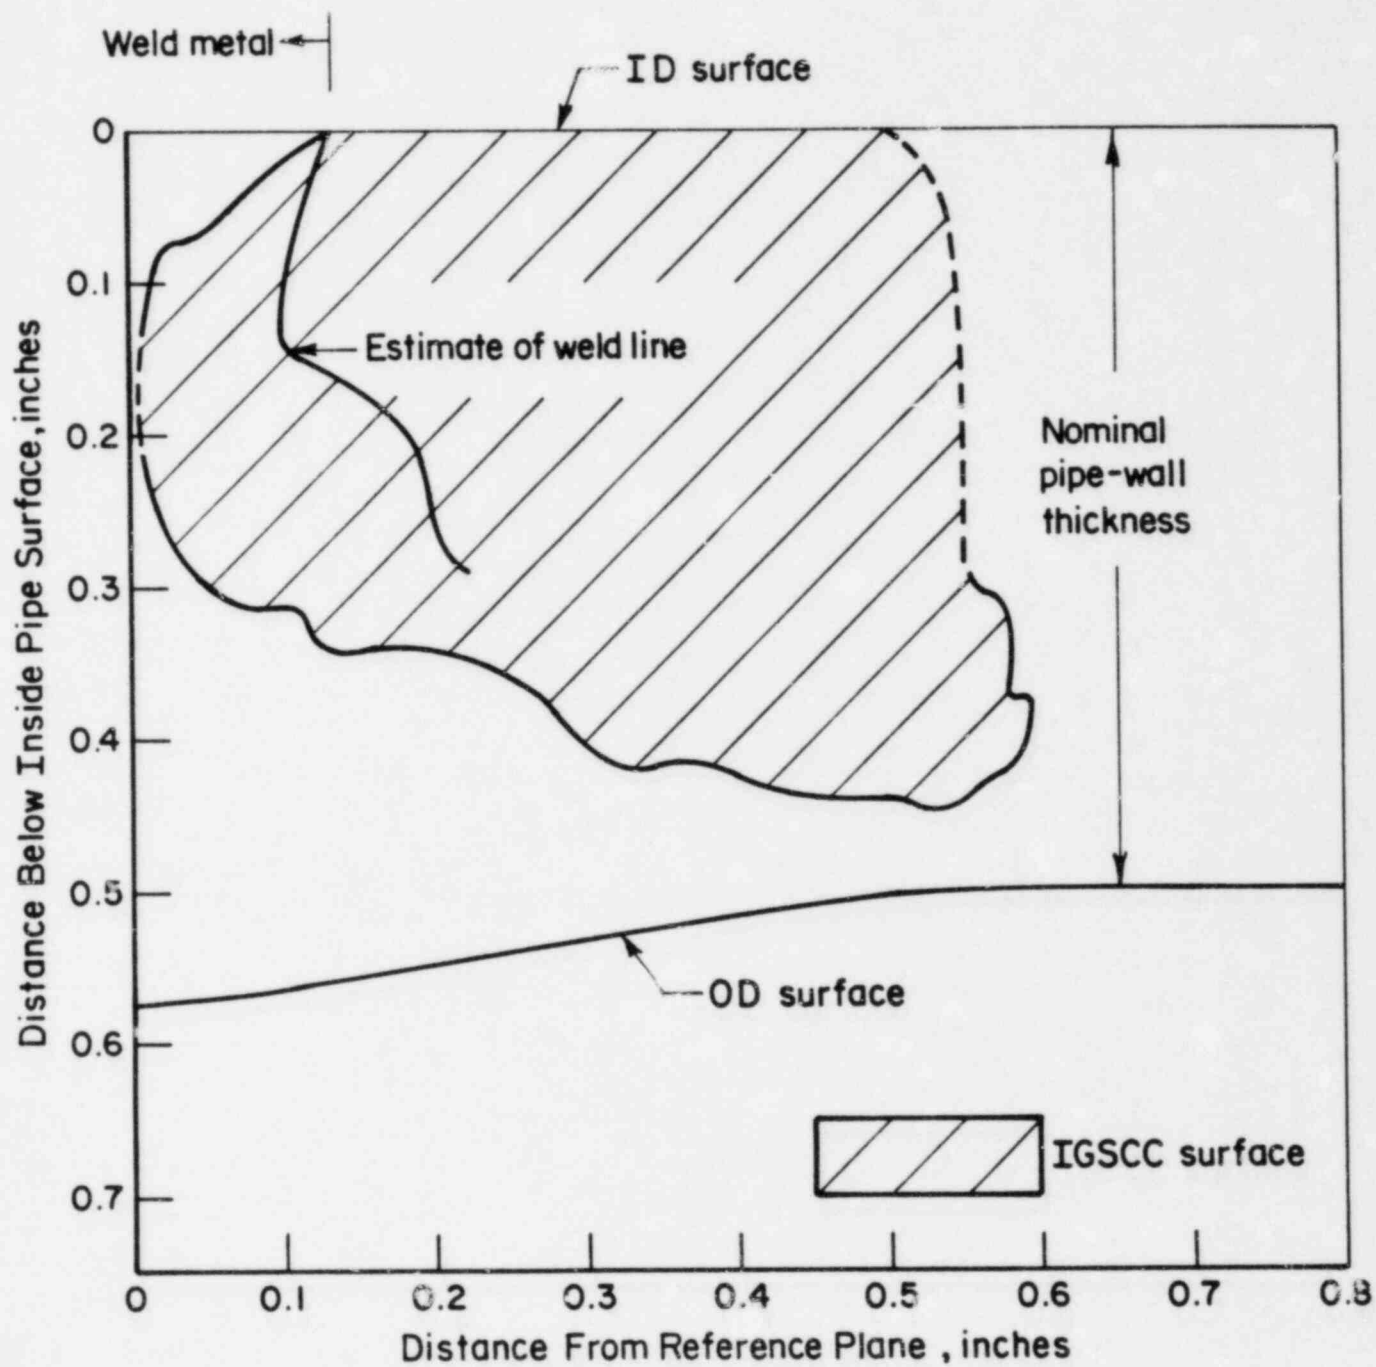
The cross-hatched region in Figure 6 represents the extent of the IGSCC surface. Included in Figure 6 are the approximate locations of the inside and outside pipe surfaces and a portion of the weld line, with respect to the crack. Although the crack-surface area was smaller, the general outline of that area was similar to that of the IGSCC at Flaw No. 1 (compare Figures 2 and 6). Also, arrest of the crack propagation in the through-wall direction again apparently occurred in weld metal.

FIGURE 6. PROFILE OF INTERGRANULAR STRESS-CORROSION CRACK AT FLAW NO. 4

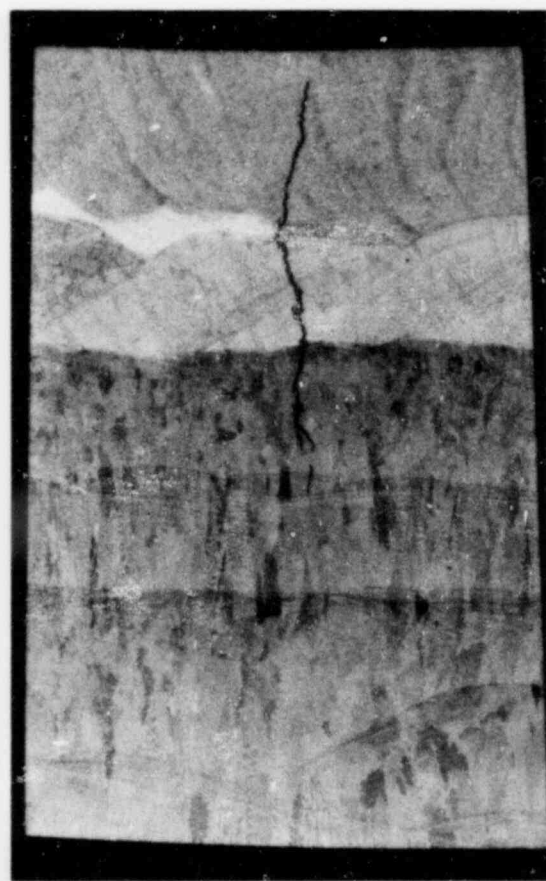
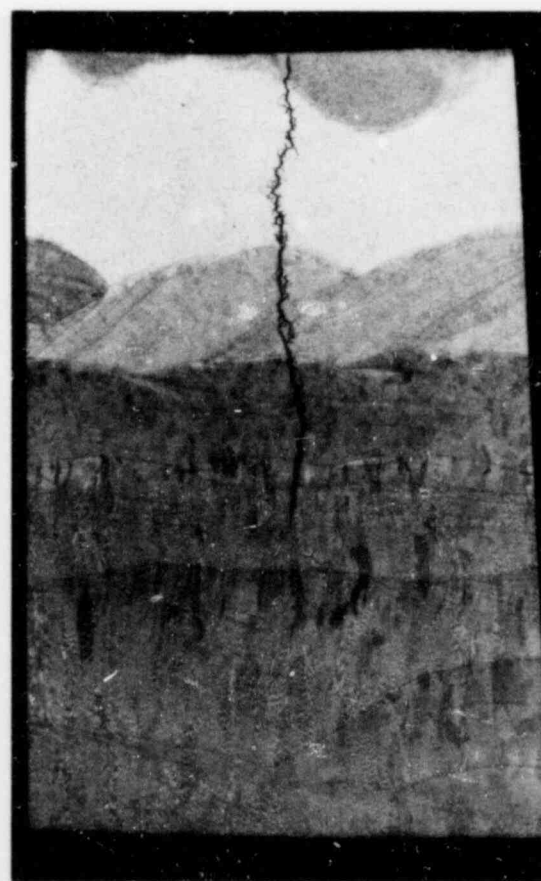
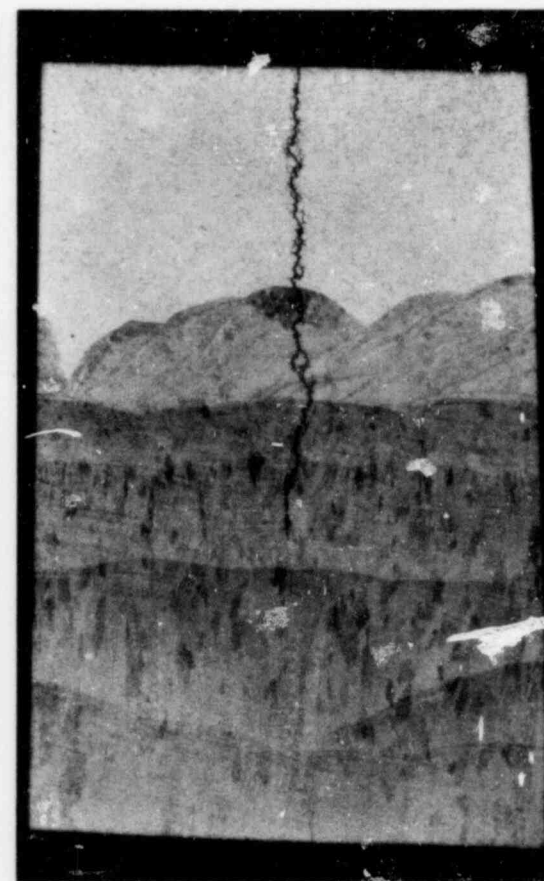
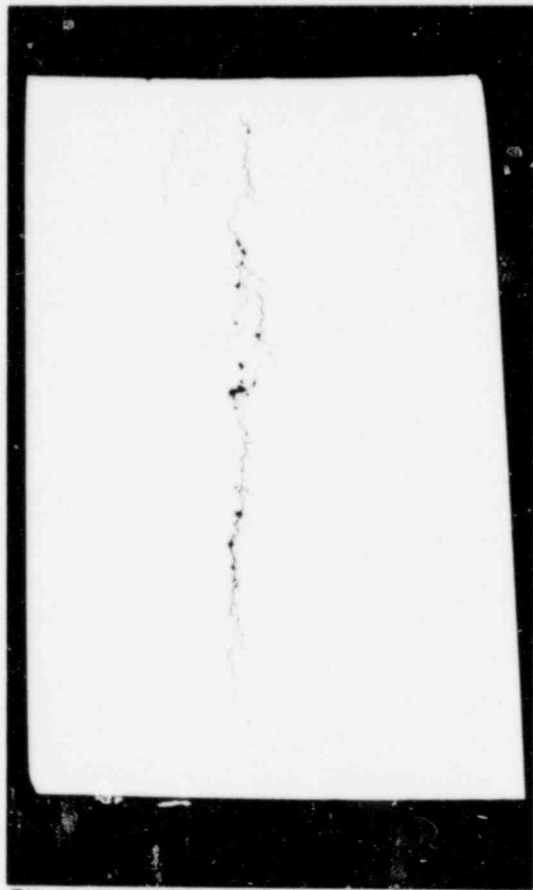
Figure 7 shows the appearance of the IGSCC at a few locations along its length. Figure 7a exhibits the crack at the 0.10-inch position. At that location, the crack was subsurface and was entirely within weld metal except for a very small portion near middepth. At the 0.125-inch position (Figure 7b), the crack was slightly beneath the inside surface of the pipe and had begun to

a. IGSCC at the 0.10-Inch Position

b. IGSCC at the 0.125-Inch Position

c. IGSCC at the 0.161-Inch Position

FIGURE 7. THE IGSCC ASSOCIATED WITH FLAW NO. 4 AT SEVERAL LOCATIONS ALONG THE LENGTH OF THE CRACK

d. IGSCC at the 0.517-Inch Position

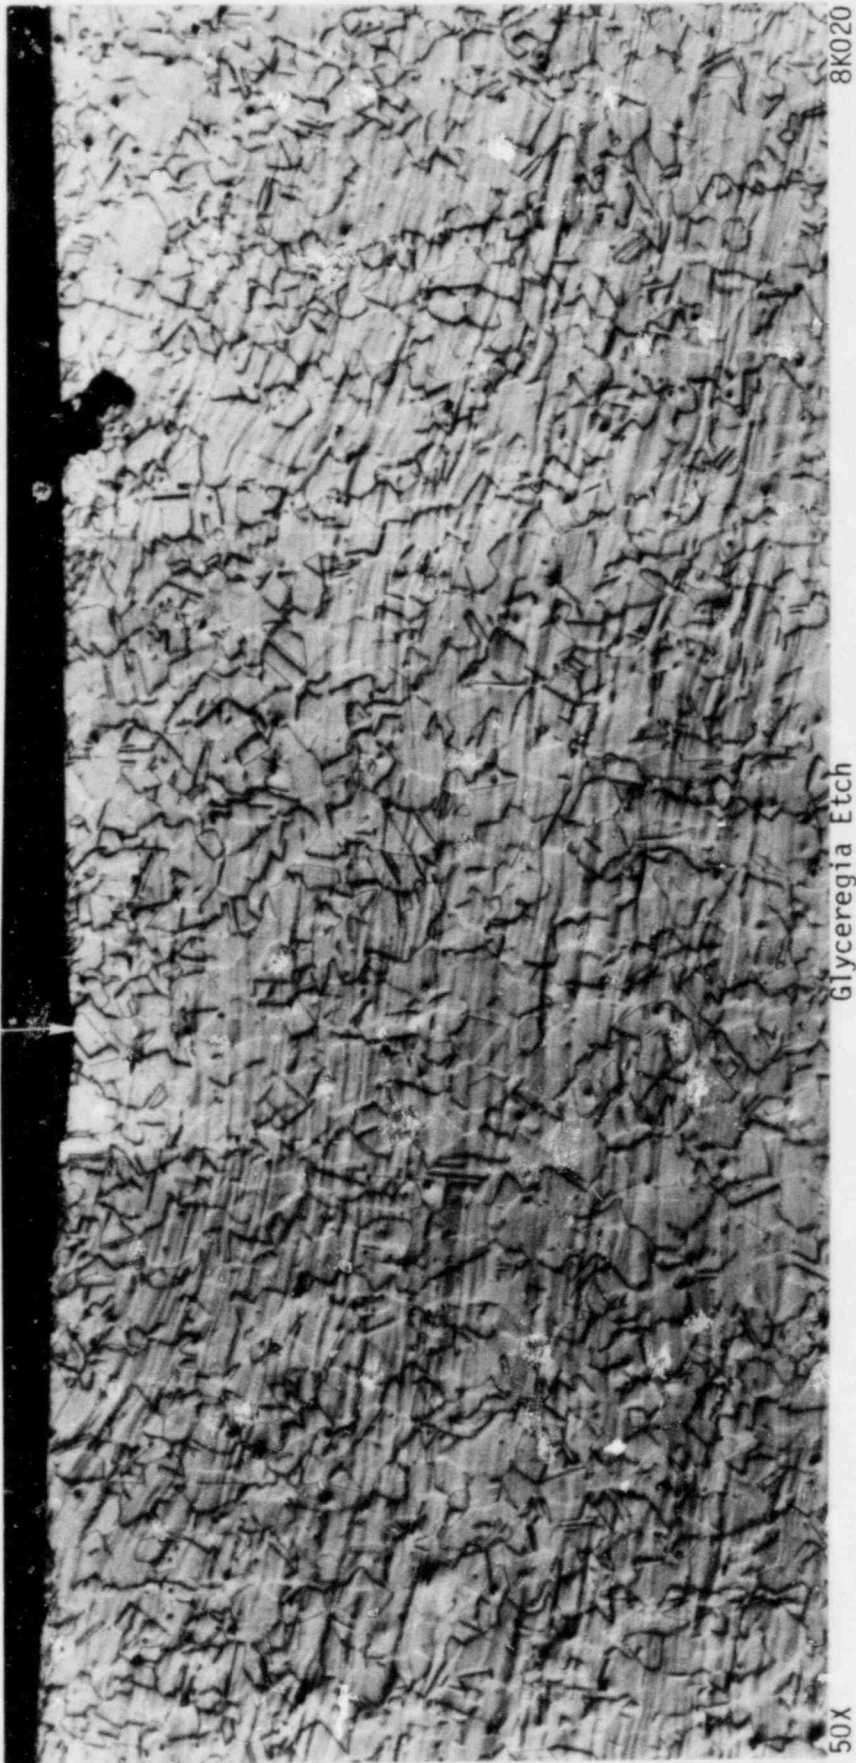
FIGURE 8. THE FLOW PATTERN OF METAL AROUND SURFACE FLAW NO. 2 OBSERVED IN SPECIMEN 2-P-F
