Subject: James A. FitzPatrick Nuclear Power Plant
Docket No. 50-333
Core Spray "A" Metallurgical Analysis

A METALLOGRAPHIC INVESTIGATION OF A
TYPE 304 STAINLESS STEEL SCHEDULE 80 PIPE

AN INVESTIGATION OF FLAWS ON THE
INSIDE SURFACE OF A TYPE 304 STAINLESS
STEEL SCHEDULE 80 PIPE

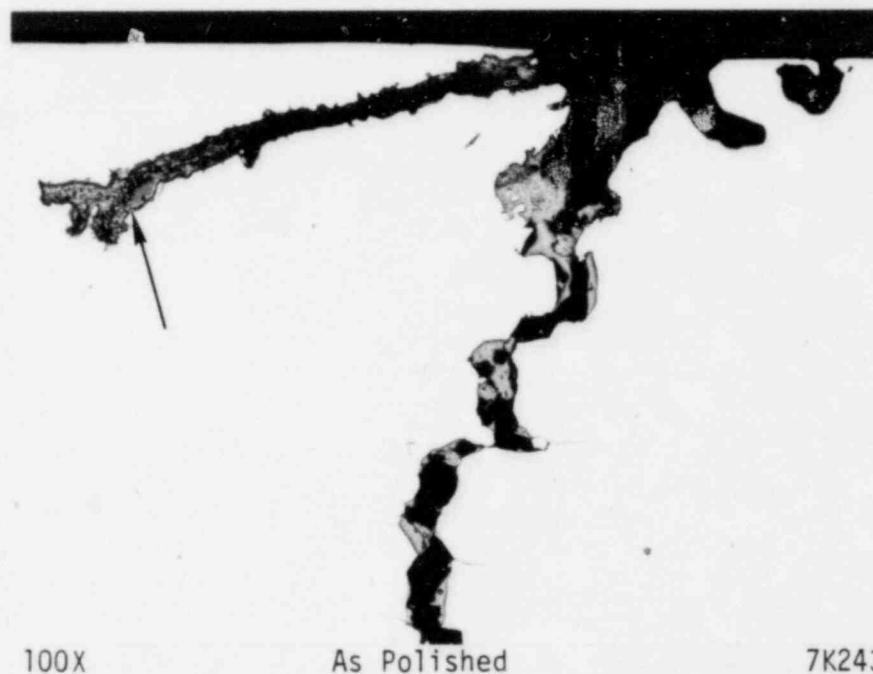
FIGURE 13. CROSS SECTION OF FLAW NO. 1 IN SECTION 1-S-S
The arrow identifies the corrosion products
in Flaw No. 1 (Area 3 in Table 4) that were
subjected to EDAX analyses.

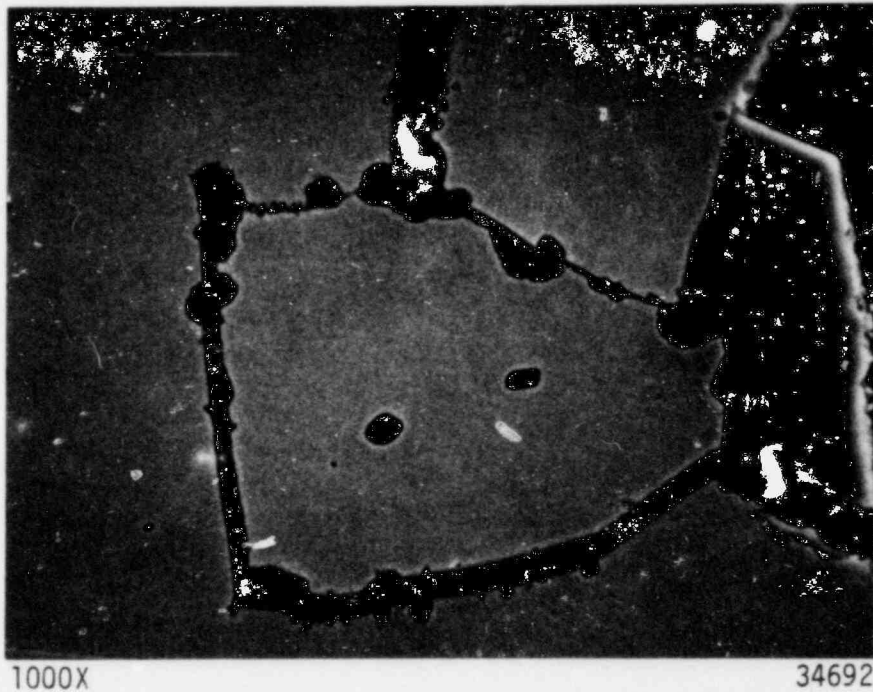
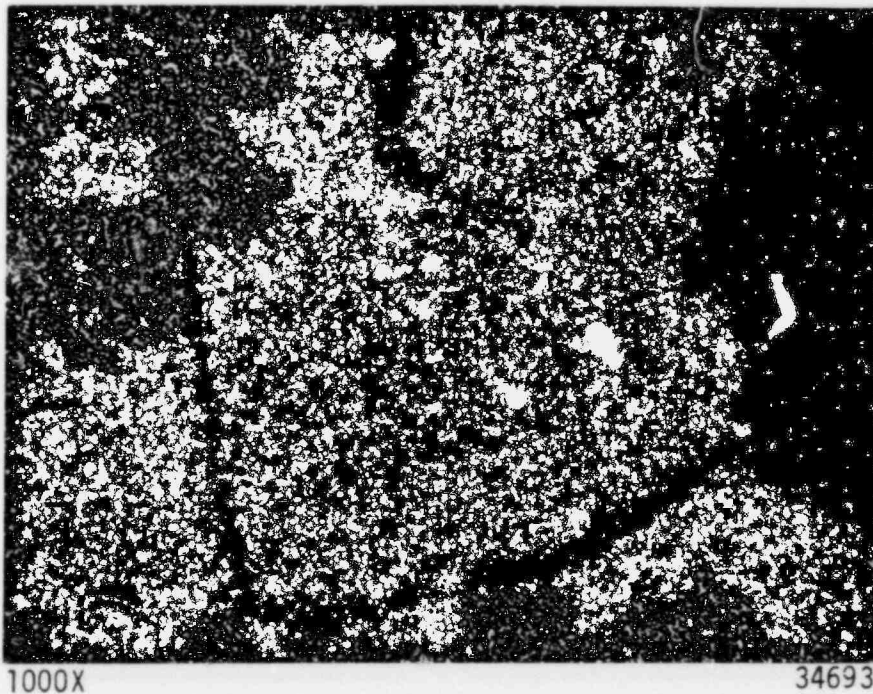
a. Region of the IGSCC Identified As Area 4 in Table 4 (SEM Micrograph)

b. X-ray-Distribution Map of Cr in the Region Shown in (a) Above

FIGURE 15. CORROSION PRODUCTS IN THE IGSCC NEAR THE INSIDE SURFACE OF THE PIPE

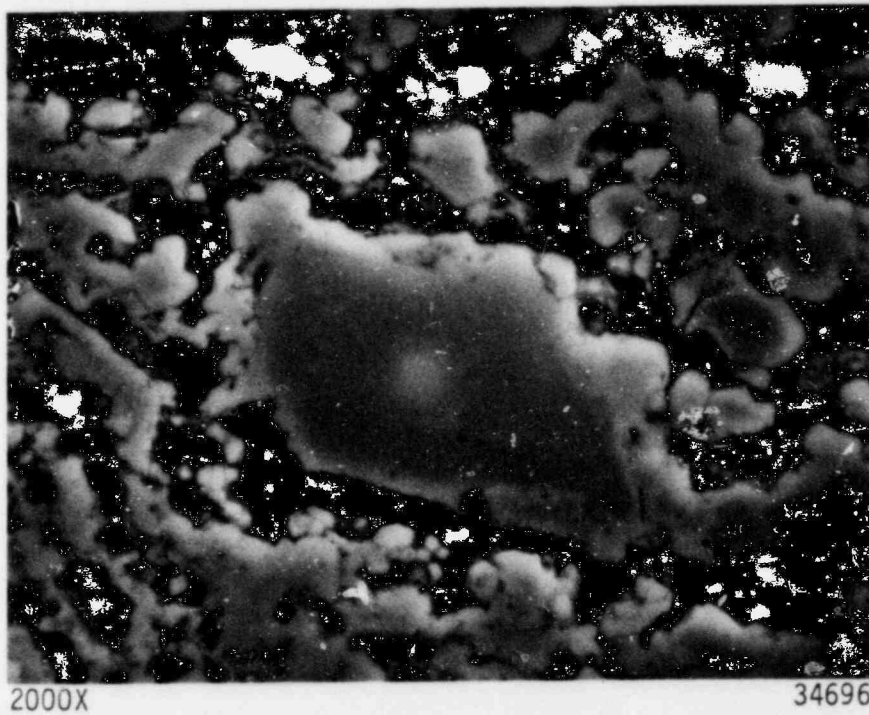
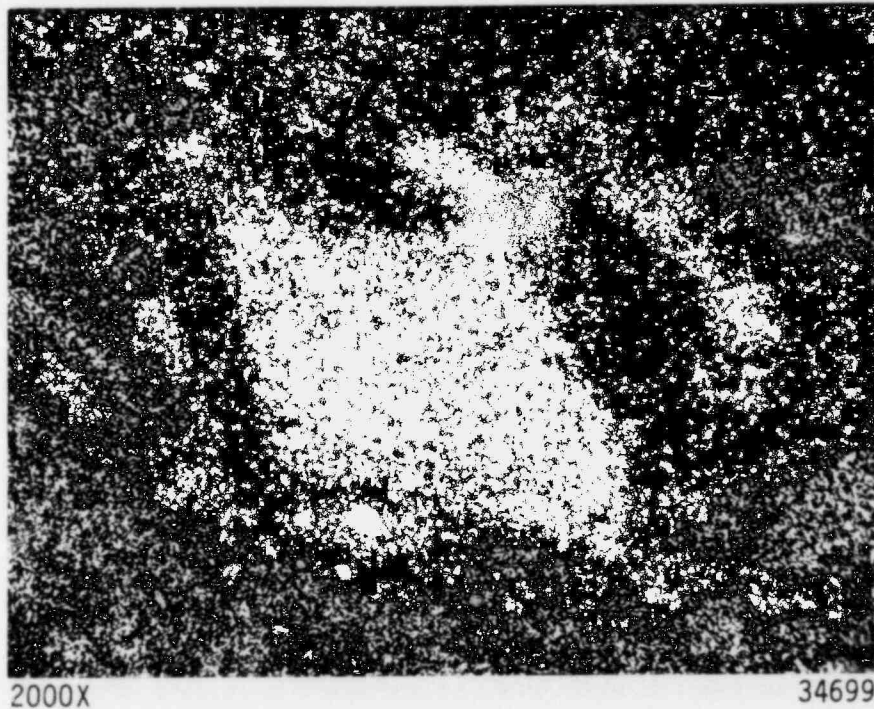
FIGURE 19. CORROSION PRODUCTS IN FLAW NO. 2 THAT WERE
SUBJECTED TO ELECTRON-MICROPROBE ANALYSES

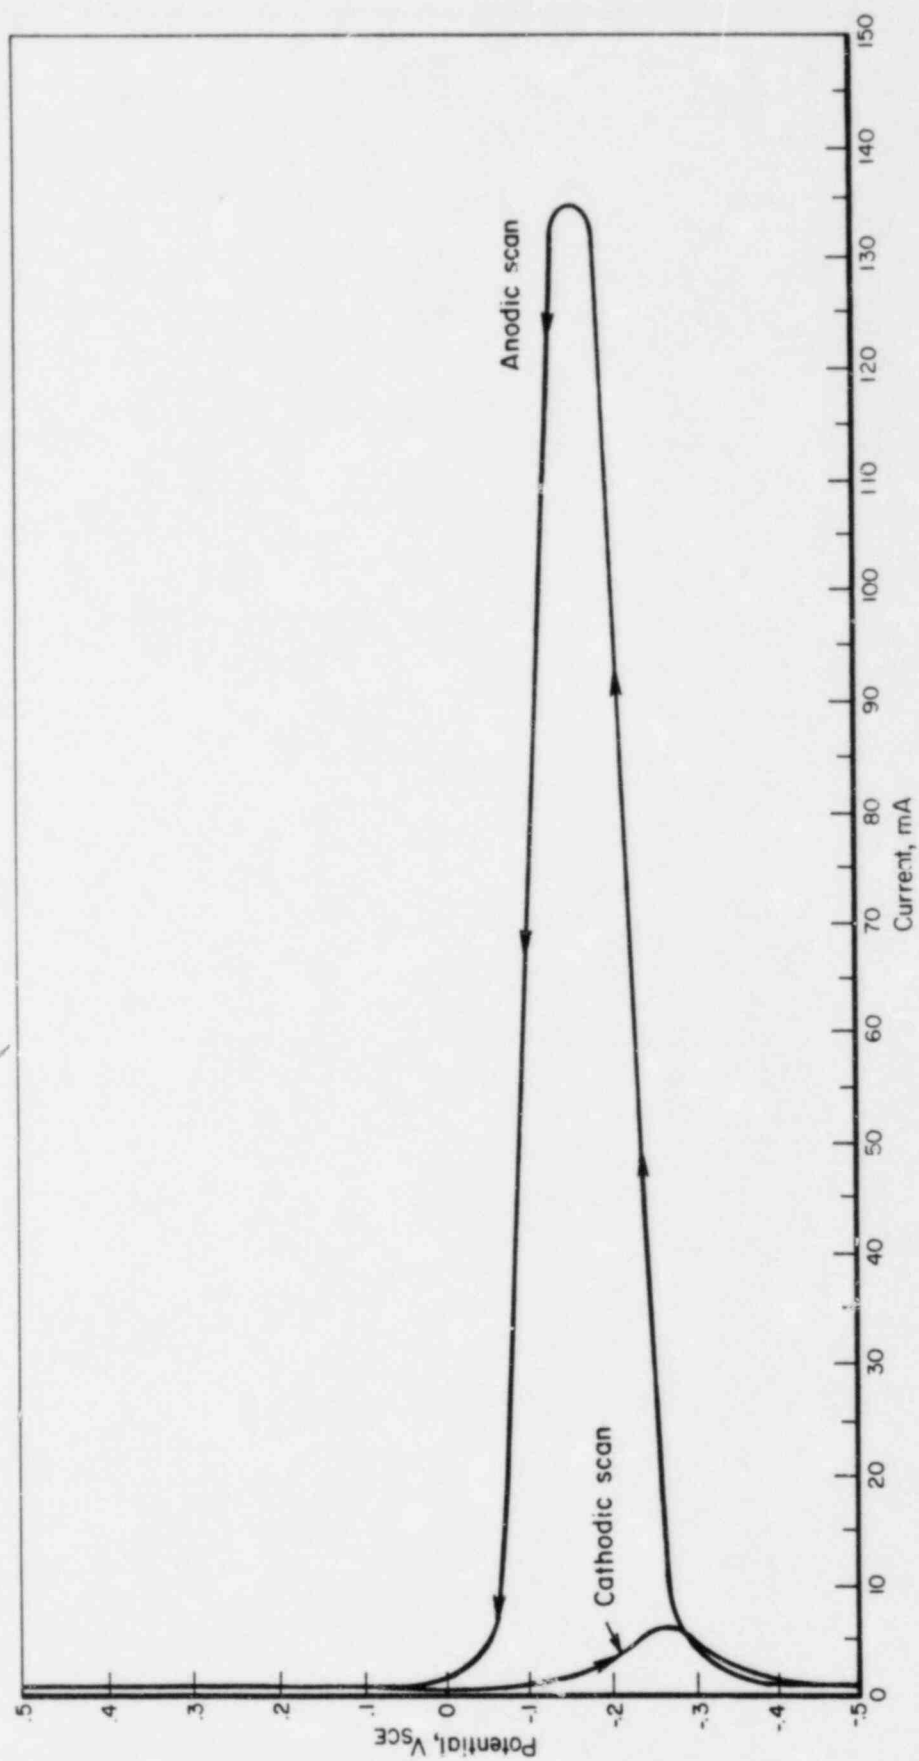
FIGURE 20. EPR CURVES FOR SAMPLE EPR-2 FROM THE WELD HEAT-AFFECTED ZONE

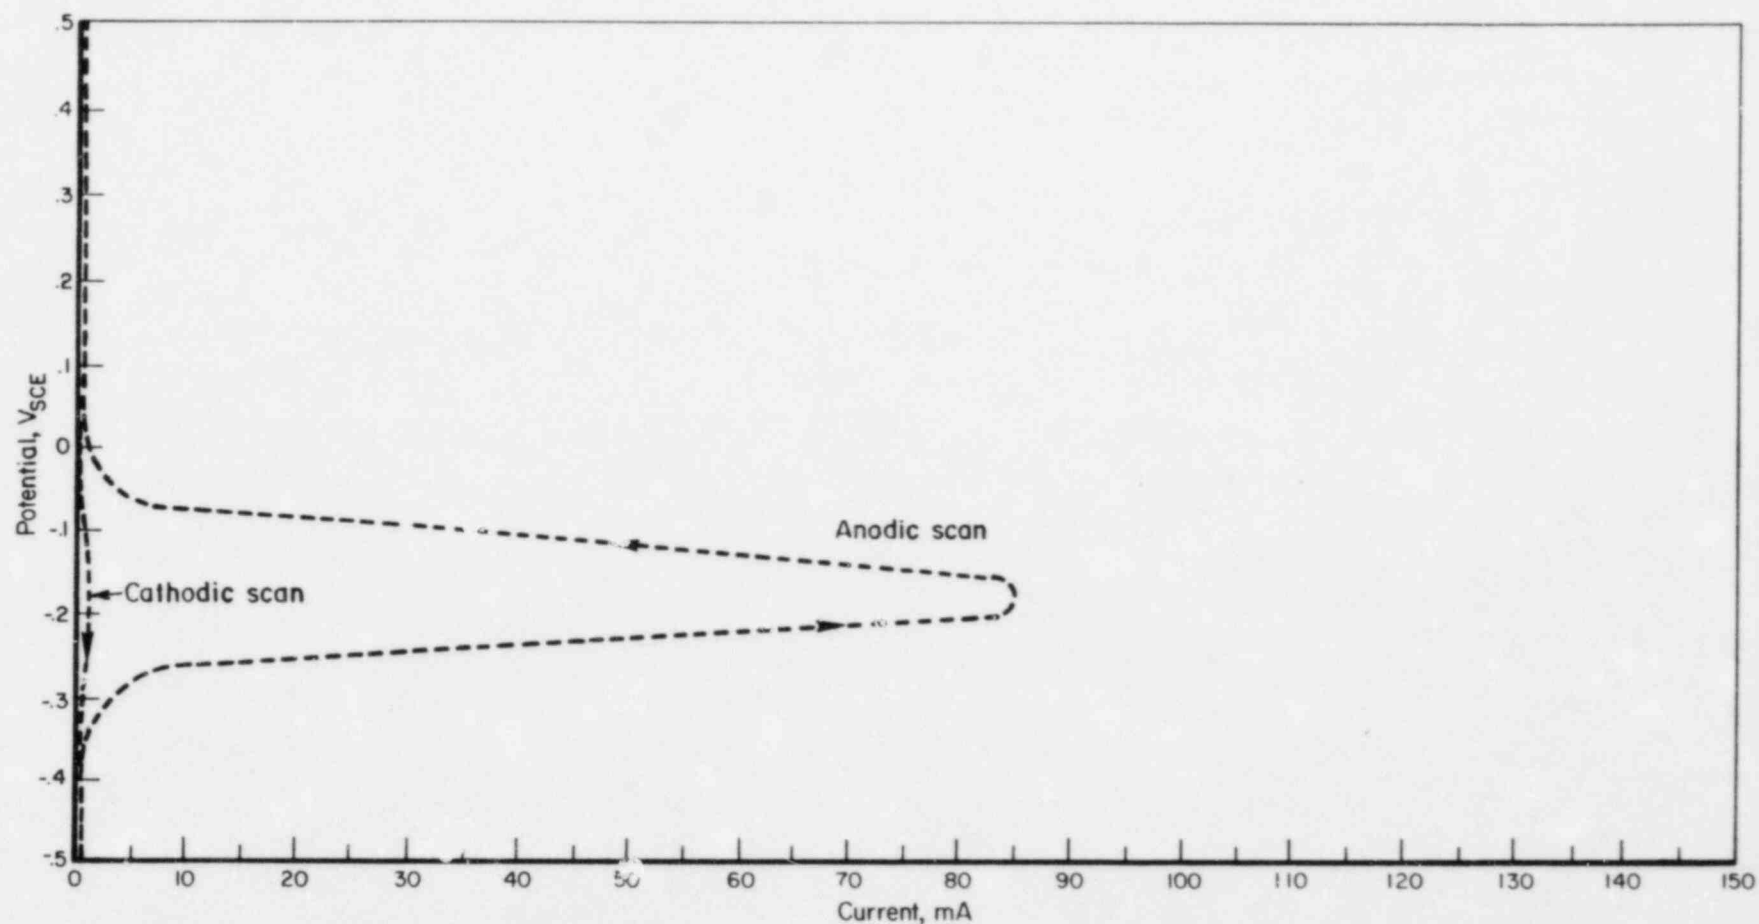
FIGURE 21. EPR CURVES FOR SAMPLES EPR-1 ID AND EPR-1 OD, AISI 304 STAINLESS STEEL PIPE REMOTE FROM THE REGION OF THE WELD
