DIABLO CANYON NUCLEAR PROJECT  
JOB # 7177  
SPEC # 8711

QUALITY ASSURANCE REPORT

Crack in Steam Generator Feedwater  
Nozzle to pipe weld  
(Generator No. 1-2)

THE M.W. KELLOGG CO.  
Avila Beach, Ca.

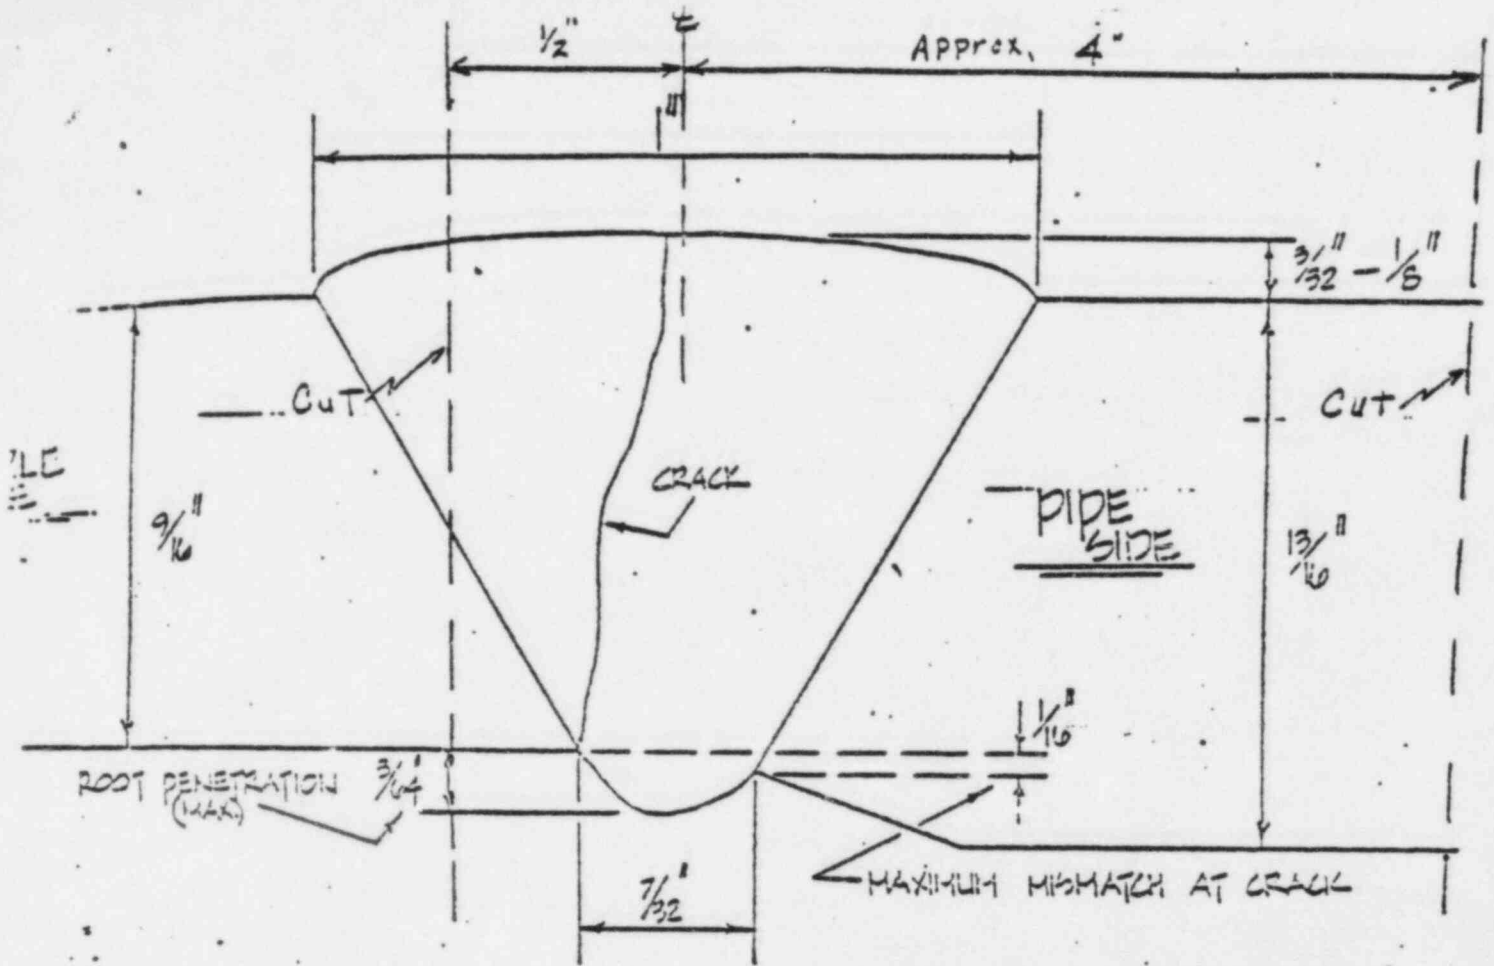
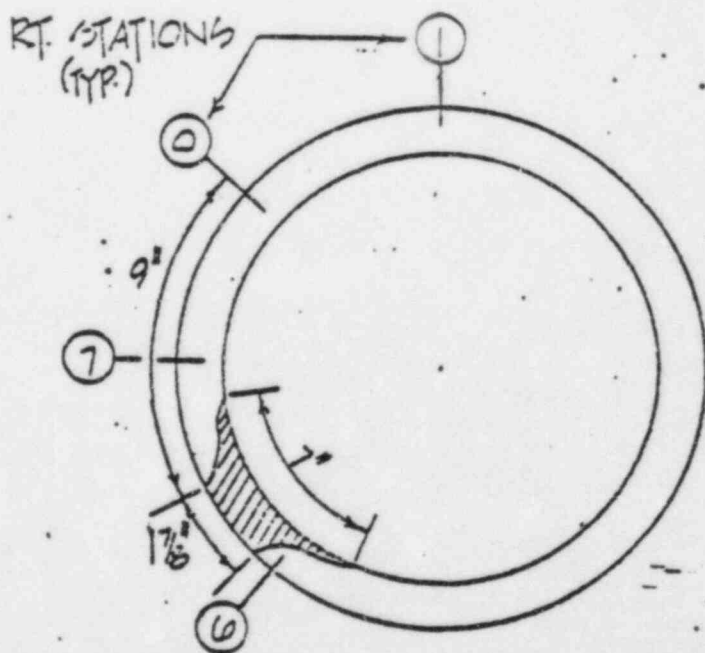
DR 3366 Rev. I  
 ATTACHMENT # 2

The piece was examined visually and by liquid penetrant on the O.D. and I.D. and a sketch made to reflect the observations. (Sketch Attached)

1. WALL THICKNESS MEASR. ARE APPROXIMATE
2. REF. TO DR. 3366 REV. A
3. STEAM GENERATOR 1-2  
 F.W. #212  
 WQ. 500145  
 LINE # KU-555-16 IV

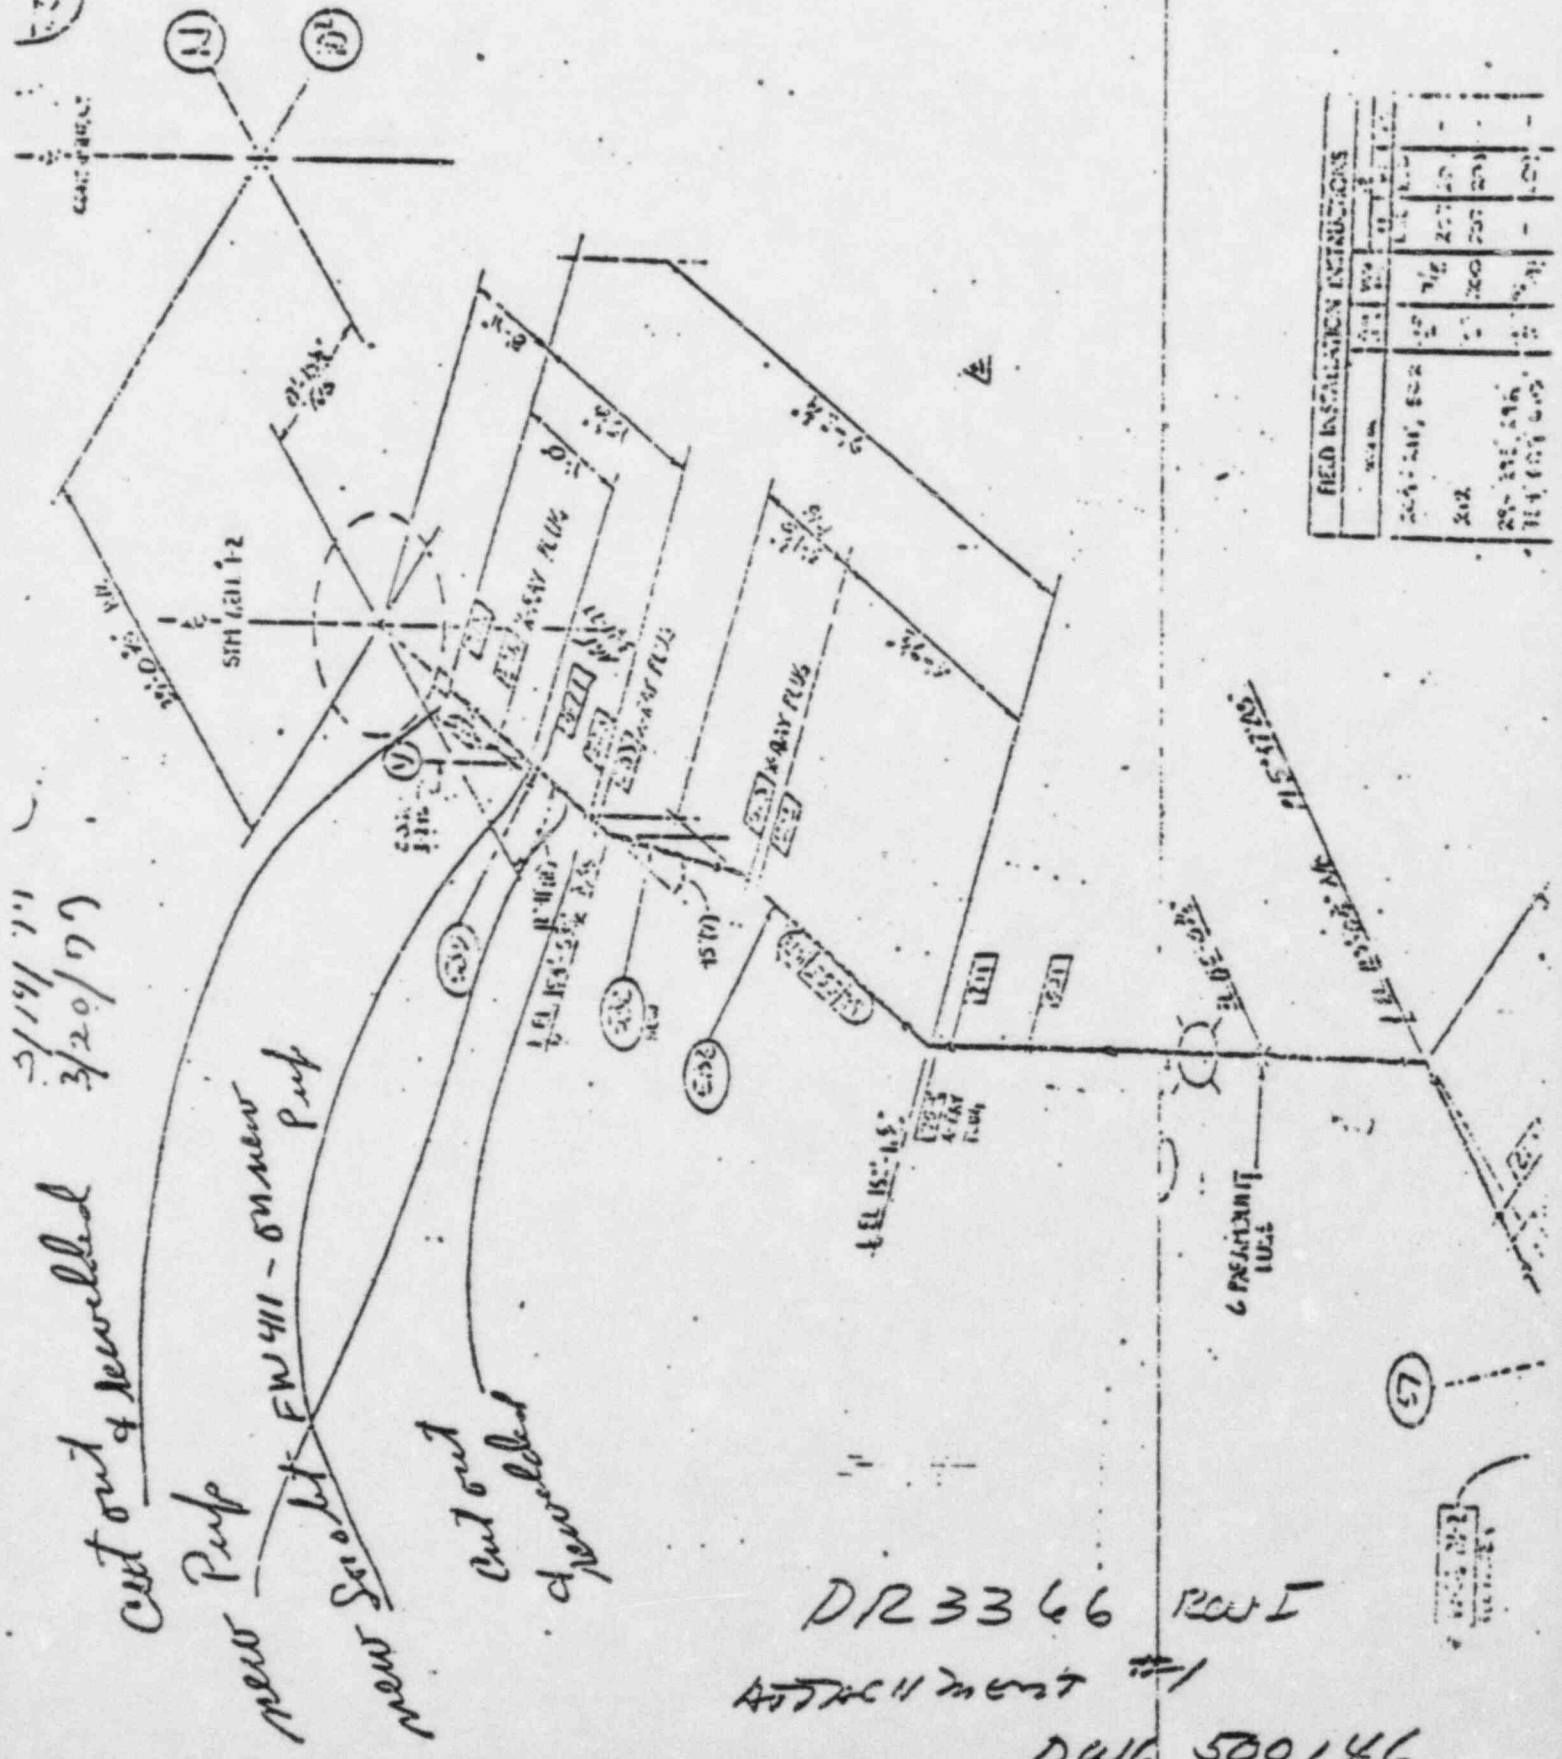
Attachment #1

Cut out & reworked

new Sewer pt. FW 411 - on new Pump

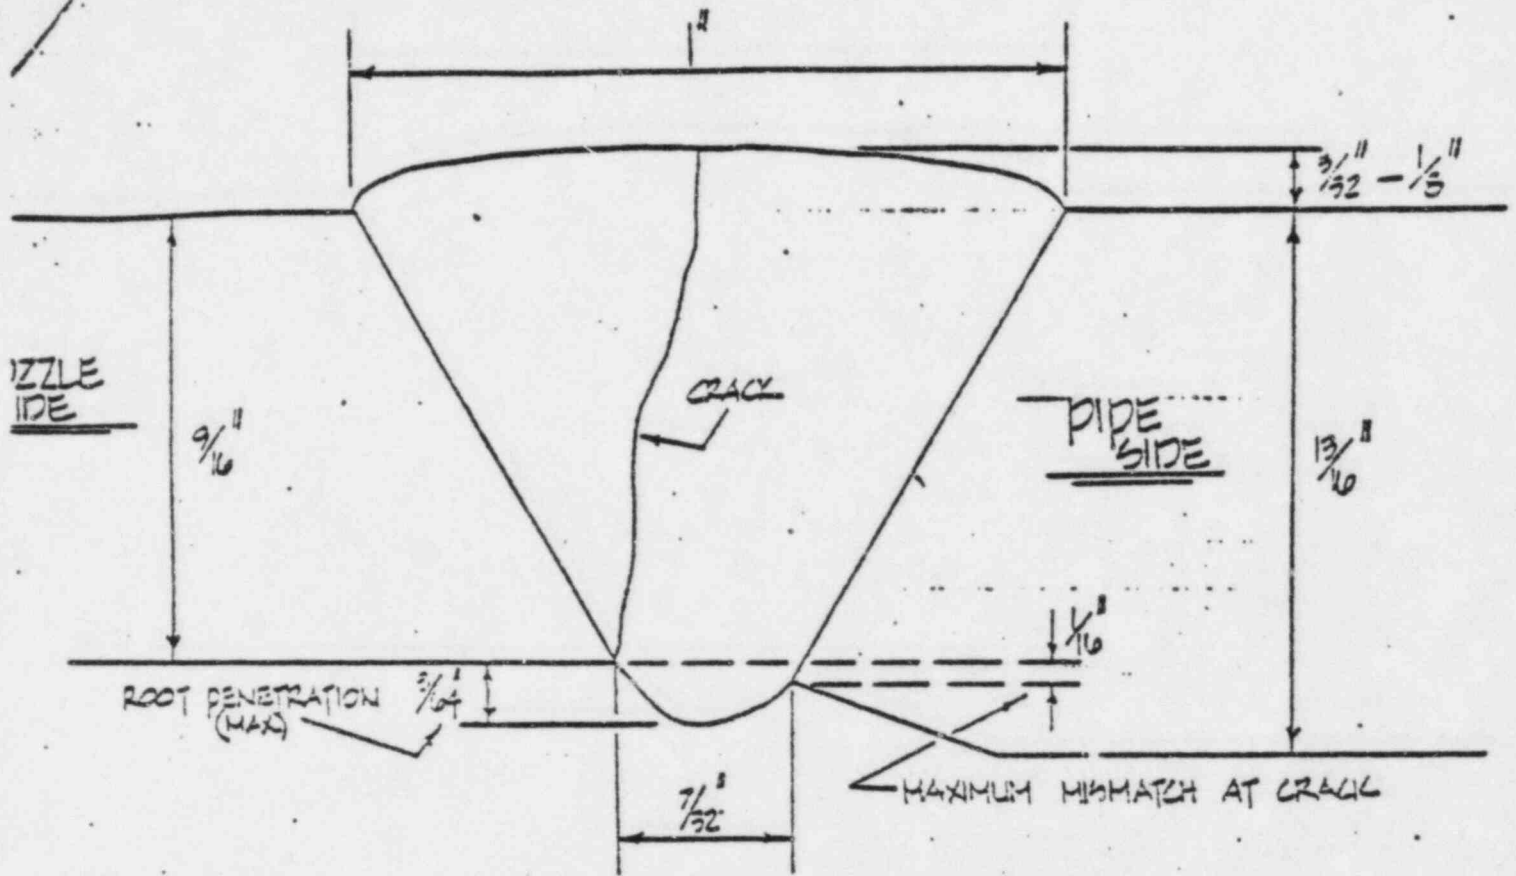
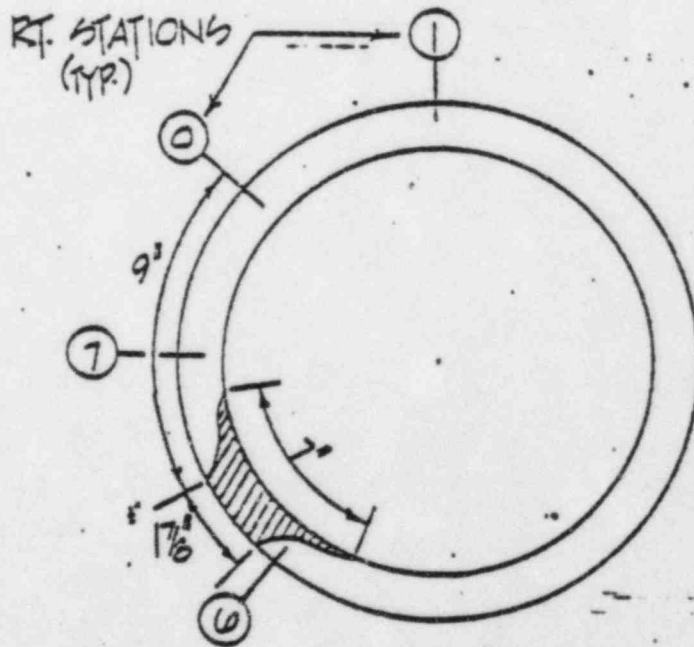
DR 3366 Rev I  
ATTACHMENT # 2

1. WALL THICKNESS MEASR. ARE APPROXIMATE
2. REF. TO DR. 3366 REV. A
3. STEAM GENERATOR 1-2  
F.W. #212  
W.D. #0014U  
-LINE # KU-553-10IV

(JOINT DETAIL)  
FOR RE-WELD  
OF FW 212

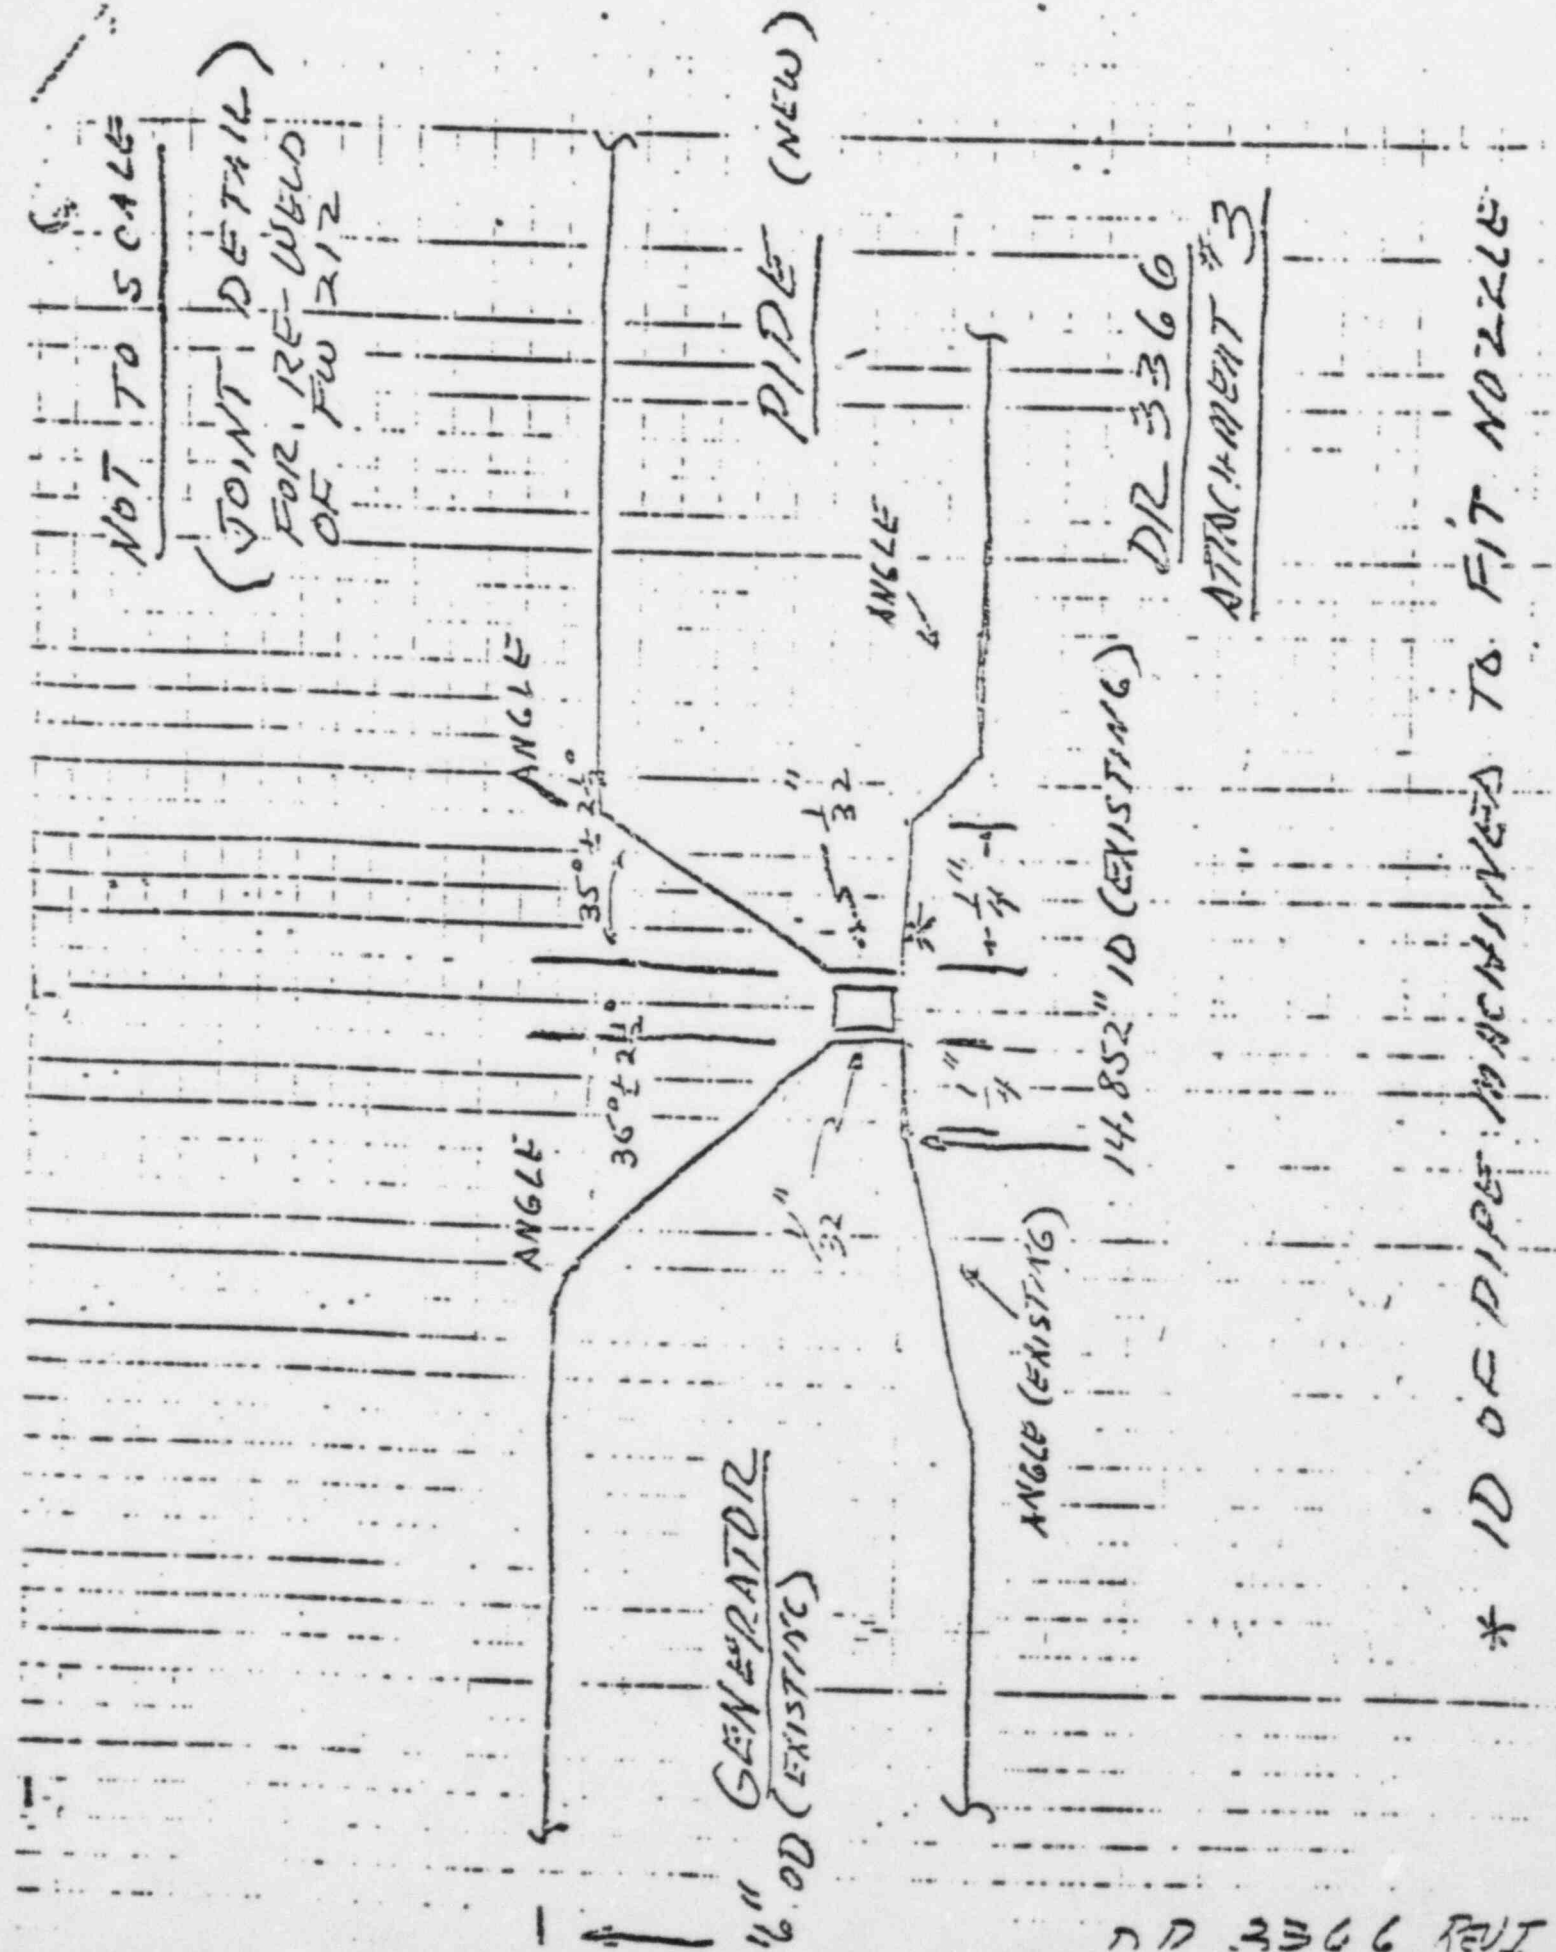
ATTACHMENT #3

\* ID OF PIPE IS ANCHORED TO FIT NOZZLE

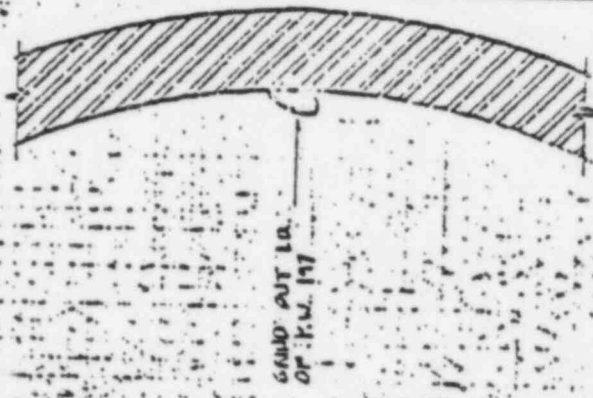
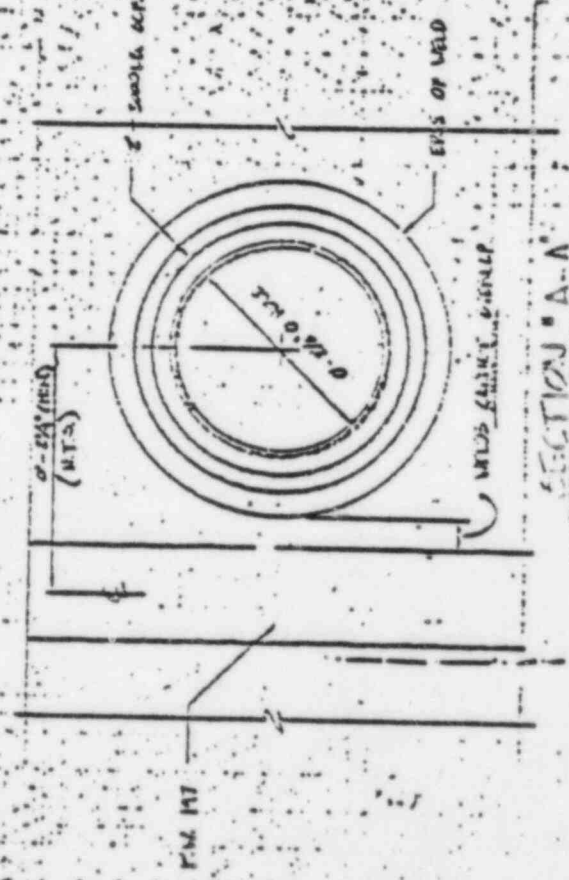
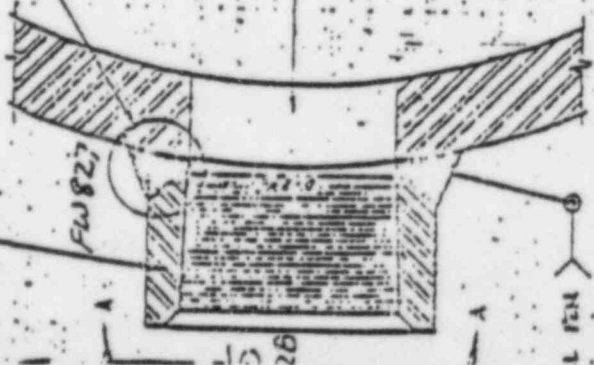
SECTION THRU PIPE NEAR F.W. 197

The review revealed a questionable indication in F.W. #197 on the feedwater lead to Steam Generator 1-1. The indication appears to be a burn through which contains linearly oriented voids. The accompanying radiographic report accepted the weld but did not indicate the presence of the burn through. Further investigation revealed that a second set of radiographs, shot at a later date, exist. This set also shows the burn through which was recorded on the radiographic report as acceptable (see copies attached).

To determine the severity of the indications in the burn through, we have made additional radiographs of the burn through area. These radiographs indicate that the voids are probably contained within the burn through and do not extend into the weld. There is no indication of propagation of the indications.

1. Weld a 2" threaded coupling to the pipe as shown on the attached sketch using weld procedure 88/89 or 92/93. (FW # 827).
2. M.T. per ESD-209.
3. Post weld heat treat the weld - ESD-218.
4. Perform a hydrotest on the weld prior to drilling into the pipe.
5. Following satisfactory completion of the hydrotest, cut the hole through the pipe wall with a hole saw (Ref. ESD-230) NOTE: Additional reinforcement of 2" opening is not required per P.G. & E. calculations
6. Using an extended shaft grinder with a cone shaped rock, grind the burn through flush with the pipe surface.
7. Radiograph the area to assure complete removal of unacceptable indications.
8. Install threaded plug and seal weld (F.W. #828).

CUT 2 1/2" Ø WALL WITH 5/16" SAW AFTER WELD.

- WELD ON 2" - SMOOTH DEFORMED COUPLER INTO COUPLER
- CUT THRU PIPE WALL WITH 2 1/2" Ø WALL SAW
- GRIND OUT I.D. OF F.W. 197
