Report 411-77.55

PACIFIC GAS AND ELECTRIC COMPANY
DEPARTMENT OF ENGINEERING RESEARCH

FAILURE ANALYSIS OF CRACKED FIELD WELD NO. 212
DIABLO CANYON UNIT 1, STEAM GENERATOR 1-2
NOZZLE-TO-PIPE WELD

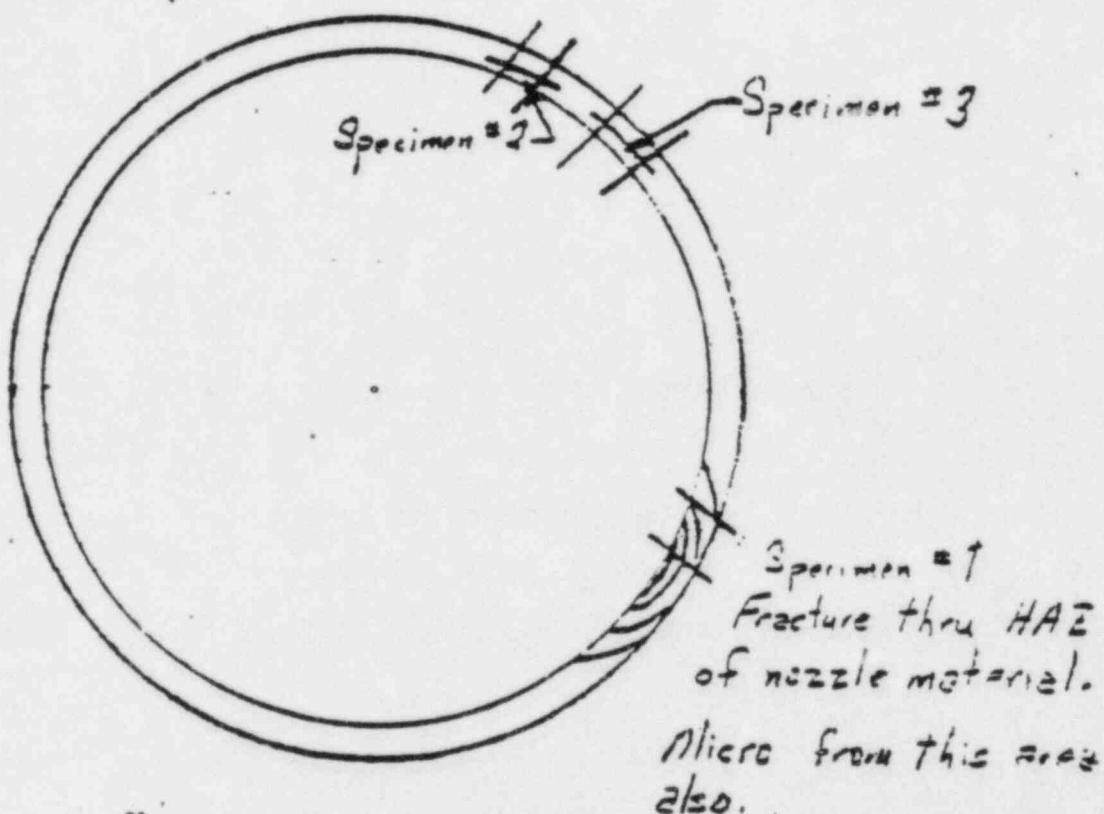
As a result of the above findings, a spool piece containing a major portion of the weld, a small section of the nozzle I.O. adjacent to the weld root, and several inches of pipe were removed for analysis. Figure 1 is a sketch of the spool piece received for analysis; included is the crack path and a sketch of the shape of the crack.

Figure 1. Schematic diagram of failed nozzle illustrating the locations from which samples were removed.

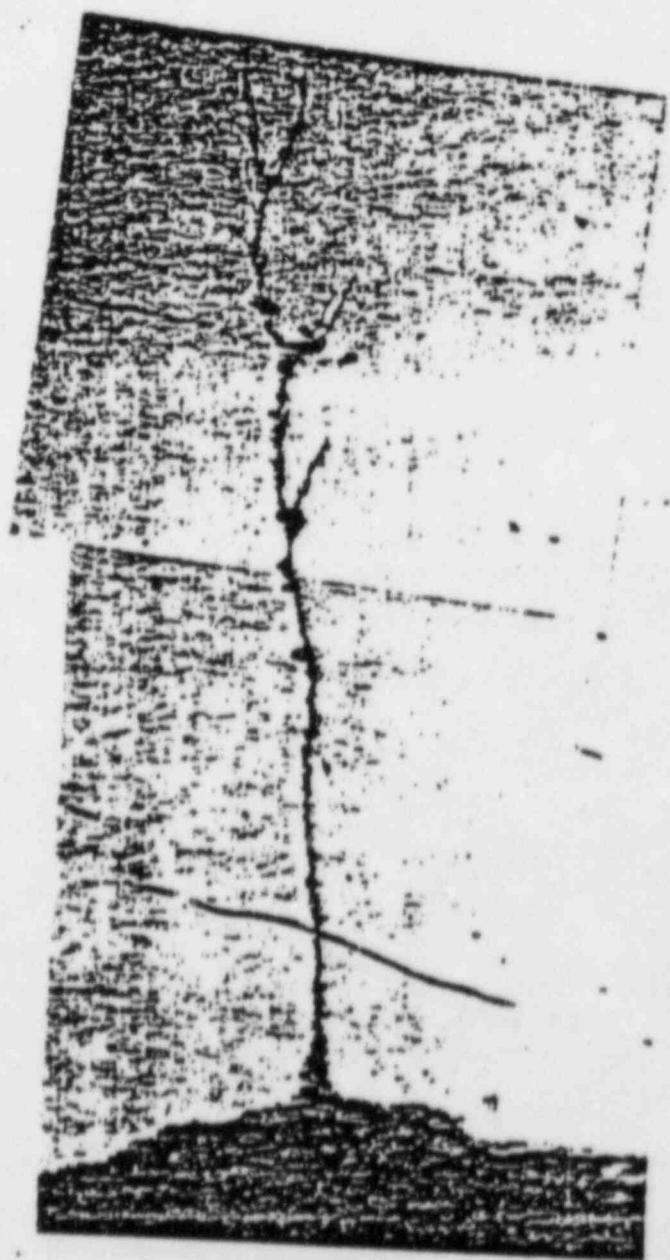
Examination of the small cracks adjacent to the main fracture, Figures 6, 7, and 8, illustrated that the cracks originate in slight depressions in the surface, grew perpendicular to the surface and at an oblique angle to the rolling direction (as revealed by the inclusion stringers), were filled with oxide, were transgranular, and exhibited some crack branching. No evidence of plastic deformation was observed. EDXA microprobes verified that the material in the cracks was probably oxide, that the base metal was carbon steel, and that the inclusion stringers were manganese sulfide, Figures 10-12.

Figure 7. Polished cross section from main fracture area showing a crack, filled with oxide, with crack branching and sulfide inclusion stringers; 450X.
