Metallurgical Examination
Cracked Field Weld No. 212
Feed Water Pipe to Nozzle; Steam Generator 1-2.

Pacific Gas & Electric Co.
Diablo Canyon Nuclear Project

Pullman Power Products Co.
Williamsport, Pennsylvania

Date: 6/23/77

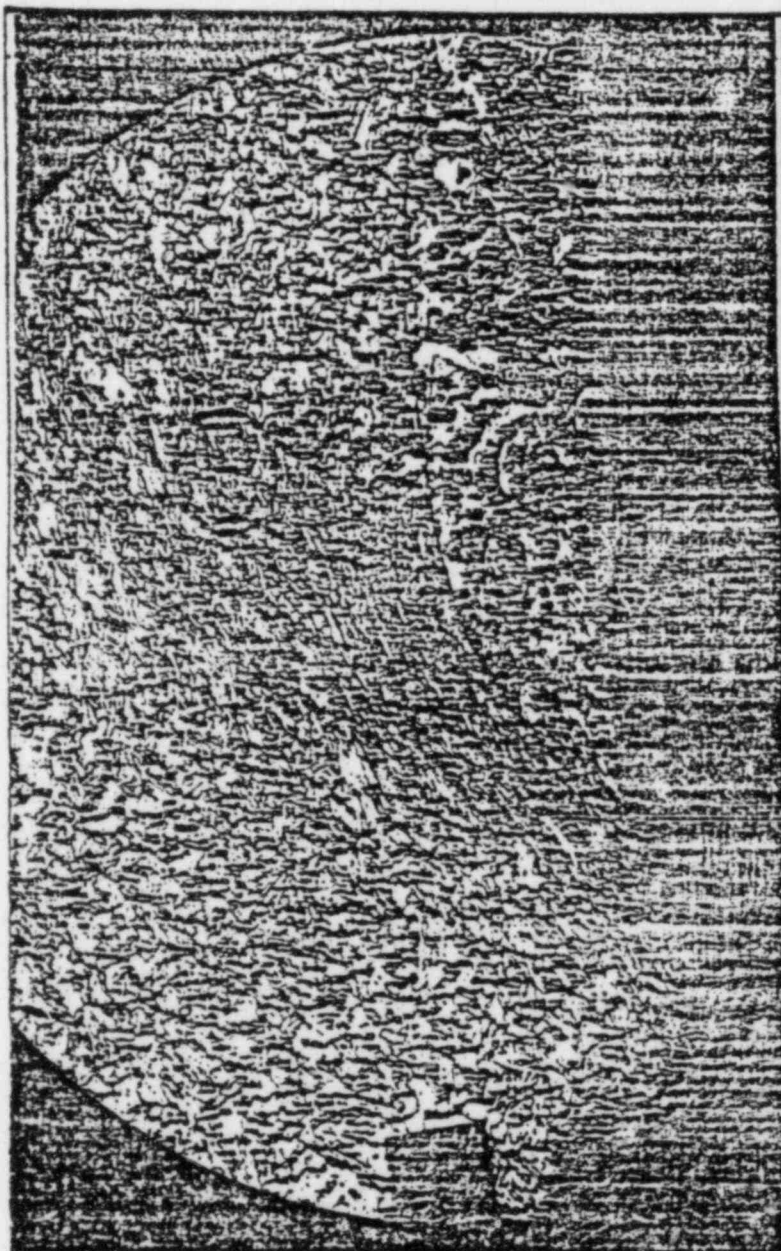
Fig. 2 is a photomicrograph of the metallic structure which was found to exist in one of these areas. The indication is that these are associated with remanent, weld bevel "land" material of the forged nozzle component. The suggestion is that, crack initiation stemmed from this locus; also that the initiating defects were localized, incipient root cracks through the land area.

Photomicrograph
Crack Evidence in Initial Weld Bevel Land

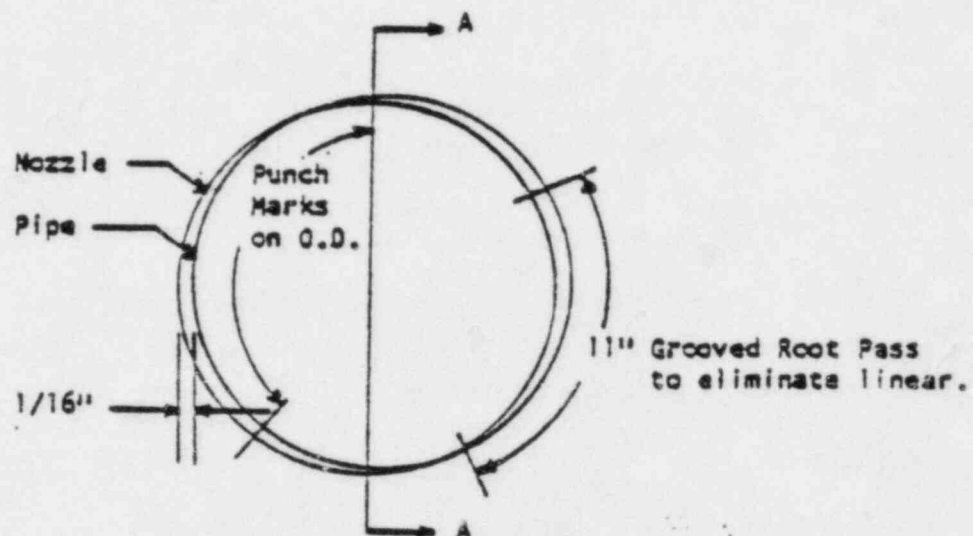
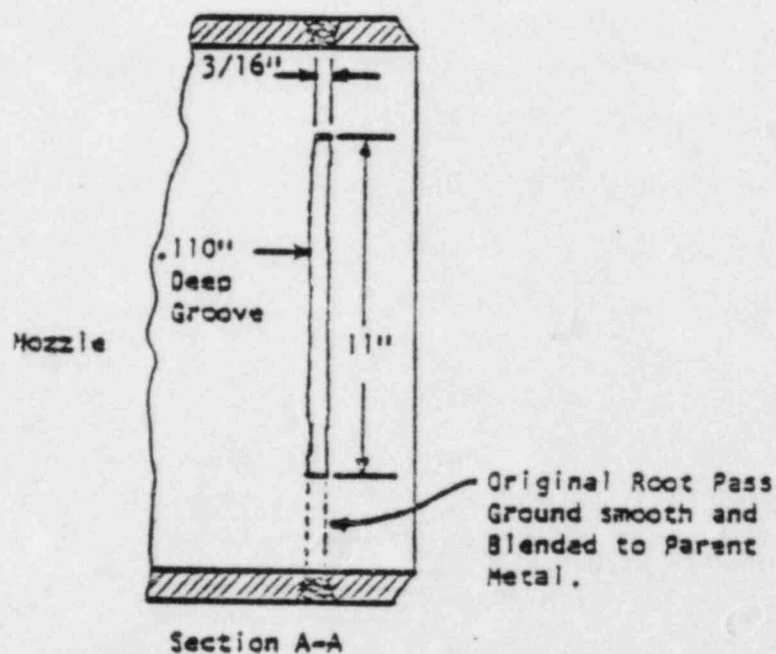
Findings at F.W. 244

NOTE: Average Wall Thickness = .580" to .600"
Remaining Wall At Groove = .450"
Punch Marks On The O.D. = .047" Deep
(Punch Marks are directly on the fusion line of F.W. 244 to $1/8''$ inside the fusion line .047" deep.)

We recommend that the root pass be ground and polished to blend with base metal surfaces. Particular care should be taken to avoid the removal of base material. Then re-examine the I.D. with liquid penetrant, if acceptable, proceed to "Recommended Disposition", Step 7 of D.R. 3453, Revision 1.
