SEABROOK STATION
Engineering Office:
1671 Worcester Road
Framingham, Massachusetts 01701
(617) - 872 - 8100

Interim 10CFR50.55(e) Report; Solid State Protection System Power Surge

NS-EPR-2638

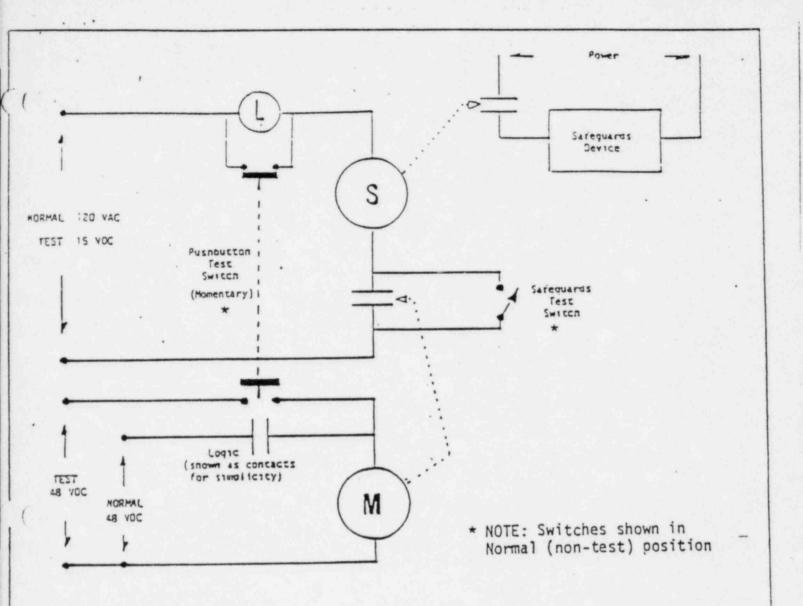
As mentioned above, output relay coil continuity is confirmed at the SSPS, without operating the relay, by reducing the circuit voltage to 15VDC from 120VAC. As shown in the sketch, operation of the master relay by means of the pushbutton test switch also removes the shunt from the SSPS proving lamp and allows the 15VDC to energize it to confirm the continuity of the output relay coil.

Upon completion of the master relay and output relay coil continuity tests, 120VAC circuit voltage is restored. However, if the switch contacts which shunt the proving lamp should fail to reclose as expected, 120VAC would be applied to the lamp in event the system were called upon to operate. Depending on the output relay coil impedance and the number

of output relays being operated by the master relay contacts, the current through the lamp could cause it to burn open before the output relay(s) energized. In such an instance associated Safeguards devices in the affected train would not actuate. Since, during circuit analysis, all identified nondetectable failures must be assumed to have occurred, the redundant Safeguards actuation train must be assumed to be similarly, if not identically, failed.

MORMAL OPERATION: Logic "contacts" close to otck: up Mester relay M. Master relay contacts close to apply 120 VAC to Slave relay S. Slave relay contacts close to power the Sarequards device.

TEST OPERATION: . Relay mode selector switch (not shown) to TEST position switches slave relay power from 120 VAC to 15 VOC. Master relay power remains 48 VOC.

· Pusnoucton test switch contacts (1) pick up Master relay M (2) removes lamo snunt to that IS VOC is applied to Slave relay coil thru proving lamo U.

- Slave relay is not picked up because of reduced voltage of 15 VOC.

If contacts shunting proving lamp L do not reclose when pushbutton PROSLEM: is released and system is return to Normal, then 120 YAC would be applied to Slave relay coil thru the proving lamp if Sarequards actuation were called for by the Logic "contacts".

Although failure of the subject test switch contacts is highly improbable, Westinghouse is recommending a minor revision to test procedures conducted from the Safeguards Test Cabinets where operation of the SSPS output relays is verified. The revision will ensure that the relay test circuits in the SSPS operated properly when the system was returned to its normal operating mode. The procedure changes are described in Attachment III and are recommended until Westinghouse completes a review of its consideration of design changes.
