AEOD TECHNICAL REVIEW REPORT

UNIT: Brunswick 2
DOCKET NO.: 50-324
LICENSEE: Carolina Power & Light Co.
NSSS/AE: General Electric Company/UE&C

TR Report No. AEOD/T309
DATE: April 25, 1983
EVALUATOR/CONTACT: S. Salah

SUBJECT: AIR IN RWCU SYSTEM INSTRUMENT SENSING LINES AT BRUNSWICK - 2

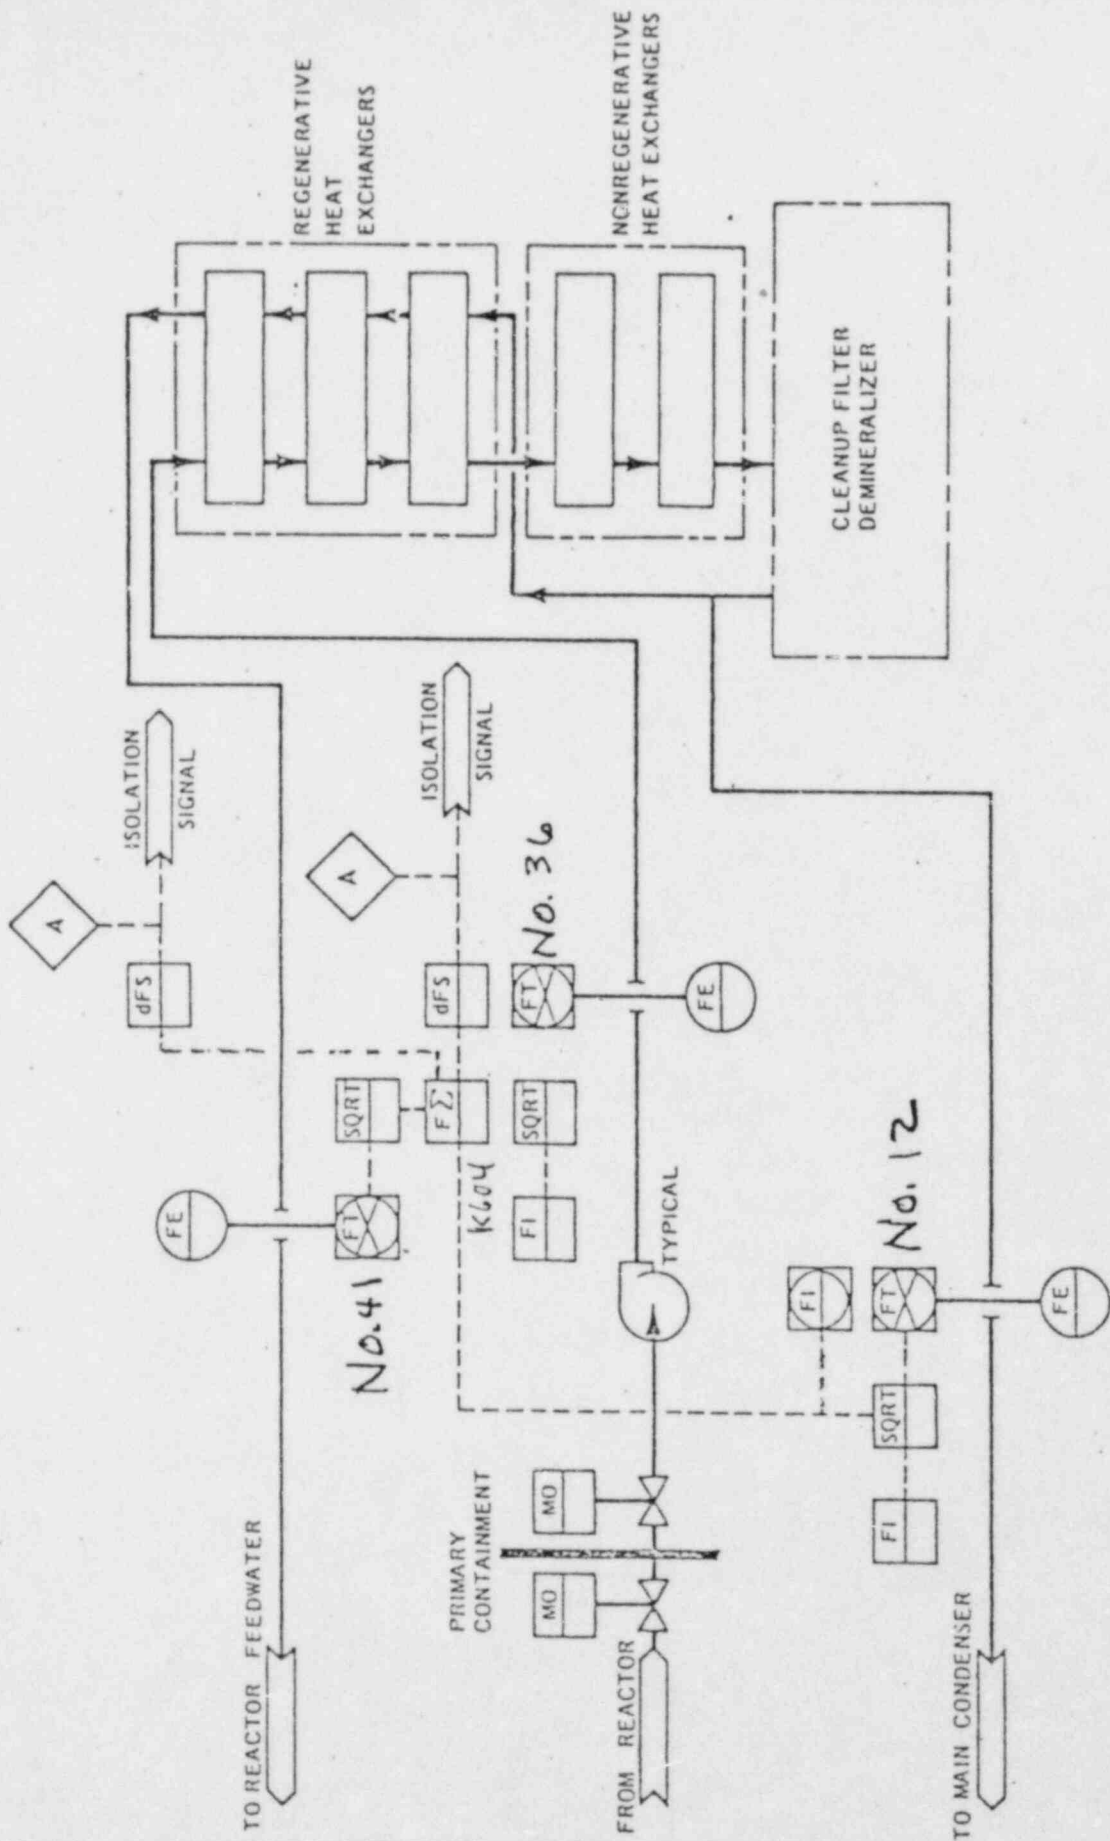
FIGURE 1
7-3-1-10-

The R615 indicator is a direct reading type and connects off one of the two parallel signals from a flow summer. Three flow transmitters, one on the RWCU suction line and one each on the two discharge lines, feed a summing circuit. This is shown in the attached figure. The summer circuit takes the suction flow and compares it with the combined discharge flow to produce a differential flow signal to the isolation circuits. The design of the instrumentation is such that prior to reaching the isolation setpoint for a differential flow, a "Differential Flow High" alarm followed by a "Differential Flow High-High" alarm is received.

The licensee investigated this incident and determined that the sensing lines to each of the three transmitters contained air, and caused an output signal error in the nonconservative direction. Analysis of the as found condition by the licensee indicated that the system would probably have isolated at approximately 65 gpm instead of the technical specification value of < 53 gpm. However, the licensee isolated the RWCU system before the isolation signal setpoint was reached. Following isolation the licensee removed the air from each of the sensing lines and the entire circuitry was recalibrated and returned to service.
