FLORIDA POWER AND LIGHT COMPANY

TURKEY POINT UNIT 3

PRELIMINARY DRAFT OF

CONTAINMENT DOME REPORT

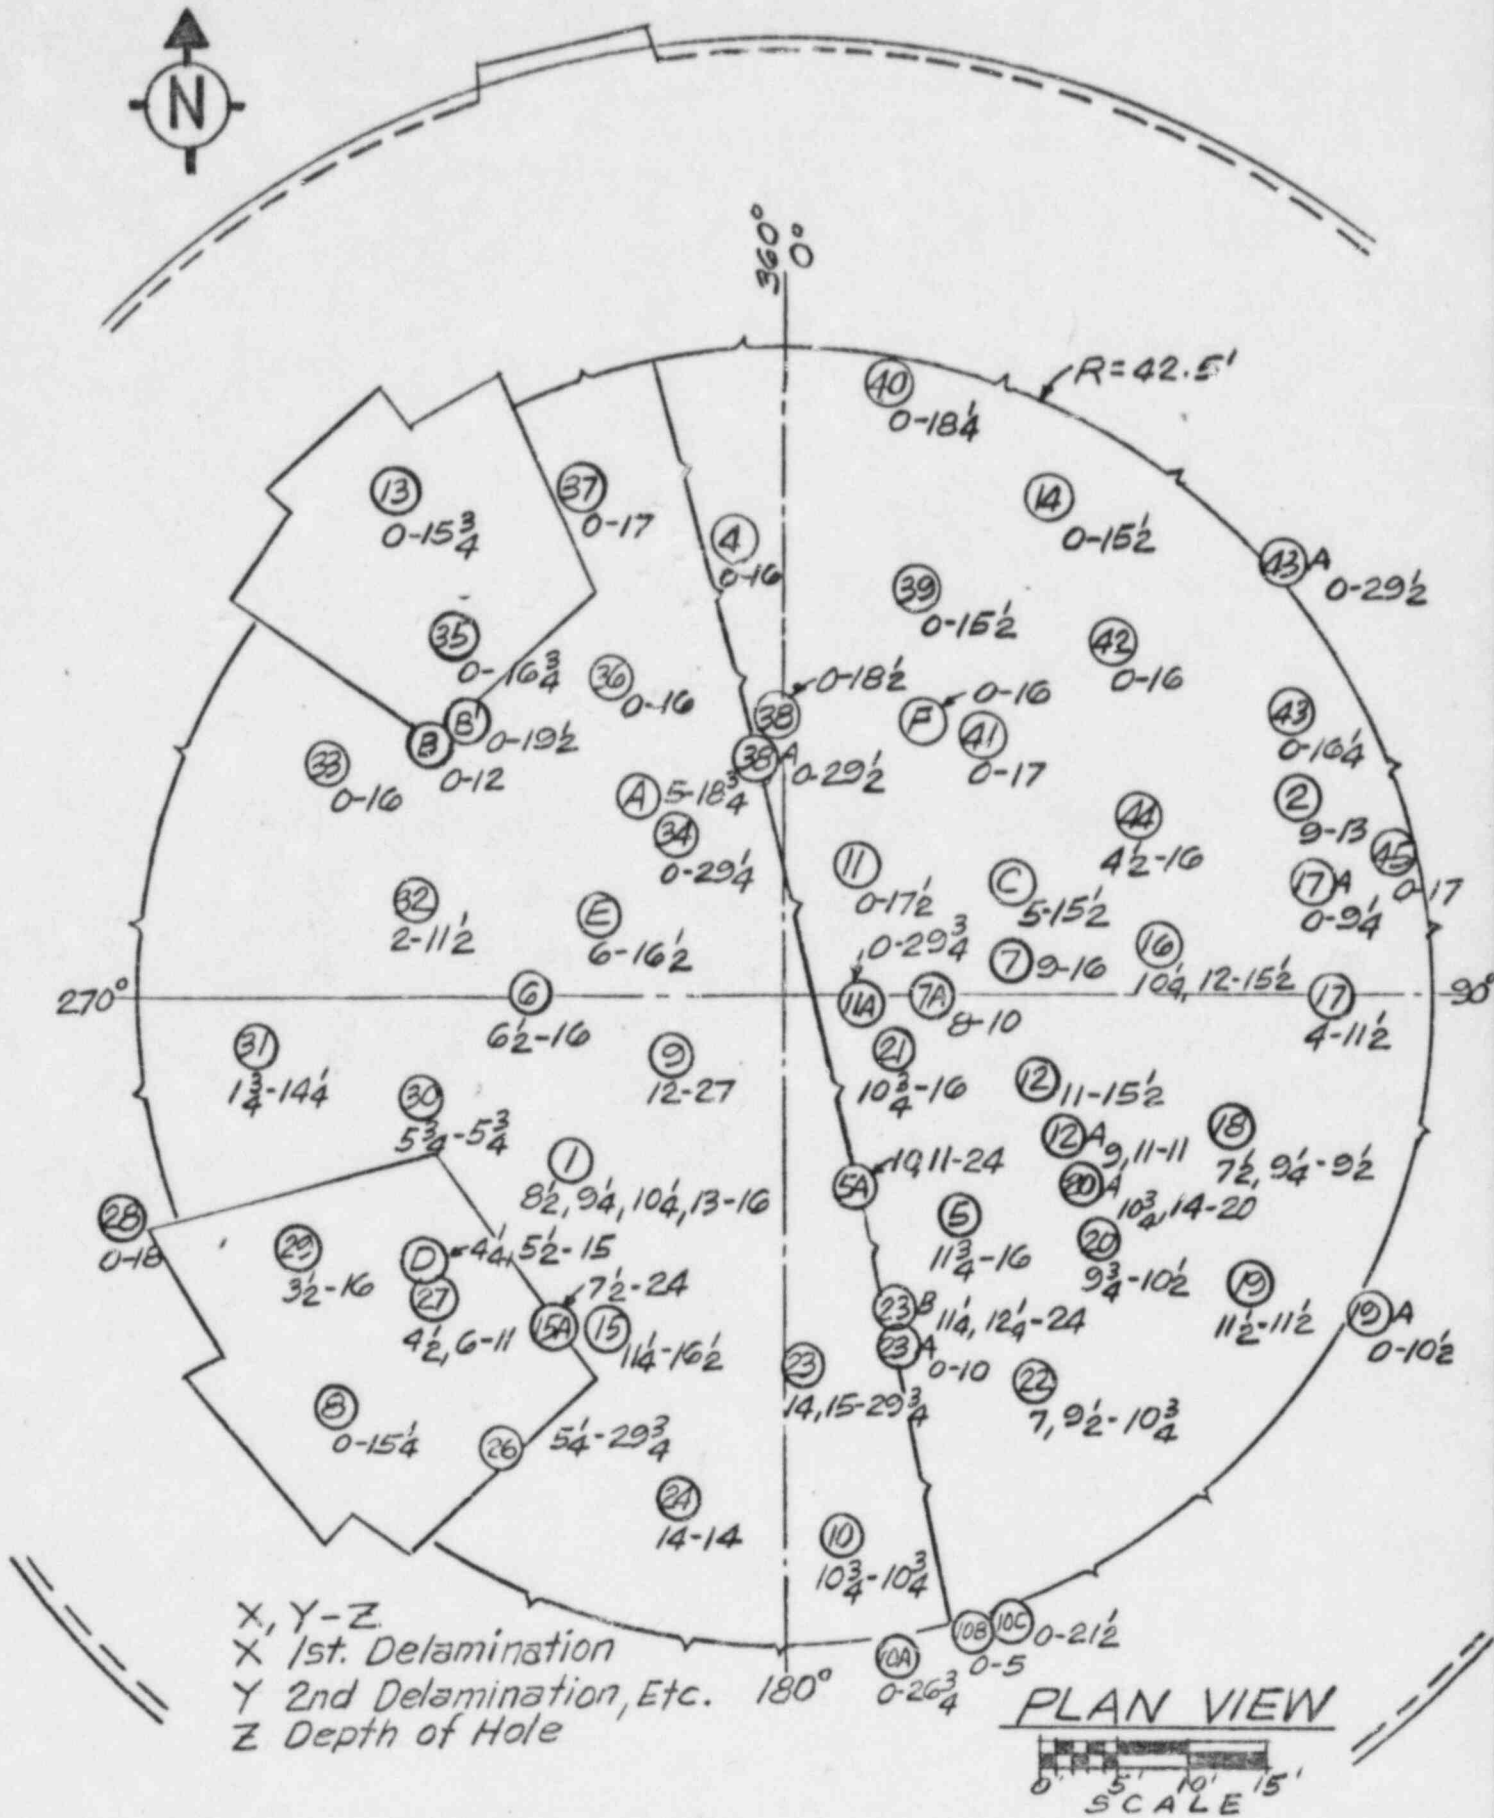
FIG. 3-1

A summary of the information obtained from coring is given in Table 3-1. To help visualize the extent and depth of the delaminations inferred from coring, Figures 3-1 and 3-2 have been included. Figure 3-1 shows the core locations together with the depth to the delaminations and the core hole depth. Figure 3-2 is an estimate, from coring information, of the depth and area extent of the delaminations.

- (1) The depth and extent of the delaminations has considerable symmetry about the meridional construction joint with major delaminations occurring on the south side of the dome.

DOME CORING RESULTS

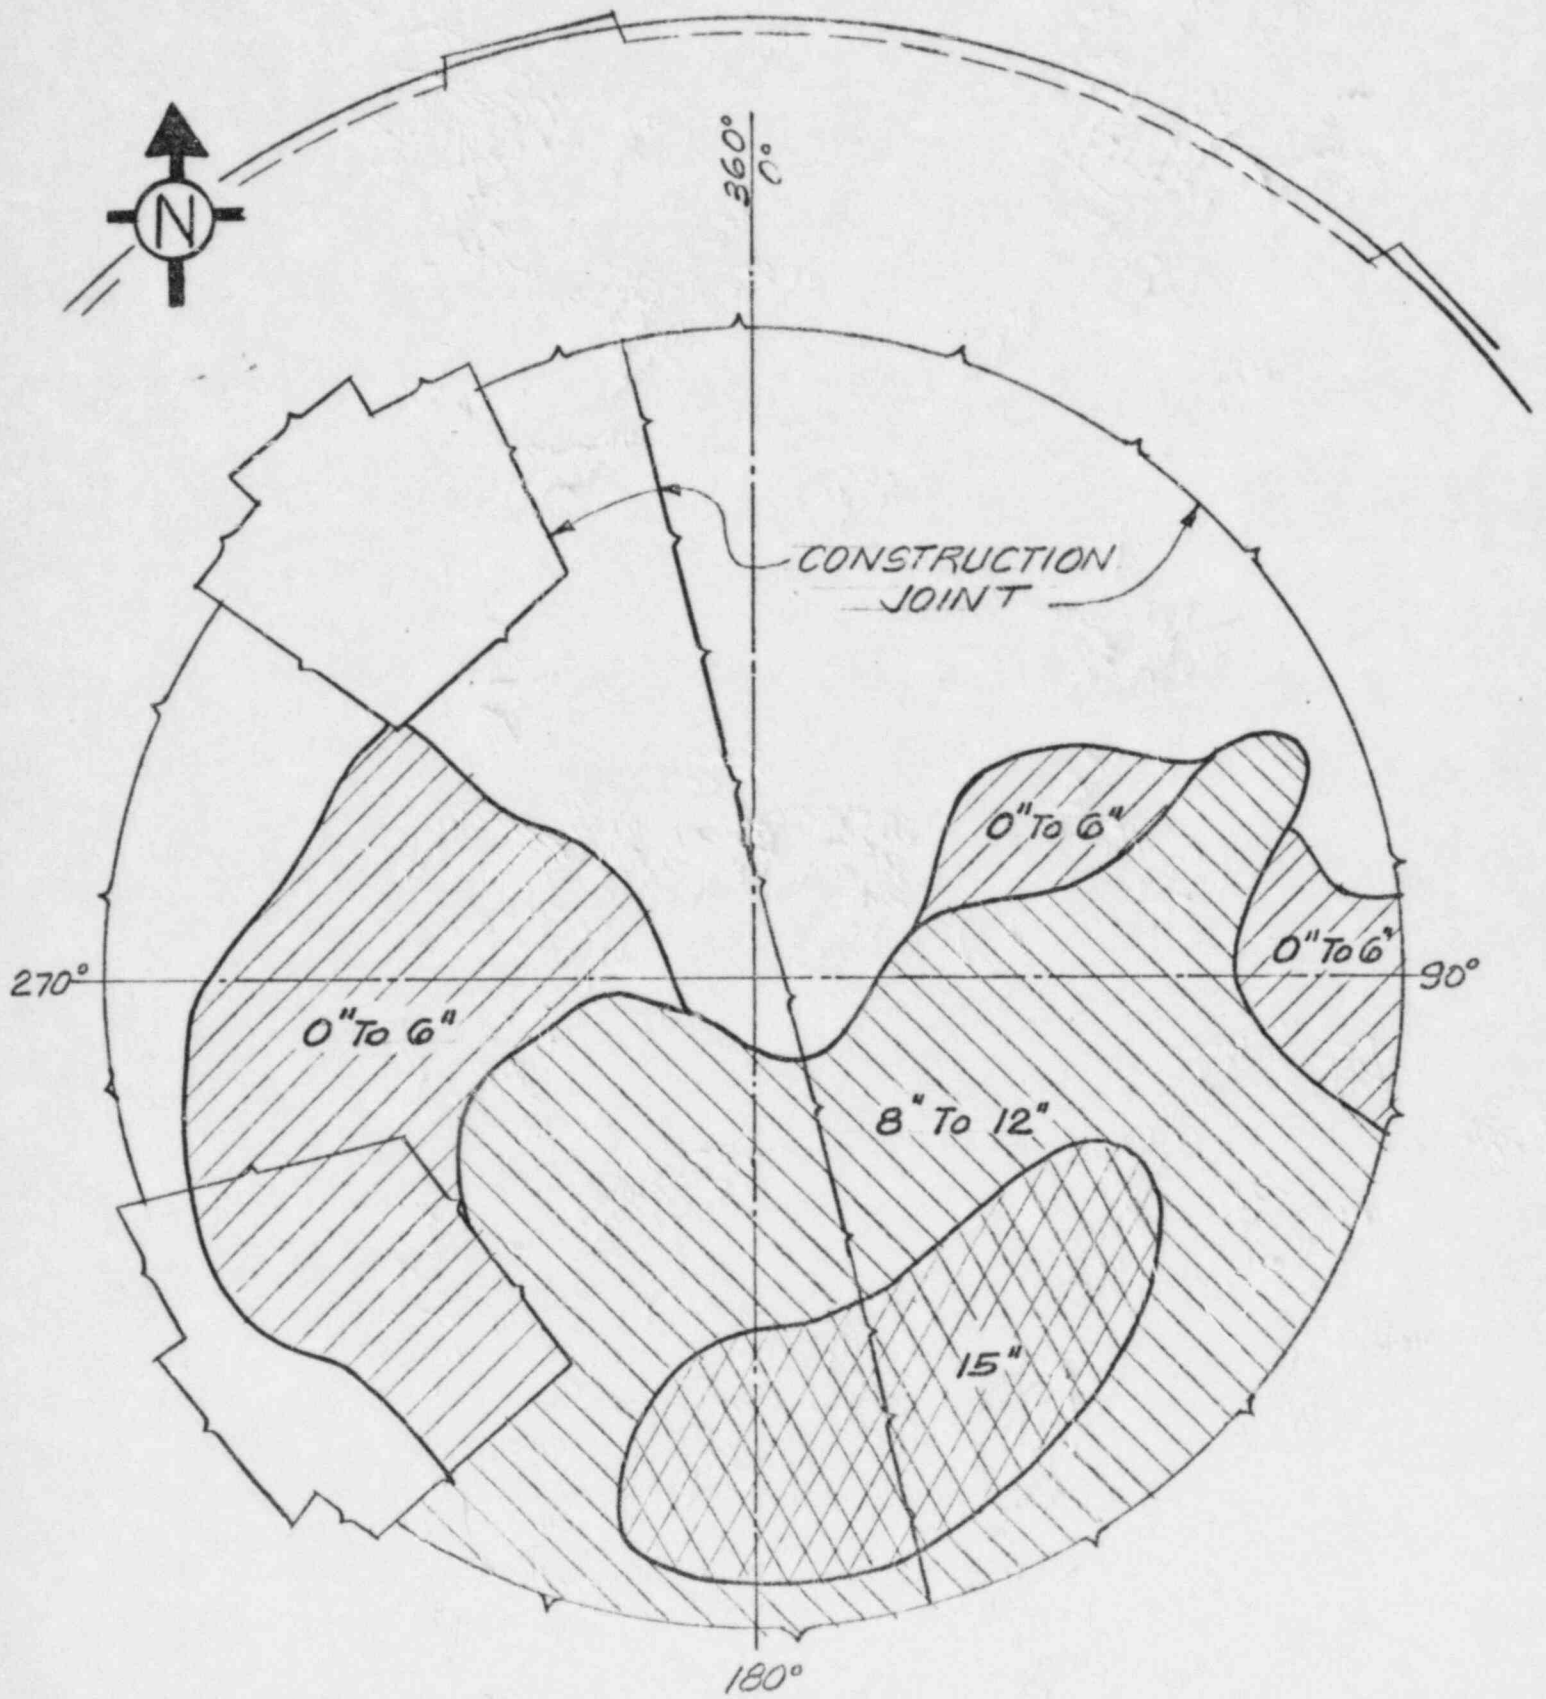
FIG. 3-2

- (2) The delaminations appear to have originated at the meridional construction joint and then progressed away from the joint getting closer to the surface with eventual outcropping or termination at a circumferential construction joint.

CONTOURS OF DELPEST DELAMINATIONS

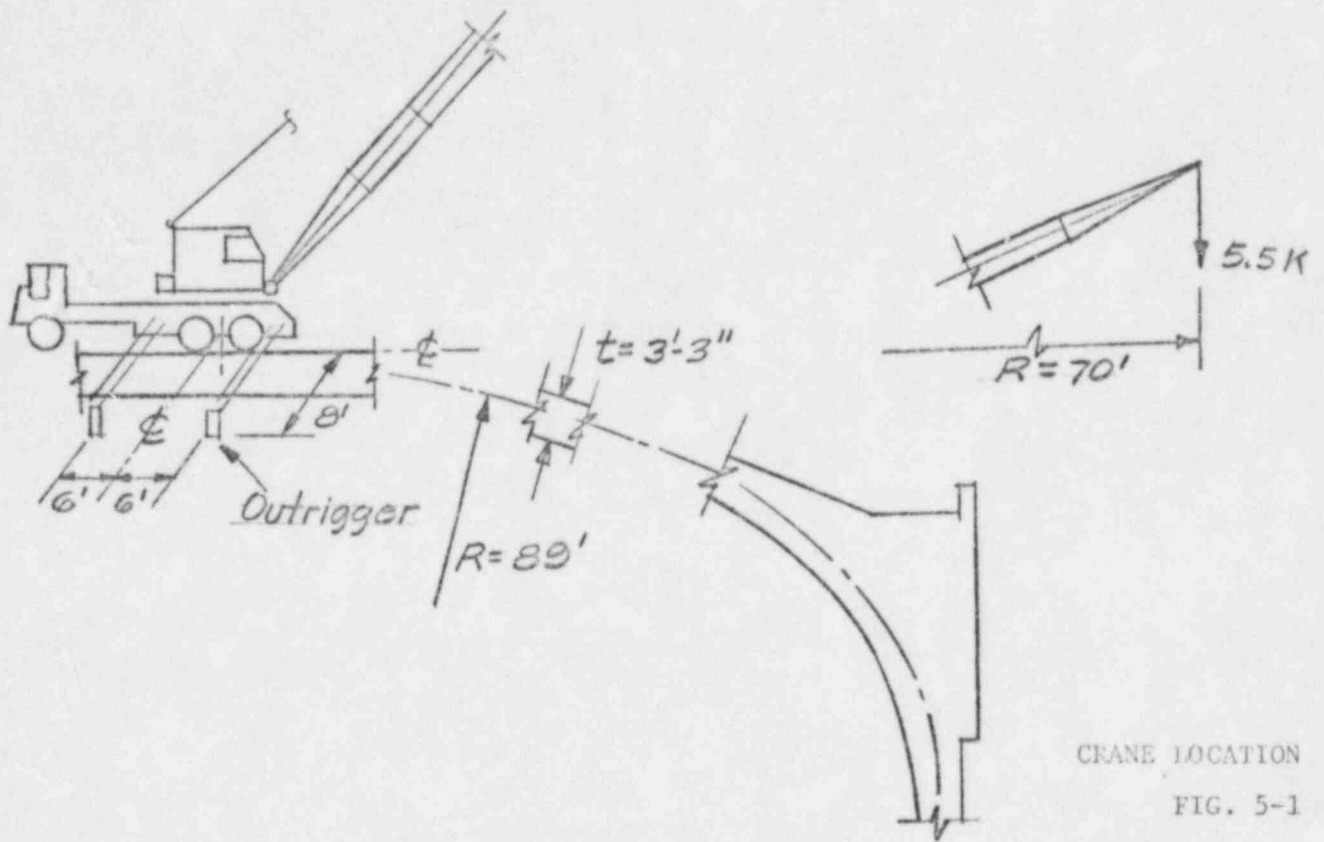
CRANE LOCATION
FIG. 5-1

Due to the low magnitude of the calculated stresses the crane is not considered a significant contributor to delamination causes.

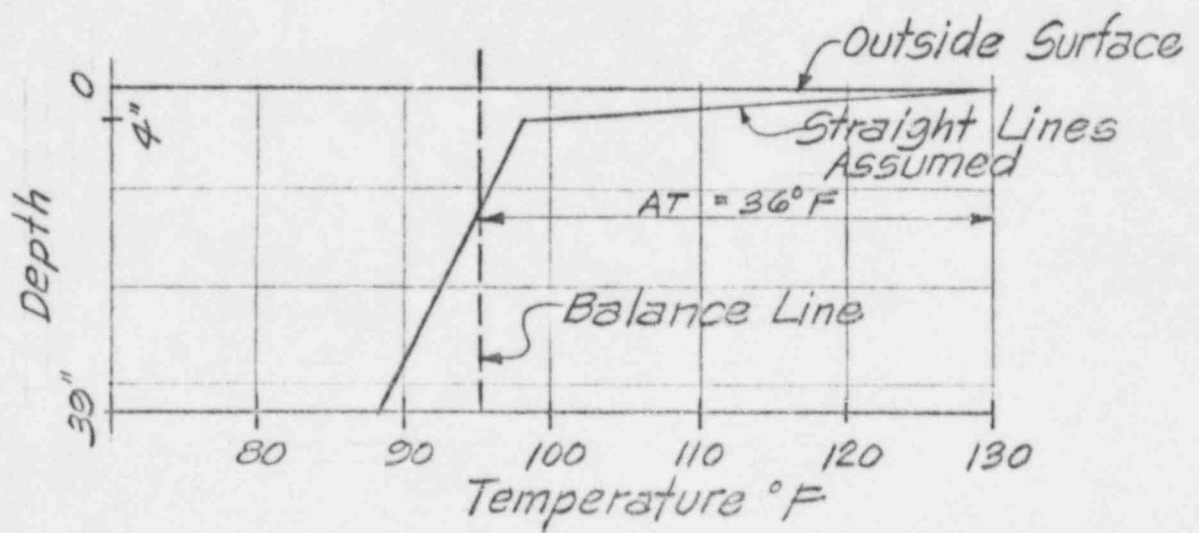
THERMAL GRADIENT
FIG. 5-2

The stresses from temperature and moisture do not peak simultaneously since one tends to reduce the other. Both are primarily surface effects and they would not cause delaminations 15" in depth. However there is a possibility that these two items could have been a contributor in causing shallow delaminations.

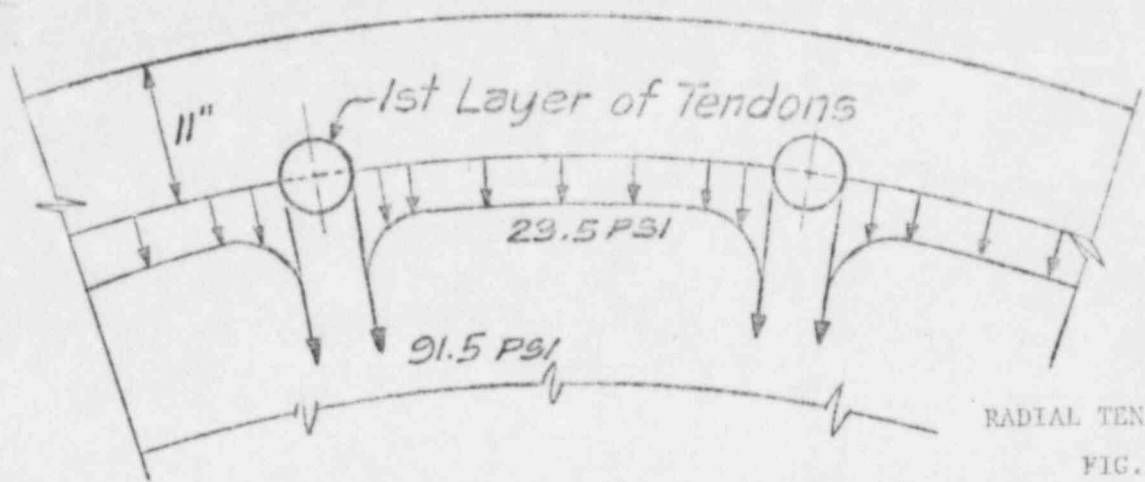
FIG. 5-3

The analysis indicates that radial tension is not a major concern due to the magnitude and distribution. In addition a failure from radial tension should not lead to multiple delaminations close to the surface as were found in the investigation of the structure.

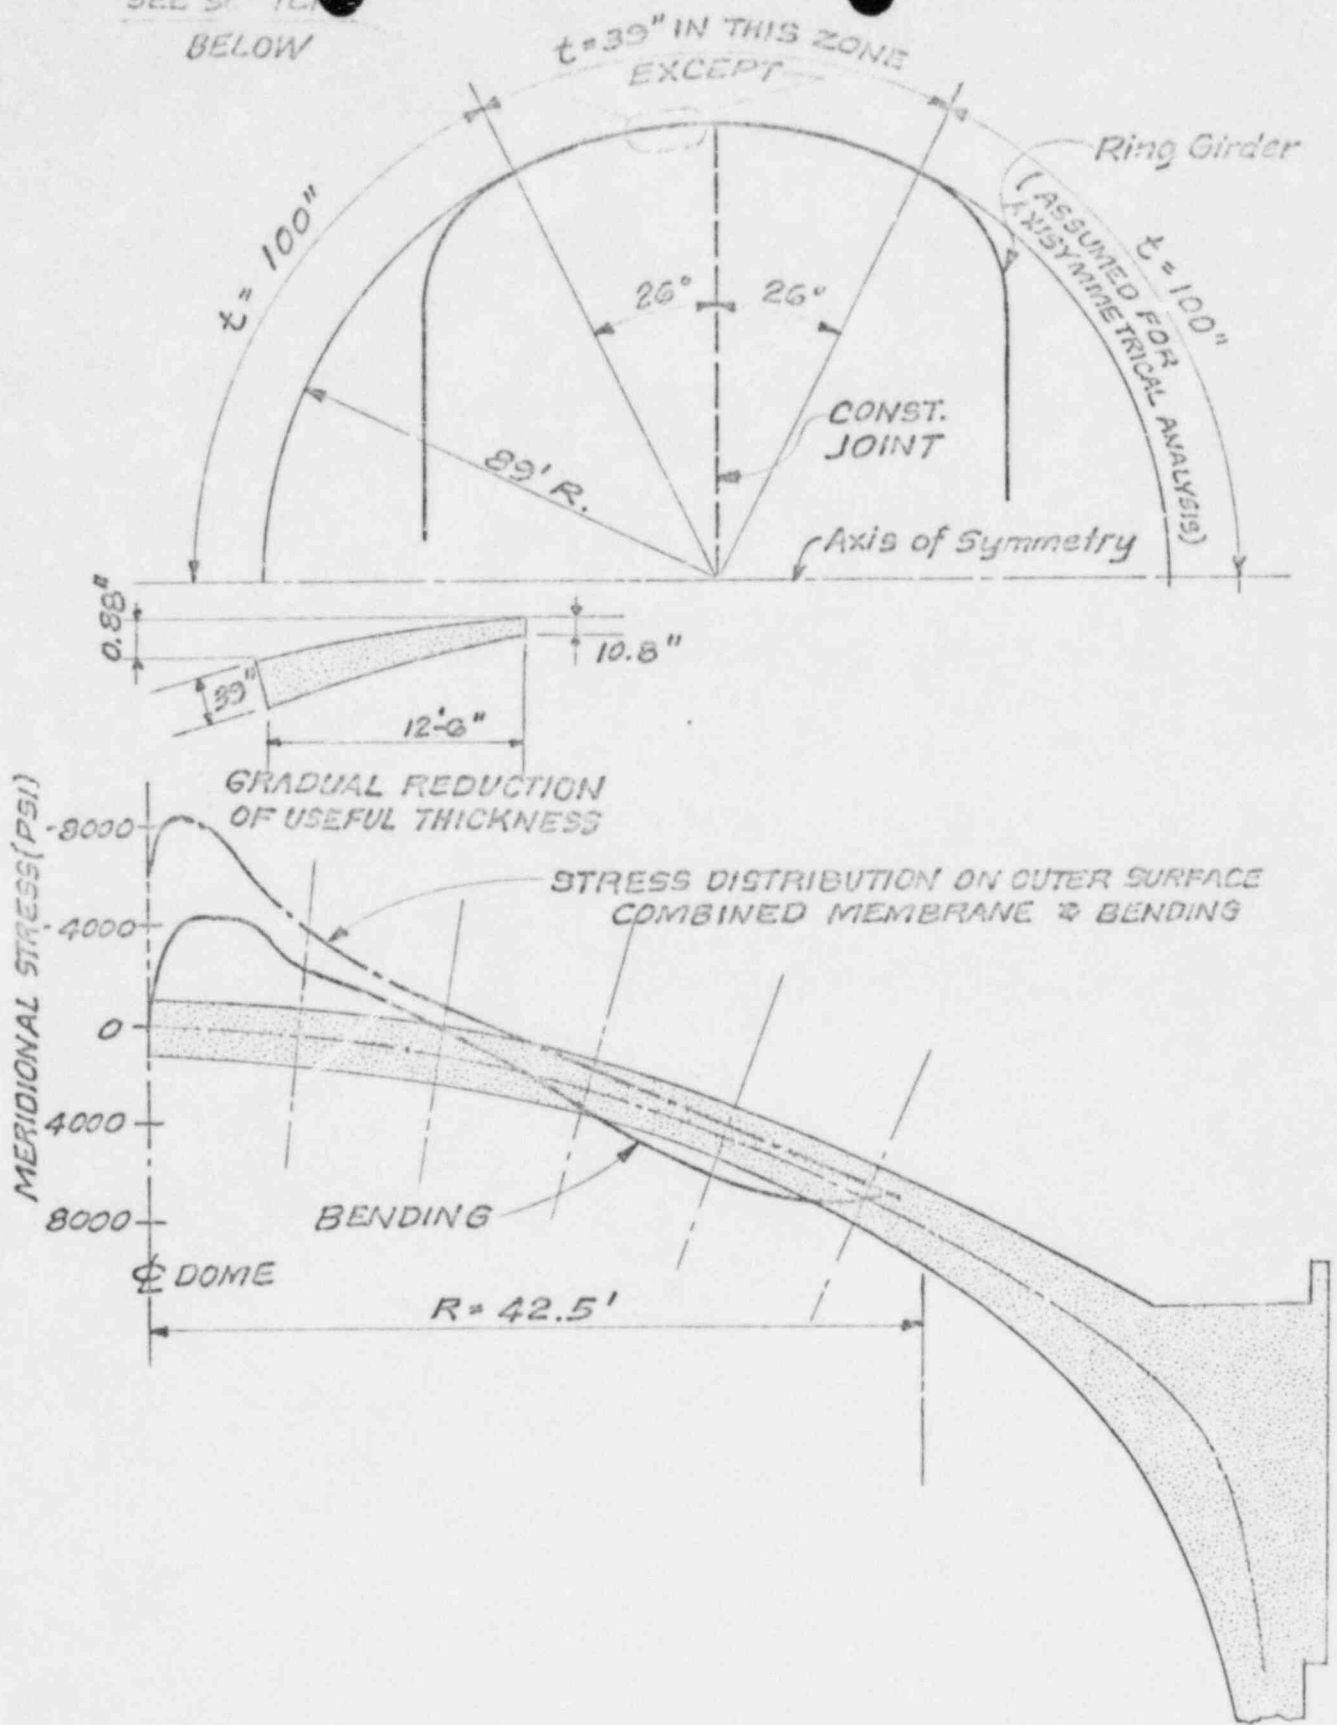
AXISYMMETRICAL SIMULATION OF THE MERIDIONAL CONSTRUCTION JOINT

An analysis was performed (using the shell program previously described) to simulate the effects of having the membrane force distributed over a small area near the surface with resulting eccentricity. In order to simplify the analysis a hemisphere was used with its equator as the construction joint. The geometry of the shell together with its comparison with the real shell geometry are shown on Figure 5-14. The shell was loaded with 100 psi in the area included by the 52° angle. The results which are also given in Figure 5-14 illustrate that both the

reduced joint area and eccentricity of membrane load leads to large calculated stresses. This analysis illustrates how faulty construction joints lead to stresses high enough to be considered one of the main contributors in causing the delaminations.
