FLORIDA POWER & LIGHT COMPANY

TURKEY POINT UNIT 3

INTERIM REPORT

CONTAINMENT DOME CONCRETE

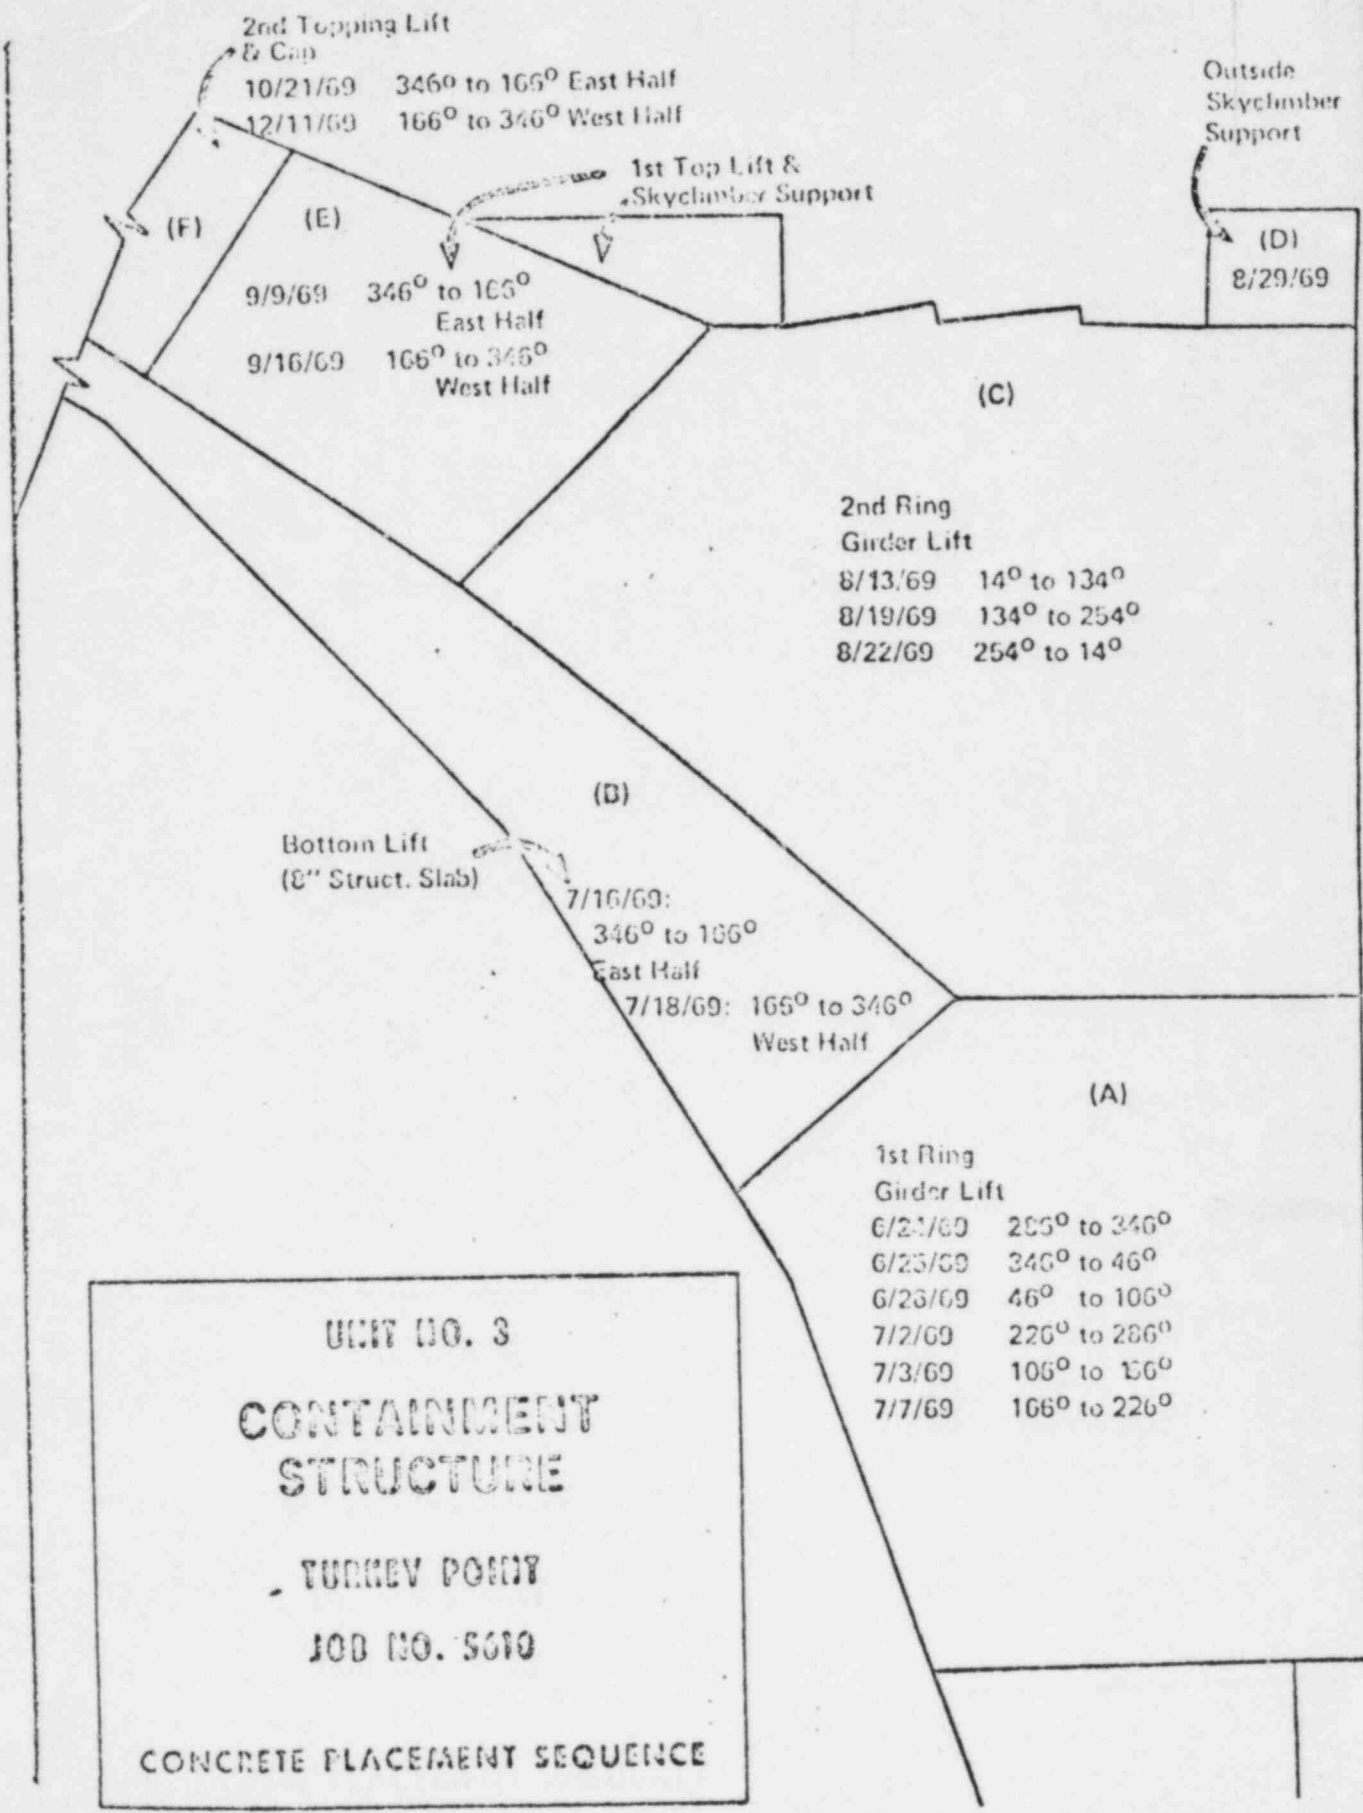
UNIT NO. 3  
 CONTAINMENT STRUCTURE  
 TURKEY POINT  
 JOB NO. 5610  
 CONCRETE PLACEMENT SEQUENCE

The sequence of concrete placement for the dome is shown in Appendix A. The lower half of the ring girder was placed in Lift (A), in 60 degree segments like a typical wall pour. Lift (B) consisted of 2-180 degree segments and covered the 8" thick structural slab which provides a work platform for installation of the tendon sheathing, and a support for the dead weight of the remaining 31 inches of the dome concrete. The upper part of the ring girder, Lift (C) was placed in 3-120 degree segments, while the Lifts (E) and (F) each consisted of 2-180 degree segments. Known concrete separation exists in Lift (F) only.

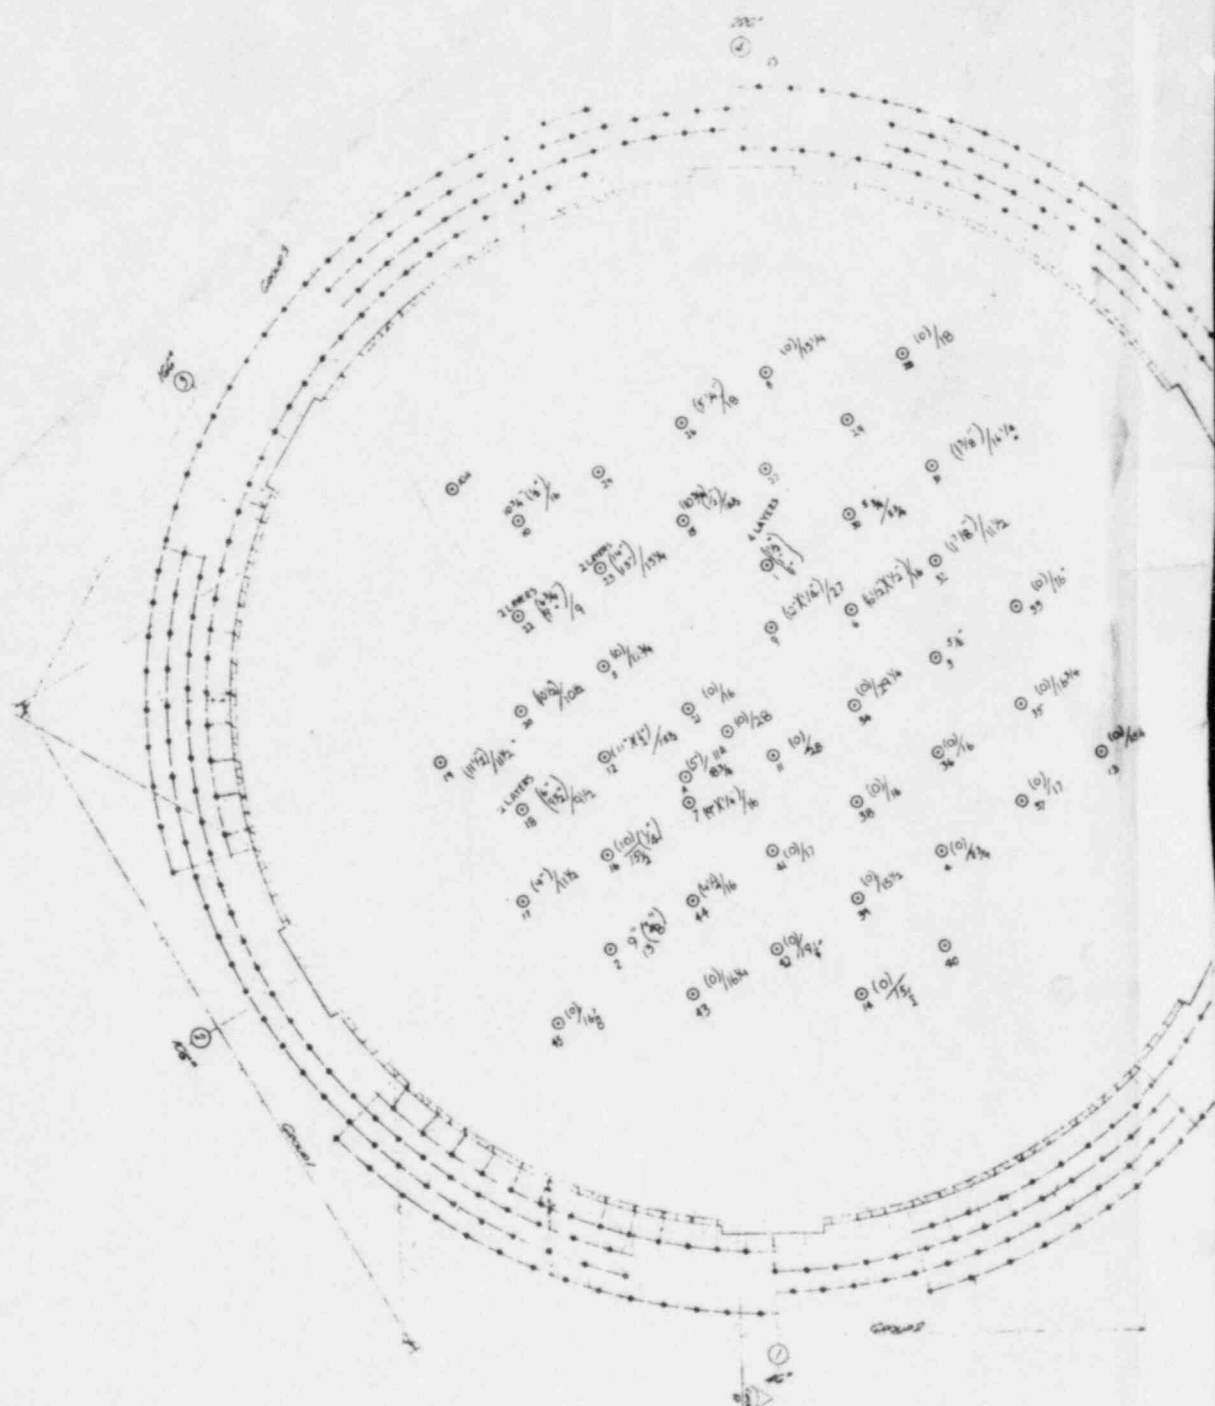
TURKEY POINT UNIT  
CONTAINMENT DOME  
CORE BORING LOG

depth of coring. In general, an attempt has been made to drill the holes to a 16 inch depth, this being supplemented by a few 29 inch deep core holes. The coring log and a sketch showing the location of core holes is included as Appendix B. The deepest lamination found is in core hole #23 at a depth of 15 inches.

No concrete separation has been found in an approximate 90 degree area, between 316 degrees and 46 degrees. In the southern portion of the dome, core holes revealed lamination even though hammer soundings did not indicate any separation.

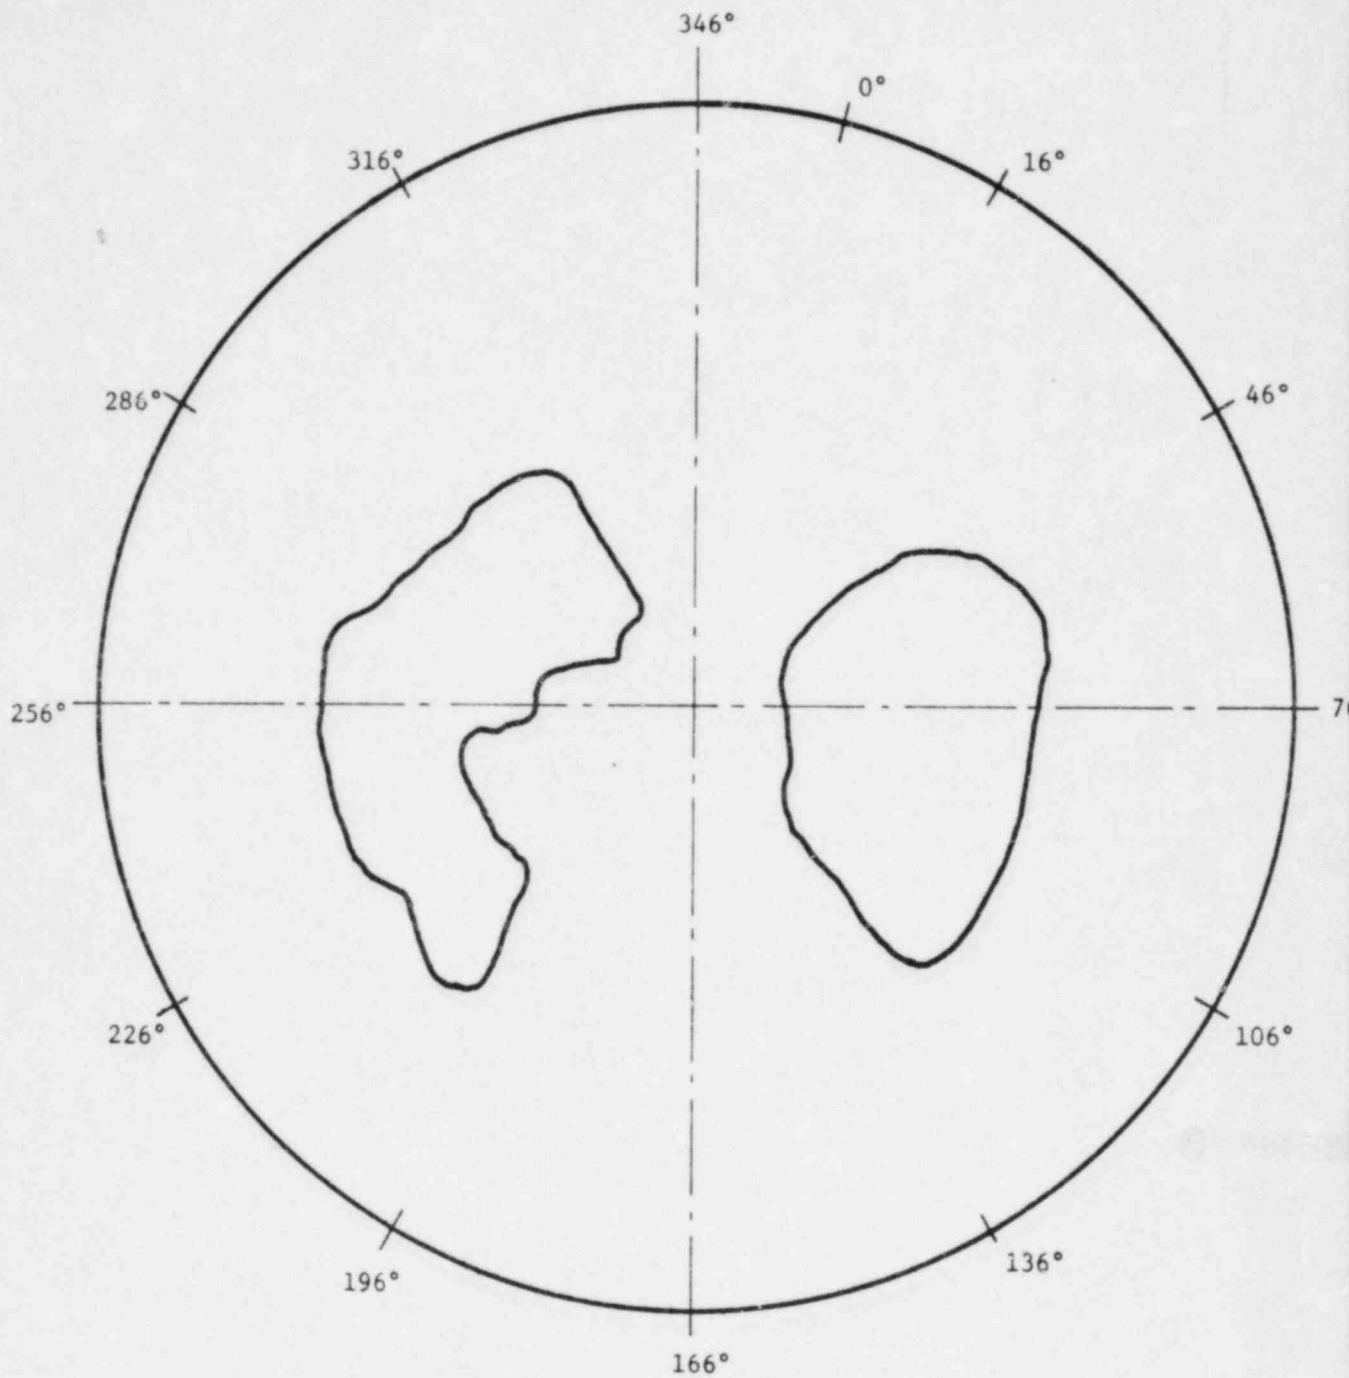
APPENDIX C

The initial investigation to determine the extent of the concrete separation below the surface was performed by soundings with a Swiss hammer and a steel sledge hammer. The steel hammer was found to be more effective in finding separations deeper into the concrete, and is reliable up to a depth of about 10 inches. The 'hollow' sounding areas as indicated by hammering technique have been marked in the sketch in Appendix C.

SEPARATION AREA  
DEFINED BY HAMMER TEST
