## SONISCOPE INVESTIGATION OF THE TURKEY POINT PLANT, UNIT NO. 3 CONTAINMENT MAT

In accordance with an agreement for consulting services between the undersigned and Bechtel Corporation, Soniscope tests have been performed on Section 6-1 of the containment mat of the No. 3 Unit of the Turkey Point Plant, located near Homestead, Florida. All testing was accomplished on Monday, May 26, 1969.

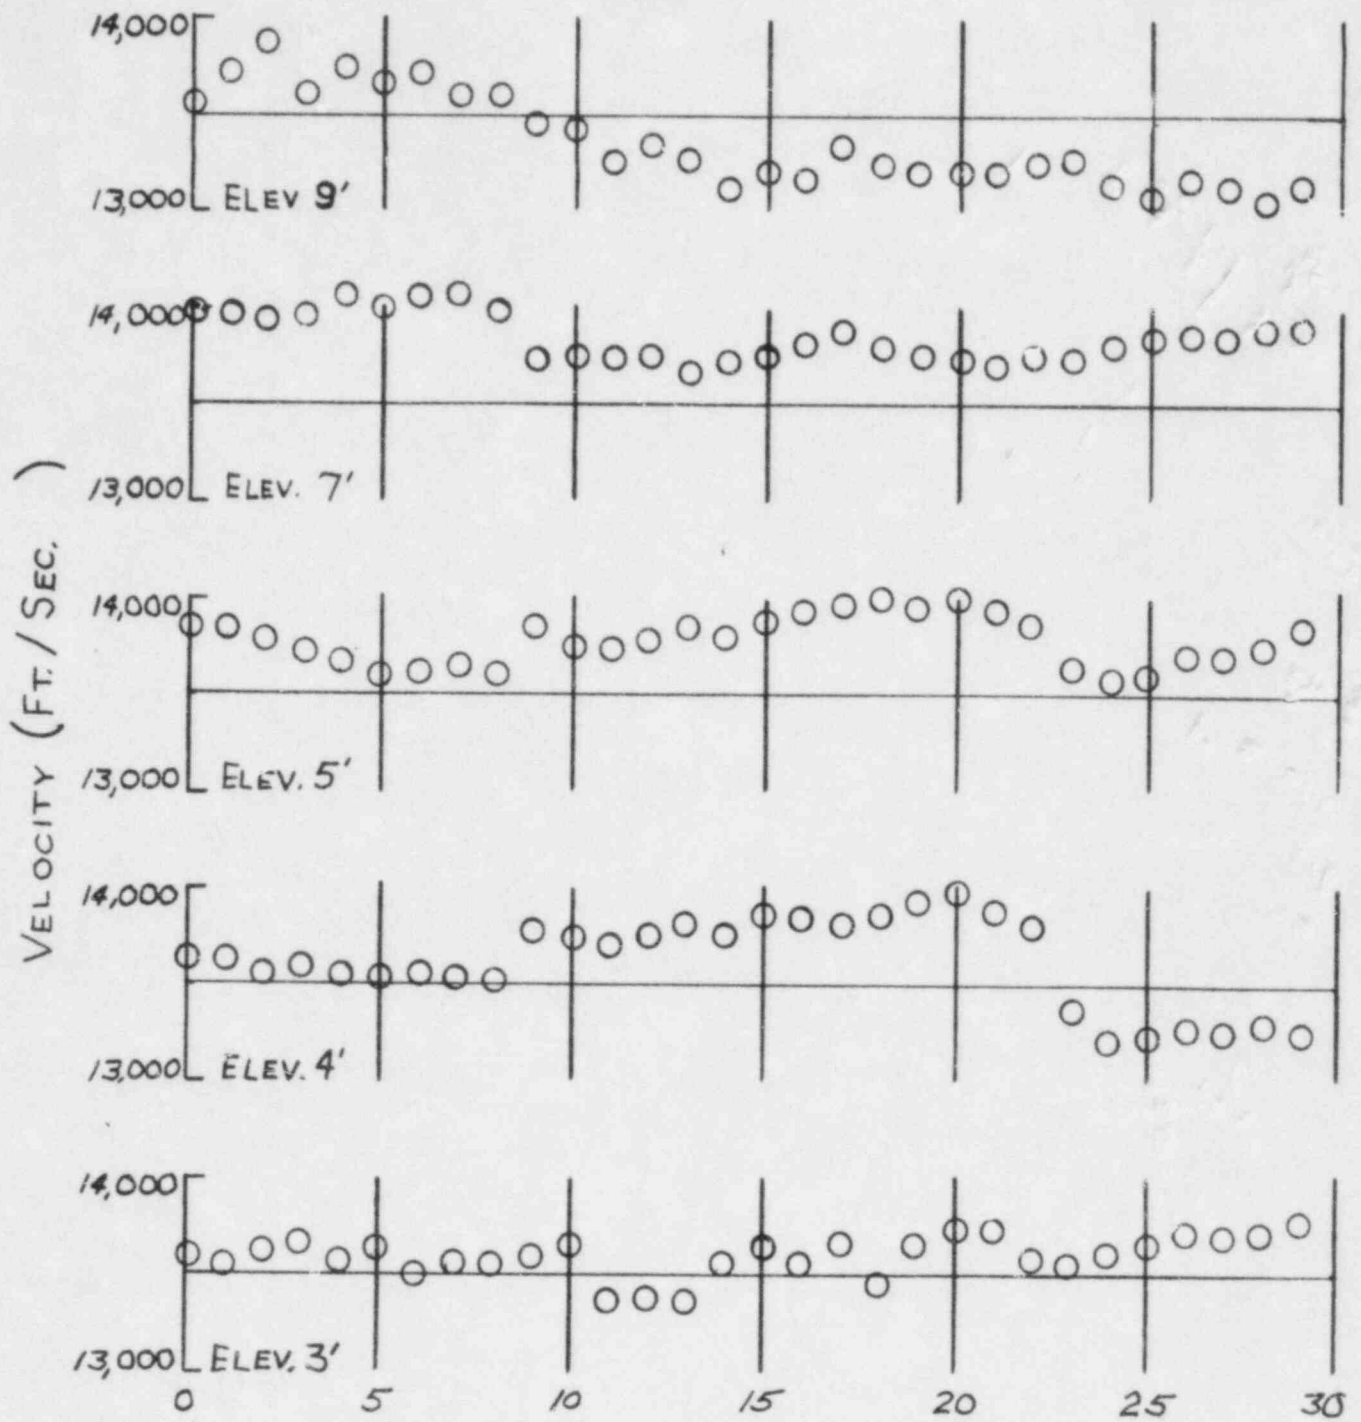
FIG. 1.  
HORIZONTAL MEASUREMENTS OF PULSE VELOCITY  
THROUGH SECTION 6-1, AT INDICATED ELEVATIONS

Figure 1 shows the results of horizontal measurements from the wall of the reactor pit to the outer wall of the containment mat in which the transmitting transducer was moved successively in two degree increments around the outer wall of the mat. During these tests the receiver, held against the inner wall of the reactor pit, occupied only three different positions. Tests were made at elevations 3 ft., 4 ft., 5 ft., 7 ft., and 9 ft. A successful test was accomplished at each position occupied.

Reference to the original report will show that in the earlier tests on the section at elevation 3 ft. there were two positions (61-3 and 61-12) at which no signal was received and fifteen positions at which the received signal was too weak to be interpreted. In the tests made on May 26, 1969 all received signals were of adequate strength and the average velocity measured throughout the elevation was slightly greater than the average of those velocities measured in April, 1968.

In the original tests at elevation 4 ft., no signal was received at test position 61-1 and at position 61-22 the received signal was too weak to be interpreted. Signals of adequate strength were received at all positions during the more recent tests. Velocities measured at positions from 61-1 through 61-21 were the same or a little higher than those measured in April, 1968. A larger than average difference between adjacent readings occurred as the transmitting transducer was moved from position 61-22 to position 61-23, and the velocities measured from position 61-23 through 61-29 were slightly lower than those measured in 1968. It should be noted that the receiving transducer, held against the wall of the reactor pit, was moved 30 degrees around the wall between tests involving position 61-22 and position 61-23, and remained at the latter position through the remainder of the tests on the section. It is believed that the reduction in velocities noted from position 61-23 through position 61-29 at elevation 4 ft. may be attributed to a slight lessening of bond between the reactor pit liner and the containment mat at position 61-30 on the reactor pit liner. Some substantiation of this belief will be pointed out on Figure 2.

In the original tests at elevation 5 ft., unreadably weak signals were received at test positions 61-22 through 61-29. Adequate signals were received at all of these positions during the more recent tests. Velocities measured through the section were about the same or slightly higher at this elevation when measured in May, 1969 than when measured in April, 1968.

At the 7 ft. elevation, adequate signals were received and high velocities measured at all positions tested in the most recent tests, as was the case in the

original tests at this elevation. No unusual variations in velocity were found.

In the original tests at elevation 9 ft., no signal was received at test positions 61-2, 61-5, 61-8, 61-14, 61-15, 61-18, 61-19, 61-20, 61-21, and 61-22, and unreadably weak signals were received at eight other test positions. Successful tests were made at only twelve of the thirty test positions. In the recently completed tests, readings were completed at all thirty positions. Signals observed in these were, however, weaker than those observed in tests at the other four elevations, and the average velocity measured in the thirty tests, 13,380 ft. per second, was somewhat lower than that measured at the other elevations (13,630 ft. per second at elevation 3 ft., 13,620 ft. per second at 4 ft., 13,760 ft. per second at 5 ft., and 13,850 ft. per second at 7 ft.).

In the original report, the difficulties associated with achieving adequate test results at the 9 ft. elevation were attributed to the presence in the slab of a shear key into which the wall would subsequently be erected. It was noted that the shear key was approximately 4 ft. deep throughout most of the section, beginning at about position 61-7, and was of sufficient depth to intercept the test signal. With the erection of the wall, the shear key has been filled with concrete and a continuous path should be available for the test signal. This construction would result, however, in two vertical construction joints which would intercept the signal path, each of which would be expected to result in some attenuation of the signal. It may be noted that the velocities measured through test position 61-6 are of approximately the same level as those measured at other elevations. At test positions beyond 61-6 the velocity began to fall off and remained lower throughout the remainder of the section. It is believed that this decrease is attributable to the presence of the two vertical construction joints in the signal path. The uniformity of the velocity measured over a large portion of the slab at the 9 ft. elevation after the general decrease in velocity had occurred suggests adequate uniformity of the concrete.

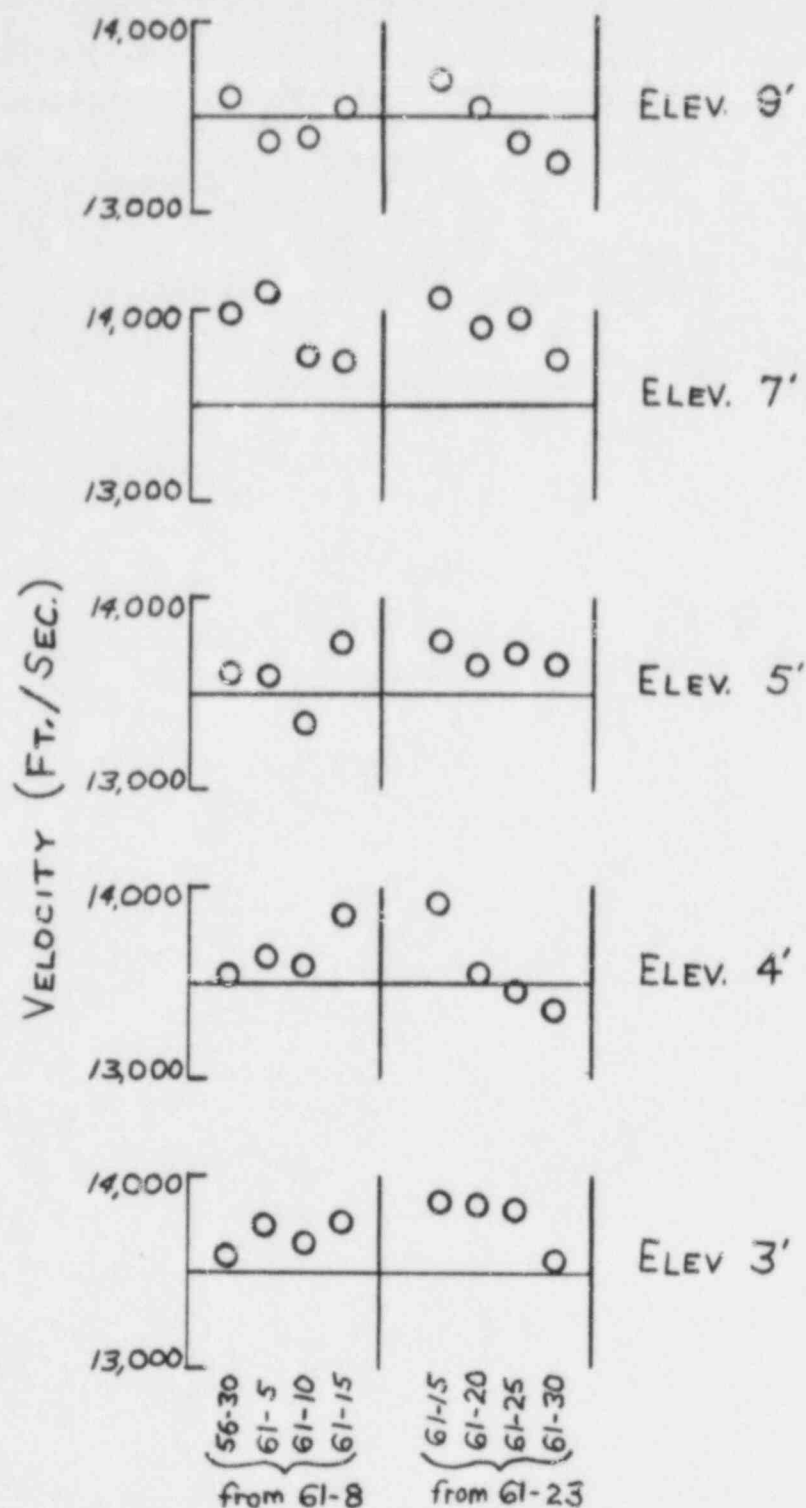
TEST POSITIONS ALONG INNER  
WALL OF REACTOR PIT  
FIG. 2

Figure 2 shows the results of supplemental horizontal tests in which the transmitting transducer was held at only two positions on the outer wall of the mat and the receiving transducer was moved through a succession of ten degree intervals

HORIZONTAL MEASUREMENTS OF PULSE VELOCITY  
REFERENCED TO POSITIONS ON REACTOR PIT LINER,  
AT INDICATED ELEVATIONS.

against the liner to the reactor pit wall. Successful tests were accomplished at all locations. In general, velocities were about the same or a little higher than those measured in April, 1968 and variability of the readings was about the same. One difference occurred at elevation 4 ft. involving test positions 61-20, 61-25, and 61-30. In the recent tests, the velocities measured at these positions were somewhat lower than those measured earlier, and increased as the transducer was moved away from position 61-30, reaching a high level of velocity by the time the transducer reached position 61-15. Attention is redirected to the horizontal tests at elevation 4 ft. in which all tests made to the outer wall (positions 61-23 through 61-29) for which the receiving transducer was held at position 61-30 against the reactor pit liner showed lower readings than average for that elevation. It is believed that these results substantiate the conclusion that there has been some lessening of the intimacy of bond between the reactor liner and the mat at and near position 61-30 at elevation 4 ft.
