SUBJECT: FOLLOW-UP REPORT TO ABNORMAL OCCURRENCE ENTITLED "CORRELATION OF FUEL
FAILURES AT DRESDEN-3 IDENTIFIED BY WET SIPPING TESTS TO CALCULATED
VIOLATIONS OF GE POLICIES"

Fuel Failures Identified at D3-ECC3 by Wet Sipping Tests and Comments Regarding the PCICMR.

Defective Fuel Assemblies Identified at
Dresden-3, End-of-Cycle 3

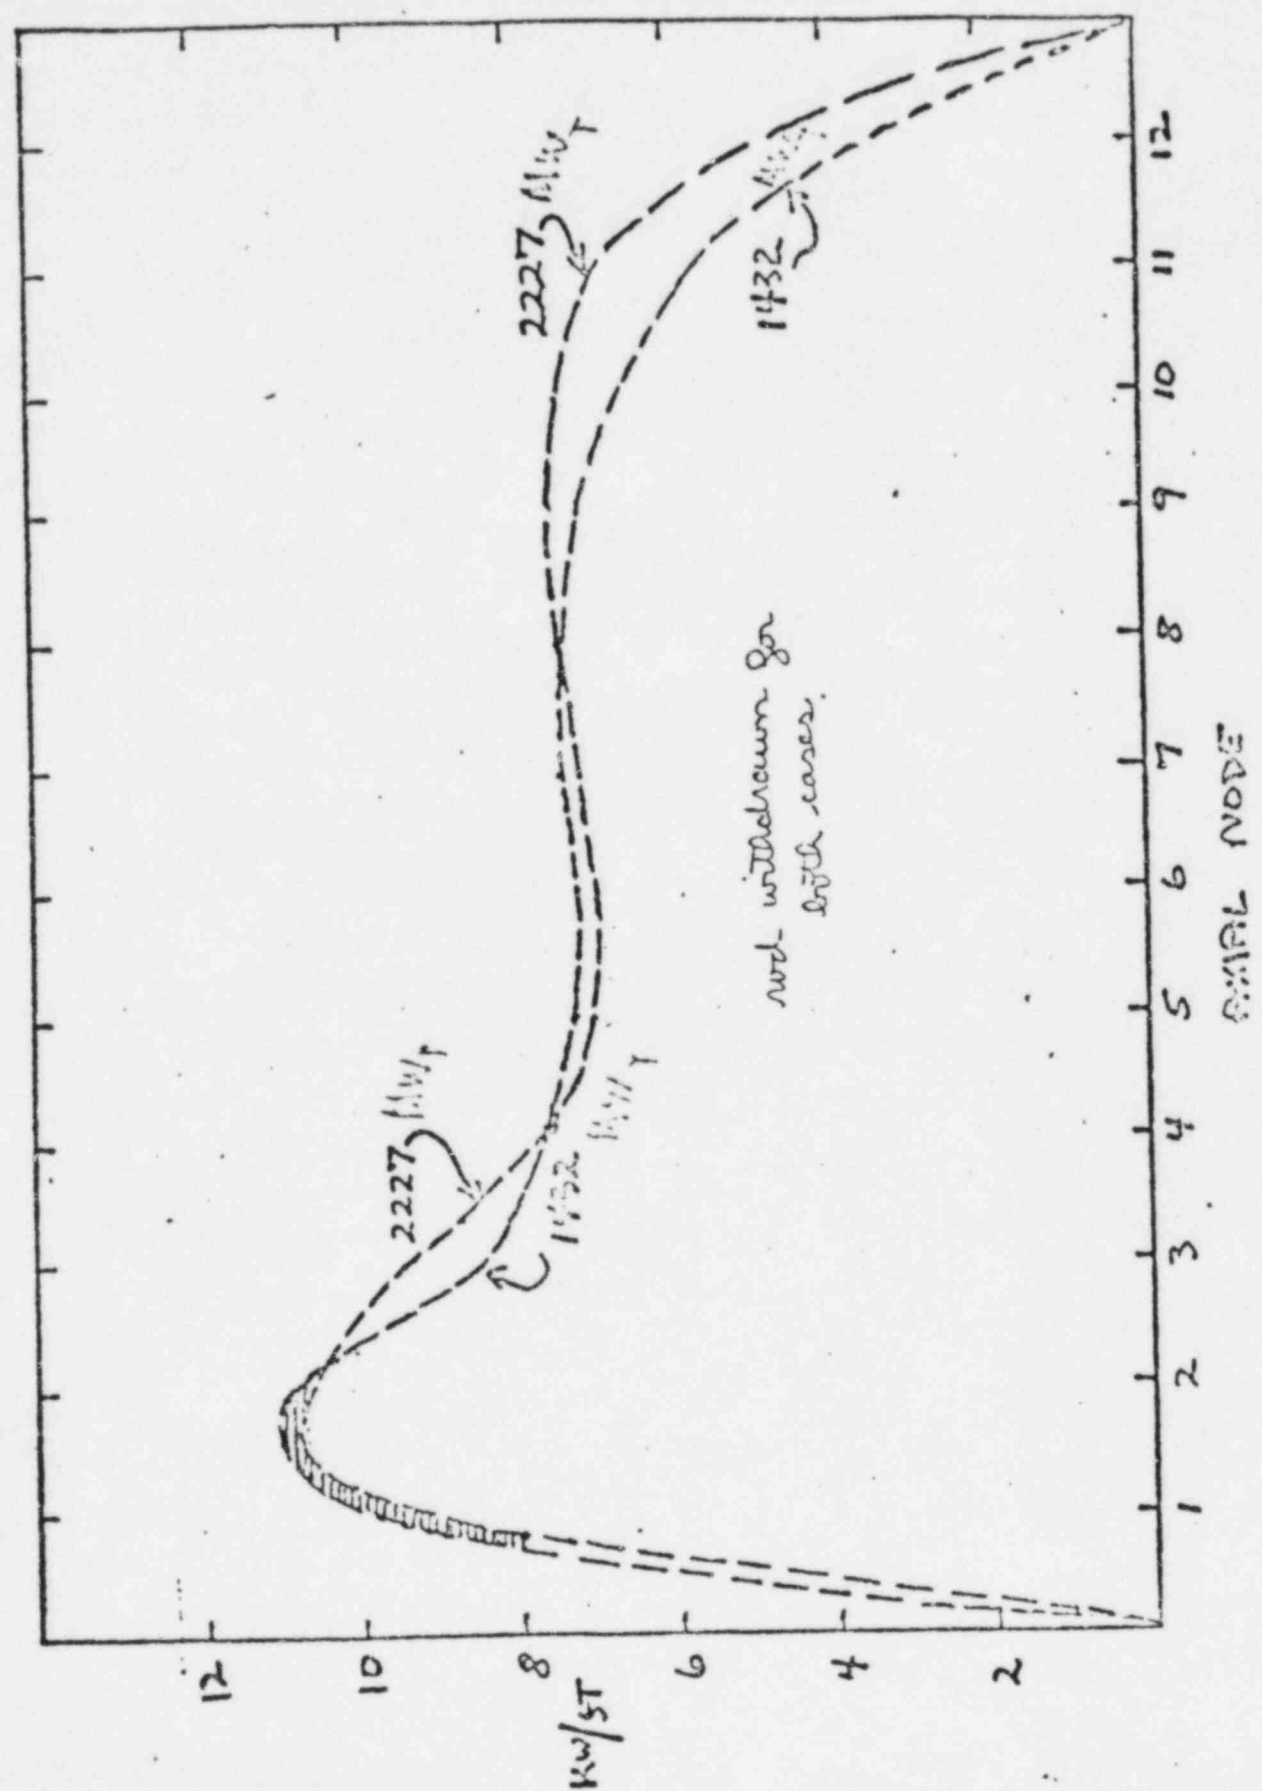
FIGURE 4

Figure 1 is a core map indicating the location of the leakers. Figures 2 to 4 graph three power distributions (equilibrium xenon) typical of the preconditioned shape (2227-Figure 4 (a)) and the shape at 6:57 a.m. on 10-31-74 (1432-Figure 4 (b)). Xenon transients, depending on core location, will increase the bottom peaks by 0 to 25%.

CORNER PIN H3 UNCONTROLLED

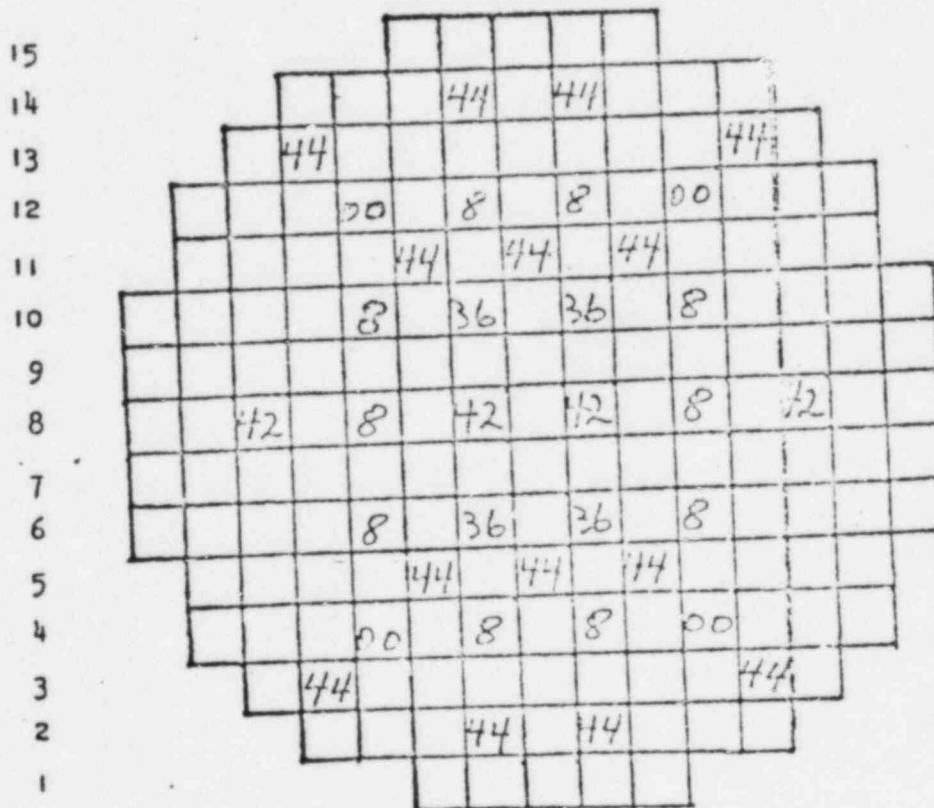
FIGURE 4(b)

6:57 AM conditions

K EFF	<u>1.00967</u>	
SE S =	<u>2.655 (12, 6, 2)</u>	(AX ?)
POWER LEVEL	<u>1432</u>	NW _{TH}
CORE INLET SUBCOOLING	<u>23.5</u>	BTU/lb
TOTAL CORE FLOW	<u>48.0</u>	M-lb/hr (in channel)
PRESSURE	<u>976</u>	PSIA
CRD	<u>0.034</u>	
DATE OF LAST SE- QUENCE CHANGE	<u> </u>

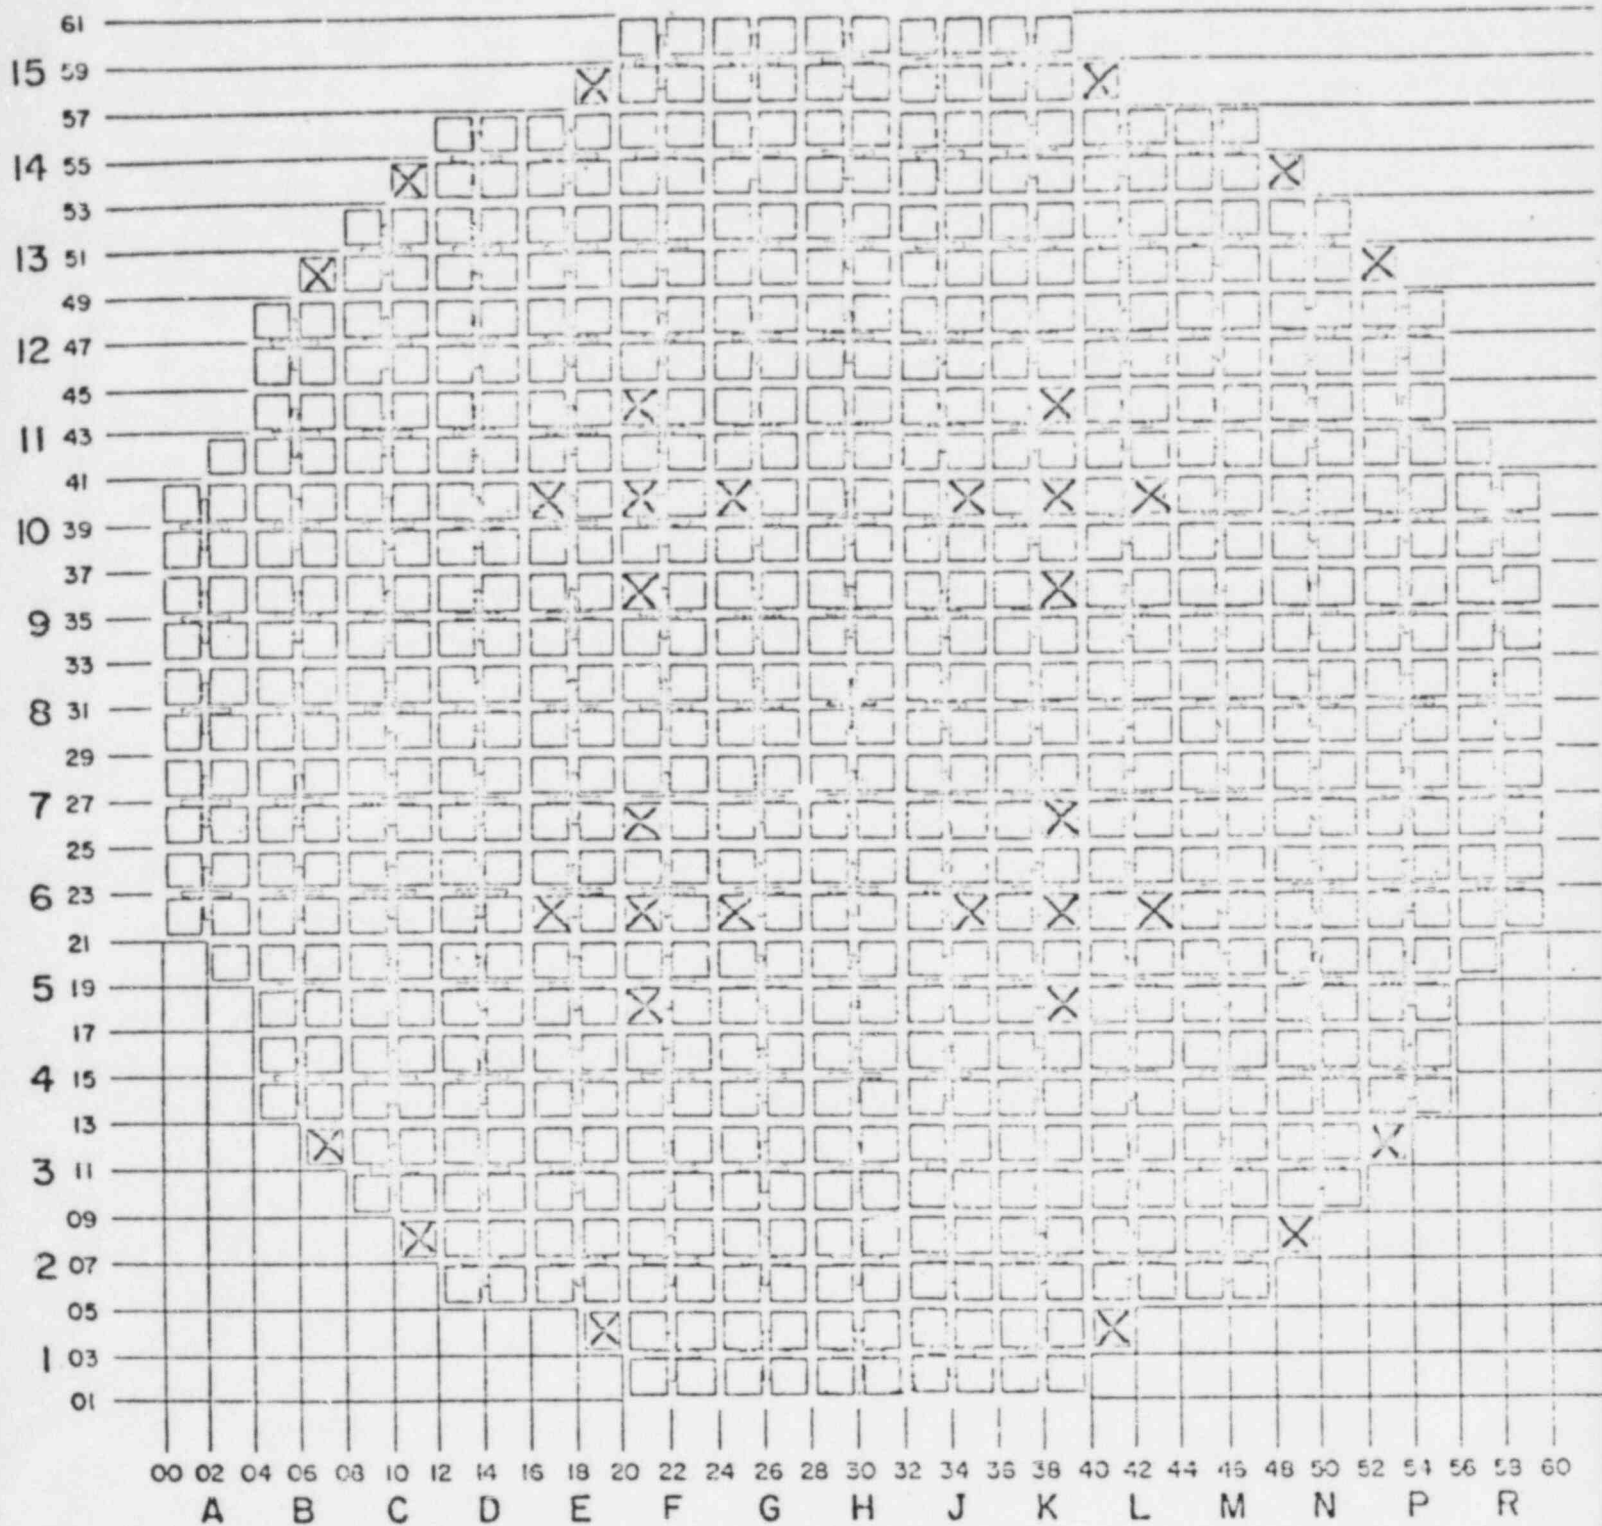
FIGURE 6

- (a) None of the Cycle 2 edge assemblies, including those moved to the center for Cycle 3, failed - Figure 6.
- (b) There were three assemblies from cells that had 3 out of 4 failures at ECC-1 that were moved to uncontrolled locations on the edge for Cycles 2 and 3. None of these three has failed yet.
- (c) Four edge assemblies failed during Cycle 3. One, DDO209, was classified as a suspect leaker at ECC-2.
- (d) Of 50 Cycle 3 assemblies that were reconstituted at ECC-1, six failed. All but one may be attributed to 10-31-74.

Edge assemblies during cycle 2

(+ 52 GEBs)

10-31-74 average exposure
 $\approx 7400 \text{ mwd/T}$
