SITE PROBLEM  
REPORT TRANSMITTAL

FILE: 13-14-386  
CONTRACT NO: 620-00 14  
SPR 386  
TITLE Electronic  
Relief Valve Modification  
DATE: 3/27/78  
STATUS CODE C

# SITE PROBLEM REPORT

| TITLE (MAX 30 CHARACTERS)<br>Electronic Relief Valve Modification | | | PROBLEM CONTACT<br>J. E. Anderson | |

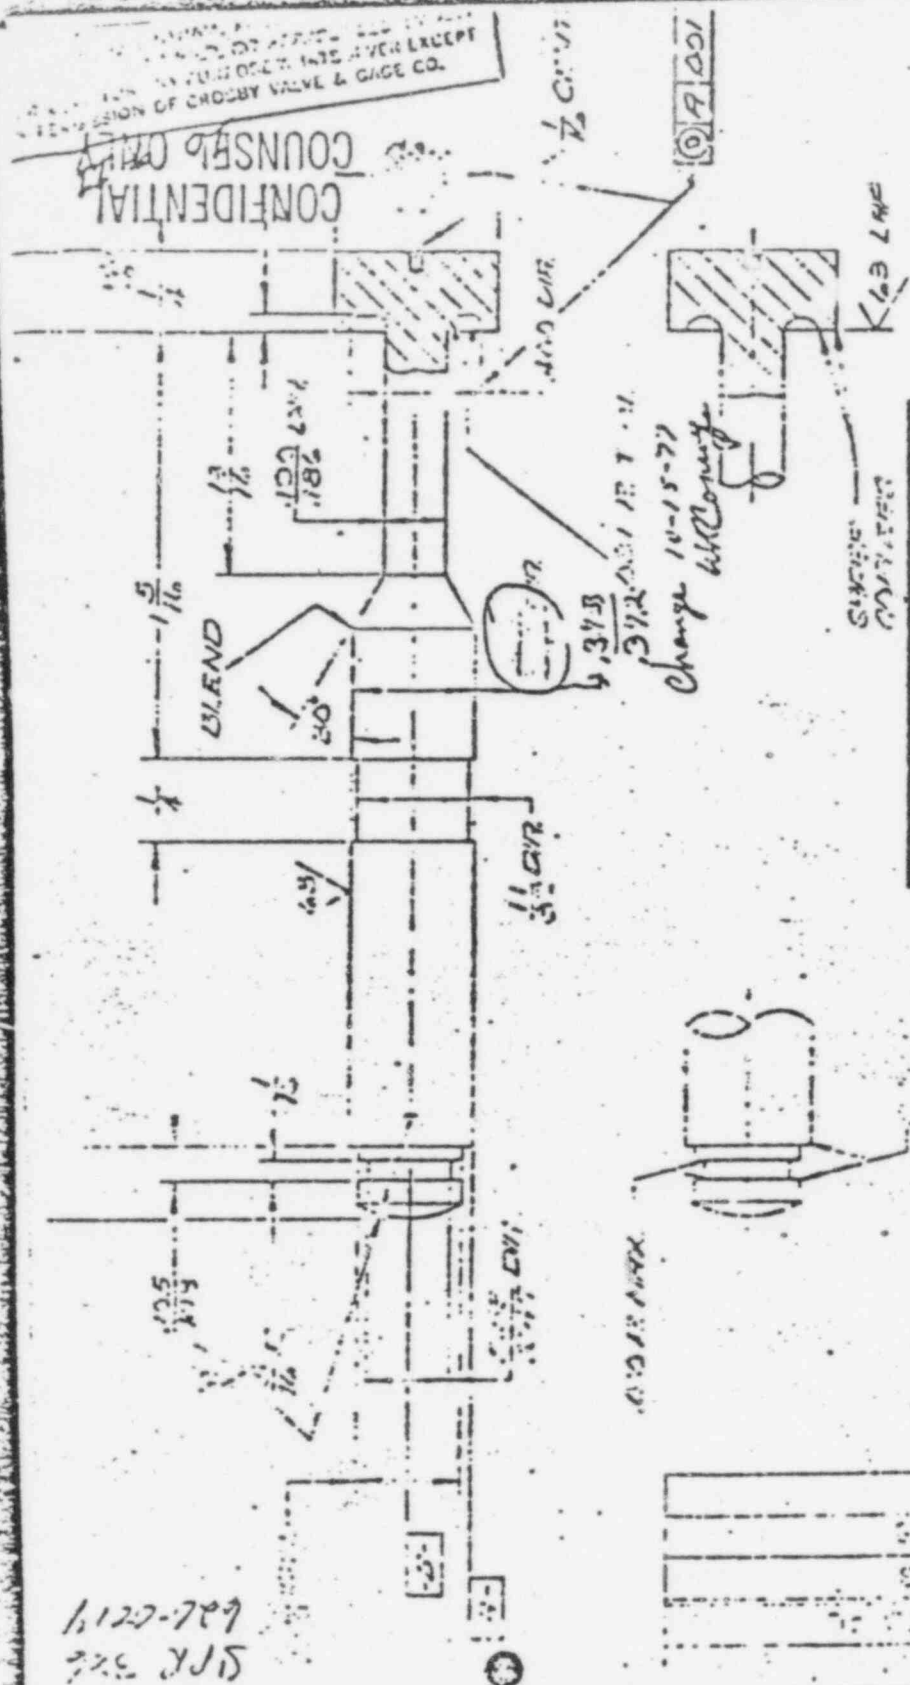
CROSBY WAVE & G.C.  
VIREN, MA, MASS.  
P.O.C (PILOT WAVE)  
100-1-SN

Crosby rep., Walt Conroy, arrived and the pilot valve assembly was removed from the main valve. Disassembly of the pilot valve revealed that the pilot valve stem had stuck open due to the close tolerance causing a binding condition between the O.D. of the stem and the I. D. of the pilot valve nozzle. Also, a small metal particle was found in the pilot stem/nozzle area. Subsequent cleaning of the inlet piping to the ERV revealed this same type of metal particles.

The Crosby representative furnished a detailed drawing of the pilot valve stem requiring a diameter of .374. This was changed to read .373 diameter .372.

by the Crosby rep., and the stem was modified accordingly by TECO Maintenance under the direction of the Crosby rep. This modification resulted in opening the clearance between the stem and the nozzle thus eliminating the binding. The nozzle was also reamed out with a reamer the same size, no material was removed.

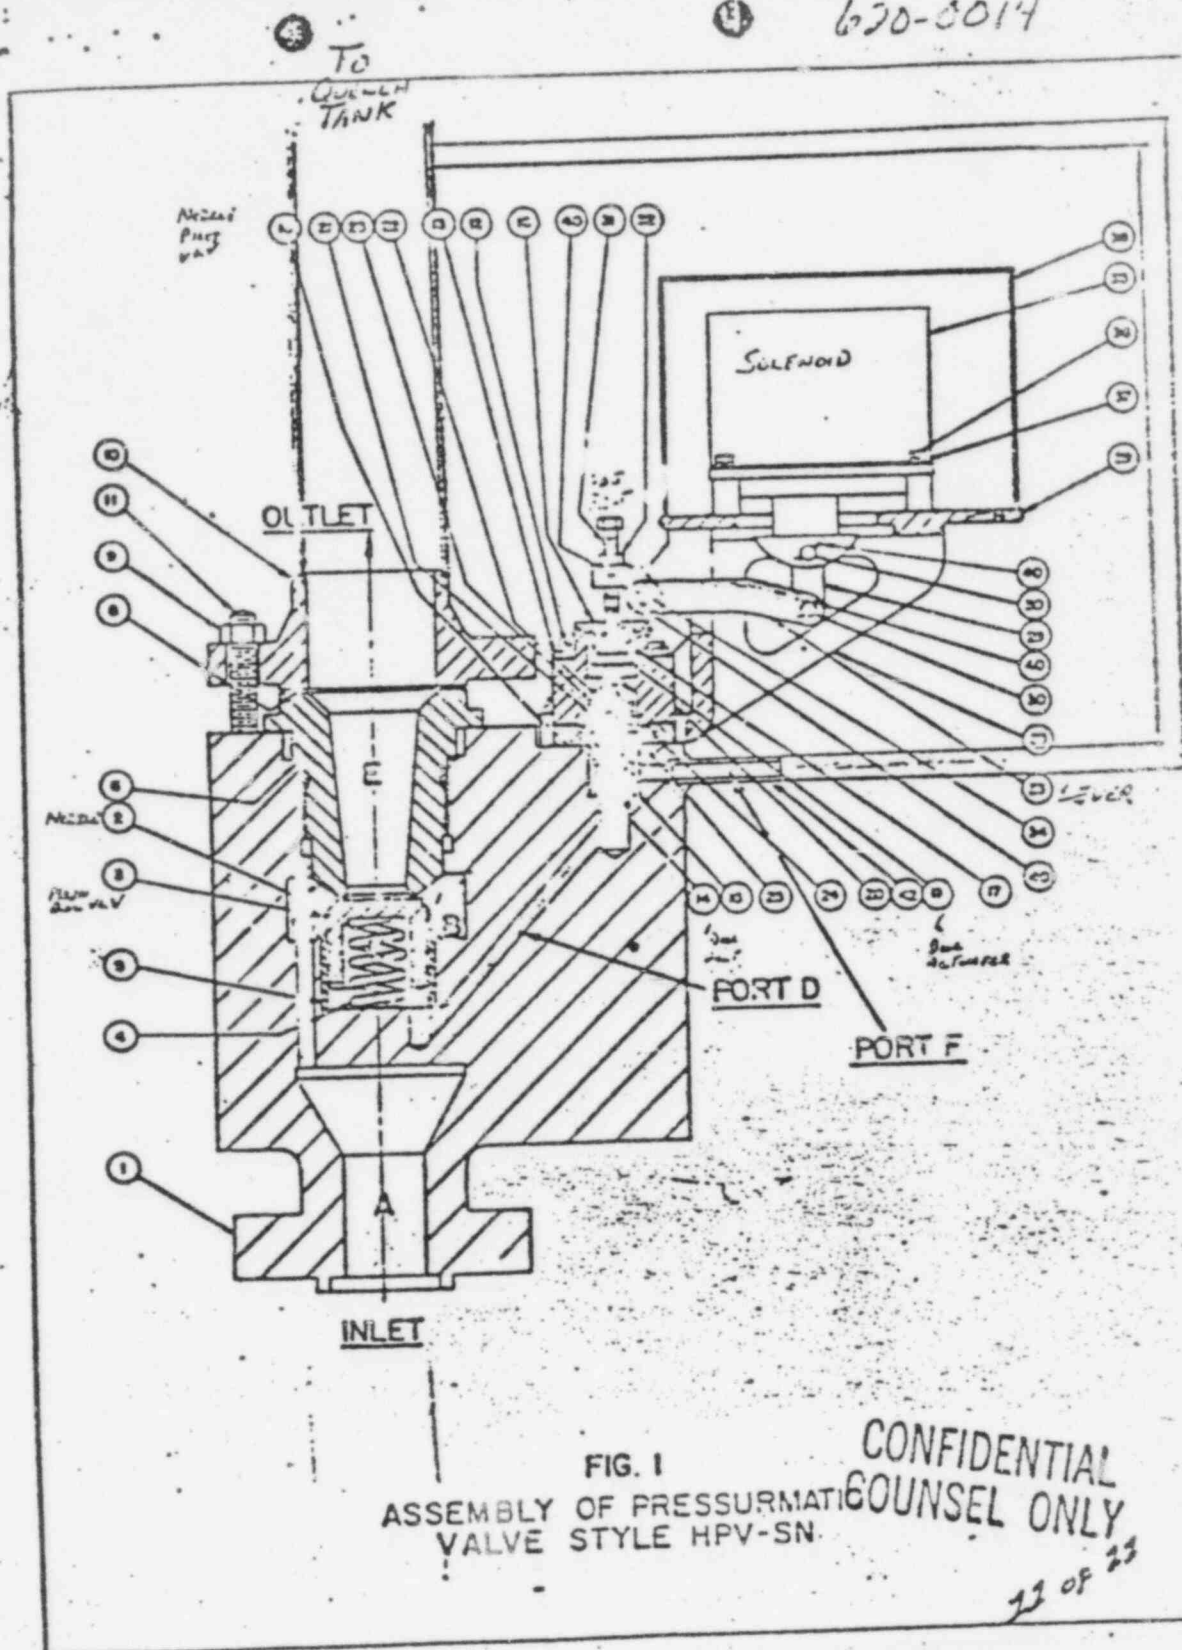
FIG. 1  
ASSEMBLY OF PRESSURIZATION  
VALVE STYLE HPV-SN

On 10/13/77, the electromagnetic relief valve was tested after the completion of repairs as outlined in SPR #369. The valve was cycled six times successfully. On the seventh test cycle the pilot valve did not close. The ERV was isolated and permitted to cool down while waiting for Crosby representatives.

All parts were cleaned and assembled. The solenoid linkage was adjusted to drop the adjustment bolt more squarely on the disc actuator. In addition, the adjustment bolt was positioned to move the pilot valve stem off the seat a maximum of .125". It had been moving off the seat some .375".
