Gegenstand / Objet / Oggetto: Cracks in Feedwater  
Spargers in the KKM Nuclear Station GE-BWR

# SPEISEWASSER- RINGLEITUNG

KKM - SE-BWR  
Feedwater - Spargers  
\* Port man's dye check  
of Jan 17, 1974

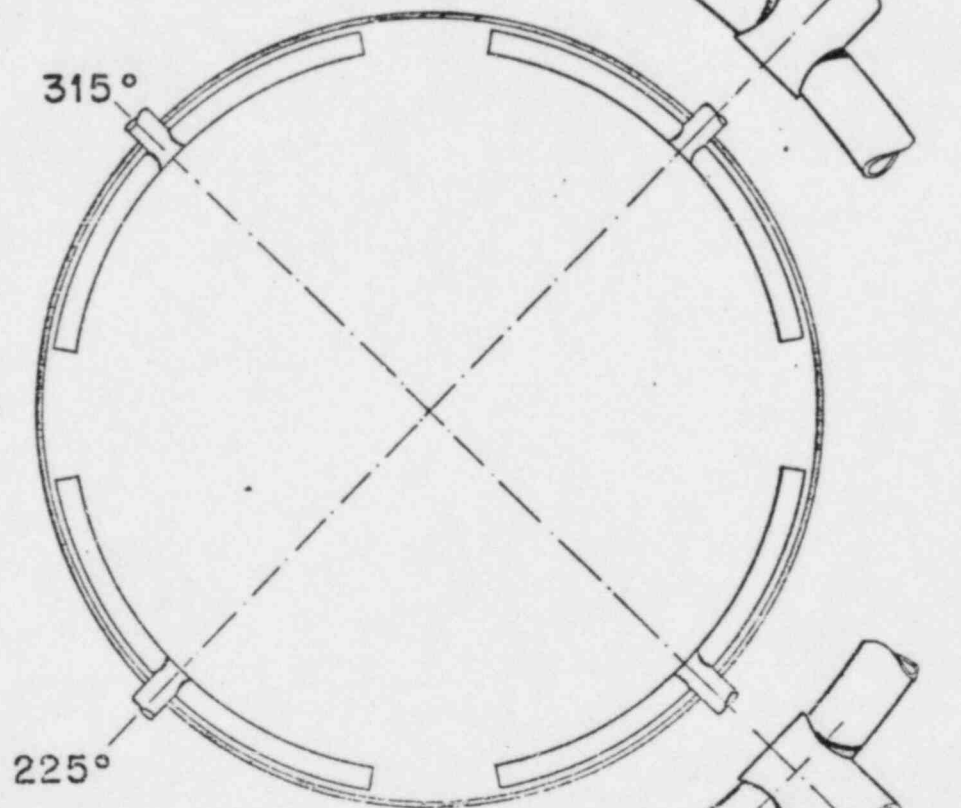
As a first test, the pretension of the spargers was checked. It was observed that on 7 out of the total of 8 sparger-halves the initial pretension was almost completely lost (the fixation bolts could be turned relatively easily).

The indications as observed in January are shown on the attached sketch, which BKW was so kind as to give us for transmittal to your office. The wet spots are marked in red.

- All humid spots seen in Sept. '73 showed up again, but appeared to be stationary.
- Two additional indications were found, one of these starting from the first flow hole at 135°. This crack appears to be very thin. It is approx. 2 in long.
- The more important cracks (thicker red) have a length of approx. one third of the pipe diameter.
- Again, none of the cracks could be seen under water, either by TV or with binoculars.

As to possible causes, GE has told us they suppose feedwater flow oscillations might have led to vibrations and subsequent fatigue at Millstone. Here at KKM we have an extremely stable feedwater control system, the entire core however, being rather noisy in the upper load range (neutron flux, jet pump flow, occasionally main steam pressure). According to GE, this is apparently normal for the high-power cores.

Red marks indicate a: humid spots remaining  
after lowering of liquid water  
level and drying of  
spargers

We have again permitted resumption of plant operation, since we considered that a) no immediate danger of sparger rupture exists, b) even in case of rupture no direct damage to the core seems possible and c) large asymmetries in flow would probably show up in the neutron flux distribution. A new check is planned for the Summer '74 first refueling shut down.
