GENERAL ELECTRIC

NUCLEAR ENERGY
DIVISION

January 28, 1974

General Electric has conducted a study of feedwater spargers to determine why cracks appeared in the spargers at the Millstone Nuclear Power Station. Our investigation has included inspections of feedwater spargers at operating plants, instrumentation of the Millstone spargers, and cold flow testing at the G.E. Sparger Test Facility in San Jose. Inspection of spargers in ten operating plants has been completed. The only plant with confirmed defects is at Millstone.

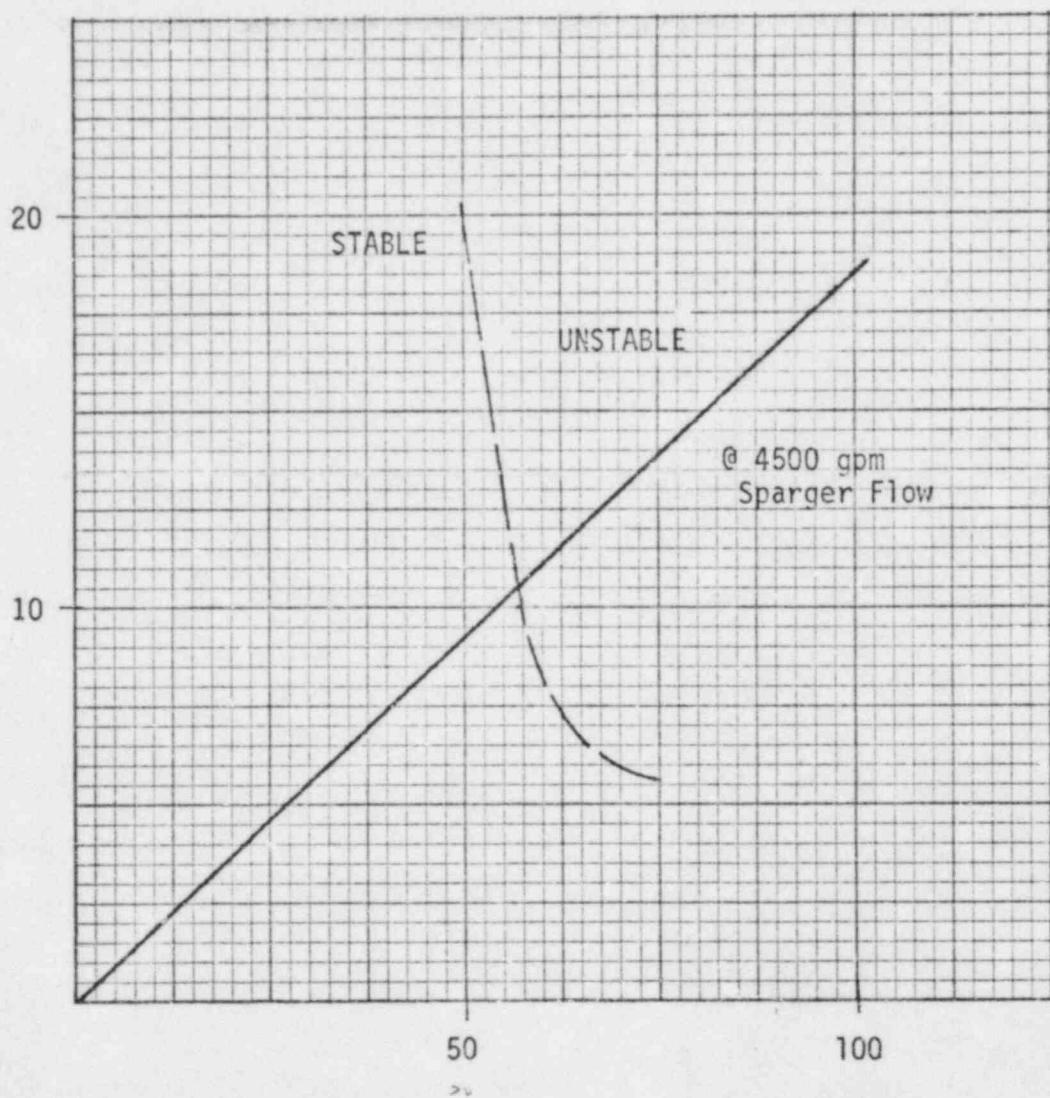
FIGURE 1

1. For a given sparger flow, the leakage is directly proportional to the average radial gap between the nozzle and thermal sleeve. (See Figure 1)
2. For a flow of 4500 gpm, the sparger is susceptible to self-excitation or leakage flow induced instability if the average radial gap is greater than .011-inches. (Figure 2 shows a feedwater sparger installation indicating the radial gap of concern.)
3. A line defining the predicted unstable region is also shown in Figure 1 for the particular sparger tested.

LEAKAGE FLOW AND STABLE AND UNSTABLE
REGIONS IN A FEEDWATER SPARGER INSTALLATION

Near Operating Plants - By expanding the feedwater sparger thermal sleeve, the radial gap between the nozzle and thermal sleeve can be reduced to a point where instability will not occur. The feedwater sparger will be removed and expanded, as necessary, to give the proper radial gap to eliminate flow induced vibrations.

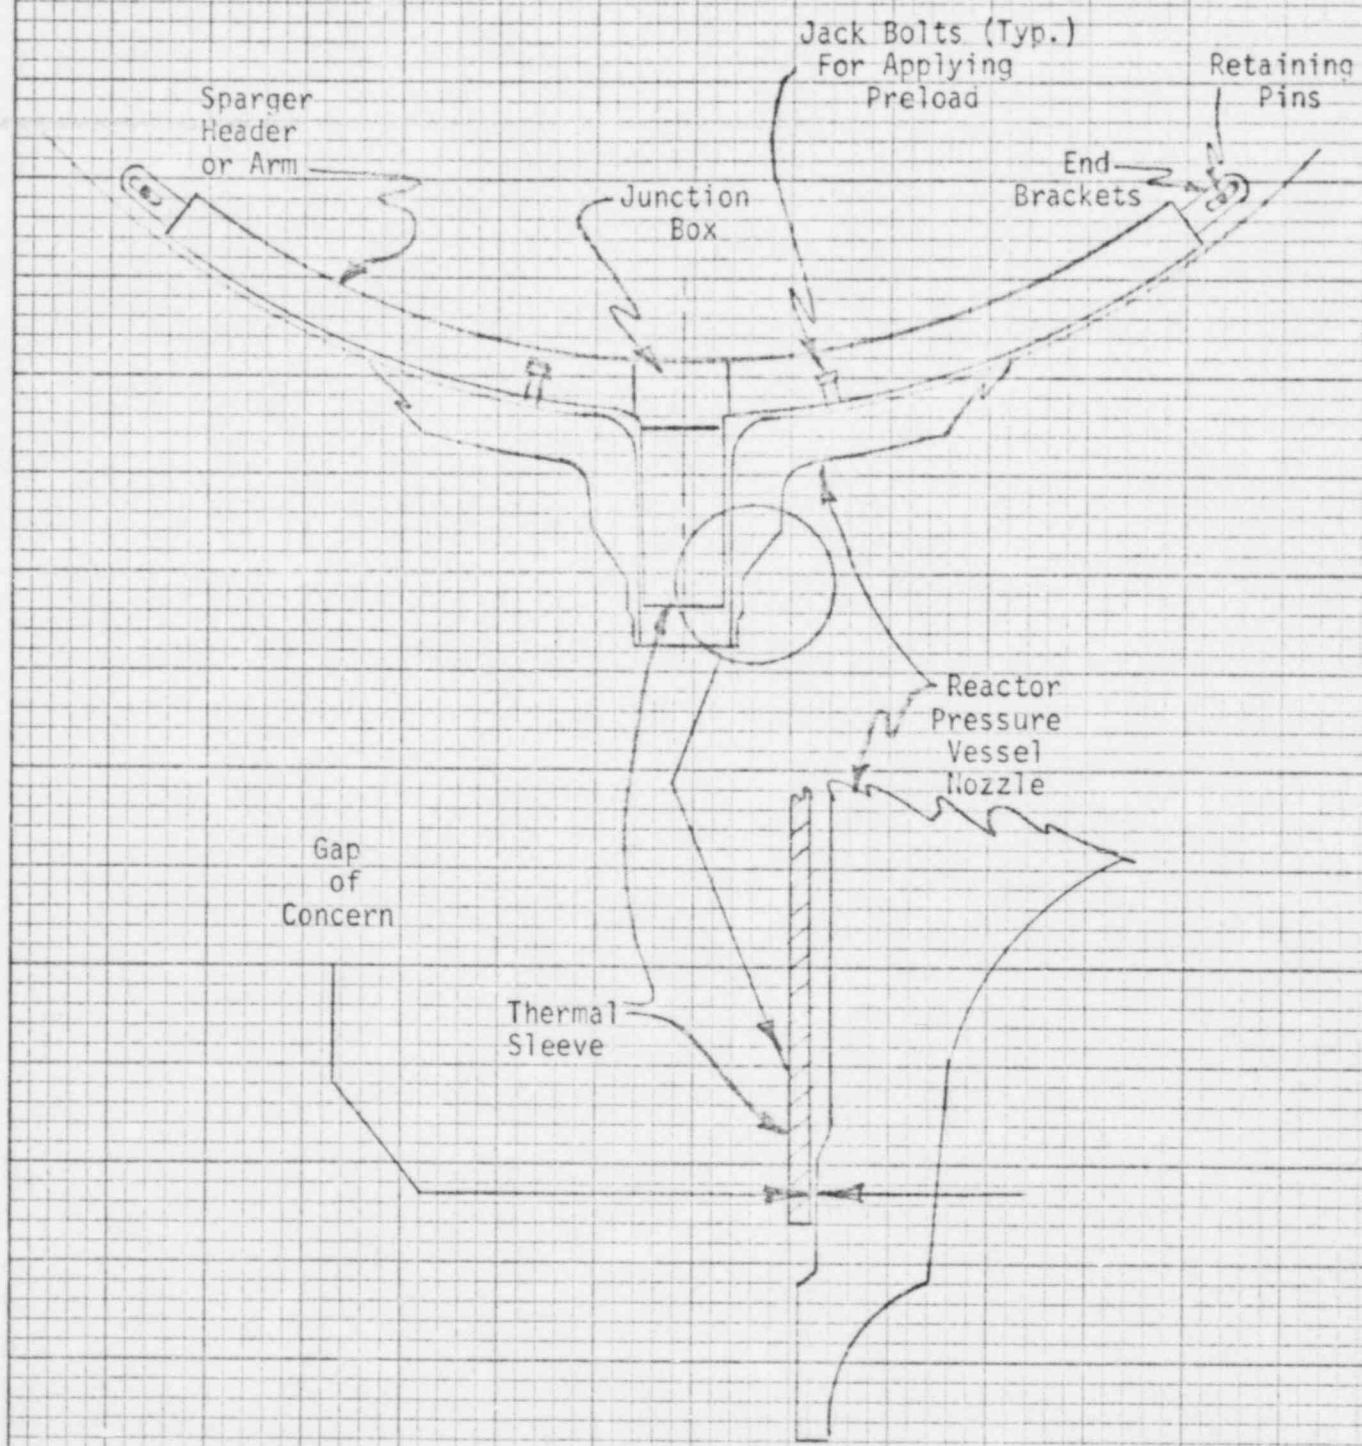
FIGURE 2

FEEDWATER SPARGER INSTALLATION
