NYN-91168

Subject: Completion of Incore Instrumentation Thimble Initial Inspections

SEABROOK STATION UNIT 1 INCORE INSTRUMENT INSPECTION AND MONITORING REPORT

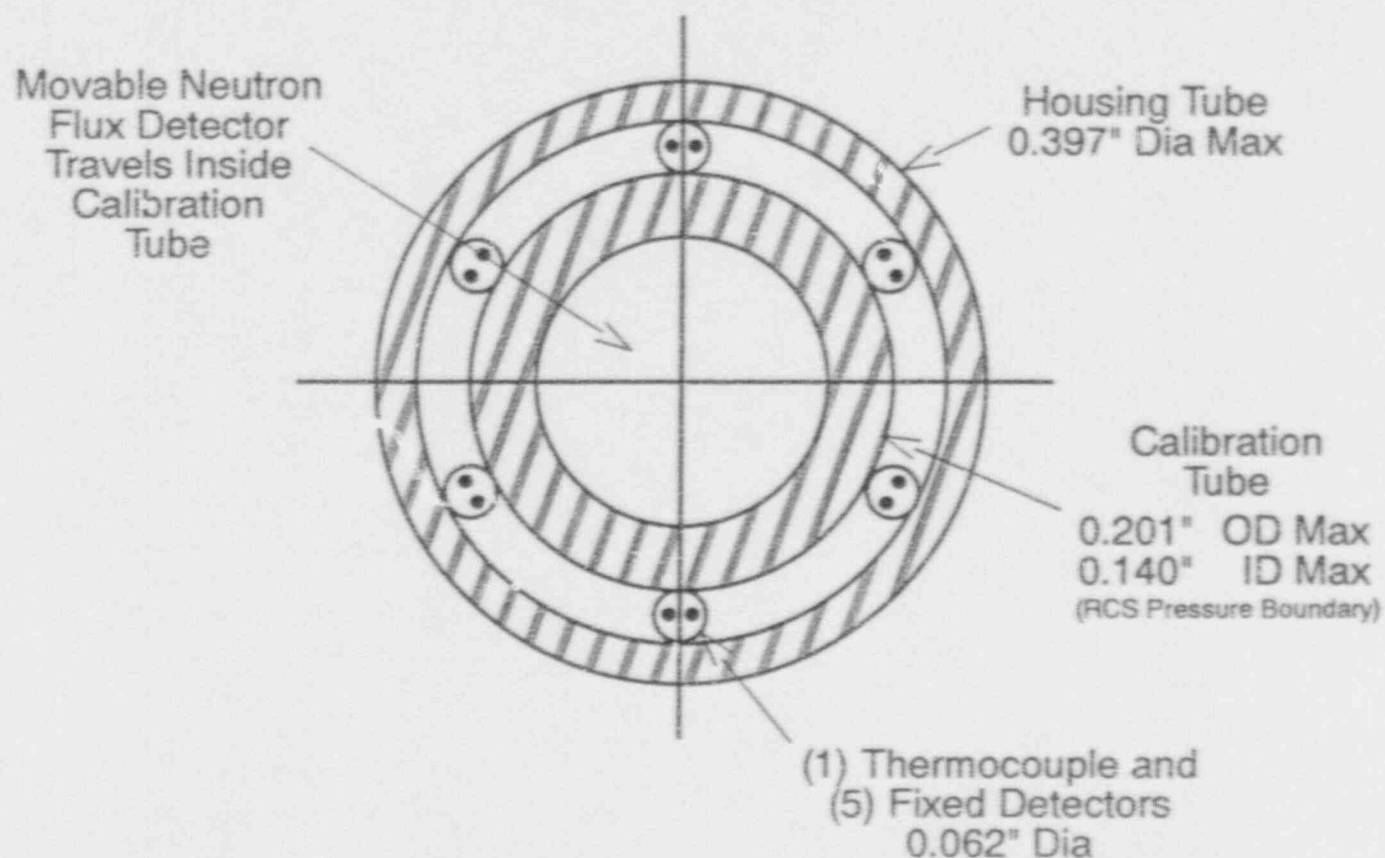
Figure 1
Cross section
of double wall concentric
thimble tube

- Double, concentric thimble tube design. Each of the fifty-eight (58) Seabrook Station incore instrument thimbles consist of an outer tube called a "housing tube" containing five fixed flux detectors and one fixed thermocouple on an inner calibration tube. (See Figure 1 for a cross section of a Seabrook Station thimble tube). The moveable neutron flux detector travels inside the calibration tube. The calibration tube is considered the reactor coolant pressure boundary; however, the housing tube can also withstand Reactor Coolant System (RCS) pressure. In the event of failure of the housing tube, reactor coolant would be contained by the calibration tube and the seal table. A failure of both the housing tube and the calibration tube would be required before reactor coolant would leak into the Containment.

Performing the eddy current inspection of the housing tubes requires a more demanding analysis since the housing tubes are separated from the eddy current probes by the calibration tube wall and the thermocouple and fixed detector leads. (See Figure 1). The analysis used to evaluate the housing tube involved three frequencies: 30 KHz, 60 KHz and 200 KHz. The 30 and 60 KHz signals provided good signal penetration of the outer housing tube while the 200 KHz signal was constrained to within the housing tube inside diameter. The phase analysis was performed on the 200 KHz signal and the 200/30 KHz mix. Amplitude analysis was performed on the 200/30 KHz mix and a 200/60 KHz mix. This technique was utilized since it provided good sensitivity to known defects in a demonstration standard fabricated from a thimble segment manufactured in the same lot as the Seabrook thimbles. Utilization of this technique allows for detection of wall loss as low as 20 percent of the housing tube wall thickness.
