SUBJECT: LICENSE DPR-25, DRESDEN NUCLEAR POWER STATION, UNIT #3, REPORT OF

ABNORMAL OCCURRENCE PER SECTION 6.6.B.1 OF THE TECHNICAL SPECIFICATIONS.

ELECTROMATIC 3-203-3A RELIEF VALVE FAILURE.

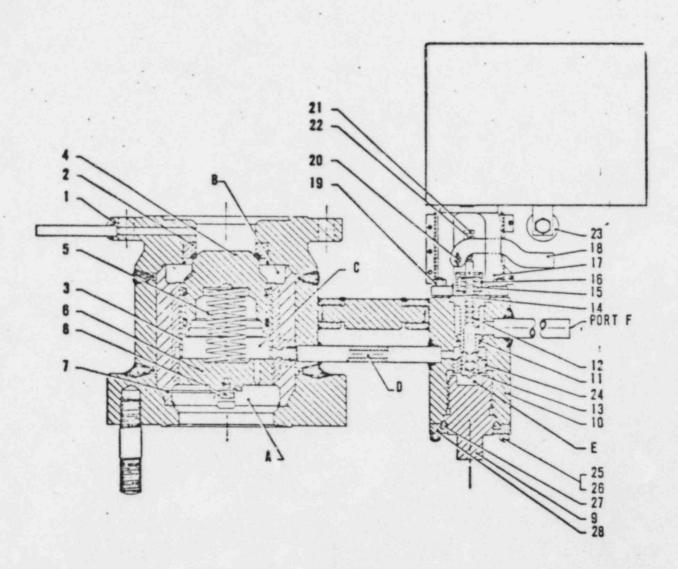
Electromatic 3-203-3A was removed from the drywell and disassembled. The disc retainer, see Part 6 of Figure 1, was found cocked and could not be unthreaded. Upon inspection, it was found that the threads were gone and the disc could be pulled out. It is thought that the threads were destroyed due to vibration as the disc retainer is made of a softer material than the valve body. Then when the pilot valve was opened, the steam leaking past the destroyed threads was sufficient to keep the valve closed.

The threads in the value body were cleaned and a new disc retainer installed. The value was then returned to service. The other four values were checked for a similar failure. The disc on value 3-203-3B could be moved approximately 1/8 to 1/4 turn. The disc was removed and the threads

were found in good condition. The other three valves were found with the disc retainer securely in place.
