Northern States Power Company
Prairie Island Nuclear Generating Plant
1717 Wakonade Dr. East
Welch, Minnesota 55089

PRAIRIE ISLAND NUCLEAR GENERATING PLANT
Docket Nos. 50-282 License Nos. DPR-42
50-306 DPR-60

Request for Approval of Alternative to ASME Code Requirements

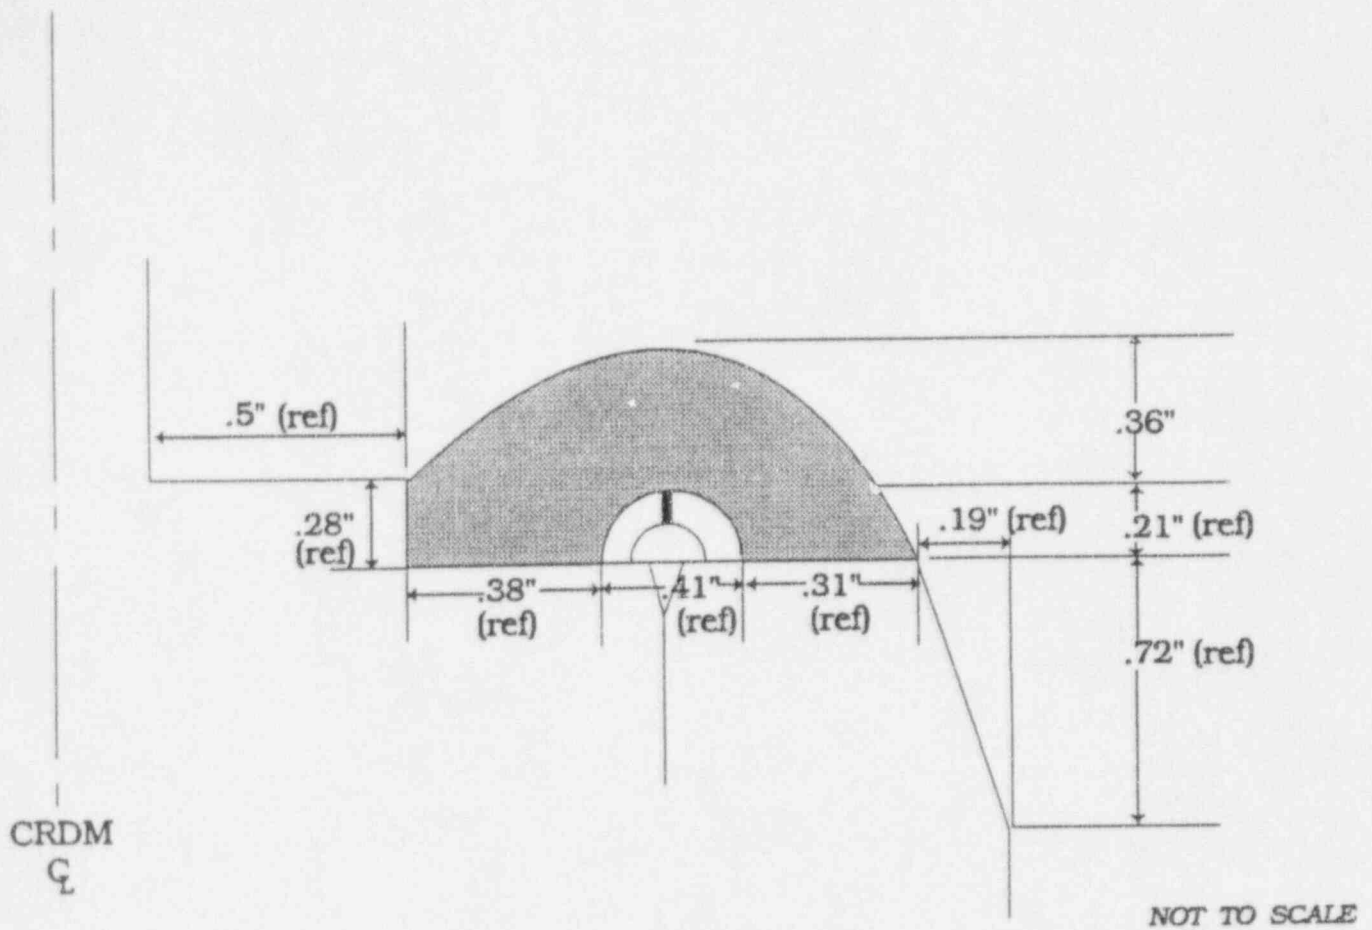
Figure 1. Canopy Seal Weld Overlay Design and Dimensions used in Analysis

The design geometry of the repair is illustrated in Figure 1. For the purpose of the present evaluation, the component was modeled as a pipe with outside radius equal to that of the latch housing (3.7 inches) and wall thickness equal to the overlay thickness in the vicinity of the latch housing outside surface (0.31 inches minimum), as shown on Figure 1. Through wall axial and circumferential flaws were evaluated. These geometries are considered to be reasonable representations of the actual design geometry. The model geometries are shown in Figure 2.

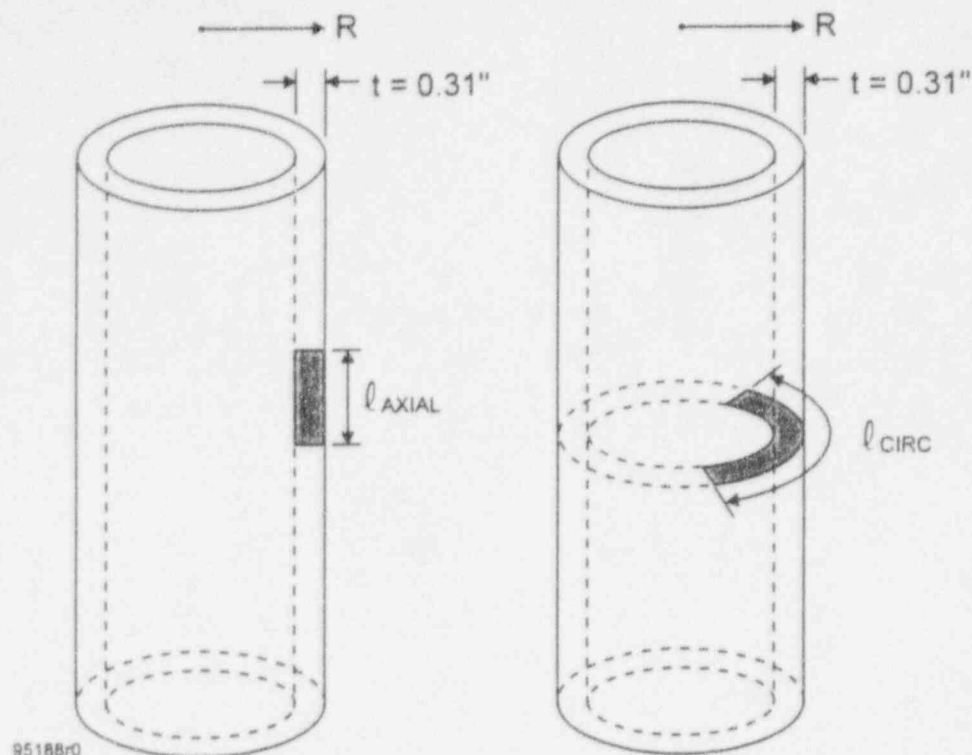
Figure 2. Modeled Geometries

$$R = \text{Outside Radius of Latch Housing} = \frac{7.386}{2}$$

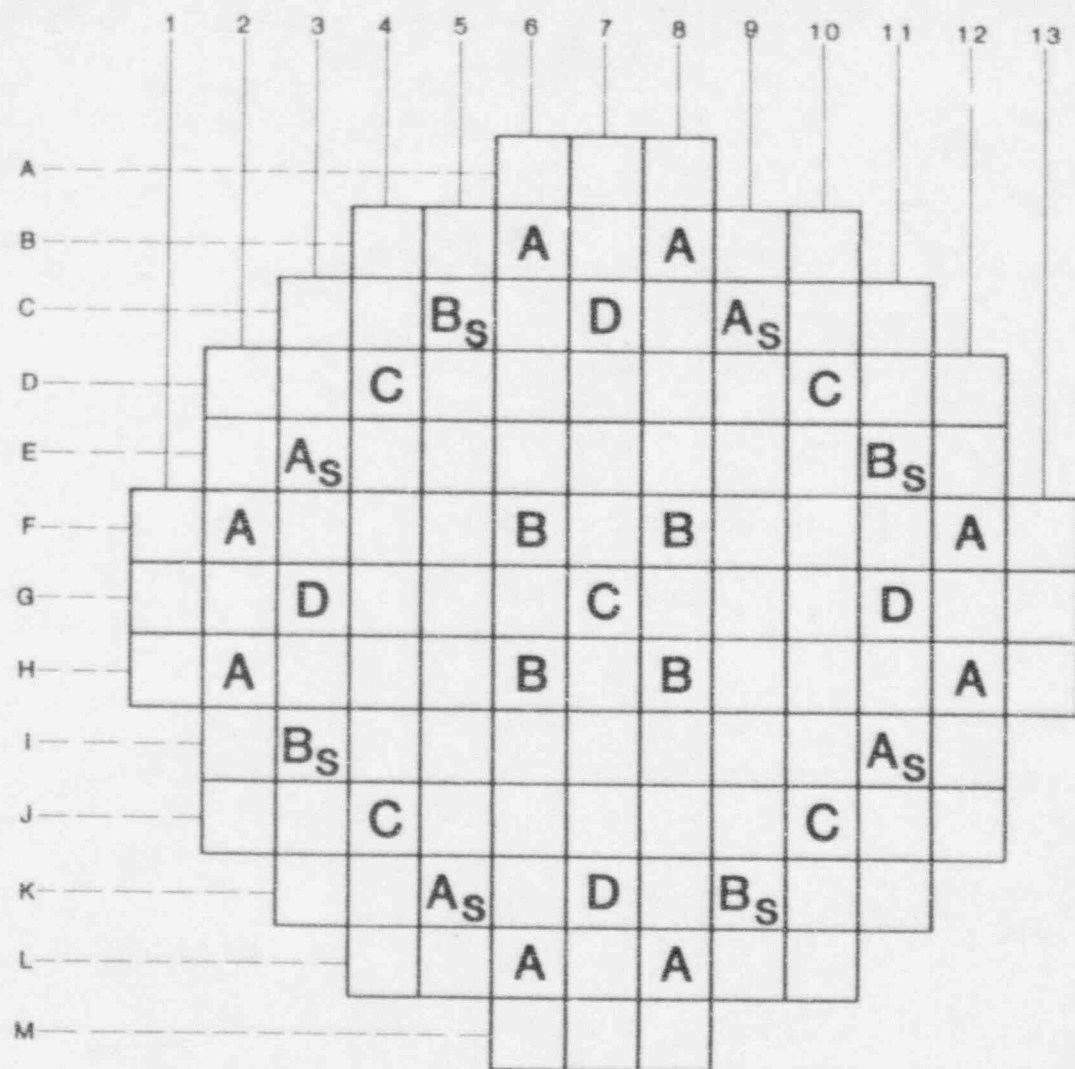
SYSTEM DESCRIPTION FIGURE B5-2

During installation of canopy seal clamp assemblies on the Unit 2 spare penetration lower canopy seal welds, boric acid residue was noted at the base of the rod position indication stack at full length control rod drive mechanism (CRDM) location H6. The residue was confined to the rod position indicator stack and upper coil housing on the CRDM stack with minor spray on surrounding rod position indication stacks, no boric acid residue was noted below the upper coil housing on the penetration or reactor vessel head insulation. The intermediate canopy seal weld area was inspected and two additional boric acid deposits were identified indicating minor leakage at locations H8 and F8 (see Attachment 3).

The repair options were evaluated and it was determined that the most appropriate repair was the use of a weld buildup rather than removing the defect and performing a weld repair. Weld buildup was an acceptable repair technique because the canopy seal weld does not provide the structural strength or the pressure boundary for the joint. A fracture mechanics analysis was performed to justify not removing the existing defect. Even though the canopy seal does not provide structural strength for the joint, the weld buildup over the canopy seal is considered a repair under the rules of ASME Section XI, IWA-4000 because the welding is performed on pressure retaining components. The need for NRC review and approval of the fracture mechanics analysis was discussed with the NRC Staff on June 1, 1995 and it was determined that no NRC review was required.
