NUCLEAR REACTOR PRESSURE VESSEL TRANSPORTATION INCIDENT

POINT BEACH UNIT 1

VOLUME I

PREPARED FOR
WISCONSIN MICHIGAN POWER COMPANY
231 WEST MICHIGAN STREET
MILWAUKEE, WISCONSIN 53201

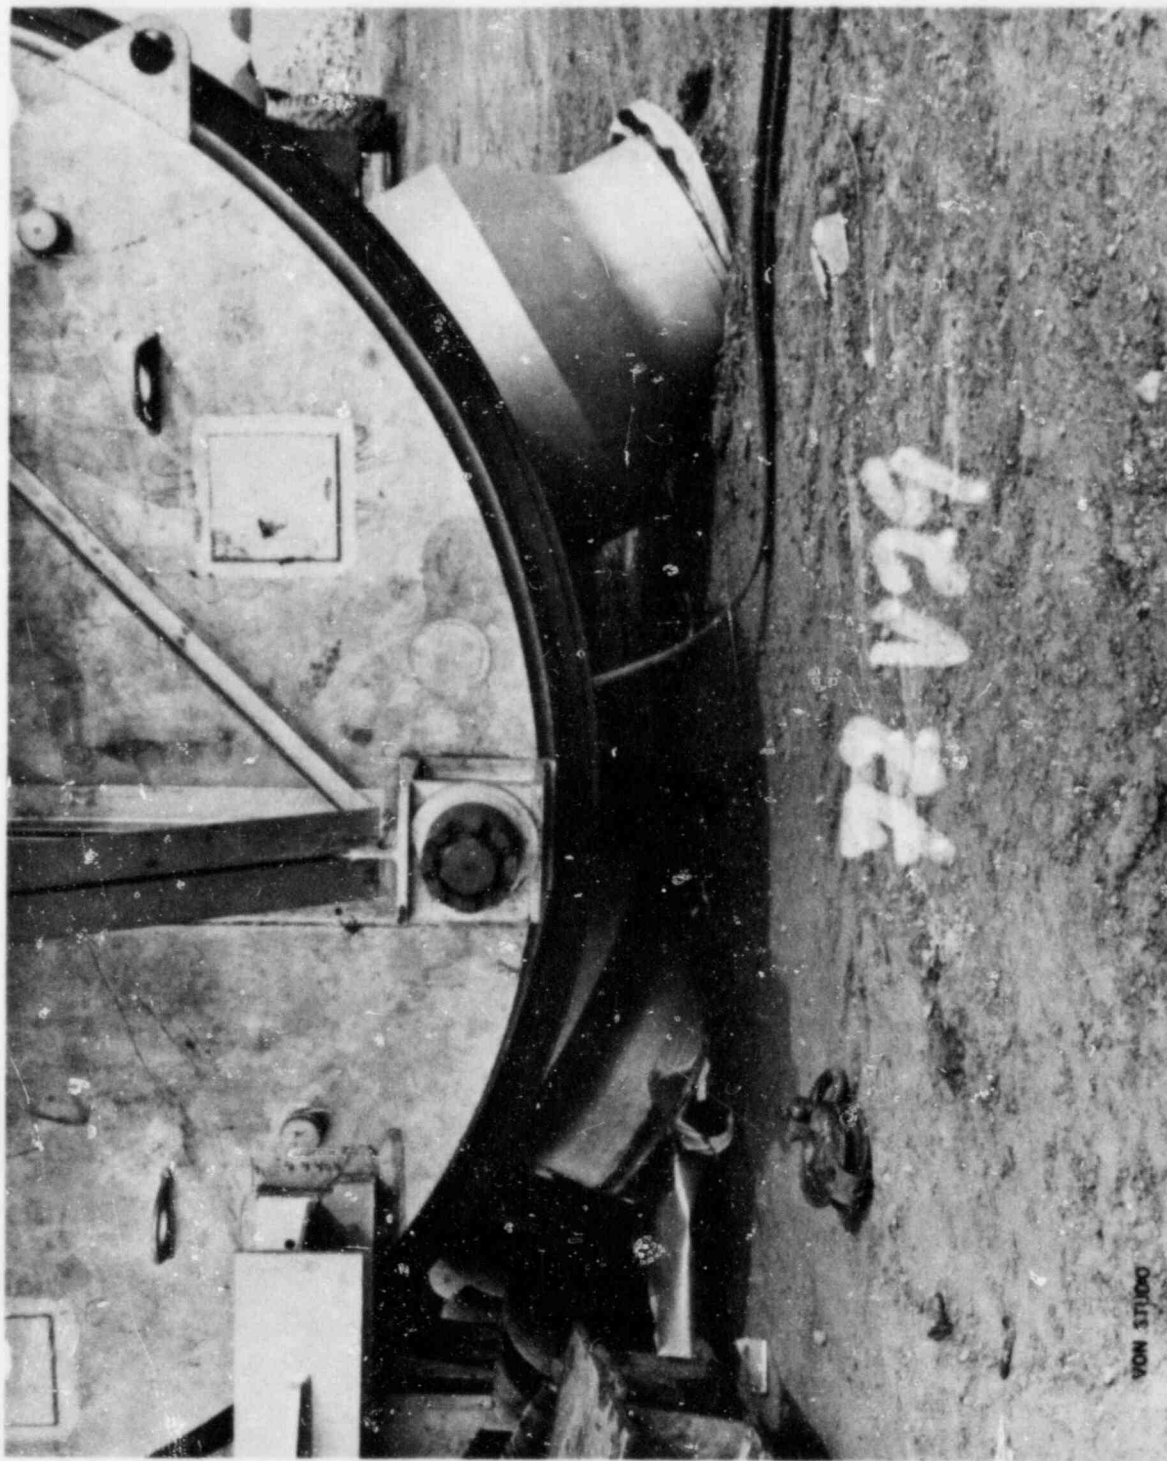
FIGURE 7. VIEW OF REACTOR VESSEL SHOWING PENETRATION OF NOZZLES INTO GROUND.

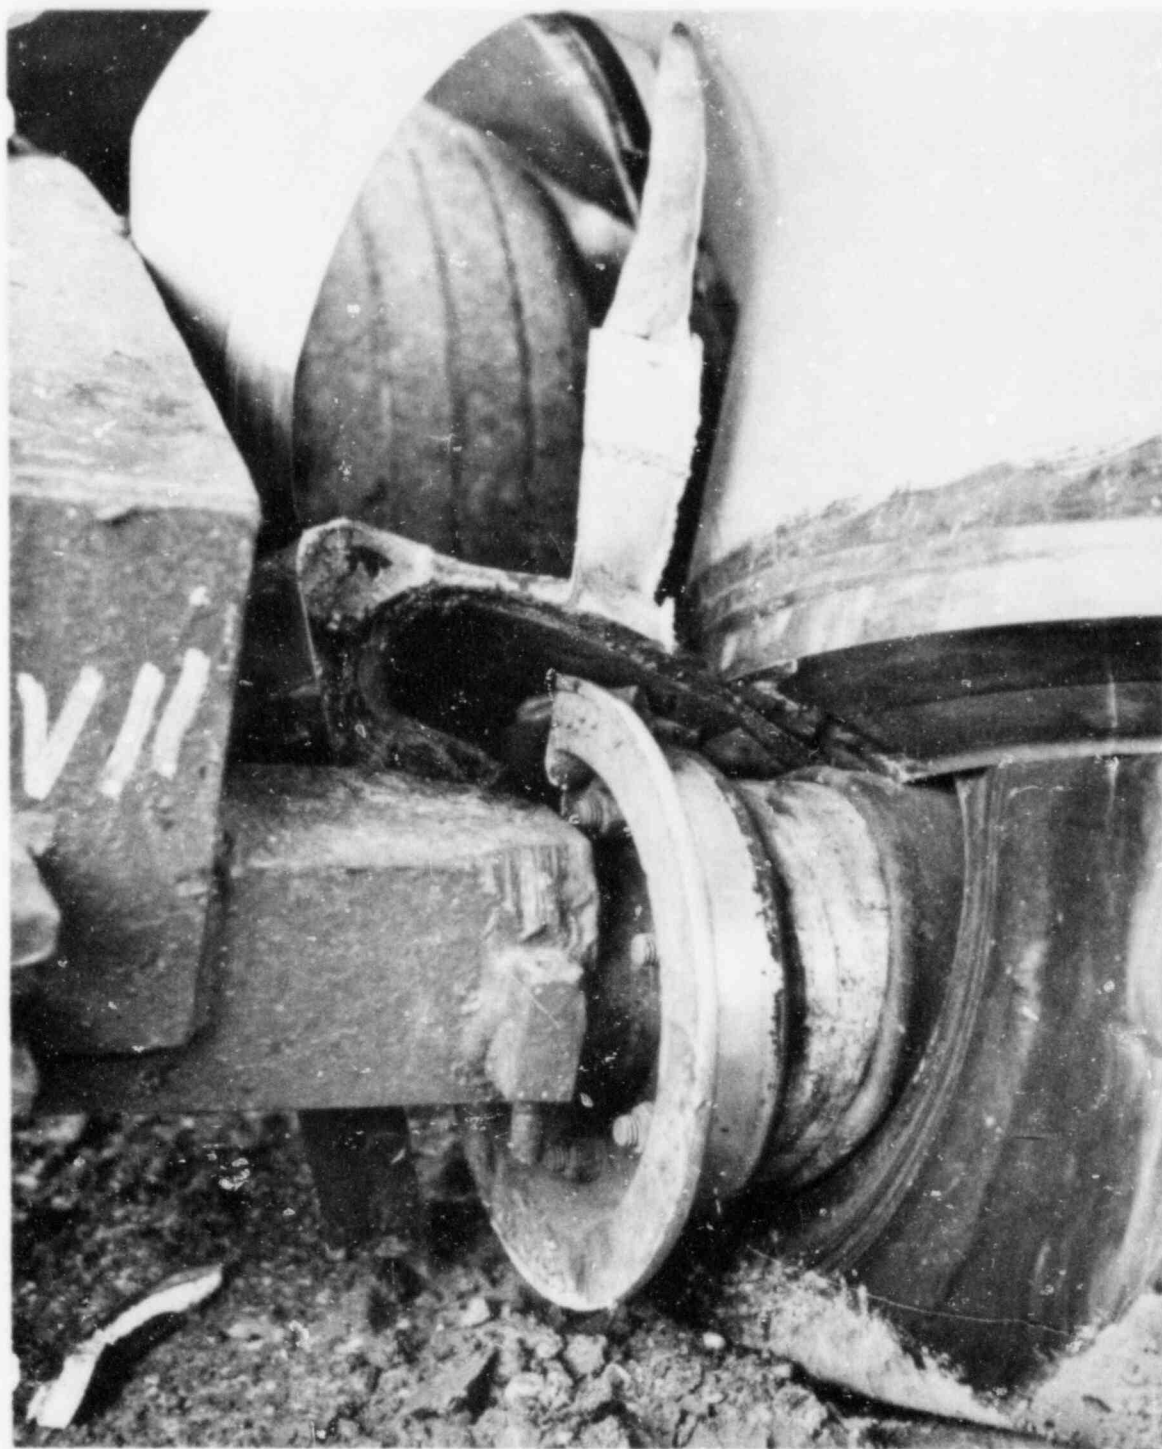
FIGURE 8. OUTLET NOZZLE RESTING ON DOLLY WHEEL RIM WITH TIRES AND AXLE EXTENDING INTO NOZZLE BORE - VIEW 1.

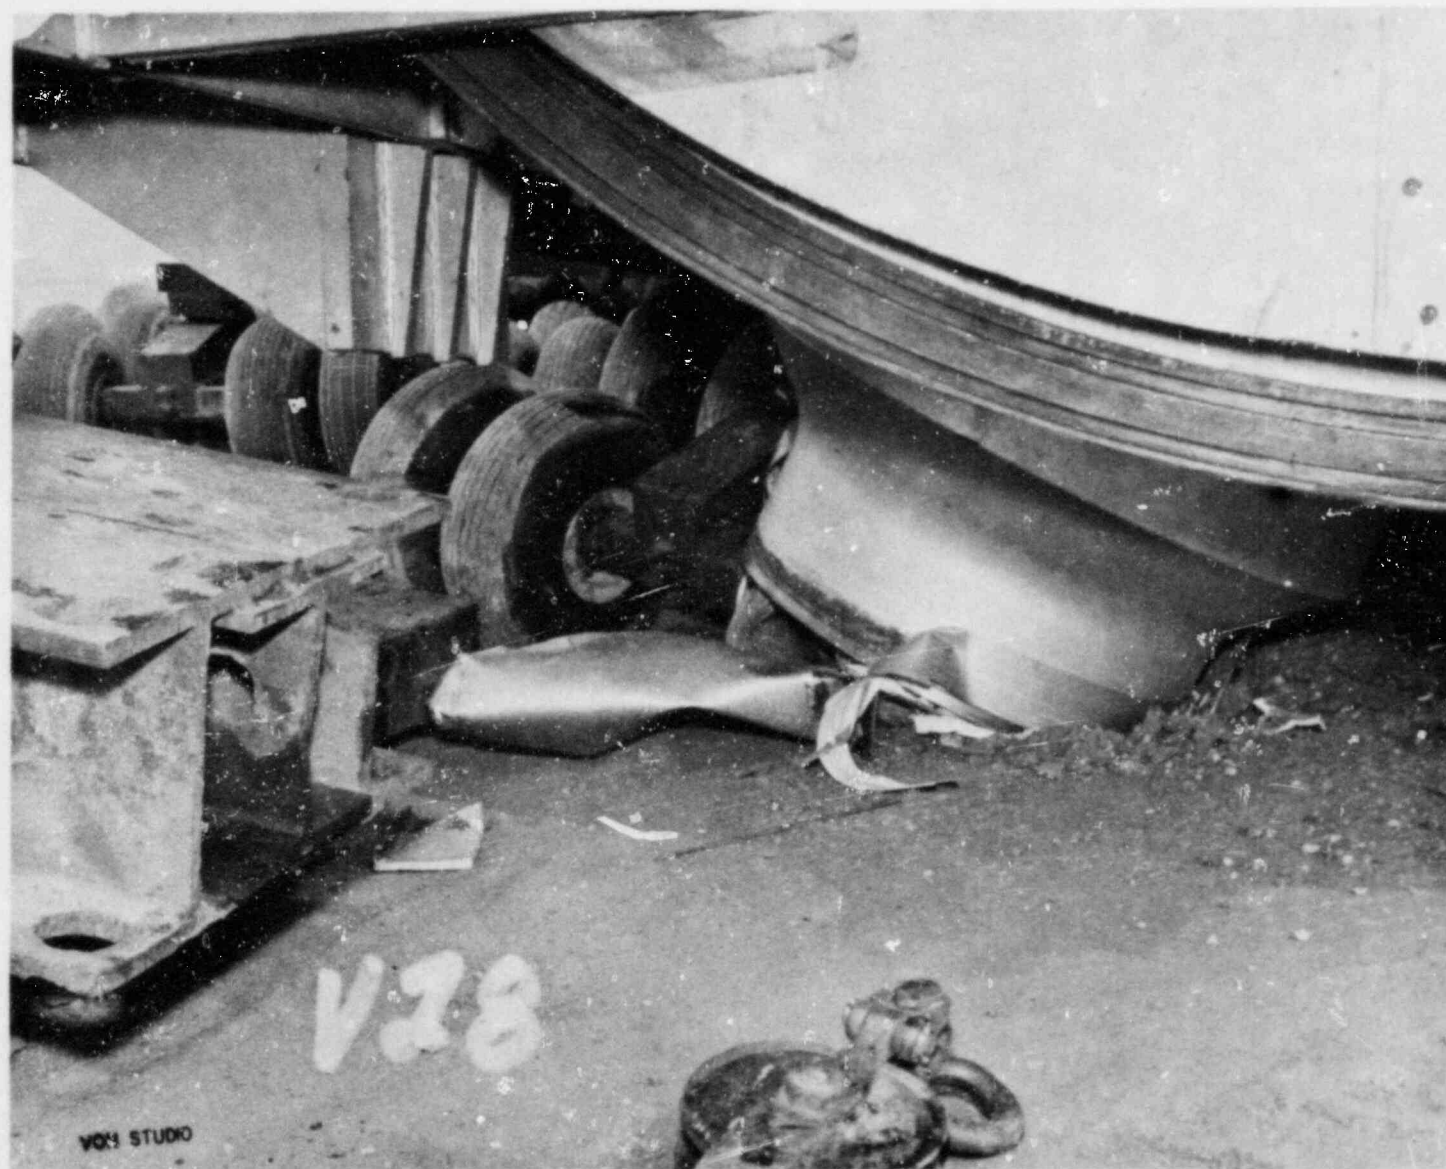
FIGURE 9. OUTLET NOZZLE RESTING ON DOLLY WHEEL RIM WITH TIRES AND AXLE EXTENDING INTO NOZZLE BORE - VIEW 2. Note penetration of nozzle into ground.

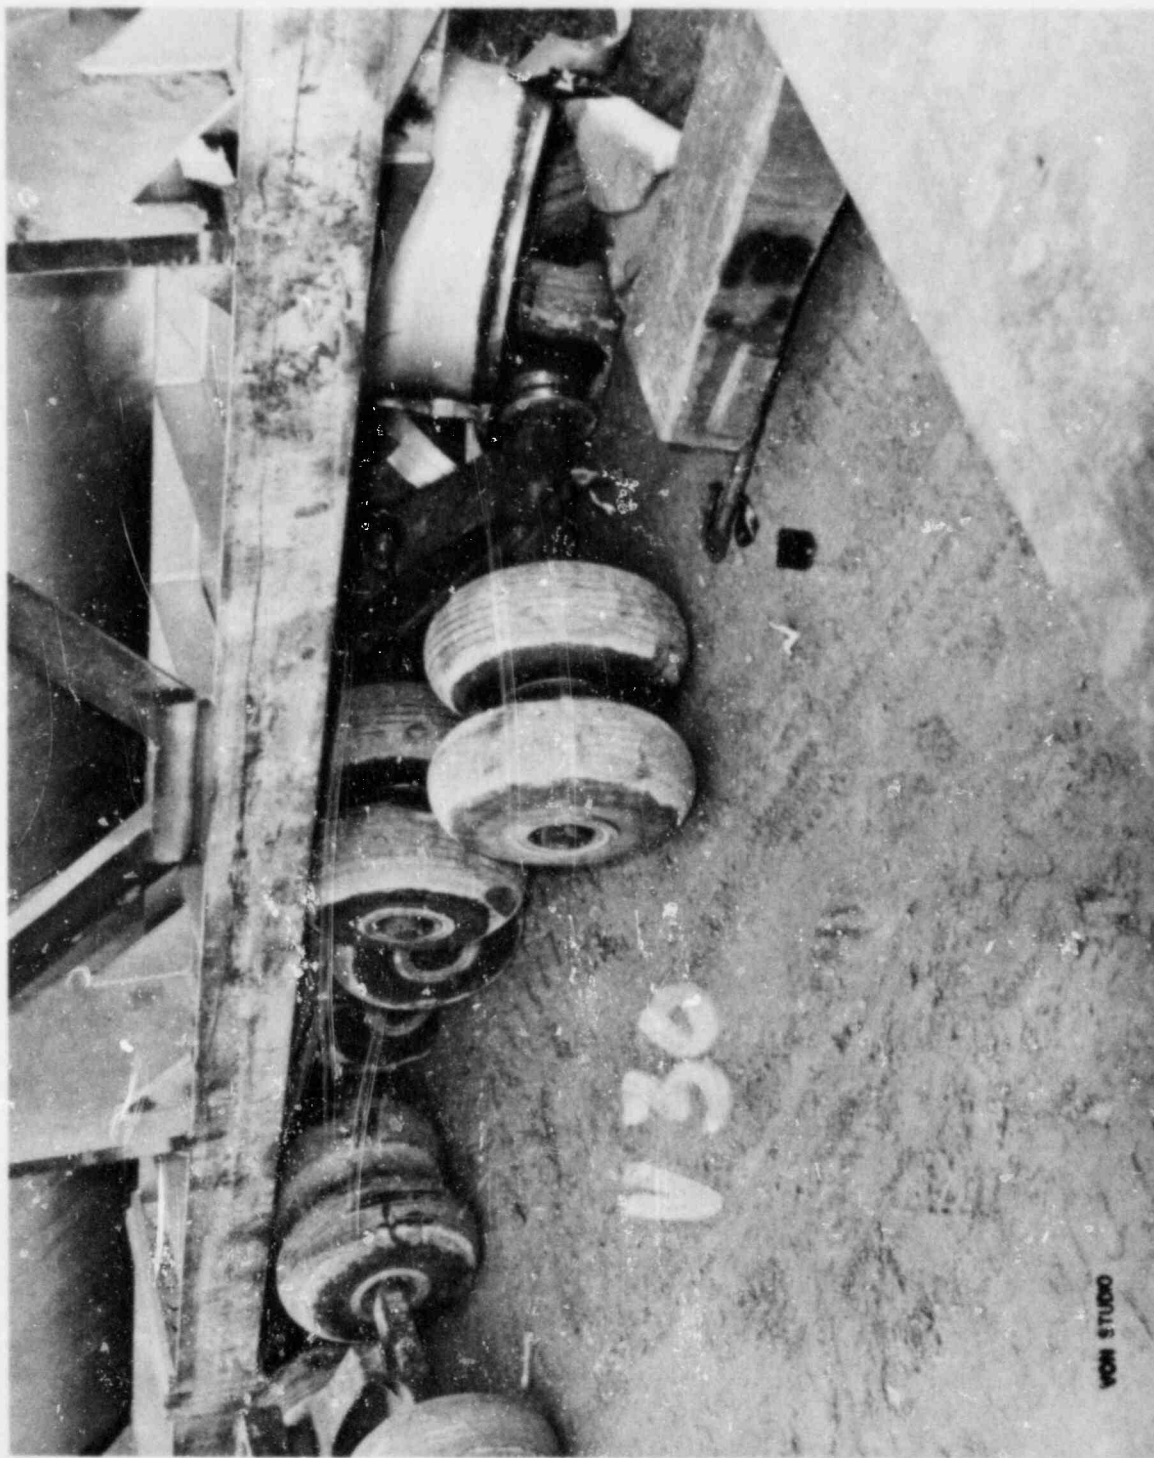
FIGURE 10. OUTLET NOZZLE RESTING ON DOLLY WHEEL RIM WITH TIRES AND AXLE EXTENDING INTO NOZZLE BORE - VIEW 3.

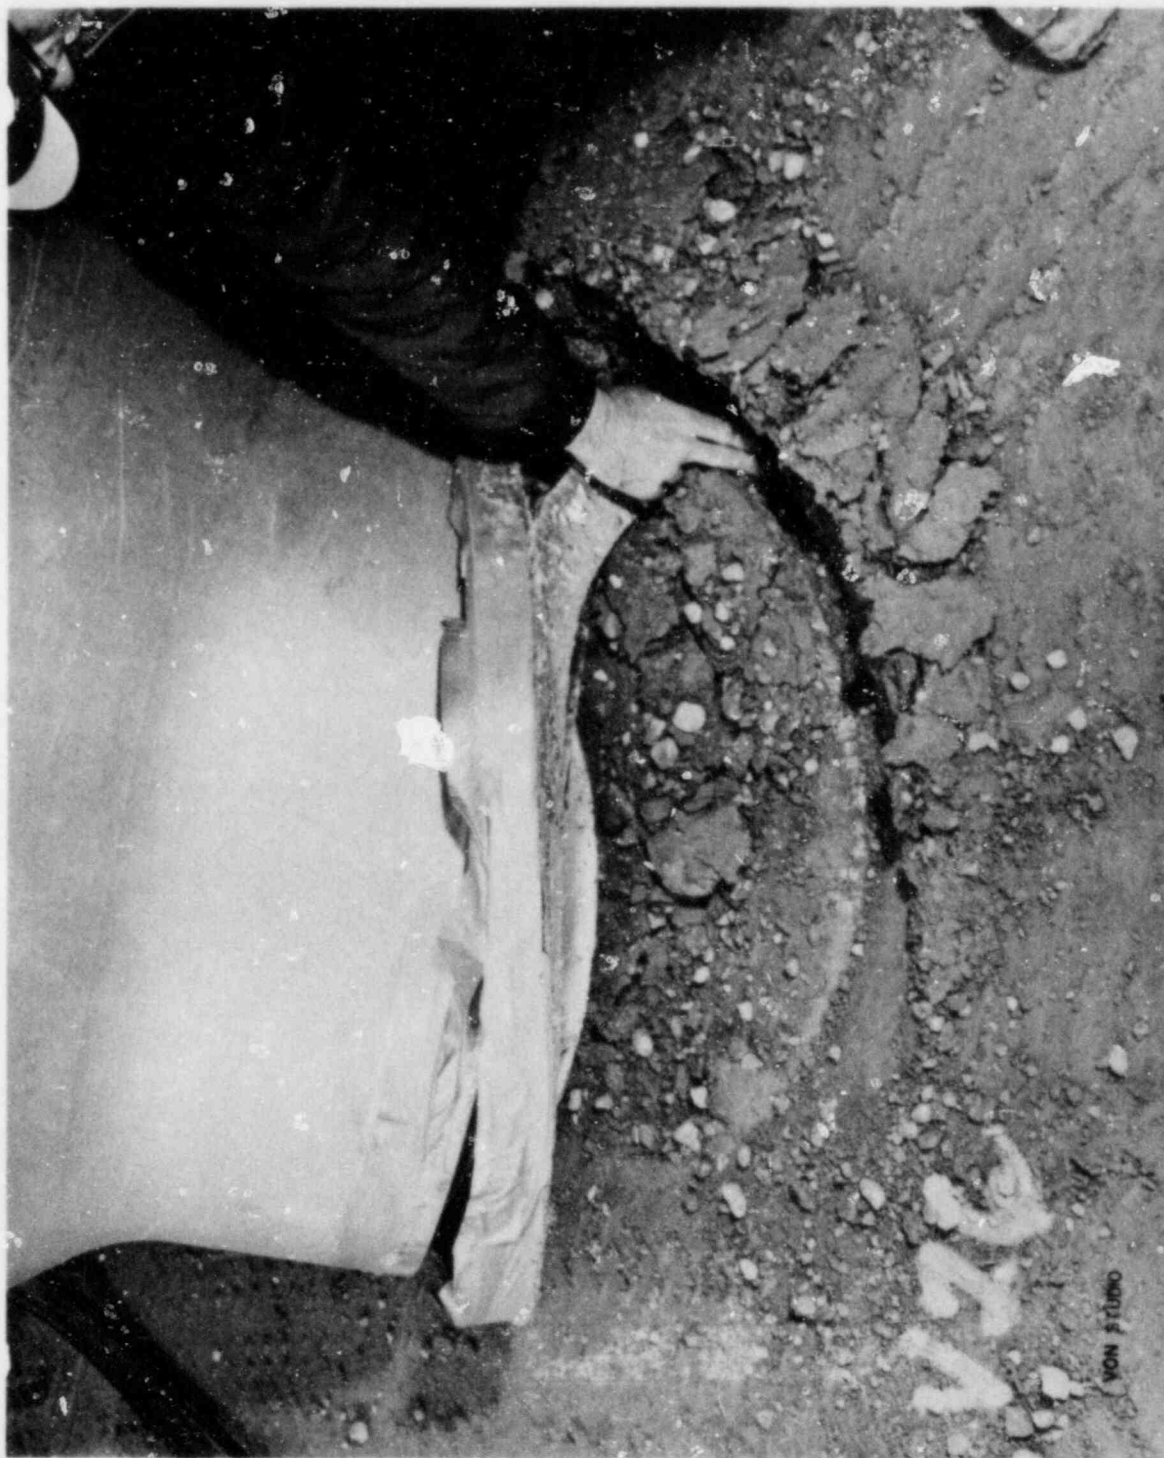
FIGURE 11. CLOSE-UP VIEW OF INLET NOZZLE ILLUSTRATING DEGREE OF PENETRATION INTO GROUND.

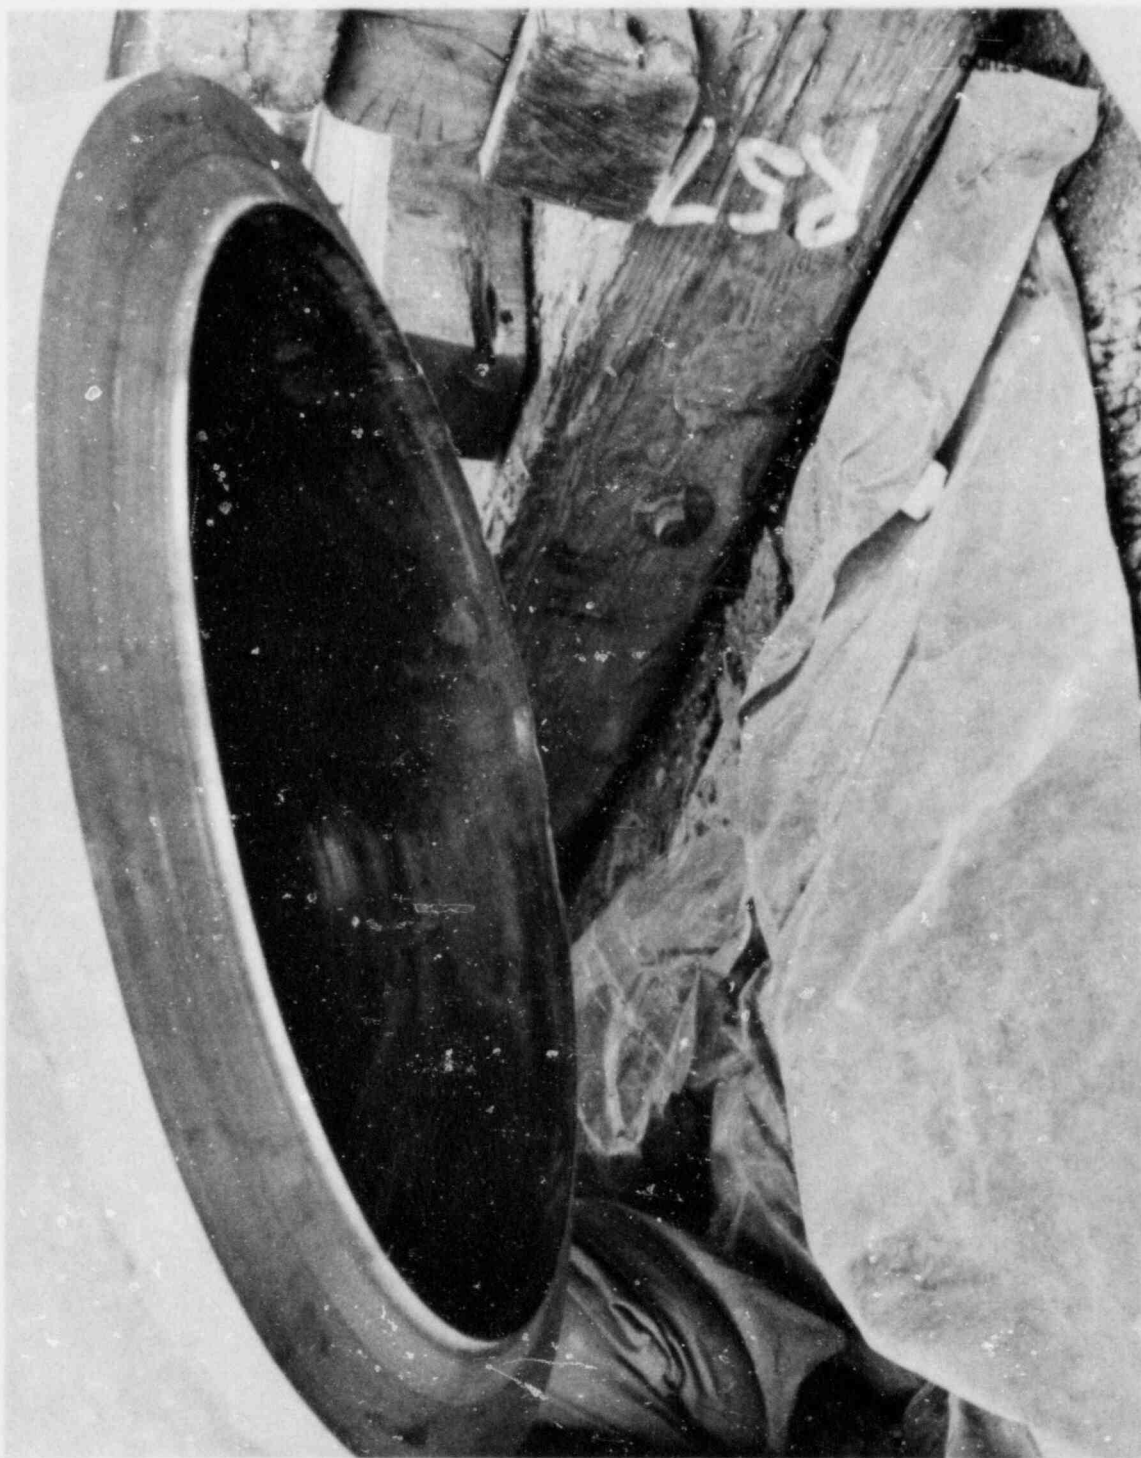
Figures 12 and 13 show the visible physical damage to the weld preparation of the inlet nozzle that penetrated the ground away from the dolly wheels. Figures 14 and 15 illustrate the visible physical damage to the outlet nozzle weld preparation caused by the rim of the dolly wheel. The internal bore of the outlet nozzle suffered some damage from the dolly axle. This damage is not visible in any of the photographs. The scar was initially judged to be about 0.045 inch deep; but after preliminary grinding that removed the upset area, it was re-evaluated and judged to be only about 0.095 inch deep. The only other visible damage to the object was some distortion of the vessel shipping skid; this can be seen in Figures 3, 4, 5, and 16.

FIGURE 12. CLOSE-UP VIEW OF INLET NOZZLE ILLUSTRATING
VISIBLE PHYSICAL DAMAGE TO LIP OF WELD
PREPARATION - VIEW 1.

Welded repairs to the damaged inlet and outlet nozzle weld end preparations and to the scored nozzle overlay were carried out in accordance with the approved procedures and are considered acceptable.

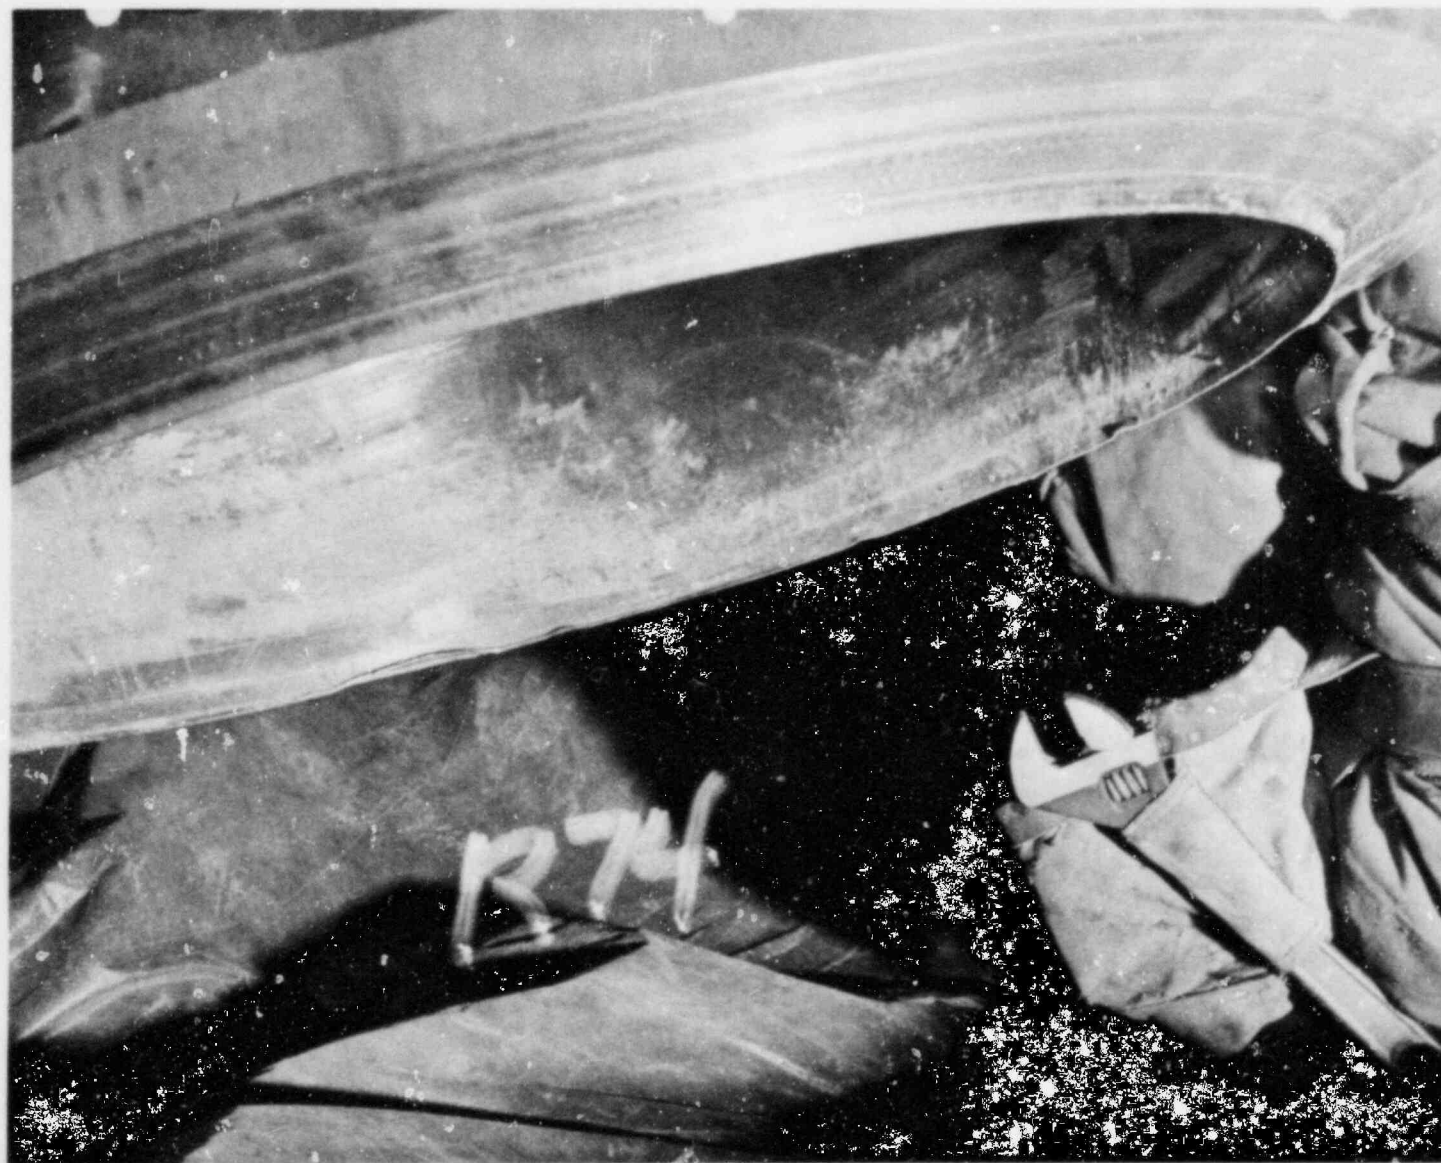
FIGURE 13. CLOSE-UP VIEW OF INLET NOZZLE ILLUSTRATING
VISIBLE PHYSICAL DAMAGE TO LIP OF WELD
PREPARATION - VIEW 2.

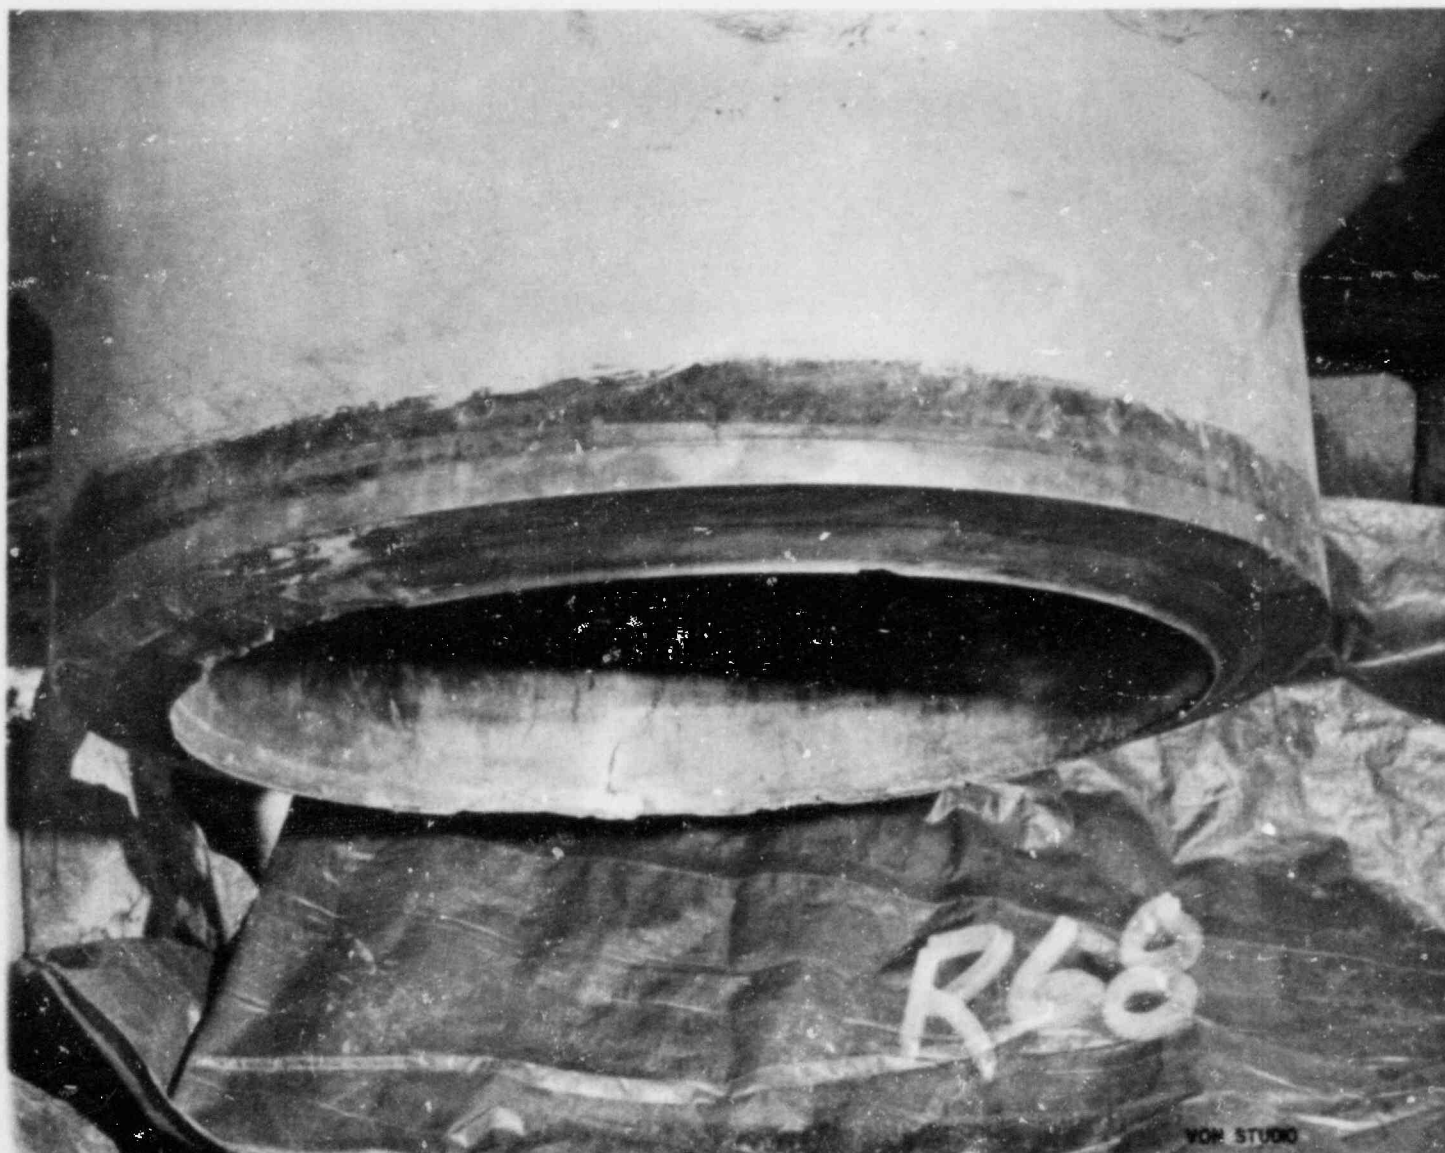
FIGURE 14. CLOSE-UP VIEW OF OUTLET NOZZLE ILLUSTRATING
VISIBLE PHYSICAL DAMAGE TO LIP OF WELD
PREPARATION - VIEW 1.

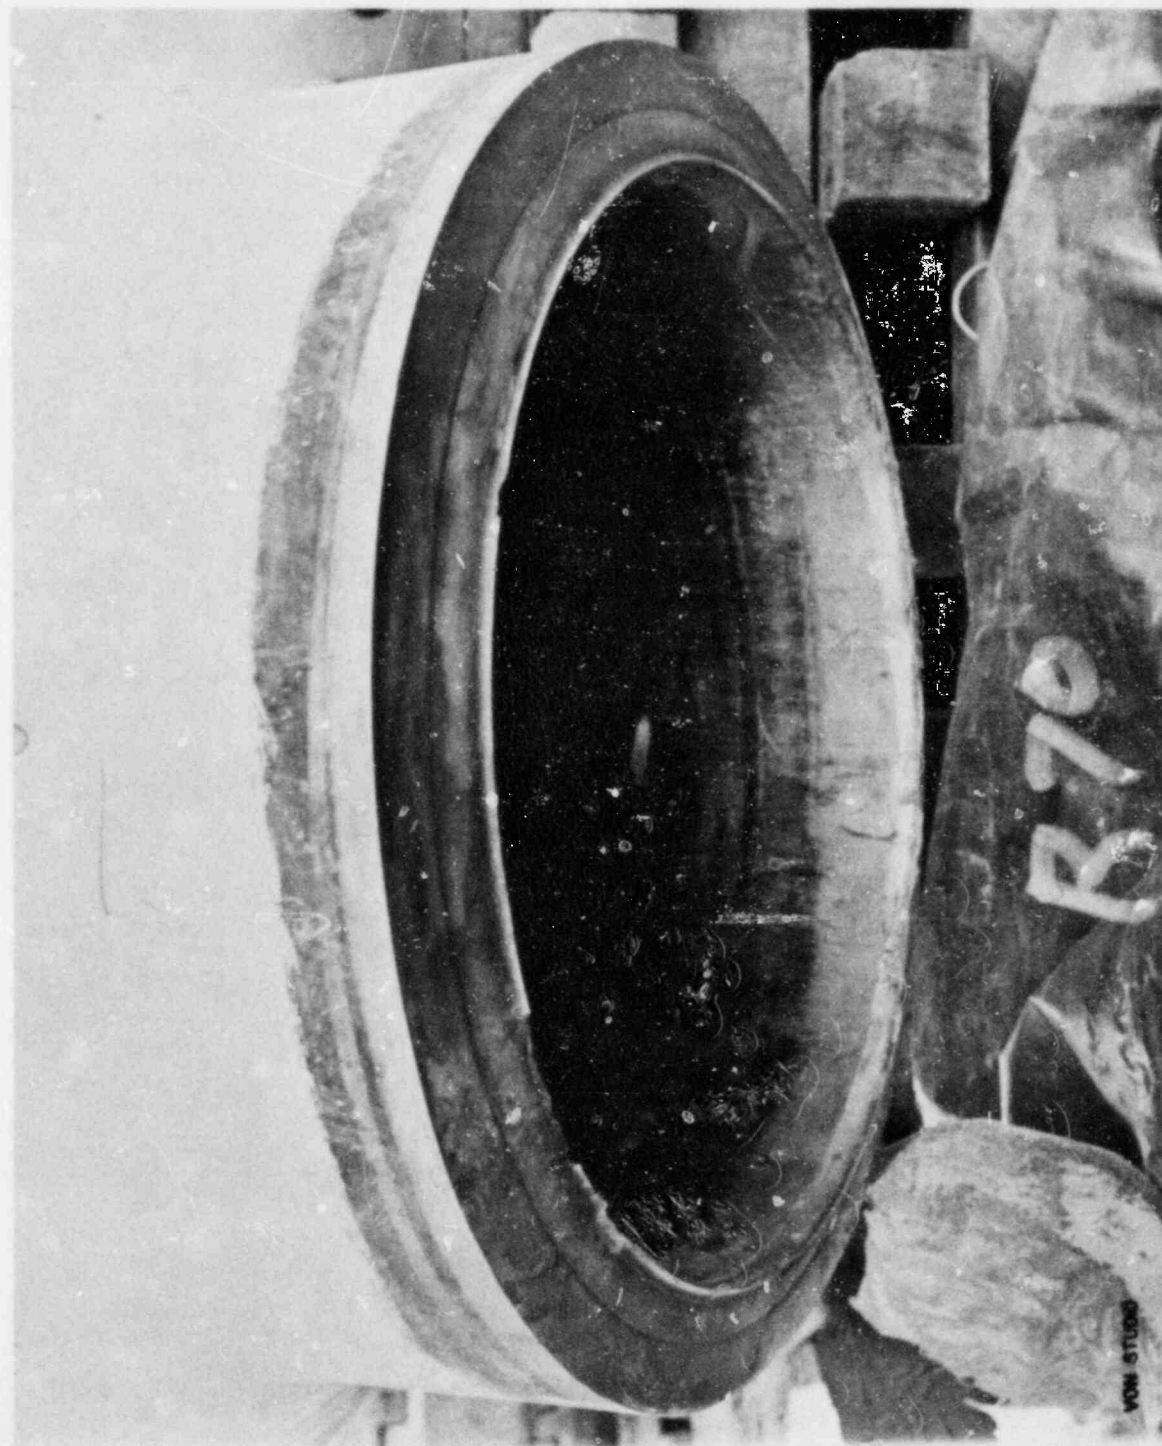
FIGURE 15. CLOSE-UP VIEW OF OUTLET NOZZLE ILLUSTRATING
VISIBLE PHYSICAL DAMAGE TO LIP OF WELD
PREPARATION - VIEW 2.

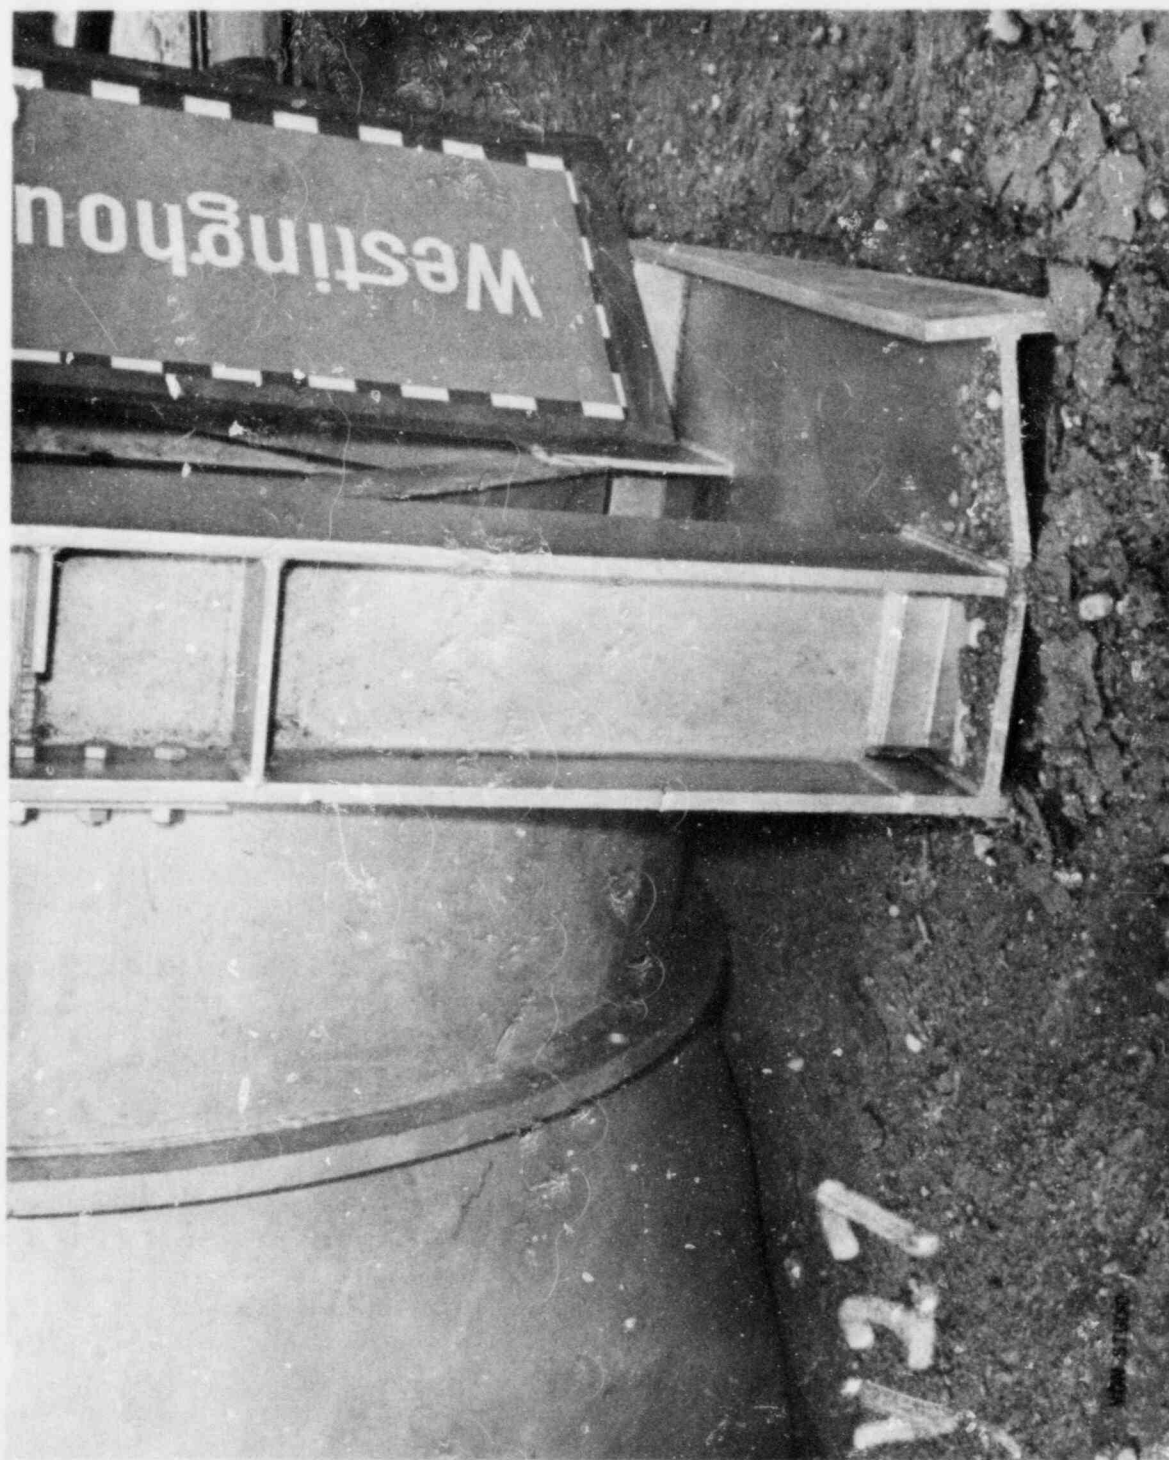
FIGURE 16. PORTION OF VESSEL SHIPPING SKID SHOWING DISTORTION.

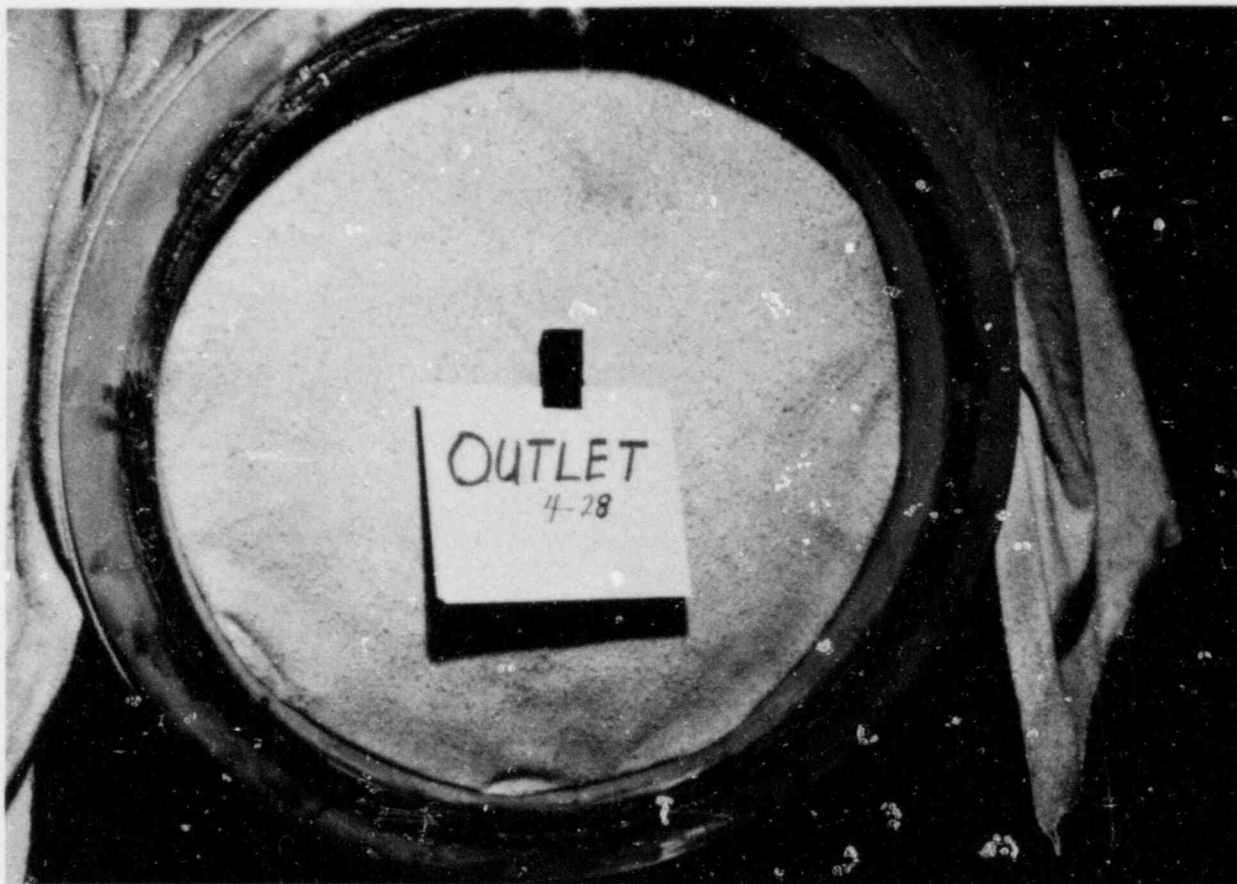
FIGURE 22. OUTLET NOZZLE DURING REPAIR WELDING -
BUILDUP OF WELD LIP.

Figure 21 illustrates the ultrasonic examination technique employed for examination of the nozzle forgings. Figure 22 illustrates the outlet nozzle during the weld buildup of the weld lip. Figure 23 illustrates the outlet nozzle after completion of the weld buildup prior to the machining operation to facilitate the ultrasonic examination of the repaired area. Figure 24 shows the liquid penetrant examination of the outlet nozzle weld preparation after the final machining operation. Figures 25 and 26 illustrate the machining operations of the inlet nozzle weld preparations.

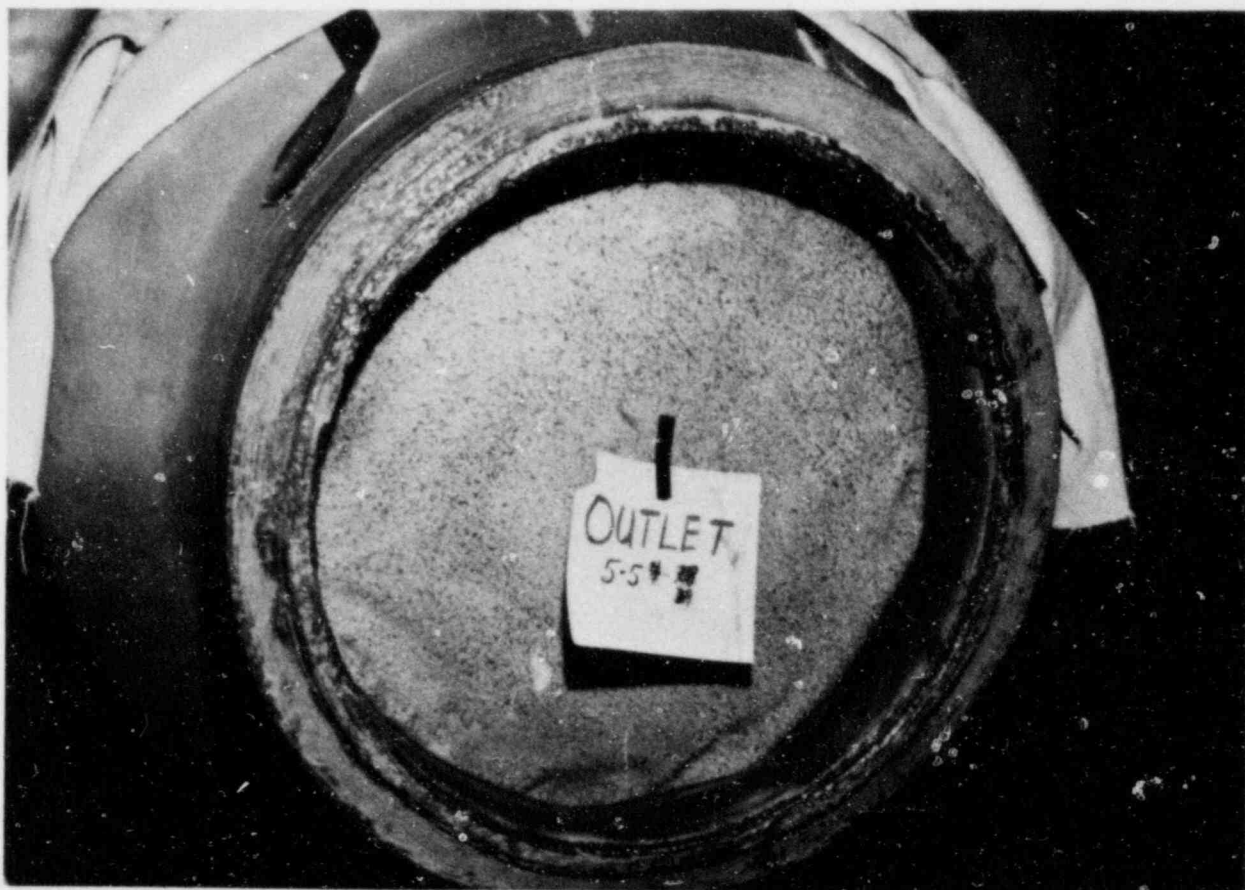
FIGURE 23. OUTLET NOZZLE AFTER COMPLETION OF WELDING THE ENTIRE WELD EDGE PREPARATION.

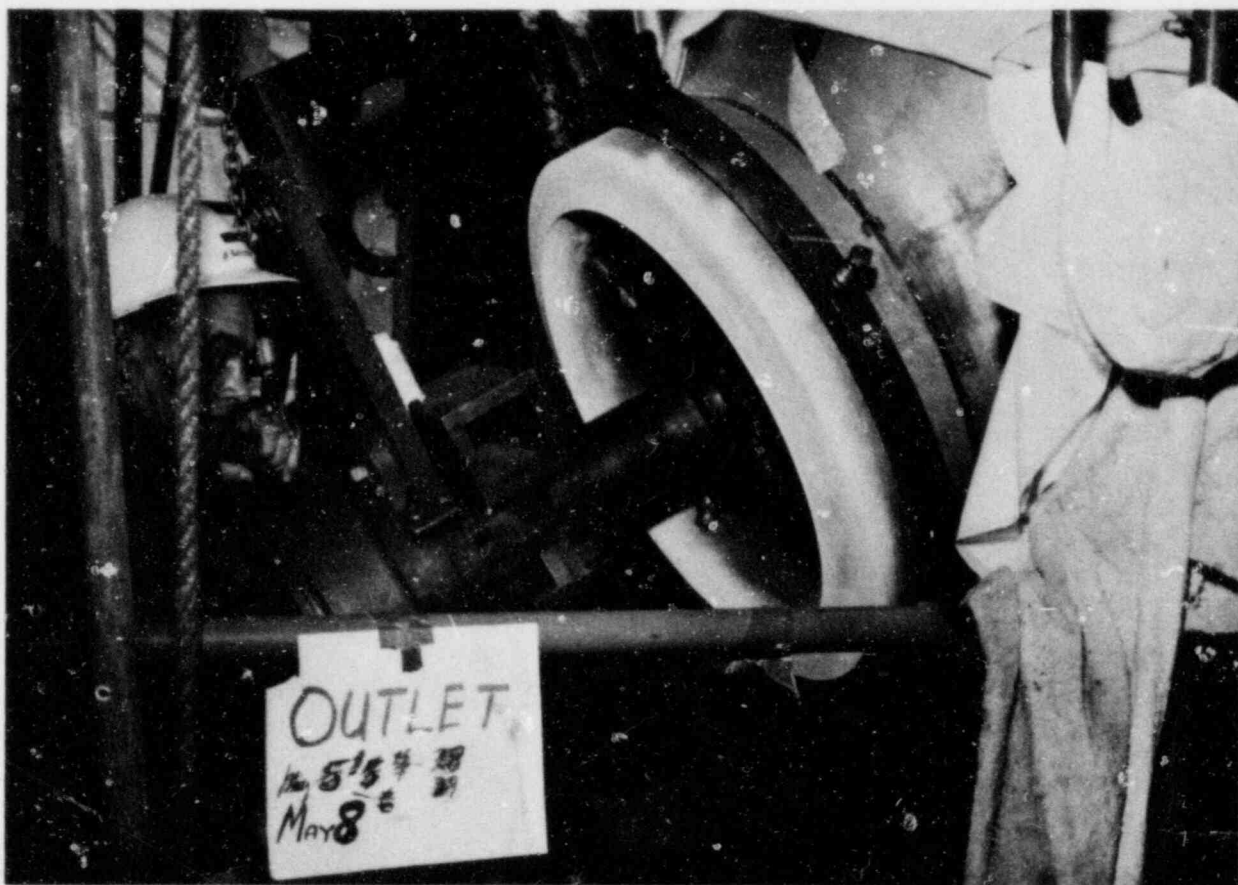
FIGURE 24. CUTLET NOZZLE - LIQUID PENETRANT EXAMINATION AFTER MACHINING.

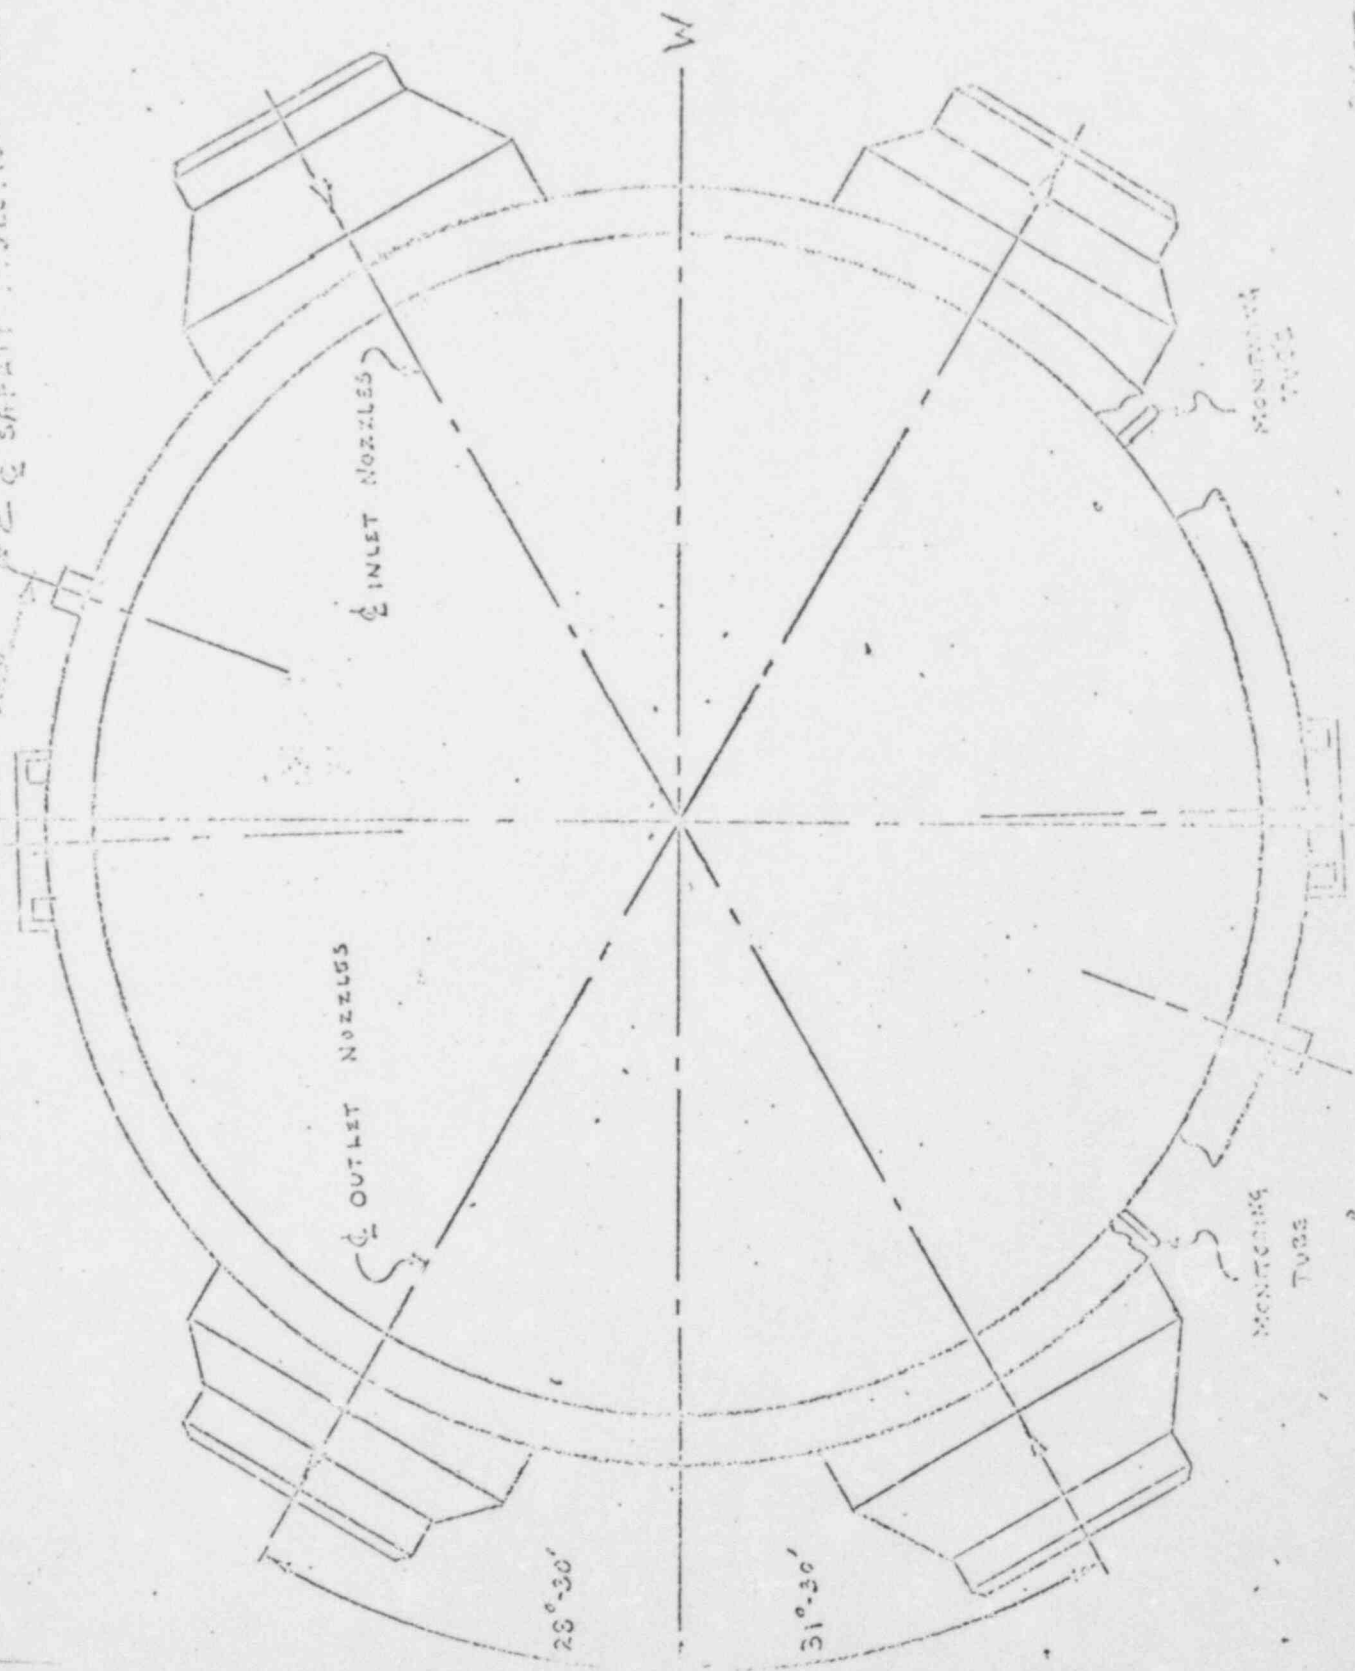
"I.E. AREA THE .055" WELDING LIP IS COMPLETELY SHOWN OFF.
