NUCLEAR REACTOR PRESSURE VESSEL TRANSPORTATION INCIDENT

POINT BEACH UNIT 1

VOLUME I

PREPARED FOR
WISCONSIN MICHIGAN POWER COMPANY
231 WEST MICHIGAN STREET
MILWAUKEE, WISCONSIN 53201

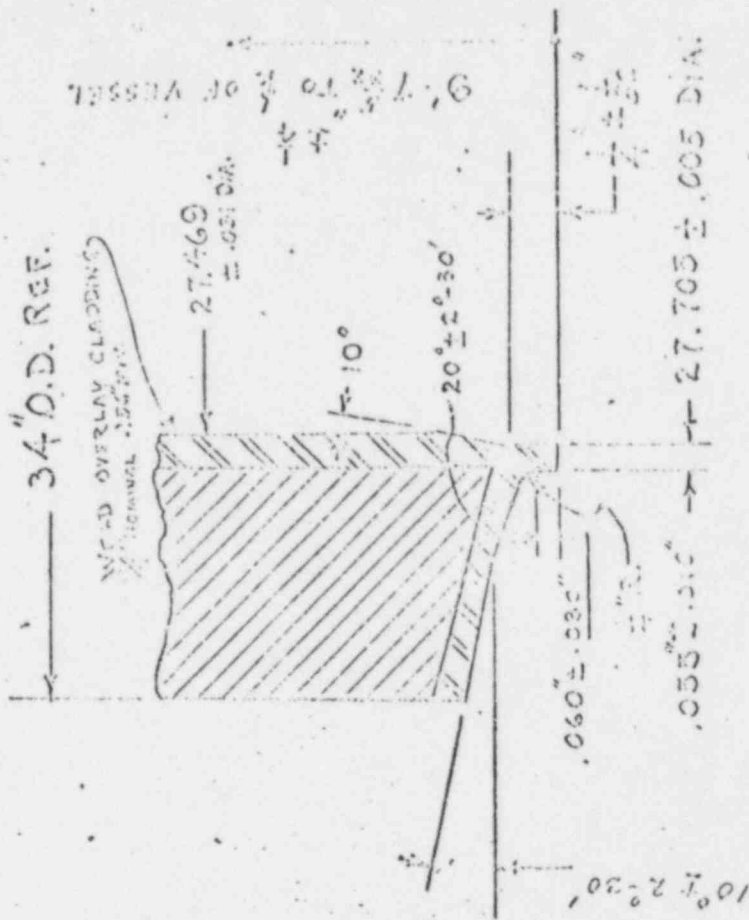
SKETCH NO. 3
INLET NOZZLE

1/2" L. AREA THE .005" WELD LIP IS PRESENT
