Report
on
Design and Stress Evaluation
of
Failed Main Steam Safety Valve Nozzle

H. B. Robinson No. 2
Carolina Power and Light Co.

Report No. DC-67

May 23, 1970

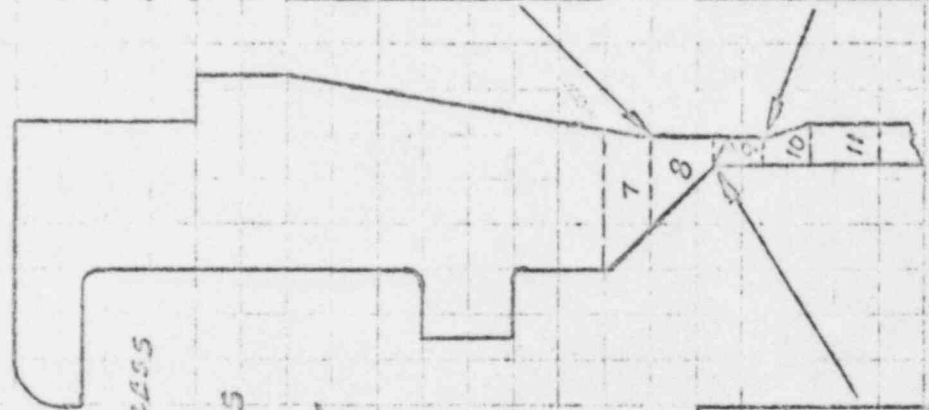
SUMMARY OF STRESS AND STRESS INTENSITY
WITH STRESS CONCENTRATION FACTOR

A STRESS CONCENTRATION
 FACTOR OF 1.5 HAS BEEN
 ASSUMED FOR THE THREE
 LOCATIONS SHOWN.
