Trojan Nuclear Plant
Docket 50-344
License NPF-1

STEAM GENERATOR TUBE INTEGRITY SAFETY ANALYSIS REPORT
FOR
TUBE SUPPORT PLATE INTERSECTIONS

PORTLAND GENERAL ELECTRIC COMPANY

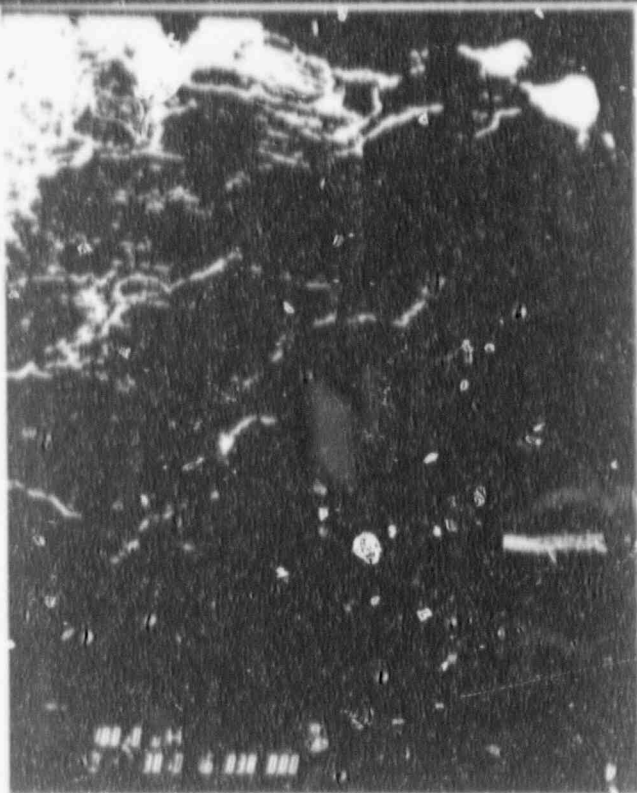
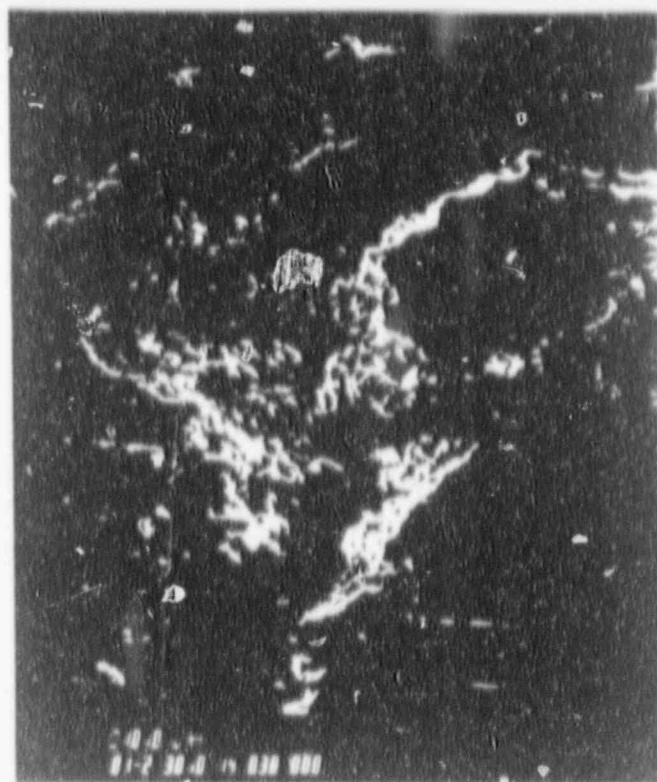
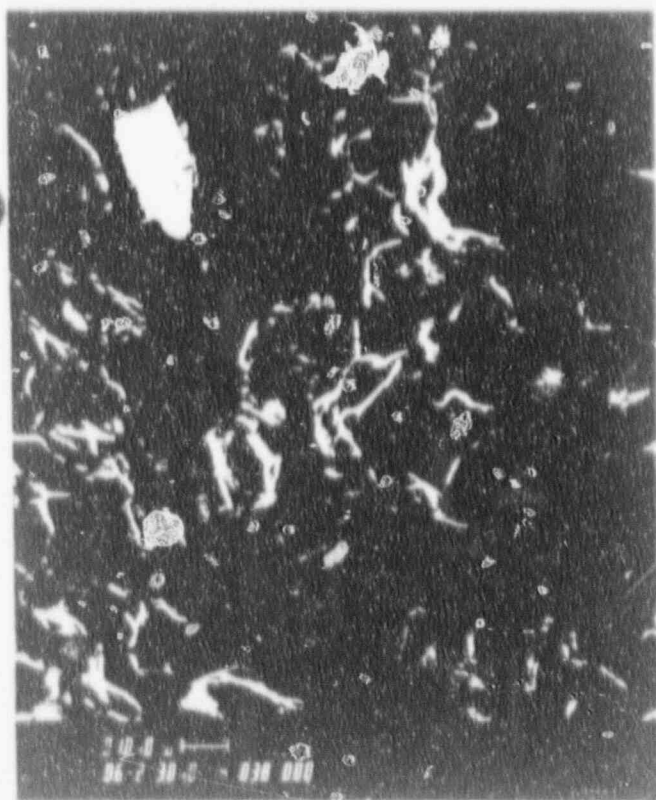
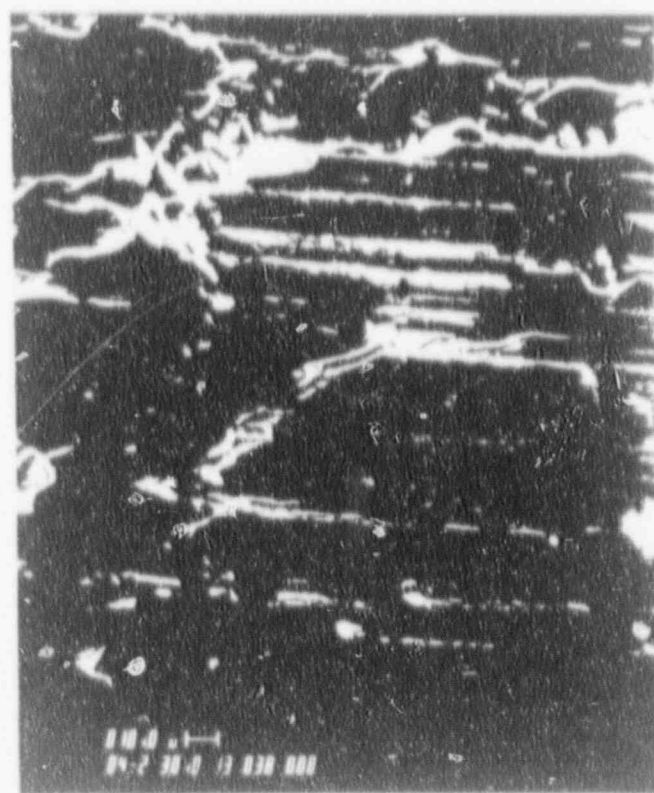
[figure 4-1. OO Surface of D'R12CB TSP #1.]

Actions taken for the first pulled tube, D R12C8, were an exception to the examination process described above. In this instance, the first TSP intersection was subjected to a leak test, but was not subsequently burst tested. Because it appeared that the tube section had been damaged in pulling, it was felt that a full burst test would not be the best use of the material. Instead, the degraded TSP intersection of the tube was created by pulling axially on a tensile machine, allowing examination of the nature of the degradation in the resulting circumferential fracture surface. Scanning electron microscope and metallographic examination found IGA and ODSCC. The maximum depth of general IGA was 43 percent through-wall. Intergranular penetration of 92 percent also was observed. The average flaw depth over this TSP intersection was 38 percent.

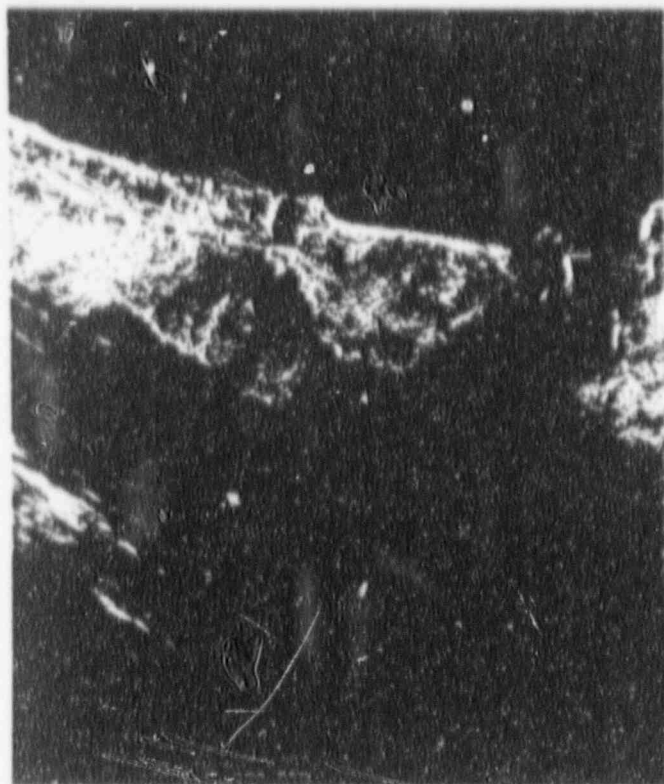
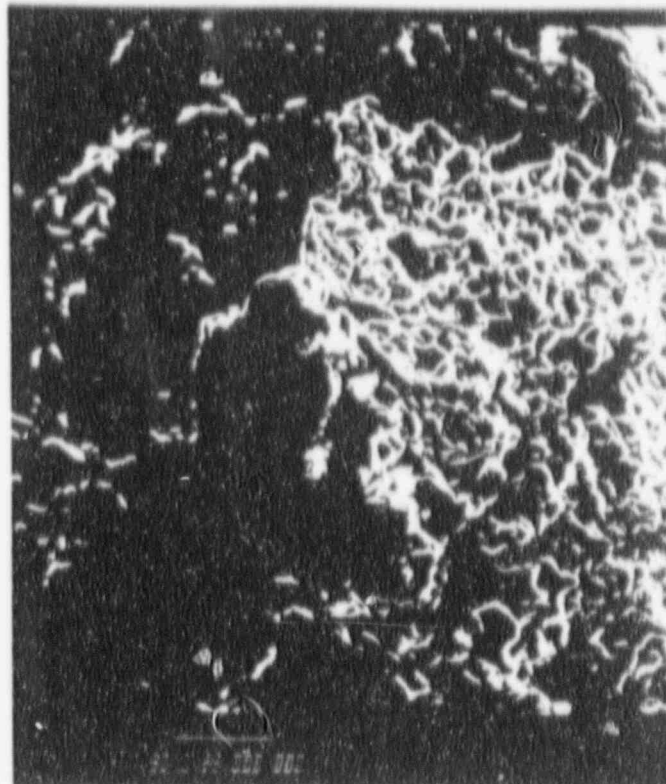
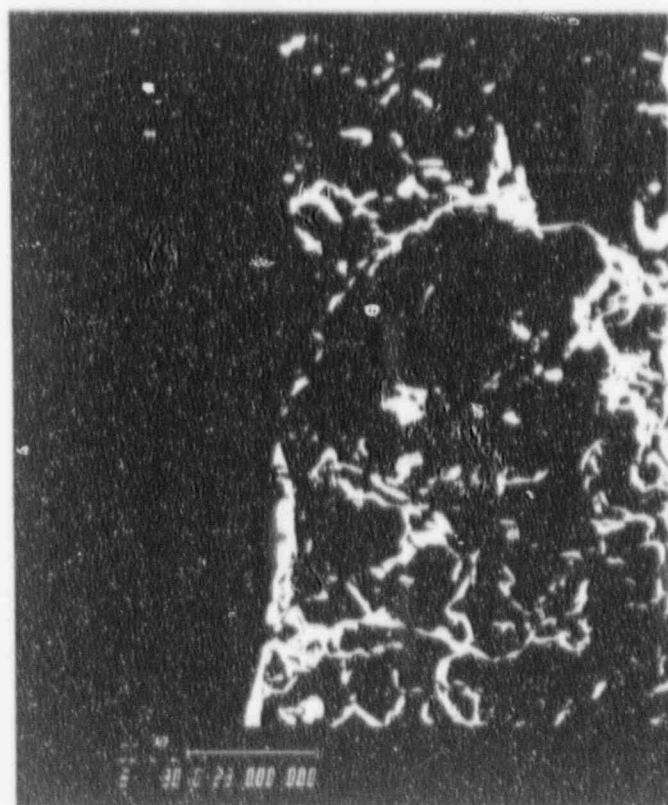
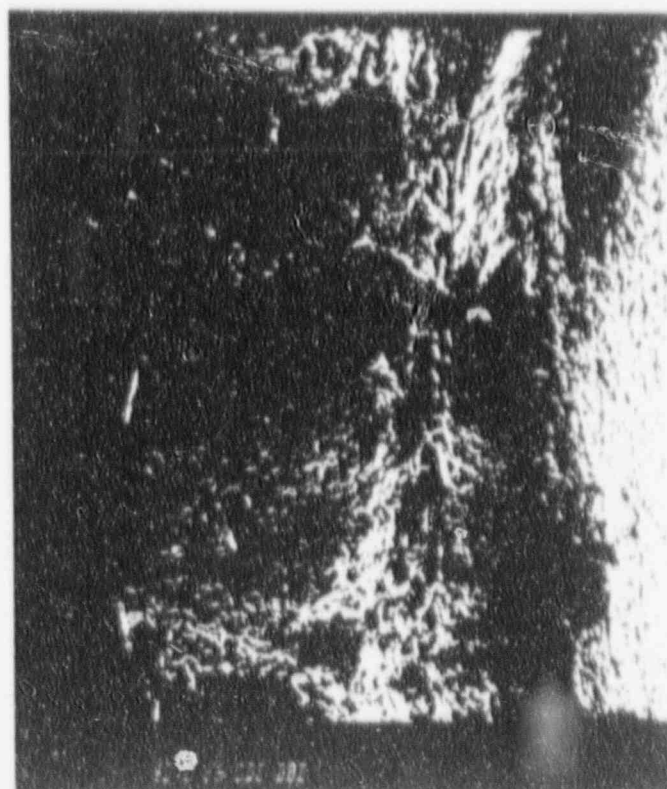
Figure 4-3: Burst Crack of CR30064 TSP #1.

Metallographic analytical results for the second tube, C R30C64, at the first TSP intersection, which was characterized as having a 3:1 indication not requiring repair, showed ODSCC microflaws with a

maximum depth of 55 percent. The second TSP intersection, which was characterized as having MAI requiring repair, showed ODSCC with a maximum depth of 64 percent. The third TSP intersection, which was characterized as having a 3:1 indication not requiring repair, showed ODSCC microflaws with a maximum depth of 50 percent. None of the TSP intersections had extensive IGA such as was found at the TSP intersections of D R12C8.

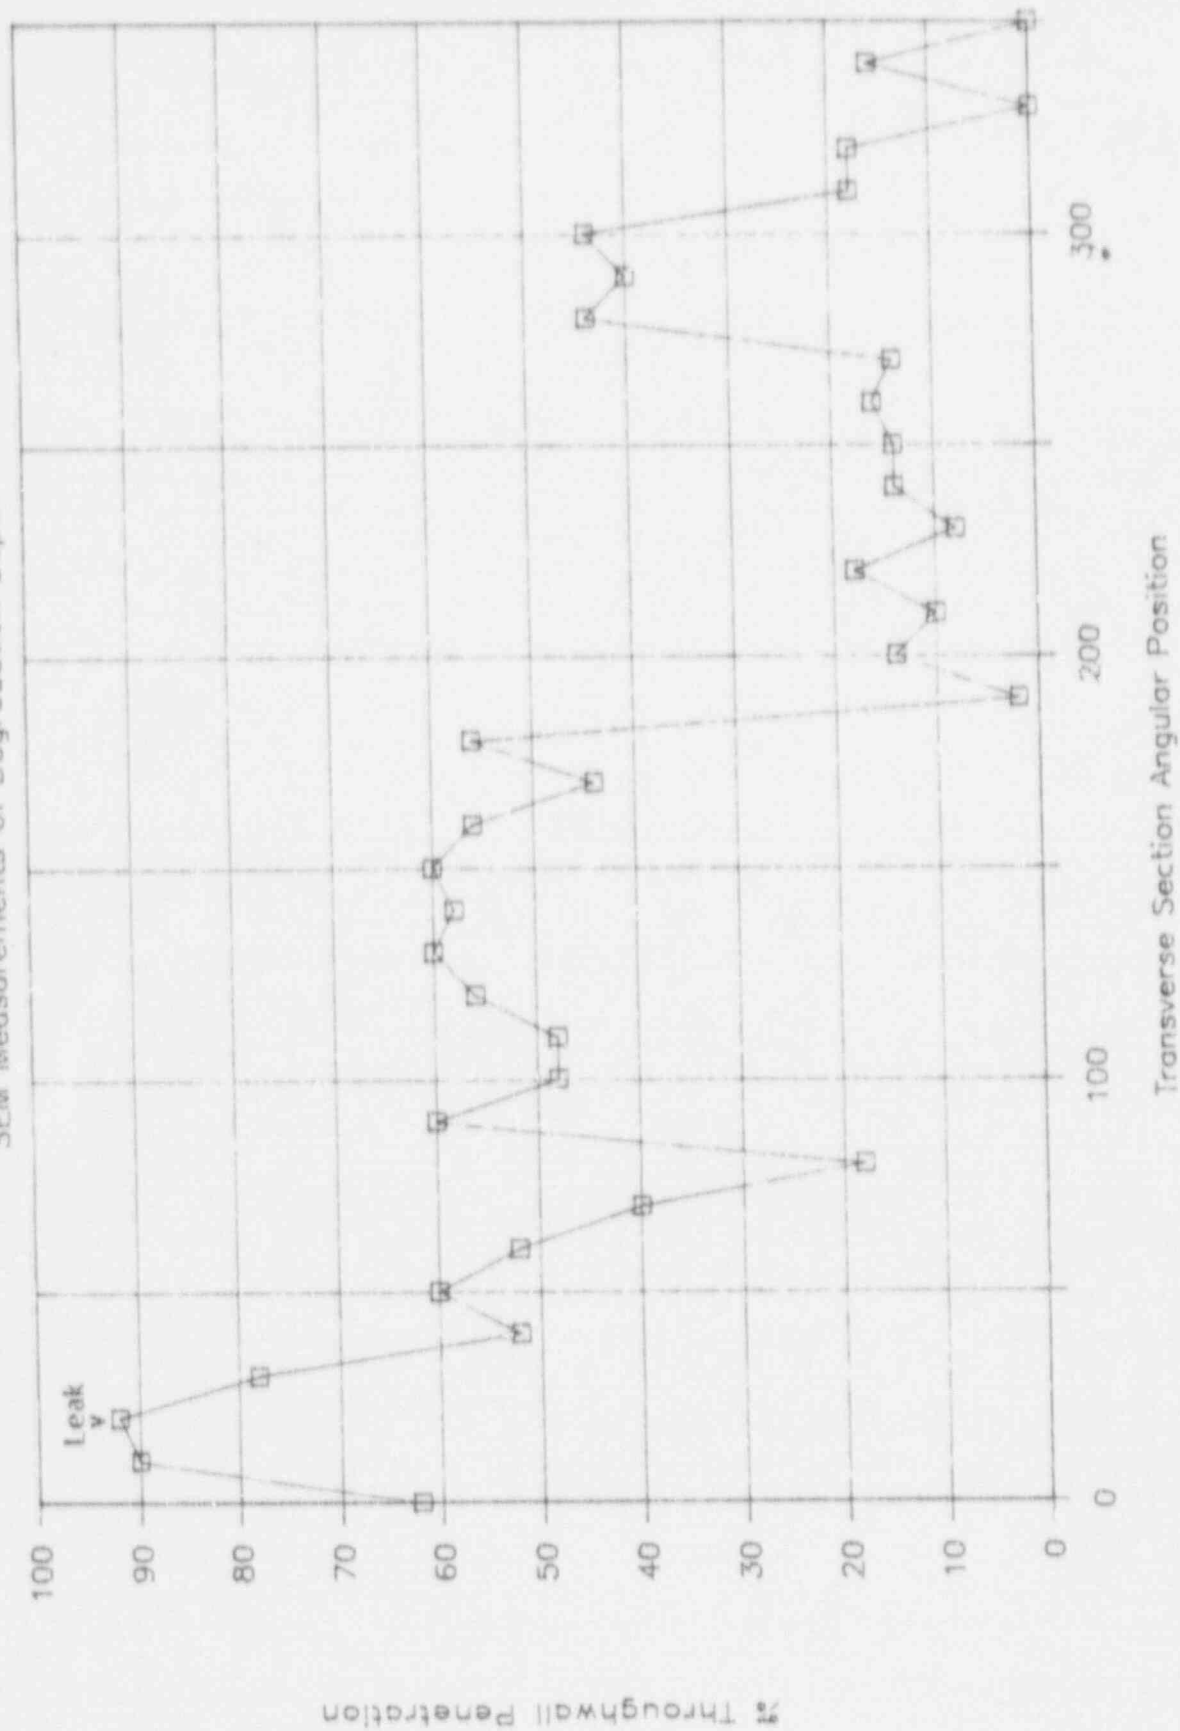
Figure 5-2. 'D'R12C8 TSP#2 Degradation

The second TSP intersection was examined by metallography without burst or tensile fracturing. The maximum depth of intergranular penetration was found to be 48 percent, with the maximum depth of general IGA at approximately 27 percent.

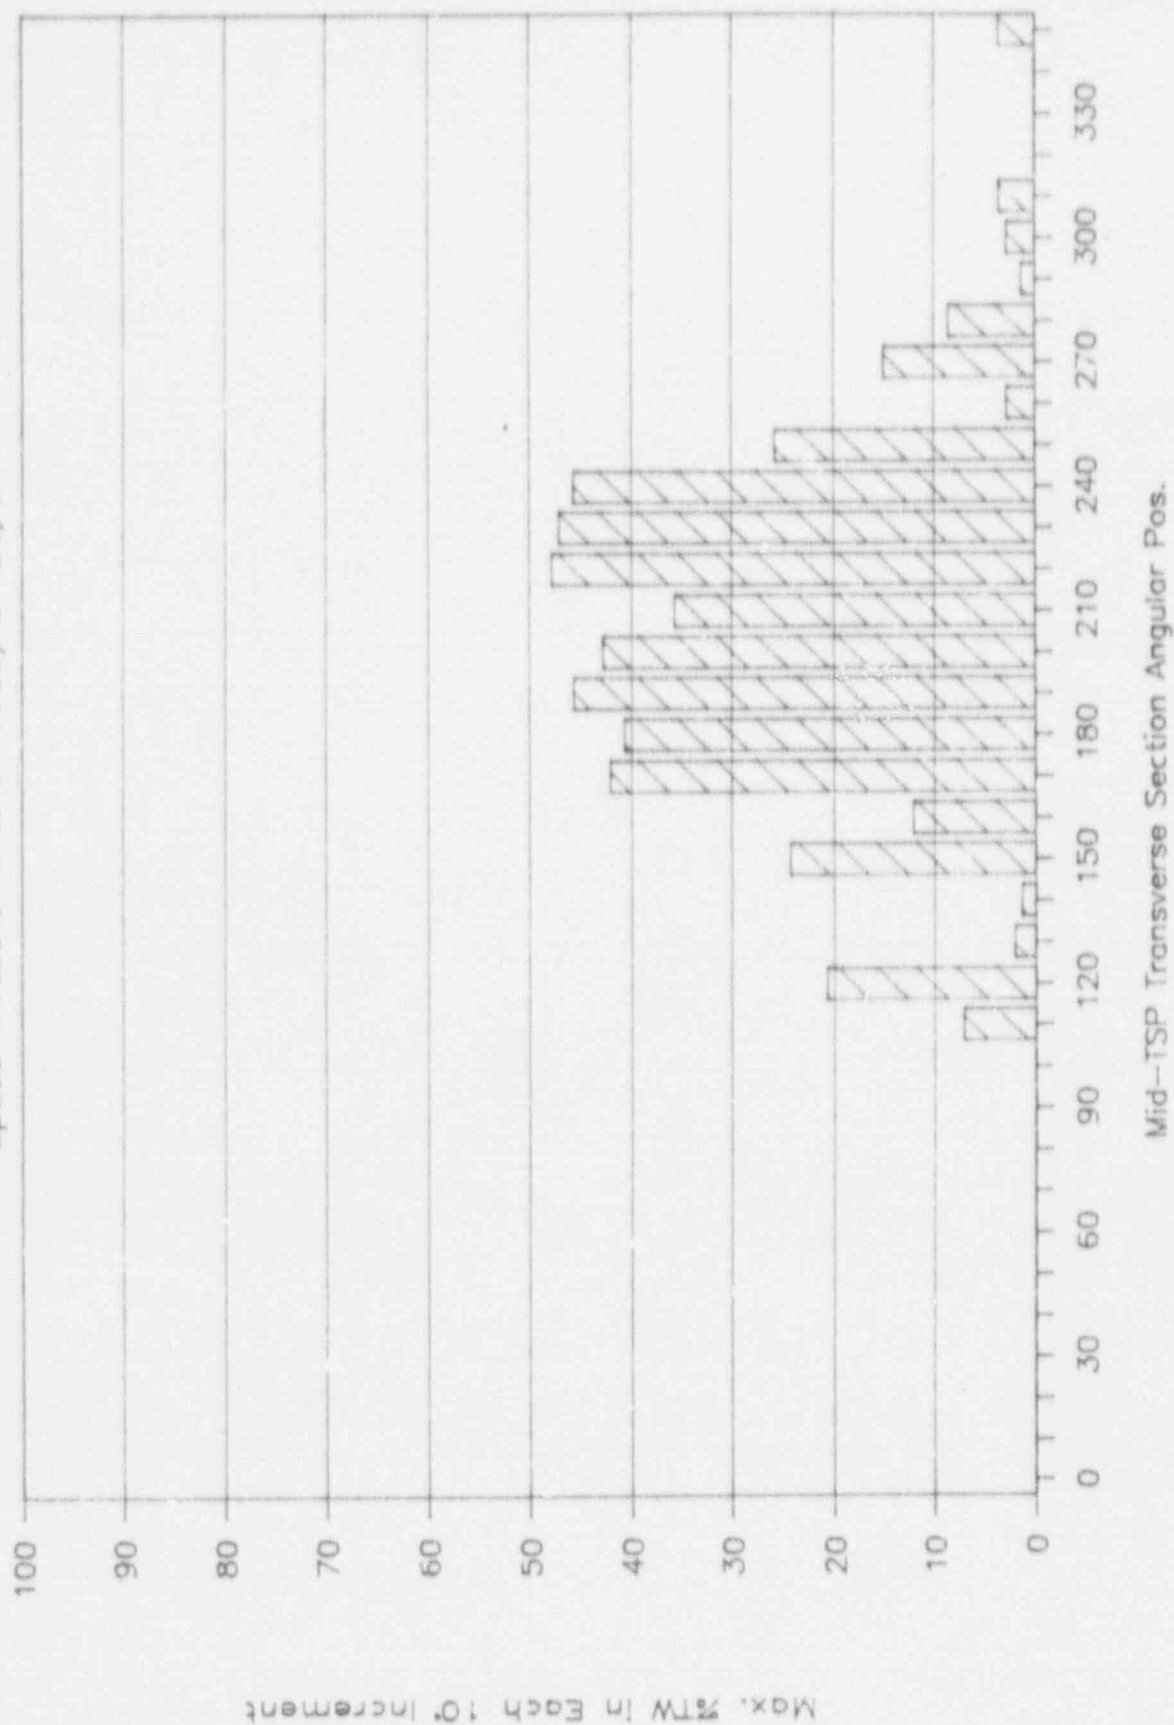
Figure 5-3. 'D'R12C8 TSP#3 Degradation

The third TSP intersection was subjected to a burst test, the results of which are shown in Appendix 2, Table 3-1. Both general and patchy IGA of up to 33 percent through-wall depth and discrete ODSCC were observed in different areas of this TSP intersection.

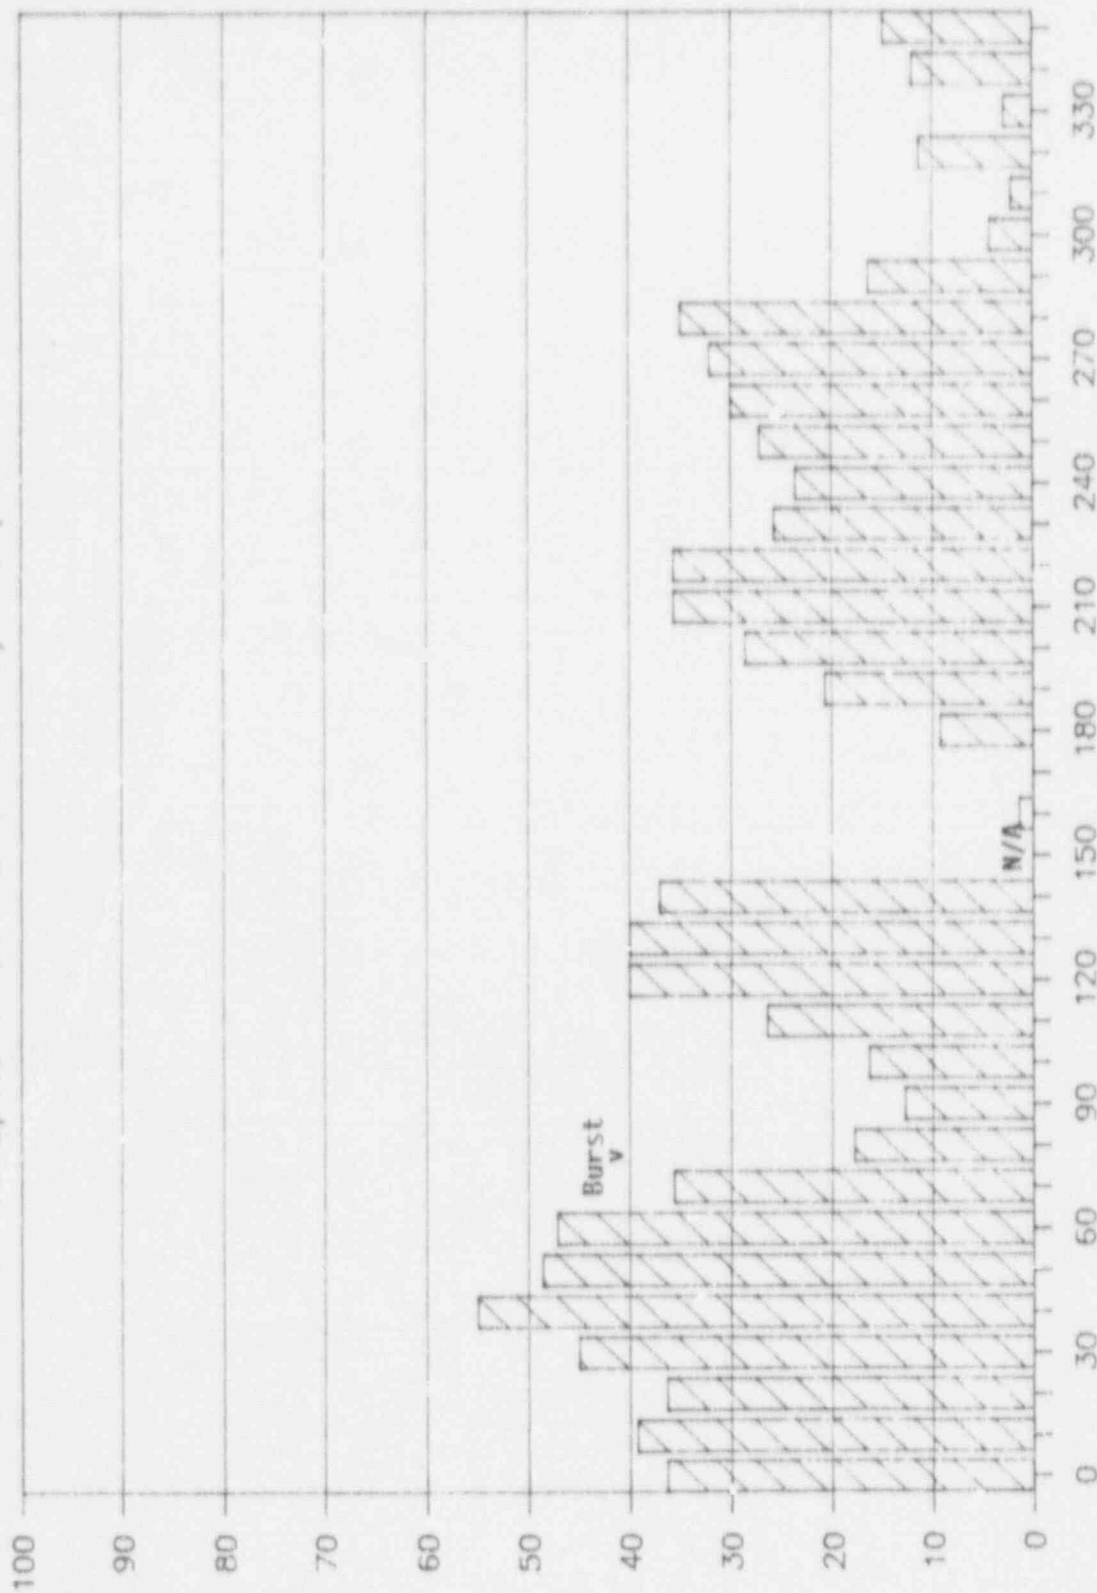
Figure 5-4. 'C'R29C70 TSP#1 Degradation

Metallographic analytical results for the first tube, C R29C70, at the first TSP intersection, which was characterized as having an SAI requiring repair, showed ODSCC with a maximum of 56 percent through-wall depth. The second TSP intersection, which was characterized as having MAI requiring repair, showed ODSCC with a maximum of 76 percent depth. The third TSP intersection, which was characterized as having a 3:1 indication not requiring repair, showed ODSCC microflaws with a maximum of 71 percent depth.
