Westinghouse Energy Systems

**Kewaunee Steam Generator  
Tube Plugging Criteria for  
ODSCC at Tube Support Plates**

November, 1991

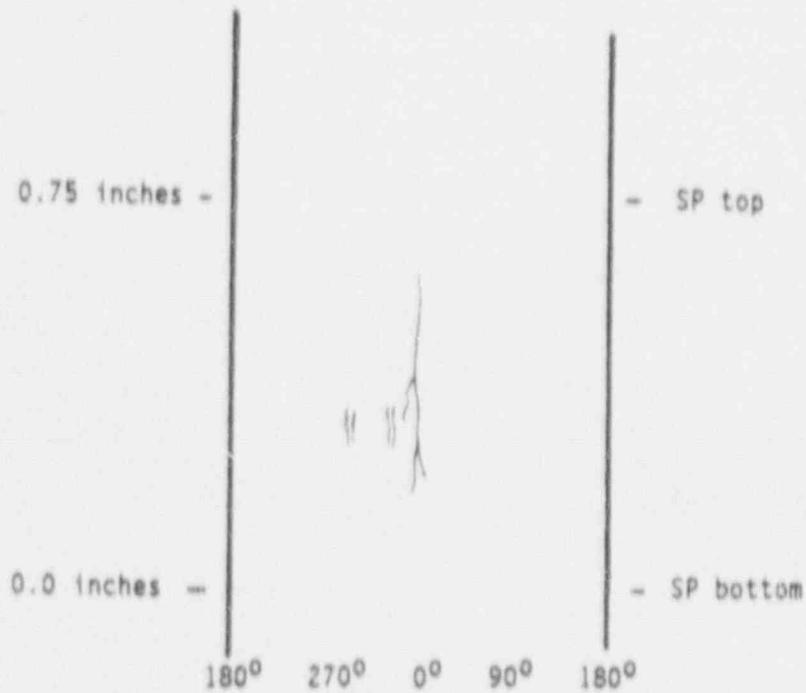
Morphology = IGSCC with moderate IGA components

Figure 4-1. Summary of crack distribution and morphology observed on the first support plate crevice region of tube R31-C46.

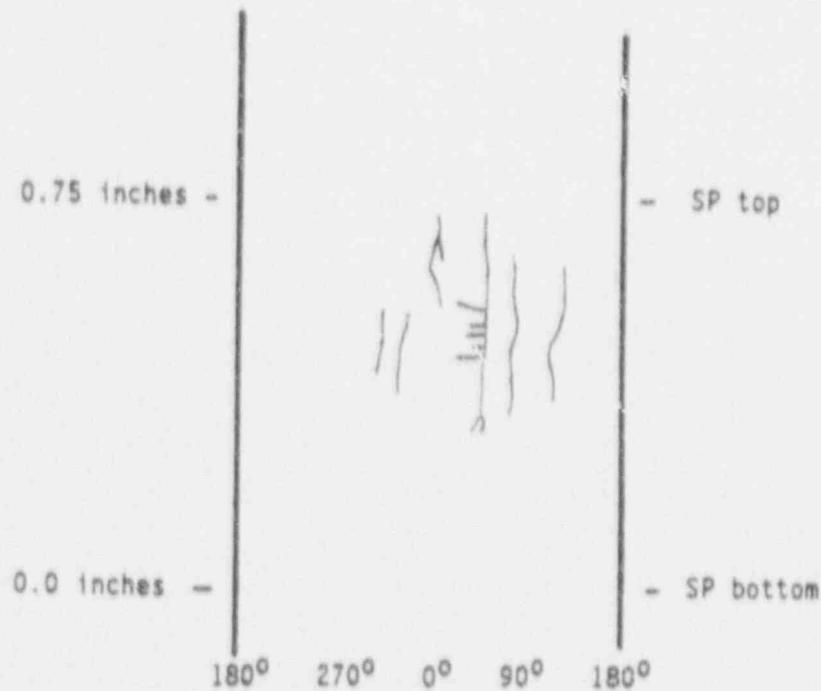
Morphology = IGSCC with some IGA aspects (circumferential cracking has more IGA characteristics)

Figure 4-3. Description of OD origin corrosion at the fifth support plate crevice region of tube R4-C61.

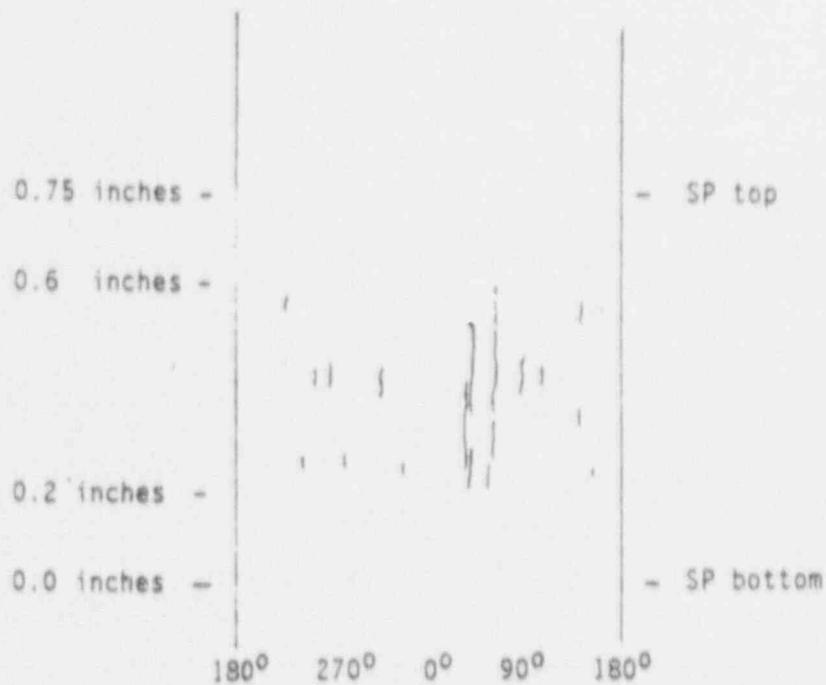
Morphology = Intergranular SCC with some IGA characteristics (width of IGA 0.012 inches)

Figure 4-5. Description of OD origin corrosion at the first support plate crevice region of tube R4-C73.

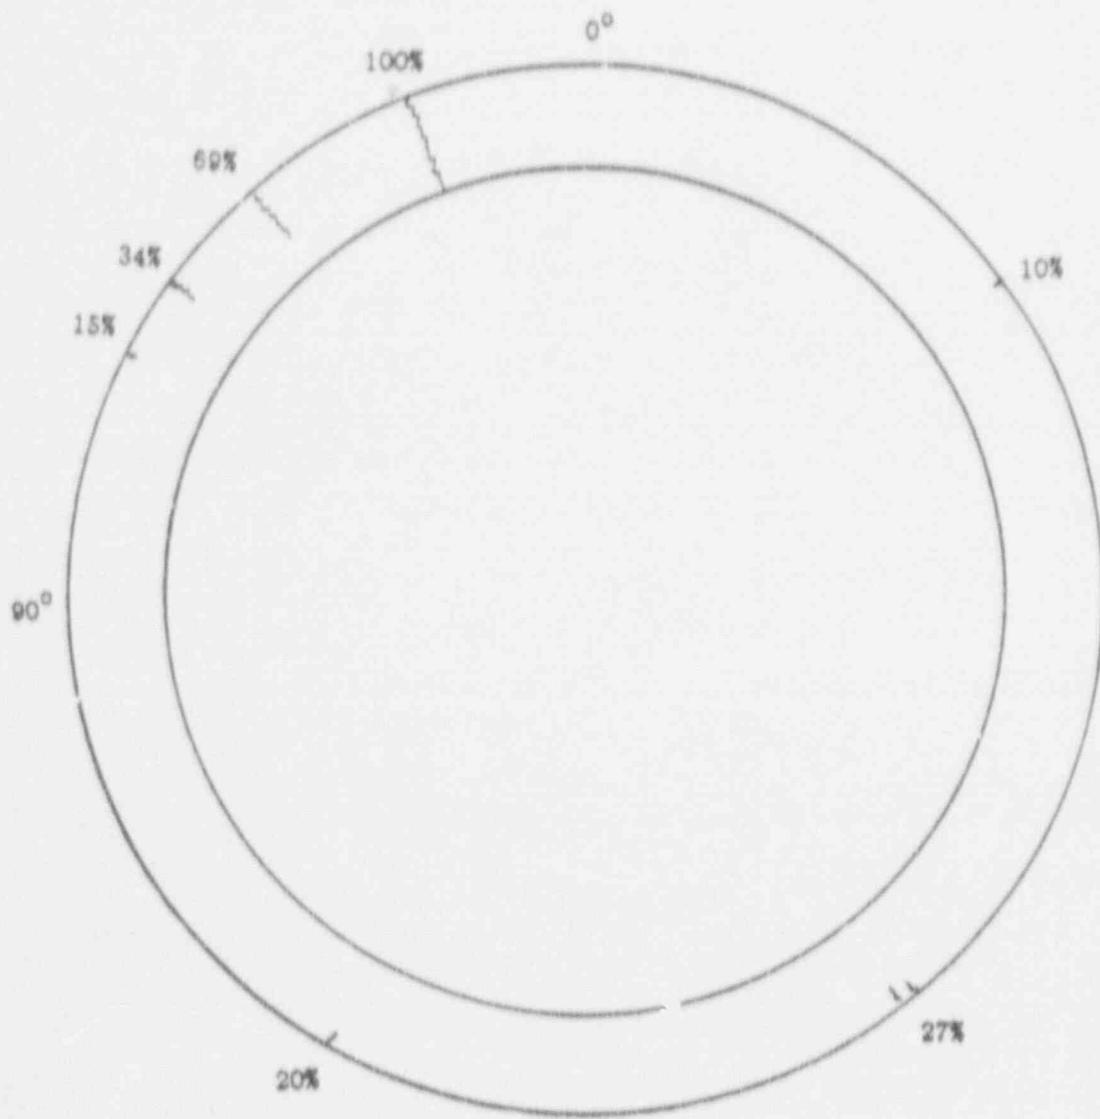
Figure 4-6. Sketch of crack distribution and depth within the center of the first support plate intersection in tube R4-C73.

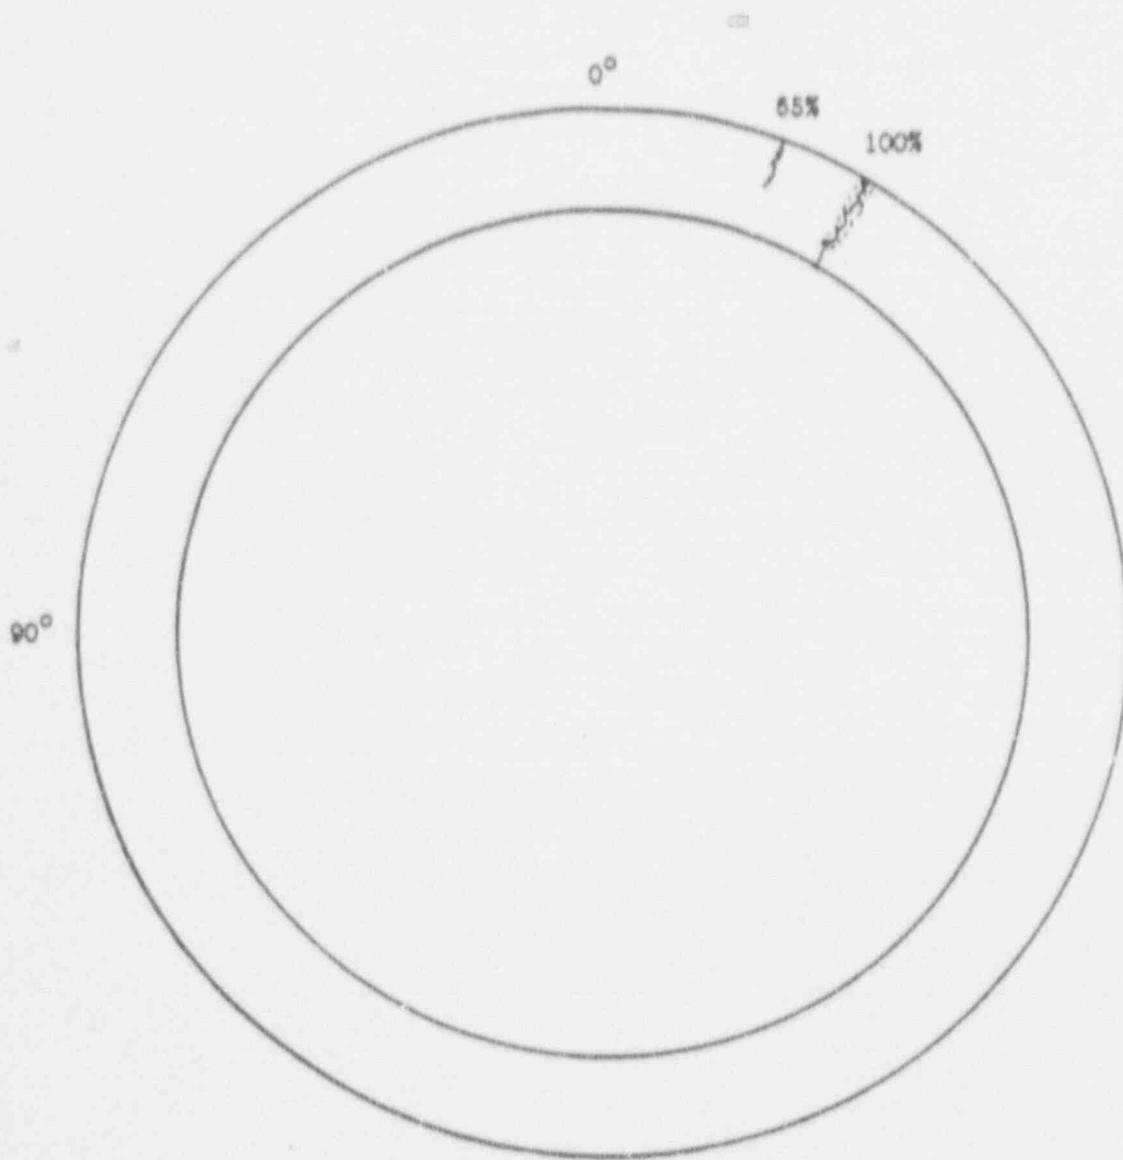
Figure 4-9. Sketch of crack distribution and depth within the first support plate crevice region in tube R21-C22.

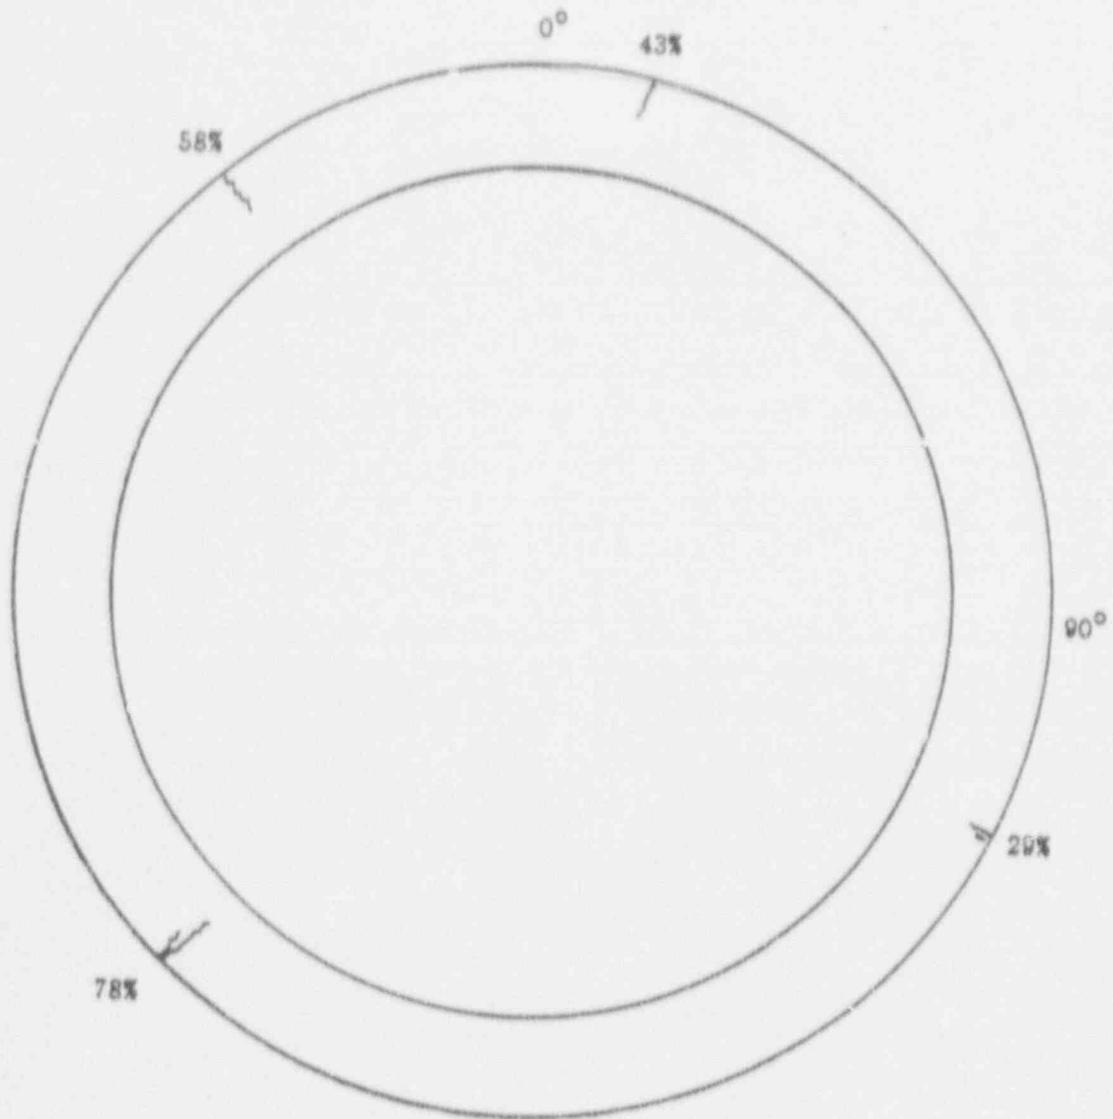
Figure 4-12. Summary of distribution and maximum depth of cracks found within the first support plate crevice region of tube R38-C46.

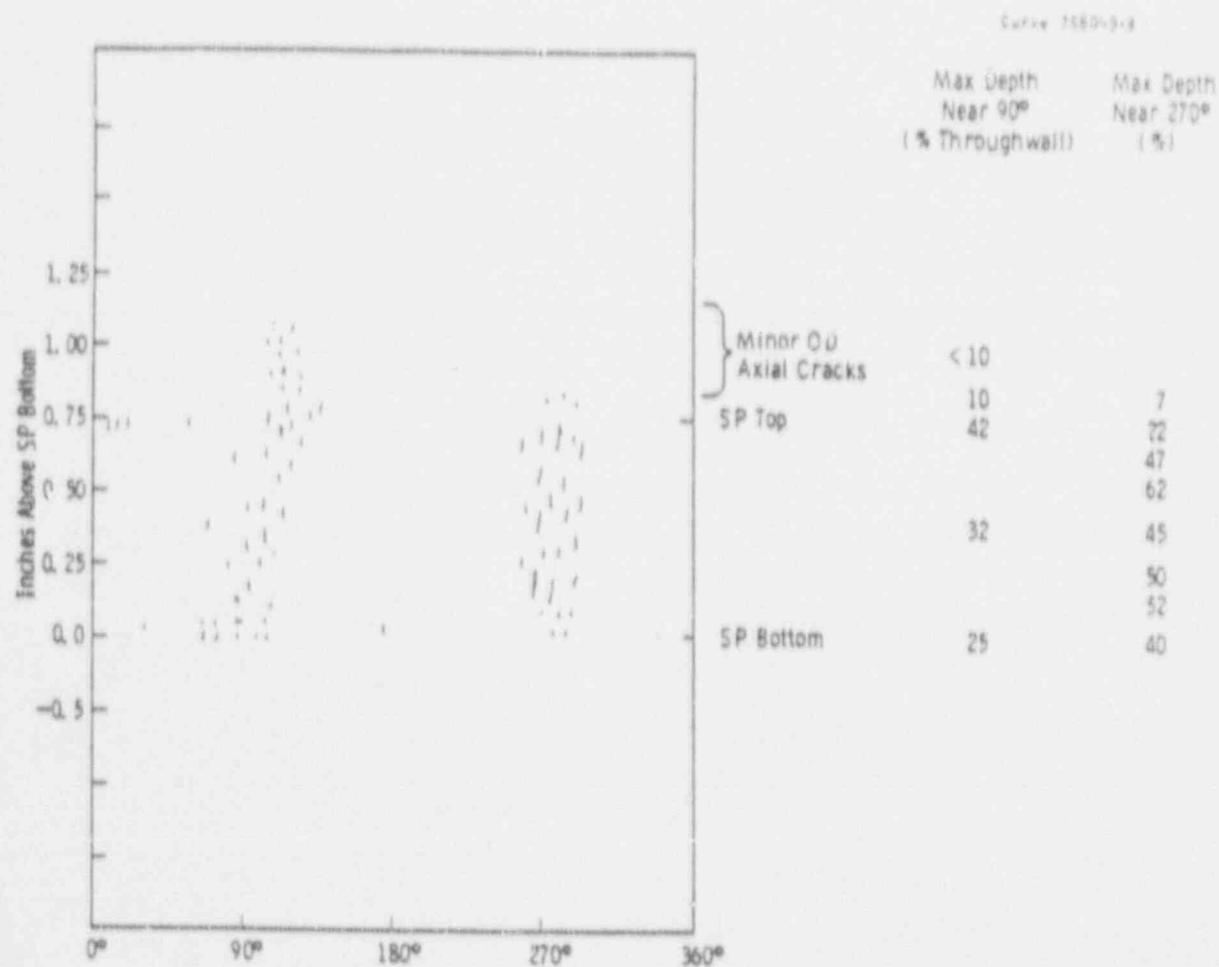
Figure 4-17. Crack network location at first support plate region on tube R20-C25 HL.

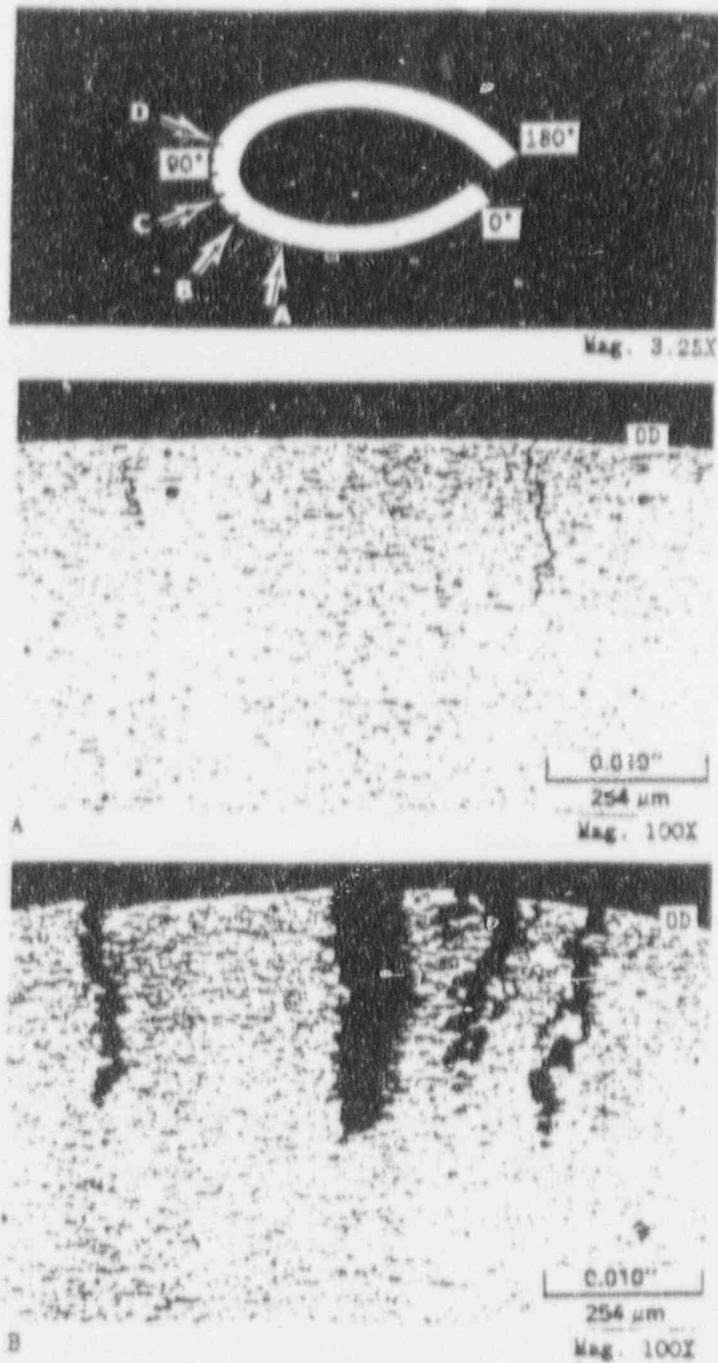
Figure 4-18. Transverse metallographic section through tube R20-C26 HL at the mid-point of the first support plate crevice region (90° deformed half) with crack details in Areas A and B.

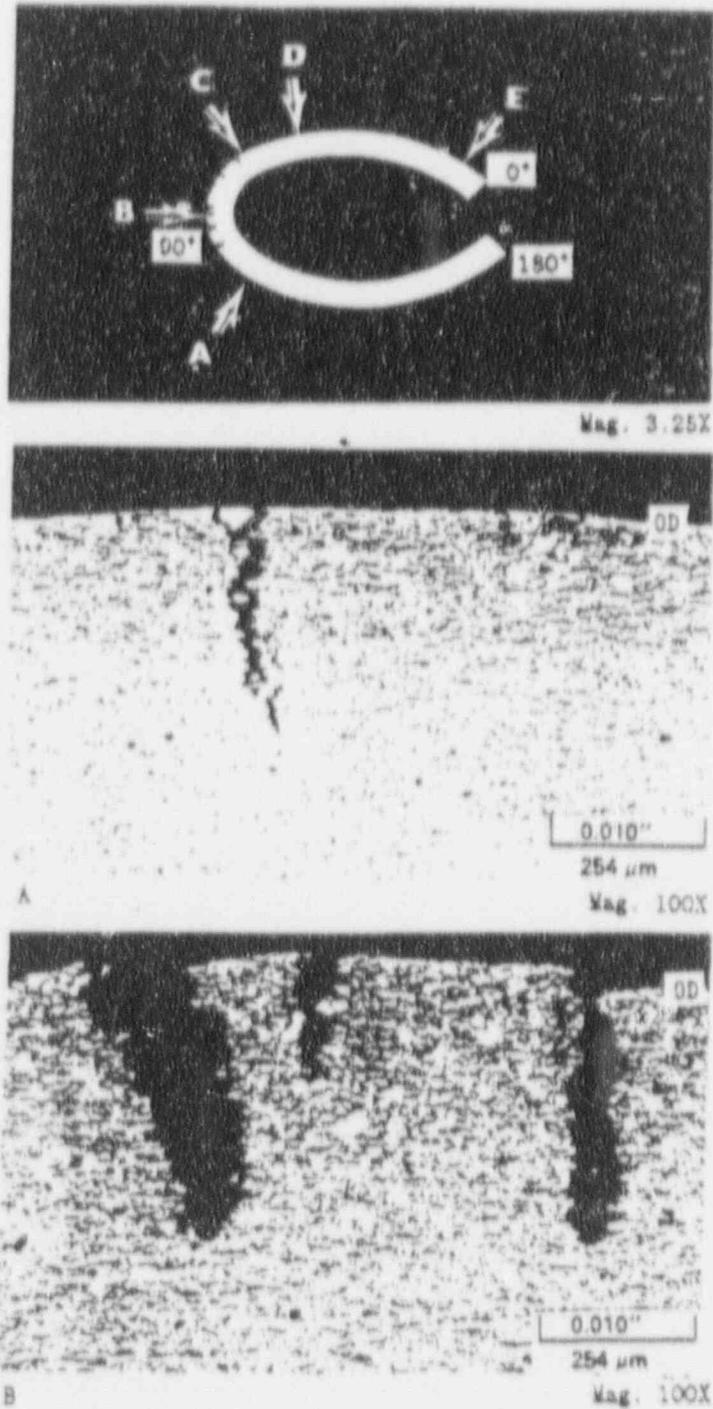
Figure 4-19. Transverse metallographic section through Plant A tube R20-C26 HL at the first support plate crevice region (90° deformed half) below the support plate crevice top with crack details in Areas A and B.

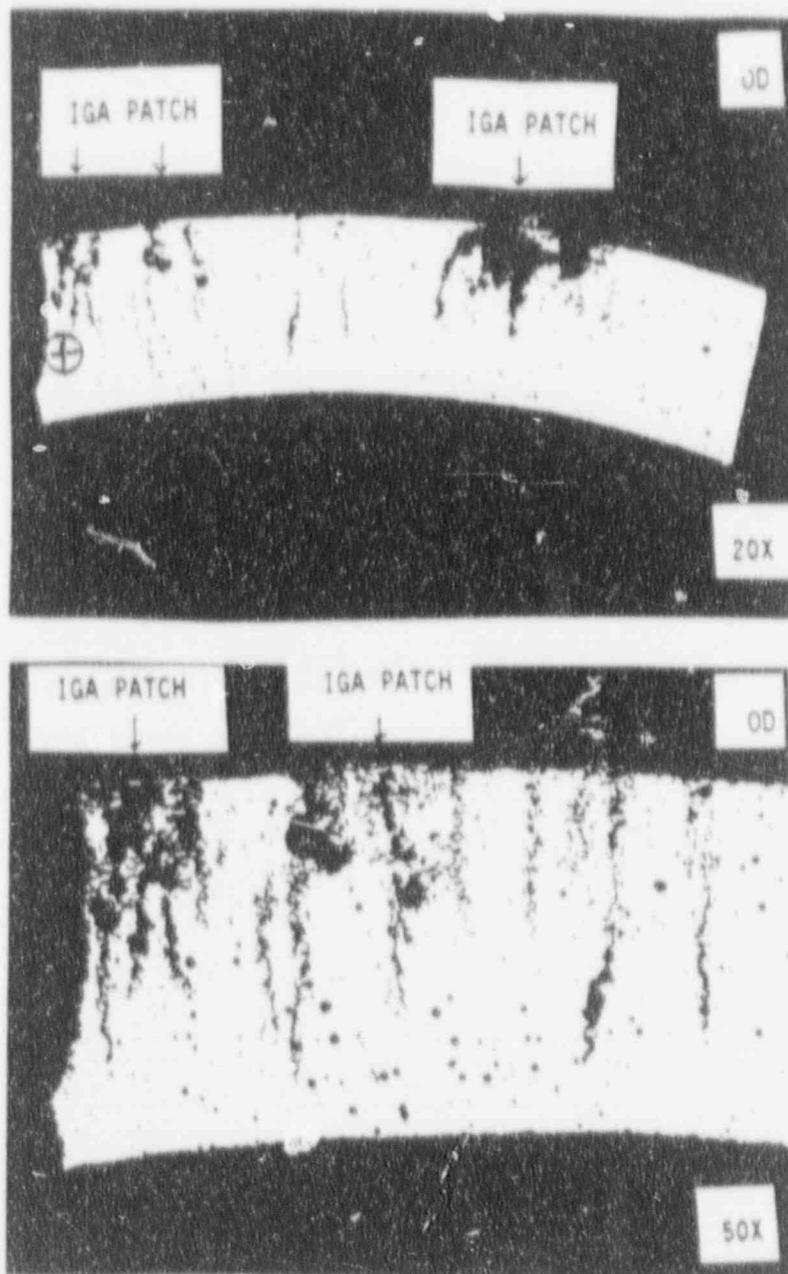
Figure 4-21. Transverse optical micrographs obtained just below the circumferential fracture at the center of the support plate. The circumferential location is that where the deepest corrosion was found. The deepest axial IGSCC is 85% through wall and three IGA patches are observed: one 43% through wall and 0.015 inch long, one 33% through wall and 0.05 inch long, and one 28% through wall and 0.015 inch long. The axial IGSCC had IGA aspects to individual cracks. These aspects can be characterized by ratios comparing the crack length (depth from OD surface) to IGA width at the mid-crack location. L/W ratios vary from 6 to 18. Plant L.

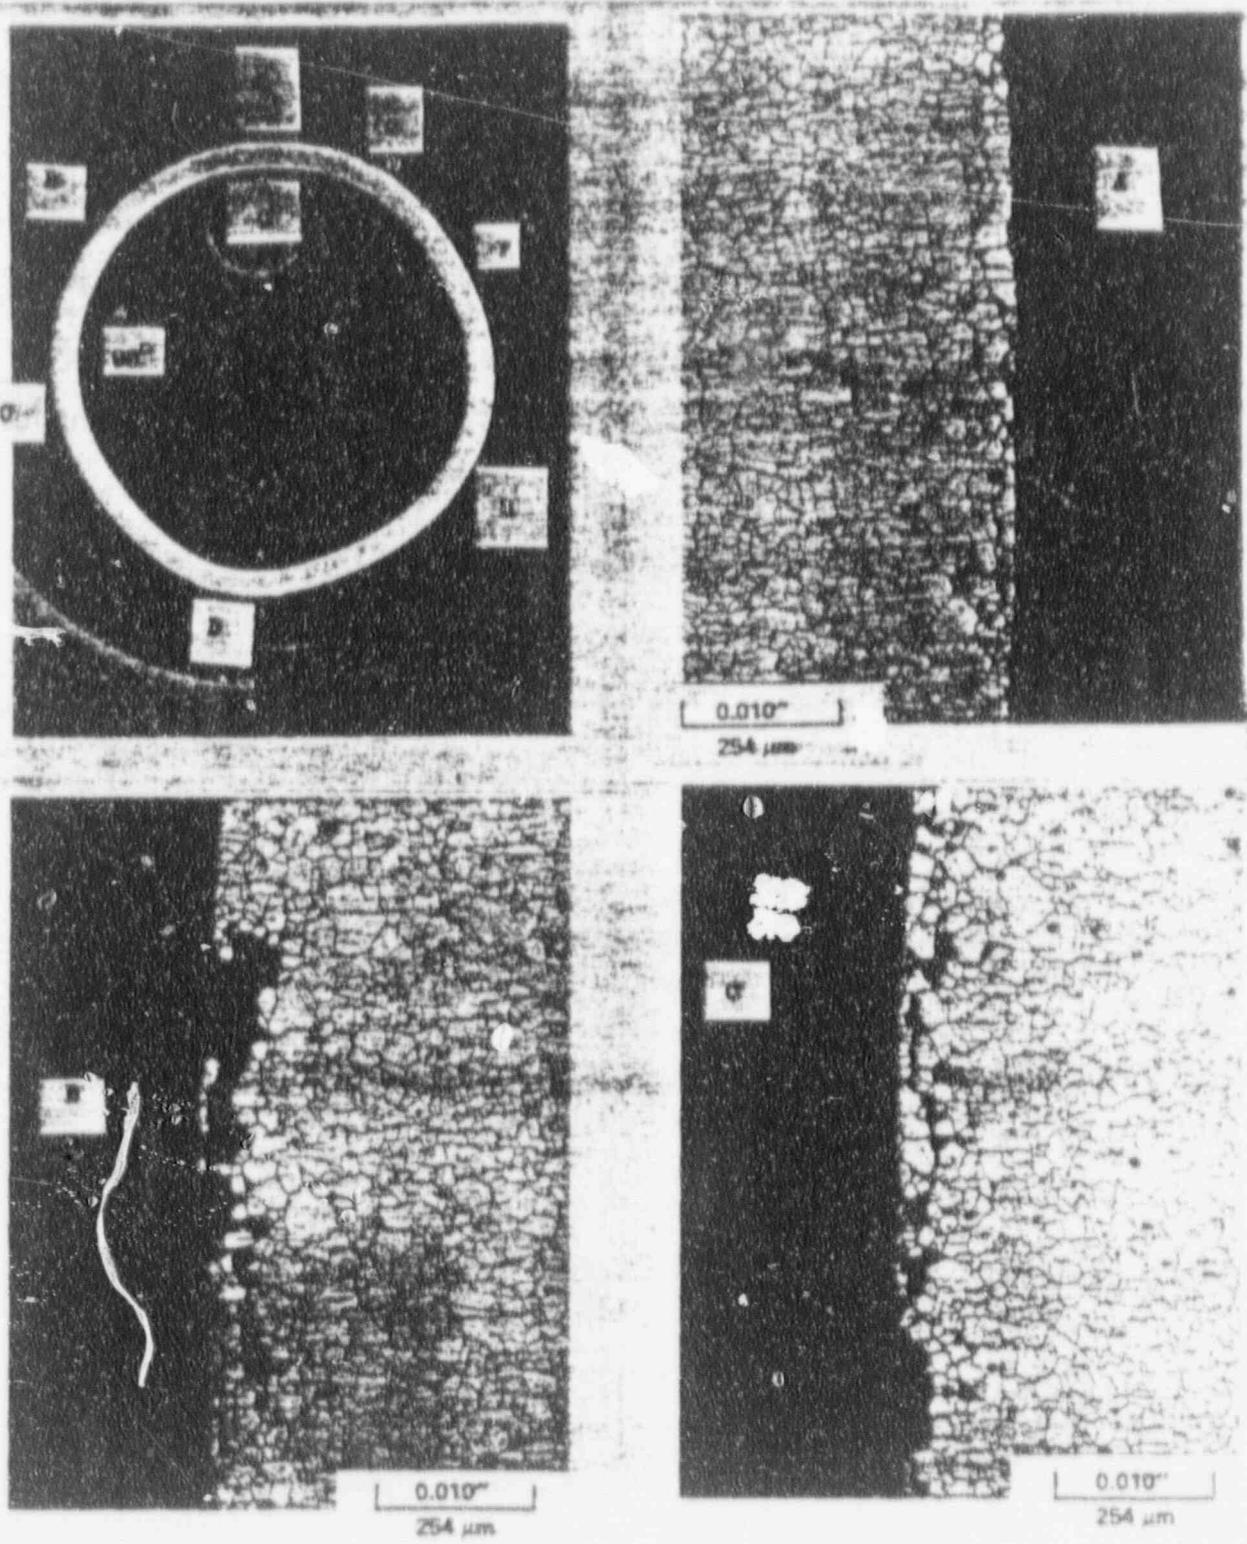
Figure 4-22 Transverse metallography at 0.2 inches above first support plate bottom edge showing almost continuous OD IGA around circumference. Maximum depth is 24%.  
 Tube R29-C46 CL, Plant M-2

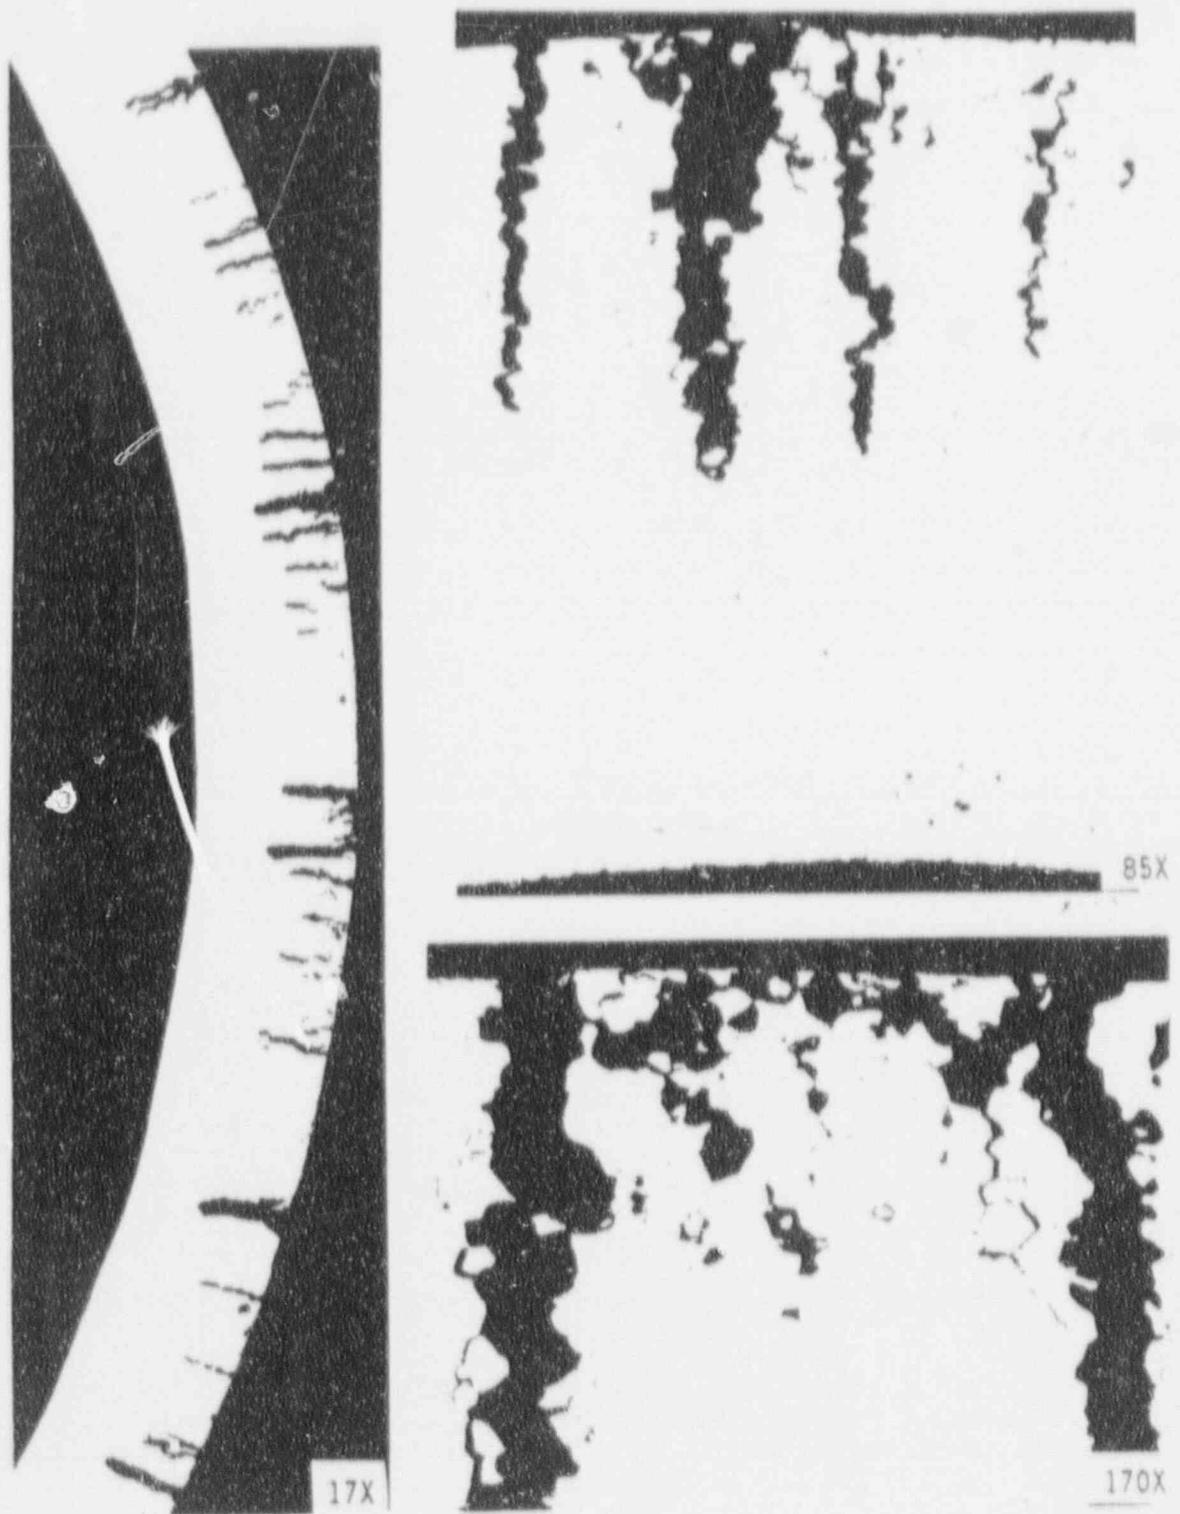
Figure 4-24 Transverse photomicrographs of intergranular corrosion at the second support plate region of tube LB-C74 from Plant J-1

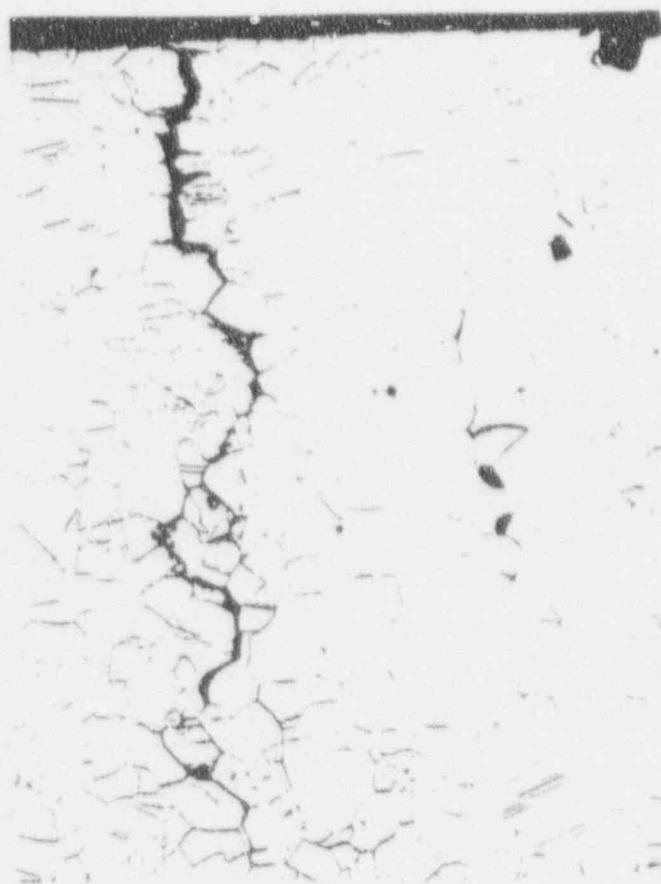
Figure 10-1 Sketch of a metallographic cross section through secondary support plate crevice cracks in Tube 543-4. A typical crack micrograph is also shown.

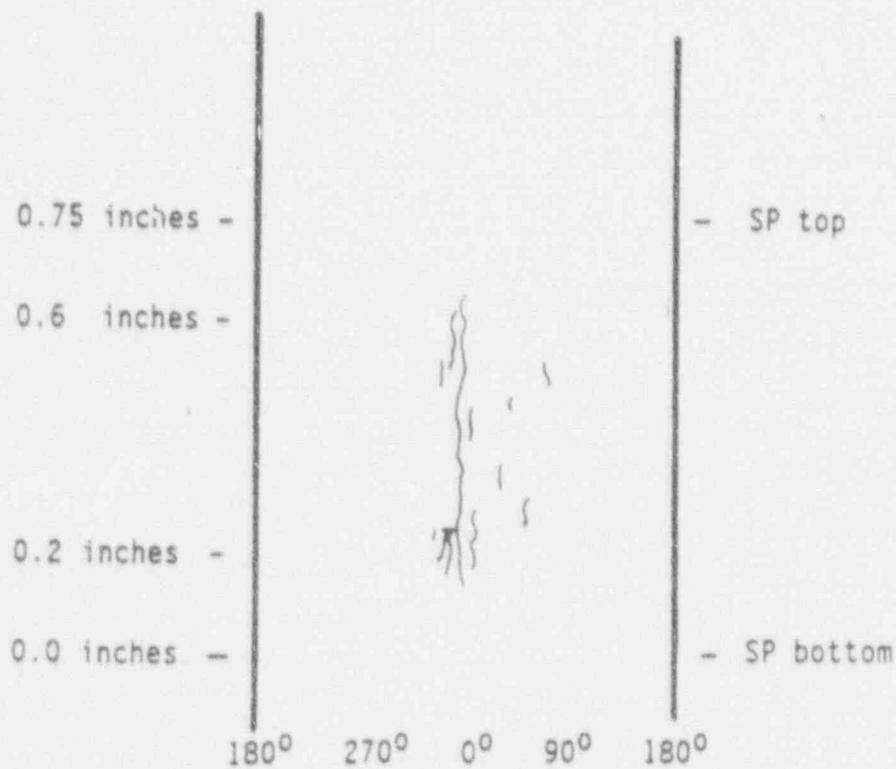
Macrocrack Length = 0.52 inches  
 Throughwall Length = 0 (98% throughwall)  
 Number of Microcracks = 6 (all ligaments with intergranular features)  
 Morphology = IGSCC

Figure 10-2 Summary of crack distribution and morphology observed on Tube 543-4.

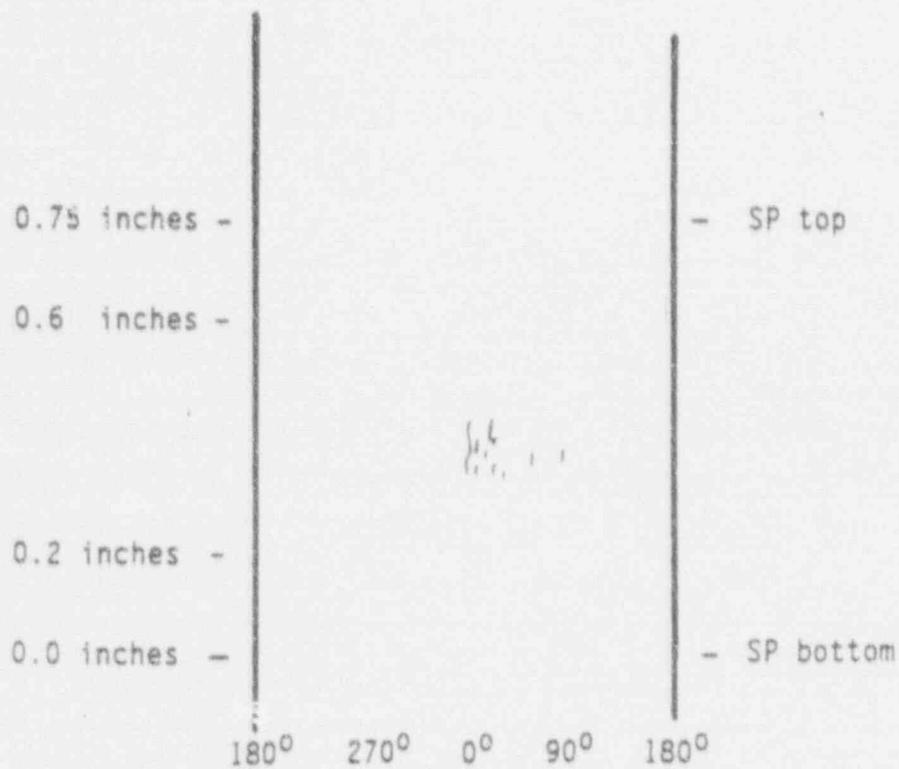
Morphology = IGSCC

Figure 10-4 Summary of crack distribution and morphology observed on Tube 525.

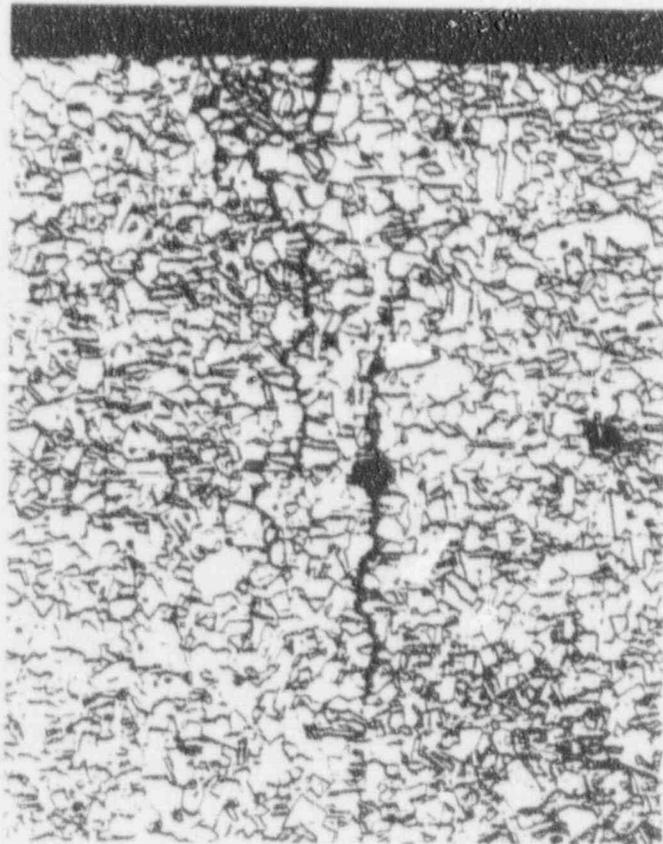
Figure 10-5 Secondary crack distribution and a micrograph of one of these cracks in a metallographic cross section of Tube 533-4.

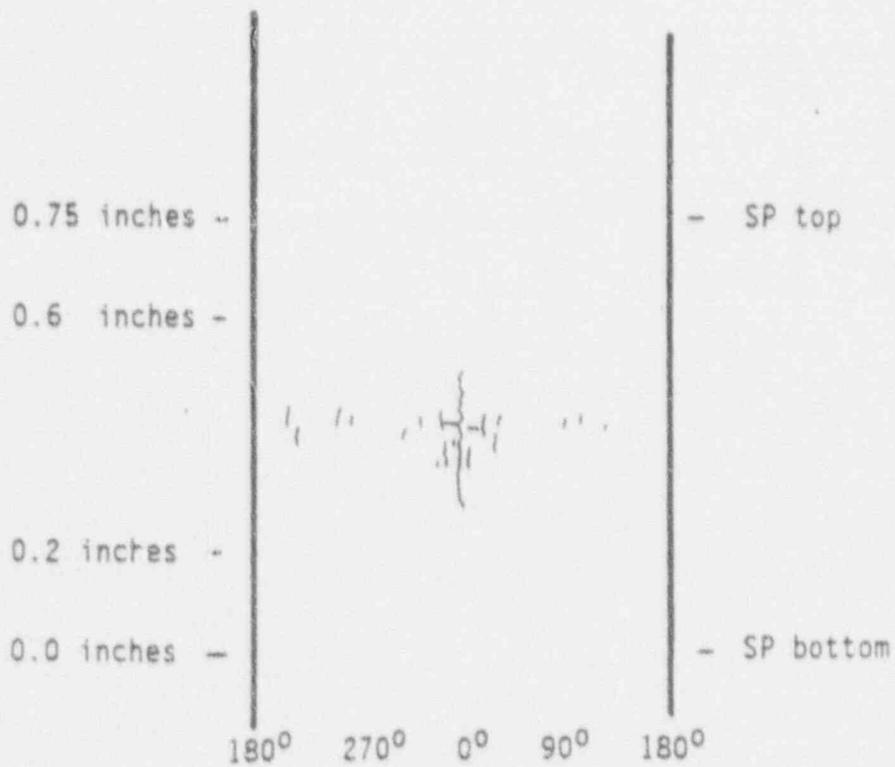
Morphology = IGSCC

Figure 10-6 Summary of crack distribution and morphology observed on Tube 533-4.

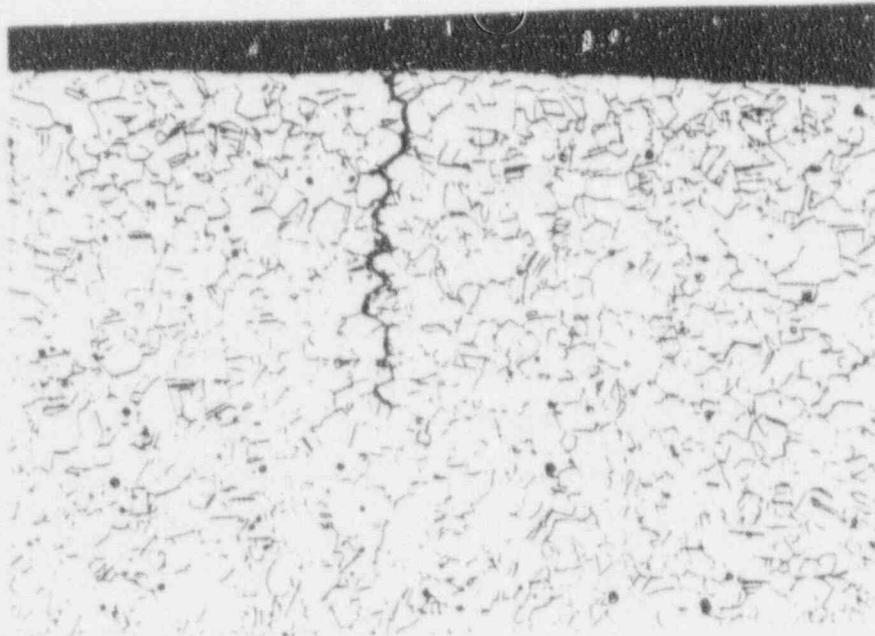
Figure 10-7 Secondary crack distribution and a micrograph of one of these cracks in a metallographic cross section of Tube 536-1.

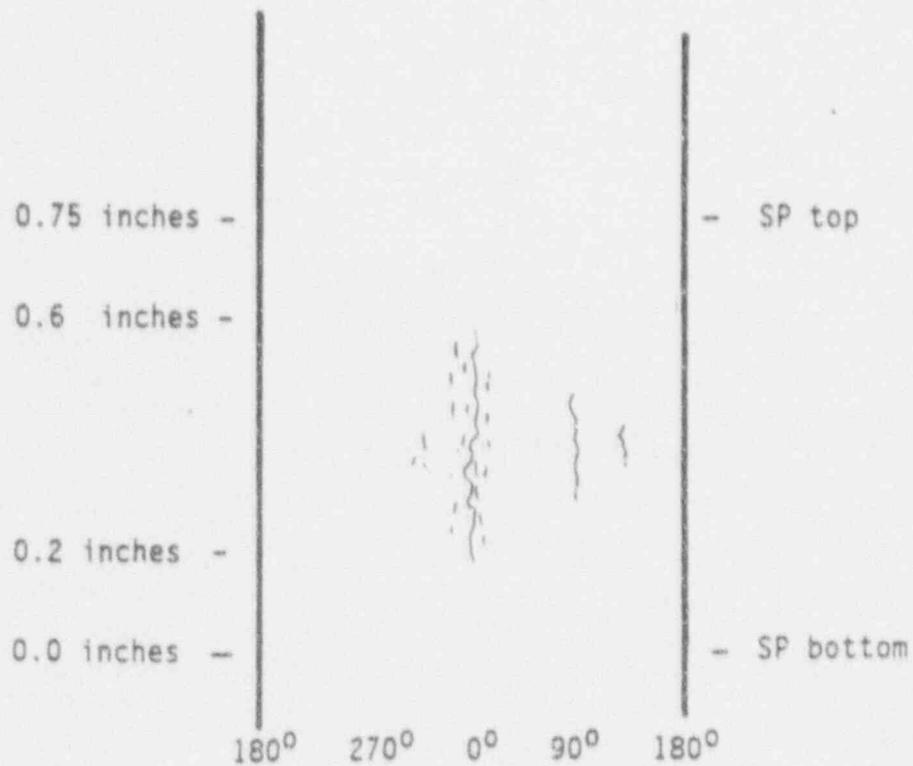
Morphology = IGSCC

Figure 10-8 Summary of crack distribution and morphology observed on Tube 536-1.

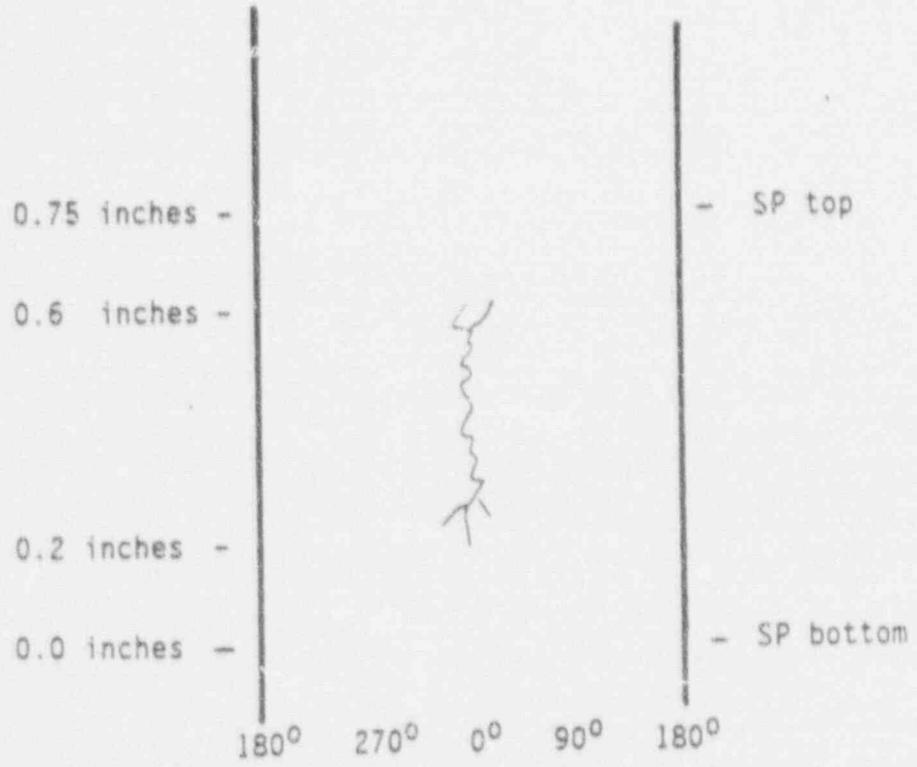
Morphology = IGSCC

Figure 10-9 Summary of crack distribution and morphology observed on Tube 558-1.

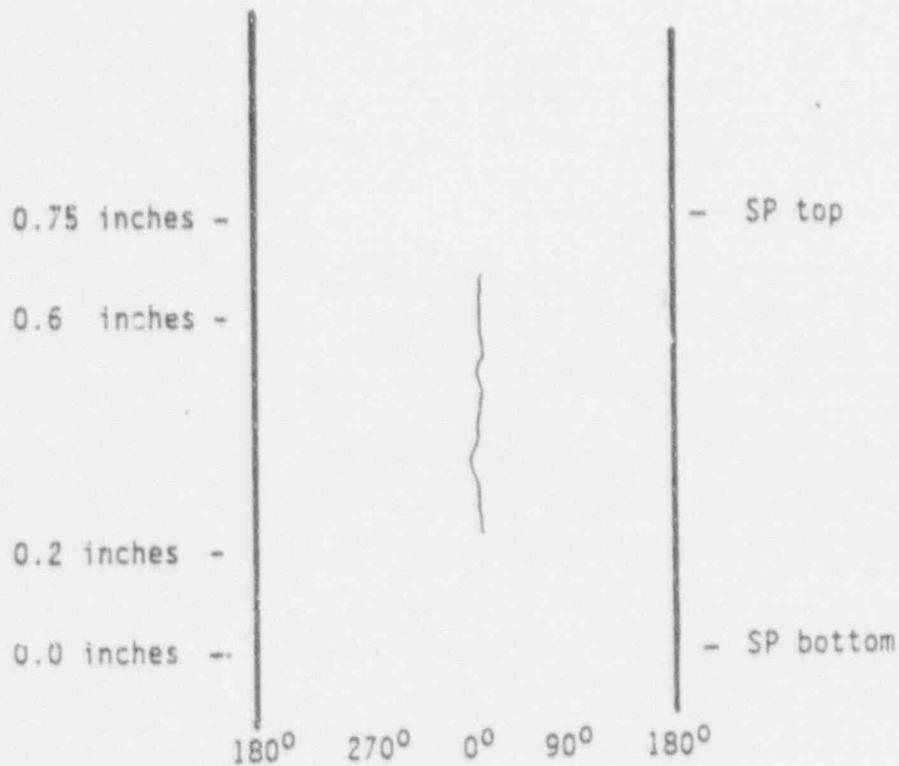
Morphology = IGSCC

Figure 10-10 Summary of crack distribution and morphology observed on Tube 571-1.

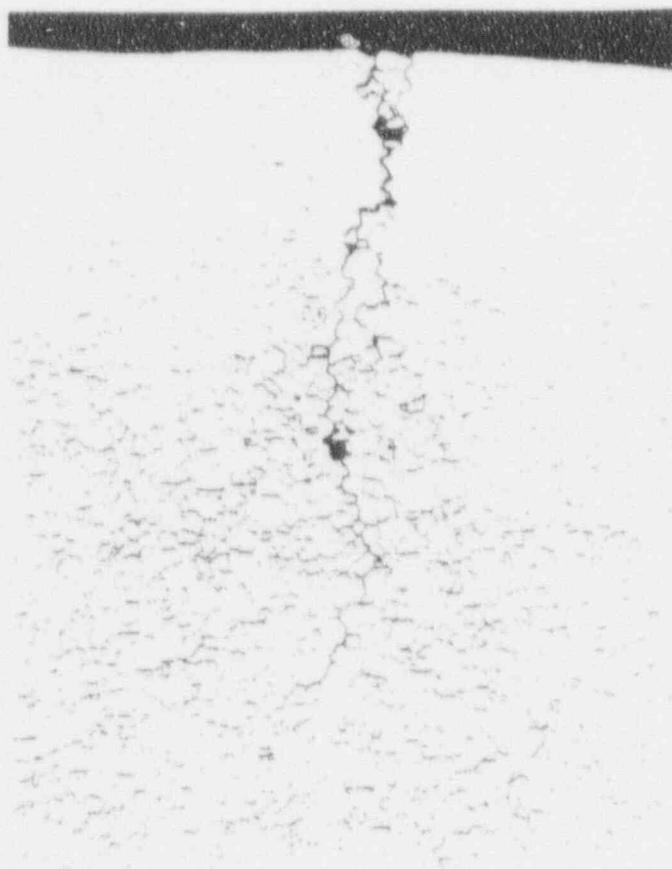
Figure 10-12 Crack distribution and a micrograph of one of these cracks in a metallographic cross section of Tube 533-3 within the steel collar region.

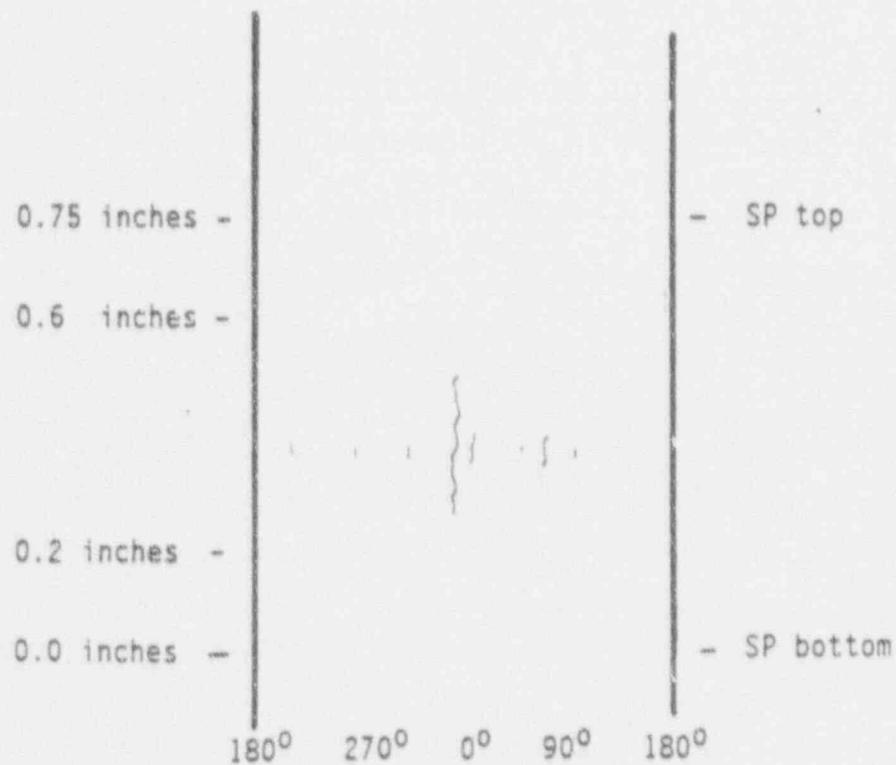
Morphology = IGSCC

Figure 10-13 Summary of crack distribution and morphology observed on Tube 533-3 at the Teflon intersection.

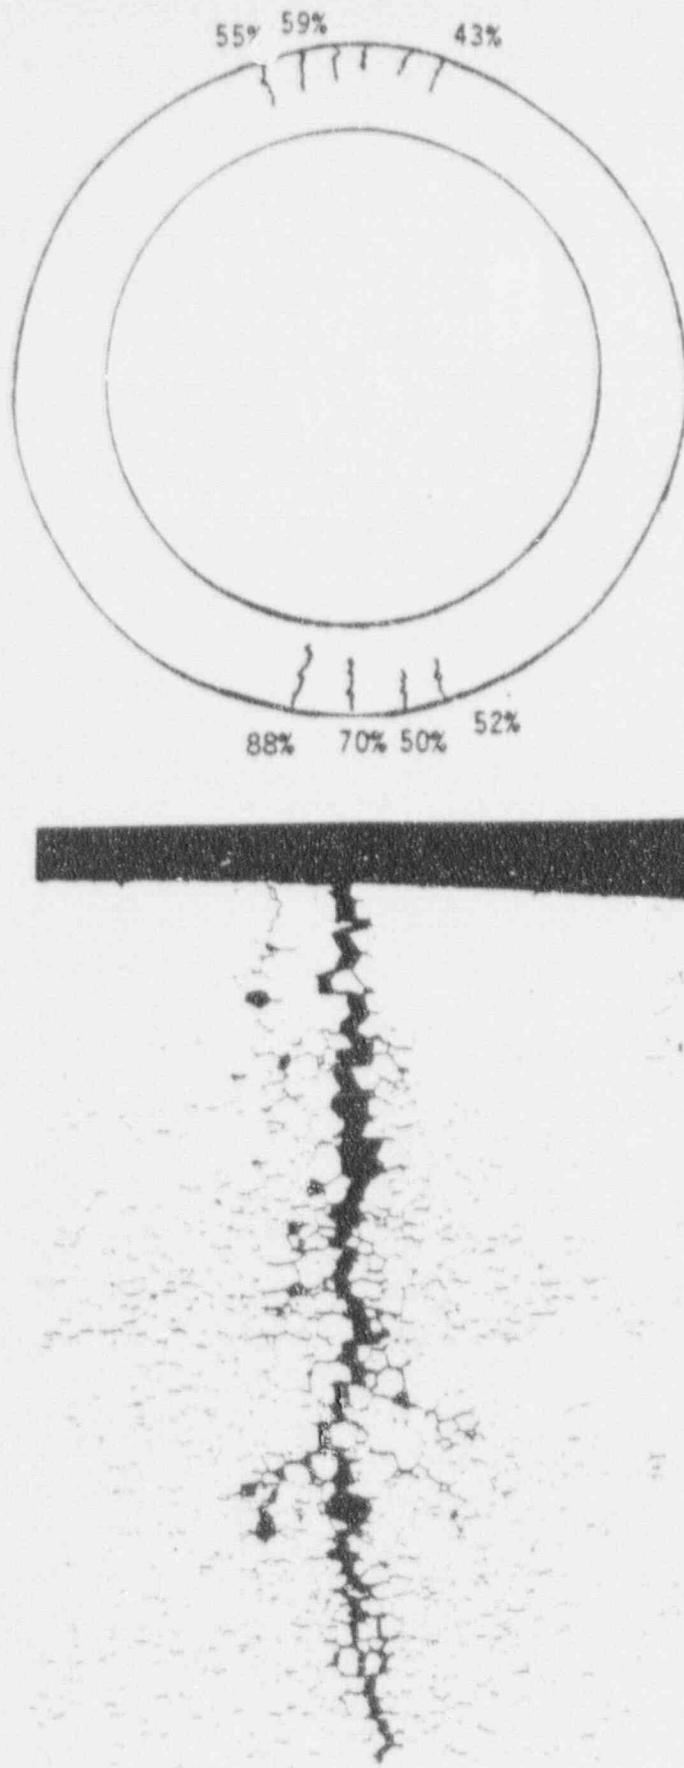
Figure 10-14 Crack distribution and a micrograph of one of these cracks in a metallographic cross section of Tube SL-FH-11 in Plane A.
