Westinghouse Energy Systems

**Kewaunee Steam Generator  
Tube Plugging Criteria for  
ODSCC at Tube Support Plates**

November, 1991

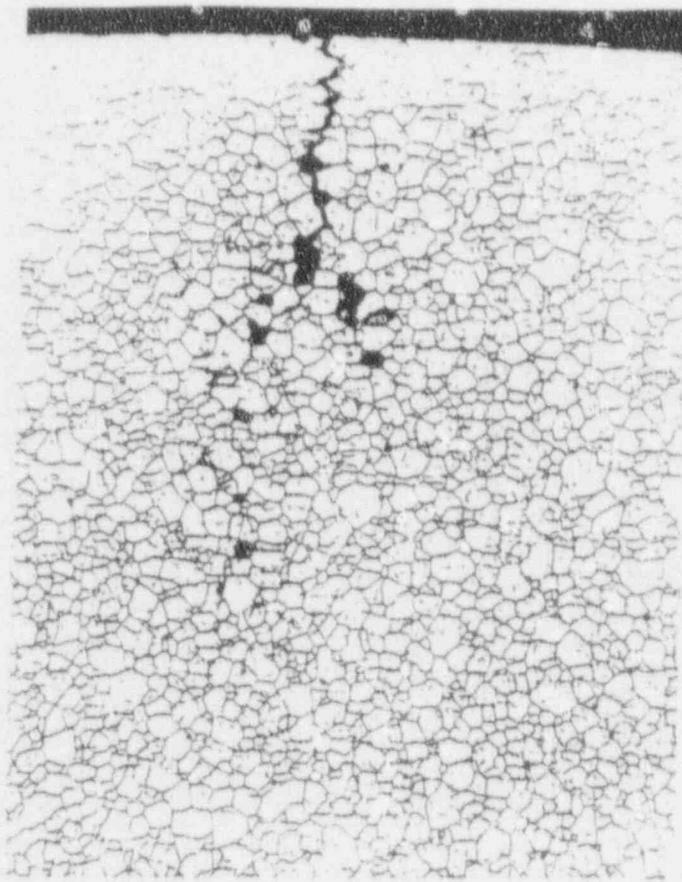
Figure 10-15 Crack distribution and a micrograph of one of these cracks in a metallographic cross section of Tube SL-FH-11 in Plane B.

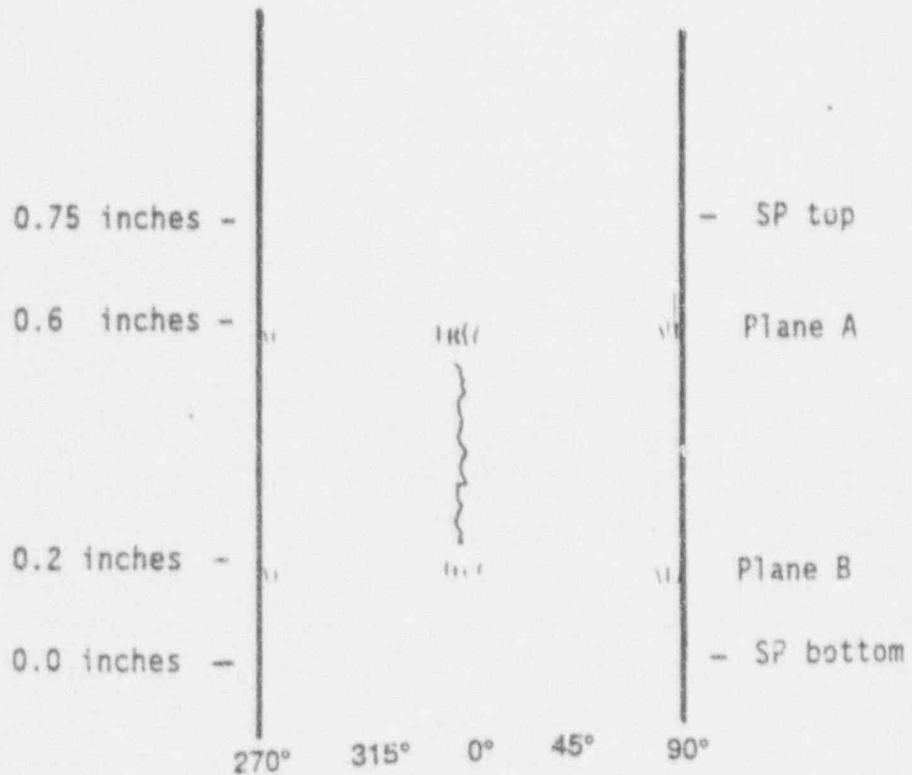
Morphology = IGSCC

Figure 10-16 Summary of crack distribution and morphology observed on Tube SL-FH-11.

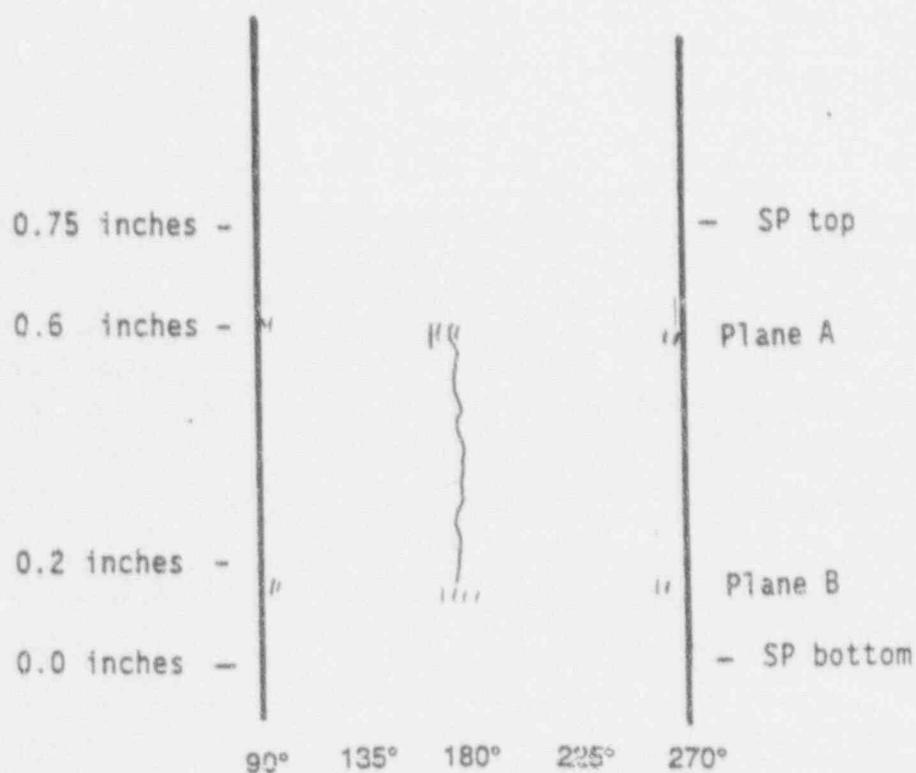
Morphology = IGSCC

Figure 10-17 Summary of crack distribution and morphology observed on second crack opened in the laboratory on Tube SL-FH-11.

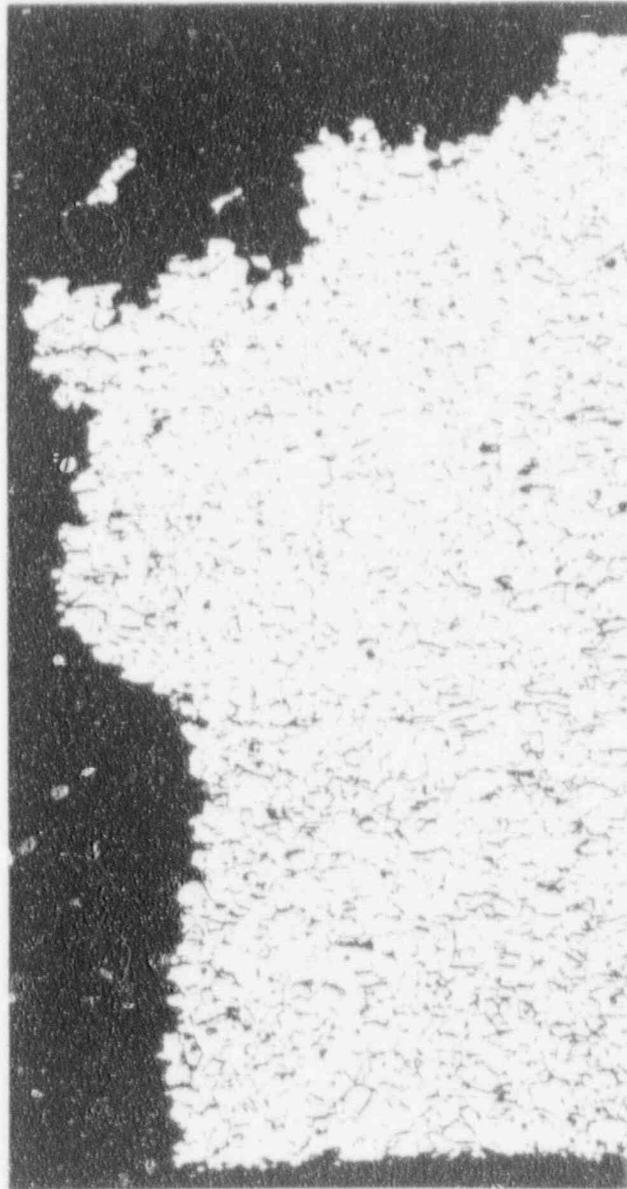
Figure 10-19 Crack morphology of the major burst opening crack (transverse section) showing it to be IGSCC with circumferential extension. Mag. 100X

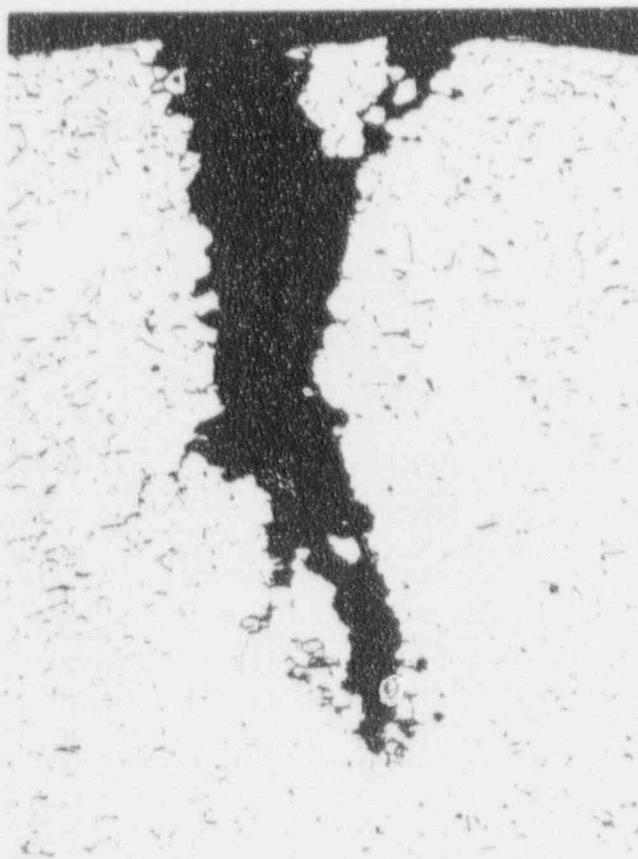
Figure 10-20 Crack distribution found by a metallographic cross section through the center of the crevice (top) and a photomicrograph of one of the secondary cracks (bottom) showing IGSCC with negligible IGA aspects. Mag. 100X

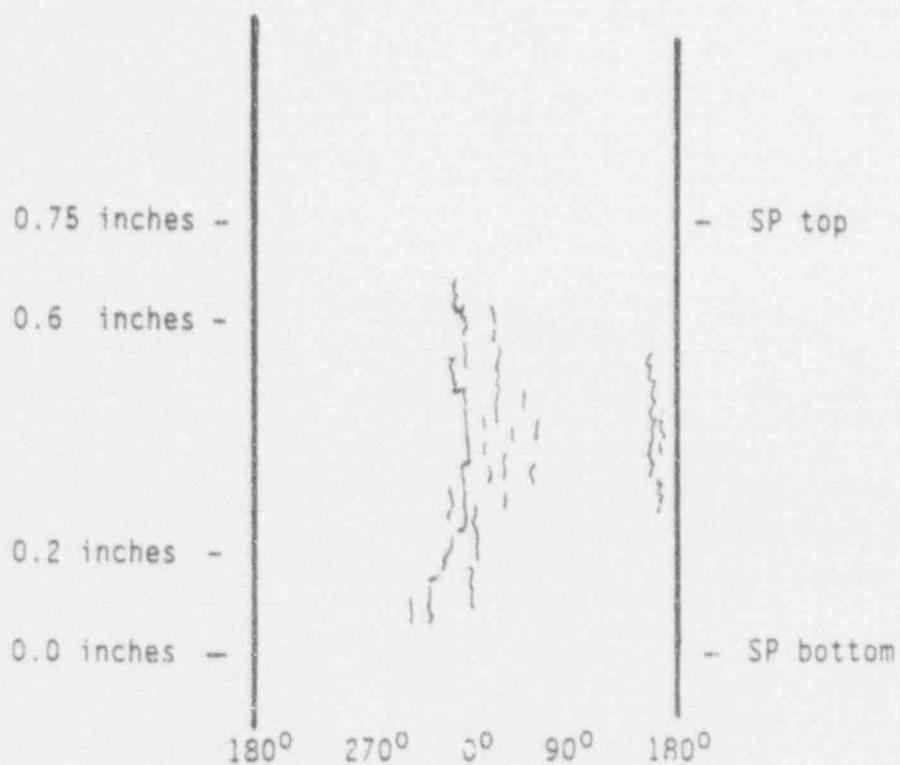
Morphology = IGSCC

Figure 10-21 Summary of overall crack distribution and morphology observed on tube 528-2.

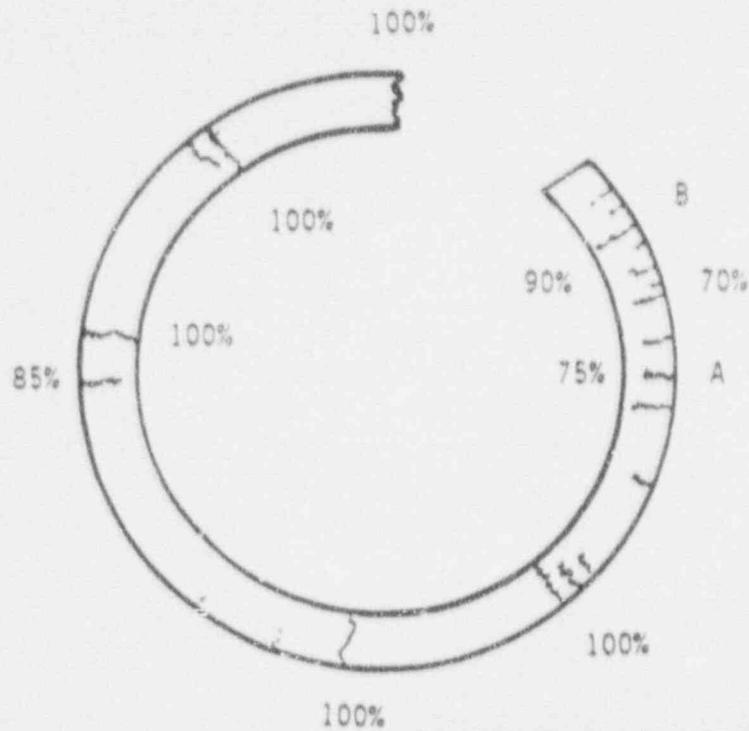
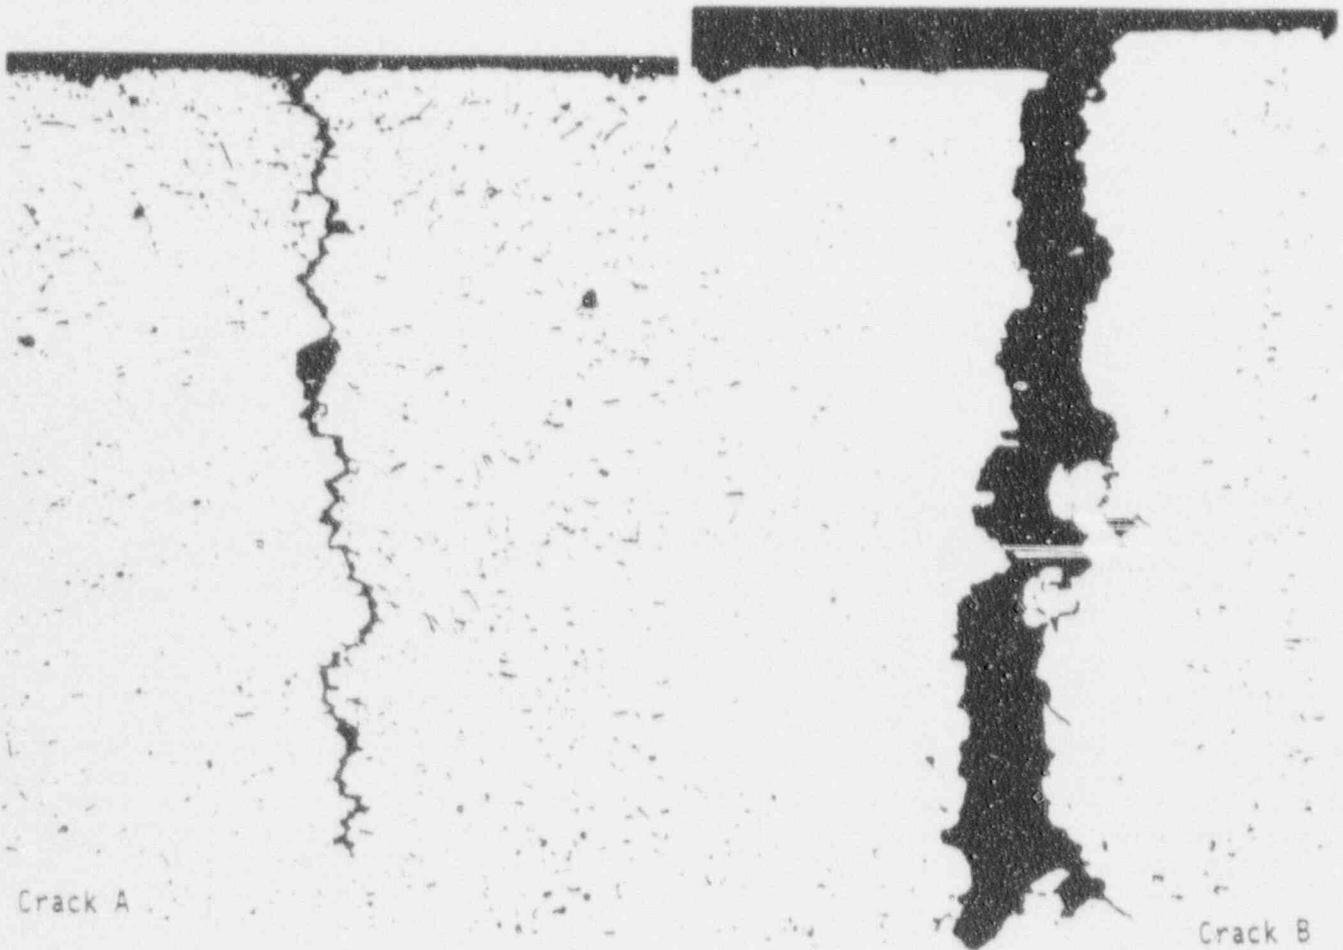
Figure 10-24 Sketch of crack distribution found by a metallographic cross section through the center of the crevice region of tube 532-1 and two photomicrographs of secondary cracks. Mag. 100X

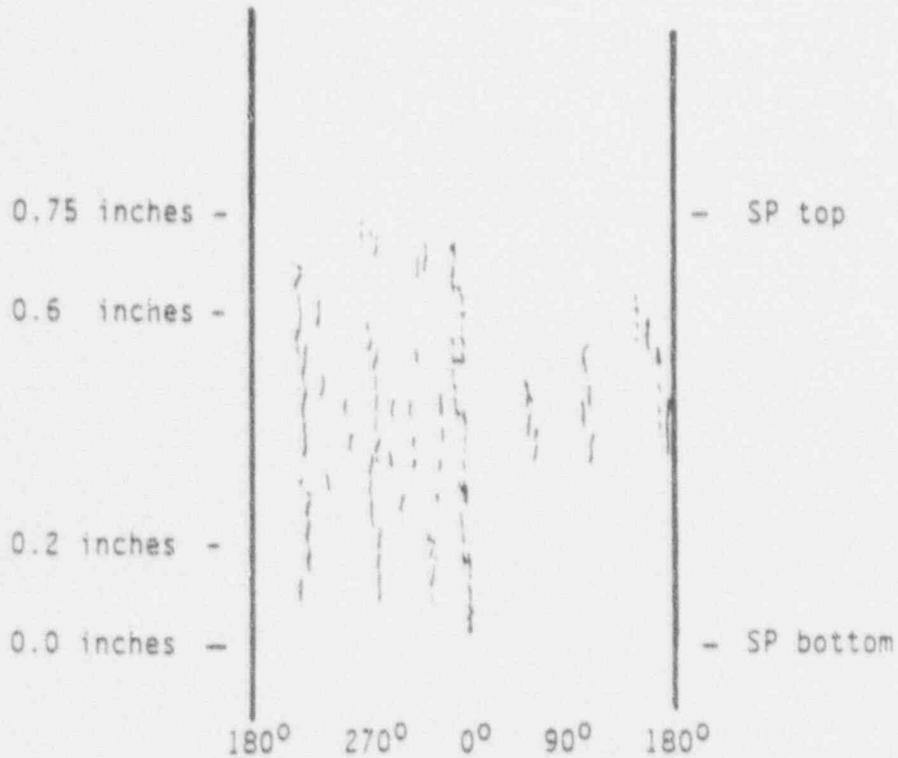
Morphology = IGSCC

Figure 10-25 Summary of overall crack distribution and morphology observed on tube 532-1.

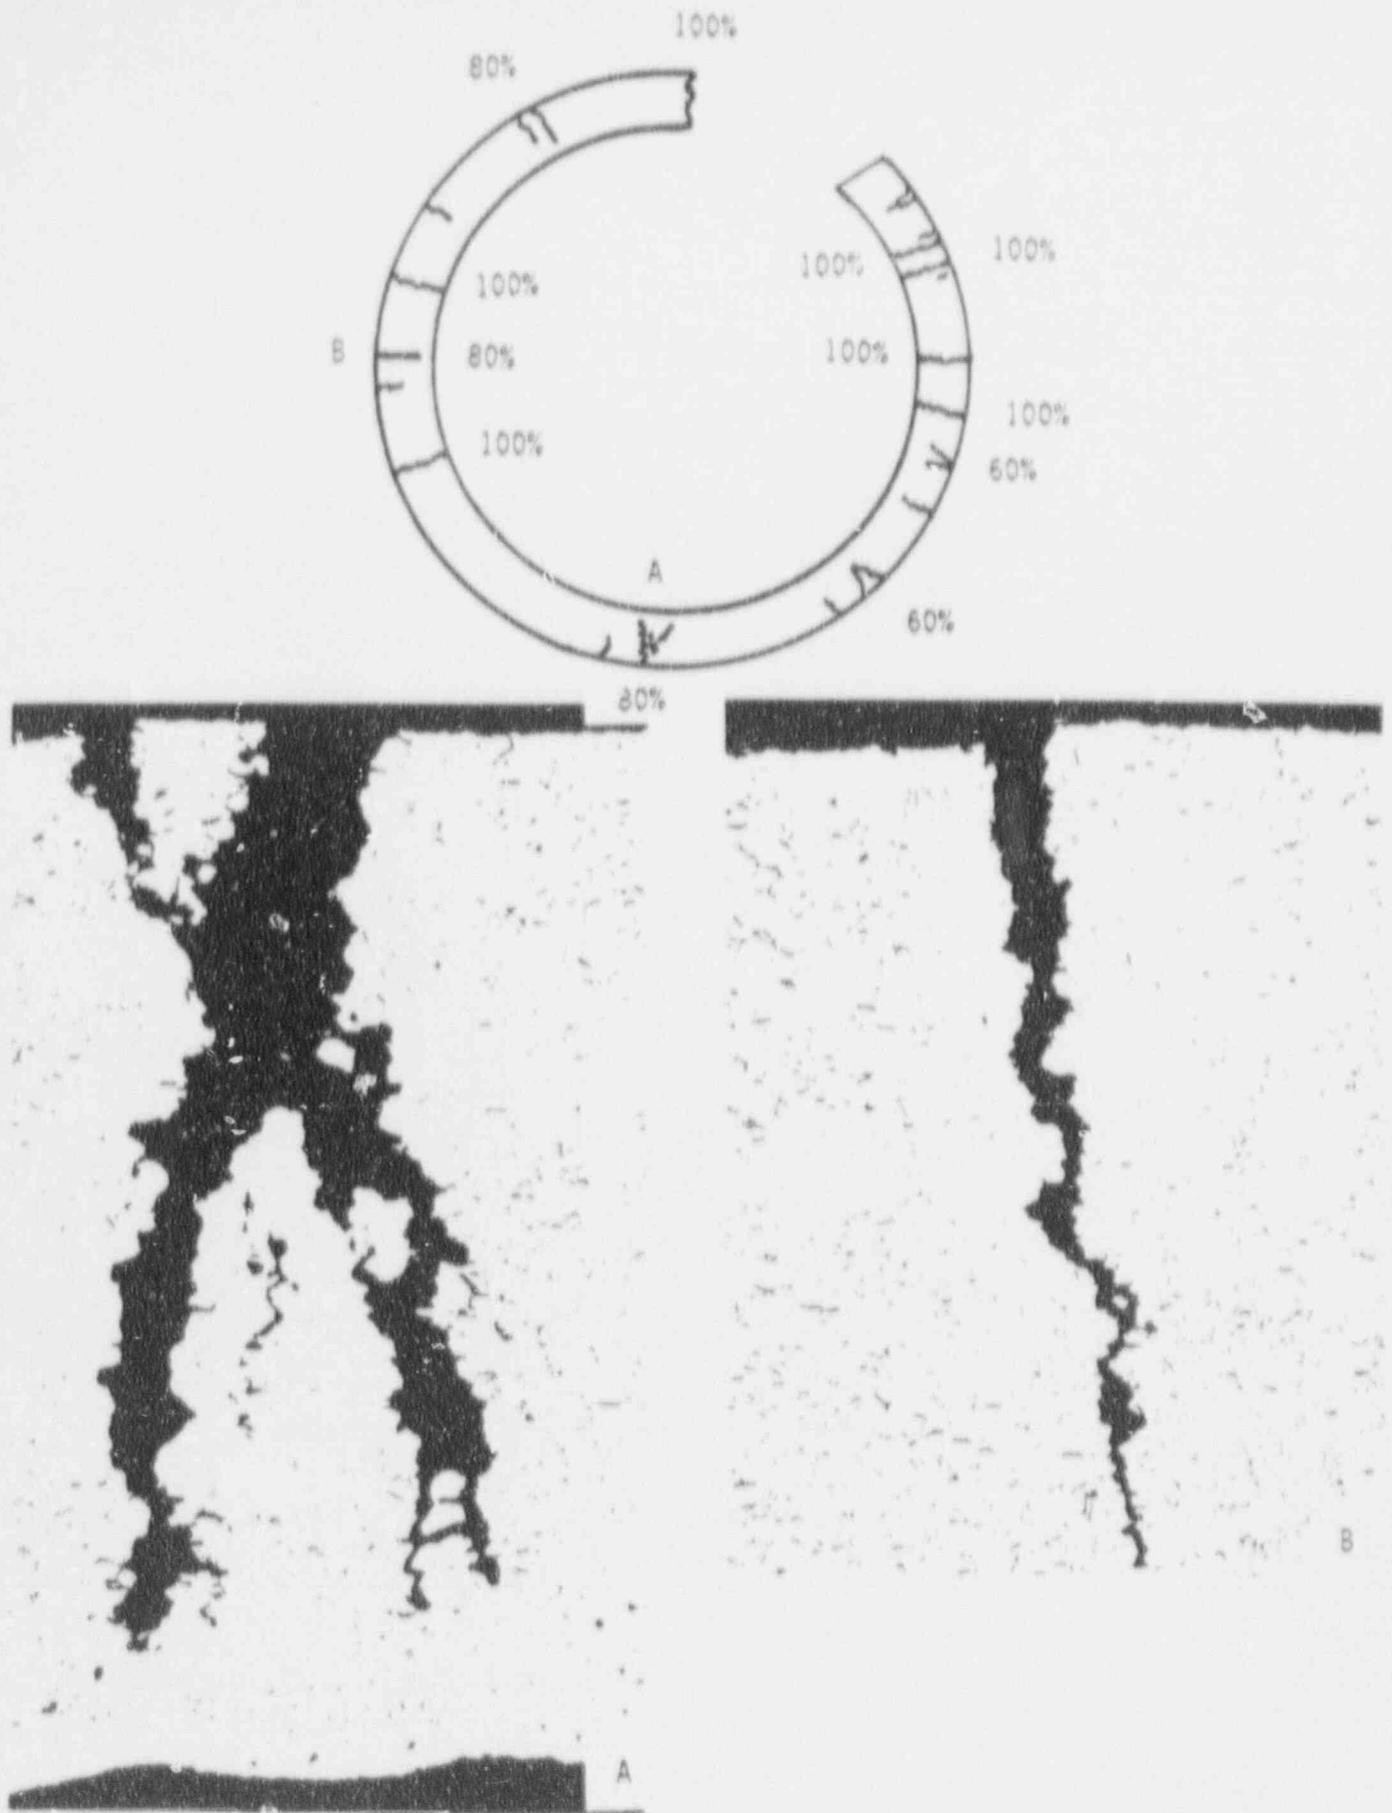
Figure 10-28 Crack distribution as revealed by a metallographic cross section through the center of the crevice of tube 532-2 and photomicrographs of secondary cracks A and B. Mag. 100X

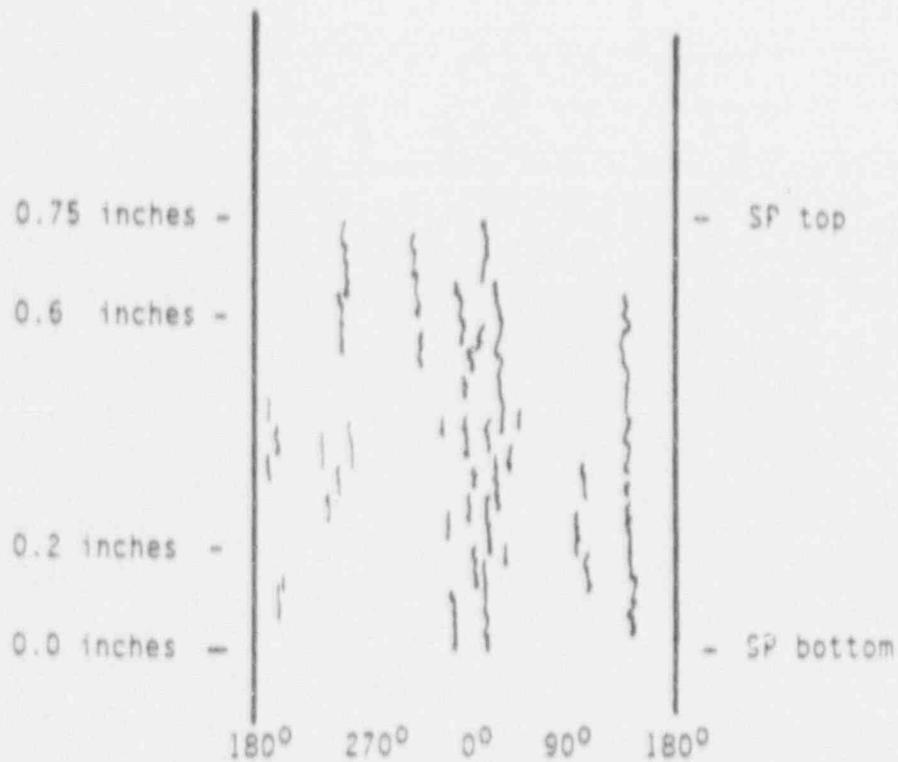
Morphology = IGSCC

Figure 10-29 Summary of the burst crack and overall crack distribution in the crevice region of tube 532-2.

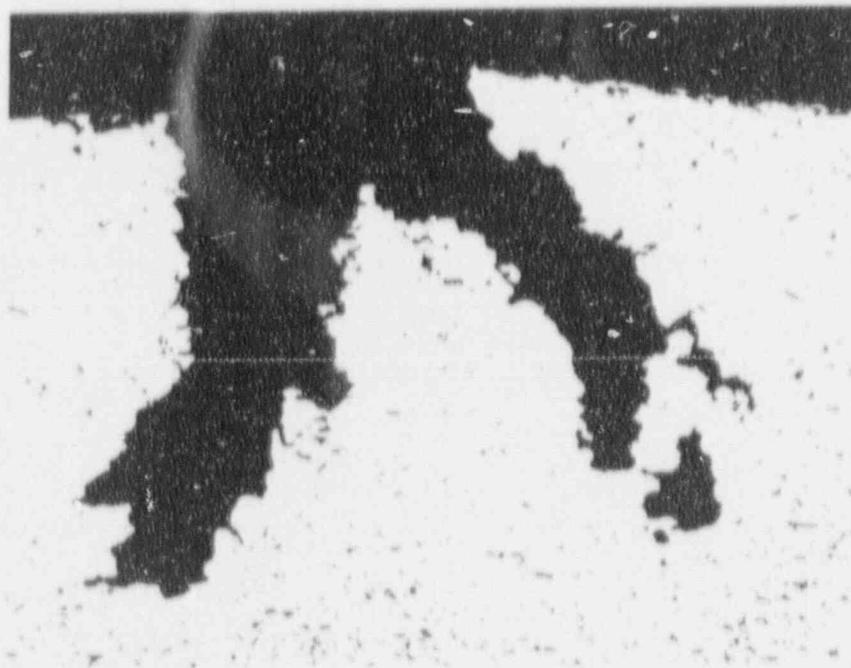
Figure 10-30 Sketch of crack distribution in a metallographic cross section of tube 535 through the center of the crevice and a photomicrograph of crack A. Mag. 100X

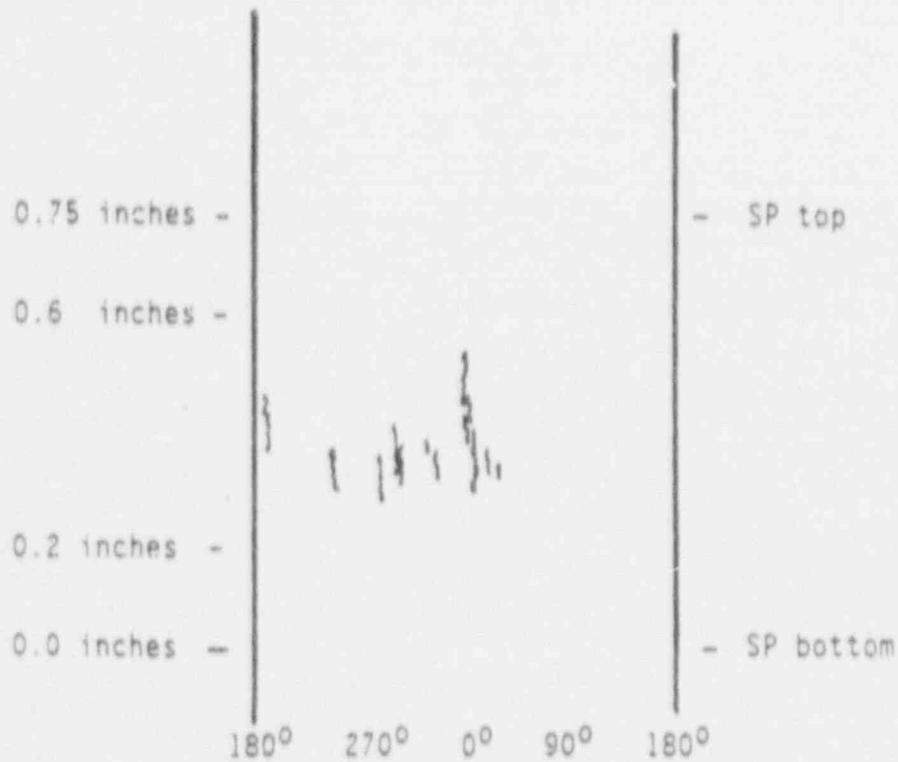
Morphology = ICSCC

Figure 10-31 Summary of the burst crack and overall crack distribution in the crevice region of tube 535-1.

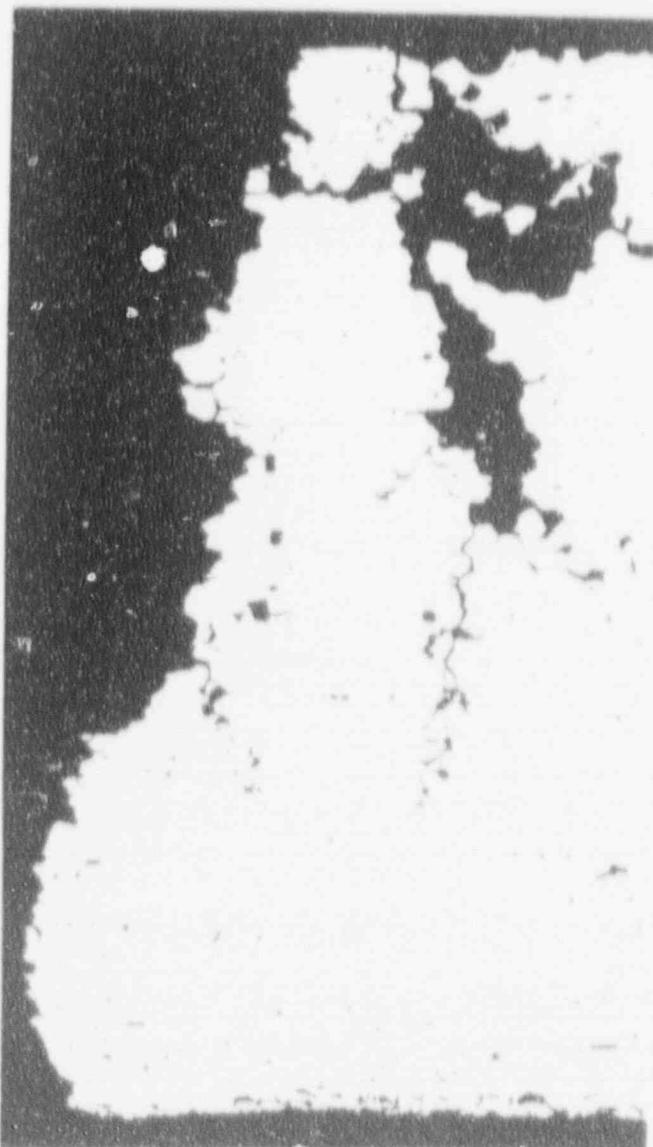
Figure 10-32 Photograph of the burst opening and a transverse photomicrograph of the burst fracture in tube 555-3.  
Mag. 100X

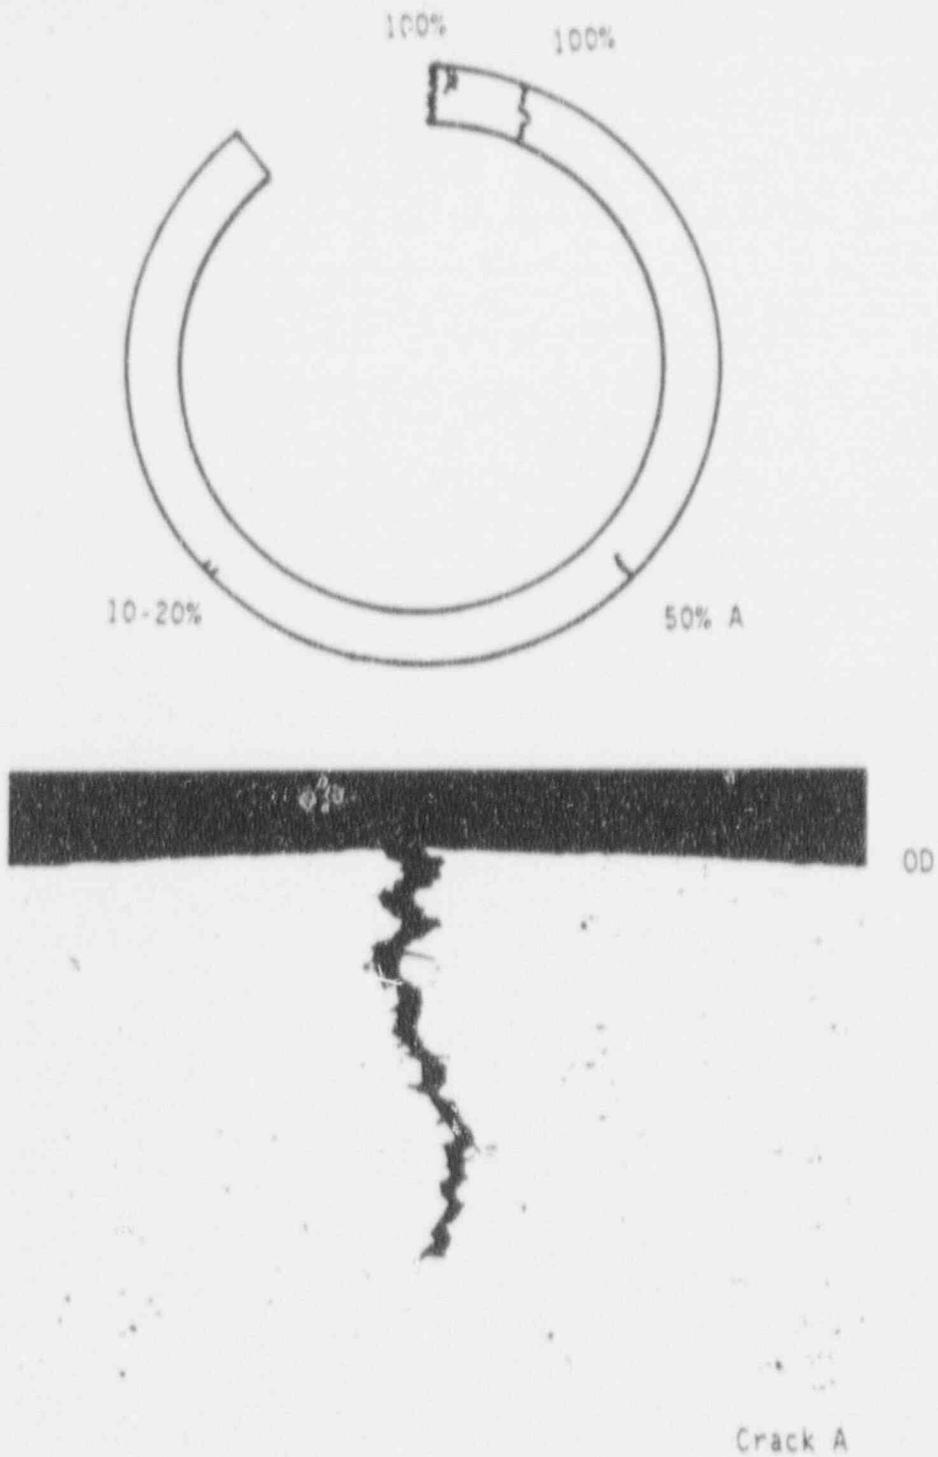
Figure 10-33 Sketch of the metallographic cross section through secondary crevice region cracks in tube 555-3. A photomicrograph of Crack A is also shown. Mag. 100X

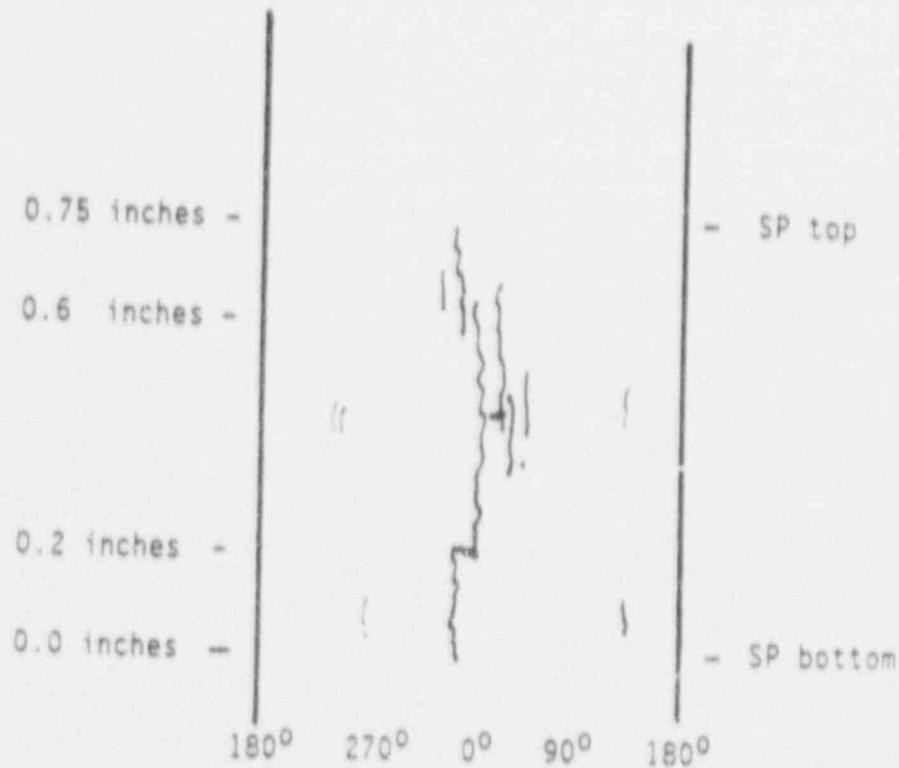
Morphology = IGSCC

Figure 10-34 Summary of burst crack observations and the overall crack distribution observed at the crevice region of tube 555-3.

| <u>Plant Tube</u> | <u>B.C. Voltage</u> | <u>Burst Pressure<br/>Pulled Tubes</u> | <u>Destructive<br/>Exam Figures</u> | <u>Circumferential Branching Description</u> | | |
|---|---|---|---|---|--|--|
| 555-3 | 10-32 to 10-34 | Burst involves irregular pattern with turn connecting ledges between cracks | | | | |

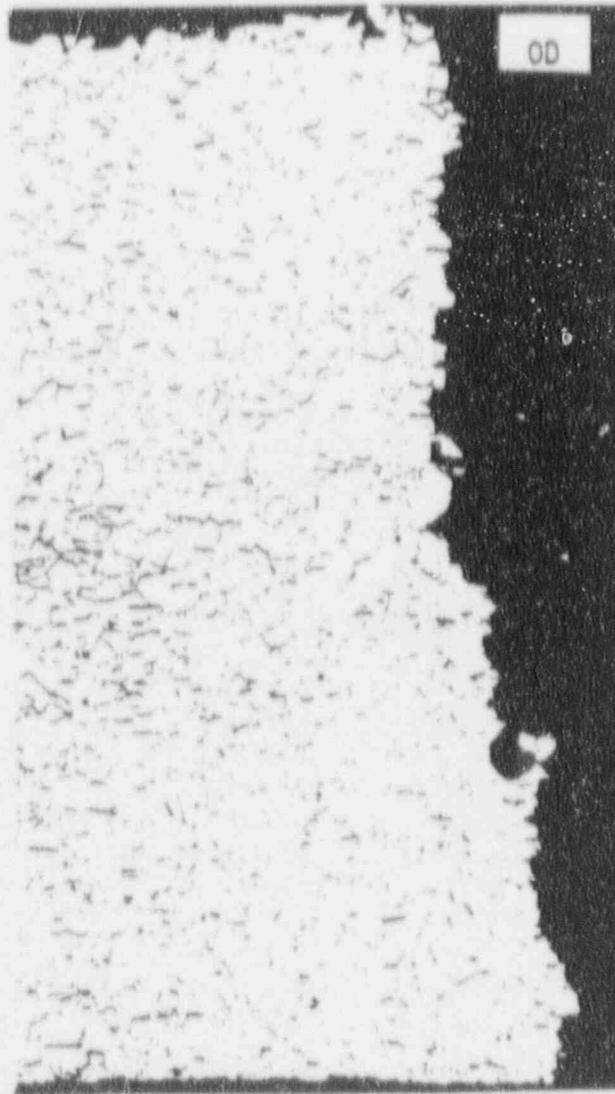
Figure 10-35 Sketch of a metallographic cross section through the center of the crevice region of tube 576-2, showing only the single burst crack, and a photomicrograph of the burst crack.  
Mag. 100X

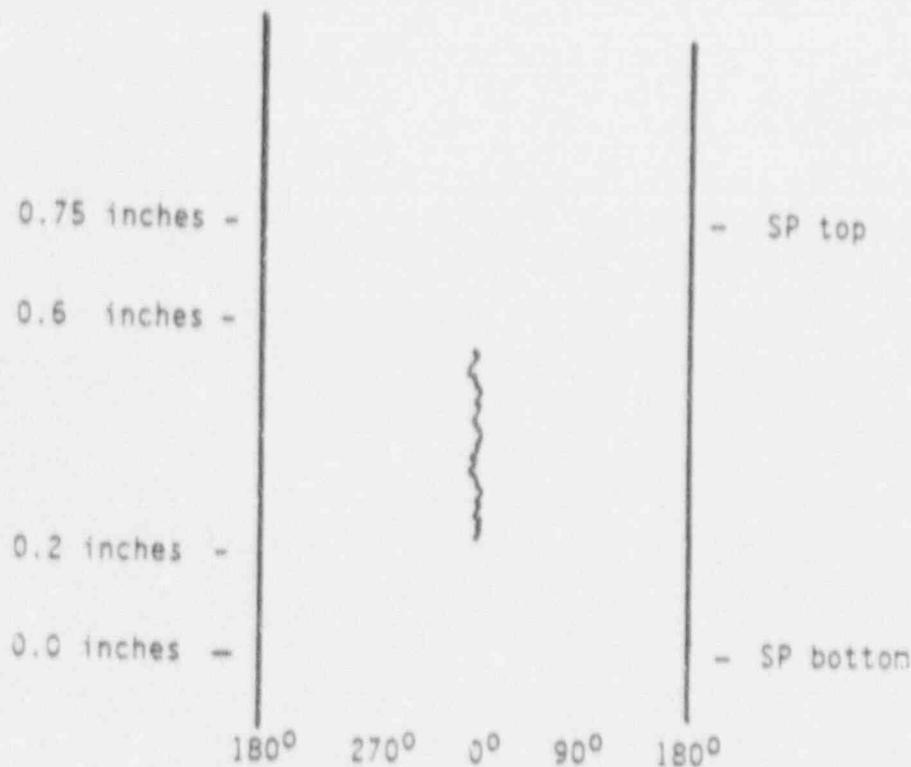
Macrocrack Length = 0.30 inch  
 Throughwall Length = 0.22 inch  
 Number of Microcracks = 1 (no ligaments)  
 Morphology = IGSCC

Figure 10-36 Summary of burst crack observations and the overall crack distribution observed within the crevice region of tube 576-2.

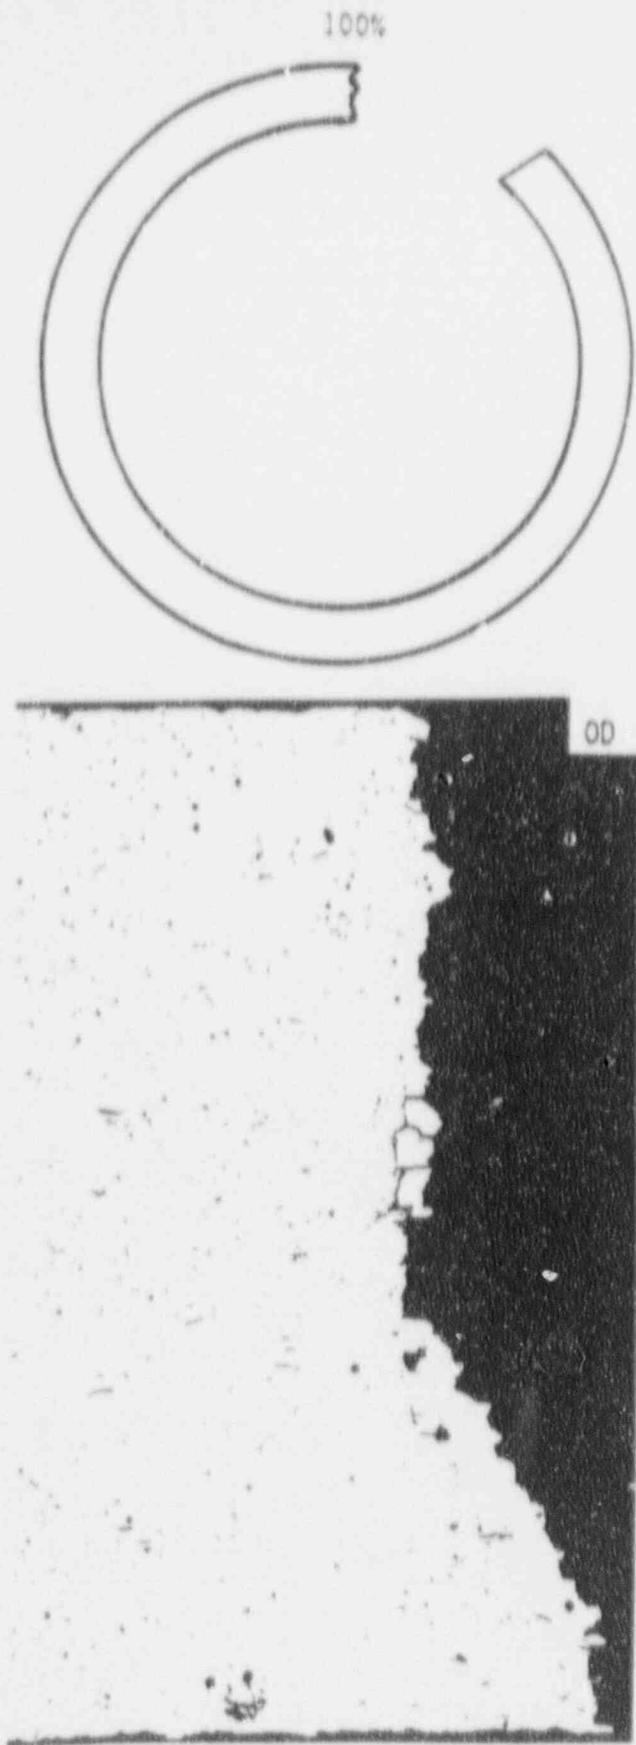
Figure 10-37 Sketch of a metallographic cross section through the center of the crevice region of tube 576-4, showing only the single burst crack, and a photomicrograph of the burst crack.  
Mag. 100X

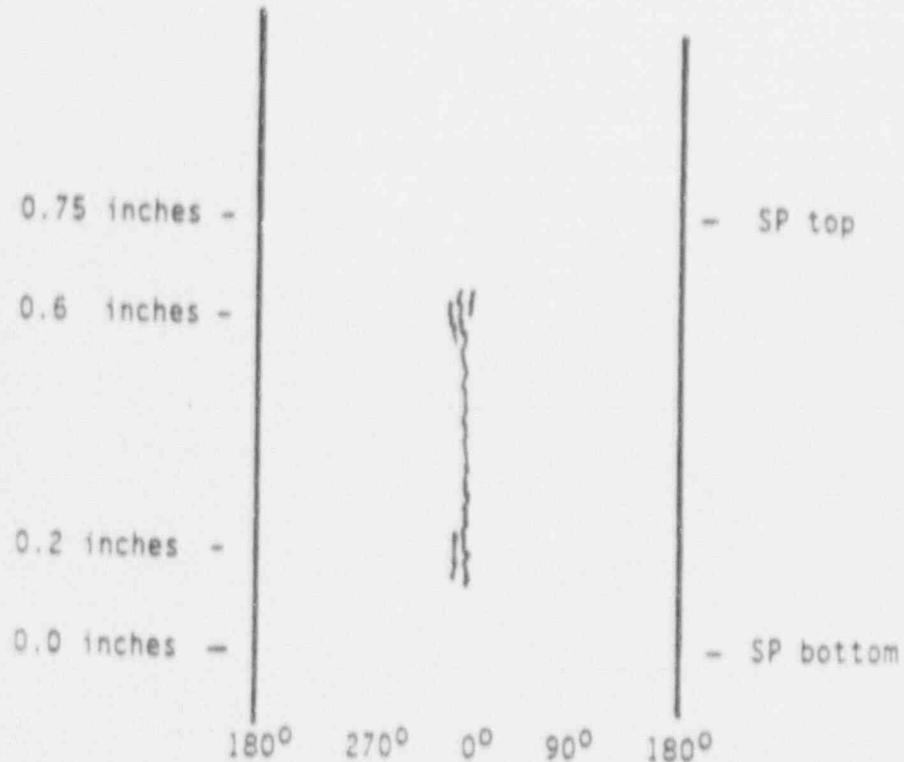
Morphology = IGSCC with negligible IGA features
