Report on
Inspection of Leaks and Cracks in the
(A) Steam Generator at H. B. Robinson II

Report No. DC 89

June 23, 1971

by: Dr. Stanley Weiss
Materials Department
University of Wisconsin-Milwaukee

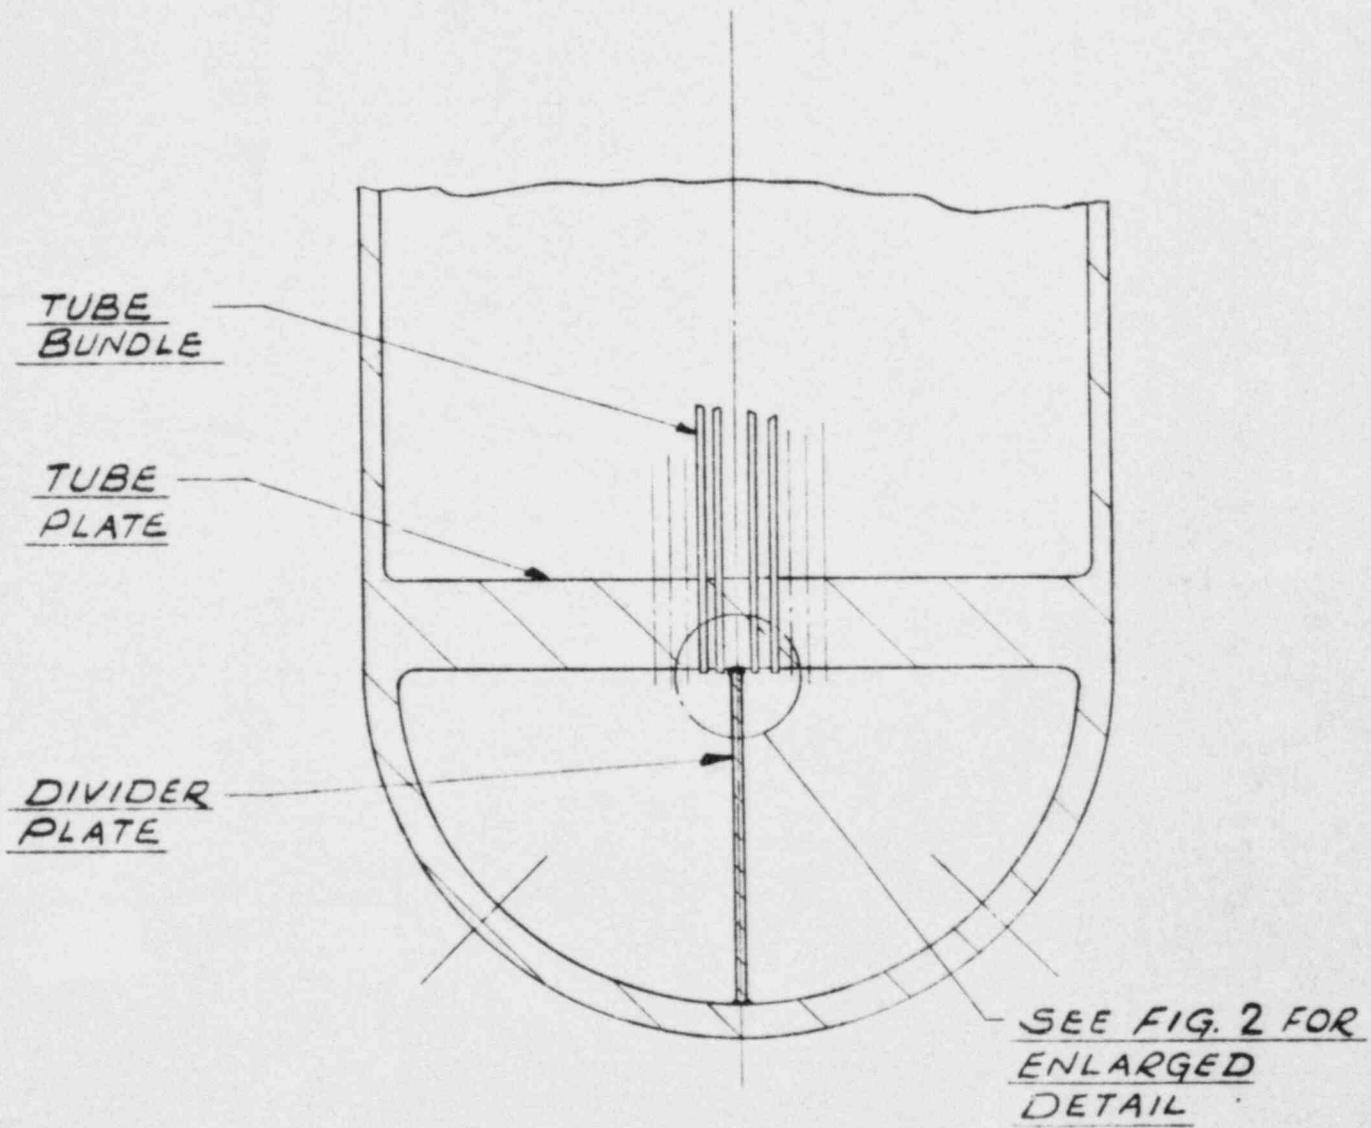
FIG. 1
"A" STEAM GENERATOR

- (1) Severe cracks were present in the fillet welds of approximately 30 tubes. The highest intensity of fillet cracking was apparent in the region included in and surrounding the 35th

These cracks were opened approximately .030 to .050 inches and were approximately semi-circular on the side of the fillet welds facing the flow divider plate.

- (4) The writer visually observed a contoured region of the cladding, adjacent to the divider plate and in the vicinity of the 40th to 50th tubes that showed definite signs of having been separated from the tube sheet.

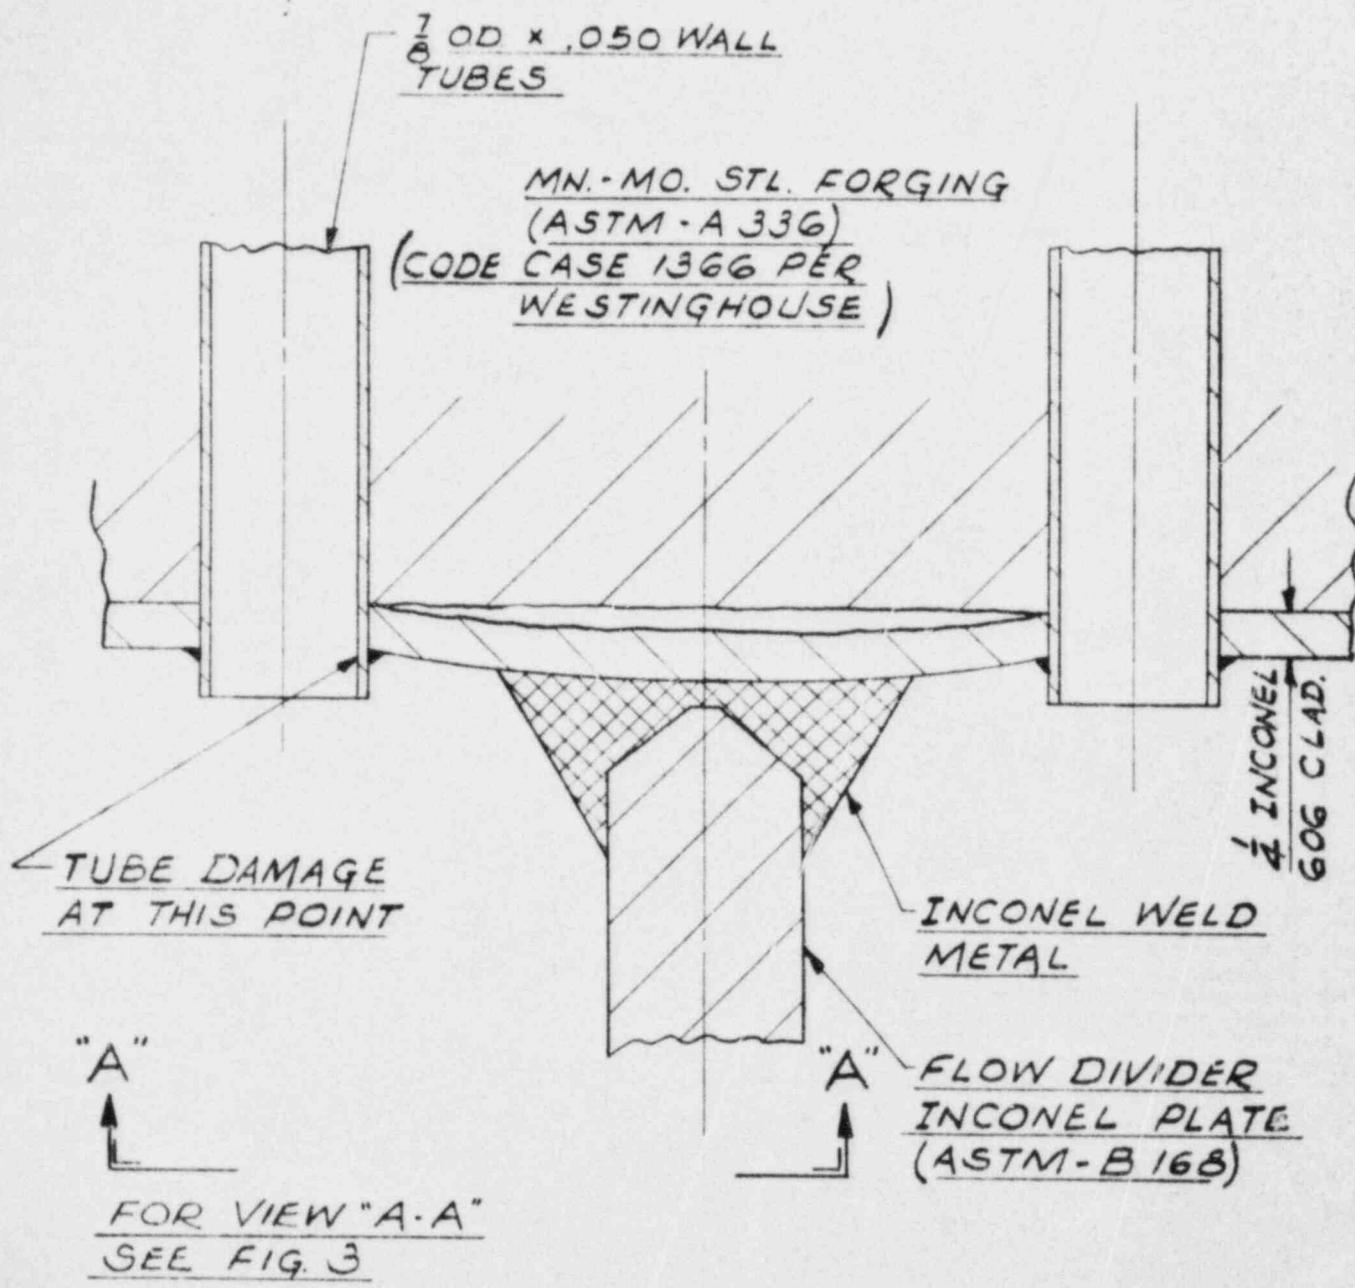
FIG. 2
ENLARGED VIEW OF
CLAD SEPARATION

- (2) Cracking in the 1/4 inch thick cladding was extensive in the region described above. These cracks were linear in the north-south direction (parallel to the divider plate) and were located approximately in line with the center of the first row of tubes. These cracks were tighter than those observed in the fillets and appeared to range in the vicinity of .005 to .010 inches wide and extended the entire length of the cladding between the cracked tubes.

APPROX. .030 TO .050
WIDE CRACKS IN
FILLET WELDS APPROX.
SEMI-CIRCULAR ON THE
SIDE OF WELDS FACING
THE FLOW DIVIDER
PLATE.

APPROX. .005 TO .010
WIDE CRACKS IN
CLADDING APPROX.
ON $\frac{1}{2}$ OF TUBES
EXTENDING THE
ENTIRE LGTH.
BETWEEN TUBES.

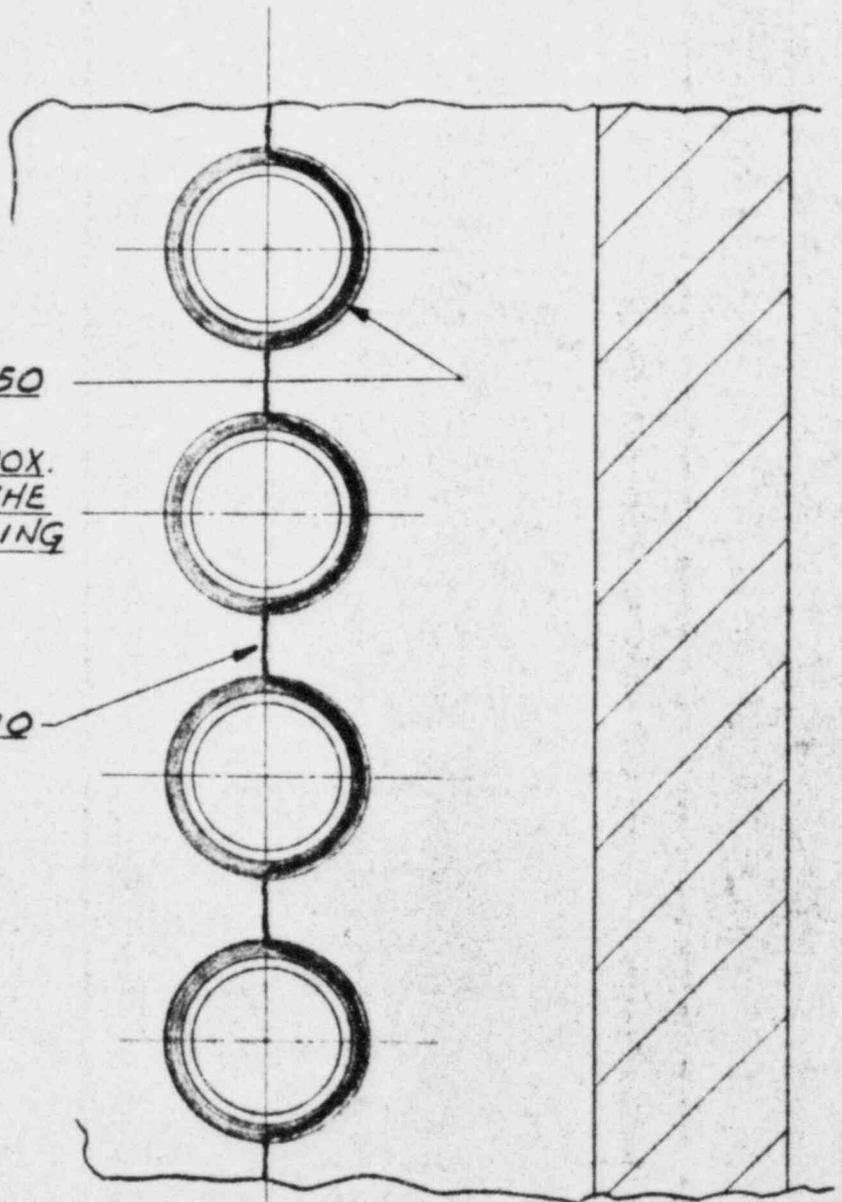
FIG. 3
VIEW "A-A"
FROM FIG. 2

- (3) Rusting and corrosion products were observed in the immediate vicinity of the fillet weld cracks progressing into the cladding cracks. This evidence shows that galvanic action and electrochemical corrosion has already occurred between the tube sheet material and the austenitic materials involved, through the borated solution which acted as an electrolyte.
