SUBJECT: CLARIFICATION OF A STEP IN OUR PRELIMINARY EVALUATION OF OPERATOR ACTION FOR GINNA SG TUBE RUPTURE EVENT

GINNA STATION
B-STEAM GENERATOR
NRC MEETING
MARCH 23, 1982

GINNA STATION
B-STEAM GENERATOR
CATEGORIZATION OF DEFECTS

RGE S/G-B POST TUBE REPAIR EVALUATION

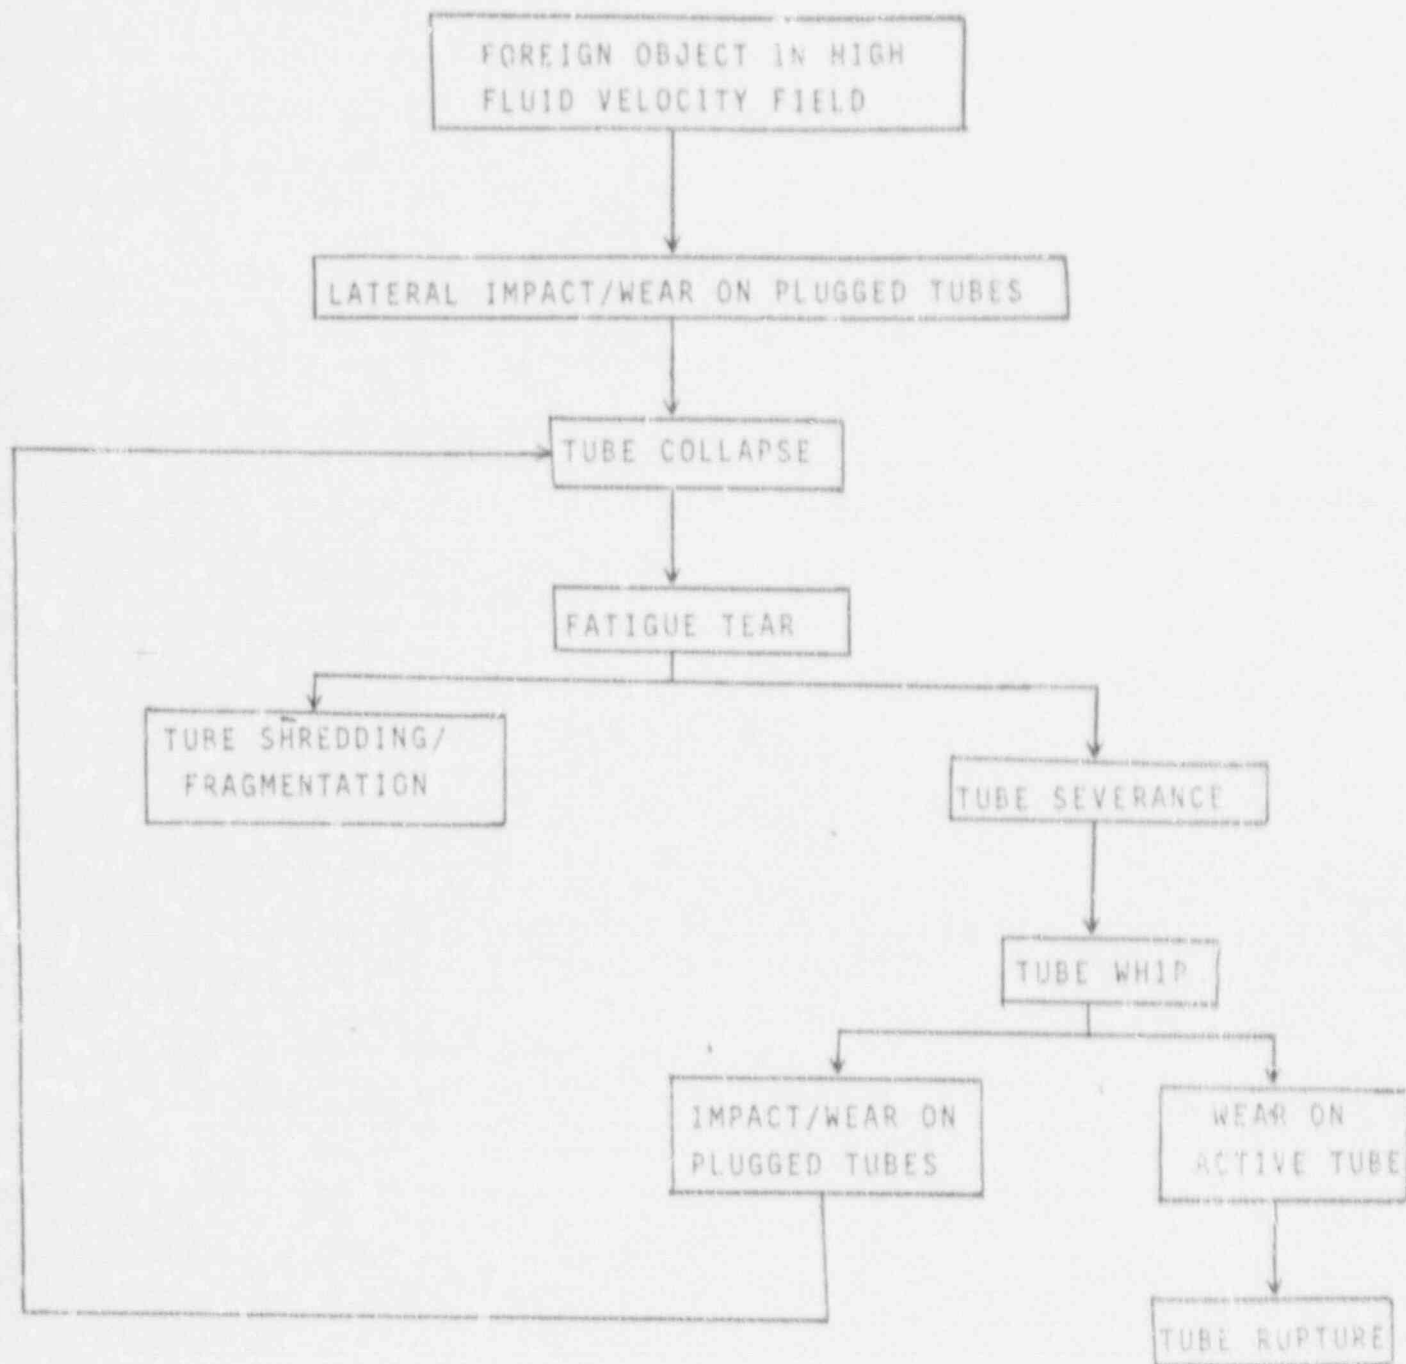
R. E. GINNA S/G B - POSTULATED TUBE RUPTURE MECHANISM

- WEAR SURFACES
- PRIMARILY RUBBING WEAR CIRCUMFERENTIAL DIRECTION
- NO EVIDENCE OF CORROSION INVOLVEMENT
- EVIDENCE OF SURFACE COLD WORKING
- FATIGUE STRIATION ON FRACTURE SURFACE
- TENSILE OVERLOAD BURST TUBE FAILURE SURFACE

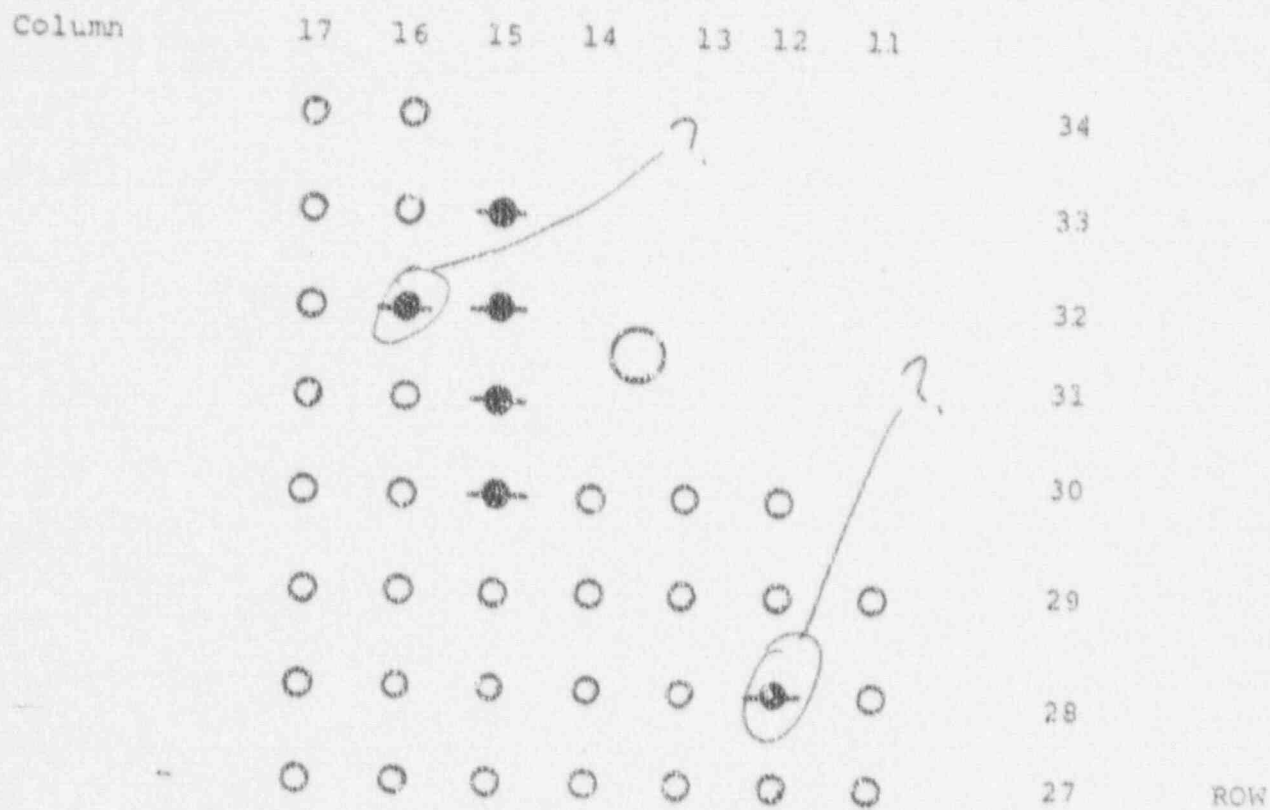
GINNA STATION
 B-STEAM GENERATOR
NO. 2 WEDGE AREA

- ⊗ Structurally Degraded (no tubes)
- ⊕ Video OD Indication (no tubes)
- Eddy Current Signal (6 tubes)
R12 C2 not shown
- Stay Bar

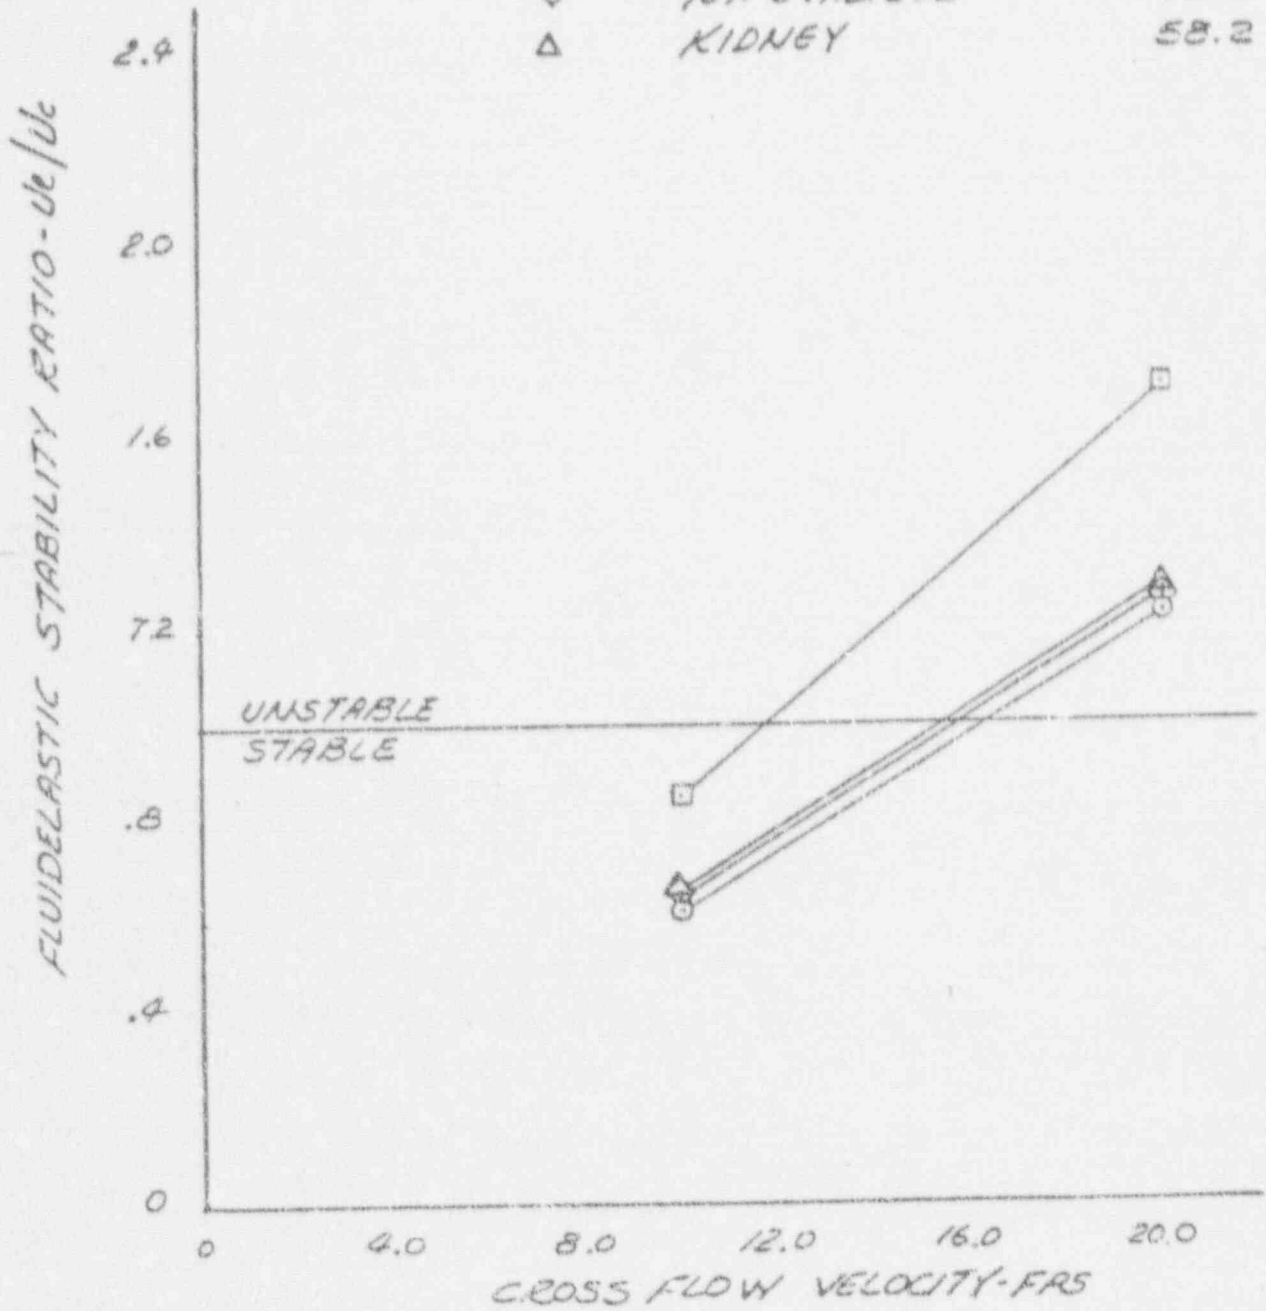
FIXED-FIXED BOUNDARY CONDITIONS
DAMPING RATIO = 0.01

SYMBOL	CROSS SECTION	1ST. MODE FREQ-H.
○	CIRCULAR	58.7
□	FLAT	48.9
◇	10% OVALIZED	58.3
△	KIDNEY	58.2

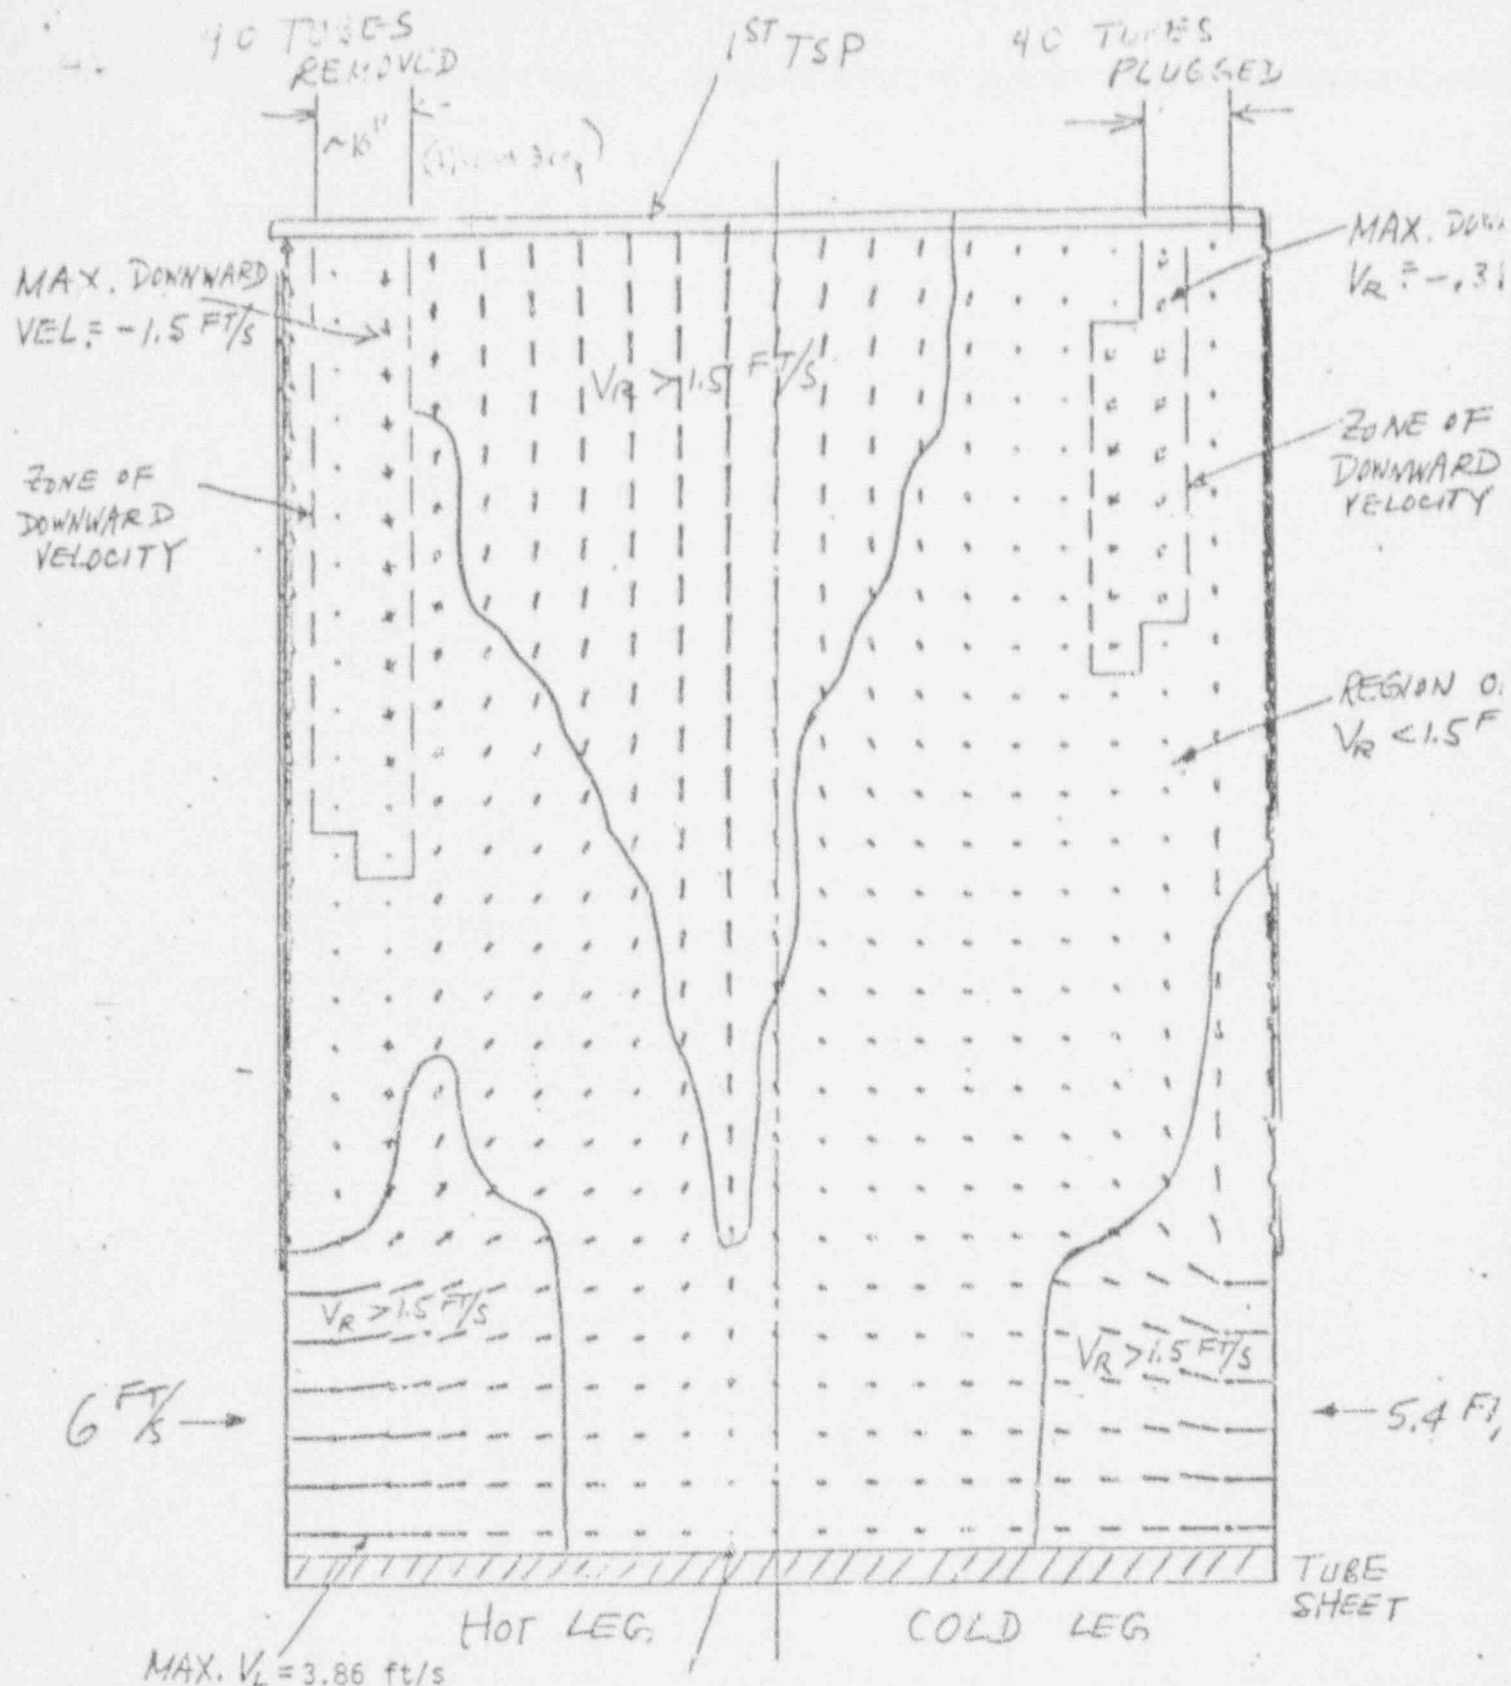
VELOCITY PATTERN OF ⁴⁰ TUBES REMOVED AT HOT SIDE AND PLUGGED AT COLD SIDE

CASE	AVERAGE VELOCITY IN TUBE REMOVAL REGION	MAX. GAP VELOCITY IN FIRST TUBE ROW DOWNSTREAM
NOMINAL	5.30	19.40
10 TUBES REMOVED	3.69	13.50
40 TUBES REMOVED	3.86	14.14

• TUBE REMOVAL DOES NOT ADVERSELY AFFECT FLOW VELOCITIES
