SUBJECT: REVIEW OF INFORMATION PRIOR TO GINNA RESTART

SUBJECT: INPUT FOR GINNA RESTART SER

GINNA STATION
 STEAM GENERATOR EVALUATION
 NRC MEETING
 APRIL 30, 1982

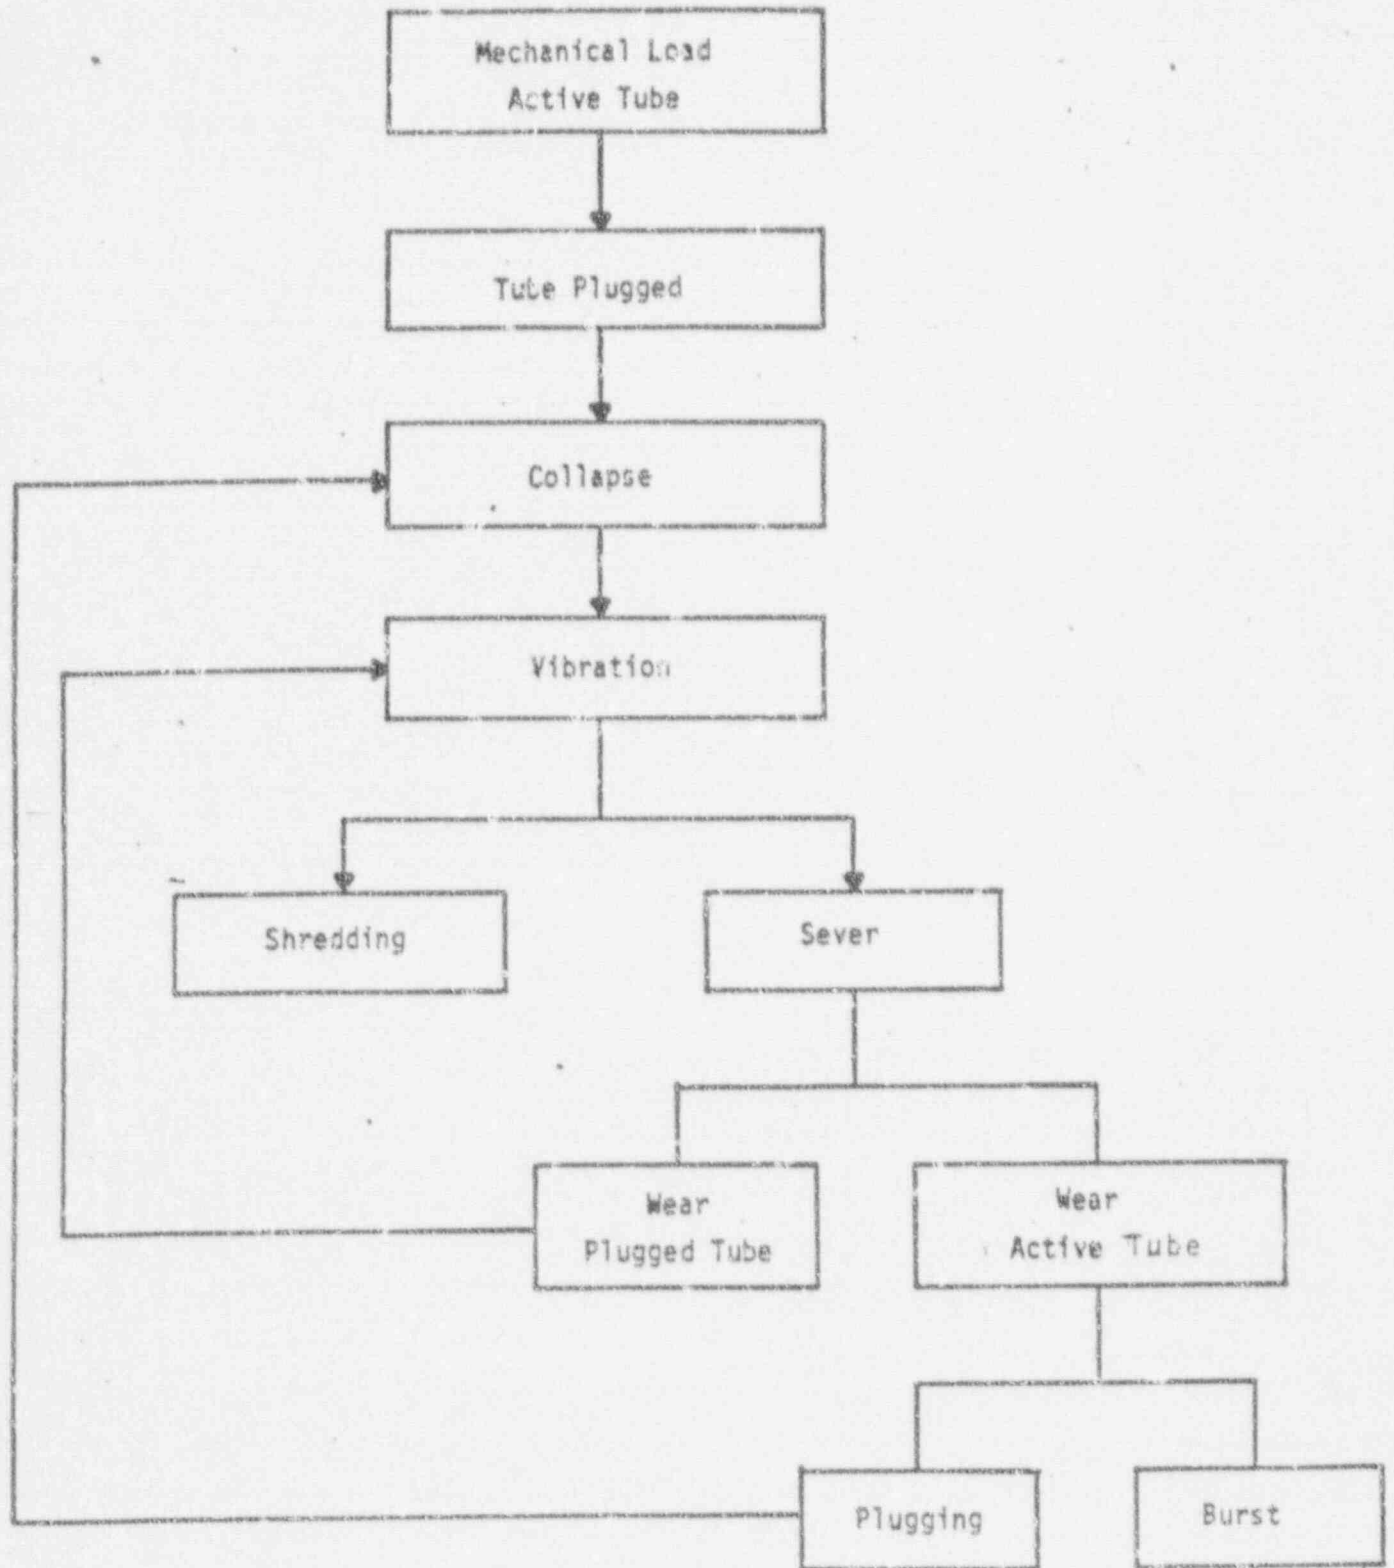
Postulated Failure Mechanism Sequence

- o MICROSTRUCTURES WERE NORMAL
- o MECHANICAL PROPERTIES WERE NORMAL
- o NO EVIDENCE OF CORROSION OF ANY TUBE
- o INITIAL METALLURGICAL SAMPLES DISPLAYED WEAR ZONES OF O.D. WALL REDUCTION WITH CIRCUMFERENTIAL STRIATIONS
- o 38 OF THE 40 WEAR ZONES SHOWED KNOOP MICROHARDNESS VALUES INDICATIVE OF COLD WORK FROM THE WEAR PROCESS
- o THE "BURST" R42 C55 OCCURRED WHERE THE WEAR ZONE HAD REDUCED THE WALL THICKNESS TO < 0.008 INCHES FOR APPROXIMATELY 4 INCHES IN LENGTH
- o THE "BURST" R42 C55 FRACTURE FACE WAS PURE SHEAR (DIMPLED RUPTURE), THE NORMAL FRACTURE MODE FOR TENSILE OVERLOAD
- o COLLAPSED AREAS OF PERIPHERY TUBES SHOWED EXTENSIVE COLD WORK 8-10 MILS IN DEPTH
- o AREAS OF SEVER AND AXIAL BREAKAGE SHOWED FATIGUE STRIATIONS
- o THE DEFECT 24" ABOVE TUBE SHEET ON R45 C47 WAS CAUSED BY RUBBING FROM SEVERED TUBE R45 C54 WHICH WAS WEDGED BETWEEN WRAPPER AND OUTER ROW OF TUBES

POSTULATED FAILURE MECHANISM

leads to tube
failure by
fatigue

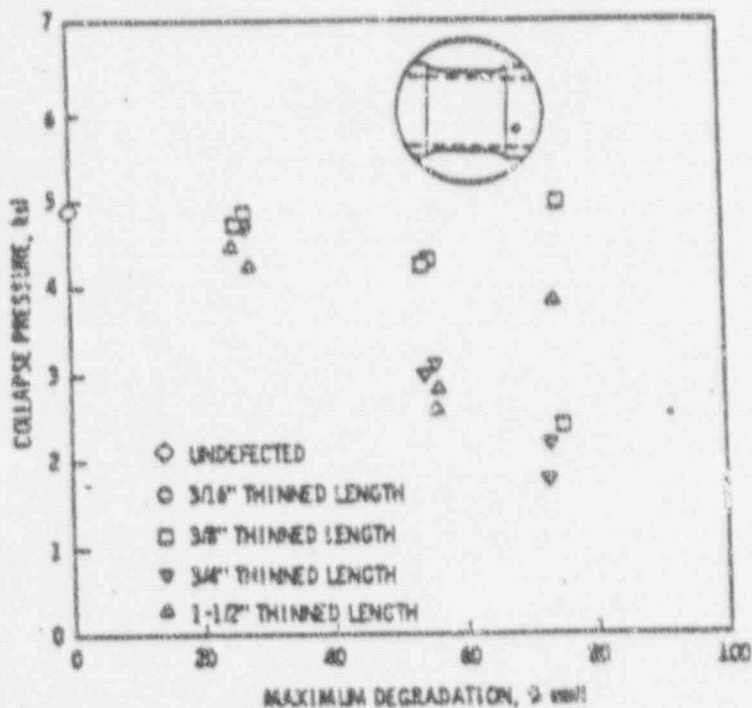
COLLAPSE PRESSURE OF UNIFORMLY THINNED TUBING

- TESTING RESULTS
 - COLLAPSE STRENGTH NOMINAL TUBE 5000 PSI
 - 80% UNIFORM THINNING FOR COLLAPSE AT 1020 PSI
- FOR A GIVEN % WALL DEGRADATION COLLAPSE PRESSURE FOR LOCALIZED THINNING WILL BE GREATER THAN FOR UNIFORM THINNING
- TUBES IN STEAM GENERATOR HAVE PASSED A PROOF COLLAPSE TEST
