U. S. NUCLEAR REGULATORY COMMISSION
REGION IV

NRC Inspection Report: 50-445/84-05

Facility Name: Comanche Peak Steam Electric Station (CPSES), Unit 1

Inspection Summary

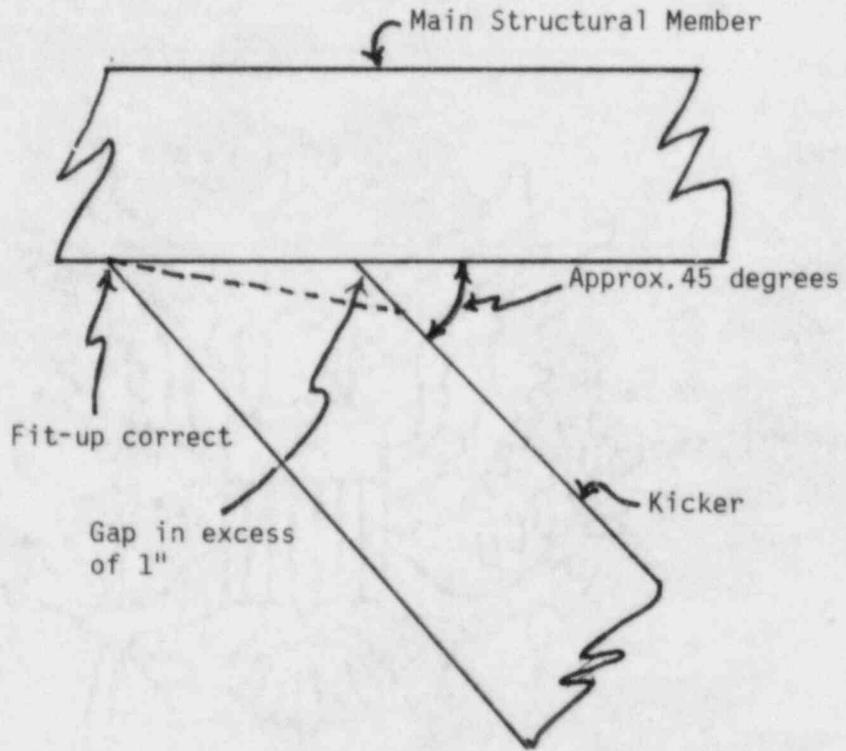
Figure 1

After inspection of the kicker attachment weld (described below), the alleged was informed of the results. The alleged then indicated that the fit-up was correct on one side of the attachment only, and that the weld prep tapered out to an excessive gap of greater than one inch on the opposite side. See Figure 1.

PLAN VIEW OF LOWER KICKER
JOINING MAIN STRUCTURAL MEMBER

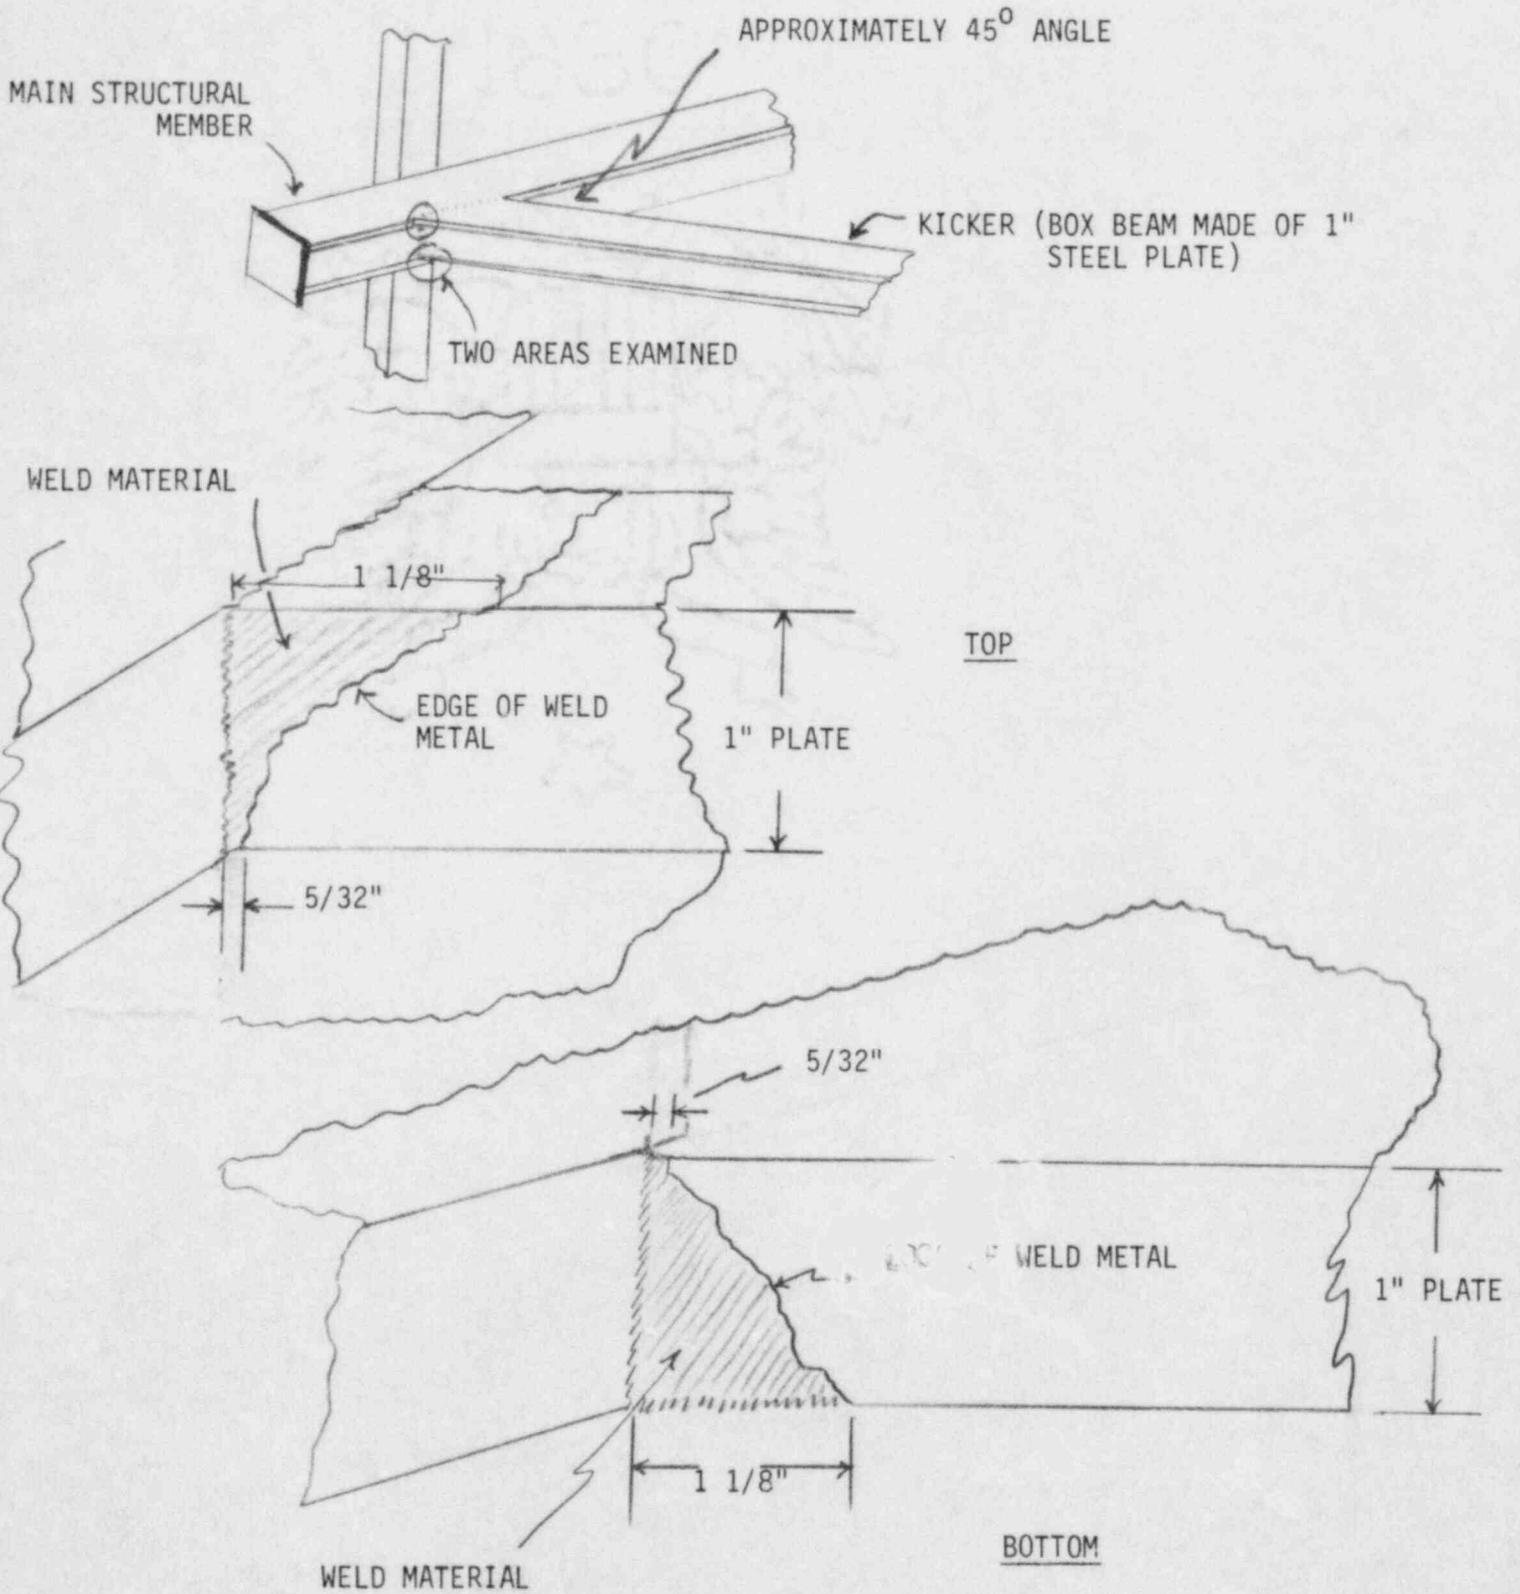
Figure (2)

At the request of the NRC inspectors, the licensee had B&R grind and etch two areas on the support. Figure 2 shows the areas examined and the observation noted. In addition to the two etched areas examined, the NRC inspectors found that the weld joining the lower kicker to the main support member was consistent in appearance (approximately 1" wide) for the full length of both the upper and lower welds. On the inside angle of the kicker (45 degrees), a small edge of the weld prep (See Figure 3) was noted approximately 1-1/8" from the edge of

plate A. The bottom weld was similar in appearance. The support had been painted; however, the size of the weld was noted to be consistent with the requirements of the B&R drawings and consistent with the experience of the NRC inspectors for similar type welds. Additional destructive testing was not done based on the evidence noted.

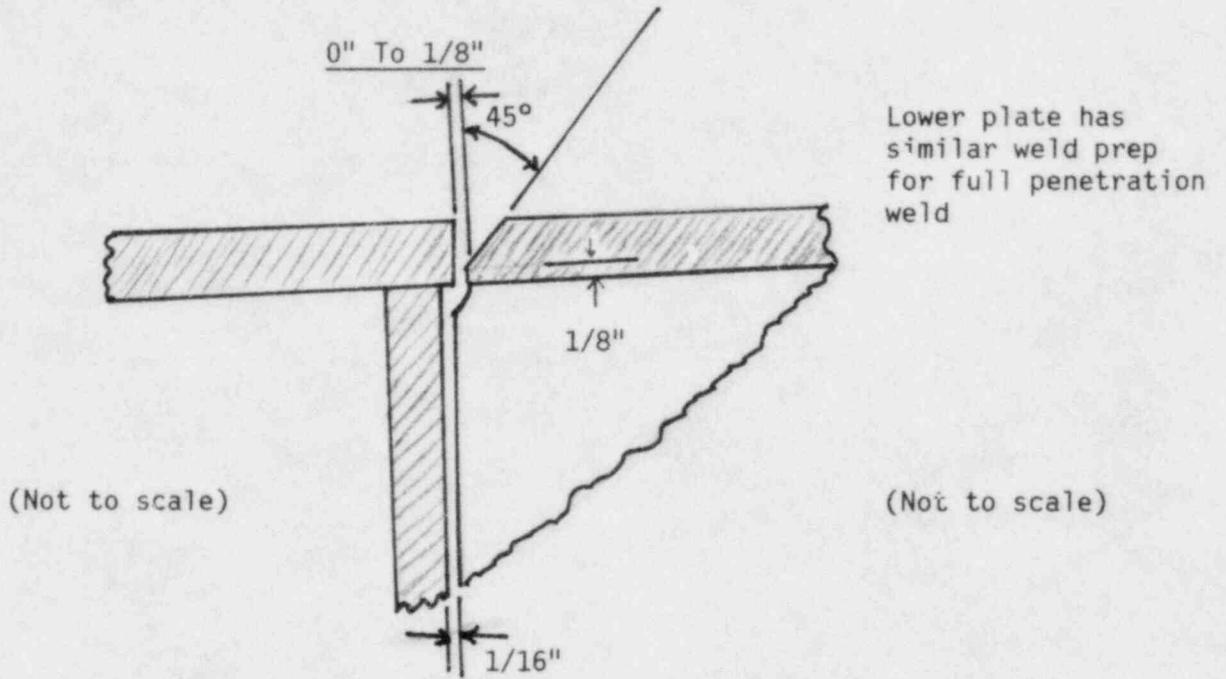
Figure 3

The NRC inspectors could not identify any evidence that would support the allegation regarding an excessive gap and unauthorized welding. There is evidence to support that the weld fit-up was done correctly. Observation of the etched areas and inspection of the remainder of the suspect weld confirmed that the requirements of the drawings were met. The requirement for weld preparation for the plates in question show that a 45 degree prep on a 1" plate for the full penetration weld with 1/8" clearance will give a 1" gap at the top of the area to be welded. See Figure 3. This is normal and according to procedures.

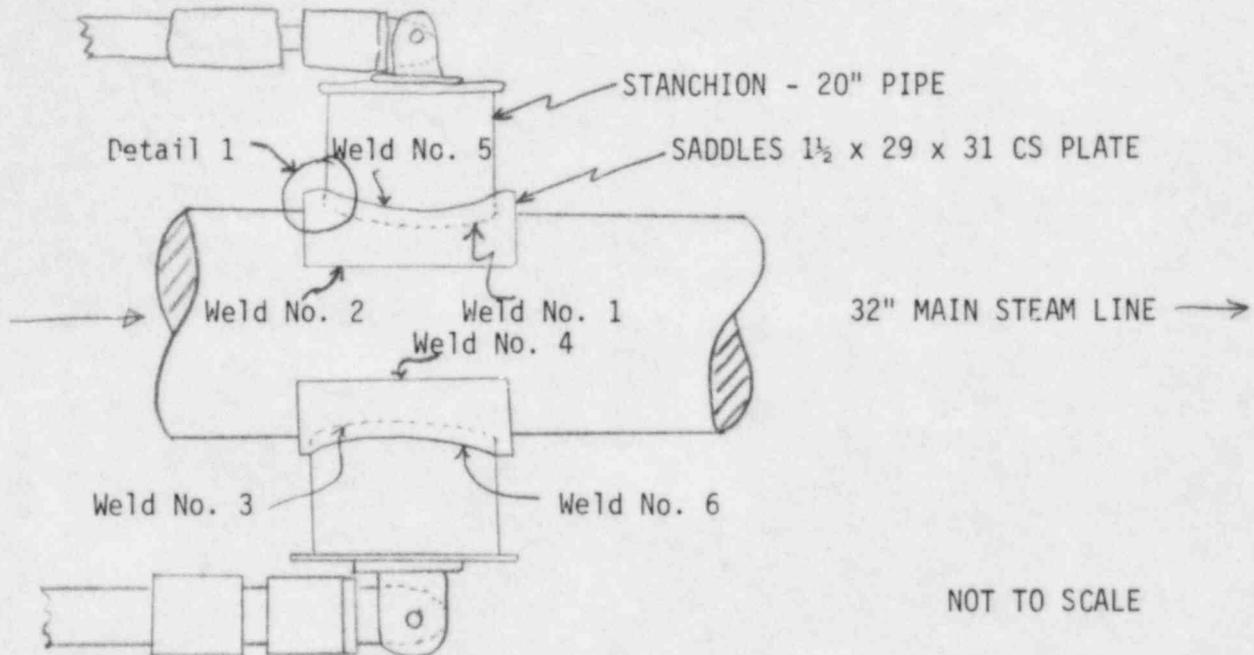
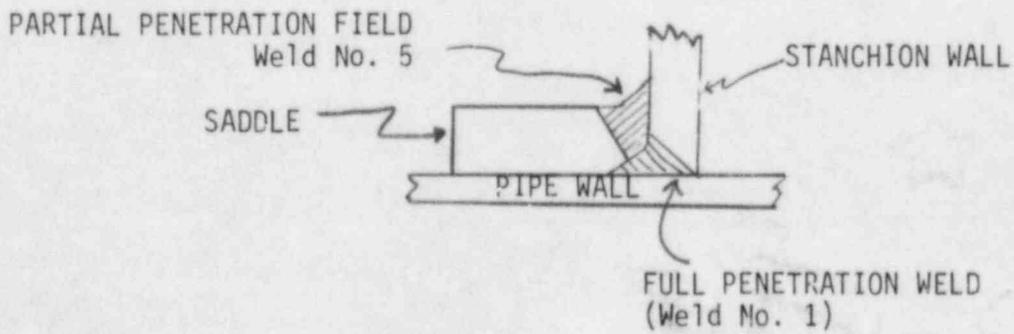
Figure 4

This support is a large ASME Code Class 2 pipe support located on the 893' 10" elevation of Unit 1, Containment Building. It extends approximately 4' out from the wall. The two support members parallel the 32" main steam line, one on top and one below. There is an upper and lower stanchion welded to the pipe, made of 20" schedule 60 pipe. The stanchions are, in turn, reinforced by 1-1/2" x 29" x 31" CS "saddle" plates also welded to the pipe. Two SMF-100-BA snubbers connect the main structure to the stanchions. See Figure 4.

DETAILS OF MS-1-003-010-C72K

- MS-1-003-010-C72K stanchions were welded in place from July 13, 1981, to July 23, 1981 (WDC 45201)
- The upper saddle was cut in two pieces and repaired in accordance with CMC 53580. The item was cut incorrectly in fab shop.
- The lower saddle is one piece, with no visual indications that the saddle was split. It is smooth, without marks indicating that a chain or hydraulic jack was used to bend the saddle.
- The saddles were welded in place between August 11, 1981, to August 19, 1981 (WDC 45197).
- QC inspections of fit-up and welding indicate welds are "satisfactory."

The NRC inspector discussed this allegation with B&R personnel in order to clarify the issues. It was determined that a lower and upper pipe saddle had been cut in four pieces, but on a support identified as MS-1-003-007-C72K. This support is attached to the main steam piping by stanchions and 2" thick saddles similar to MS-1-003-010-C72K. However, the saddles, or reinforcing pads, were cut into four pieces as authorized by CMC 65236. This support was examined by the NRC inspector. The saddles had been modified, as indicated in the CMC; however, there was no evidence that would indicate heating and bending of the left rear quarter of the lower pad. There was also no visible evidence of bending of the pipe in the area of the saddles.
