SAFETY EVALUATION BY THE OFFICE OF NUCLEAR REACTOR REGULATION

FACILITY OPERATING LICENSE NO. NPF-4  
VIRGINIA ELECTRIC AND POWER COMPANY  
OLD DOMINION ELECTRIC COOPERATIVE  
NORTH ANNA POWER STATION, UNIT NO. 1  
DOCKET NO. 50-338

1 INTRODUCTION

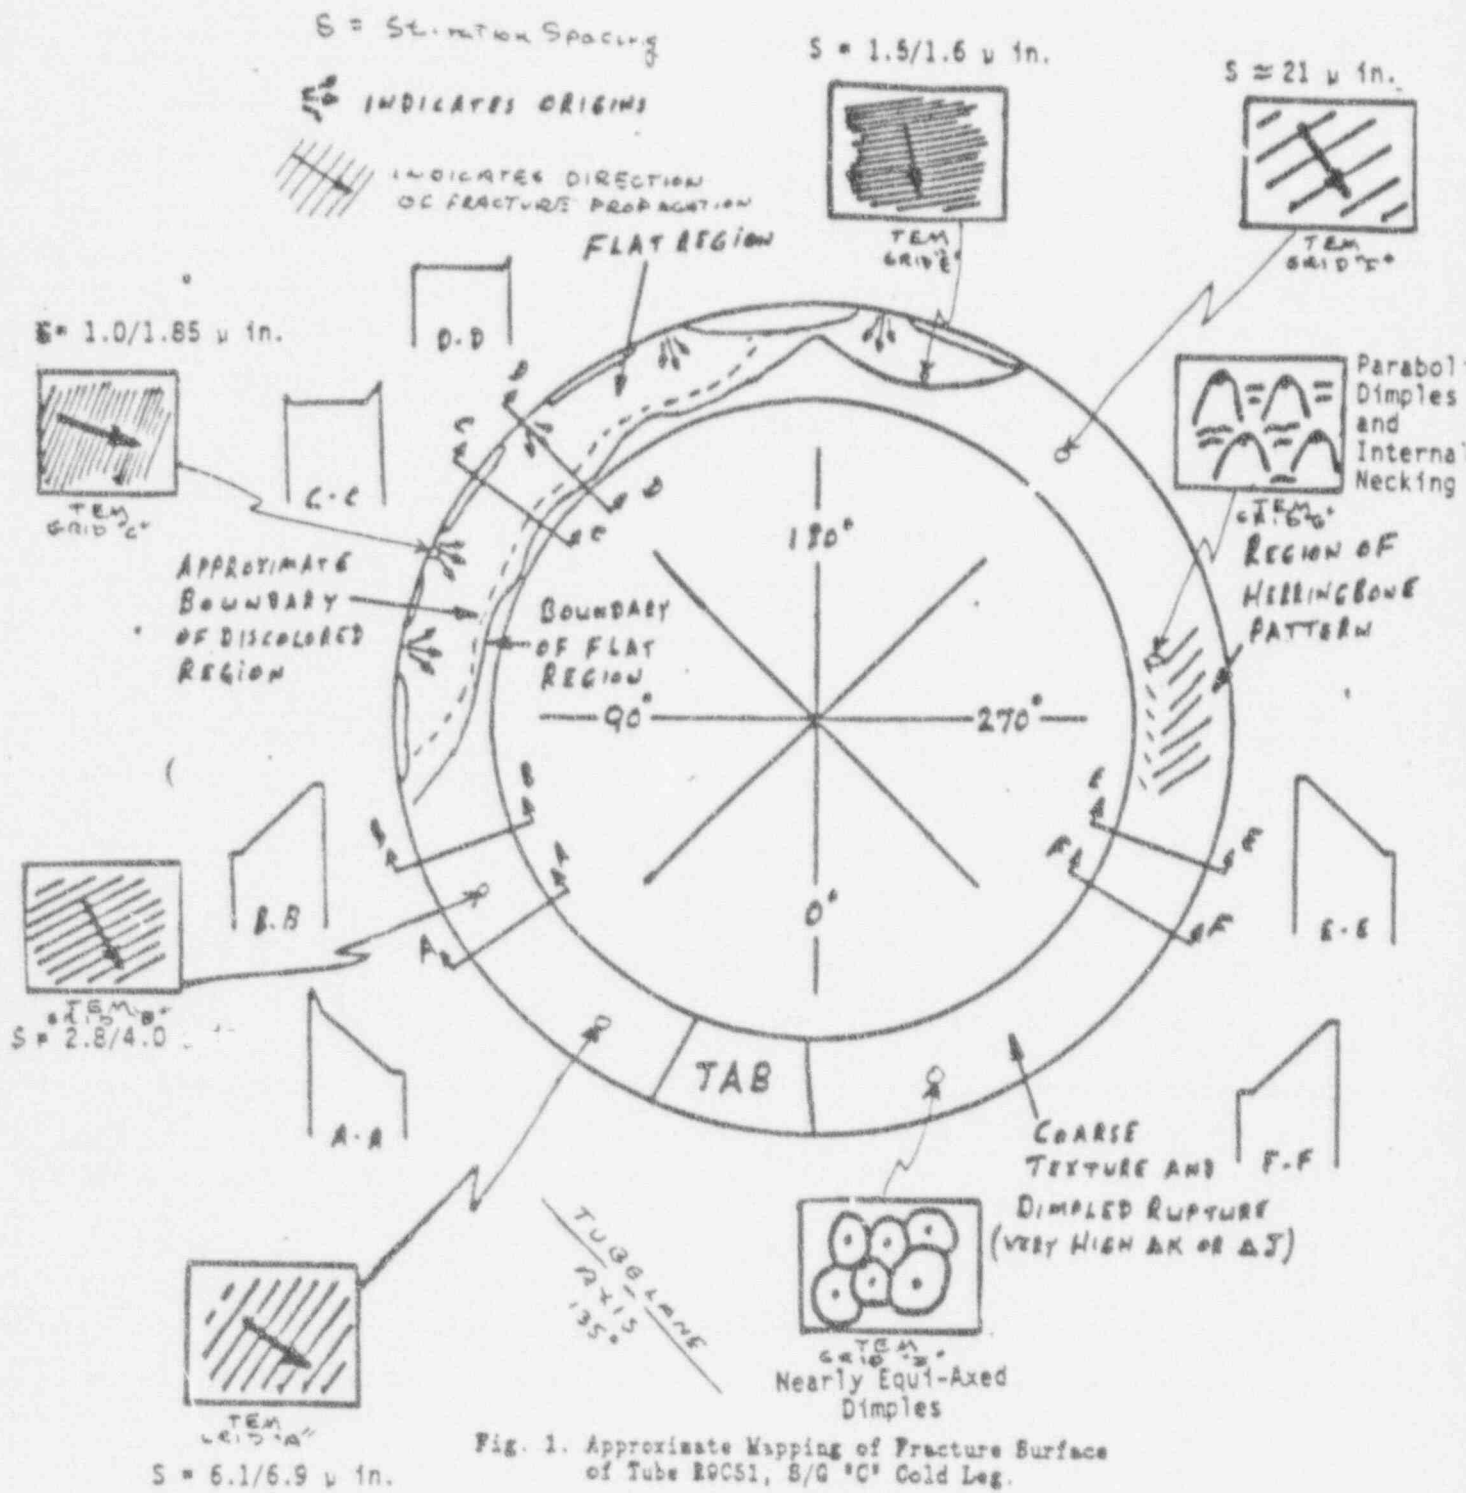
Fig. 1. Approximate Mapping of Fracture Surface of Tube B0CS1, S/G "C" Cold Leg.

With reference to Figure 1 (taken from Reference 3), which summarizes the fractographic observations schematically, the 45° location corresponds to the plane of the U-bend. Multiple fracture initiation "origins" occurred between approximately 90° and 180°. The tubing between 90° and 180° is determined to have protruded approximately 0.07 inches above the top edge of the support plate. This location is the fracture region closest in elevation to the top edge of the support plate. The highest elevation of the fracture is located at 315° and is approximately 0.17 inches above the top edge of the support plate.

On the fracture face, a dark deposit was noted from approximately  $90^\circ$  to  $150^\circ$ . Typically the deposit extends from the OD to  $3/4$  through-wall. An analysis of these deposits showed that they had a composition similar to adjacent OD deposits and that they contain elements which would be expected from secondary side water-borne deposits. Fatigue cracks initiated in this location. The significance of these deposits is that they may show the shape of the early macro-crack before faster crack growth rates occurred which did not leave sufficient time for disposition of water-borne material. From the shape of the deposit, it is believed that the macro-crack initially broke through-wall over a  $40^\circ$  crack front that extended from  $100^\circ$  to  $140^\circ$ . Fatigue striation orientation data also support this hypothesis.

Oxidation and/or fretting was observed on most of the fracture surface but was most severe at about the  $135^\circ$  position. It was heavy throughout the region containing most of the crack origins and of diminishing severity at locations proceeding in the clockwise direction from about  $170^\circ$  and counter clockwise from about  $70^\circ$ . This suggests that the oldest portion of the crack occurred at about the  $135^\circ$  position.

A summary of fractographic features and striation spacing measurements is presented in Table 2 and in Figure 1, which also give the estimates of cyclic stress levels that can be made from the striation spacing as described below. Replicas or "grids" of the fracture surface were examined in a transmission electron microscope (TEM). These TEM fractographic examinations were performed to provide the resolution needed to definitively determine if the striation-like markings observed during scanning electron microscope (SEM) fractography were indeed fatigue striations and to provide quantitative data pertaining to their spacing. The striations run perpendicular to the direction of local crack propagation. The striations develop as a consequence of repeated blunting and resharping of the crack tip during the cyclic applications of load, so each striation marks the position of the crack tip at the time it was formed. The striation spacing provides a rough estimate of the crack growth rate per cycle.

The region from about 90° to 155° is generally flat (orientation: normal to wall) throughout except for small portions that have shear orientations (45° to wall) adjacent to the OD and ID surfaces, with a fine fracture texture. Most

of the remainder of the fracture is oriented at about  $45^\circ$  to the wall surface except for a flat area surrounding a minor crack origin at about the  $190^\circ$  location. Clockwise from  $180^\circ$  an initially fine texture becomes rougher with a "herringbone" pattern evident near the  $270^\circ$  region, indicating an accelerating rate of crack propagation.

Fine to coarse fatigue striations occur at locations from about  $190^\circ$  to  $250^\circ$  and from about  $30^\circ$  to  $70^\circ$ . The fatigue striation spacing increased (indicating higher propagation rates) as the crack propagated around the circumference of the tube in a clockwise direction from about the  $190^\circ$  position and counter clockwise from about the  $70^\circ$  position. Higher propagation rates in the  $190^\circ$  to  $300^\circ$  positions than in the  $70^\circ$  to  $15^\circ$  regions indicates eccentric loading or a component of torsional loading.

Parabolic dimples with internal necking between dimples were the predominant fractographic features at about the  $270^\circ$  position. These features are indicative of very high fatigue propagation rates. This position is within the regions of herringbone pattern and coarse texture observed during visual examinations.

Within the region from about  $280^\circ$  clockwise  $360^\circ$  to  $15^\circ$ , there is a rough texture (fractographic examination revealed dimpled rupture in this region) indicative of overload fracture. Equiaxed dimples indicative of the overload portion of the fracture were observed at about the  $310^\circ$  position. These fractographic features, coupled with the macroscopic features, indicate that the overload fracture occurred throughout the region defined above.

The tab-shaped area near region marked  $0^\circ$  has a rough fracture texture and orientation consistent with a final overload fracture.
