South Texas Project  
Unit 1  
Docket No. STN 50-498  
Licensee Event Report 92-001  
Regarding an Entry into Specification 3.0.3

LICENSEE EVENT REPORT (LER)

TITLE (4) **Entry Into Specification 3.0.3 Due to 2 Trains of Essential Chillers Being Inoperable**

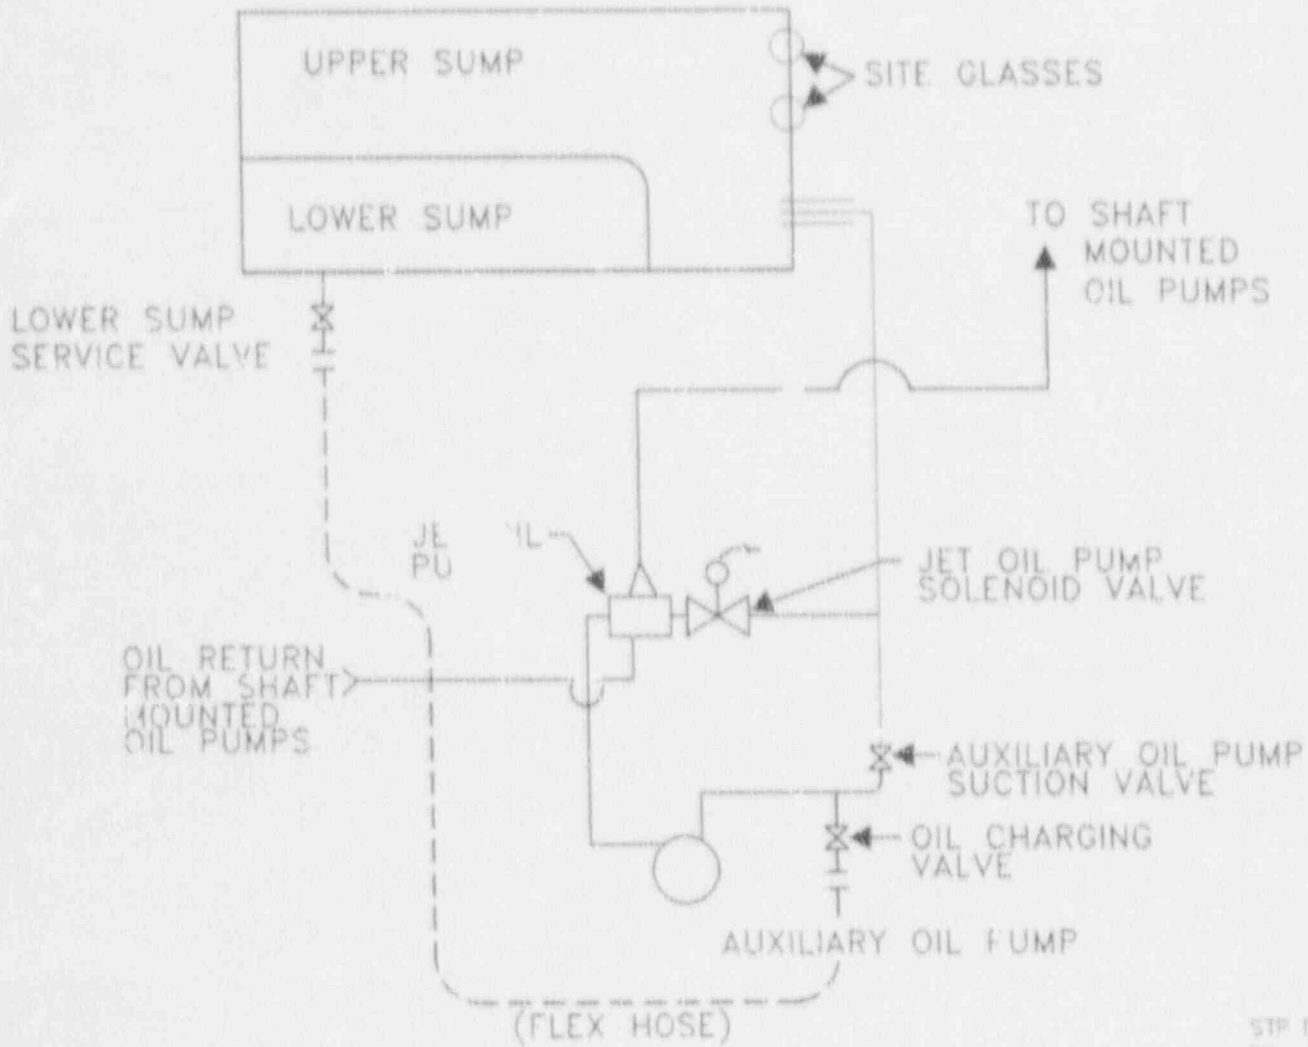
STP D-0824  
REV 0

Refer to the attached figure for clarification of the following. During normal start of the Essential Chillers, a start signal energizes the Auxiliary Oil Pump which takes a suction on the upper sump and discharges to the suction of the shaft mounted oil pumps in the chiller compressor. It is necessary for the Auxiliary Oil Pump to run for 30 seconds and provide a constant pressure, to satisfy the chiller starting circuit and allow Essential Chiller compressor start. When the Essential Chiller is in stand-by, oil will tend to migrate to the lower oil sump, either due to seal leakage or leakage past the Jet Oil Pump Solenoid Valve. When the chiller is in operation, unit differential pressures are such that oil is drawn from the lower sump to the upper sump. The process for transferring oil from the lower sump to the upper sump, with the chiller secured, is contained in a Plant Maintenance Procedure. The procedure requires an oil filled hose to be attached between the Lower Sump Service Valve and the Oil Charging Valve. By closing the Auxiliary Oil Pump Suction Valve, opening the Oil Charging Valve, opening the Lower Sump Service Valve and manually running the Auxiliary Oil Pump, oil is transferred from the lower sump to the upper sump, where indicated level is determined by sight glasses. When in this configuration, the increased resistance to flow via the Auxiliary Oil Pump prevents the pump

from developing sufficient discharge pressure to satisfy the chiller starting circuit. Therefore, the evolution of transferring oil renders the chiller inoperable, a circumstance not addressed procedurally.

The root cause of this event was procedural inadequacy. A Plant Operations procedure requires contacting Maintenance for an unsatisfactory Essential Chiller indicated oil level. A Maintenance procedure provides direction for transferring oil from the lower sump to the upper sump. Neither procedure provides a caution step to indicate that the process renders the chiller inoperable, nor does the Operations Procedure contain guidance for compensatory action that would maintain chiller operability during the evolution.

A contributing factor to the event is the chiller design which results in the need for transferring oil from the lower to the upper sump. With this type unit, some oil migration is expected to occur, a situation exacerbated by excessive valve end/or seal leakage.

1. Plant Operations personnel have been informed by Night Orders of the impact of transferring oil on chiller operability.
2. Plant Engineering and Plant Operations will Field Change the Plant Operating Procedures to provide guidance on manual auxiliary oil pump operation to allow an Essential Chiller with a low indicated oil level to be considered operable and started to restore upper sump oil level. This action will be completed by March 6, 1992.

5. Maintenance will revise applicable procedures for transferring lube oil in the Essential Chillers to clarify the effect on chiller operability and the compensatory actions Plant Operations may take to maintain chiller operability while transferring lube oil in the chillers. This action will be completed by June 15, 1992.
