Jersey Central Power & Light Company

January 17, 1973

Subject: Oyster Creek Station
Docket No. 50-219
Valve Malfunctions

ATTACHEMNT I

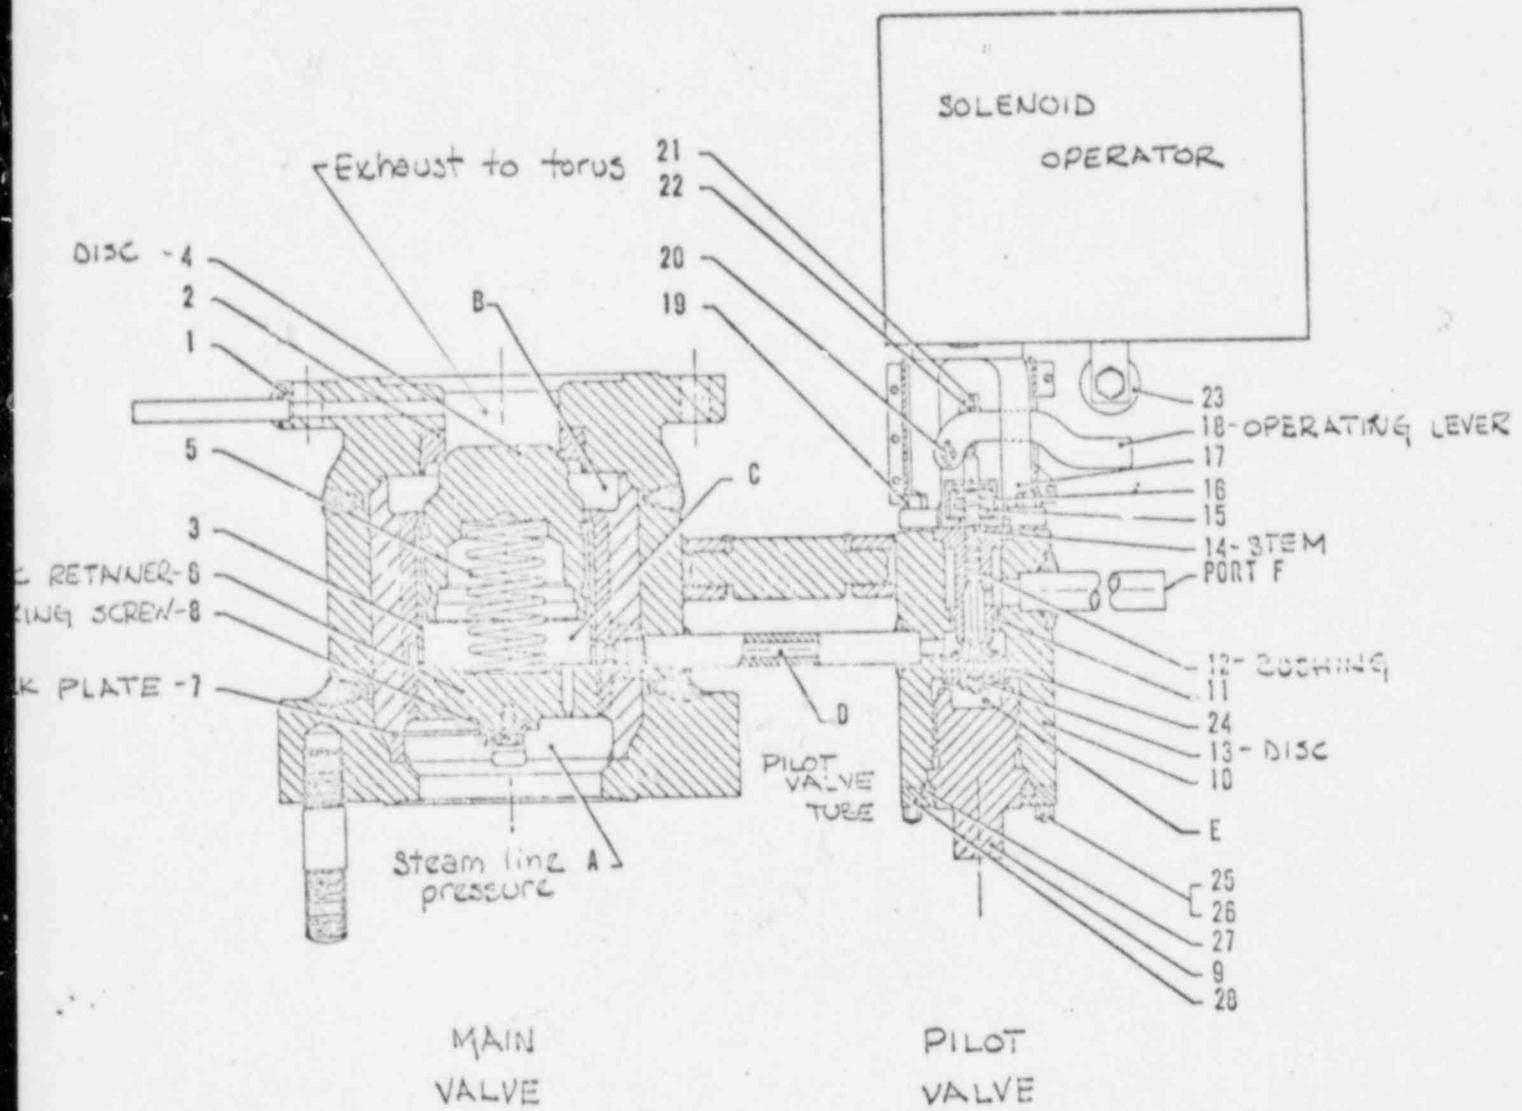
FIGURE 1

Figure 1 attached identifies the valve parts under discussion.

Further investigation revealed that a piece of thread material from the disc retainer of the main valve had blown through the pilot valve tube. During the valve actuation it became lodged between the pilot valve seat and disc, thus the pilot valve was not able to fully close which, in turn, maintained the main valve in an open position.

It was also noted that the tie wire, lock screw and lock arm were missing from the disc retainer. Since the lock arm and screw were missing from the "D" valve, the remaining 4 relief valves were removed for inspection. As a result of this inspection, it was found that a small tab from the lock arm of the "B" relief valve had also broken off. Similar parts for the other 3 valves were found to be in place and secure. In addition, it was observed that the valve operator's spring guide for the "E" relief valve was misaligned, thus causing the solenoid plunger to be restricted in its upward travel.

ELECTROMATIC RELIEF VALVE

In order to prevent recurrence of lock arm failures, these components were removed from all relief valve assemblies. A new method of preventing disc retainer rotation was installed. This method consists of pinning the disc retainer to the cage. Dresser Company, manufacturer of the valves, was contacted concerning this repair and approved same, taking into consideration that the installation of a set screw can in no way cause the clearance between the threads to increase. All other lead threads on each disc retainer were examined and feathered edges removed as necessary. The spring guides for the "E" valve were realigned and the solenoid plunger was checked for freedom of movement.
