METALLURGICAL EXAMINATION & REVIEW
OF
CASTING DEFECTS
IN THE
STAINLESS STEEL VALVE BODIES
LOCATED IN THE CLASS ONE SYSTEMS
OF THE
OYSTER CREEK REACTOR

No. DC-31

March 3, 1969

REPORT OF RT-REVIEW AND SITE-INSPECTION OF ANCHOR STAINLESS VALVE BODY-CASTINGS FOR PRIMARY AND SAFEGUARDS SERVICE IN OYSTER-CREEK NUCLEAR POWER PLANT

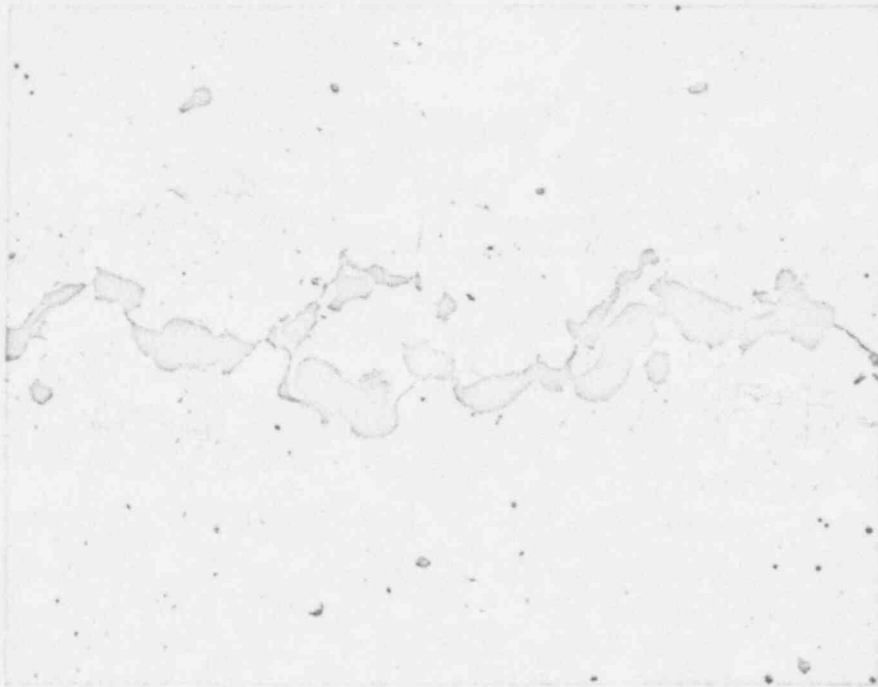
A close examination of the metallographic specimens taken from the top surface of the rim was performed by the author. These sections were taken from the area of the visually observed defects and were located in both longitudinal and transverse orientations. The valve had received, prior to machining, a homogenizing treatment of approximately one-half hour at 2000°F, followed by a water quench.

An example of the defects observed in these microsections is shown in Exhibit C. This micrograph shows that these indications are a combination of microshrinkage voids and hot tears. More specifically, it appears that the microvoids (shrinkage) are essentially linked by hot tears. These defects were metallographically observed, in some cases, to be greater than one-inch in length. No evidence of excessive mold-metal reaction was metallographically observed.

1. The casting defects found in the valve bodies installed in the class one systems of the Oyster Creek reactor were metallographically determined to be the result of solidification shrinkage and hot tearing and were manifested as linked microvoids.

Micrograph of a typical casting defect found in valve number V-20-41 during the metallographic examination performed at APED-GE-San Jose, California. Lightly etched - 250X.
