L77-320

Docket No. 50-346
License No. NPF-3

Supplement to Reportable Occurrence NP-32-77-16
Davis-Besse Nuclear Power Station Unit 1
Date of Occurrence: September 24, 1977

1. SUMMARY

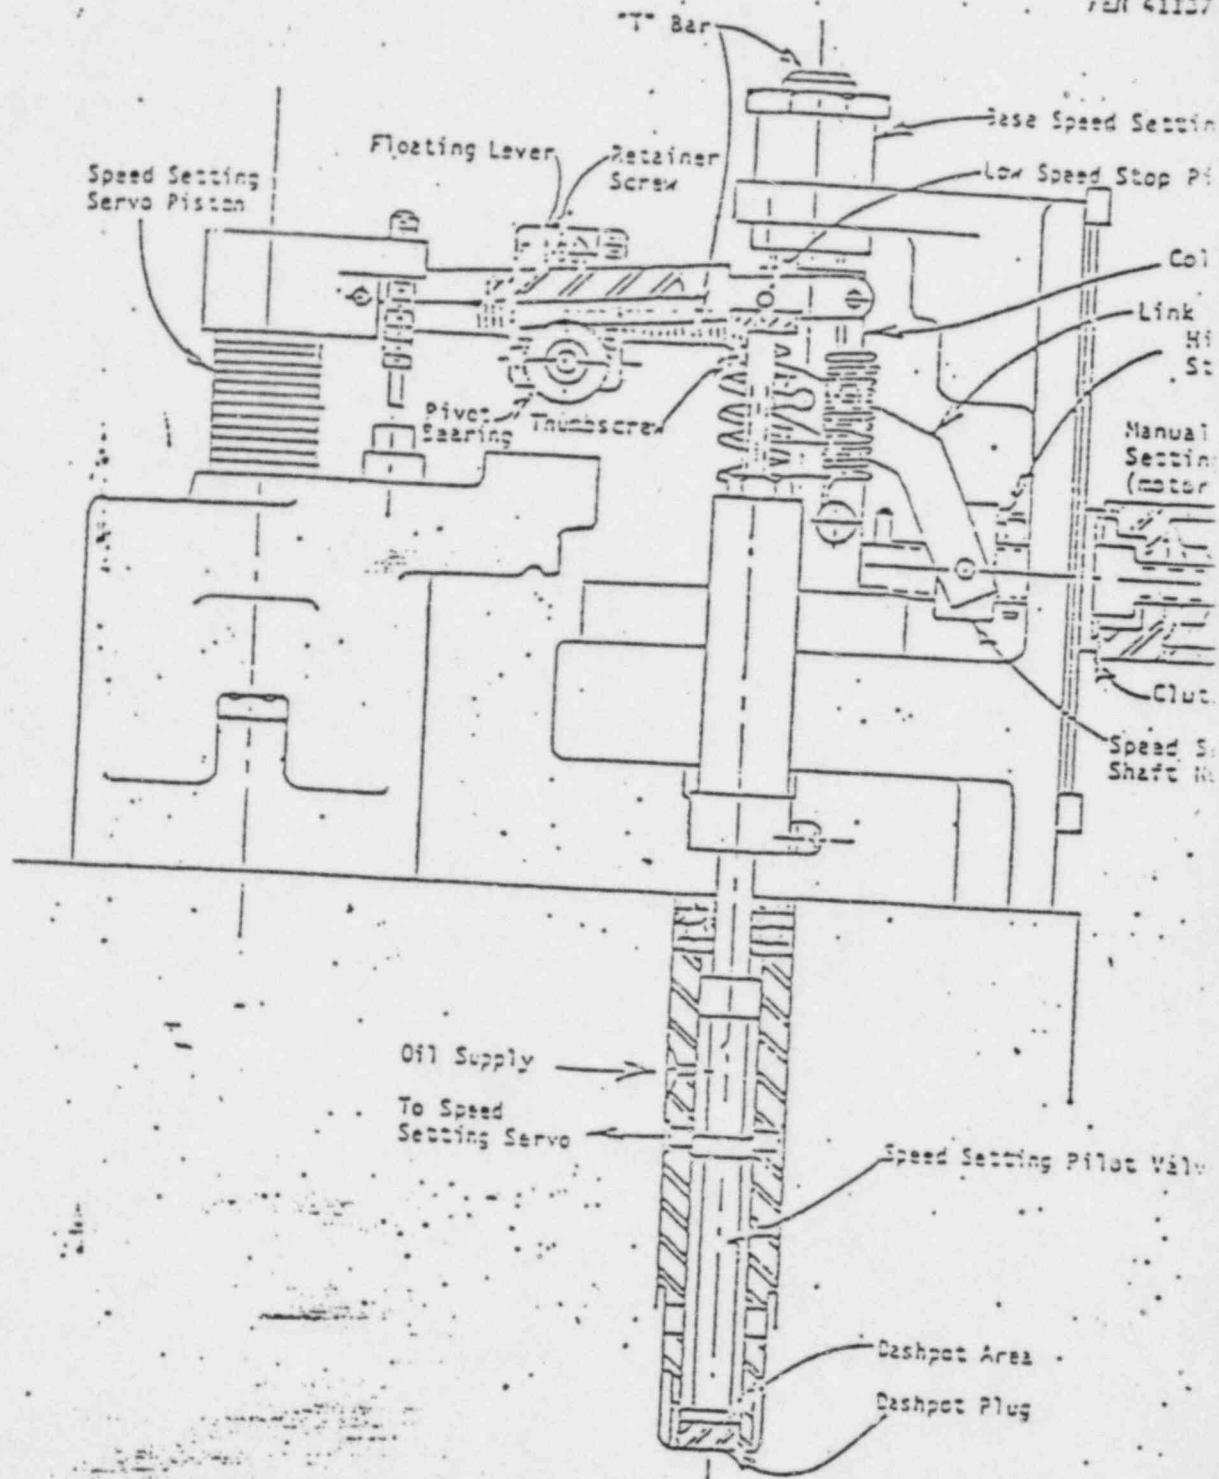
FIGURE 6-1

Before describing the modifications made to the auxiliary feedwater turbine (AFTT) governor, the governor action which resulted in the binding will be described. Figure 6-1 is a drawing of the Woodward Governor PG-PL speed setting mechanism showing the governor in the bound up condition. The sequence of events creating this condition is as follows:

The required parts were manufactured, the unneeded parts removed and the governors were reassembled. The governors were tested at the Woodward factory and the tests confirmed that the modifications did remove all possibility of the undesired binding of the governors. Surveillance testing at the station has also confirmed that the auxiliary feedpump turbine governors function properly.
