UNITED STATES
NUCLEAR REGULATORY COMMISSION
REGION III
799 ROOSEVELT ROAD
GLEN ELLYN, ILLINOIS 60137

MEMORANDUM FOR: D. G. Eisenhut, Director, Division of Licensing, NRR
FROM: R. F. Warnick, Director, Office of Special Cases
SUBJECT: RECOMMENDATION FOR NOTIFICATION OF LICENSING BOARD

SUBJECT: BOARD NOTIFICATION 83-109

OVERHEAD FLUID GROUTING TEST PROGRAM

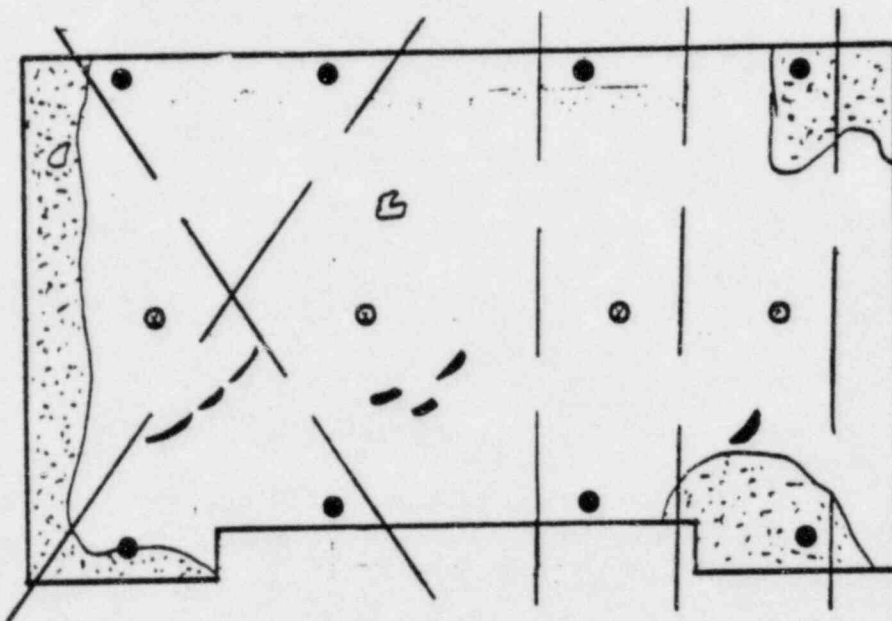
4. Noticeable general air bubble pattern? Yes, minor

5. Calculated void area in excess of 1/4" Ø nominal sizing = 0.7% percent of surface area.

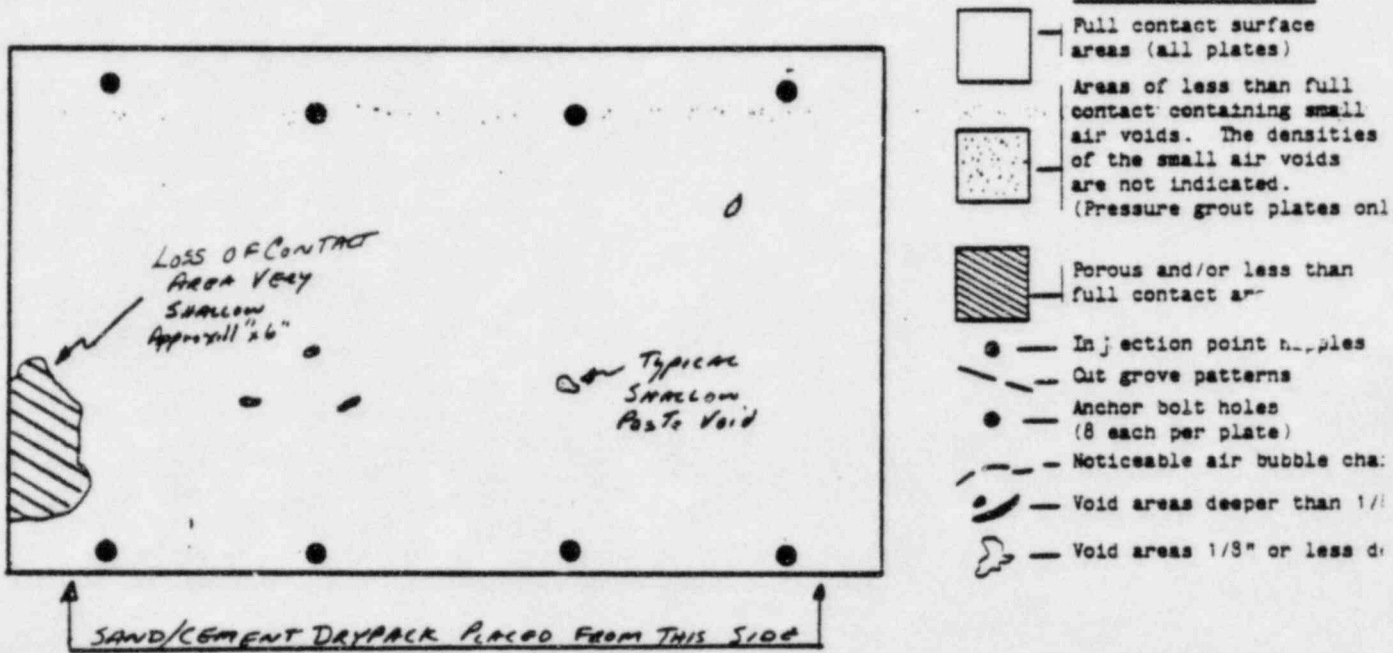
4. Noticeable general void pattern? No

5. Calculated void area in excess of 1/4" Ø nominal sizing = 2.49%
 percent of surface area. Neglecting lost contact area = 0.1%

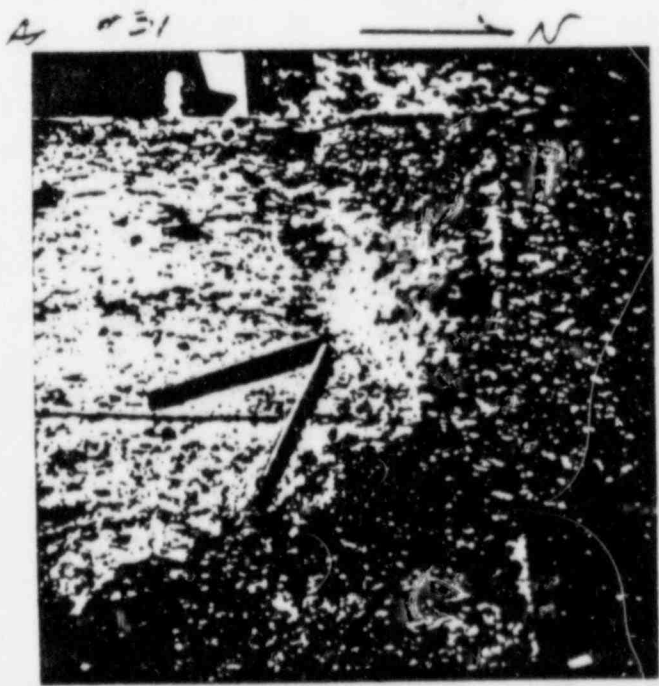
7/7/83 PLATE No. 5B (NORTH WEST CORNER)
 APPARENT LOSS OF CONTACT AREA
 2 1/2" x 6". THE N.B. APPEAR TO HAVE SLIPPED
 ON THE WEST SIDE. (1 1/2" TO 2" GIRT I.P.)
