SUBJECT: Supplement to Repair to the Jet Pump
Instrumentation Penetrations

This supplement to our above referenced letter of June 20, 1984, S. L. Daltroff (PECo) to D. G. Eisenhut, provides additional information relative to the Peach Bottom Atomic Power Station Unit 3 Reactor Pressure Vessel Jet Pump Instrument Nozzle Seals N8-A and N8-B.

PHILADELPHIA ELECTRIC COMPANY
PEACH BOTTOM ATOMIC POWER STATION

JULY 23, 1984 REVISIONS TO ATTACHMENT C
SAFETY EVALUATION FOR THE OPERATION OF
PEACH BOTTOM ATOMIC POWER STATION
UNIT 3

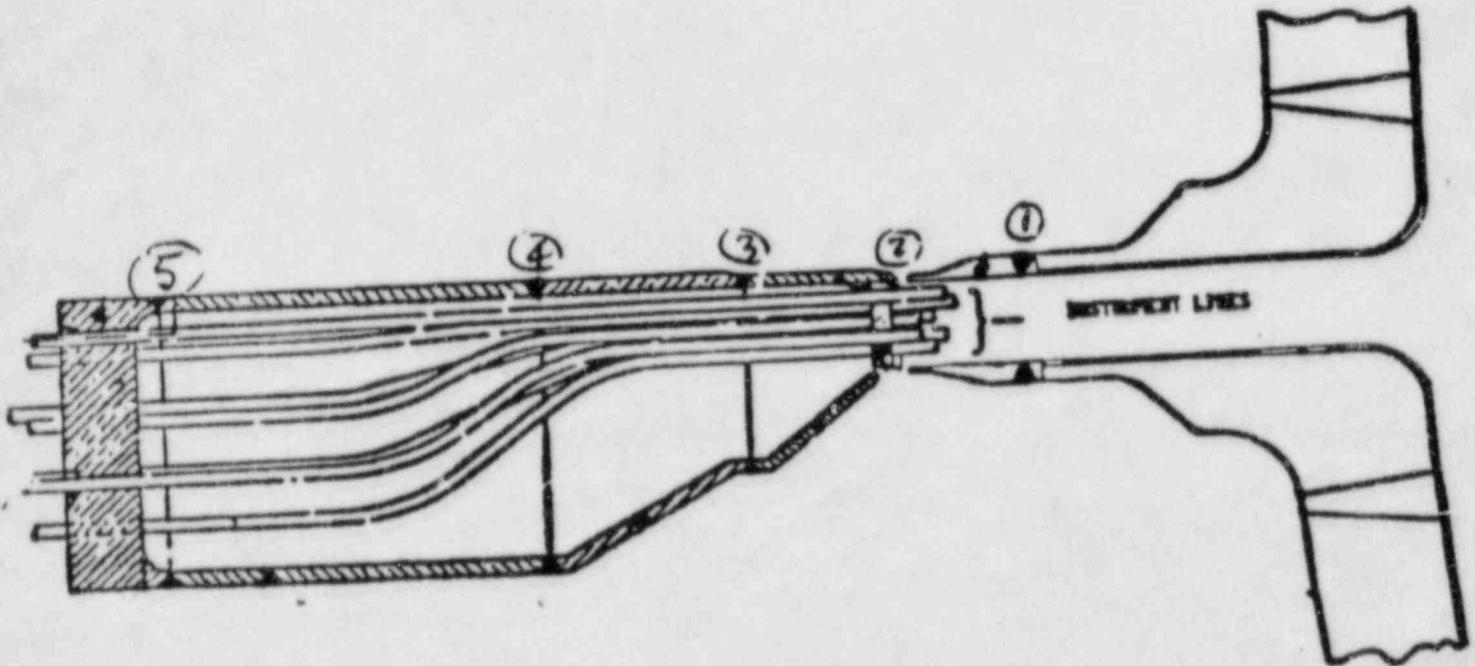
FIGURE 1

Philadelphia Electric Company performed inspections of the Peach Bottom Unit 3 jet pump instrumentation penetrations in response to I.E. Information Notice 84-41 and NRC Generic Letter 84-11. As part of this program, both liquid penetrant and ultrasonic examinations were performed on the five welds associated with each jet pump instrumentation penetration. Circumferential crack-like indications were found on weld No. 2 on each of the two jet pump instrumentation penetrations (see Figure No. 1). In addition to the crack-like indications, the "B" loop No. 2 weld also showed three pin-hole leaks.

The "A" loop circumferential indication was in the 12 o'clock position on the safe-end side of the No. 2 weld. The "B" loop circumferential indication with three pin-hole leaks was in the 12 o'clock position on the reducer side of the No. 2 weld. The pipe material of the eccentric reducer and the safe end at both locations are ASTM A182-F304 and ASTM A336-F8, respectively. Both components are 4" nominal, forged Schedule 80 TP-304 Stainless Steel. The minimal wall thickness of these piping components is 0.337".

JET PUMP INSTRUMENTATION
SEAL AND SAFE END

Overlay weld procedures were prepared to perform these temporary repairs with the concurrence of the on-site representative of the Hartford Steam Boiler Inspection and Insurance Company. Both welds received the weld overlays as recommended by General Electric Company. These overlays were made to provide additional structural reinforcement and prevent potential leakage.

General Electric Company recommended applying a 0.125" thick by 1.5" wide full circumferential overlay on each weld to assure leak-free operation for a minimum of 18 months of full power operation.
