# Failure Evaluation of General Electric SB-1 and SB-9 Reactor Mode Switches

Prepared by V. P. Bacanskas

Franklin Research Center

Prepared for  
U.S. Nuclear Regulatory  
Commission

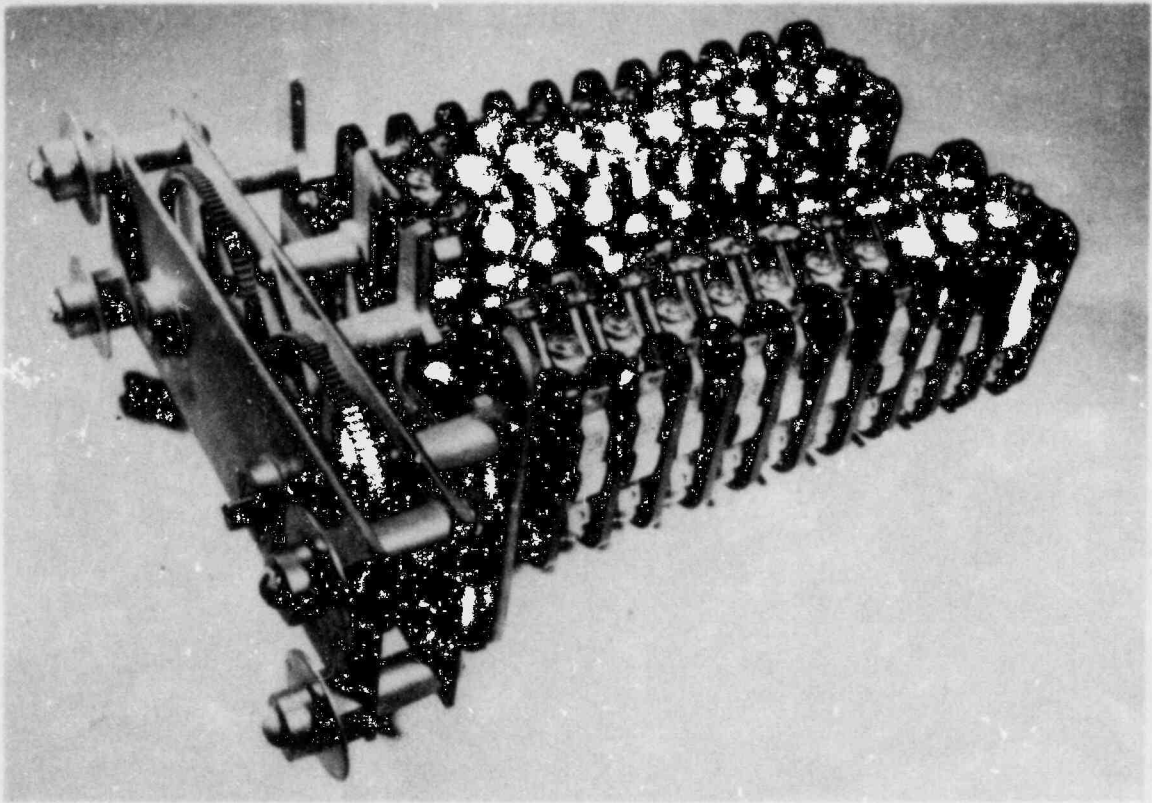
Figure 1. Switch 5896-1

Switch 5896-1 (Figure 1) is a GE Type SB-1, 10-stage, 2-bank, gear-driven tandem switch. The switch has 20 contacts on each bank. The GE drawing number on the tag affixed to the rear of the switch is 0226A9653G1X2. This switch is the original reactor mode switch from Quad Cities Unit 1 and was in service for more than 10 years.

Switch 5896-1 was inspected on October 4, 1983. The switch was received without the switch handle and the NEMA 1\* terminal covers. There was no sign of any external damage to the switch. There was, however, a buildup of dust on the phenolic blocks separating each pair of contacts. The dust was evident only on the face of the phenolic separator facing the control board surface. As explained by Commonwealth Edison personnel, the reactor mode switch is mounted in a manner such that the switch stages hang vertically. Thus, the single surface experiences the dust buildup as the opposite face of the preceding phenolic separator is directly above it. Wire identification tags made of cloth and numbered 1 and 2 were found underneath the contact terminal screws on contacts 1 and 2. The brass inserts in the final stage directly behind the cam shaft were not threaded, indicating that the NEMA 1 terminal covers could not be secured in place.

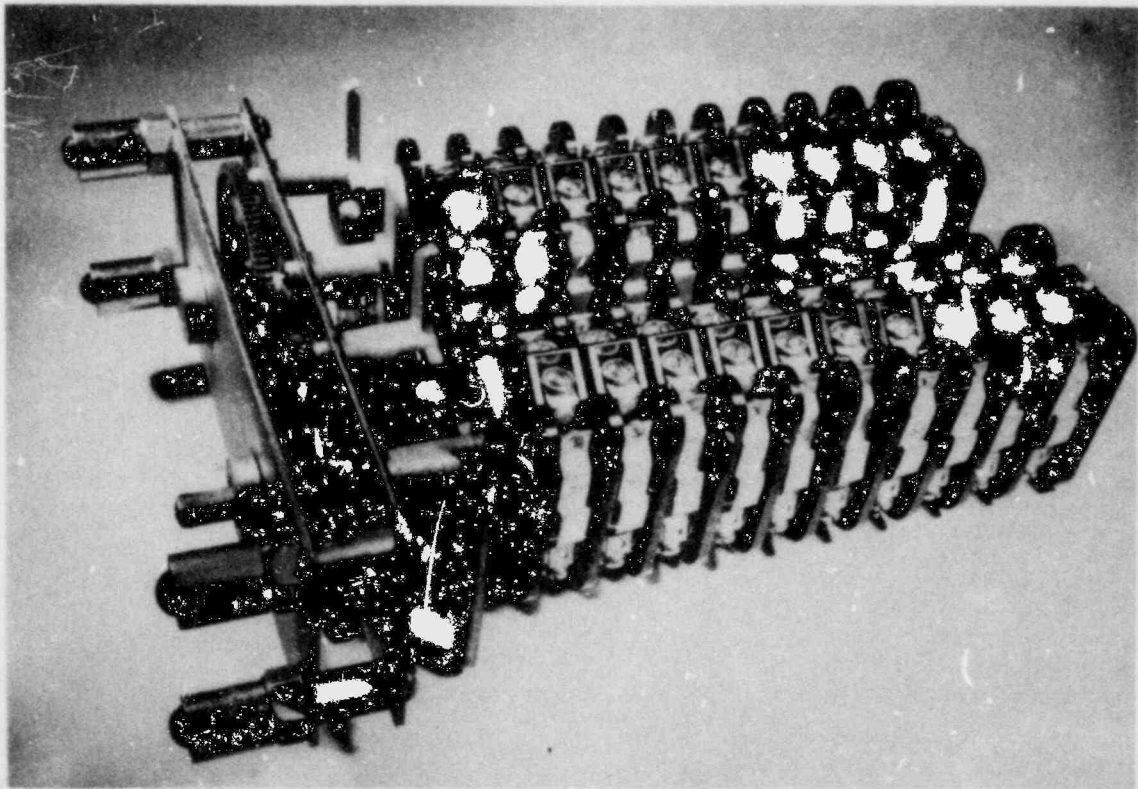
Figure 2. Switch 5896-2 with Terminal Covers Removed

Switch 5896-2 (Figure 2) is a GE Type SB-1, 10-stage, 2-bank, gear-driven tandem switch. The switch has 20 contacts on each bank, and was supplied with a keylock handle, escutcheon plate, and two keys. The GE drawing number on the tag affixed to the rear of the switch is 226A9859G1X2. The switch was purchased as a replacement part for Quad Cities Units 1 and 2 by Commonwealth Edison and had been in storage since January 1978.

Switch 5896-2 was received and inspected on October 20, 1983. The switch was in a "like-new" condition and free from any dust buildup. Two differences were noted from Switch 5896-1. The cam shaft extension that mates to the switch handle was more than two times as long as that of Switch 5896-1. Also, the brass insert in the final stage was threaded for securing the NEMA 1 terminal covers in place. The switch was received with the NEMA 1 terminal covers in place.

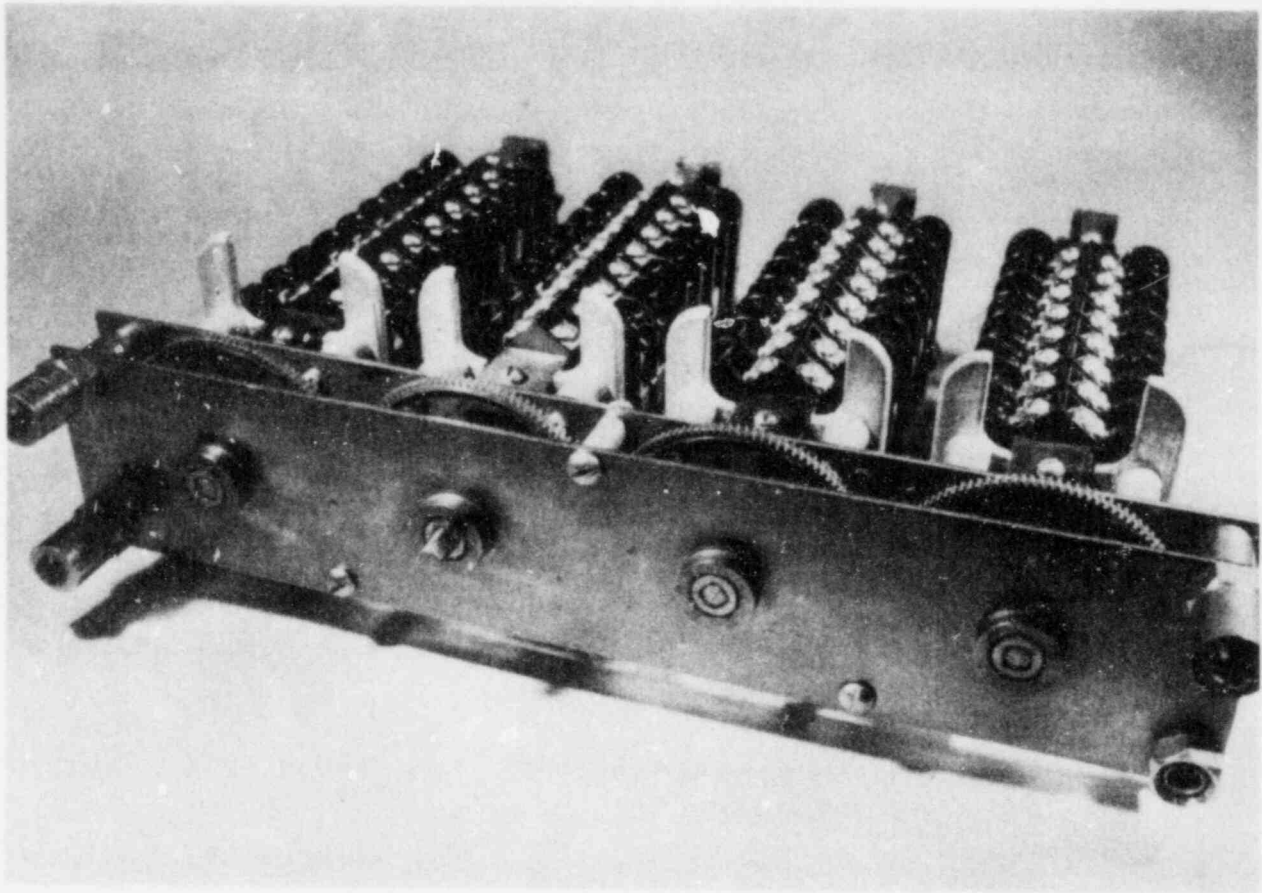
Figure 3. Switch 5896-3 with Terminal Covers Removed

Switch 5896-3 (Figure 3) is a GE Type SB-9, 8-stage, 4-bank, gear-driven tandem switch. The switch has 16 contacts on each bank for a total of 64 contacts. The GE drawing number on the tag affixed to the rear of the switch is 262A6750P001. The switch was purchased from GE and was received on December 19, 1983.

Switch 5896-3 was inspected on December 20, 1983. The switch was received in a "like-new" condition but without a switch handle, and one of the mounting screws and spacers was missing. The switch was received with all four NEMA 1 terminal covers in place. Unlike the terminal covers from Switch

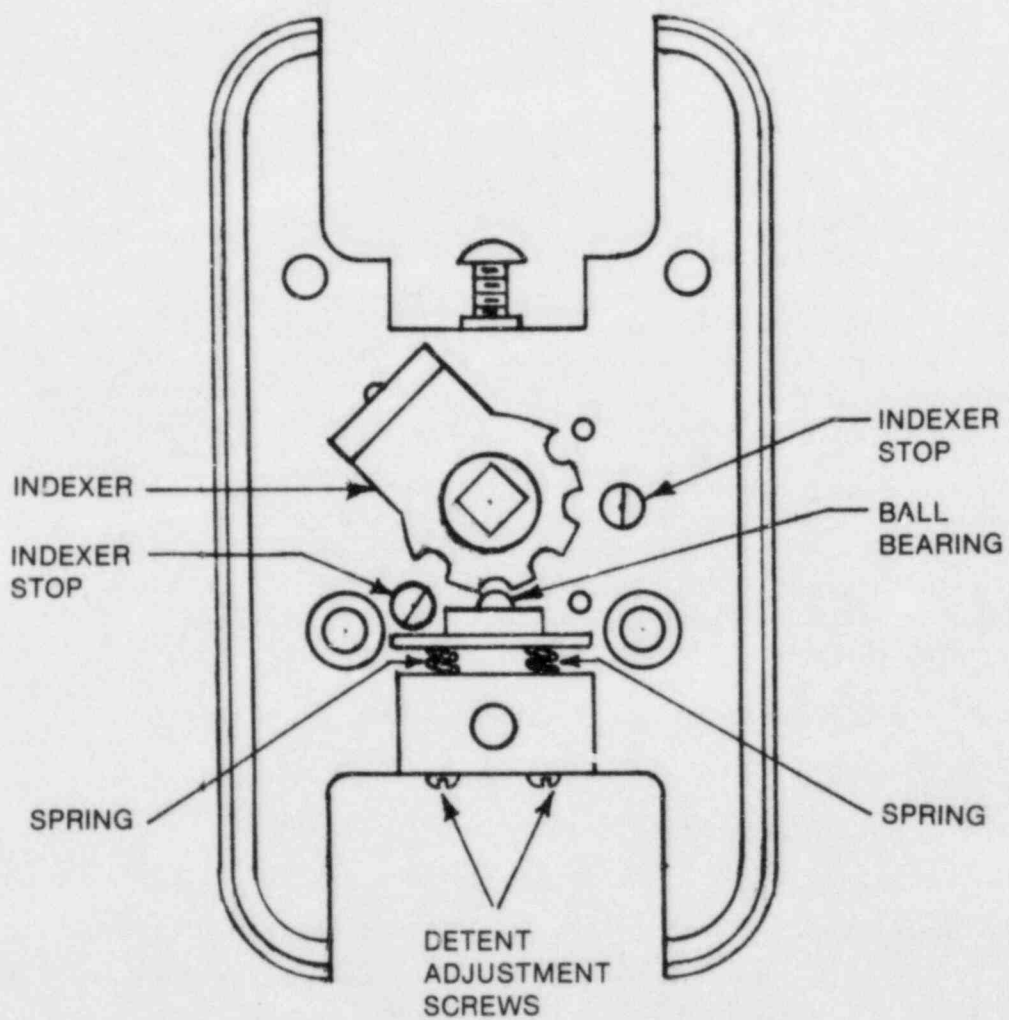
Figure 4. SB-1 Switch Indexer Mechanism

The false detent in the switch operation was initially attributed to the switch position indexers. As a result, the indexers from Switches 5896-1 and 5896-2 were examined under a microscope to identify any significant wear or machining imperfections that could contribute to the false detent. The indexers from Switch 5896-1 showed a wear line at the point at which the indexer surface contacts the ball bearing used to maintain the detent. The edges of the detent slot were slightly rounded at the point of wear. The effect of the wear on the indexer is to allow the ball bearing to ride in the groove created by the wear and to relieve some of the compression on the indexer springs (Figure 4).

The most probable cause of the switch malfunctions appears to be a combination of effects relating to the design of the indexer mechanism for the SB-1 switch and the contact development for this specific application. Figure 4 provides a drawing of the switch indexer mechanism, and Table 4 lists the number of contacts traveling from open to closed when changing the switch from position to position. Investigation of the false detent noted during the functional testing revealed that the false detent is dependent upon the adjustment screw positions of the detent springs of the indexer mechanism and the number of contacts closing in a particular switch position.

In examining the indexer mechanism, it was found that the adjustment screw position causes the torque required to move the switch handle from position to position to vary and can also change the operator's perception of when the detent position is reached. The greater the number of threads visible on the detent adjustment screws, the smaller the torque required to turn the switch handle and the greater the tendency to place the switch in a false detent position. Tightening of the detent spring adjustment screws makes it more difficult to change switch positions but tends to remove the possibility of inadvertently leaving the switch in an intermediate position (false detent); the larger turning torque required at the handle to start the position change tends to drive the switch past the false detent and into the next position, although the false detent still occurs occasionally.

1. Control room operators should be informed of the possibility of the false detent on the SB-1 switch, including methods to detect and to avoid the occurrence of this condition.

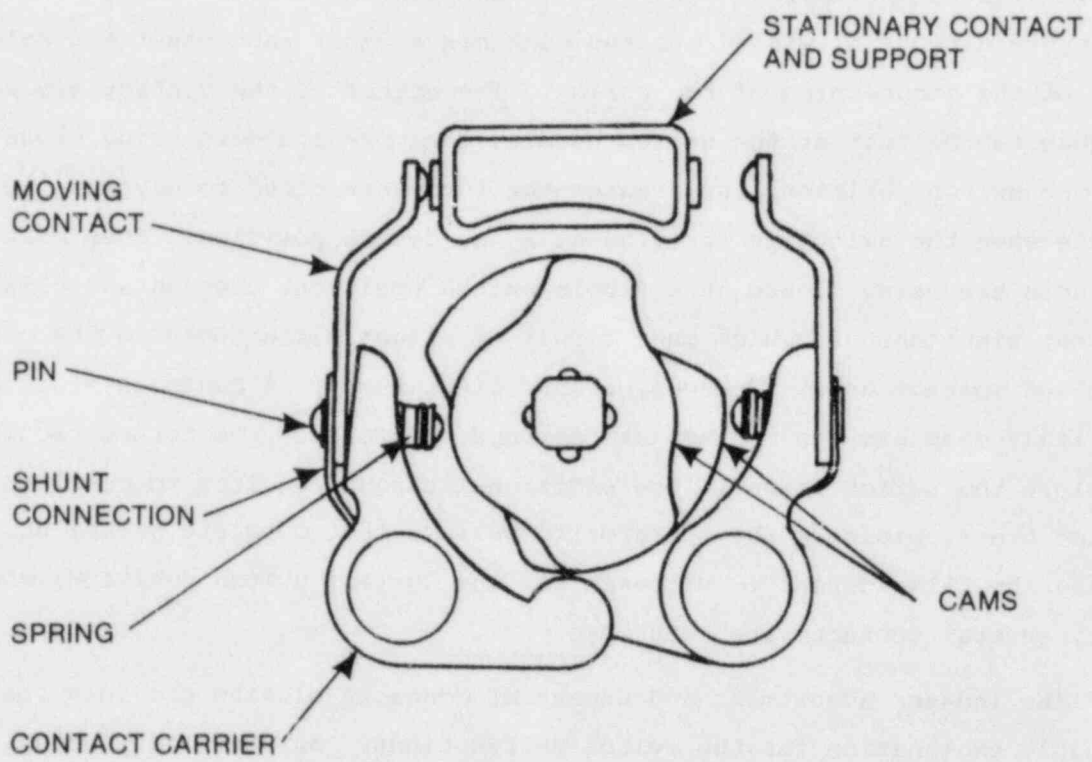
Figure 5. Cam-Operated Contacts

provide a wiping action with the stationary contact so that oxidation buildup is removed by switch operation. The moving contact is constructed of several pieces: the contact arm, contact carrier, shunt connection, pin, and spring. Figure 5 shows these parts. The switch is designed so that when a closing cam pushes a contact to the closed position, the moving contact first touches the stationary contact at a point below the center of the stationary contact. Continued movement of the cam presses the moving contact against the stationary contact, causing a wiping action of the moving contact and compression of the spring. The contact carrier forces the moving contact in an upward direction, wiping the two contacts against each other and releasing some of the compression of the spring. The effect of the contact arm spring torques can be felt at the switch handle; the more contacts being closed in any one switch position, the greater the torque required to move the switch handle when the switch is arriving at a new detent position. When multiple contacts are being closed at a single switch position, the contact closures are not simultaneous, which is a result of slight differences in the contact cams and contact arms. However, a sufficient number of contacts close and partially compress the contact arm springs to increase the torque required to complete the switch travel. The additional torque required to complete the switch travel misleads the operator to believe that complete travel has taken place; the false detent is mistaken for the correct switch position, when, in fact, several contacts are left open.

The indexer adjustment and number of contacts closing provides the most probable explanation for the switch malfunctions. As previously noted, when received, Switch 5896-1 had three complete threads showing (loose detent). The false detent was first noticed during functional testing of the switch when moving the switch from the run to the start-up/hot-standby position. As can be seen from Table 4, 15 contacts close during this operation. With the smaller torque required to move the indexer out of the run position and the larger torque required to compress most of the 15 springs on the contacts as they are closed, the resistance of the switch handle to movement just prior to the start-up/hot-standby position when transferring from the run position led the operator to believe that the full travel position had been reached. It was noted that not all contacts had closed when this false detent position had been reached. Tightening of the detent spring adjustment screws did make it

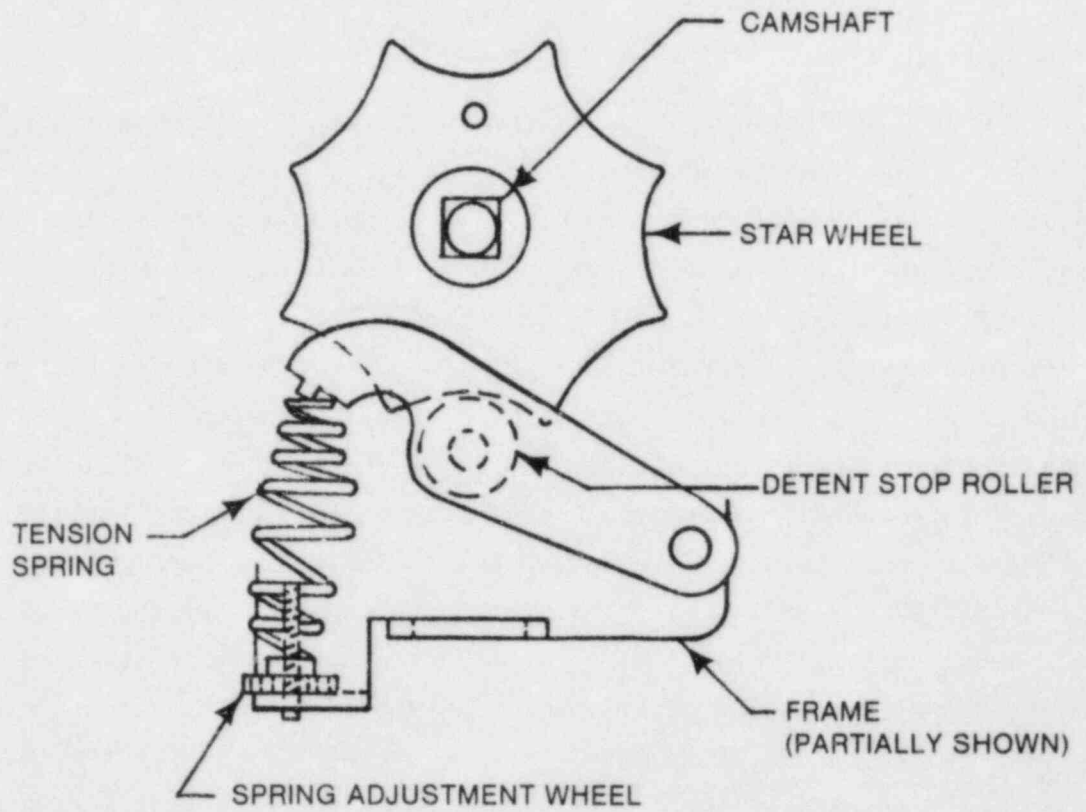
Figure 6. SB-9 Detent Mechanism

The SB-9 switch is similar in design and construction to the SB-1. With the exception of the indexer mechanisms, the parts from the two switches appear to be interchangeable. No new failure modes were identified for the SB-9 switch. The failure modes identified in Appendix A, "Failure Modes and Effects Analysis of GE SB-1 Reactor Mode Switch," are also applicable to the SB-9 switch; however, evaluation of these failure modes leads to the conclusion that they are low probability events for both switch designs and are easily identifiable upon inspection.

- o The SB-9 switch, with its more positive detent mechanism, is not susceptible to the false detent condition noted on the SB-1 switch.
- o The review of the SB-9 switch design did not reveal any new failure mechanisms.

4. When replacement of existing SB-1 reactor mode switches is contemplated, the SB-9 switch should be considered for its more positive detent mechanism.
