# Ruptured Cesium-137 Well-Logging Source at Shelwell Services, Inc., Hebron, Ohio

**U.S. Nuclear Regulatory  
Commission**

Manuscript Completed: November 1983  
Date Published: April 1984

This U.S. Nuclear Regulatory Commission (NRC) report documents the circumstances surrounding the September 13, 1983, cesium-137 sealed source rupture incident at the Shelwell Services, Inc., facility in Hebron, Ohio. It focuses on the period from approximately 4:00 p.m. (EDT) on September 13, 1983, when the source ruptured, to October 5, 1983, when the radiological emergency response aspects of the event were concluded. Information outside these periods is recounted as necessary. The incident resulted in radiation doses to two licensee employees that exceeded the regulatory limits for whole-body and extremity exposures, and contamination of the licensee's facility, private residences, public buildings, and the personal effects of the licensee's employees, families, and friends. The emergency response required the combined efforts of NRC, U. S. Department of Energy, and state personnel. The report describes the factual information and significant findings associated with the event and, thereby,

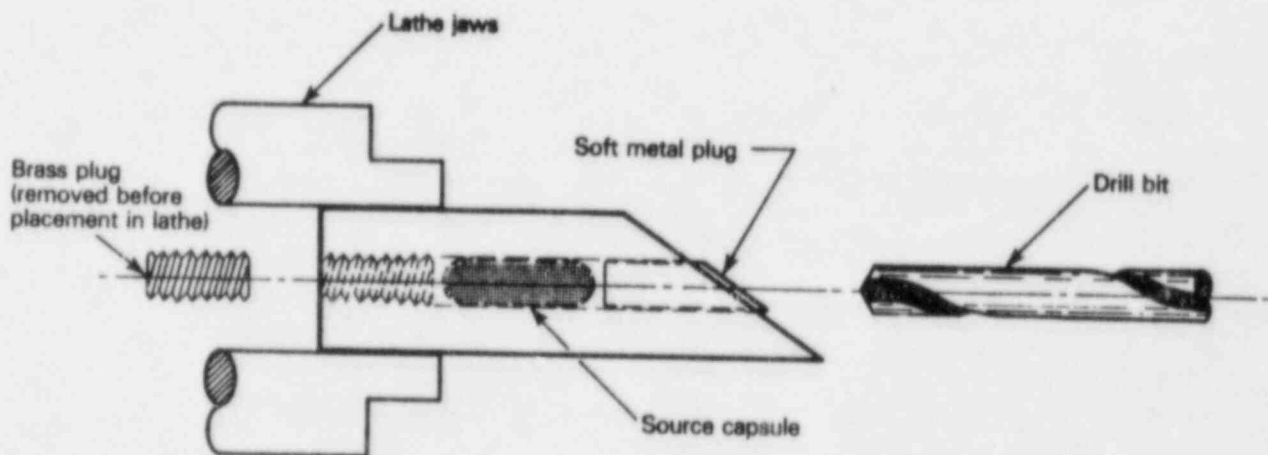
- (1) The source holder was mounted onto a lathe, the brass plug on the holder's cavity was removed, and the open end was placed in the lathe chuck (Figure 10).

Figure 10. Source holder as placed in lathe.

The work progressed as planned until the machinist guessed that the drill bit had broken into the source capsule. When the holder was removed from the lathe, the source capsule dropped out and was caught in a rag. The individuals noticed a hole in the source capsule and a brownish material escaping from the source capsule.

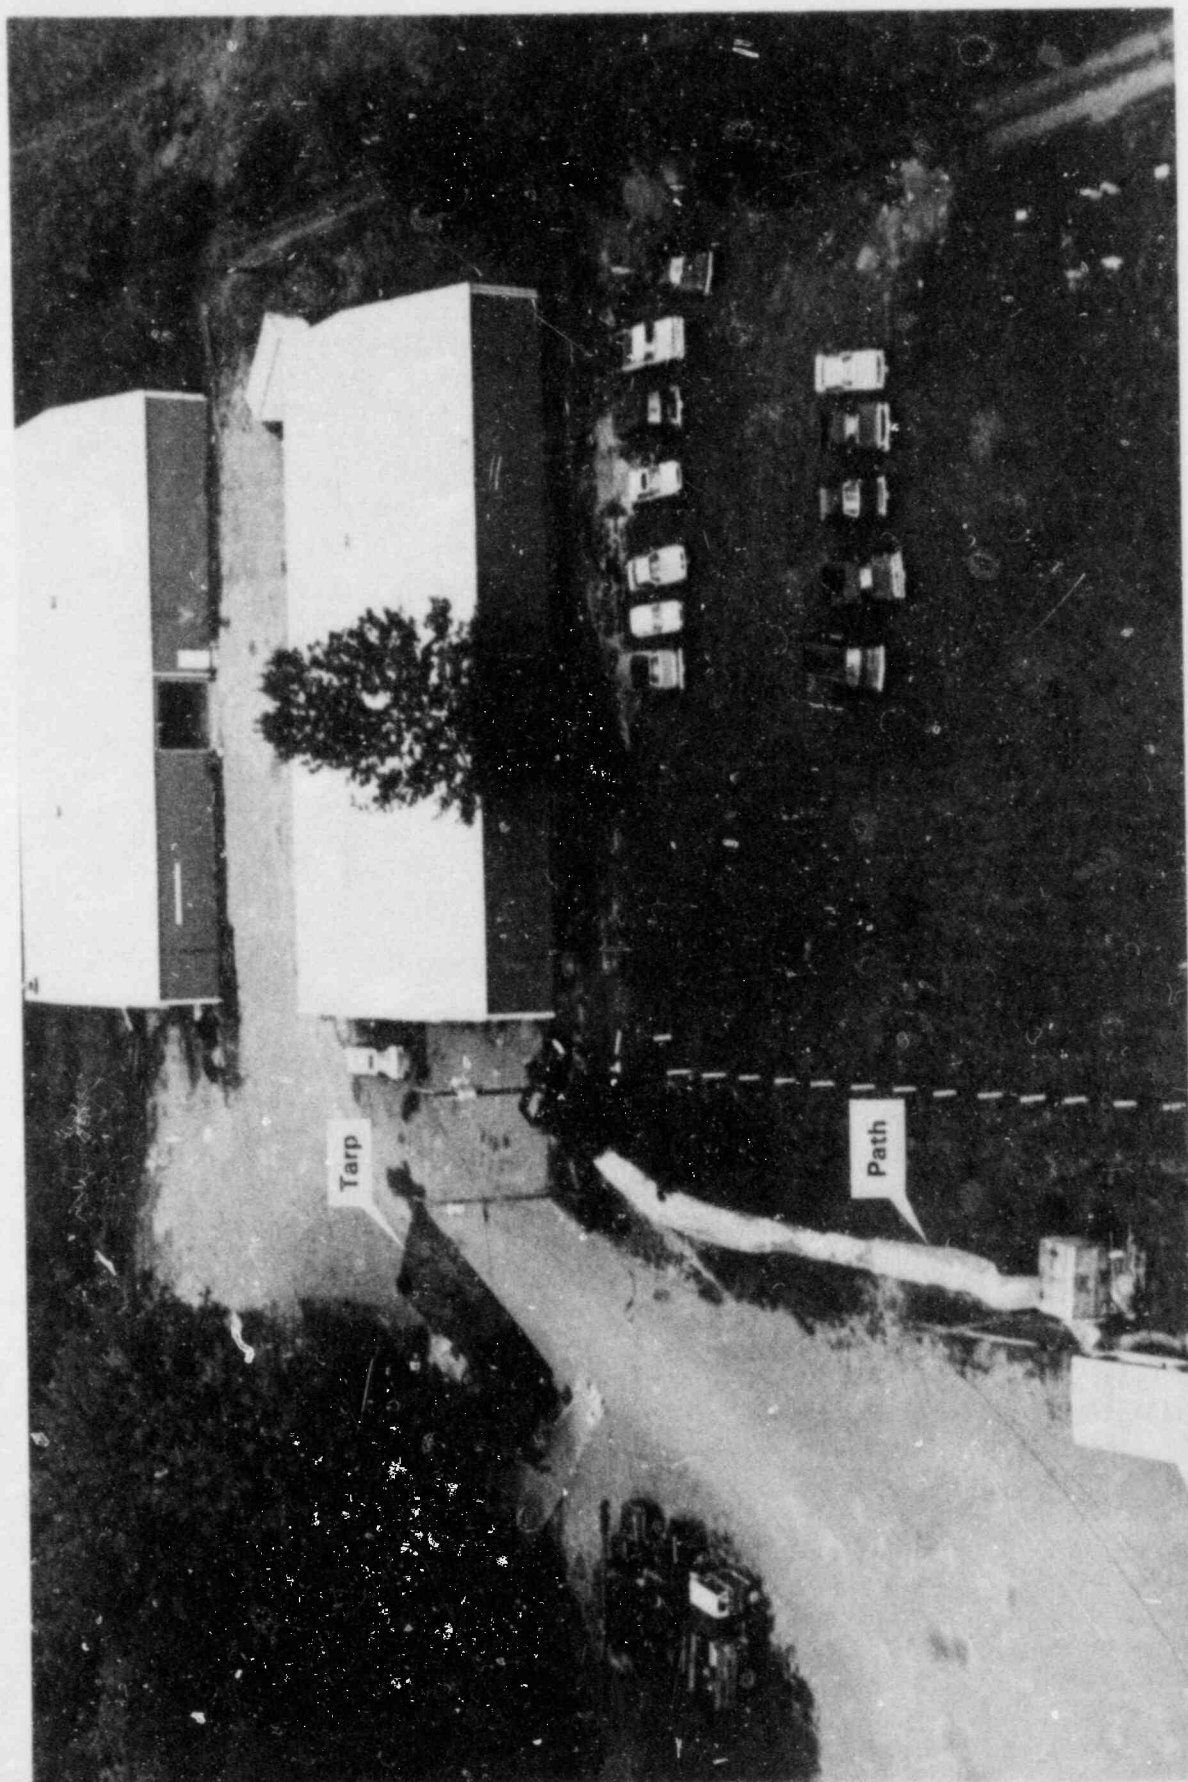
The ruptured cesium-137 source was believed to be composed of cesium chloride, in powder form, readily soluble in water. Heavy rains throughout the morning of September 16, 1983, some 60 hours after the source rupture, washed some of the tracked contamination into the rocks and soil of the licensee's access drive. This was the first of four rains that occurred during the emergency response phase of the operation. Areas of the licensee's access drive having the highest levels of contamination were covered with plastic to reduce migration through the soil. This included a walkway leading from Building 2 to the office trailer and an area west of the incident building where contaminated items, generated during the licensee's initial cleanup attempts, had been placed (see Figure 12).

Figure 12. Plastic covers over contaminated areas.

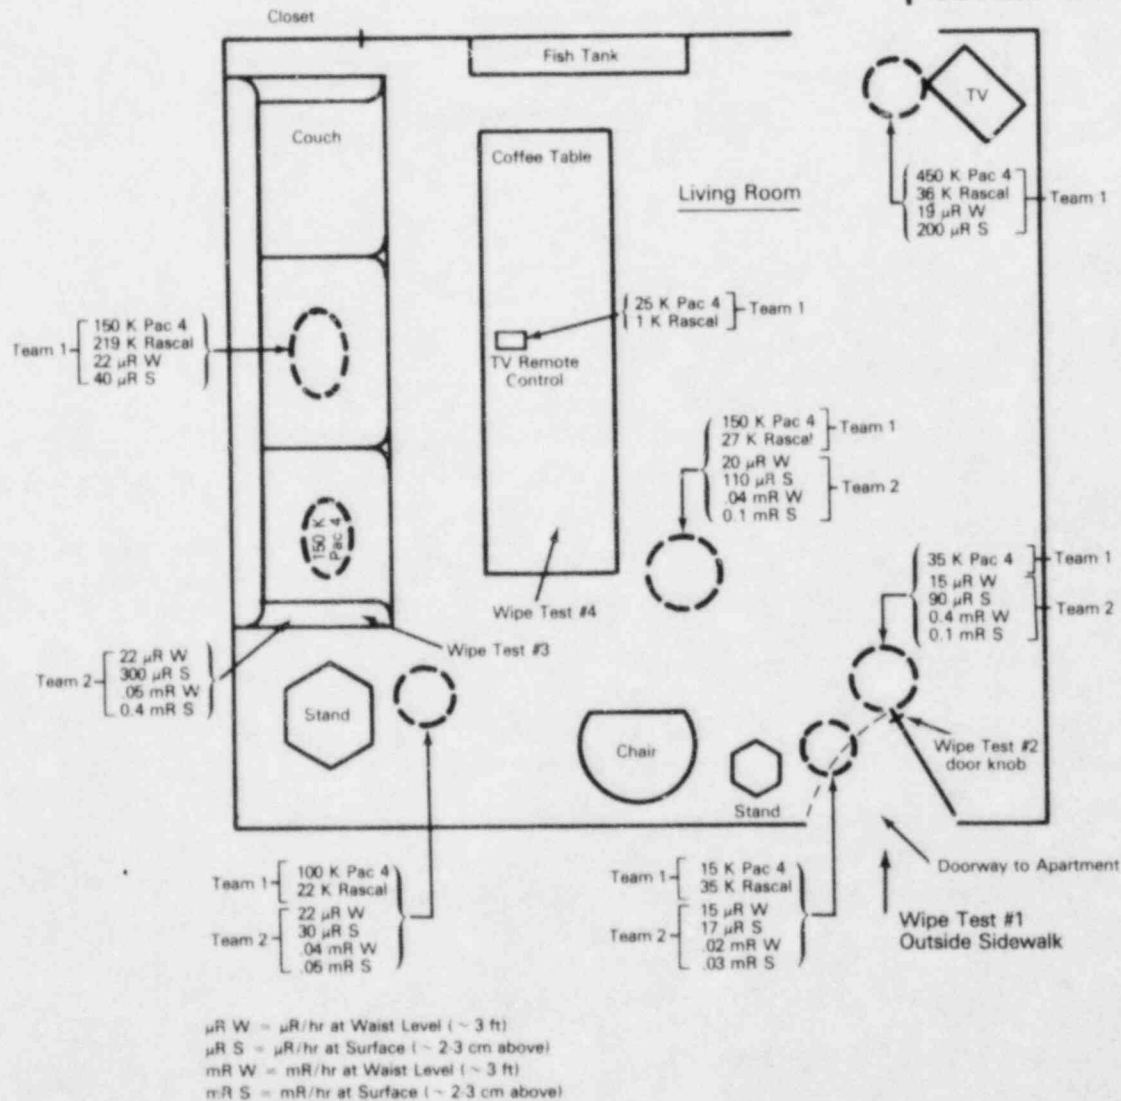
Figure 14. Sketch of a contaminated living room.

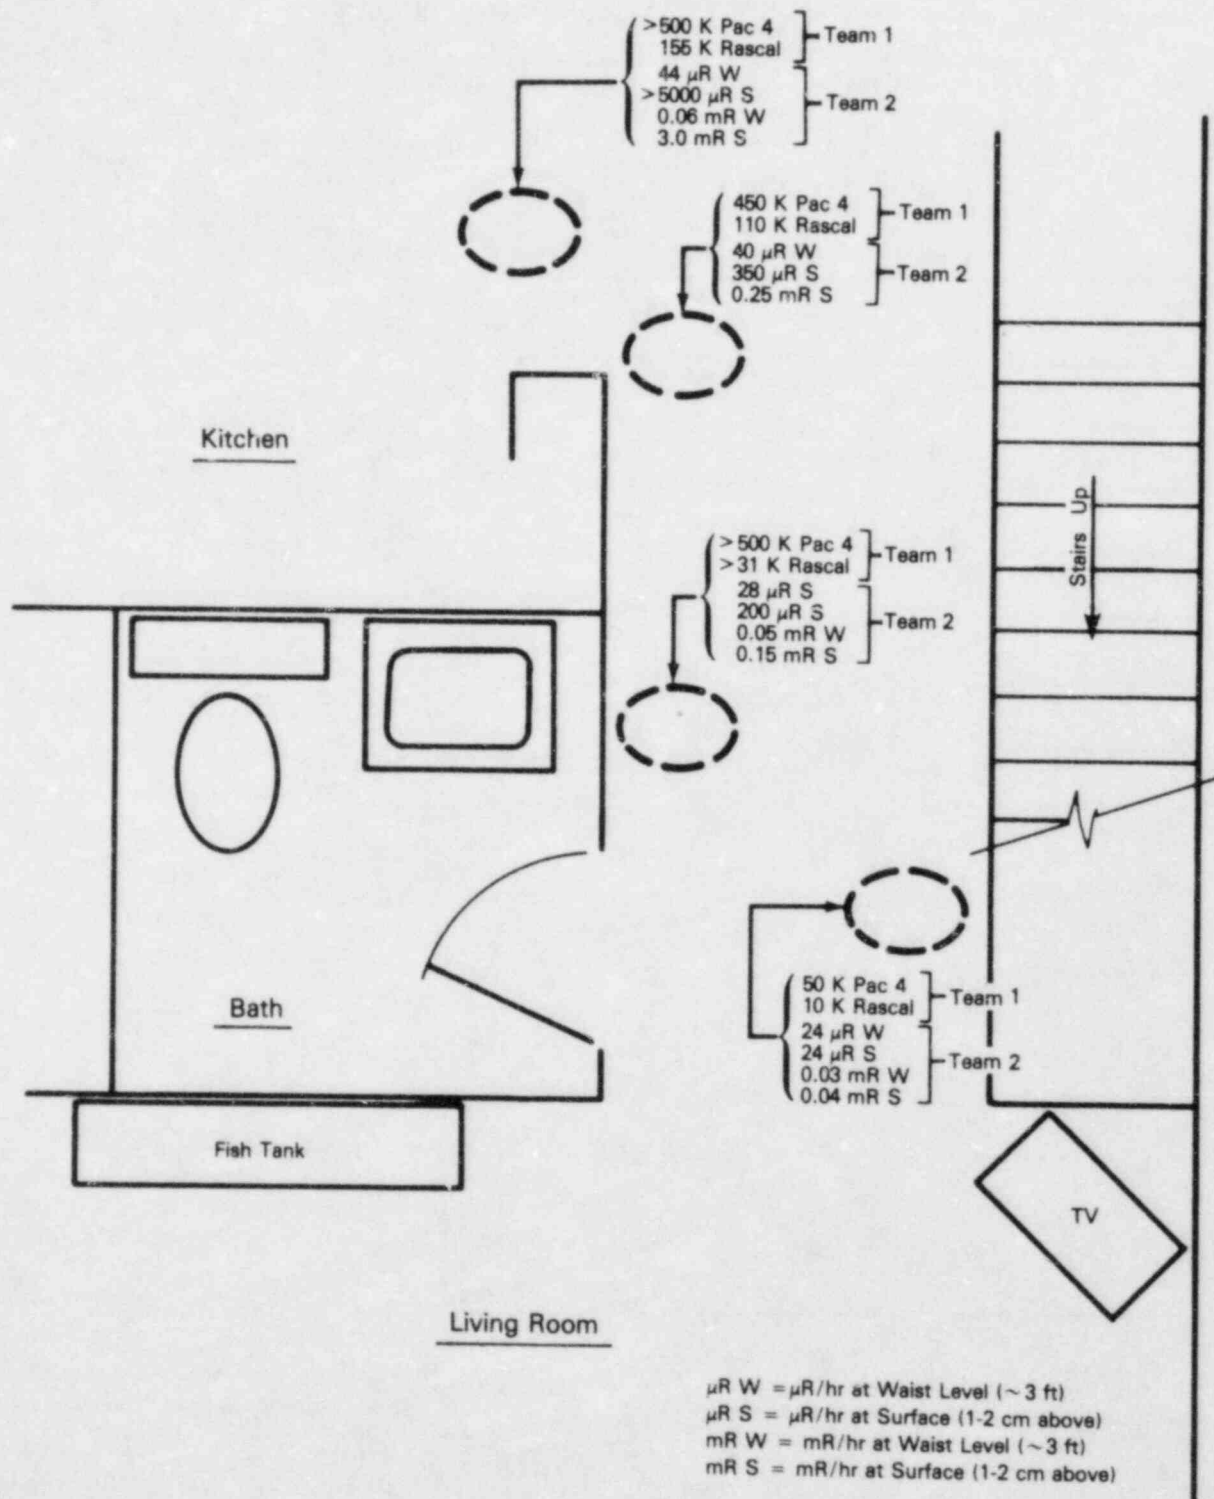
Figure 15. Sketch of a contaminated hallway.

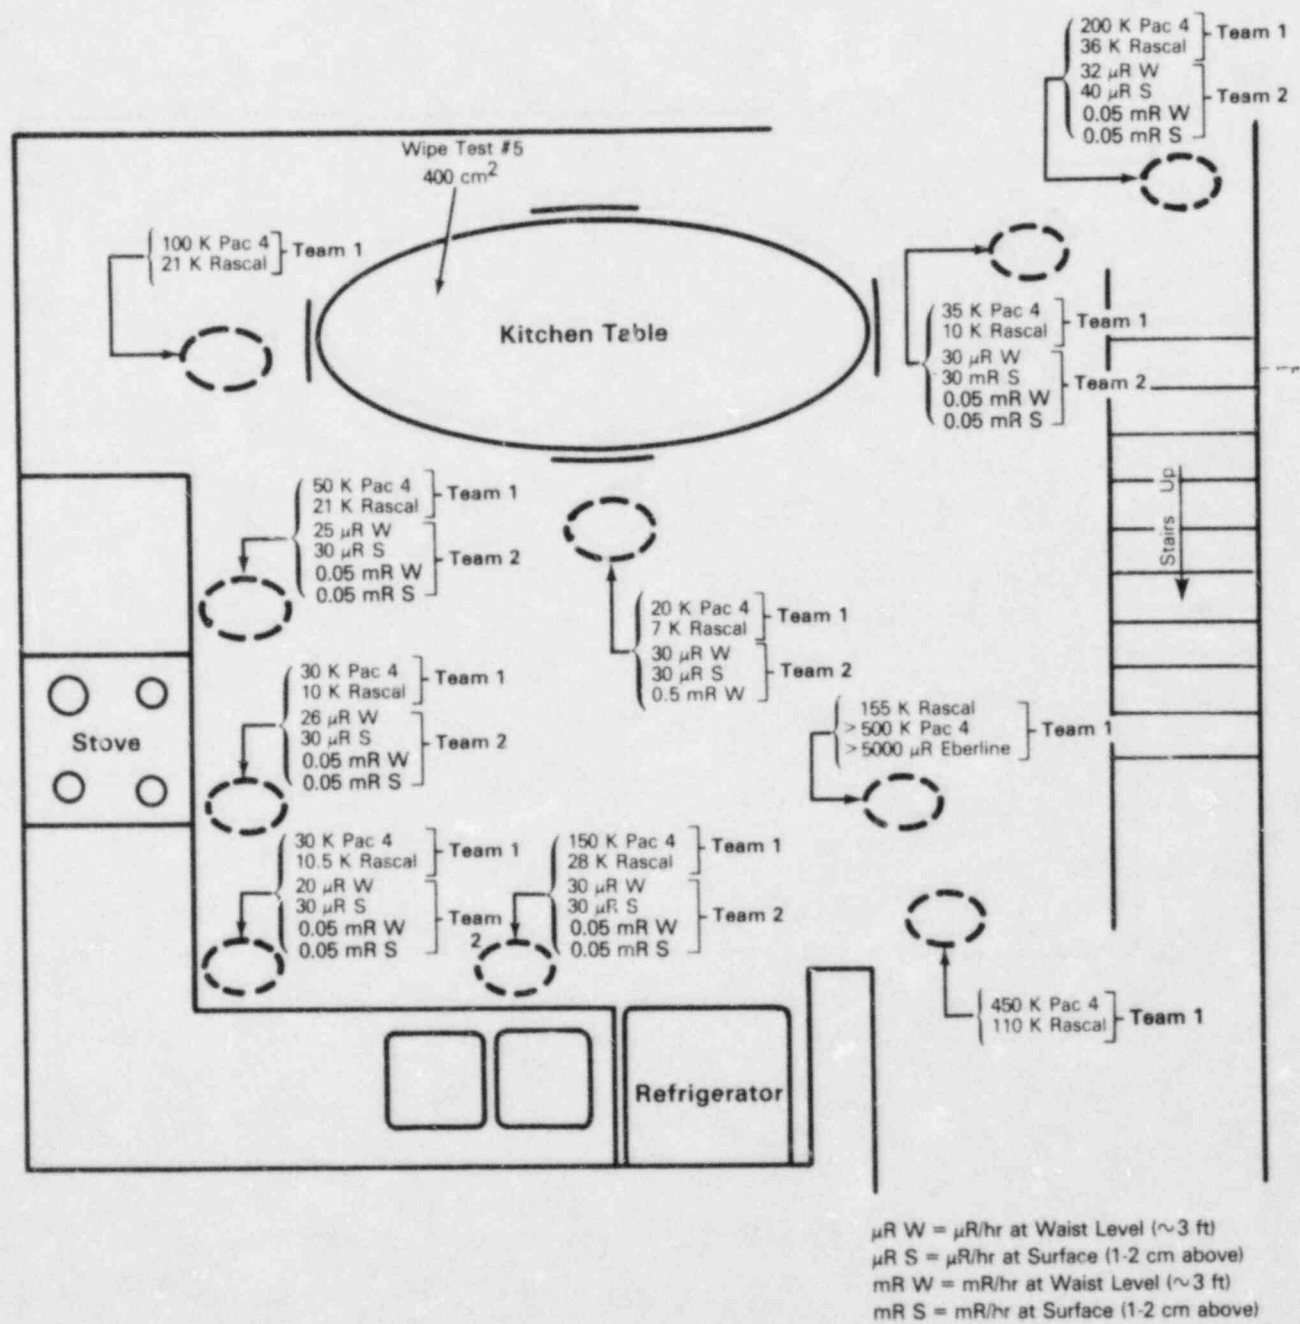
Figure 16. Sketch of a contaminated kitchen.

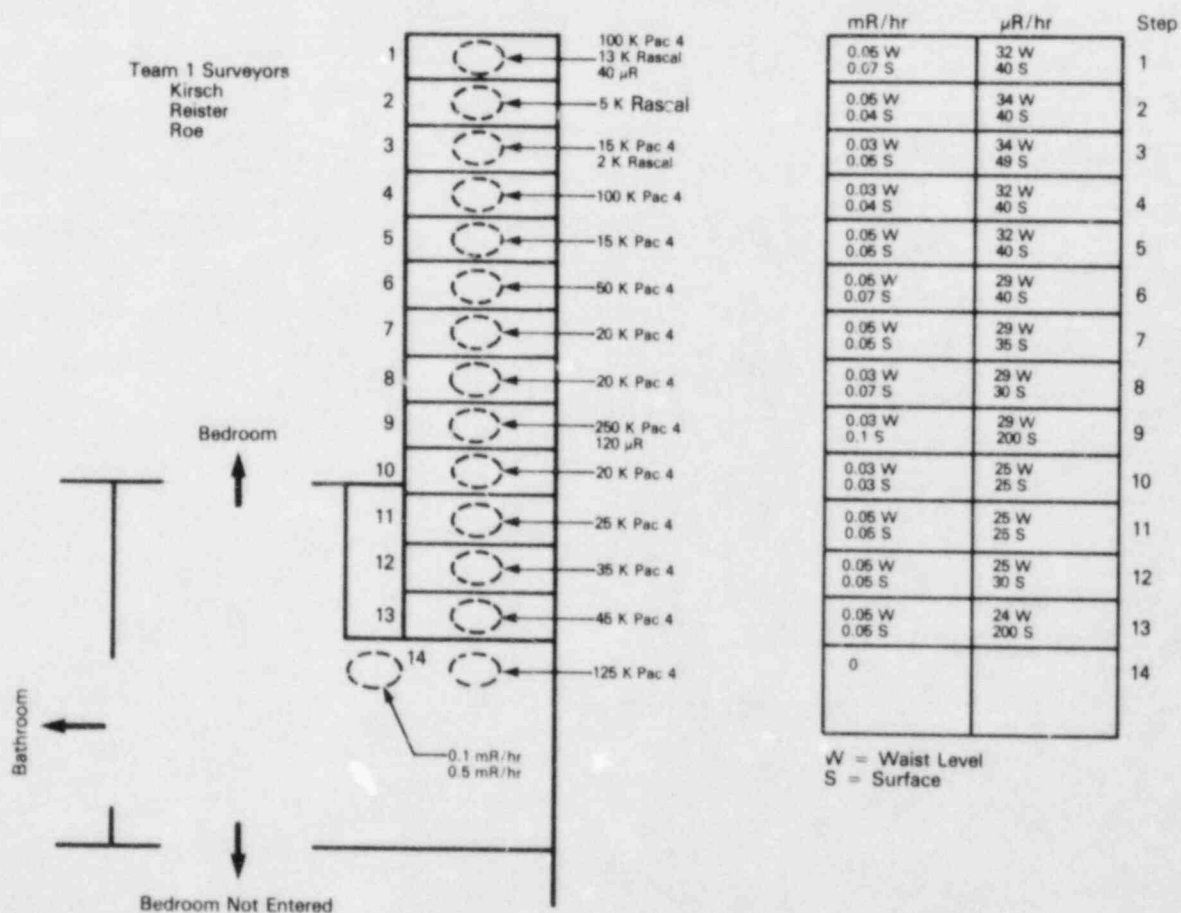
Figure 17. Sketch of a contaminated stairway.

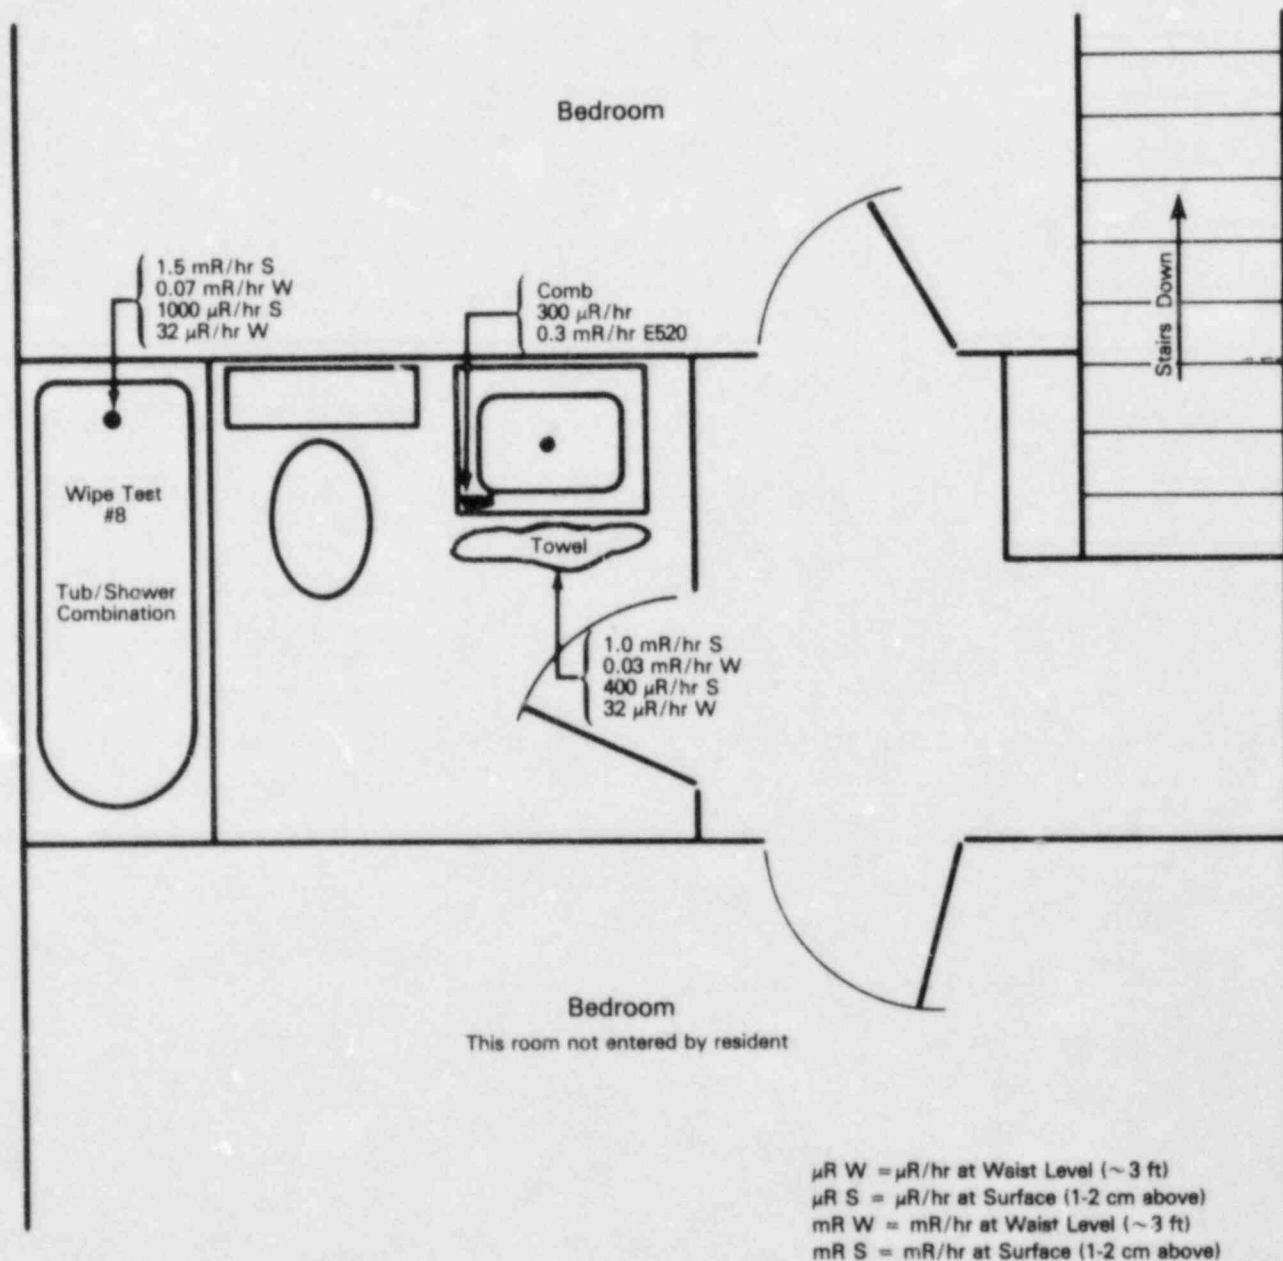
Figure 18. Sketch of a contaminated bathroom

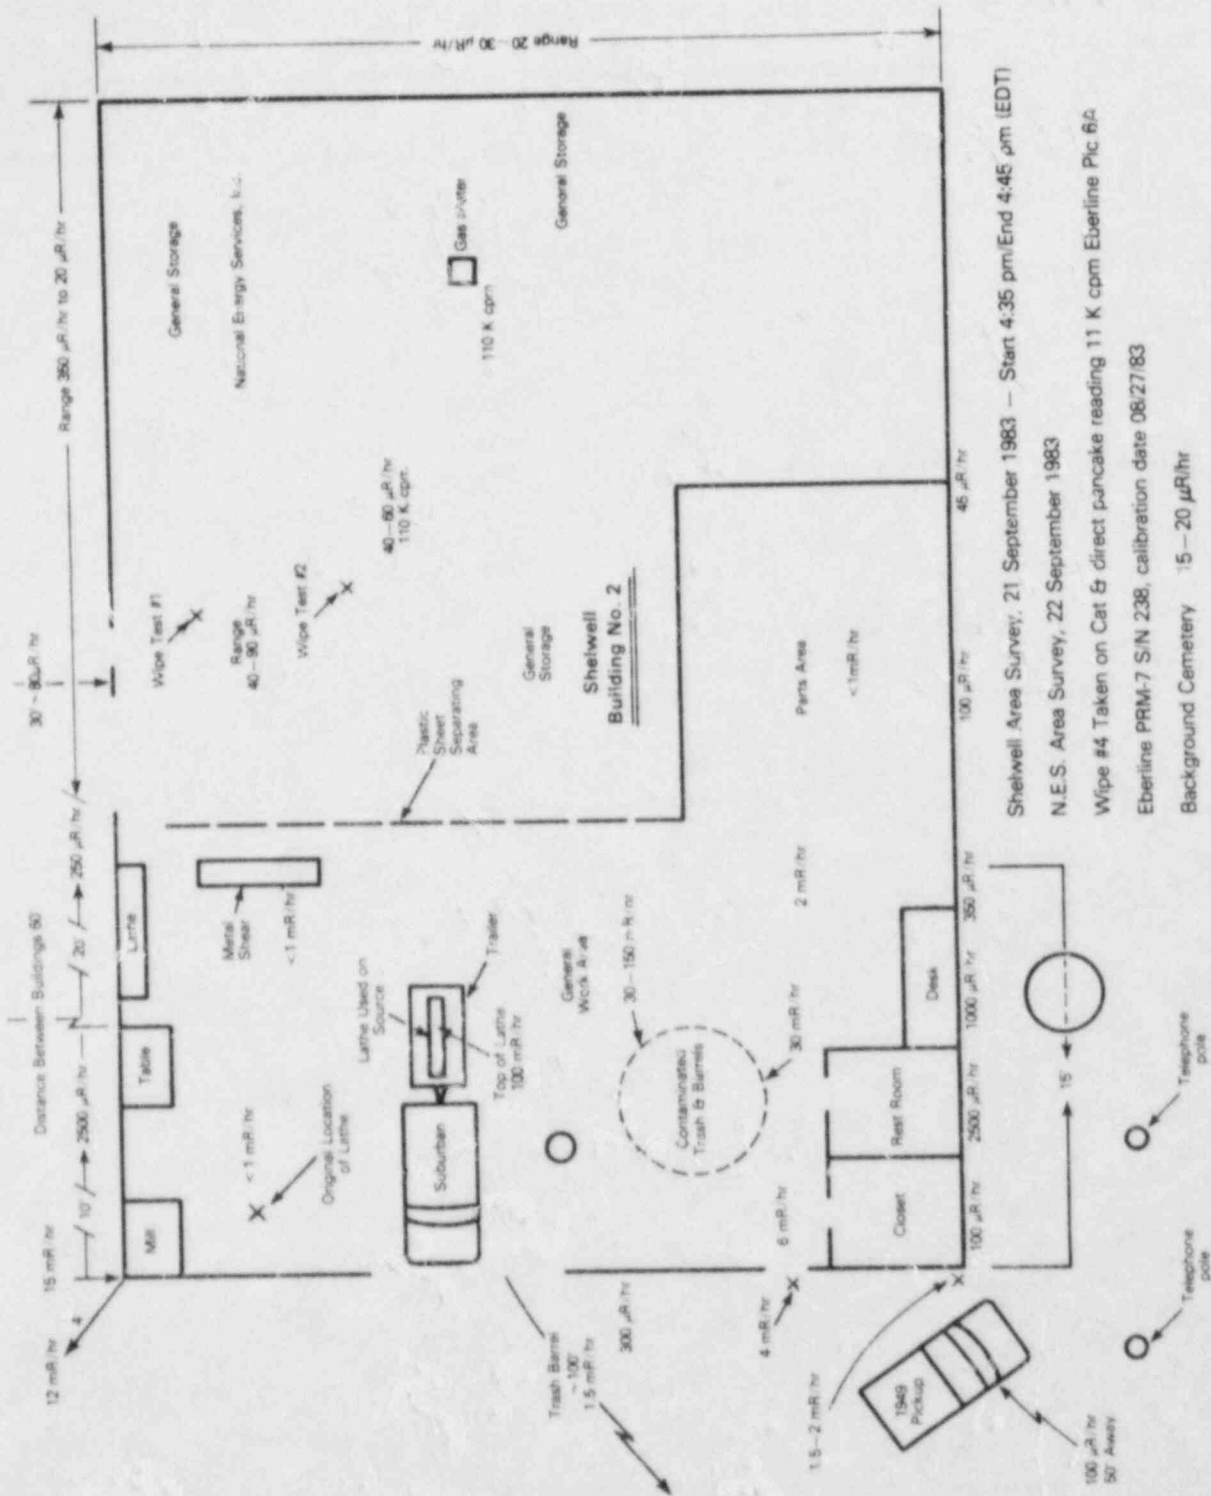
Figure 20. Sketch of Shelwell Building 2, including survey results.

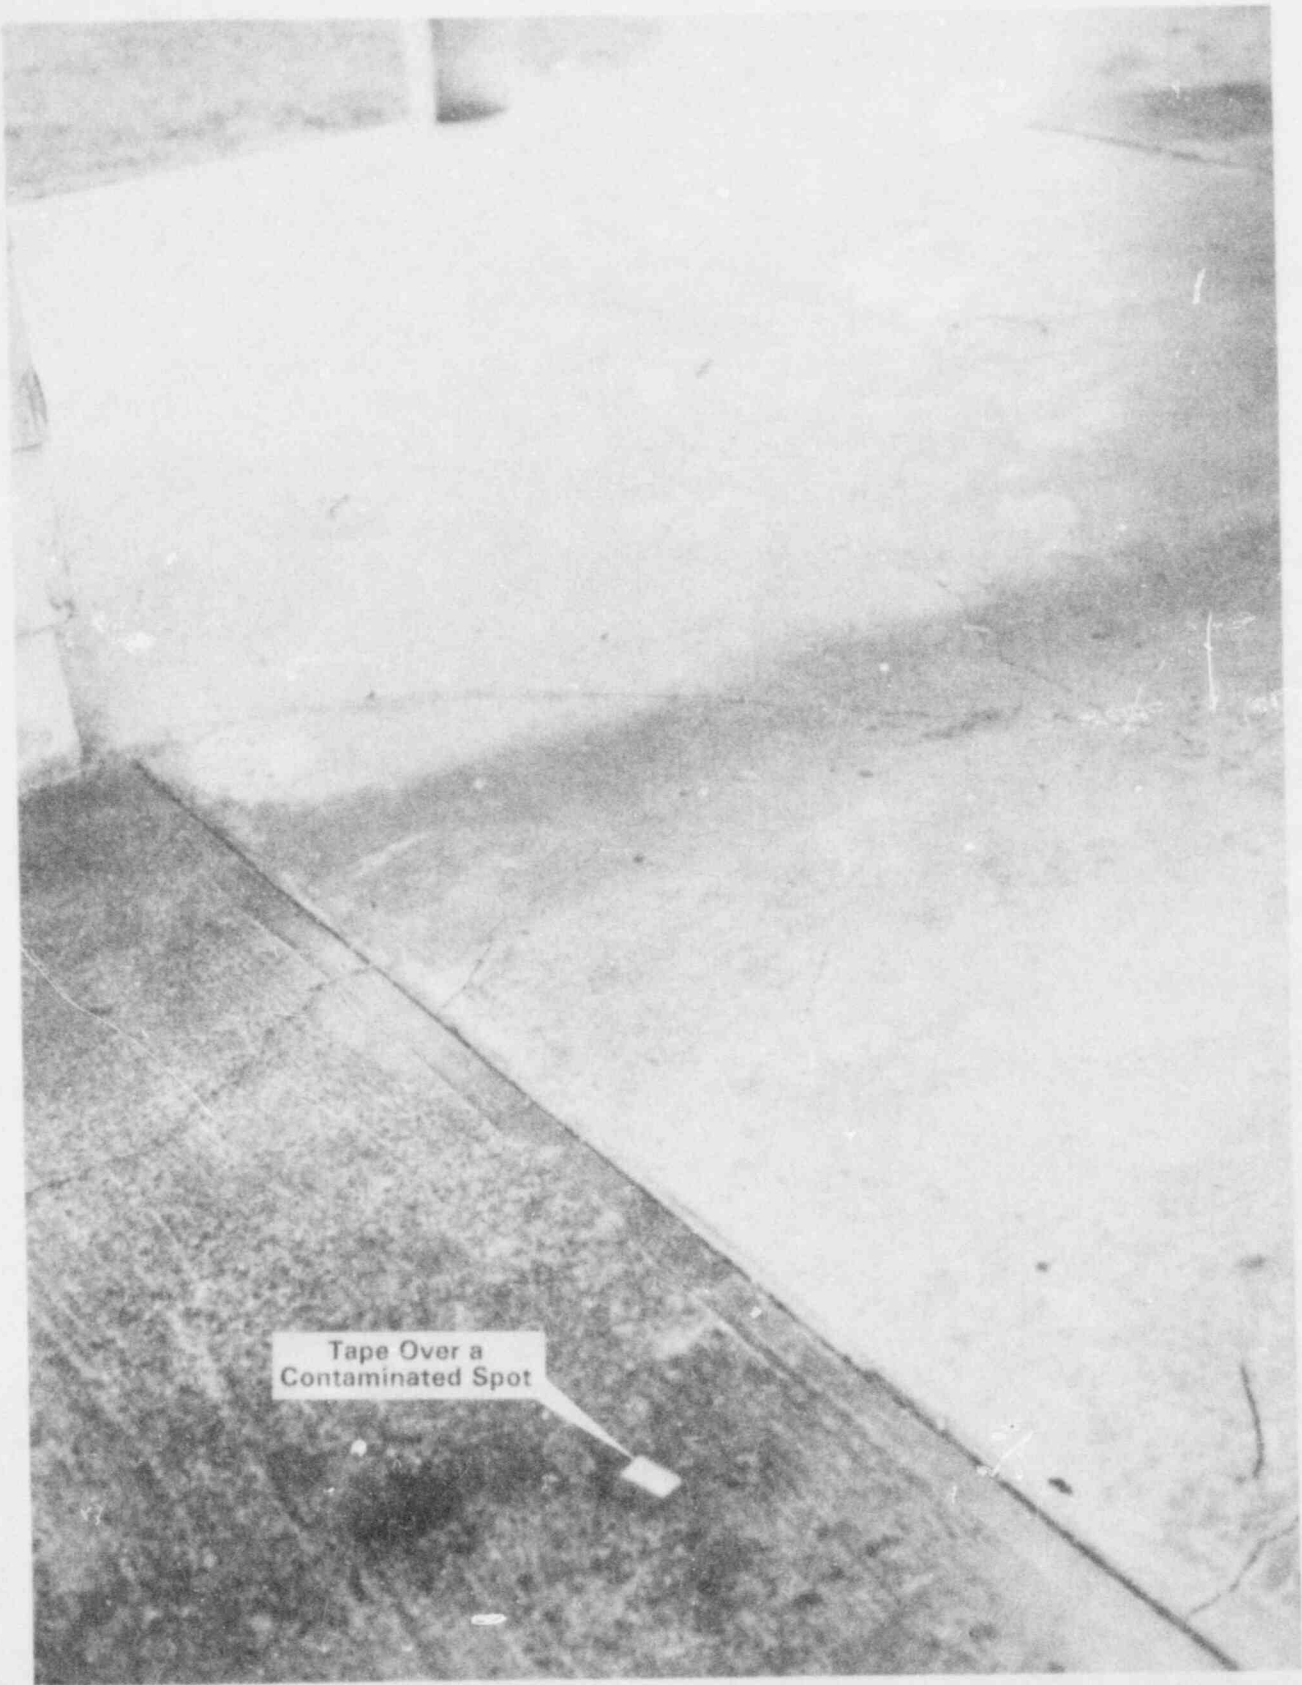
Figure 21. Contaminated driveway.

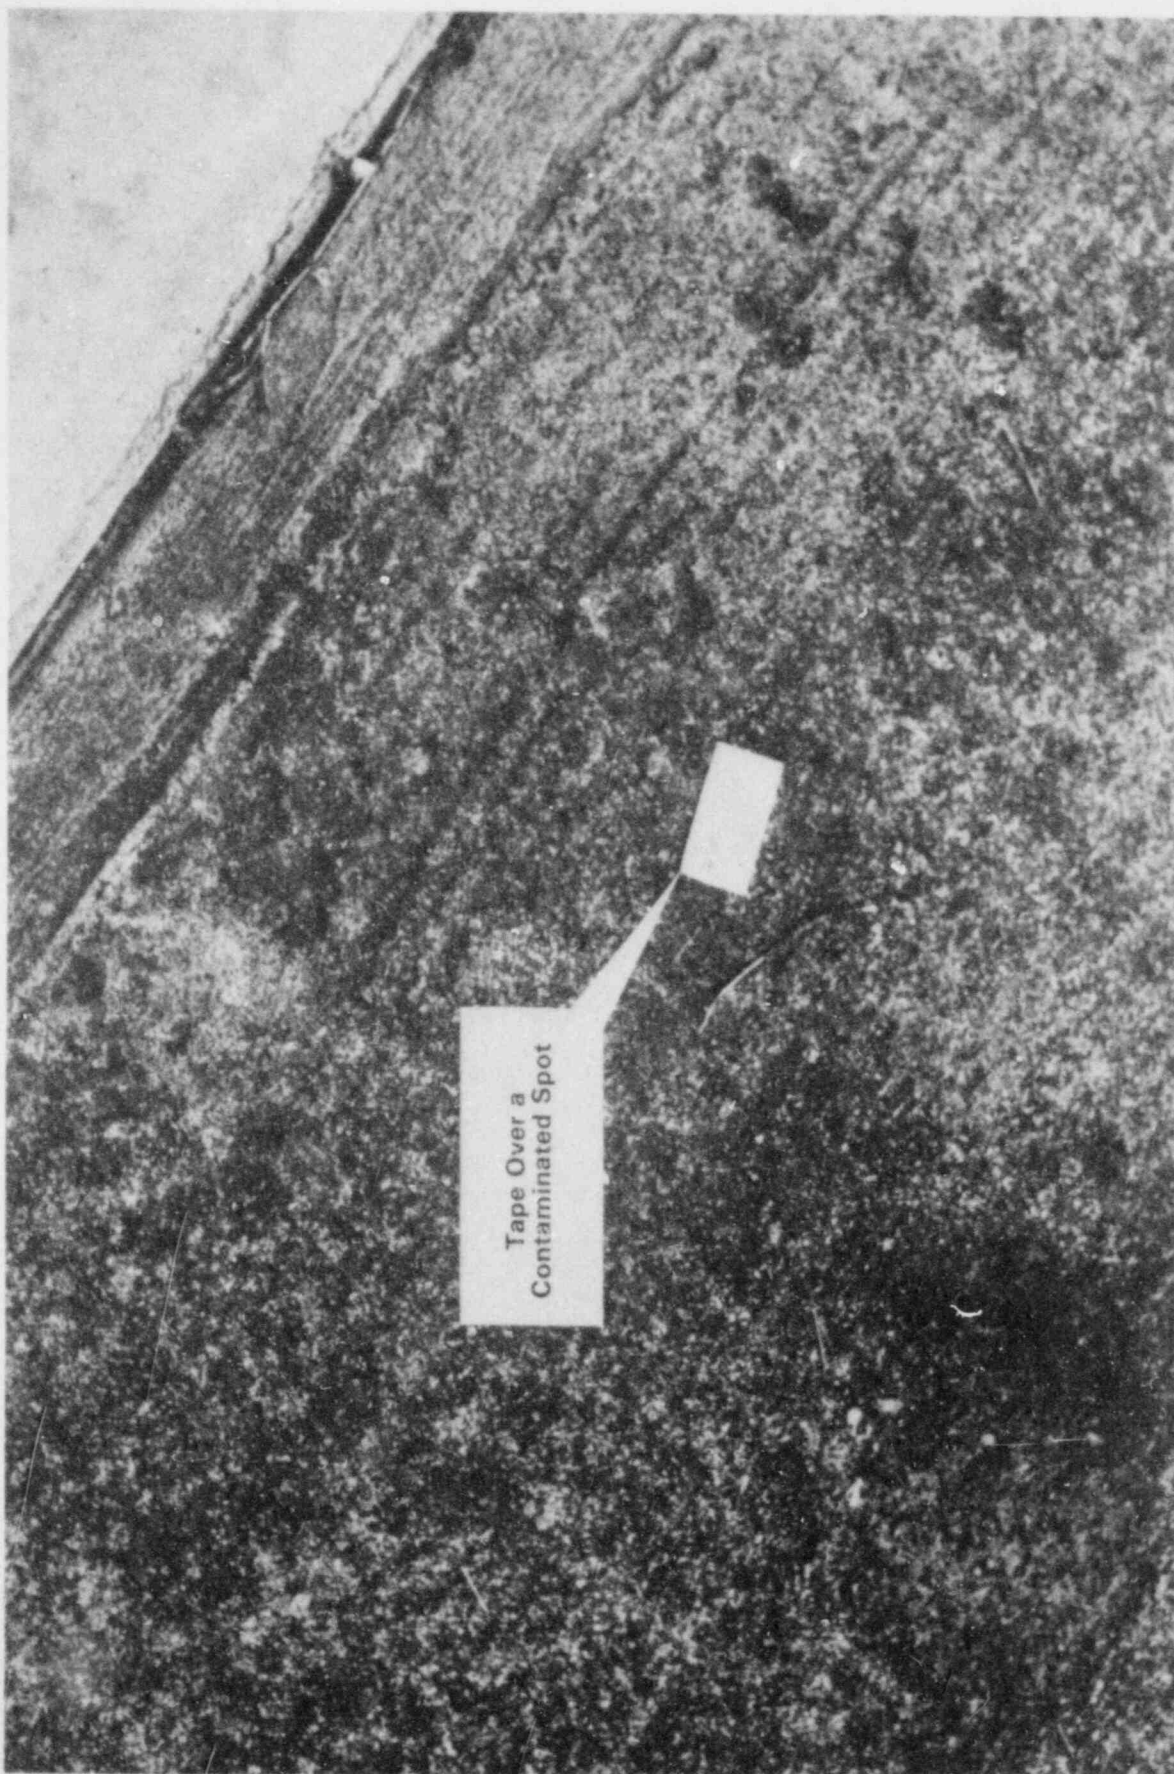
Figure 22. Contaminated driveway (closeup).

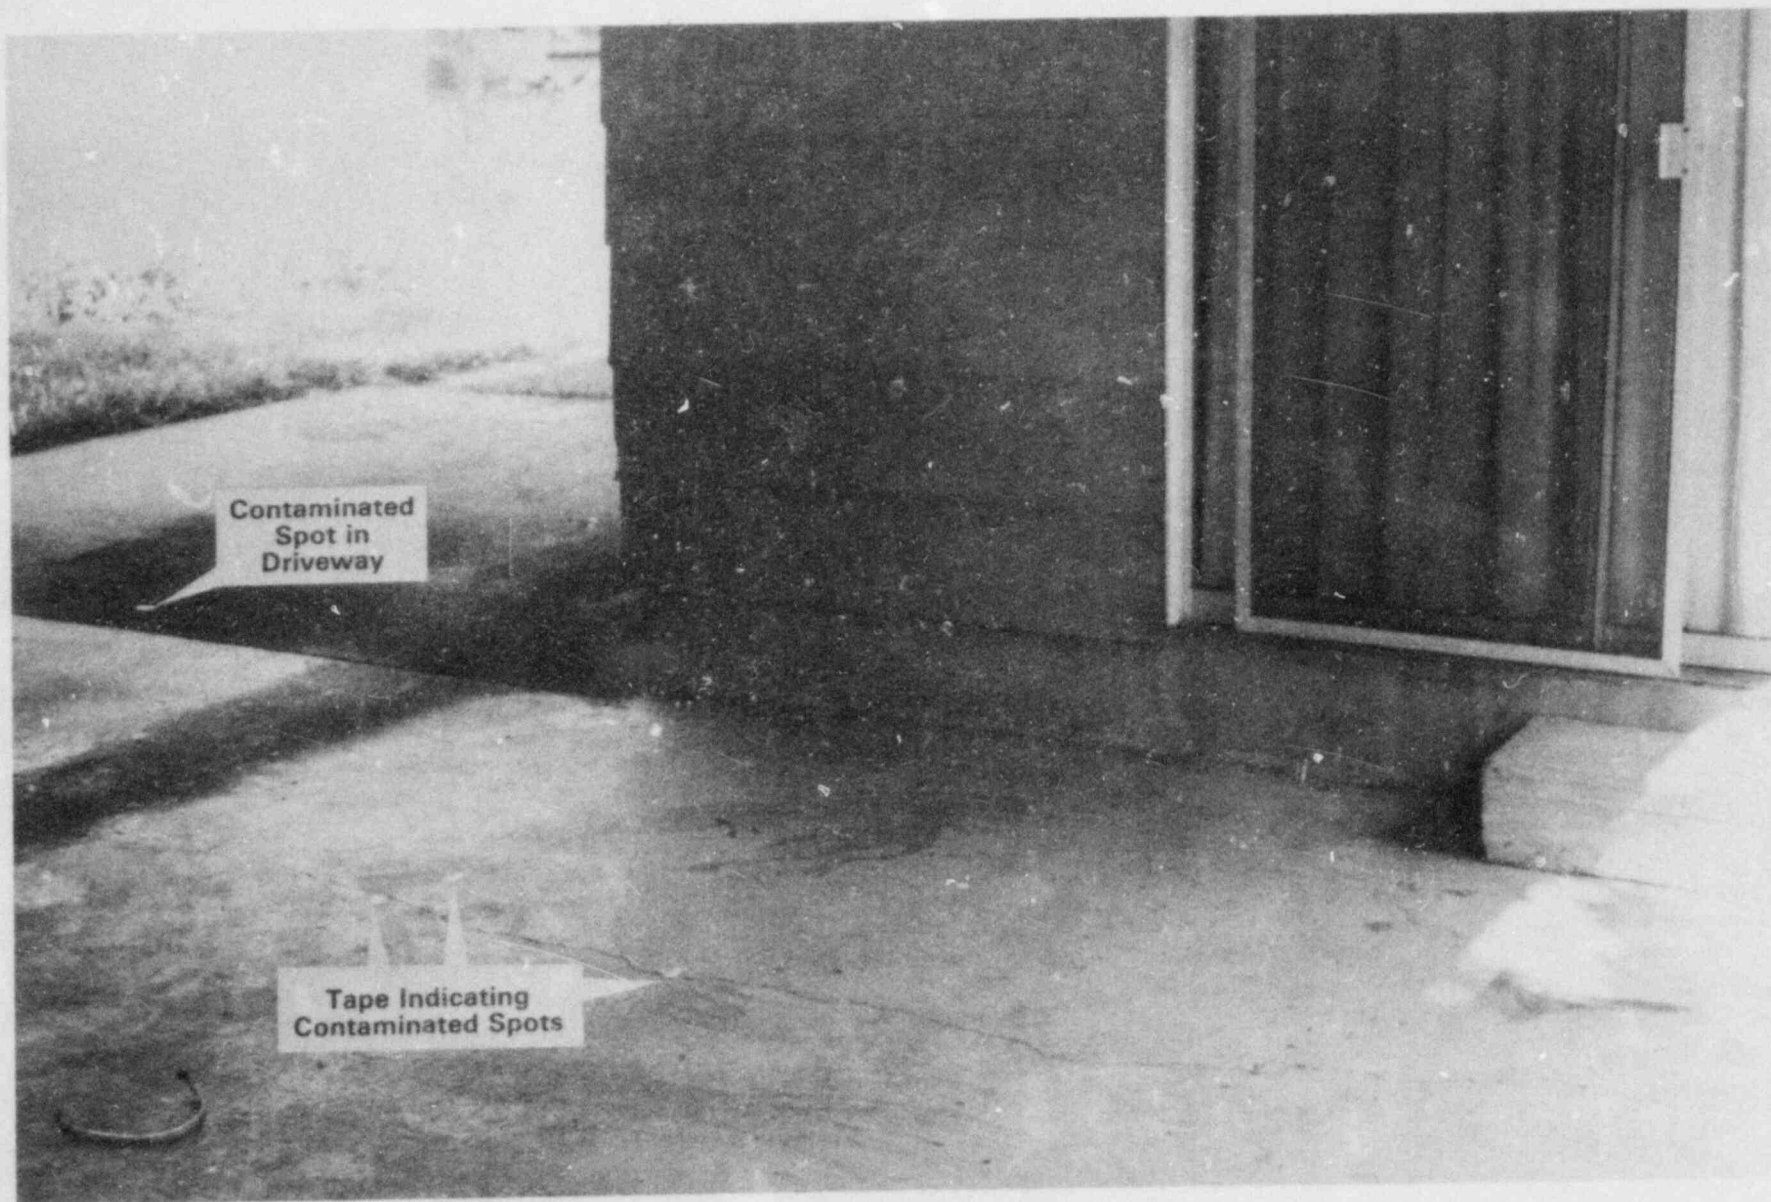
Figure 23. Contaminated carport.

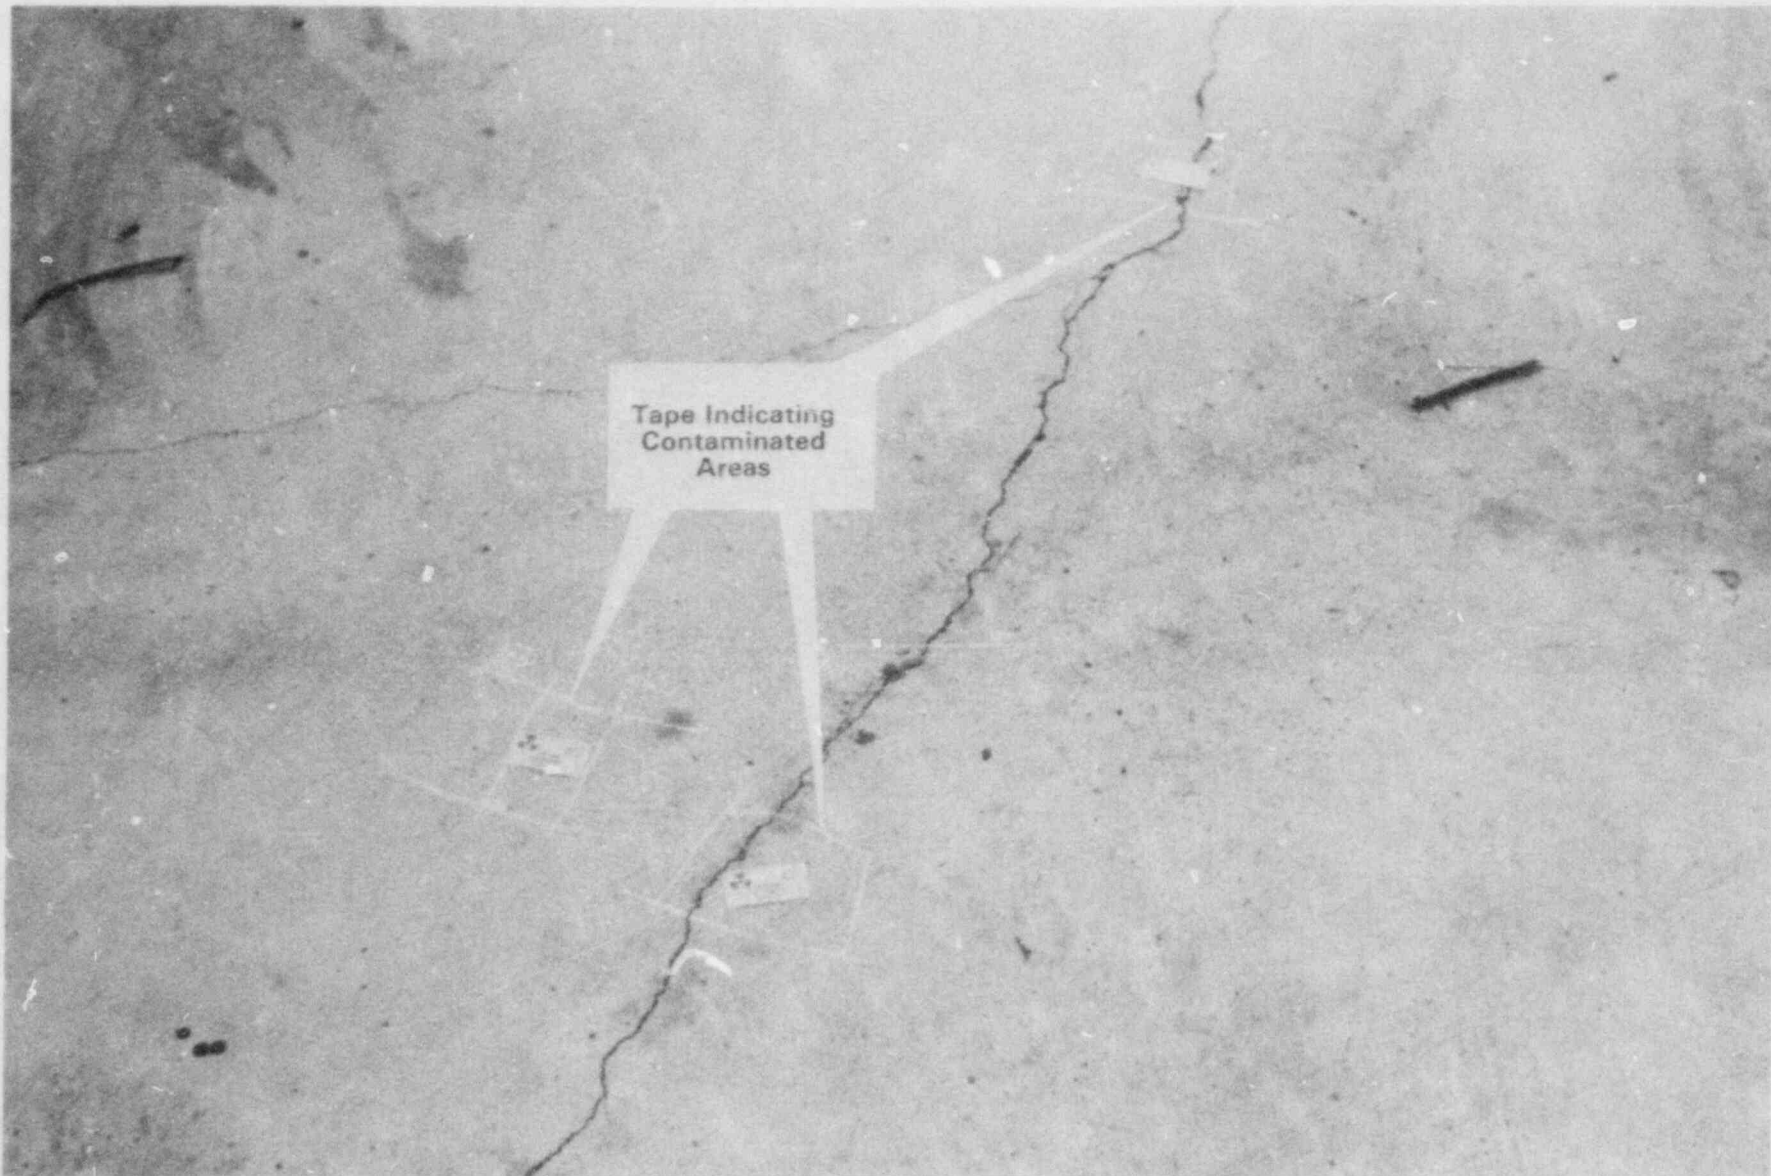
Figure 24. Contaminated carport (closeup).
