# Ruptured Cesium-137 Well-Logging Source at Shelwell Services, Inc., Hebron, Ohio

**U.S. Nuclear Regulatory  
Commission**

Manuscript Completed: November 1983  
Date Published: April 1984

This U.S. Nuclear Regulatory Commission (NRC) report documents the circumstances surrounding the September 13, 1983, cesium-137 sealed source rupture incident at the Shelwell Services, Inc., facility in Hebron, Ohio. It focuses on the period from approximately 4:00 p.m. (EDT) on September 13, 1983, when the source ruptured, to October 5, 1983, when the radiological emergency response aspects of the event were concluded. Information outside these periods is recounted as necessary. The incident resulted in radiation doses to two licensee employees that exceeded the regulatory limits for whole-body and extremity exposures, and contamination of the licensee's facility, private residences, public buildings, and the personal effects of the licensee's employees, families, and friends. The emergency response required the combined efforts of NRC, U. S. Department of Energy, and state personnel. The report describes the factual information and significant findings associated with the event and, thereby,

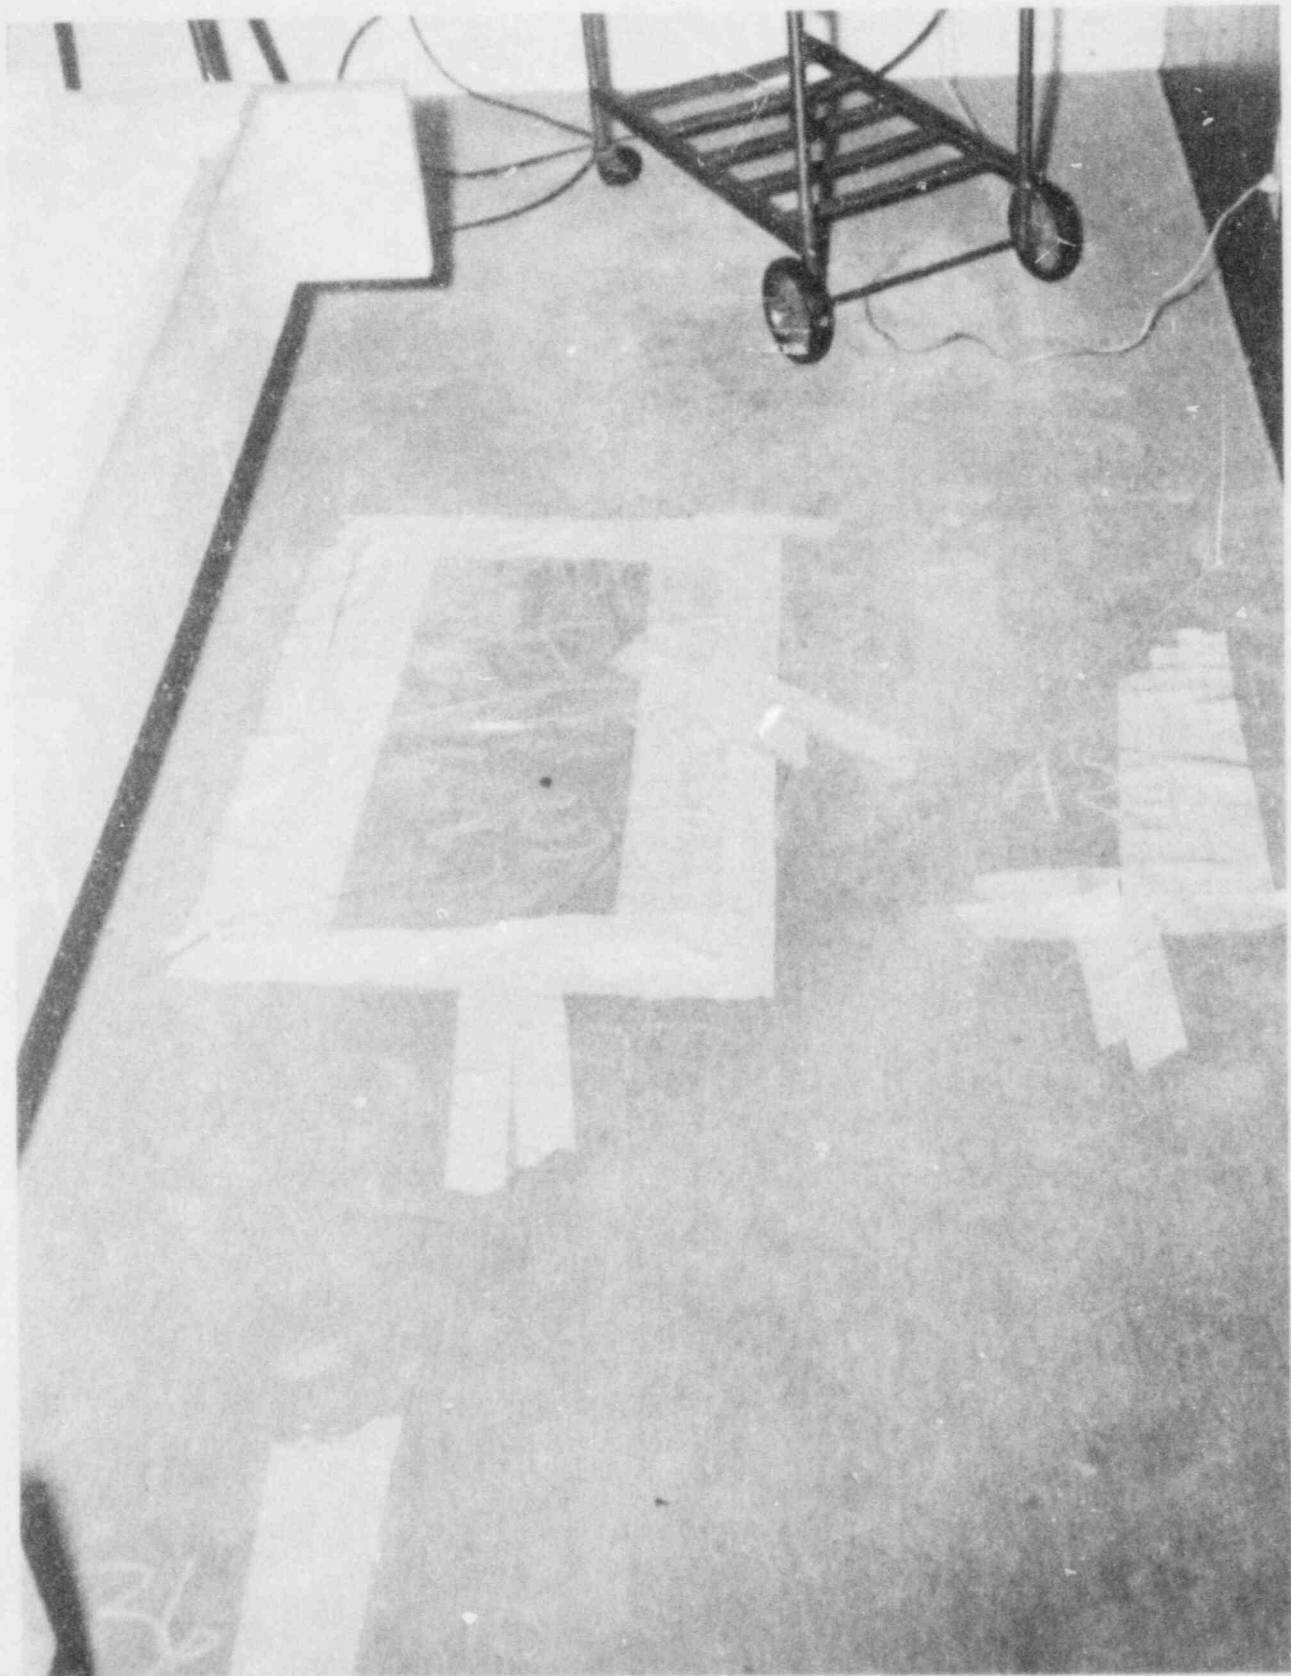
Figure 25. Contaminated bedroom.

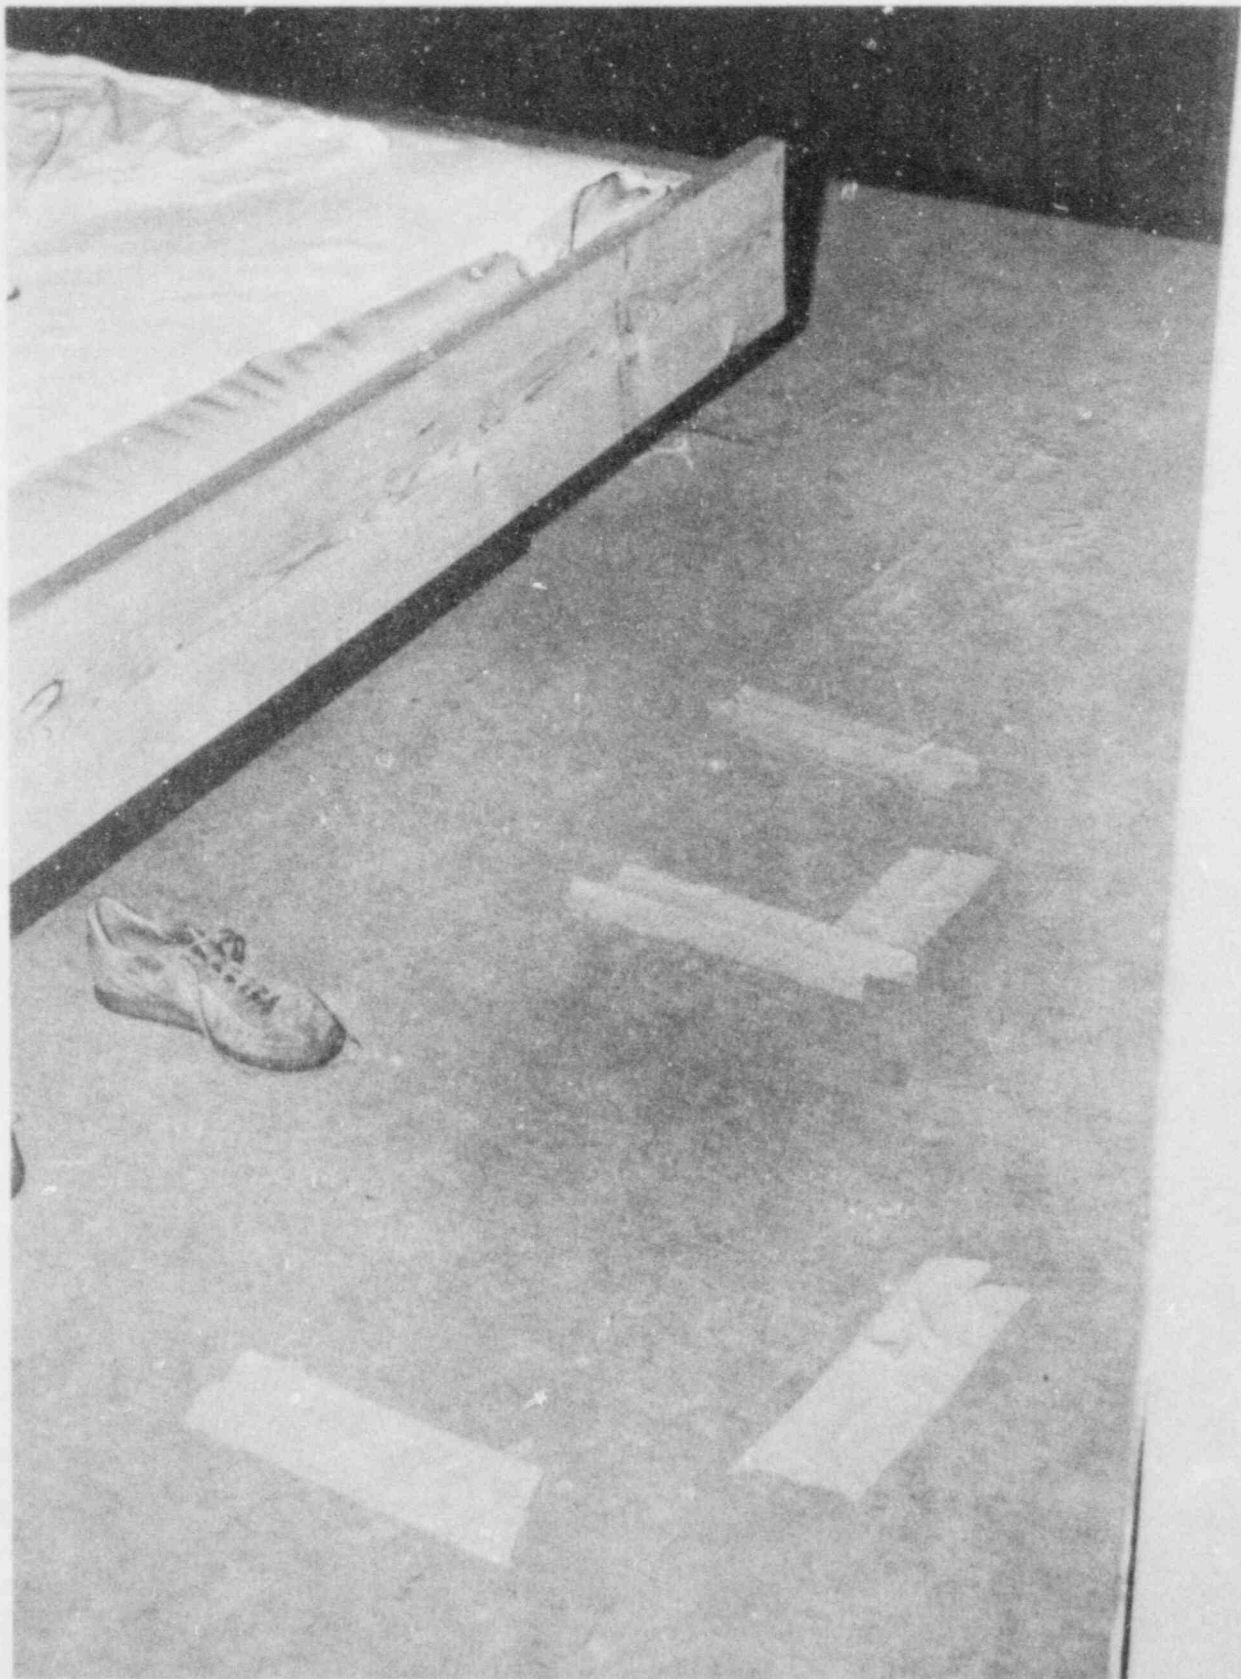
Figure 26. Contaminated bedroom.

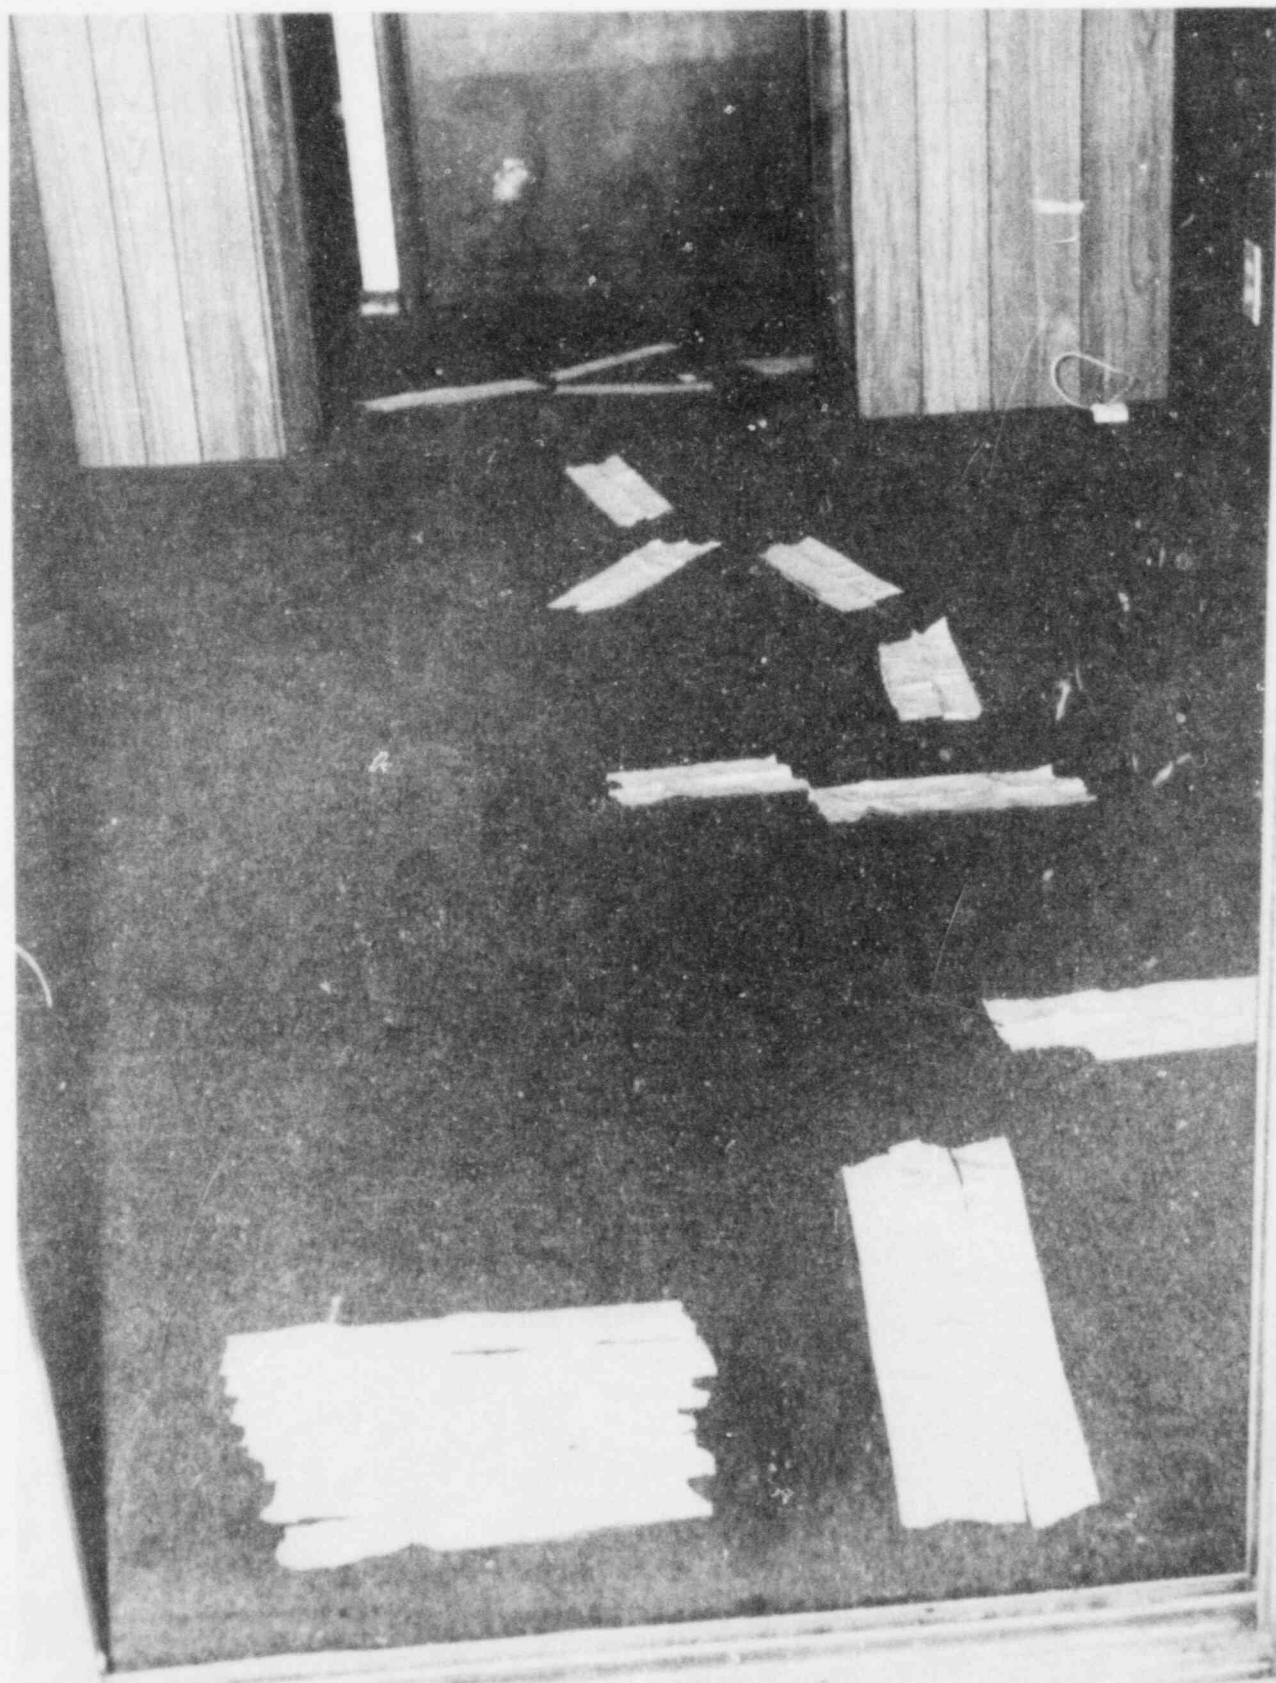
Figure 27. Contaminated family room.

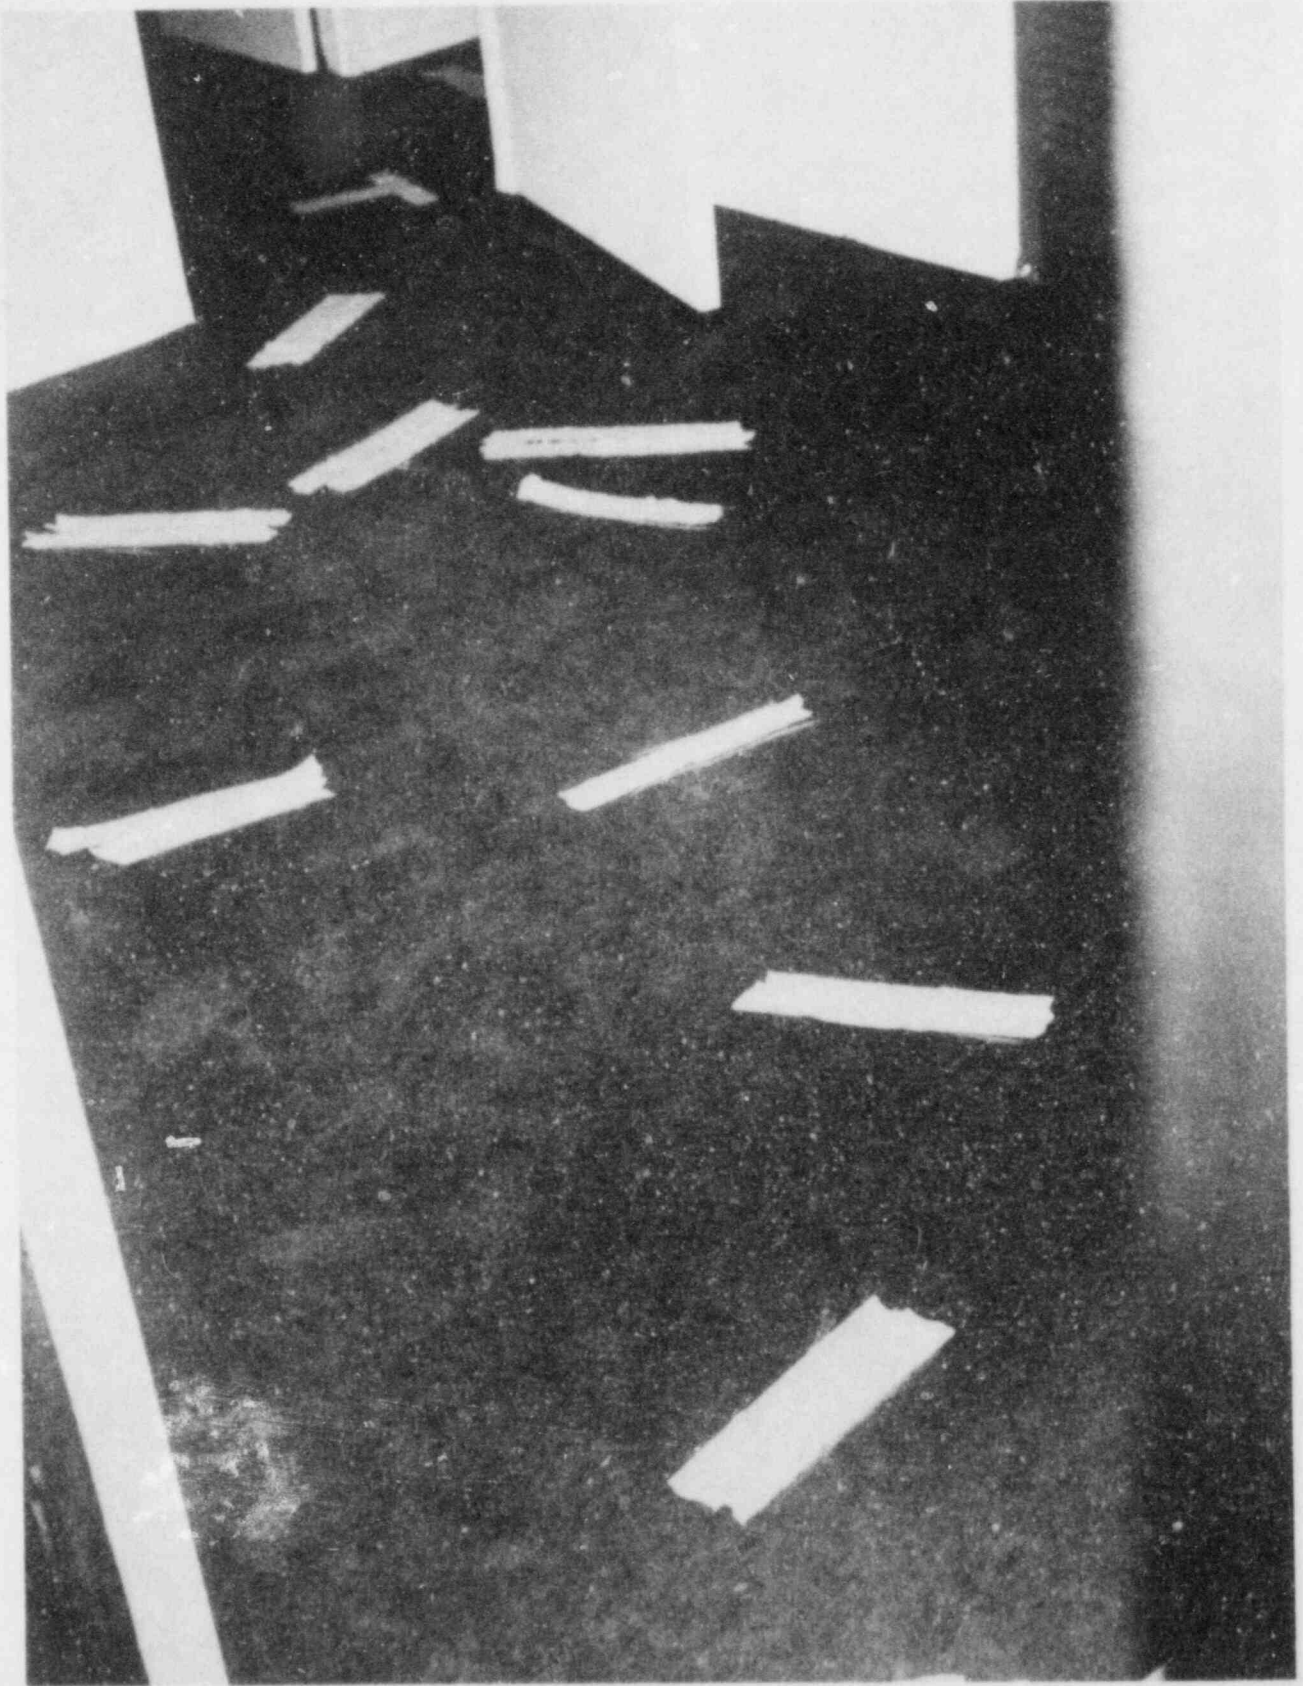
Figure 29. Contaminated bedroom.

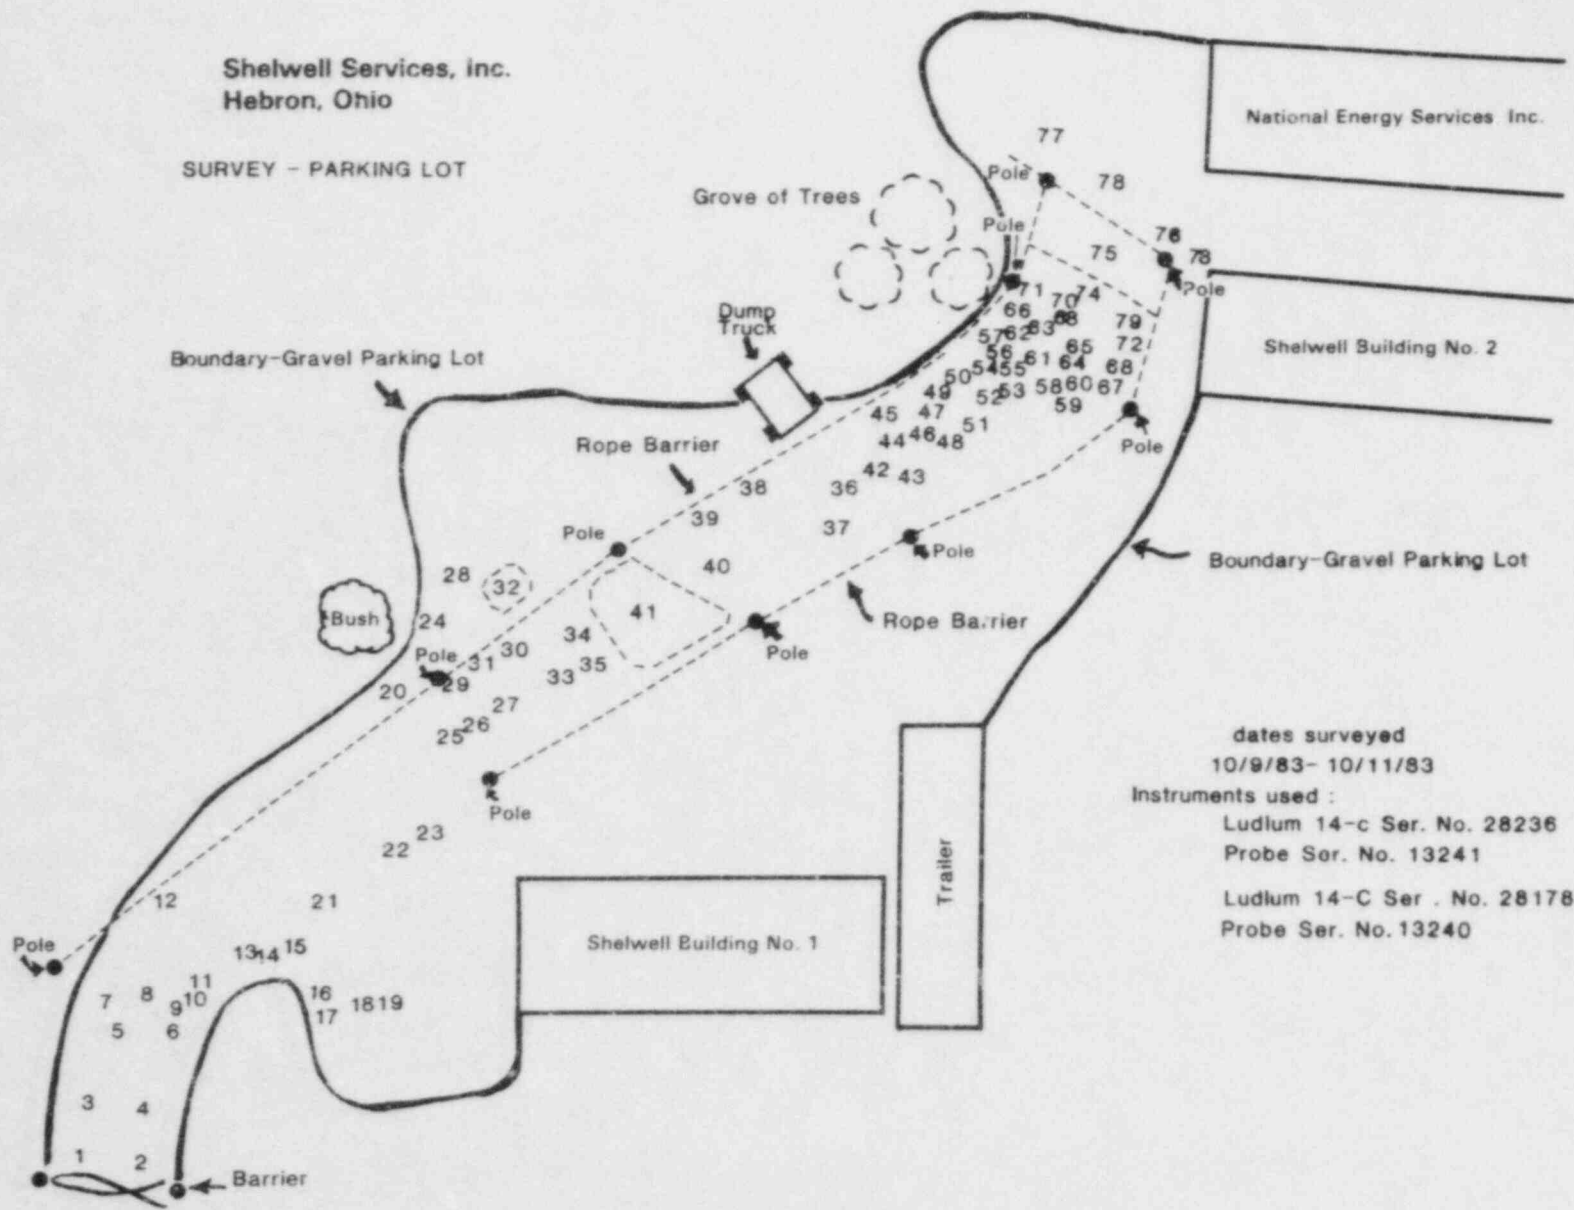
Figure 30. Sketch of contaminated roadway, with survey results.
