Ruptured Cesium-137 Well-Logging Source at Shelwell Services, Inc., Hebron, Ohio

**U.S. Nuclear Regulatory
Commission**

Region III

This U.S. Nuclear Regulatory Commission (NRC) report documents the circumstances surrounding the September 13, 1983, cesium-137 sealed source rupture incident at the Shelwell Services, Inc., facility in Hebron, Ohio. It focuses on the period from approximately 4:00 p.m. (EDT) on September 13, 1983, when the source ruptured, to October 5, 1983, when the radiological emergency response aspects of the event were concluded. Information outside these periods is recounted as necessary. The incident resulted in radiation doses to two licensee employees that exceeded the regulatory limits for whole-body and extremity exposures, and contamination of the licensee's facility, private residences, public buildings, and the personal effects of the licensee's employees, families, and friends. The emergency response required the combined efforts of NRC, U. S. Department of Energy, and state personnel. The report describes the factual information and significant findings associated with the event and, thereby, provides a data base for subsequent detailed analyses and

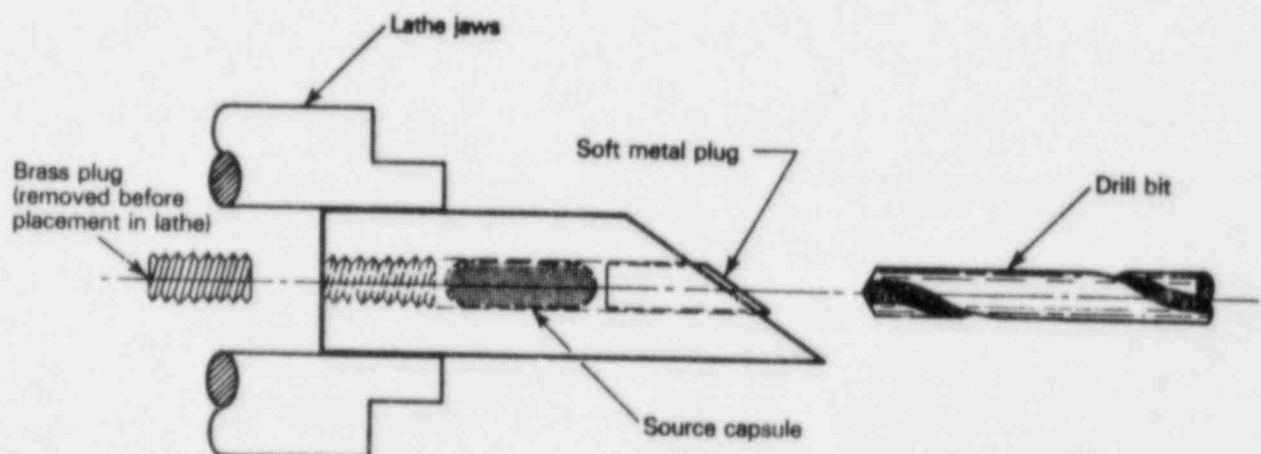
- (1) The source holder was mounted onto a lathe, the brass plug on the holder's cavity was removed, and the open end was placed in the lathe chuck (Figure 10).

Figure 10. Source holder as placed in lathe.

- (2) With the lathe turning the holder, a drill bit was worked into the holder along the axis of rotation removing a soft metal which was plugging the bottom of the source holder cavity.
- (3) The drill bit was to work through the soft metal plug until it reached the source capsule. Then, based on the assumption that the source was doubly encapsulated in very hard stainless steel, the drill bit would not penetrate the capsule but would just push it free.

The work progressed as planned until the machinist guessed that the drill bit had broken into the source capsule. When the holder was removed from the lathe, the source capsule dropped out and was caught in a rag. The individuals noticed a hole in the source capsule and a brownish material escaping from the source capsule.

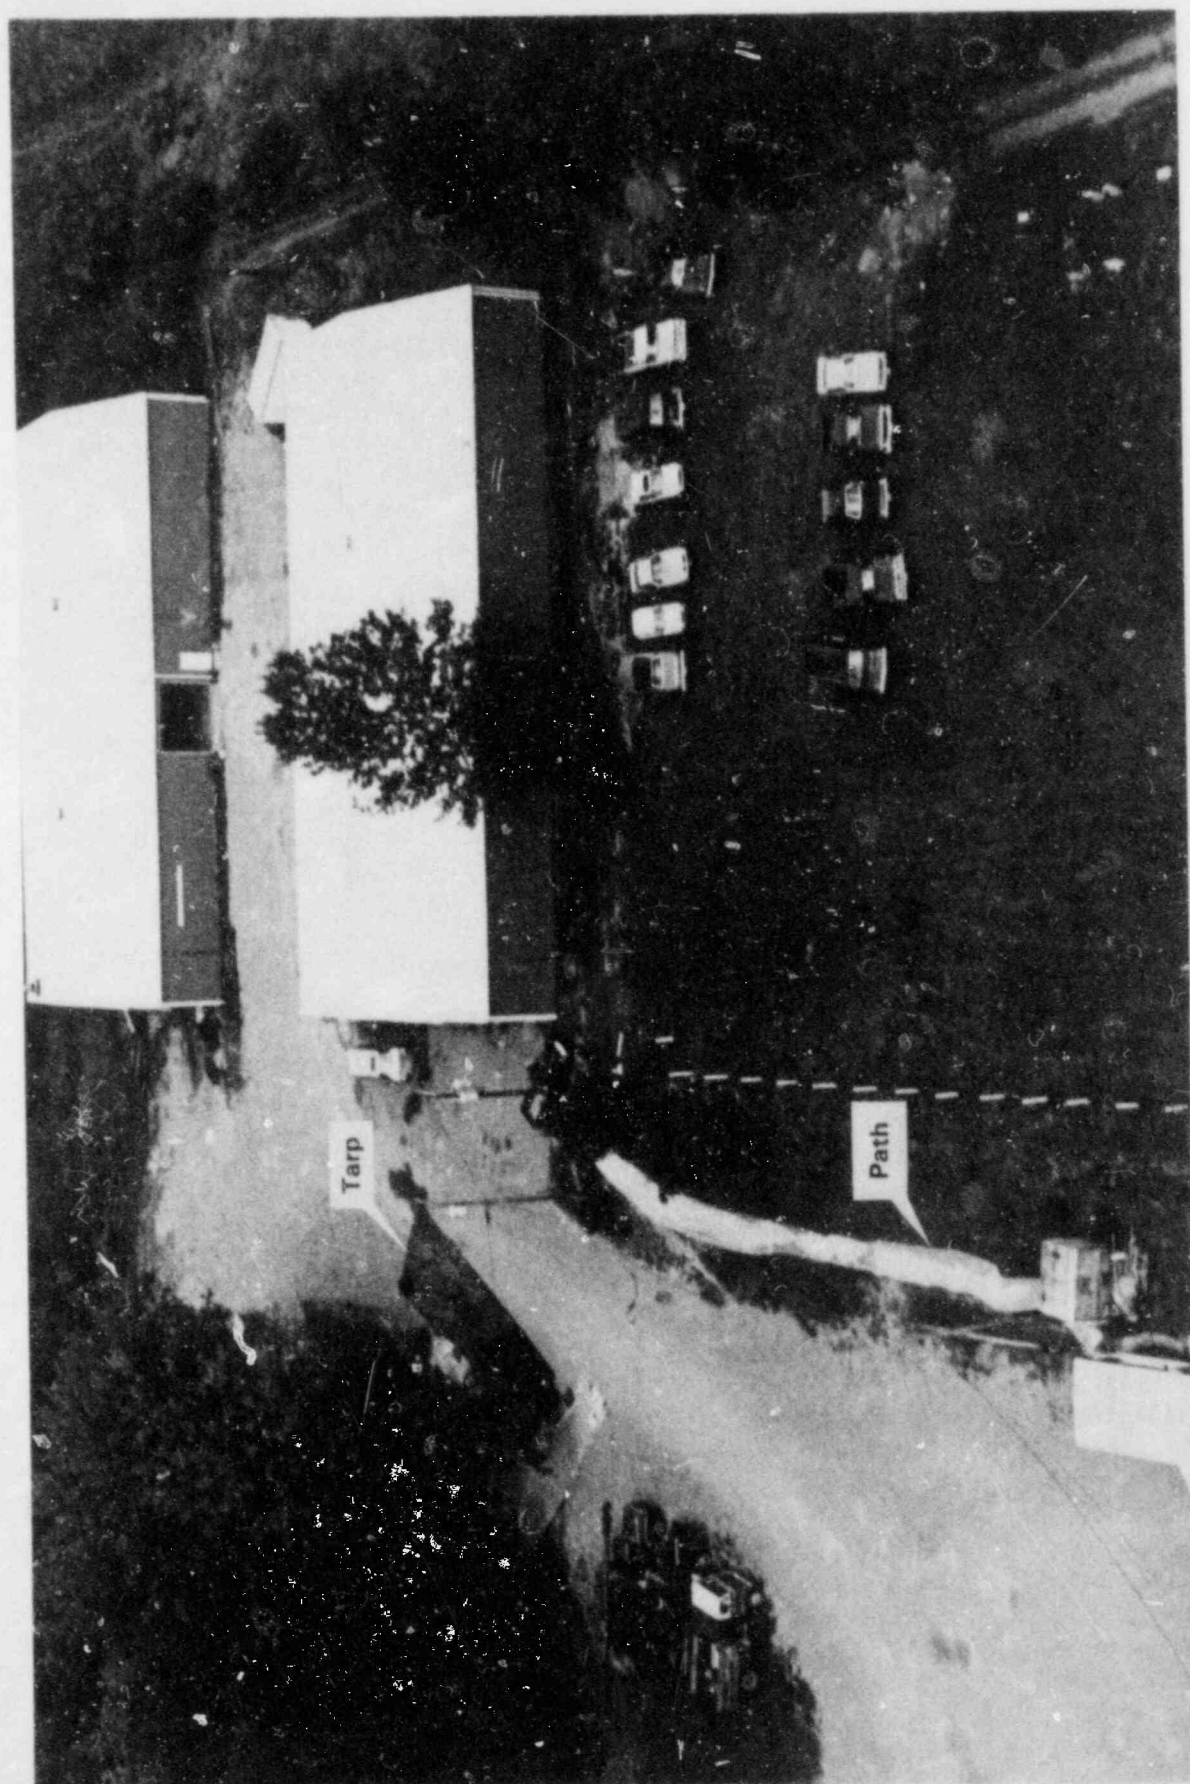
The ruptured cesium-137 source was believed to be composed of cesium chloride, in powder form, readily soluble in water. Heavy rains throughout the morning of September 16, 1983, some 60 hours after the source rupture, washed some of the tracked contamination into the rocks and soil of the licensee's access drive. This was the first of four rains that occurred during the emergency response phase of the operation. Areas of the licensee's access drive having the highest levels of contamination were covered with plastic to reduce migration through the soil. This included a walkway leading from Building 2 to the office trailer and an area west of the incident building where contaminated items, generated during the licensee's initial cleanup attempts, had been placed (see Figure 12).

Figure 12. Plastic covers over contaminated areas.

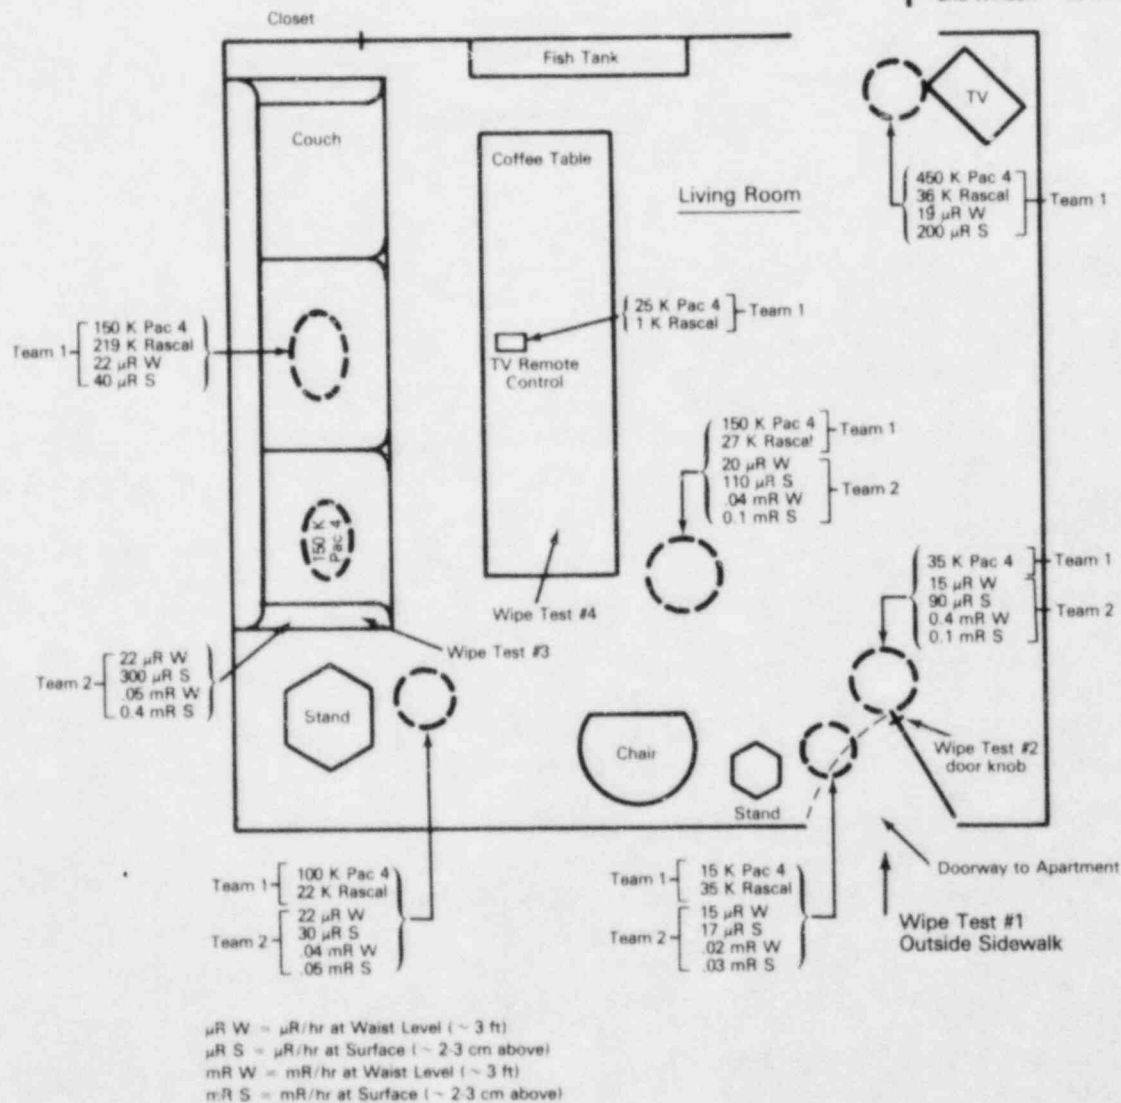
Figure 14. Sketch of a contaminated living room.

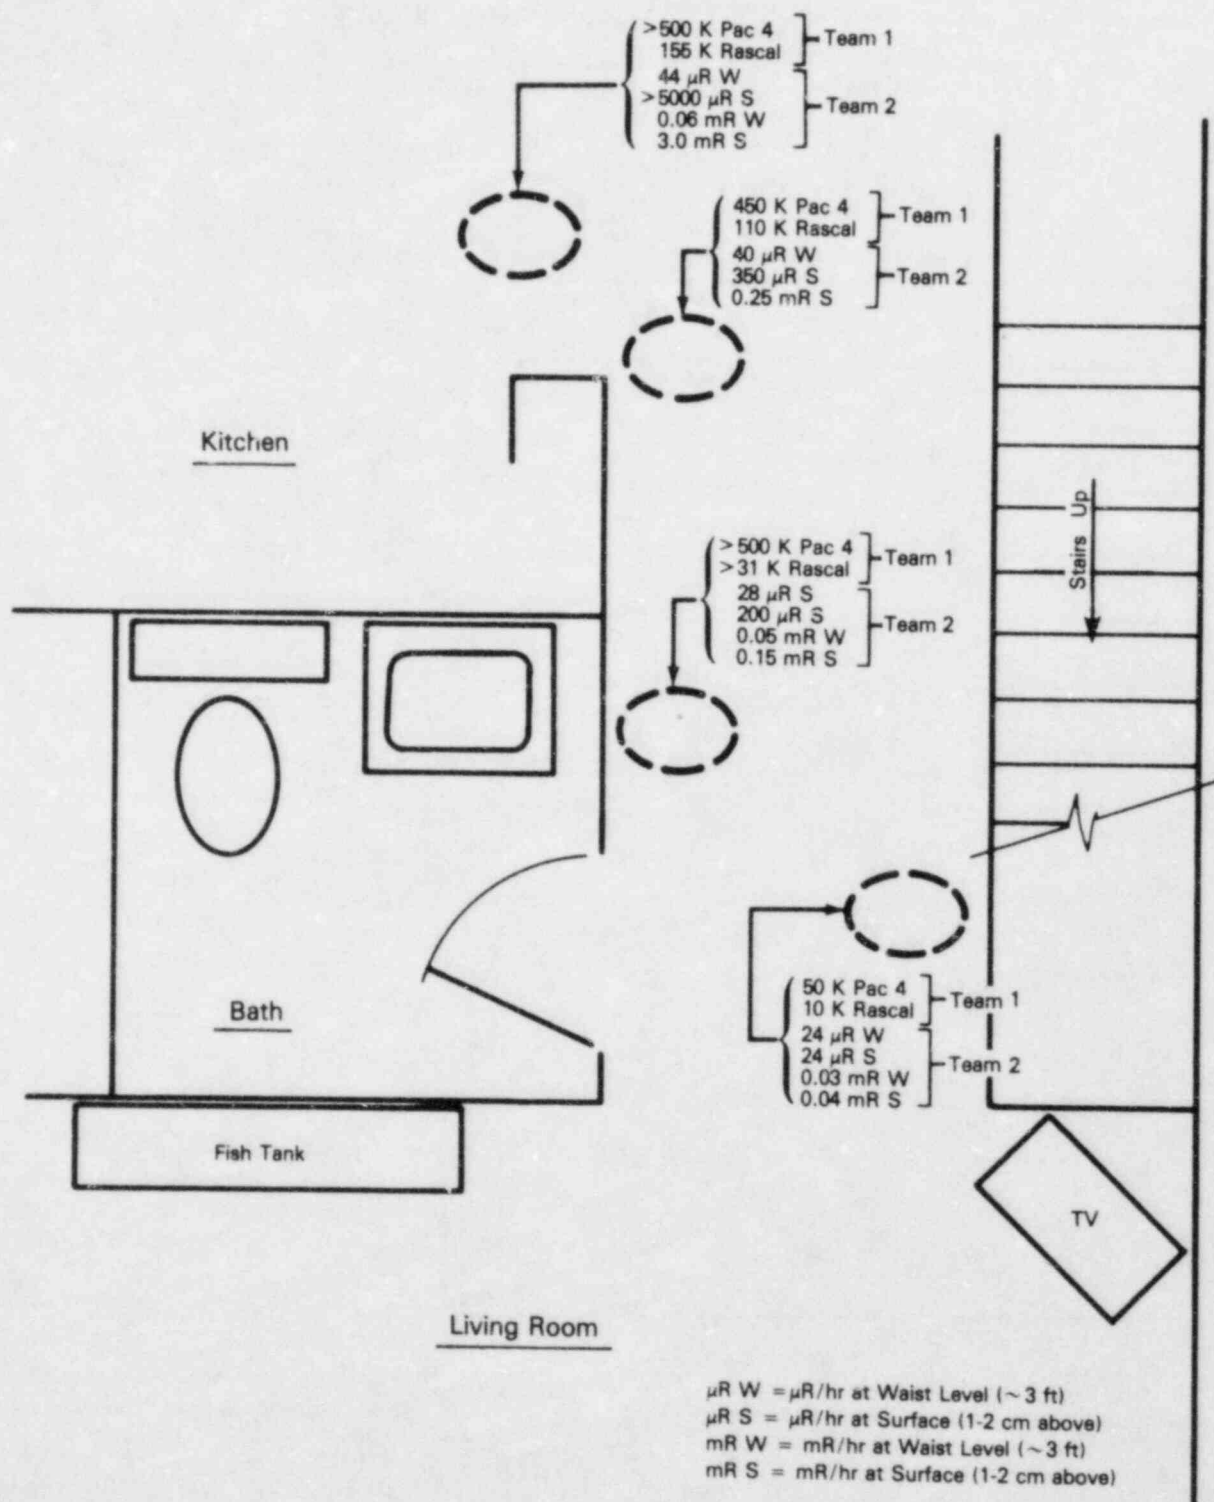
**HALLWAY & DOWNSTAIRS BATH SURVEY
RESIDENCE #46
September 17, 1983**

Figure 15. Sketch of a contaminated hallway.

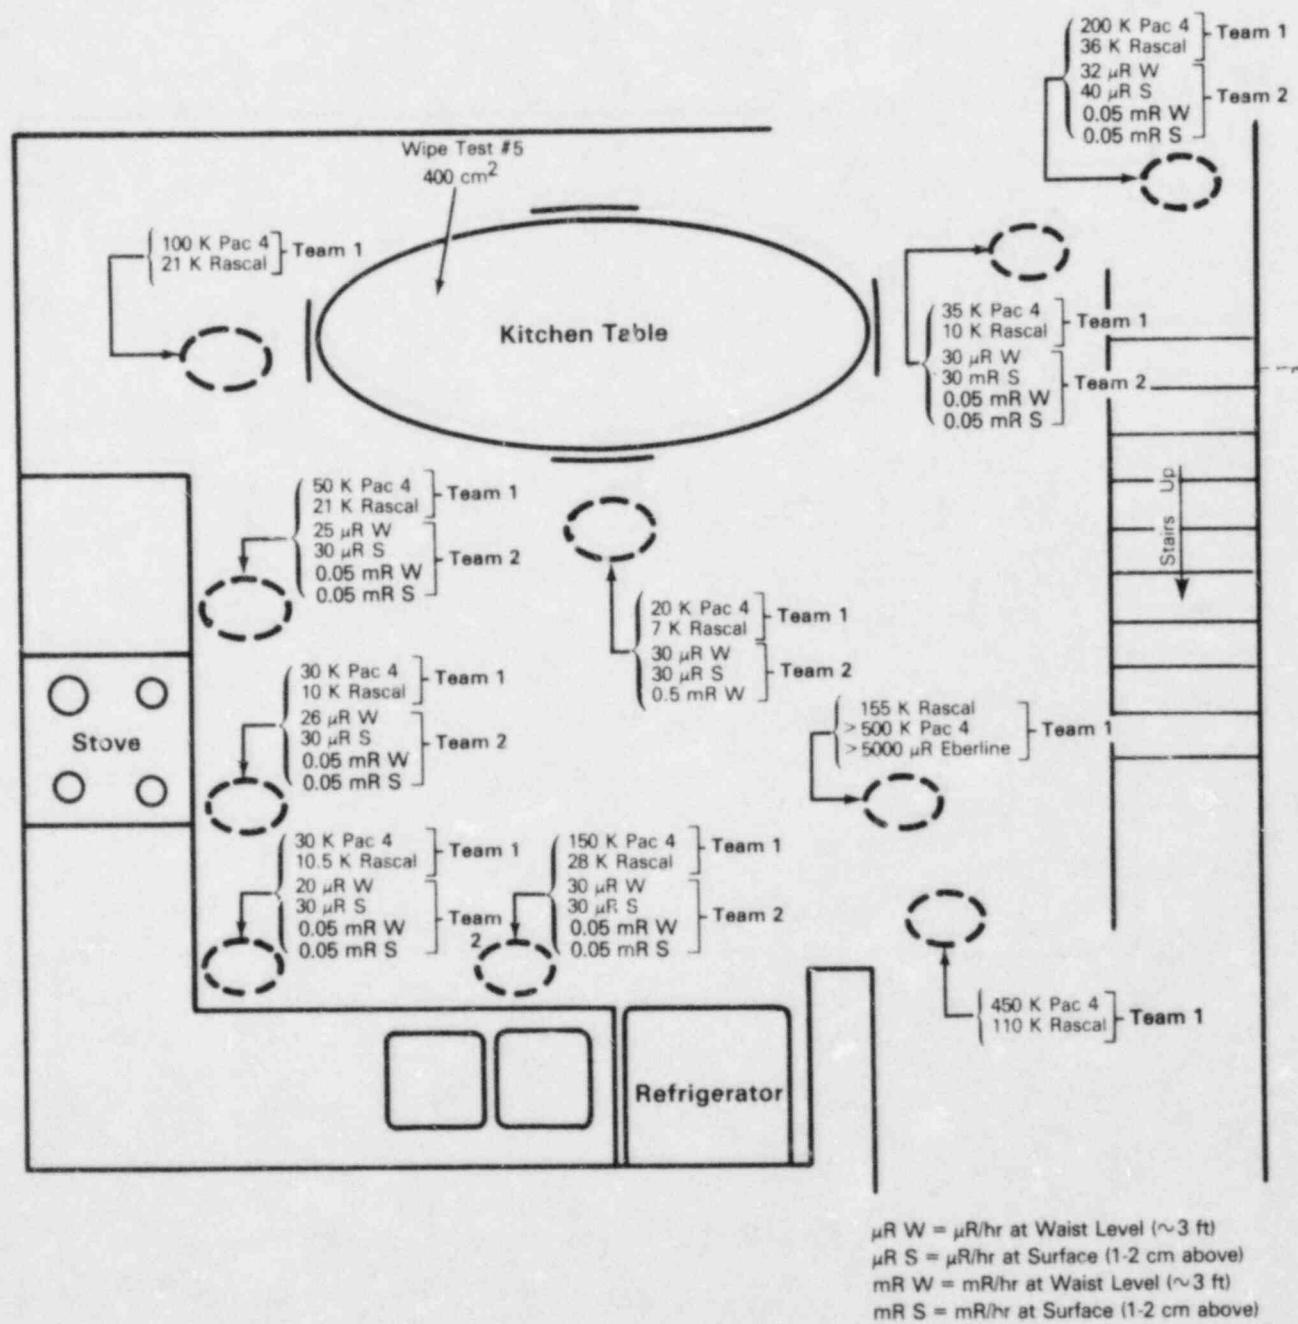
SURVEY OF RESIDENCE #46
September 15 - 17, 1983

Figure 16. Sketch of a contaminated kitchen.

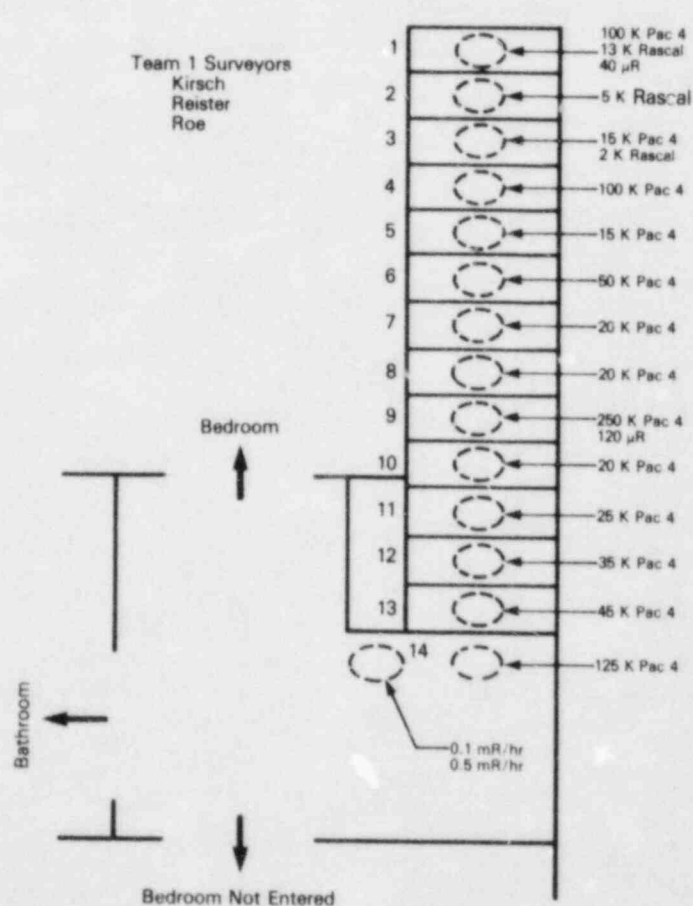
STAIRWAY SURVEY RESIDENCE #46

mR/hr	μ R/hr	Step
0.06 W 0.07 S	32 W 40 S	1
0.06 W 0.04 S	34 W 40 S	2
0.03 W 0.06 S	34 W 49 S	3
0.03 W 0.04 S	32 W 40 S	4
0.06 W 0.06 S	32 W 40 S	5
0.06 W 0.07 S	29 W 40 S	6
0.06 W 0.06 S	29 W 36 S	7
0.03 W 0.07 S	29 W 30 S	8
0.03 W 0.1 S	29 W 200 S	9
0.03 W 0.03 S	25 W 25 S	10
0.06 W 0.06 S	25 W 25 S	11
0.06 W 0.06 S	25 W 30 S	12
0.06 W 0.06 S	24 W 200 S	13
0		14

Figure 17. Sketch of a contaminated stairway.

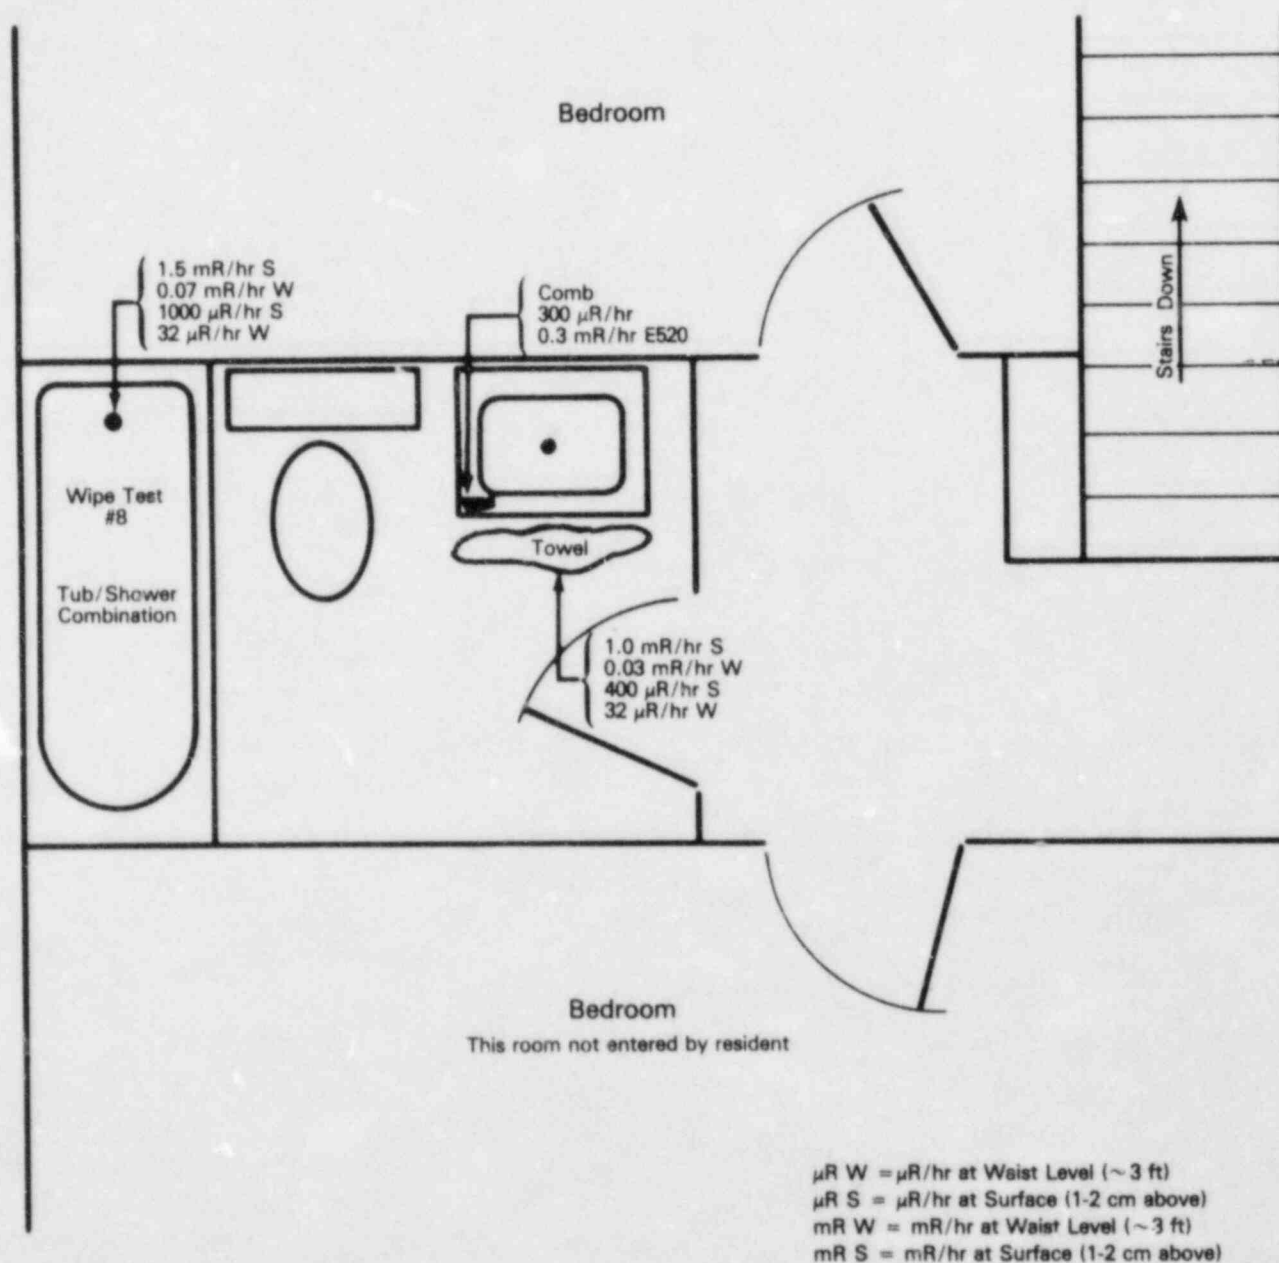
UPSTAIRS BATHROOM BATH SURVEY
RESIDENCE #46
September 17, 1983
 (Team 1 Results Only)

Figure 18. Sketch of a contaminated bathroom

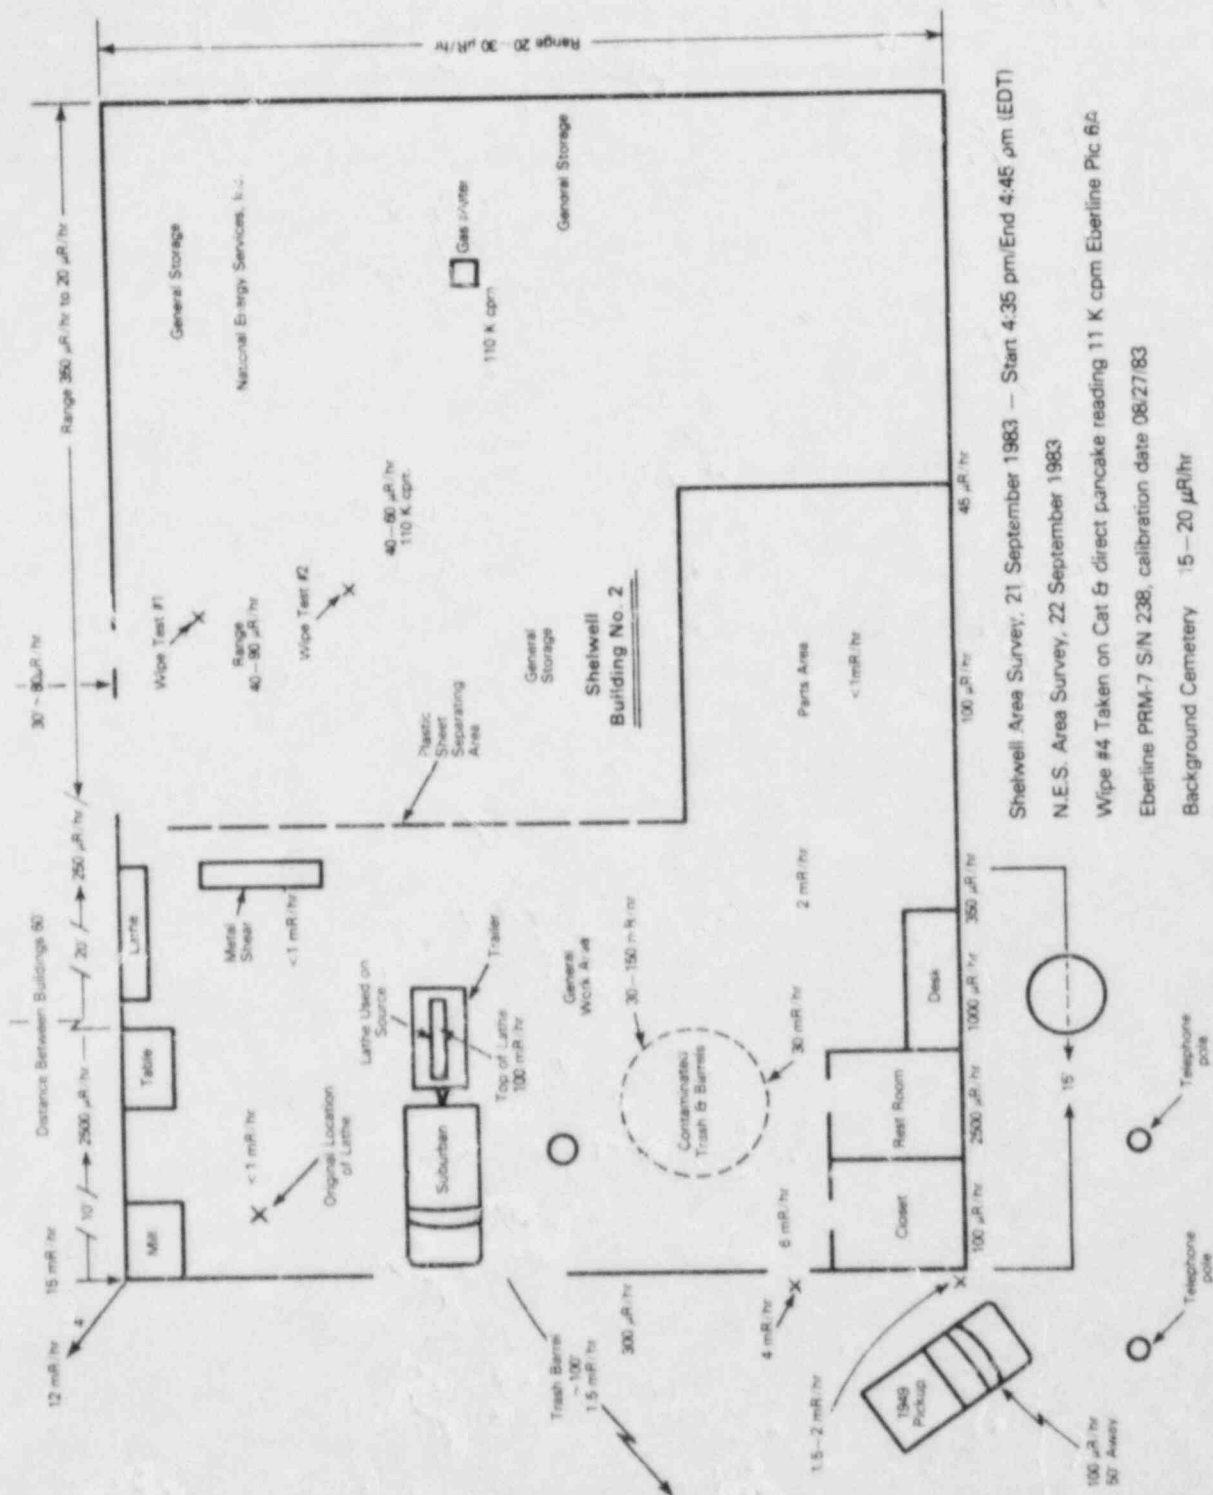
Figure 20. Sketch of Shelwell Building 2, including survey results.

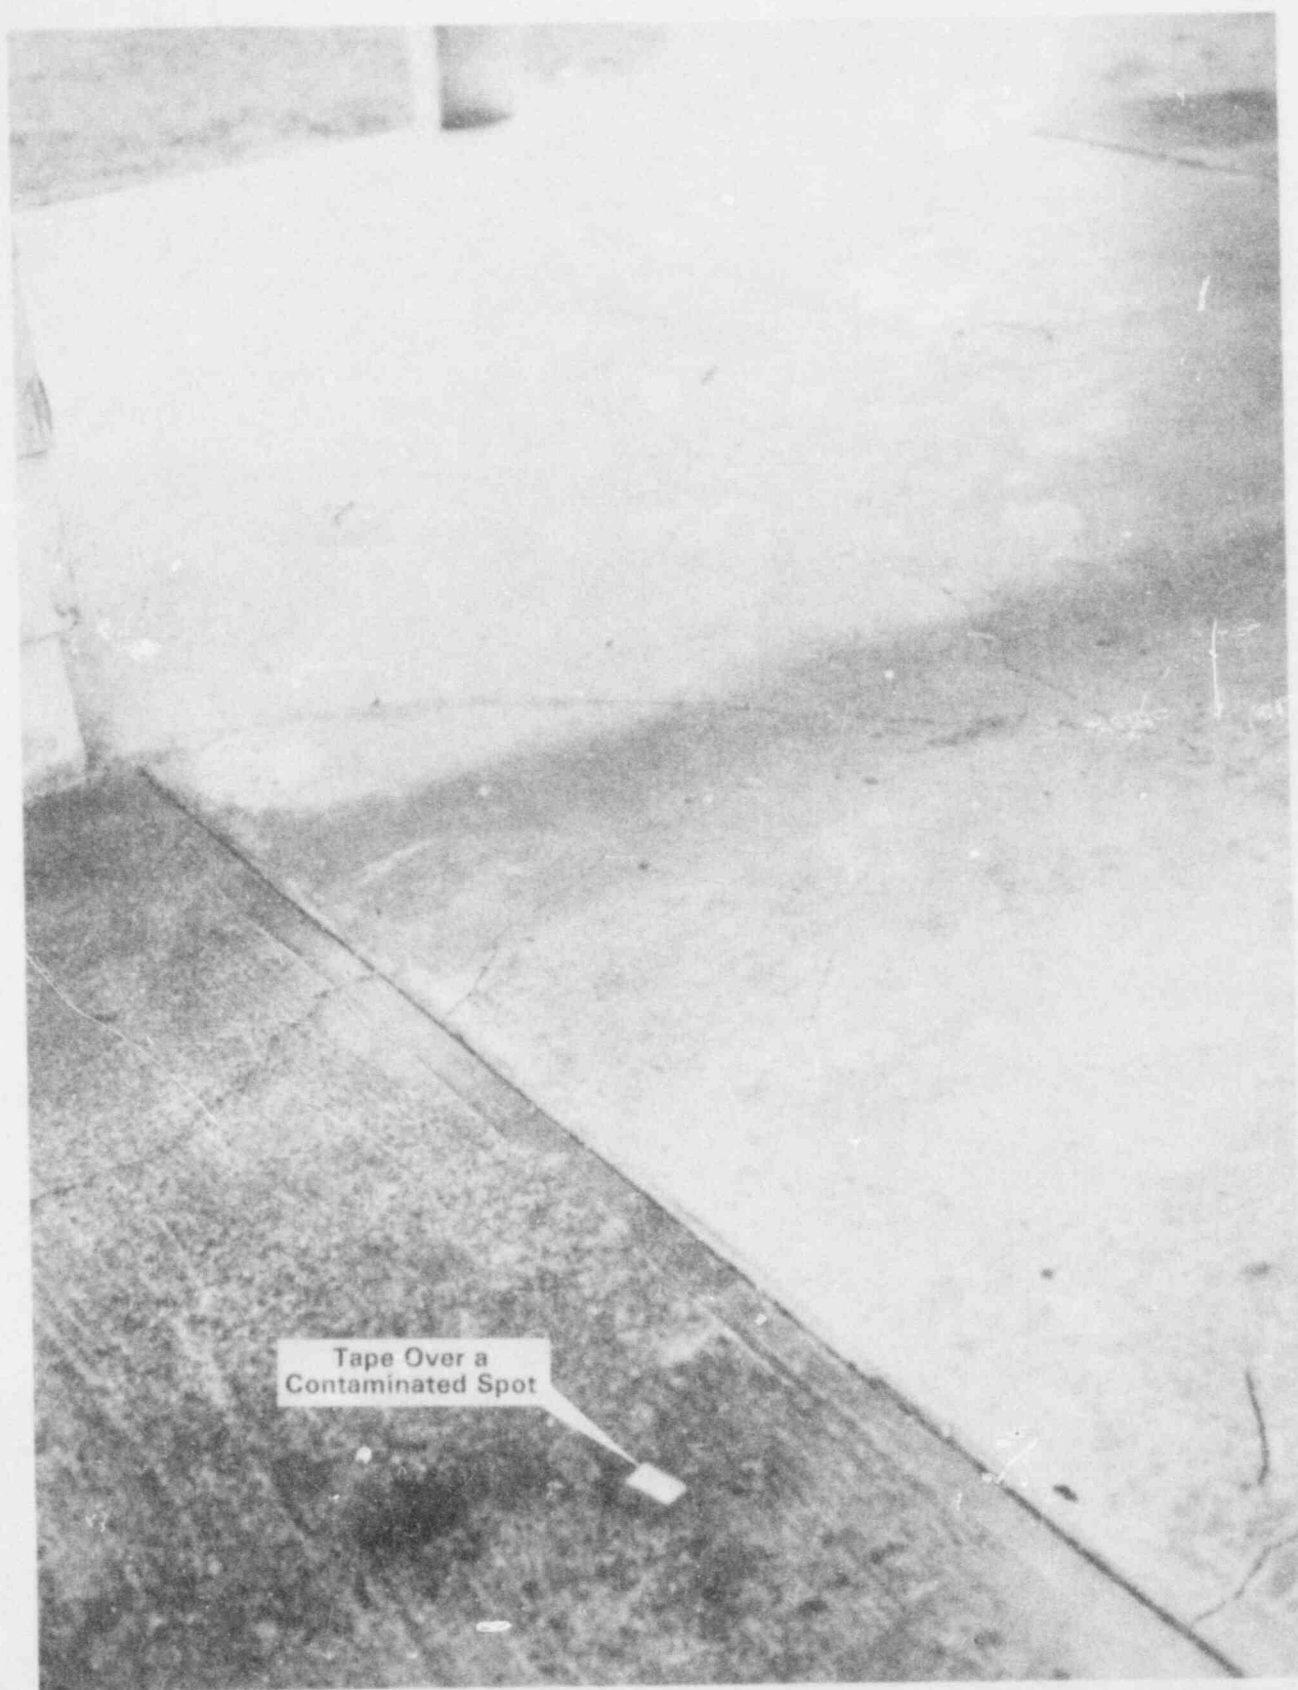
Figure 21. Contaminated driveway.

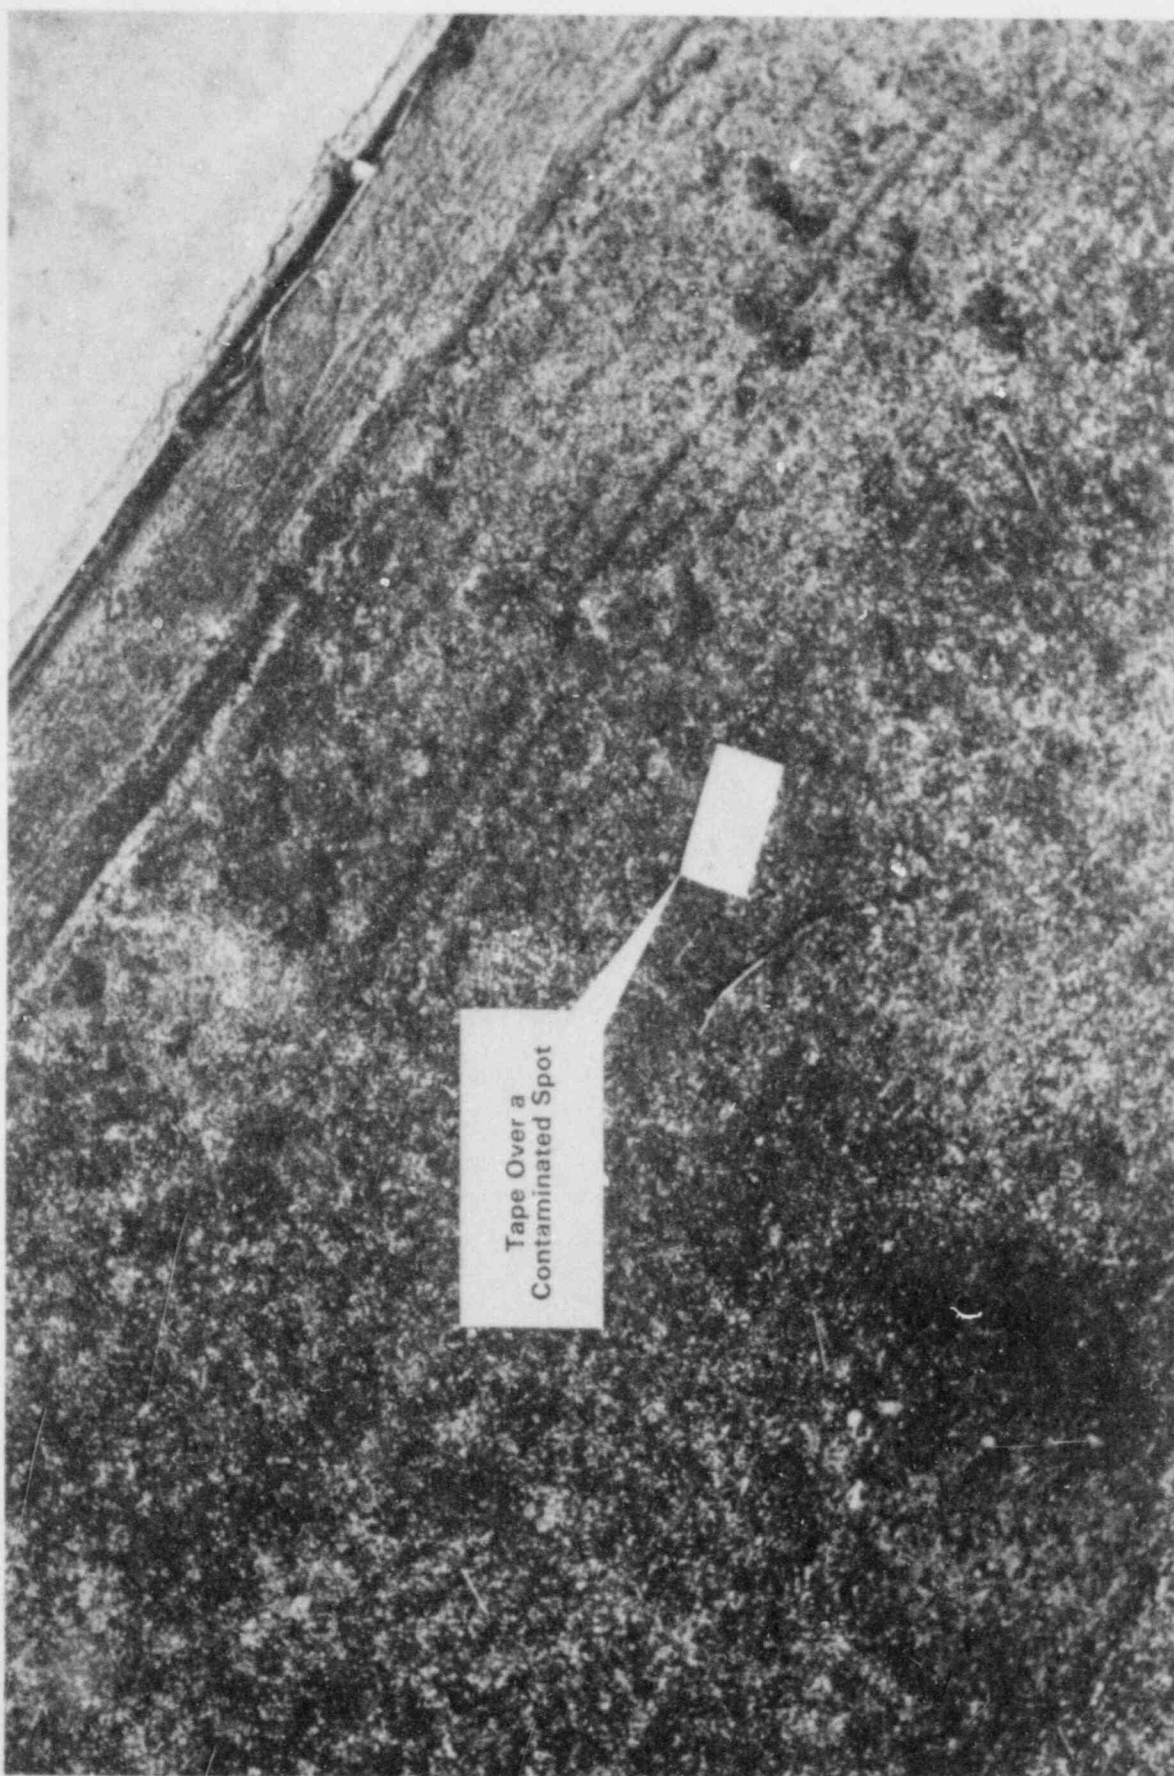
Figure 22. Contaminated driveway (closeup).

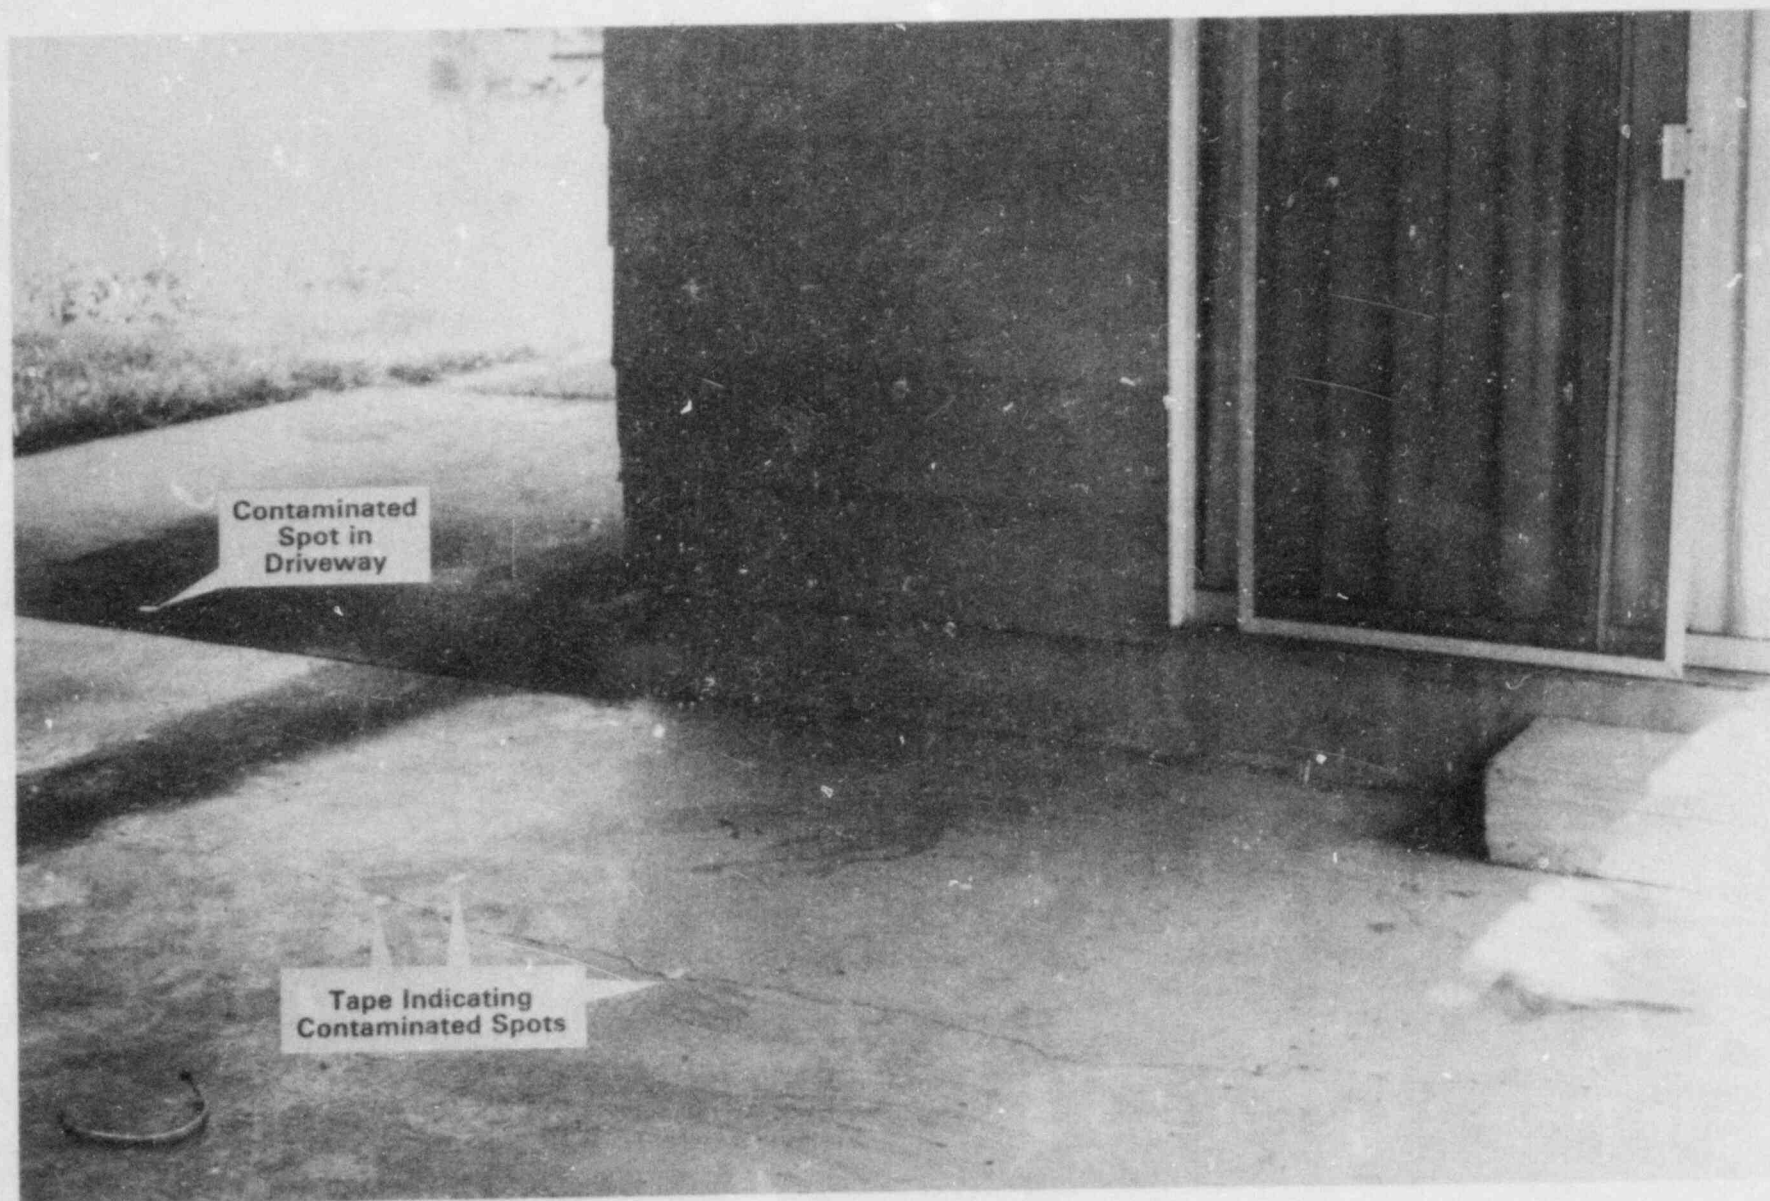
Figure 23. Contaminated carport.

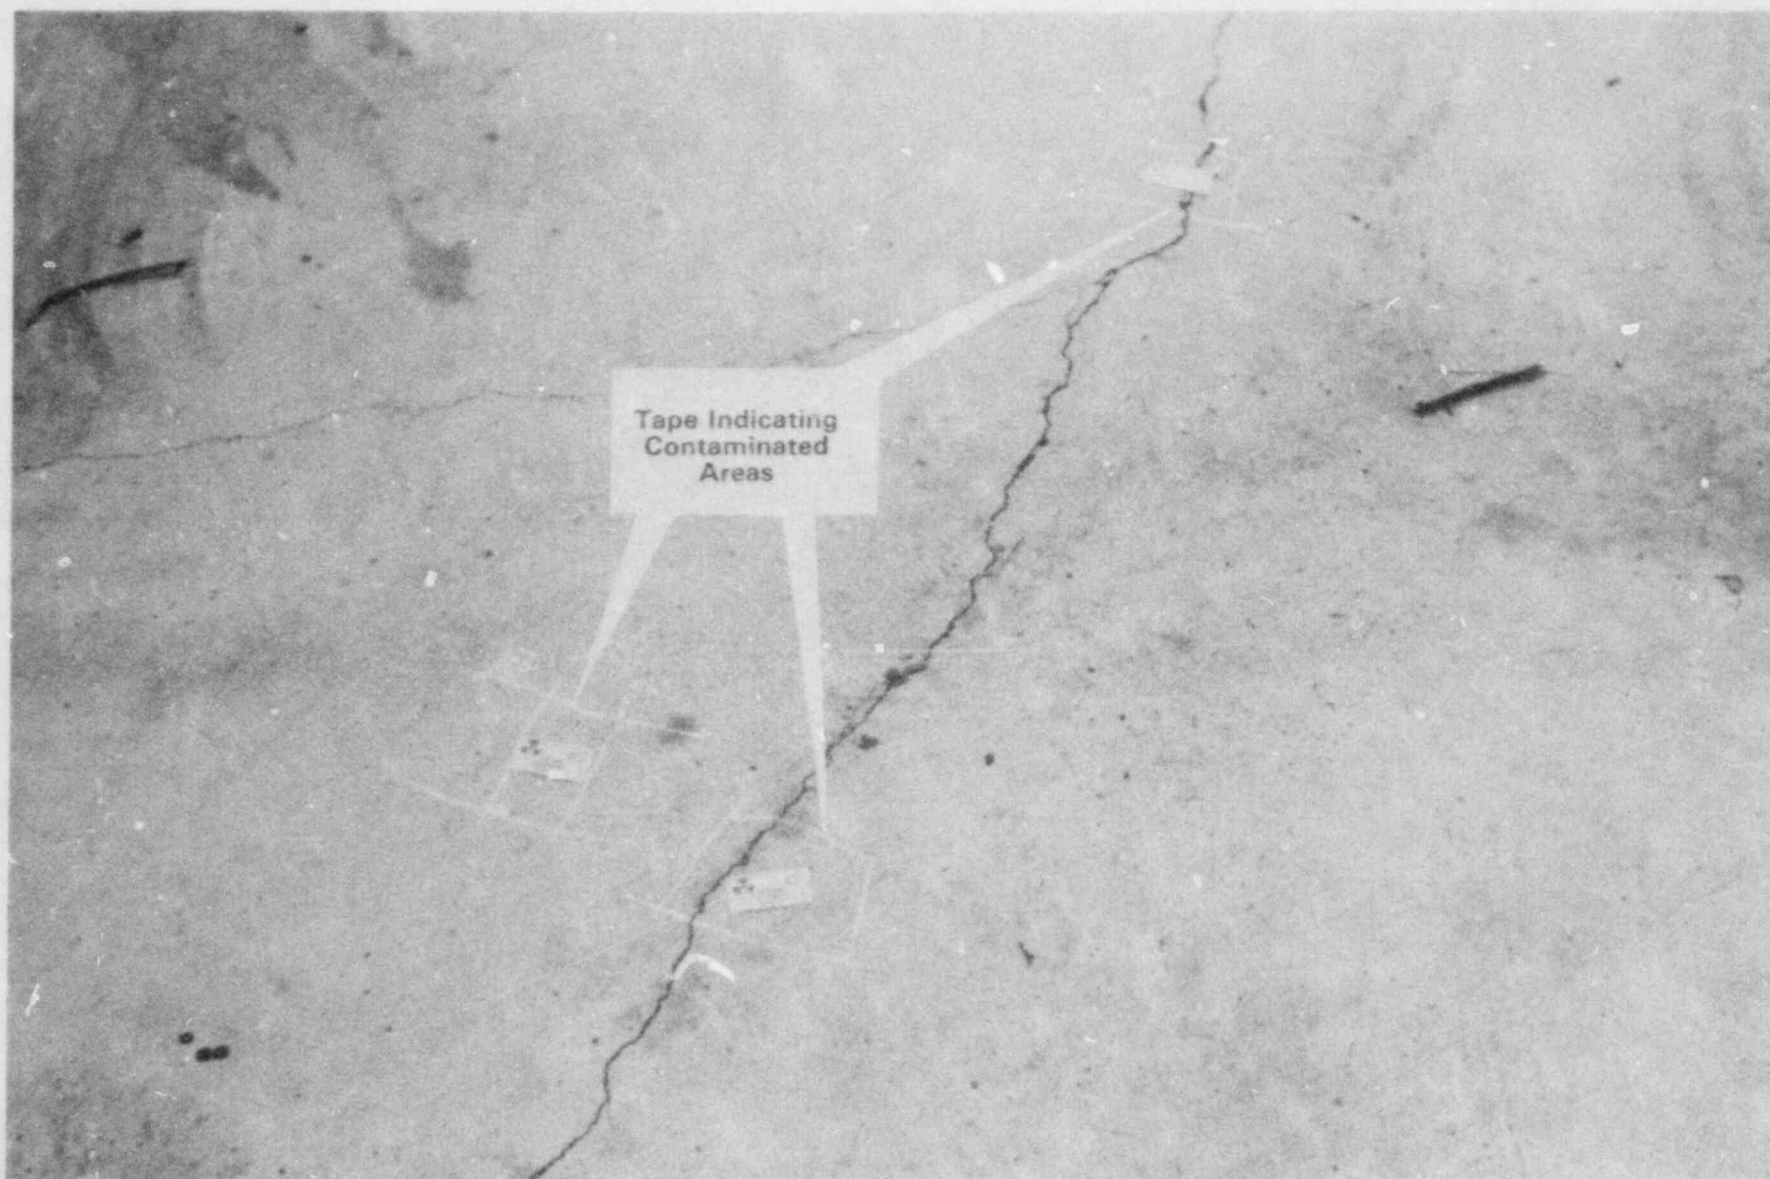
Figure 24. Contaminated carport (closeup).

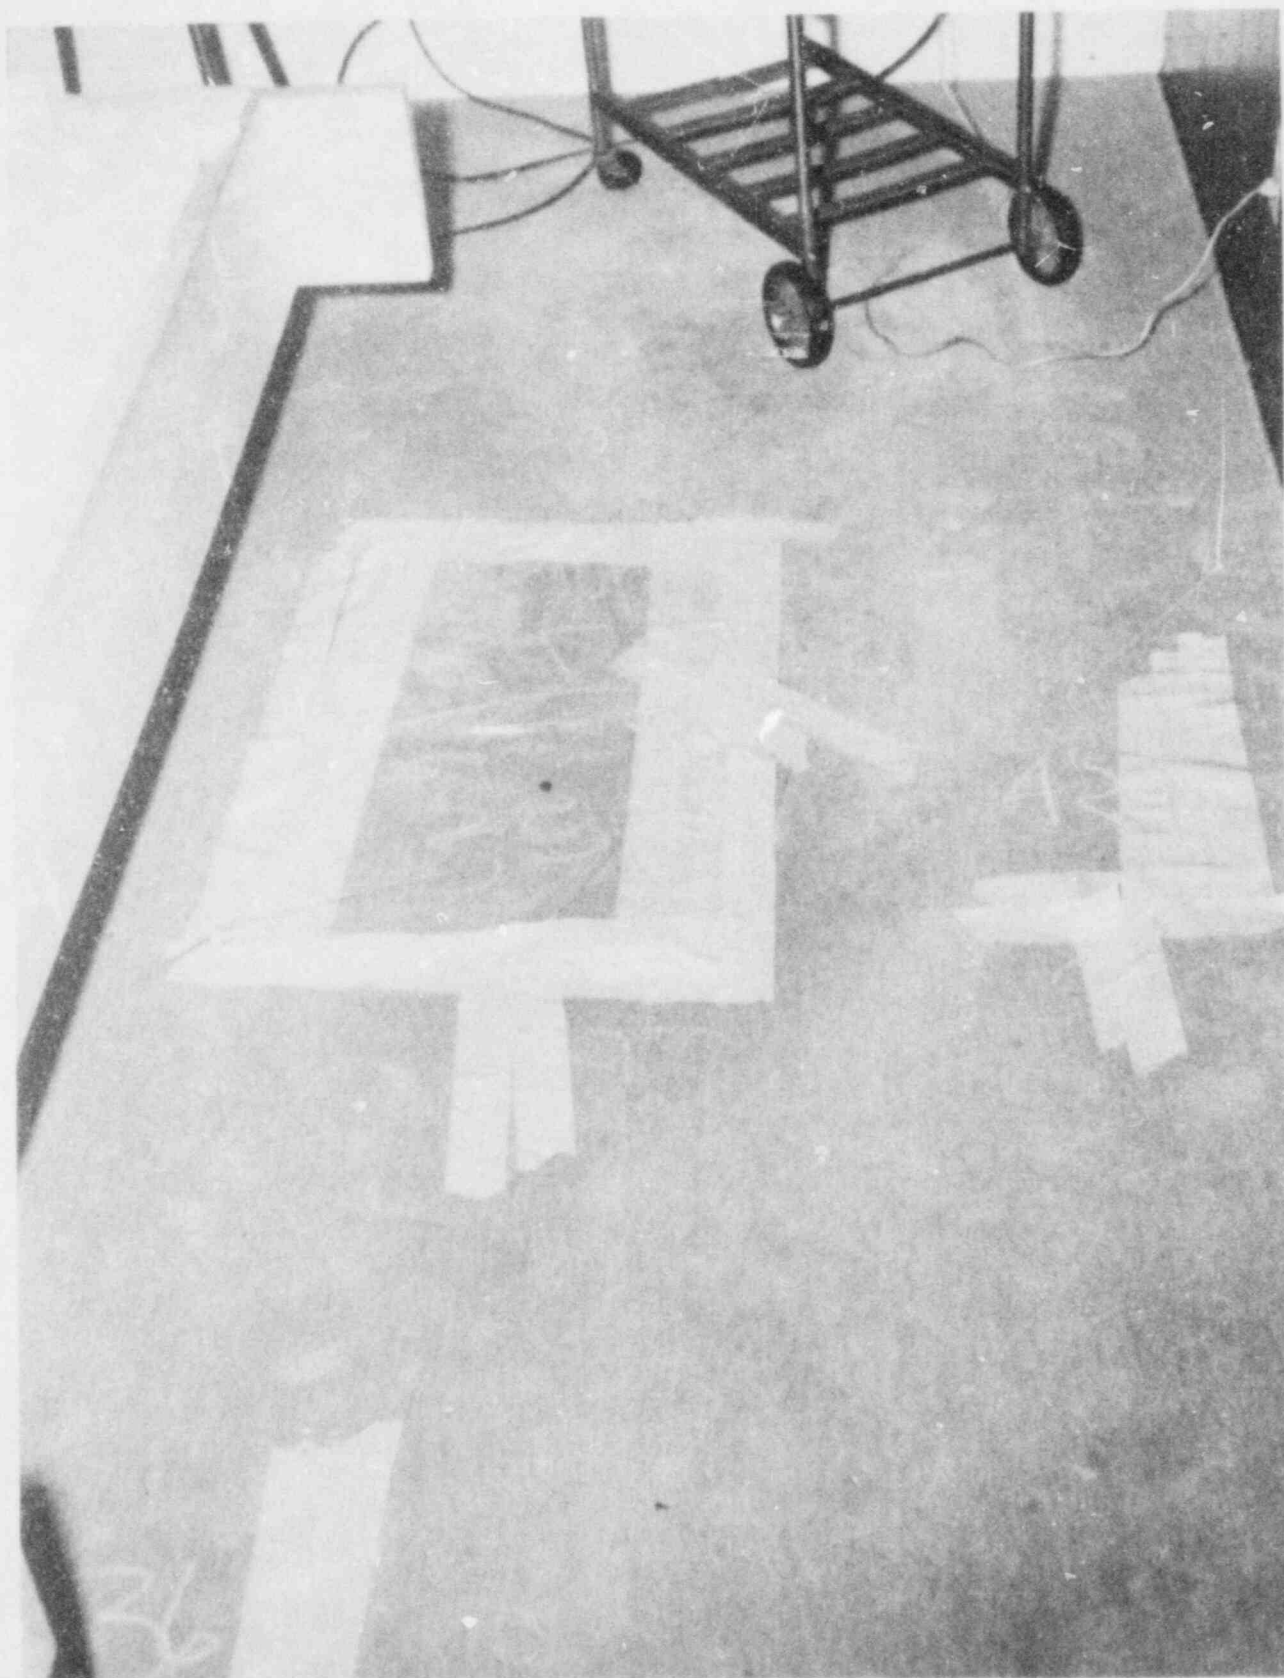
Figure 25. Contaminated bedroom.
