Ruptured Cesium-137 Well-Logging Source at Shelwell Services, Inc., Hebron, Ohio

**U.S. Nuclear Regulatory
Commission**

Region III

This U.S. Nuclear Regulatory Commission (NRC) report documents the circumstances surrounding the September 13, 1983, cesium-137 sealed source rupture incident at the Shelwell Services, Inc., facility in Hebron, Ohio. It focuses on the period from approximately 4:00 p.m. (EDT) on September 13, 1983, when the source ruptured, to October 5, 1983, when the radiological emergency response aspects of the event were concluded. Information outside these periods is recounted as necessary. The incident resulted in radiation doses to two licensee employees that exceeded the regulatory limits for whole-body and extremity exposures, and contamination of the licensee's facility, private residences, public buildings, and the personal effects of the licensee's employees, families, and friends. The emergency response required the combined efforts of NRC, U. S. Department of Energy, and state personnel. The report describes the factual information and significant findings associated with the event and, thereby, provides a data base for subsequent detailed analyses and

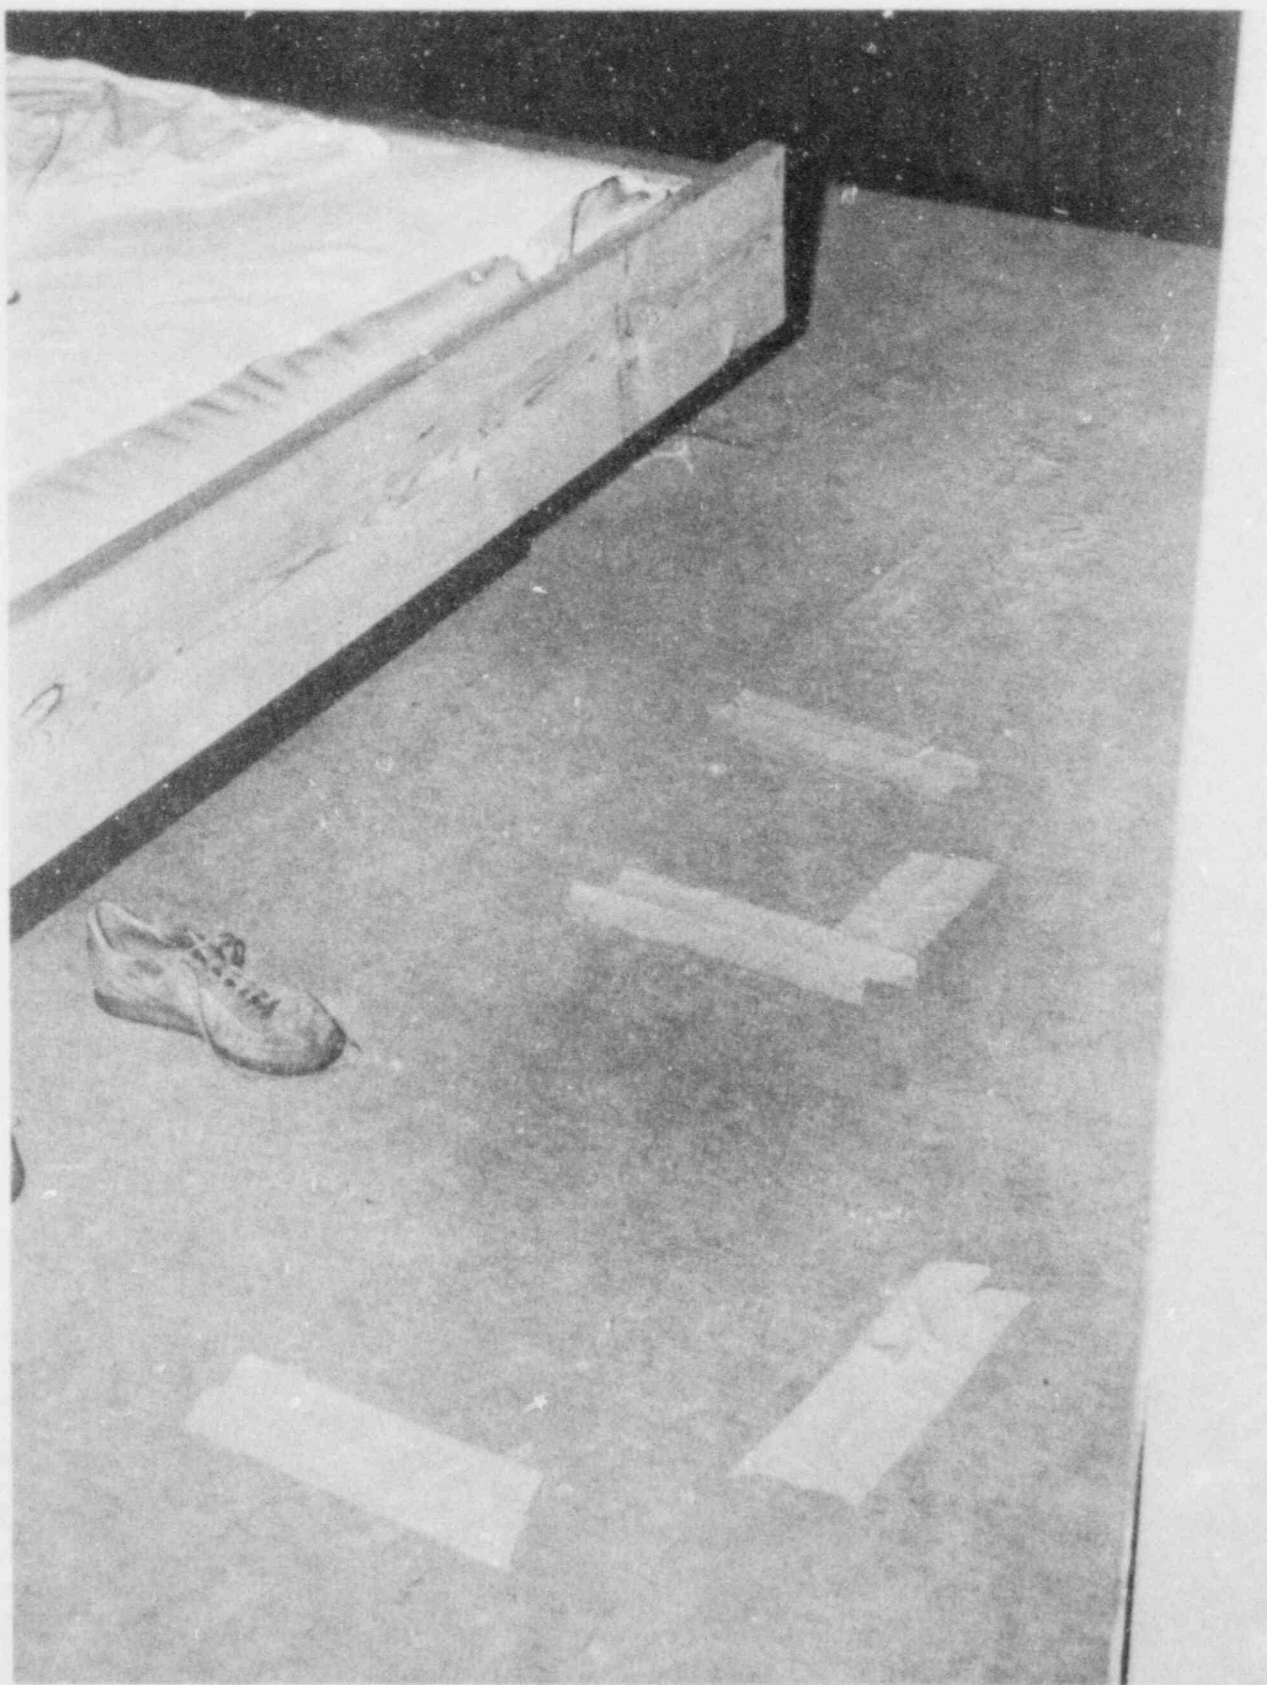
Figure 26. Contaminated bedroom.

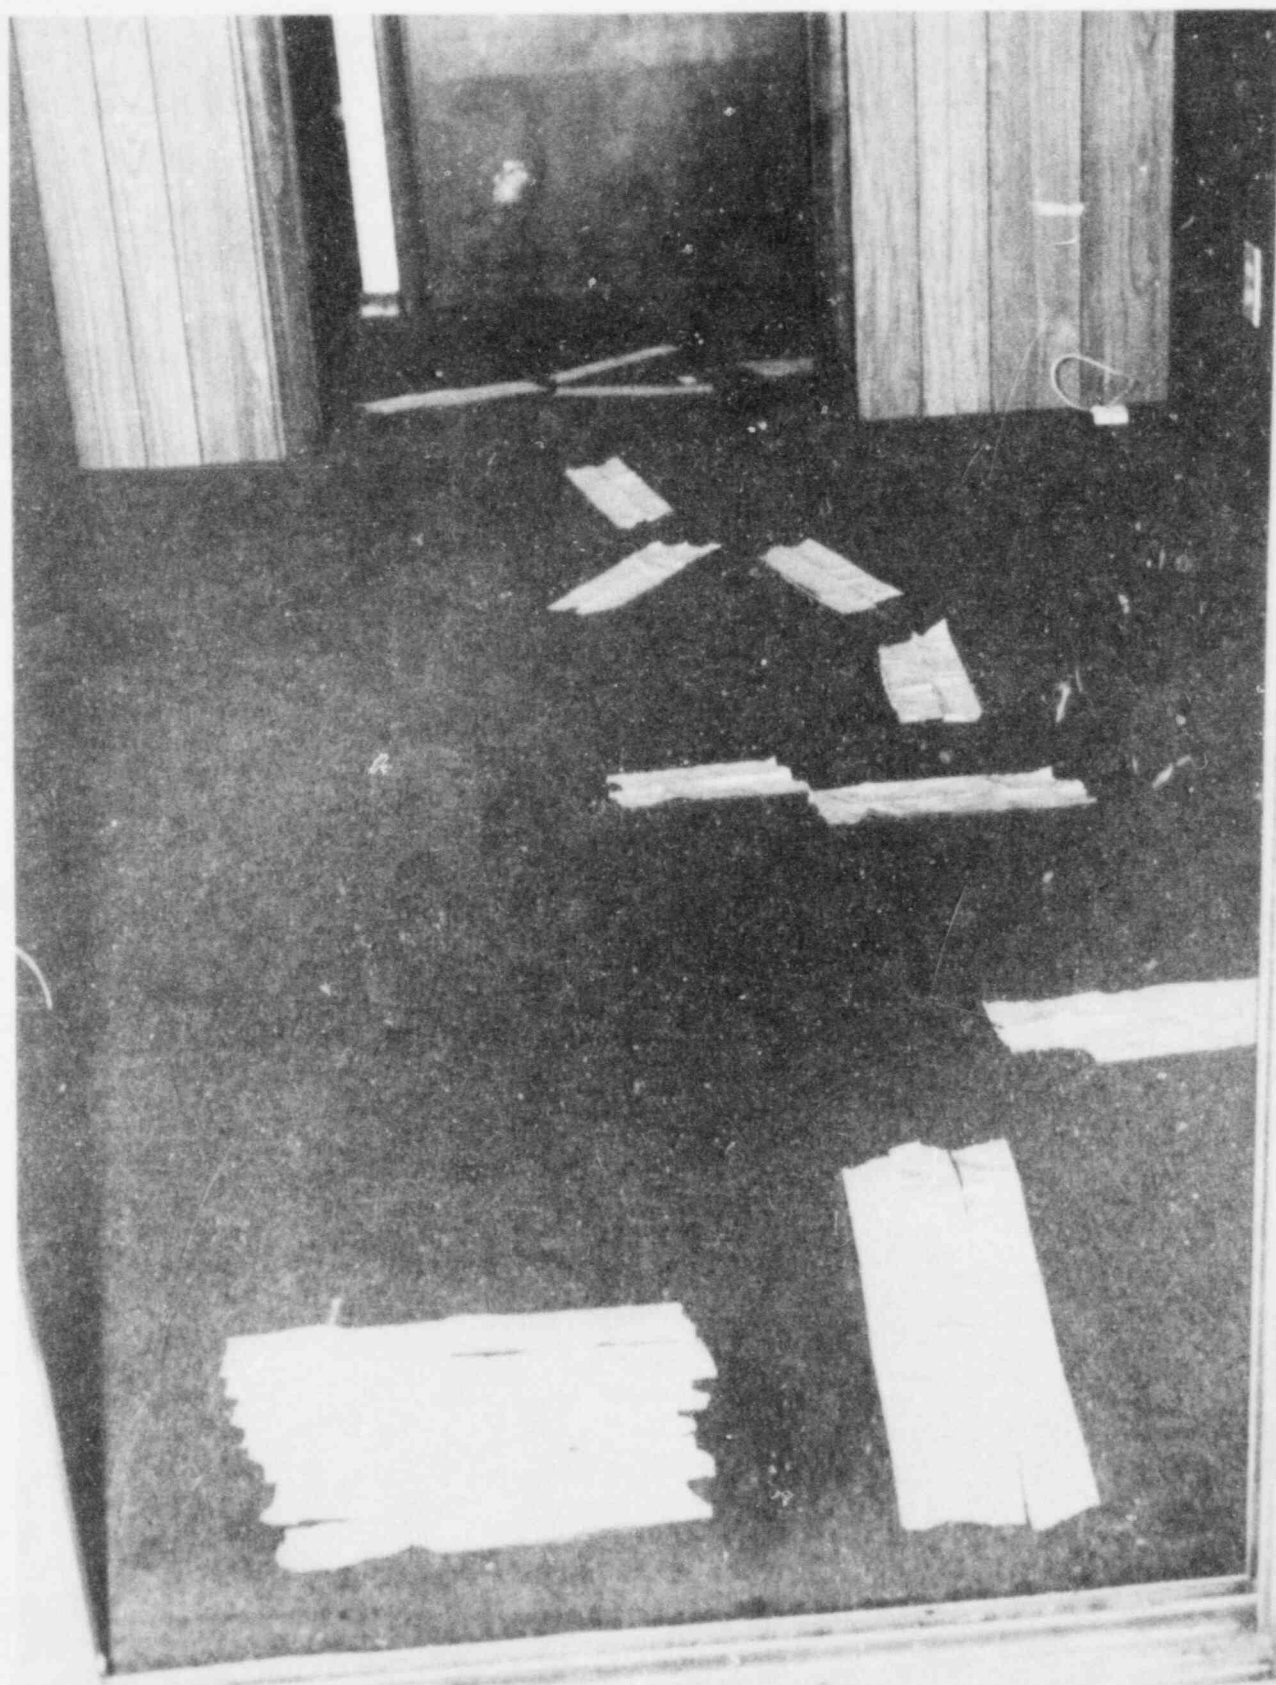
Figure 27. Contaminated family room.

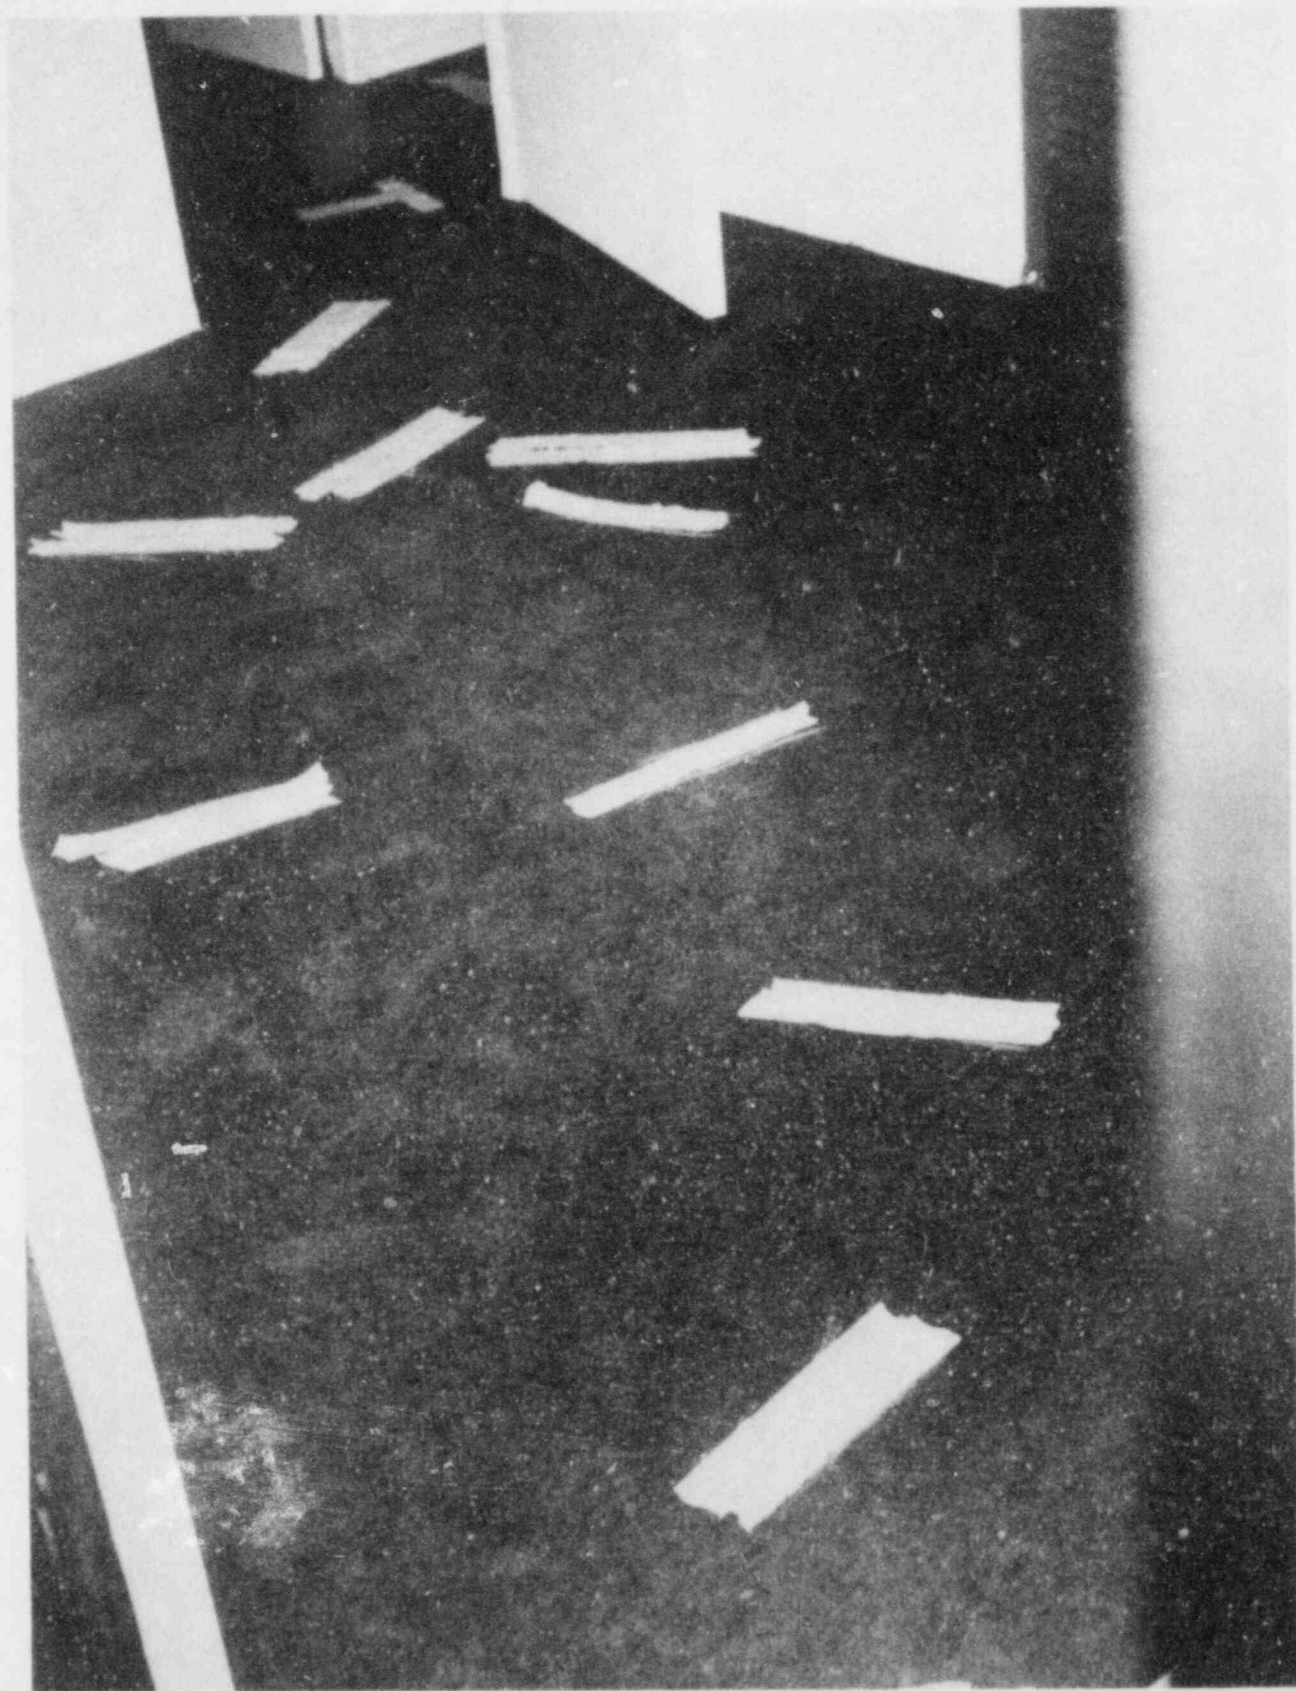
Figure 29. Contaminated bedroom.

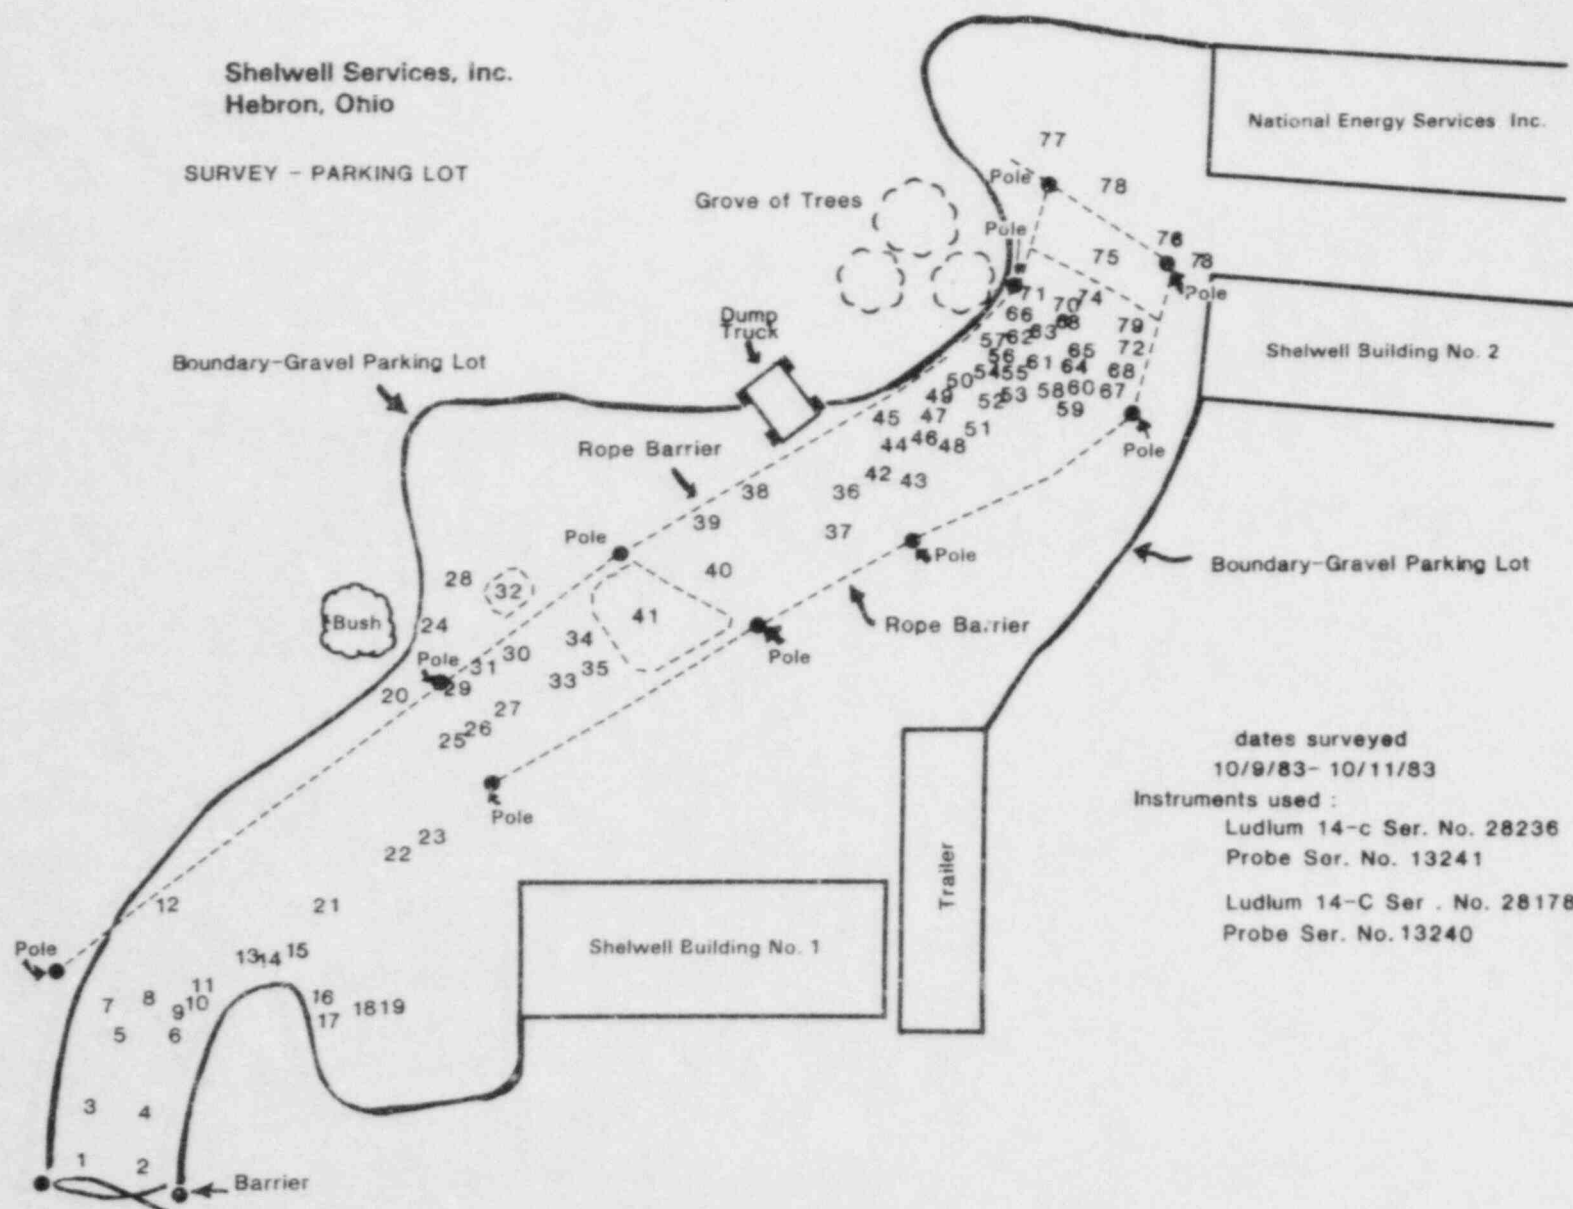
Figure 30. Sketch of contaminated roadway, with survey results.
