MIDLAND NUCLEAR UNITS 1 & 2
CANONIE CONSTRUCTION COMPANY

FILL PLACEMENT QA-QC DAILY REPORT

To G. L. Richardson
 Subject Midland Project, Units 1&2
 Moisture Requirements for
 Backfill prior to Placement
 GLR-02-78-043, QAR SD-40

Subject Midland Project Job 7220
Moisture Requirements for
Backfill Prior to Placement
Spec. C-210, Rev. 5
BCBE-1802

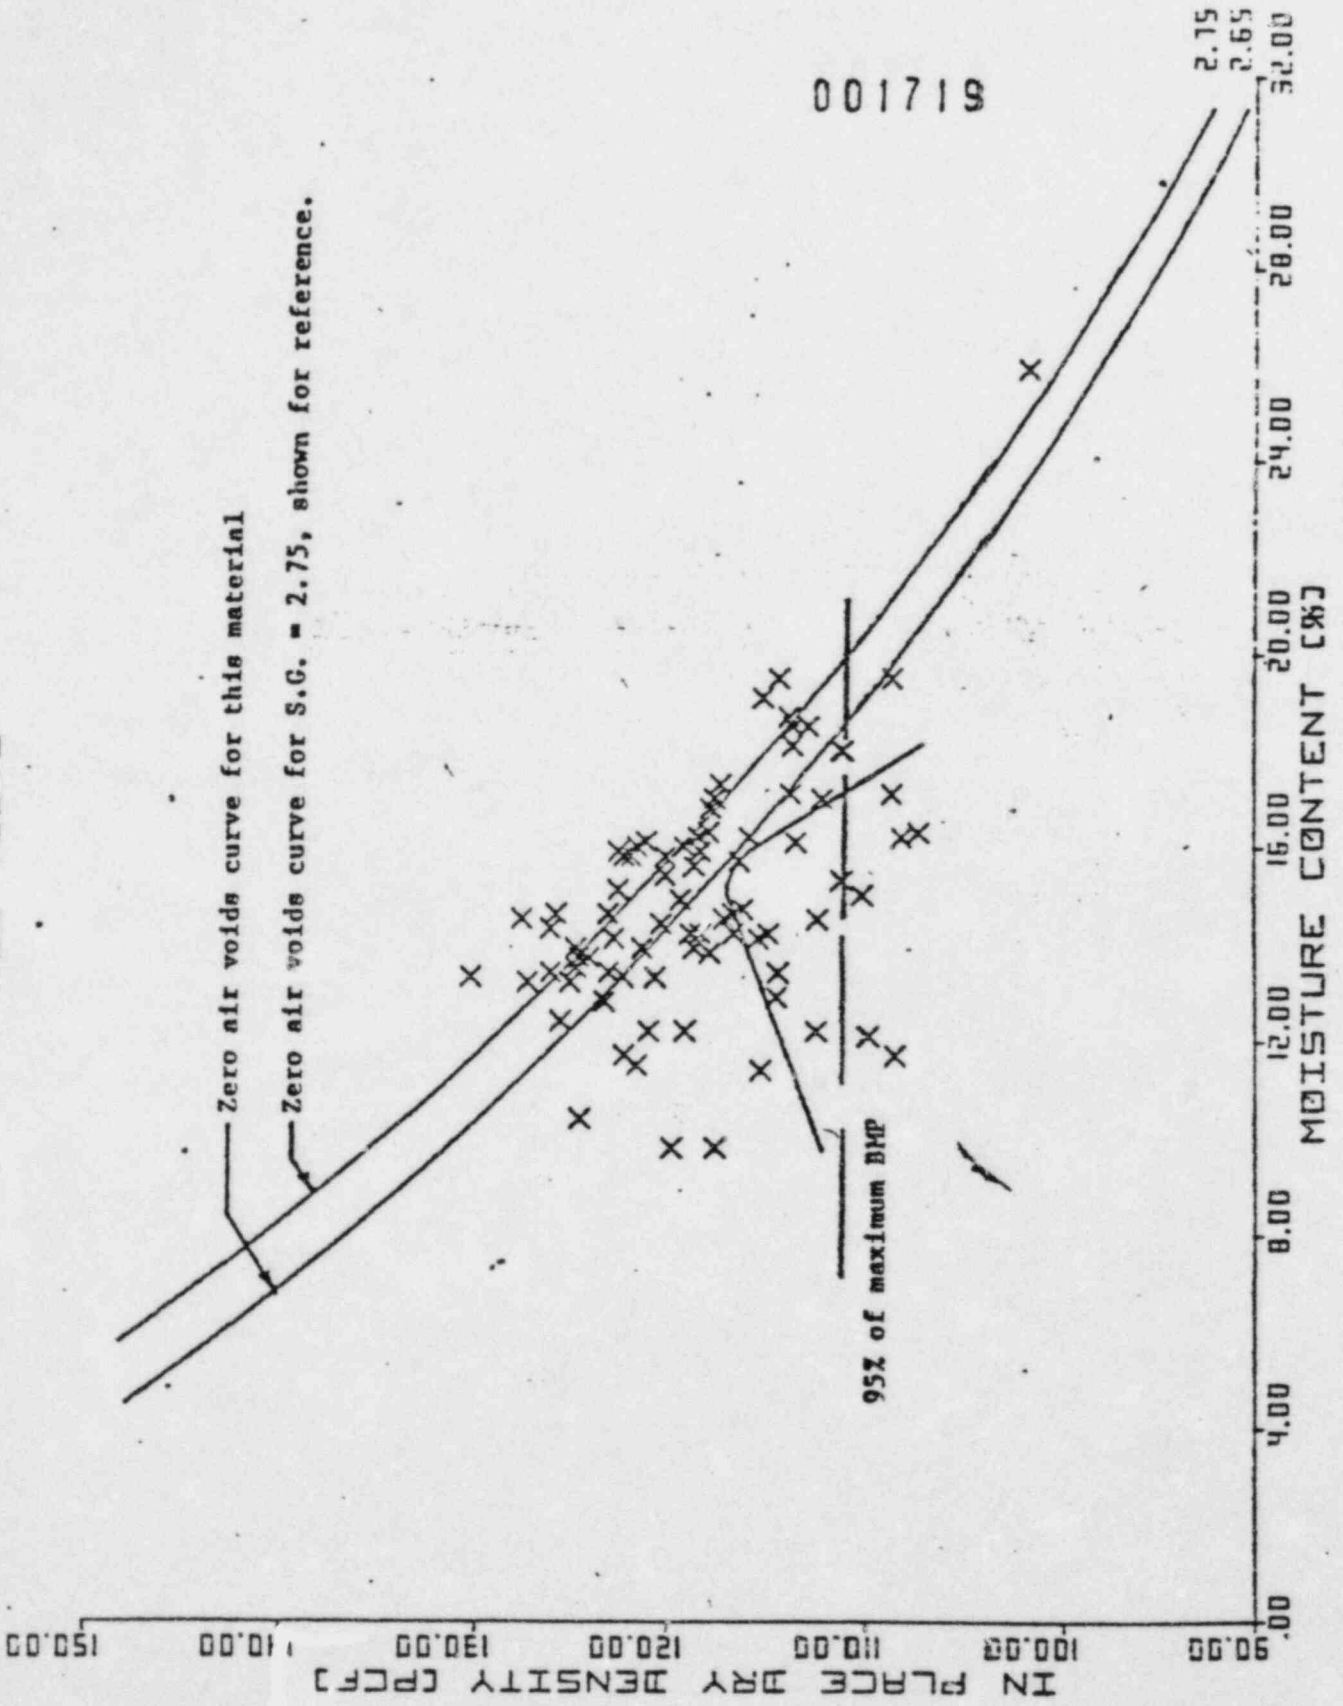
FIGURE 1

MOISTURE-DENSITY FOR GMP 218
 SPECIFIC GRAVITY = 2.65
 ALL TESTS

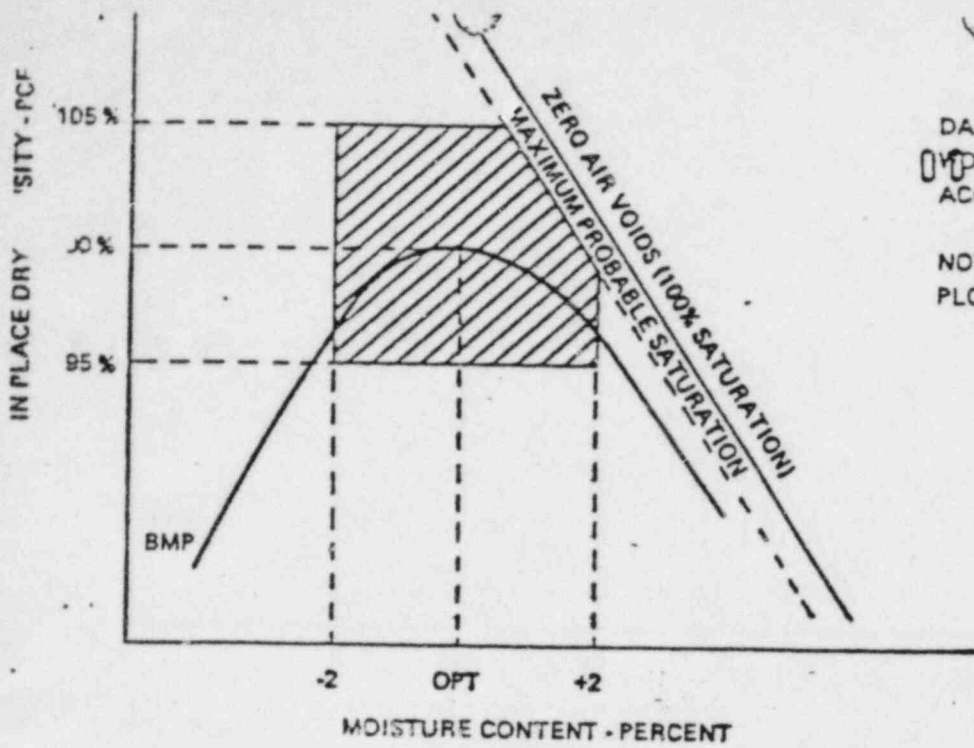
FIGURE 7-A

DATA POINTS THAT PLOT IN SHADED AREA
 WOULD BE GENERALLY ACCEPTABLE
 ACCORDING TO SPECIFICATIONS

NOTE: ABOUT 25% OF ALL FIELD DATA
 PLOTS IN THE SHADED AREA

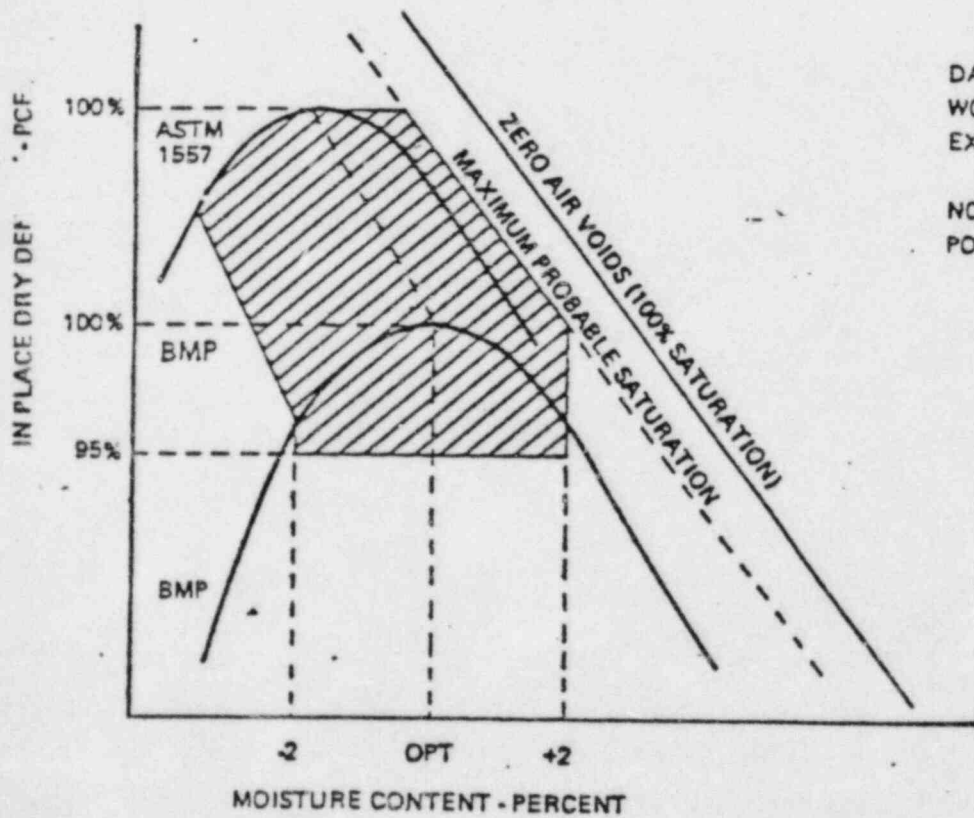
DATA POINTS THAT PLOT IN SHADED AREA
 WOULD BE ACCEPTABLE REGARDLESS OF
 EXACT SPECIFICATION WORDING

NOTE: ABOUT 40% OF ALL FIELD DATA
 POINTS PLOT IN THE SHADED AREA

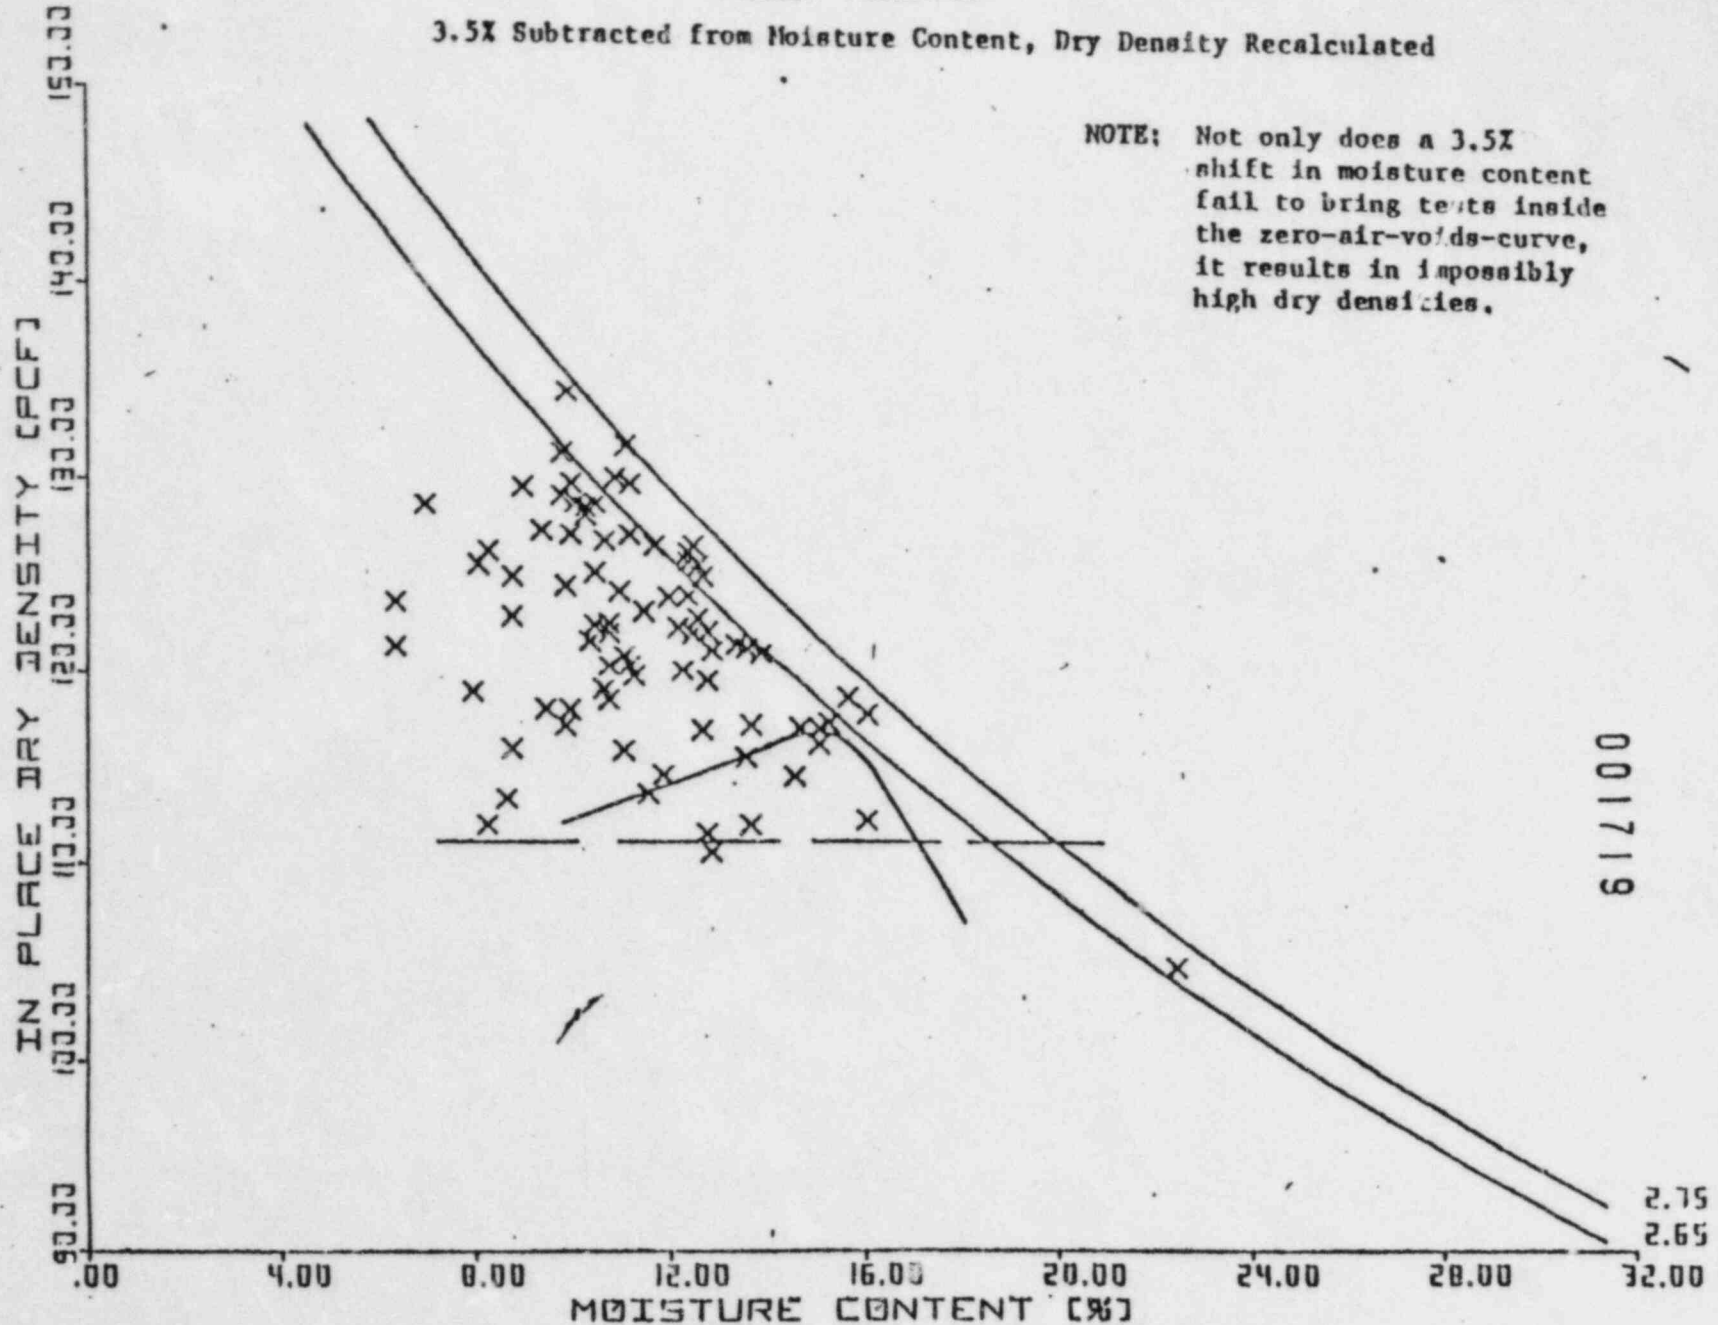
FIGURE 9

3.5% Subtracted from Moisture Content, Dry Density Recalculated

NOTE: Not only does a 3.5% shift in moisture content fail to bring tests inside the zero-air-voids-curve, it results in impossibly high dry densities.

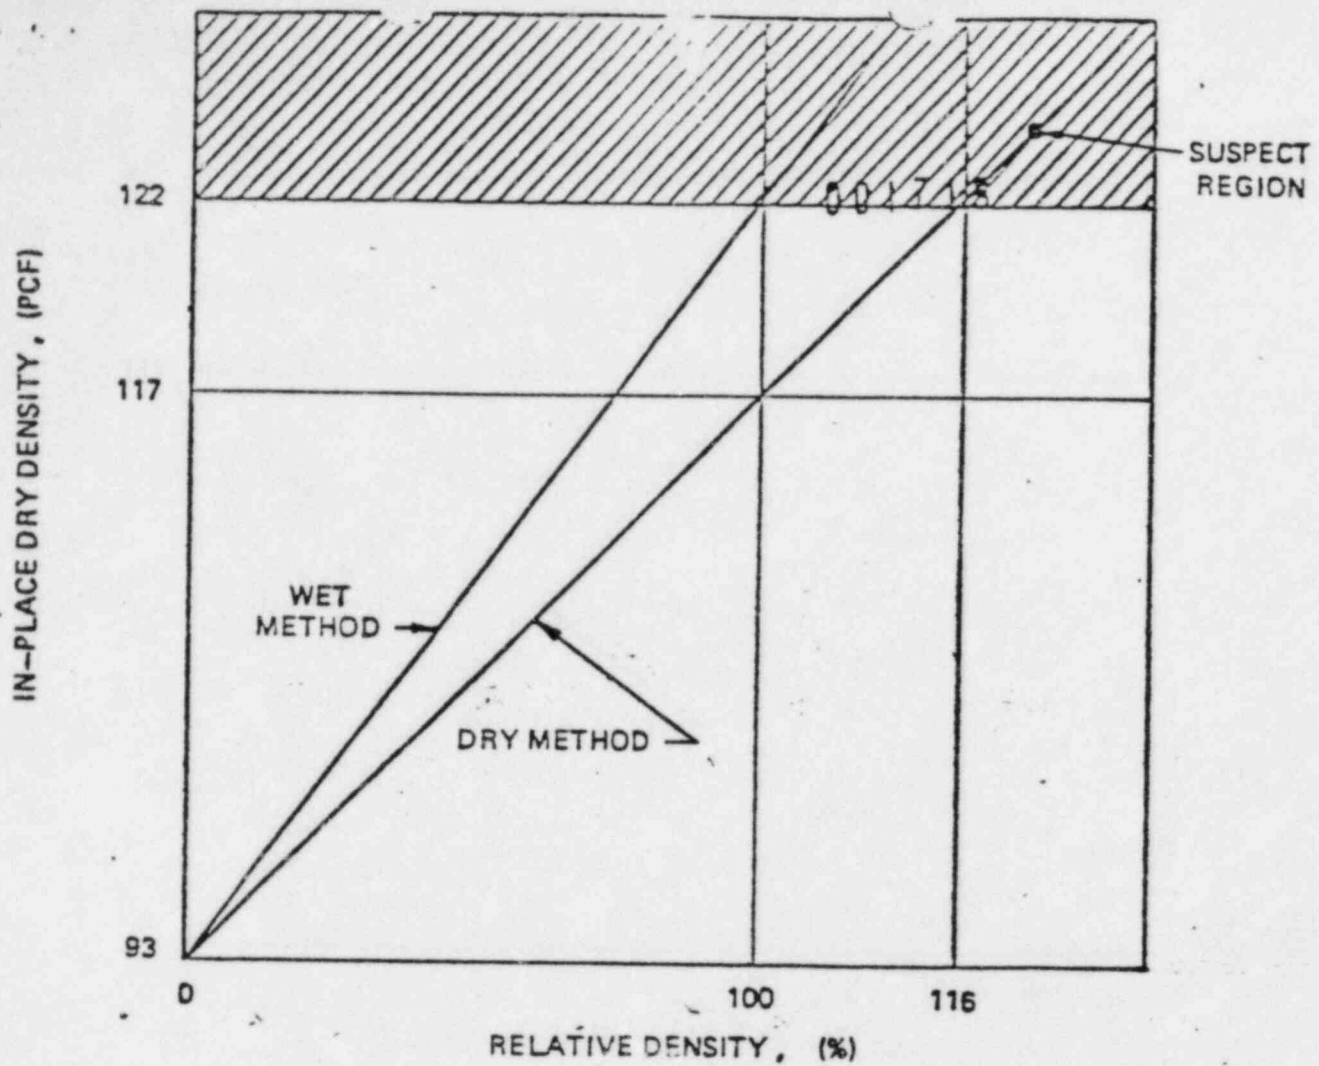
FIGURE 10

NOTE: VALUES FOR DRY DENSITY ARE TYPICAL OF A RANDOM FILL SAND. ANY TESTS SHOWING MORE THAN 117% RELATIVE DENSITY WOULD BE SUSPECT IN THIS EXAMPLE. STRUCTURAL SANDS TEND TO SHOW ONLY 2 OR 3 PCF INCREASE IN MAXIMUM DENSITY AND THUS RESULTS AT MUCH LOWER RELATIVE DENSITY WOULD BE SUSPECT, SAY 105 - 110 PERCENT
