SUBJECT: TIA - NORTH ANNA UNIT 1 STEAM GENERATOR TUBE FAILURE EVENT

NORTH ANNA UNIT 1
STEAM GENERATOR TUBE RUPTURE
AND
REMEDIAL ACTIONS TECHNICAL
EVALUATION
SEPTEMBER 1987

The purpose of this report is to document the evaluations of the North Anna Unit 1 Steam Generator "C" Row 9 Column 51 tube rupture event and the steam generator modifications which will be made to minimize the requisite conditions for future occurrence of a similar event.

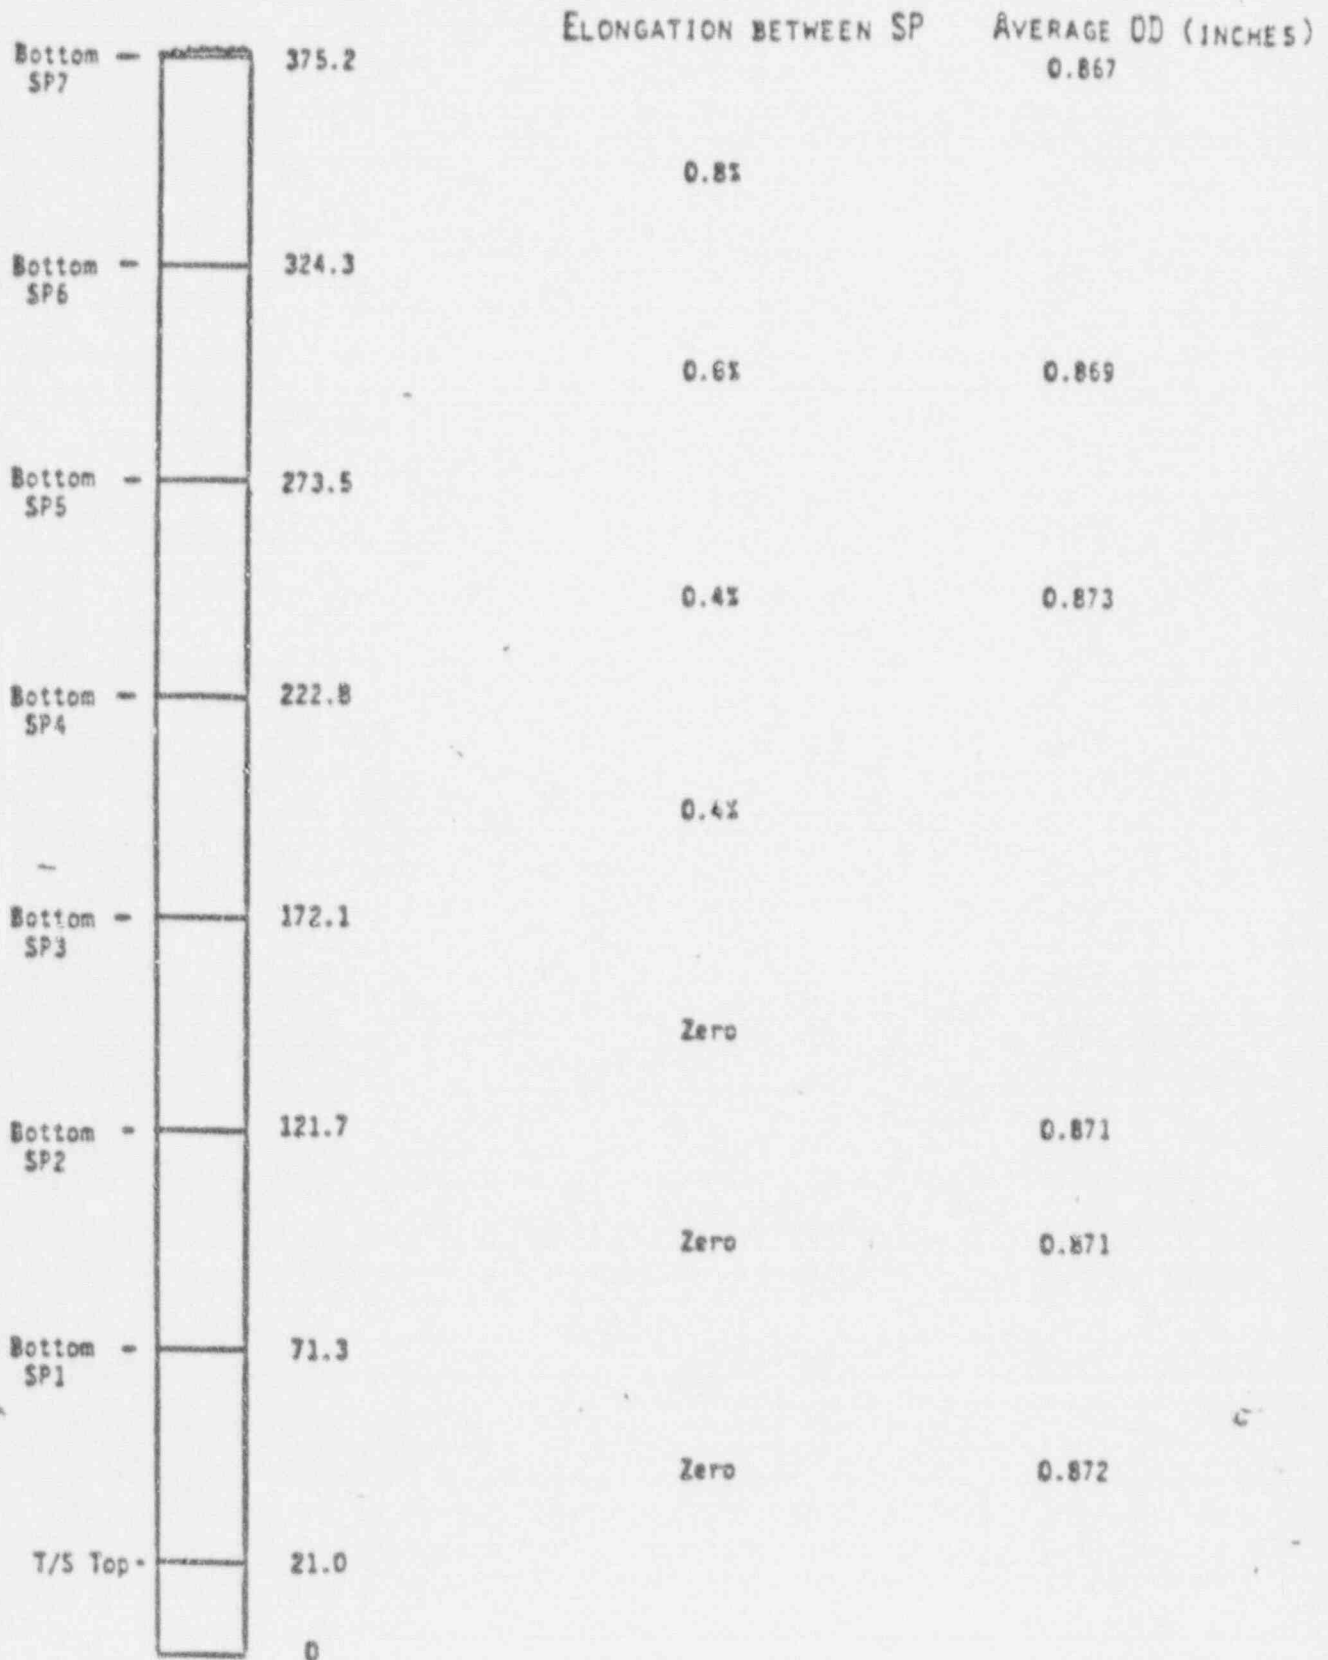
The cold leg tube segment was removed with 0.9 inches of elongation occurring during the tube pull. The elongation was observed to be confined to above the third support plate and to increase with increasing elevation. Between the sixth and seventh support plates, 0.8% elongation occurred resulting in a reduction of the average tube OD from 0.871-0.872 to approximately 0.867 inches. The pull forces required to remove the tube were as follows: 103.6 ksi to break the tube free; 62-65 ksi after 4 feet of removal; 41.4 ksi after 8 feet; 6.9 ksi after 21 feet; and less than 0.8 ksi thereafter. These data suggest that support plate denting in the upper cold leg support plate restrained the tube during the tube pull. (Field eddy current measurements also showed significant denting at these locations as shown in Figure 3.1-7.) Table 2.1-1 and Figure 2.1-1 summarize measurements made on the pulled tube.

DIMENSIONS OF PULLED TUBE R9-C51CL FROM N. ANNA 1 S/G C

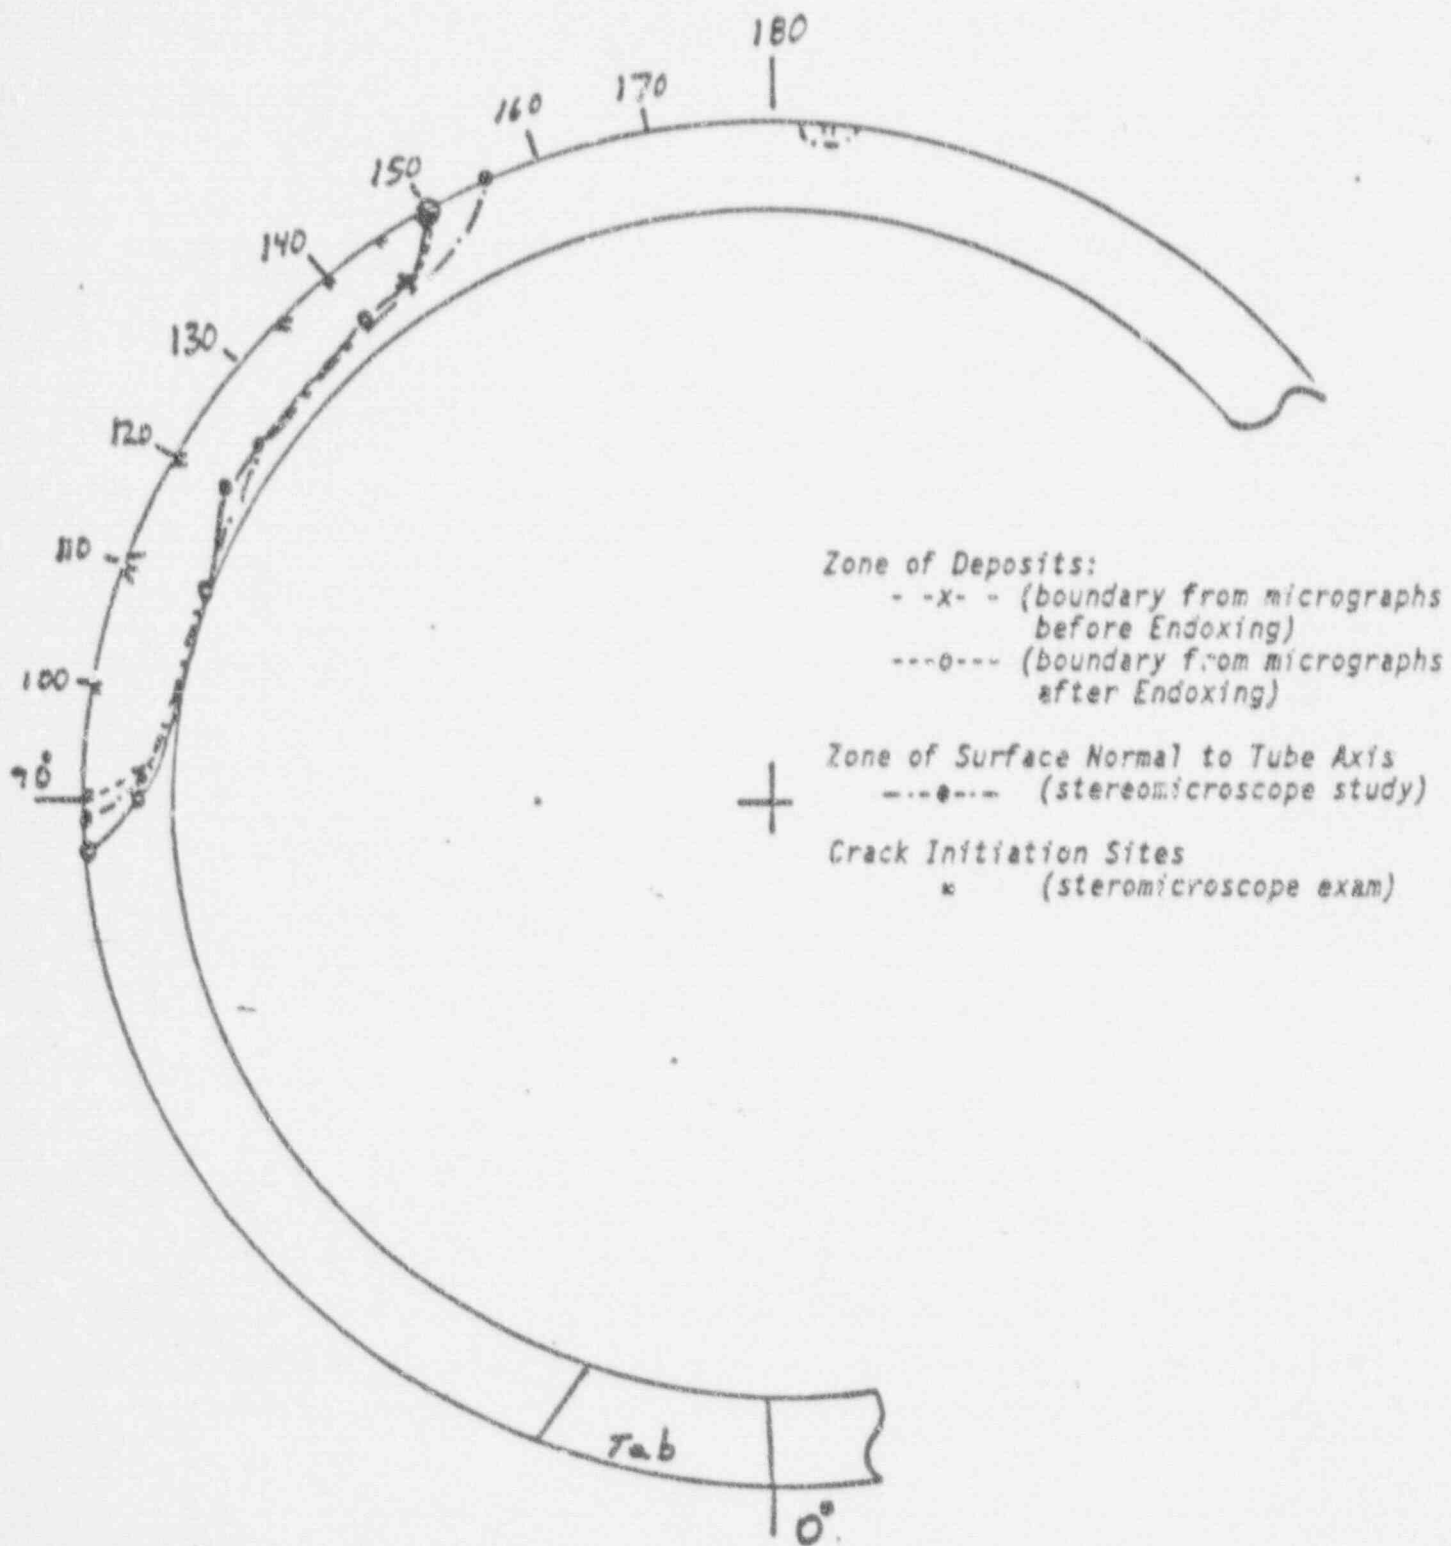
closest in elevation to the top edge of the support plate. The highest elevation of the fracture is located at 315° and is approximately 0.17 inches above the top edge of the support plate. On the fracture face a dark deposit was noted from approximately 90° to 150° . Typically the deposit extends from the OD to $3/4$ through-wall, although it may have touched the ID locally. Figure 2.2-2 shows a photograph of the fracture face in which the deposit is observed, and Figure 2.2-4 shows a sketch of the deposit boundary. An analysis of these deposits showed that they had a composition similar to adjacent OD deposits and that they contain elements which would be expected from secondary side water-borne deposits (Tables 2.2-3 and -4). Later it will be shown that fatigue cracks initiated in this location. The significance of these deposits is that they show the shape of the early macro-crack before faster crack growth rates occurred. From the shape of the deposit, it is believed that the macro-crack initially broke through-wall over an approximately 40° crack front that extended from approximately 100° to 140° . Fatigue striation orientation data, presented later, also support this hypothesis.

FIGURE 2.2-4 Schematic of fracture face region which was covered by deposits

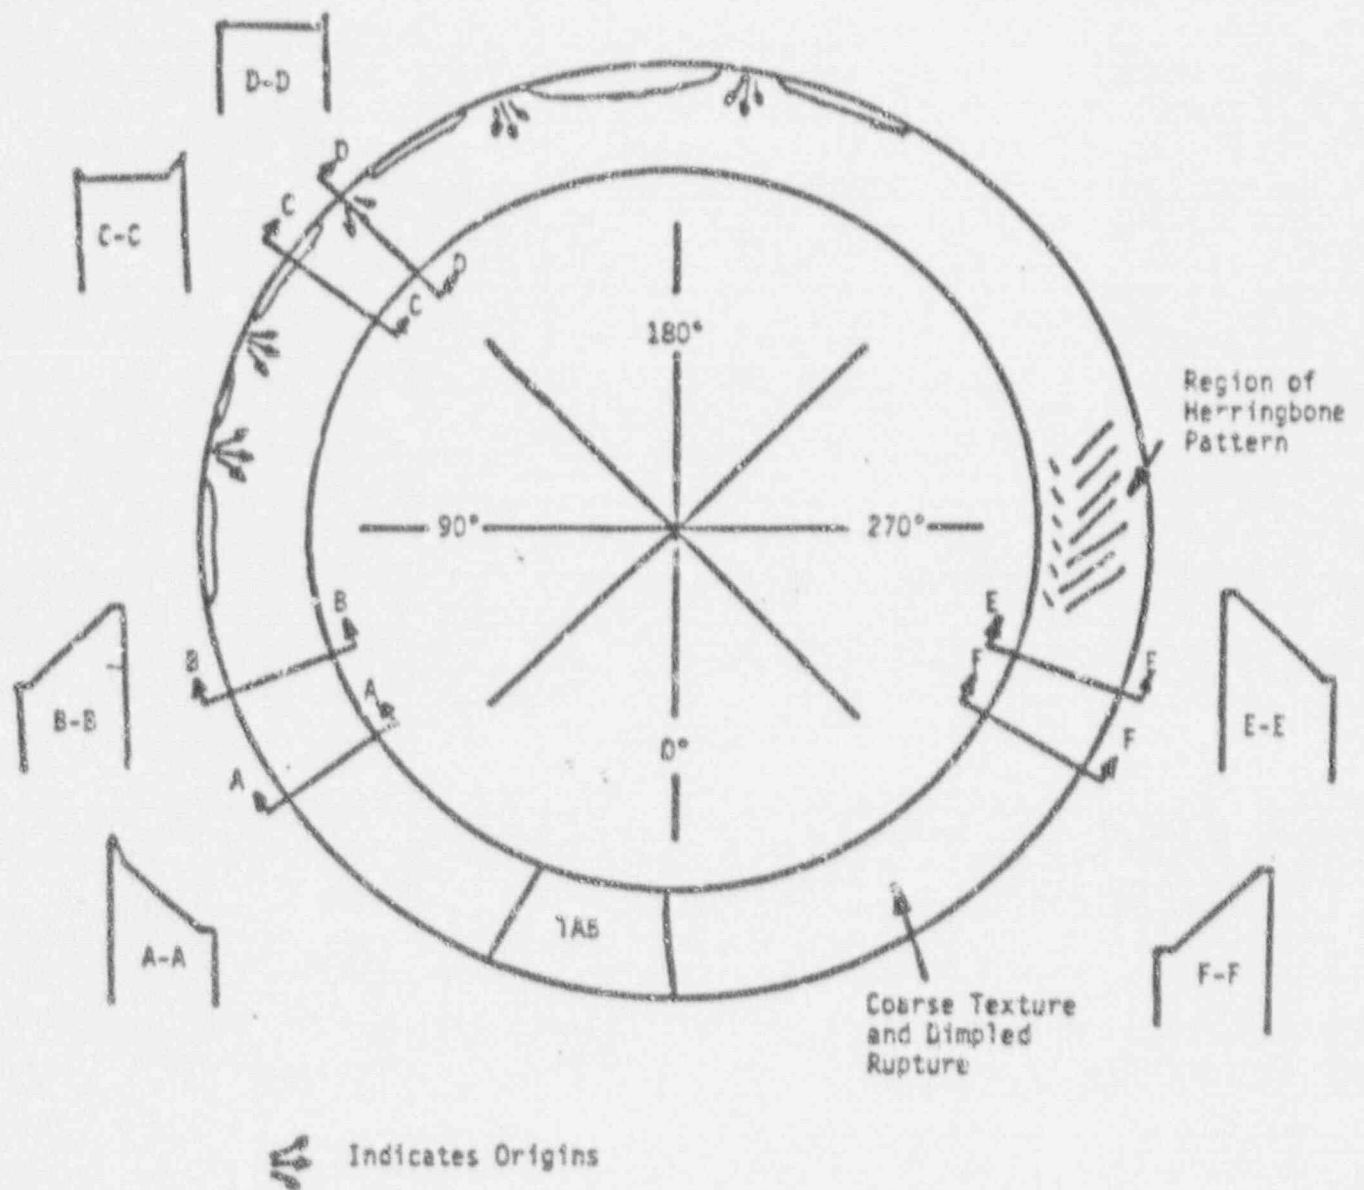
Visual examinations and macroscopic examinations of the fracture surface and the OD surface adjacent to the fracture surface were conducted to determine the surface condition and to determine crack origins and paths of crack propagation. The salient features observed during these examinations are summarized in Figure 2.2-5 and consist of the following:

1. Tab-shaped area near region marked 0° has a rough fracture texture and orientation consistent with final overload fracture.
2. Region from about 90° to 155° is generally flat (orientation: normal to wall) throughout most of wall except for small portions that have shear orientations (45° to wall) adjacent to the OD and ID surfaces.

3. Most of the remainder of the fracture is oriented at about 45° to the wall surface except for a flat area surrounding a minor crack origin at about the 190° location.

4. The fracture occurred by multiple initiation - all on the OD surface. A number of "origins" were identified from fracture surface markings (tear ridges) and contour on OD surface with four principal initiation sites found at approximately 110° , 120° , 135° and 150° . Figure 2.2-6 shows a photograph of these locations after the deposit had been partially removed by cathodic descaling.

5. Fracture Texture:
 - a. Within flat region: fine texture.
 - b. Counterclockwise from 90° : fine texture.

- c. Clockwise from 180° : initially fine. Texture becomes rougher with herringbone pattern evident near 270° region indicating an accelerating rate of crack propagation.
- d. Within the region from about 280° through 360° to 15° : rough texture (fractographic examination revealed dimpled rupture in this region) indicative of overload fracture.

FIGURE 2.2-5 Approximate Mapping of Fracture Surface of Tube R9C51, S/G "C" Cold Leg.

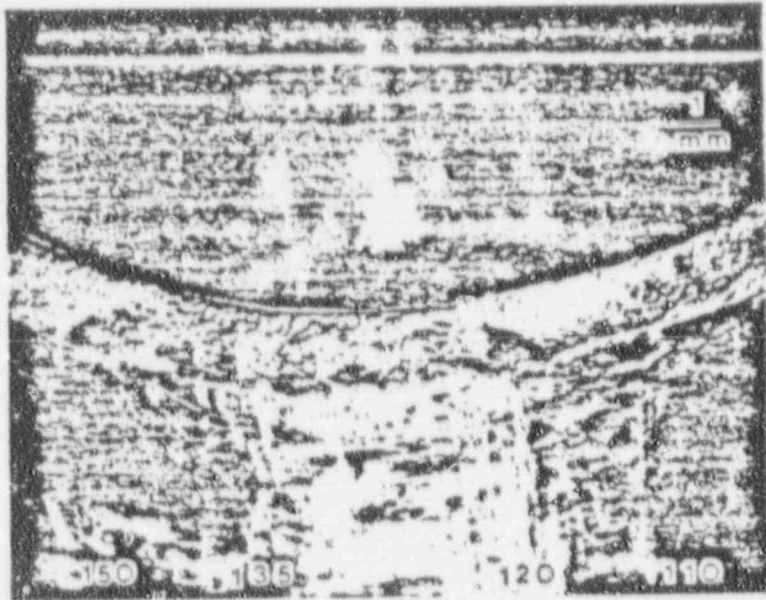
FIGURE 2.2-6

Light photograph indicating multiple origins of cracks on the OD of FS on Piece 9B2 after cathodic cleaning.

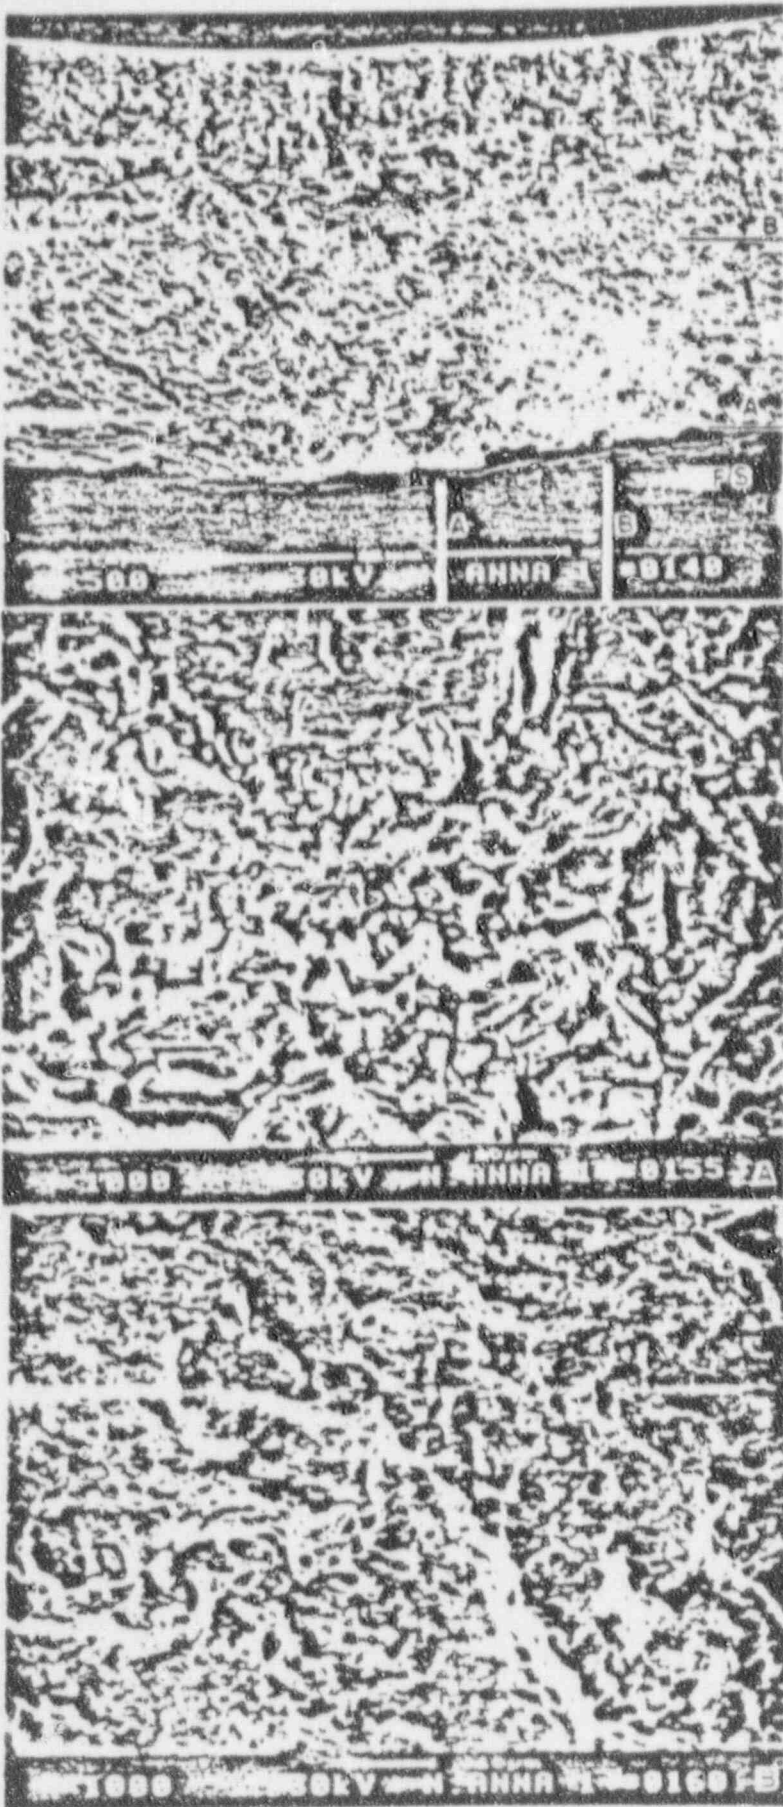
FIGURE 2.2-7

SEM fractographic examinations of the fracture surface confirmed the conclusions of the optical-macroscopic examinations that the crack origins were located on the OD surface. At low to intermediate magnifications, as illustrated in Figure 2.2-7, the fracture (in the 30° to 210° portion of the fracture) has a transgranular, feathery, cleavage-like faceted appearance. The feathery appearance results from microscopic tear ridges (which, like macroscopic tear ridges, run in the direction of local crack propagation) and small regions of ductile fracture (produced by ductile cutting) which interconnect multi-level, finger-like plateaus and sub-regions on those plateaus. Dimpled rupture (the predominant mechanism of ductile, overload fracture) was found only in the final portion of the fracture (from about 310 through 360° to the 15° portion of the fracture). At higher magnifications (also illustrated in Figure 2.2-7 frequent variations in the direction of local crack propagation of nearly $\pm 45^{\circ}$ (both vertically and horizontally), could be noted as indicated by changes in the orientation and direction of the plateaus. Crack growth occurred simultaneously along facets at different levels so that tear ridges and undercutting of one facet by another was a common occurrence. Such phenomena are common to fatigue crack propagation.

SEM micrographs at various locations near the 135° crack origin on the FS of Piece 9B2.

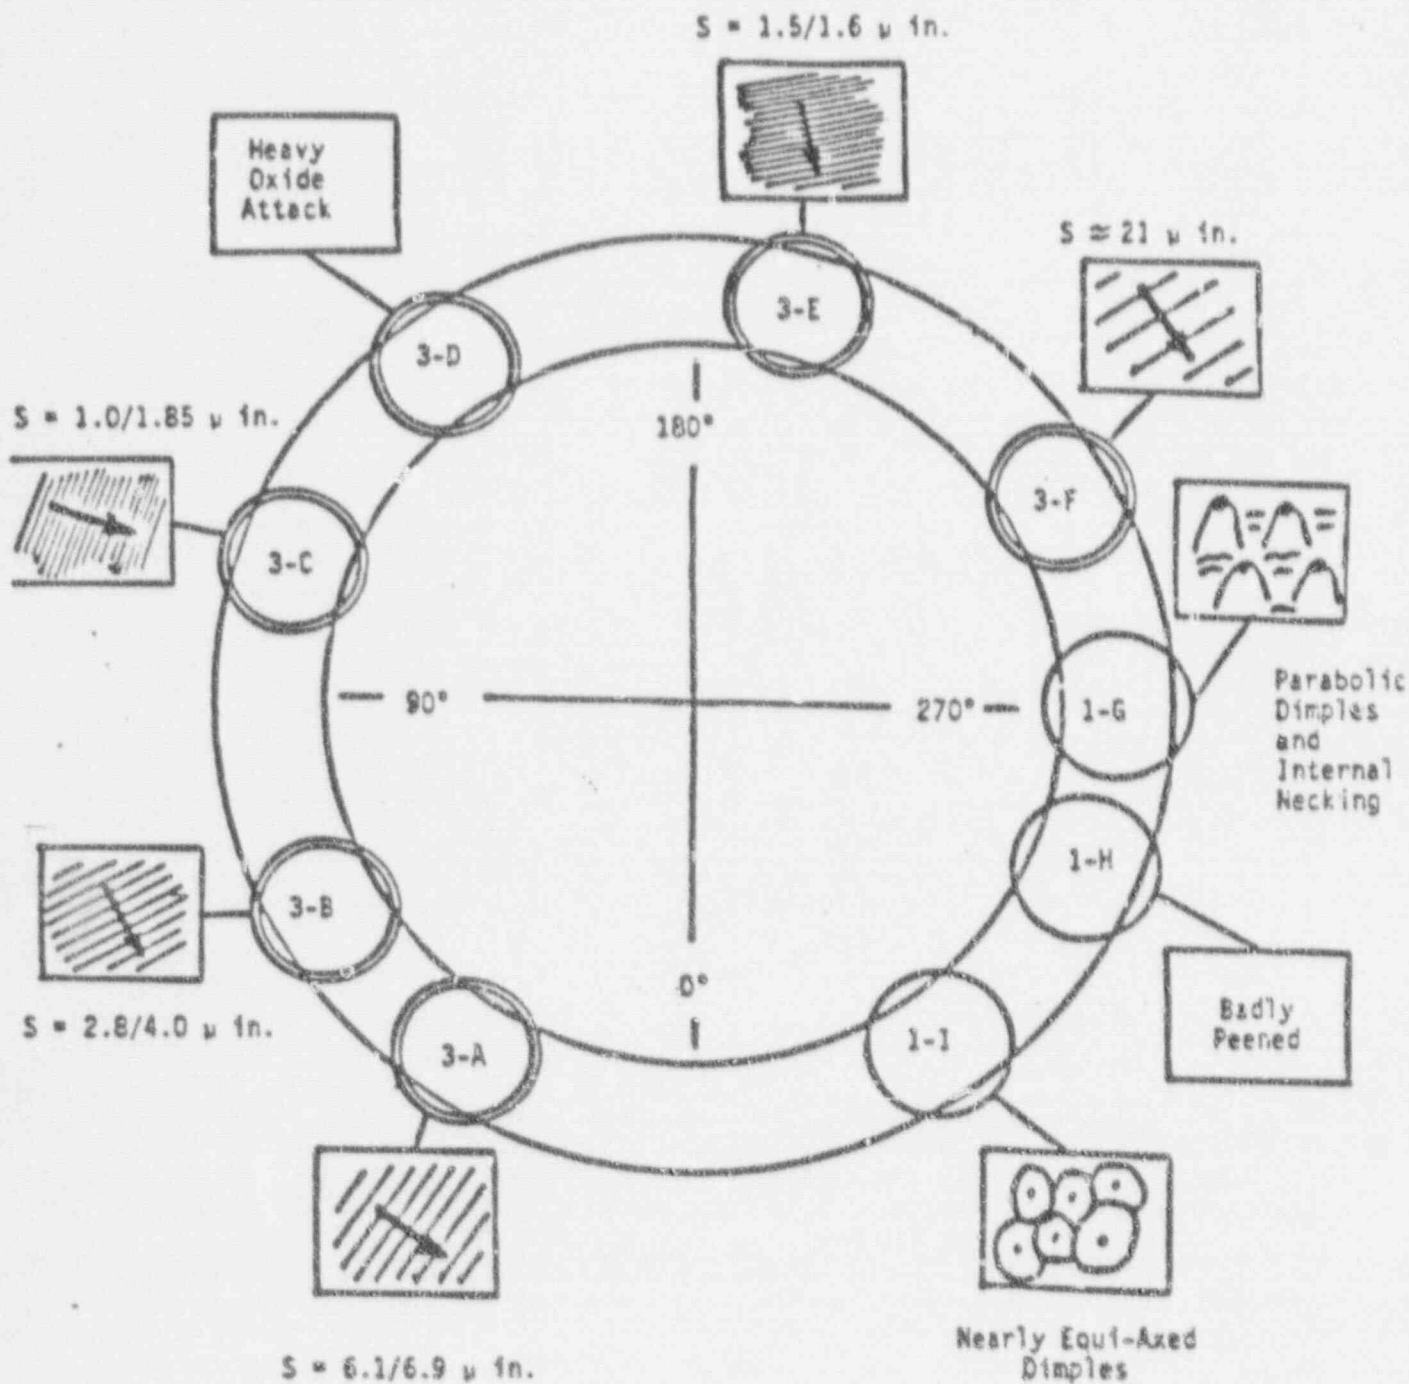
The salient features observed during the TEM fractographic examination are schematically shown in Figure 2.2-9 and summarized below:

FIGURE 2.2-9 Note: Arrows Indicate Direction of Fracture Propagation

Schematic Representation of Features Observed During TEM Fractographic Examination of Fracture Surface of Tube R9C51, S/G "C" Cold Leg.

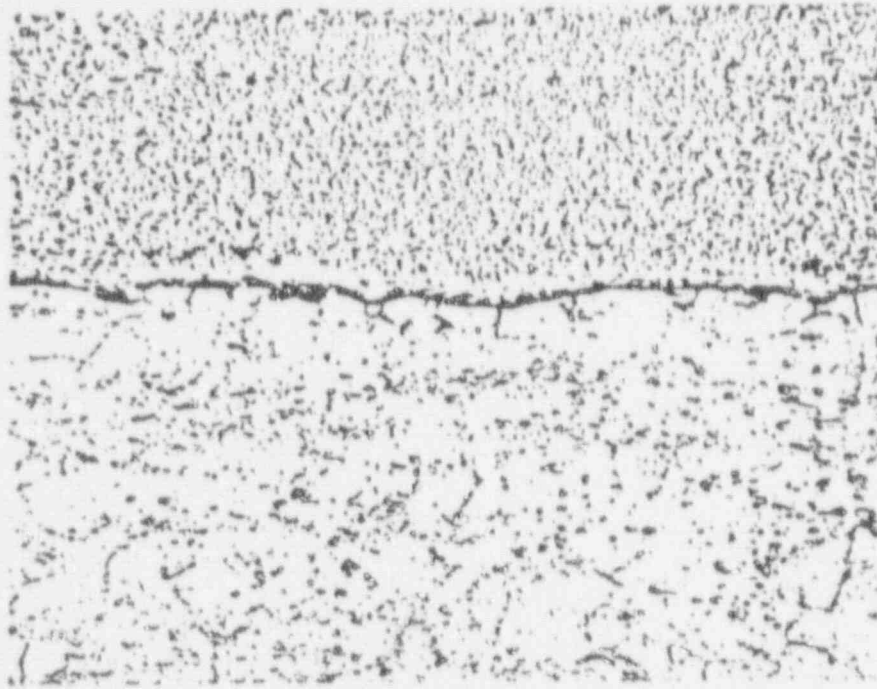
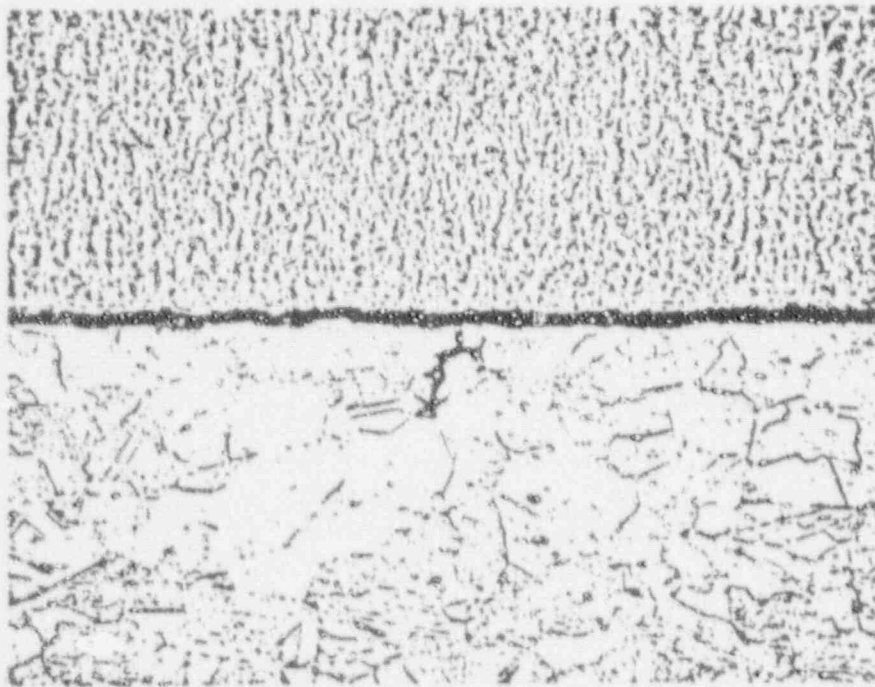
ID surface
at 165°
(typical penetration)

OD surface
at 155°
(maximum penetration)

Figure 2.2-10 Longitudinal metallography of intergranular penetrations of ID and OD surfaces within seventh support plate crevice at 165° and 155°.

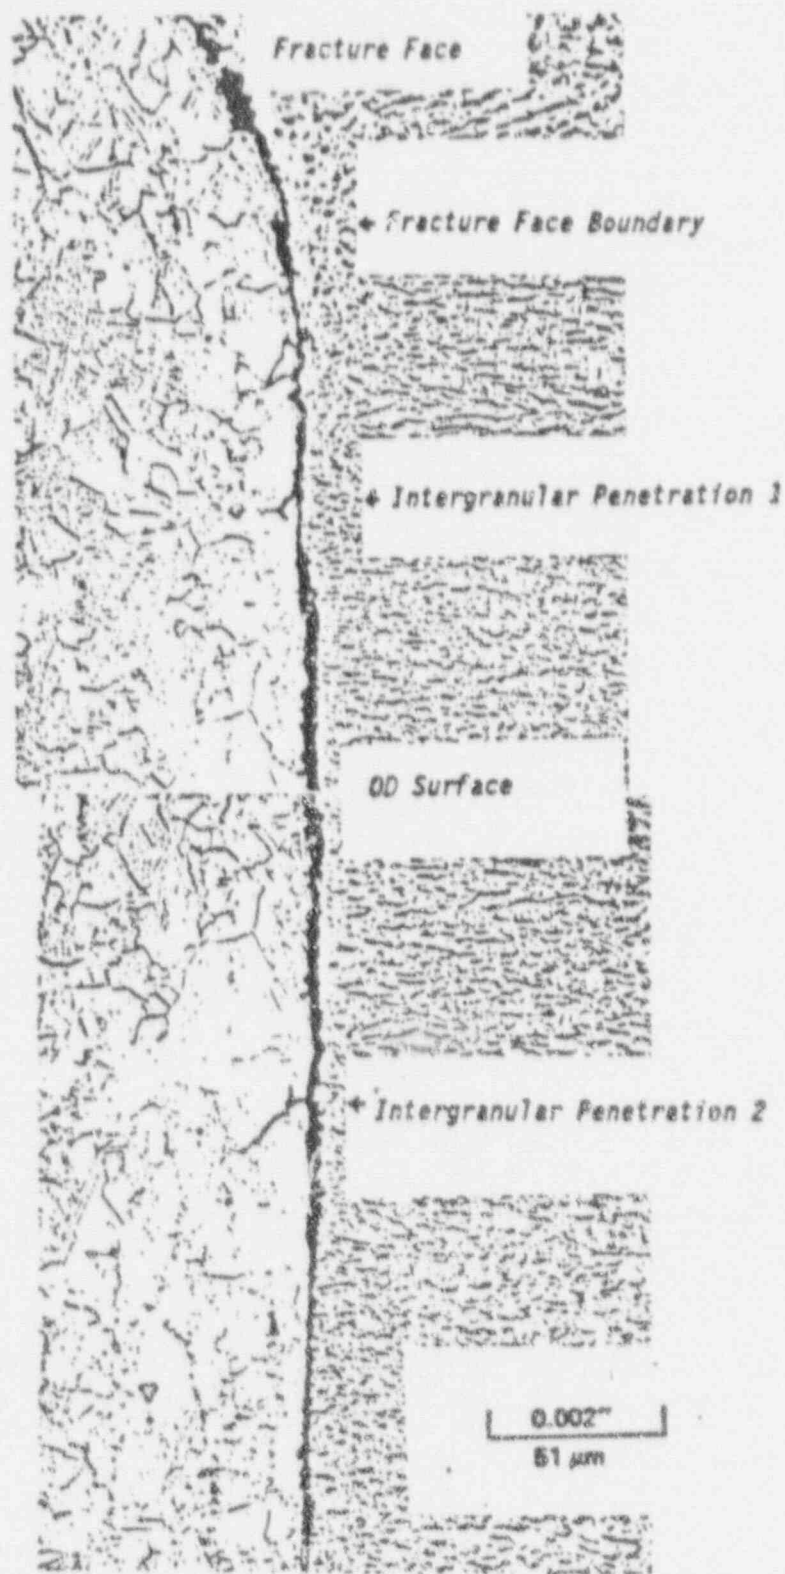
FIGURE 2.2-11 Longitudinal metallography of OD intergranular penetrations nearest fracture face at 155°.

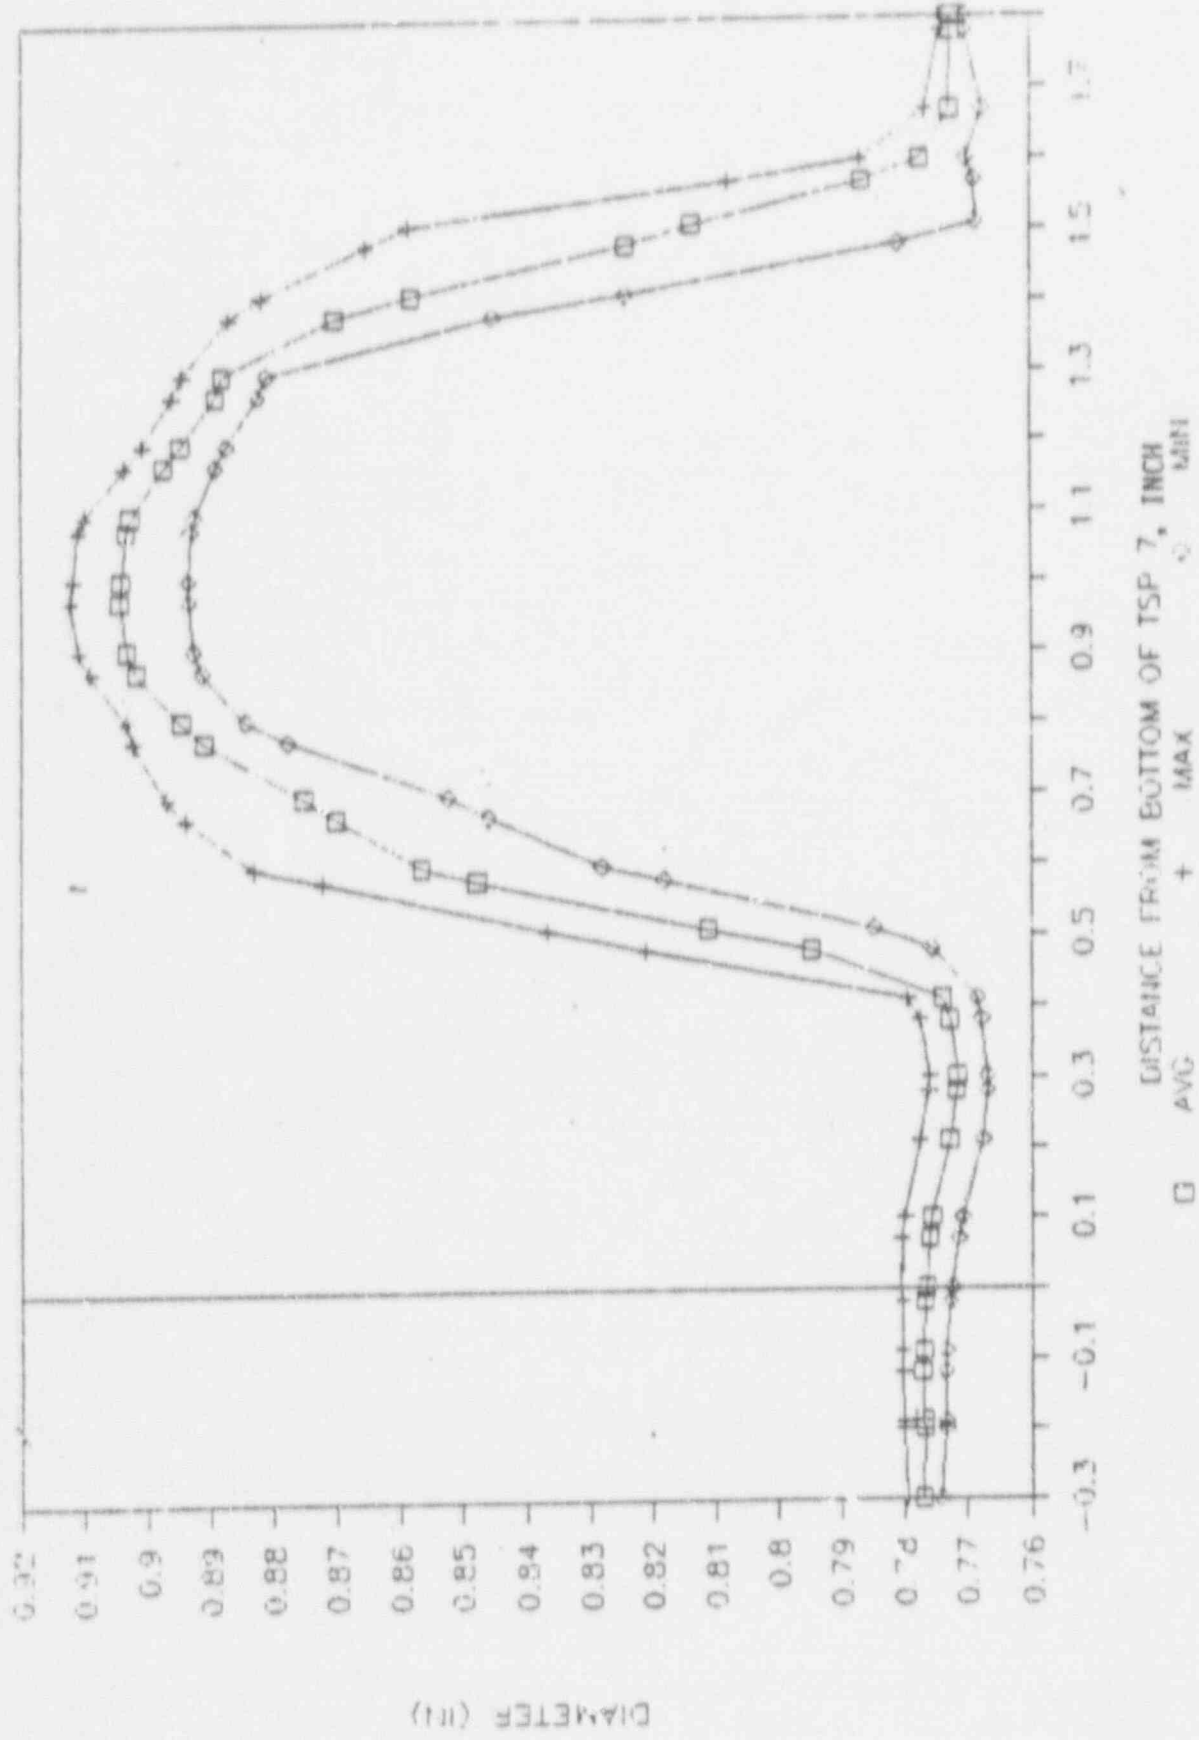
FIGURE 3.1-6 Severed Tube Profilometry Data

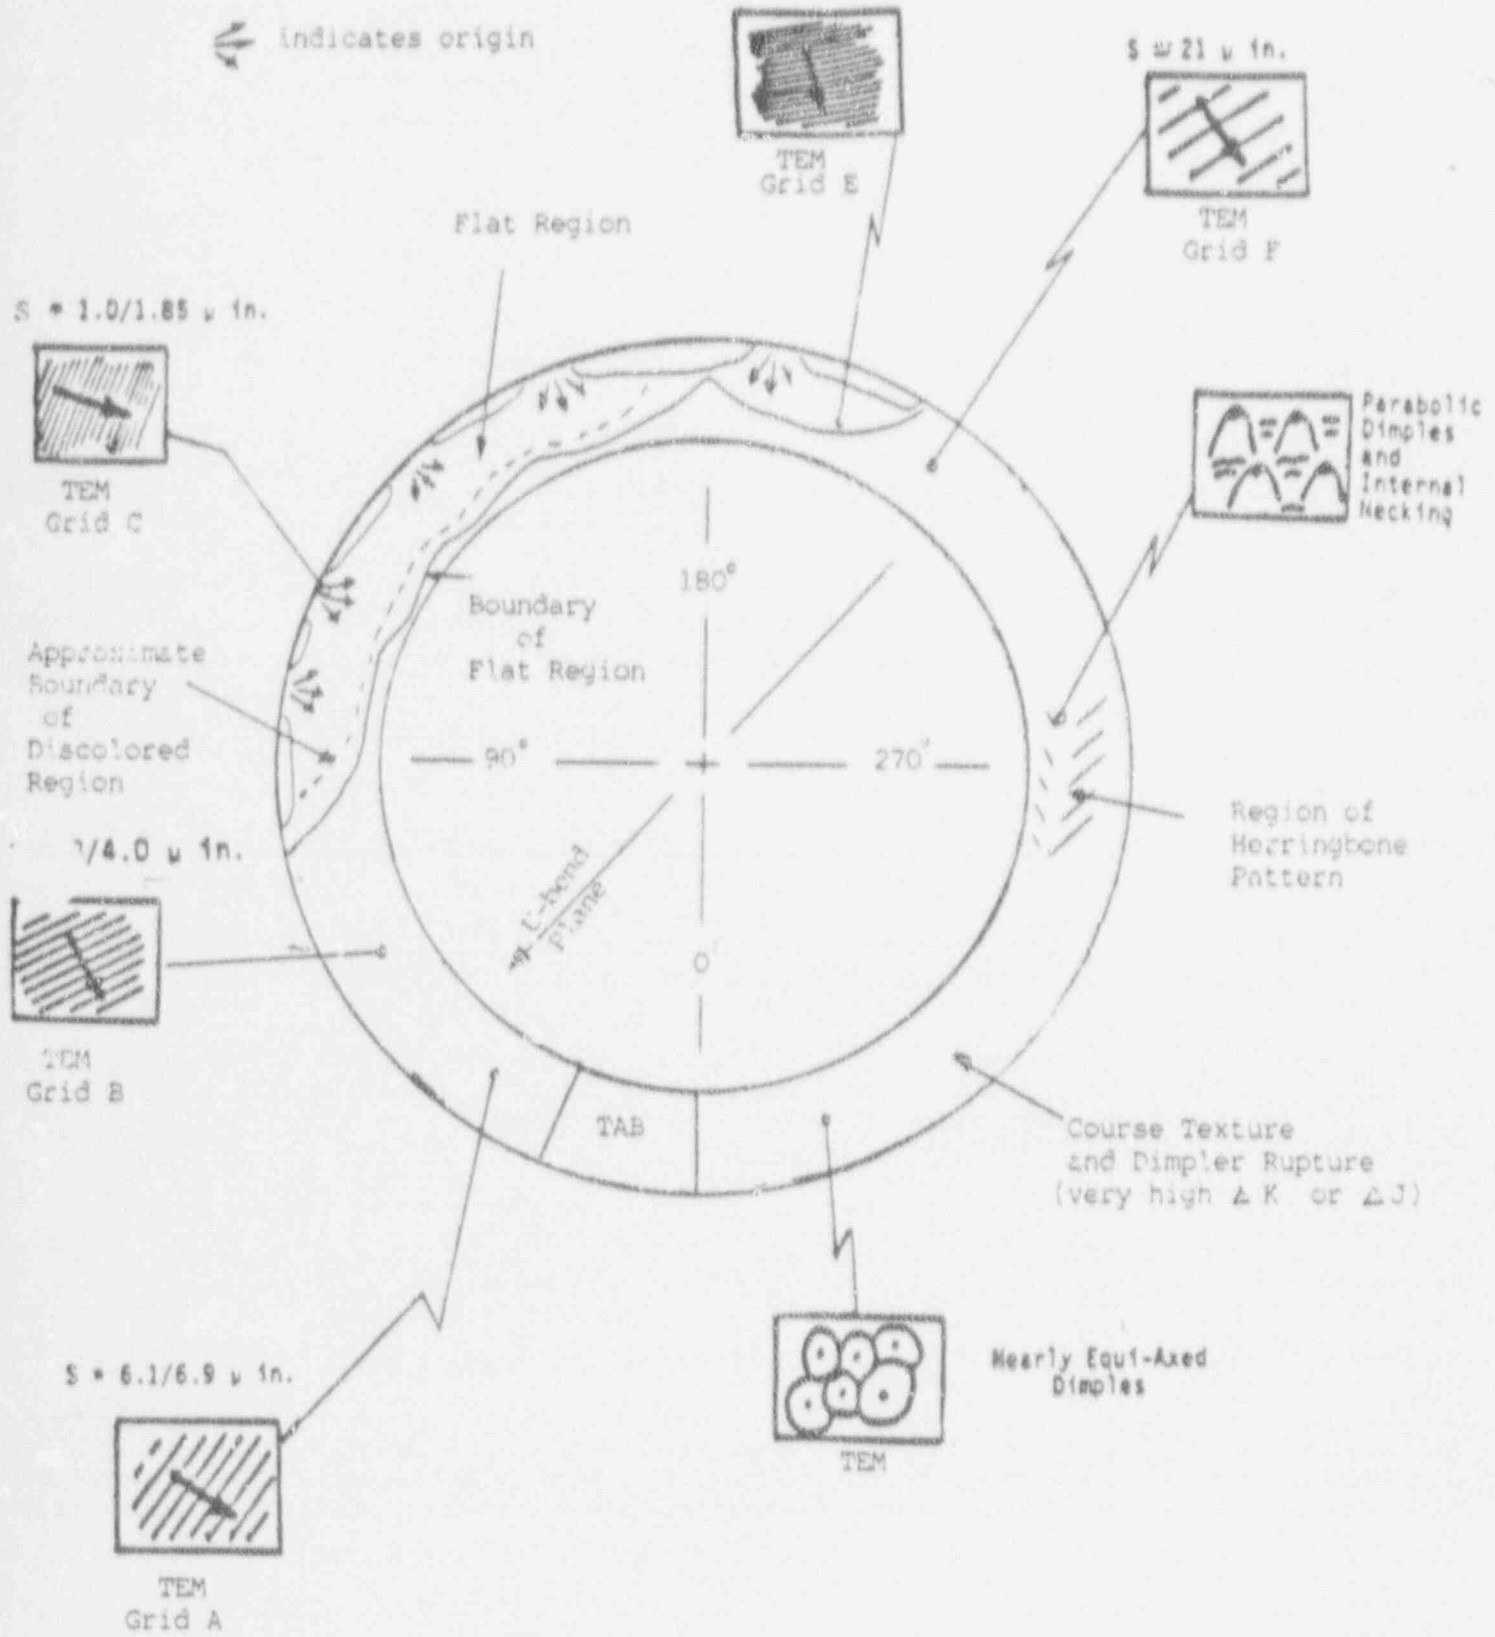
Figure 1 - Approximate mapping of fracture surface of tube R9-C51, S/G c

of the remainder of the fracture is oriented at about 45° to the wall surface except for a flat area surrounding a minor crack origin at about the 190° location. Clockwise from 180° , an initially fine texture becomes rougher with a "herringbone" pattern evident near the 270° region, indicating an accelerating rate of crack propagation.
