Iowa Electric Light and Power Company

Subject: Duane Arnold Energy Center
Pocket No: 50-331
Op. License DPR-49
Licensee Event Report #92-003

TITLE (4): Fire Barrier Degraded as a Result of an Unsealed Penetration following a Design Modification

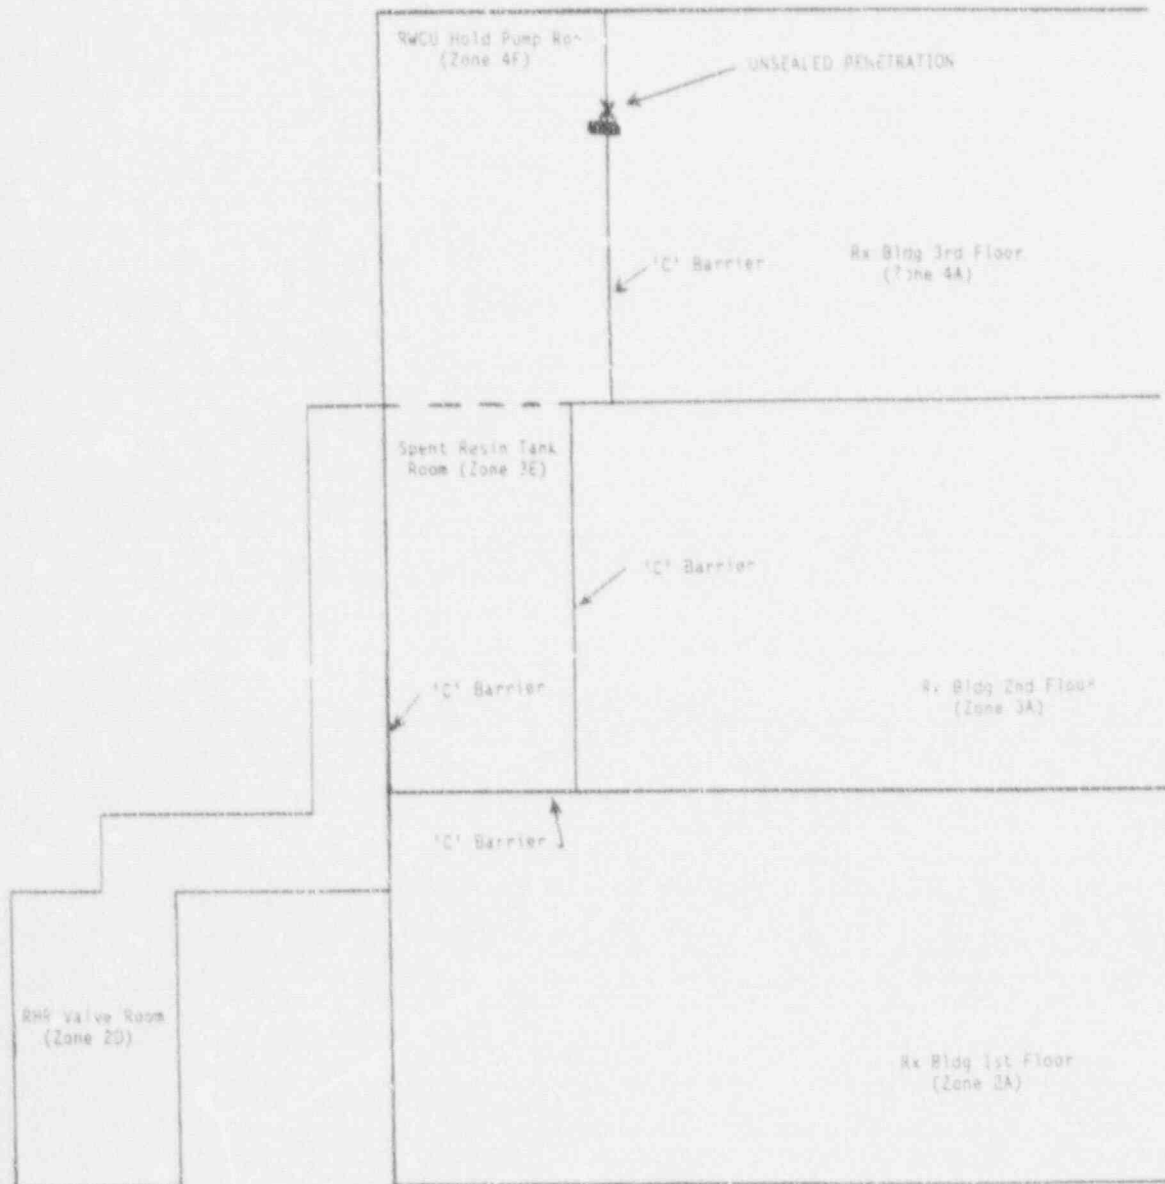
RELATIVE POSITIONS OF APPLICABLE FIRE ZONES AND BARRIERS
(diagram does not represent actual room sizes or locations)

The barrier in question, which the DAEC classifies as a type "C" (see note 1) fire barrier, is used to meet 10 CFR 50 Appendix R separation requirements for safe shutdown equipment. When "C" barriers are used to meet Appendix R requirements, more than one "C" barrier must be intact between the safe shutdown equipment fire zones. The fire zones which did not meet the separation requirement due to the inoperable "C" barrier caused by the unsealed fire penetration are zones 4A (reactor building third floor) and 3A (reactor building second floor), zones 4A and 2D (Residual Heat Removal (RHR) valve room), and zones 4A and 2A (first floor reactor building). The two fire zones (4F-RWCU hold pump room and 3E-spent resin tank room) which a fire must pass through to get from zone 4A to any of the above mentioned zones do not contain safe shutdown equipment. (see attached diagram)
