MIDLAND UNITS 1 & 2  
JOB NO. 7220

REVIEW OF U.S. TESTING  
FIELD AND LABORATORY CONSTRUCTION  
TEST DATA ON SOILS USED AS FILL

BECHTEL ASSOCIATES PROFESSIONAL CORPORATION  
July 1979

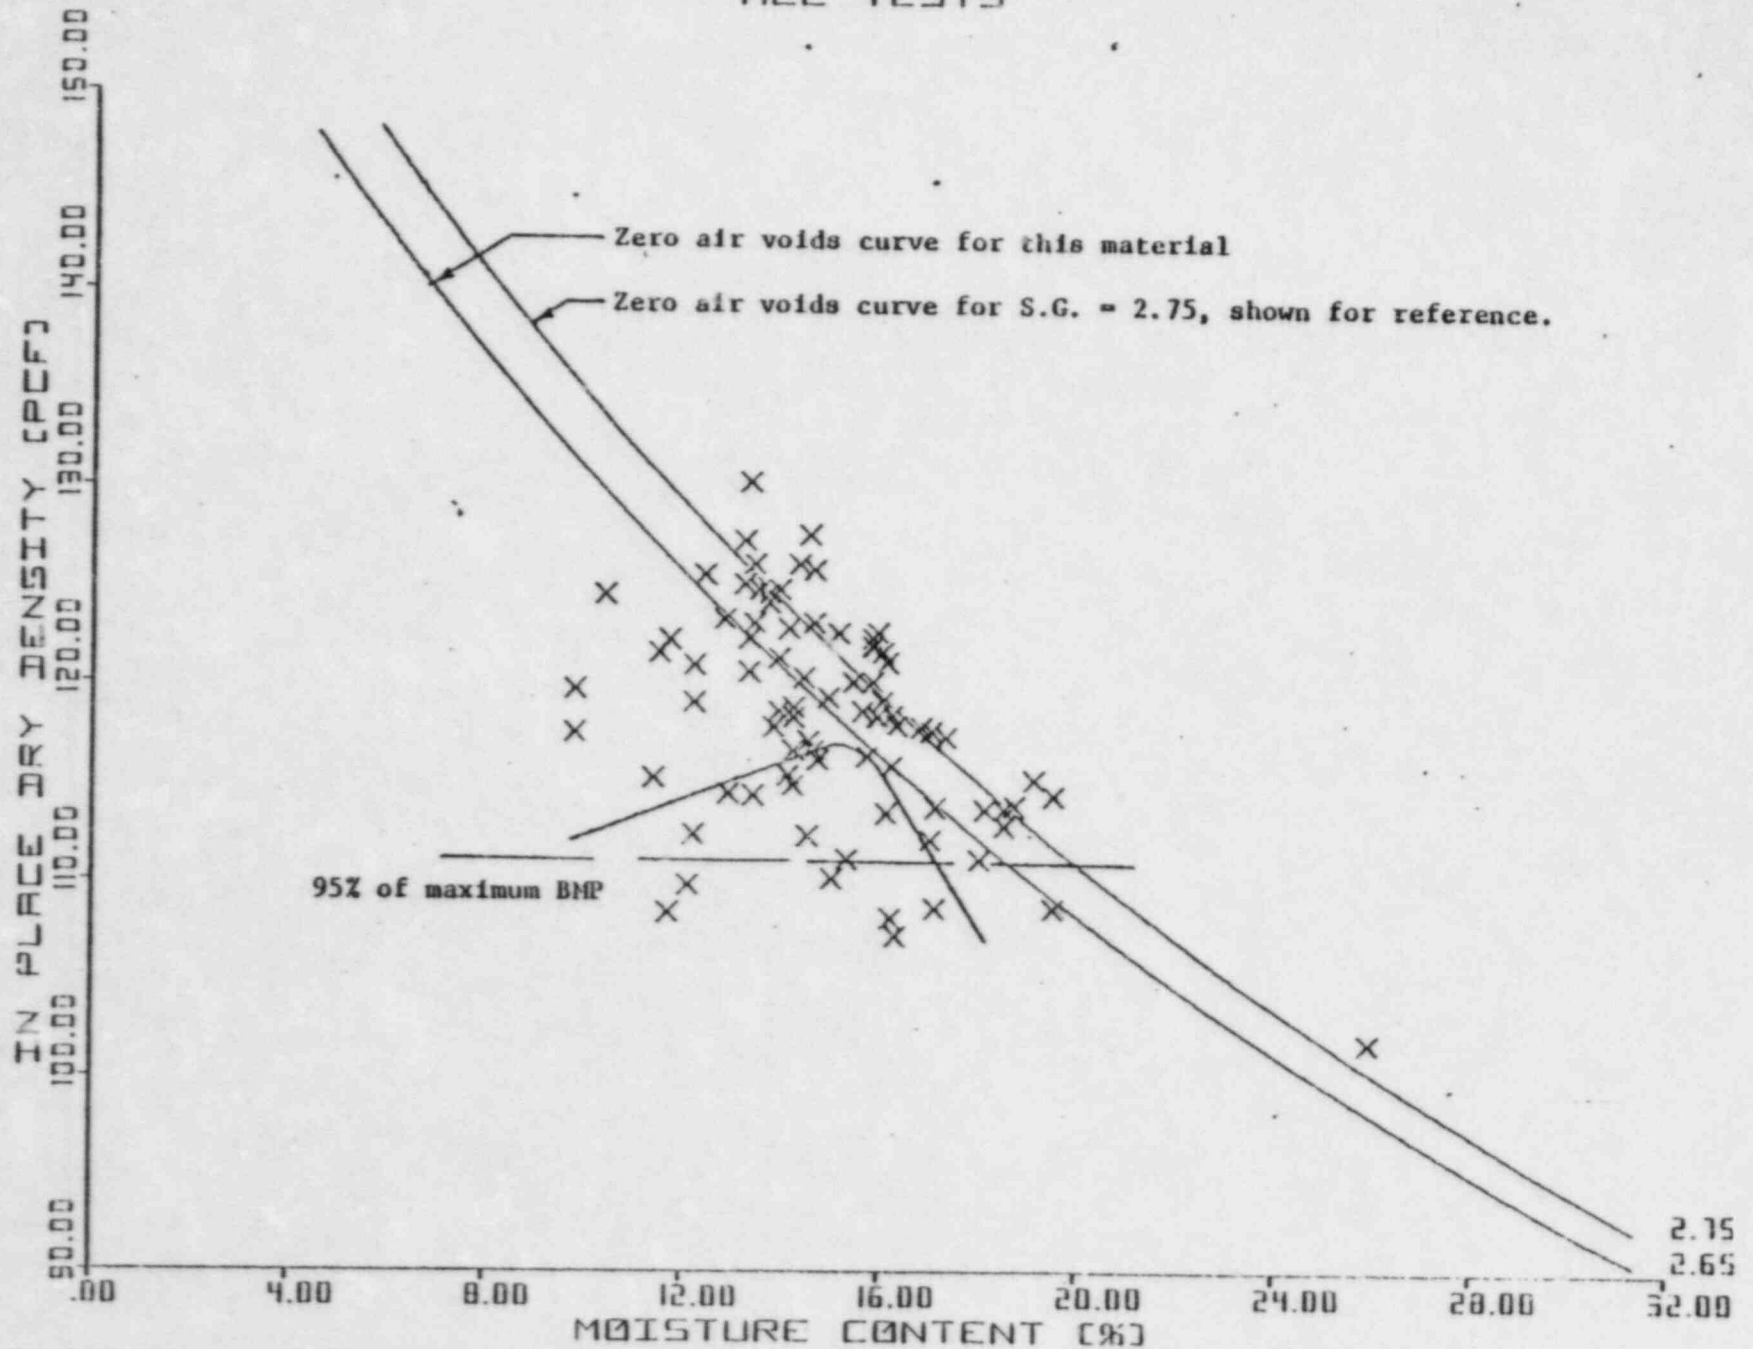
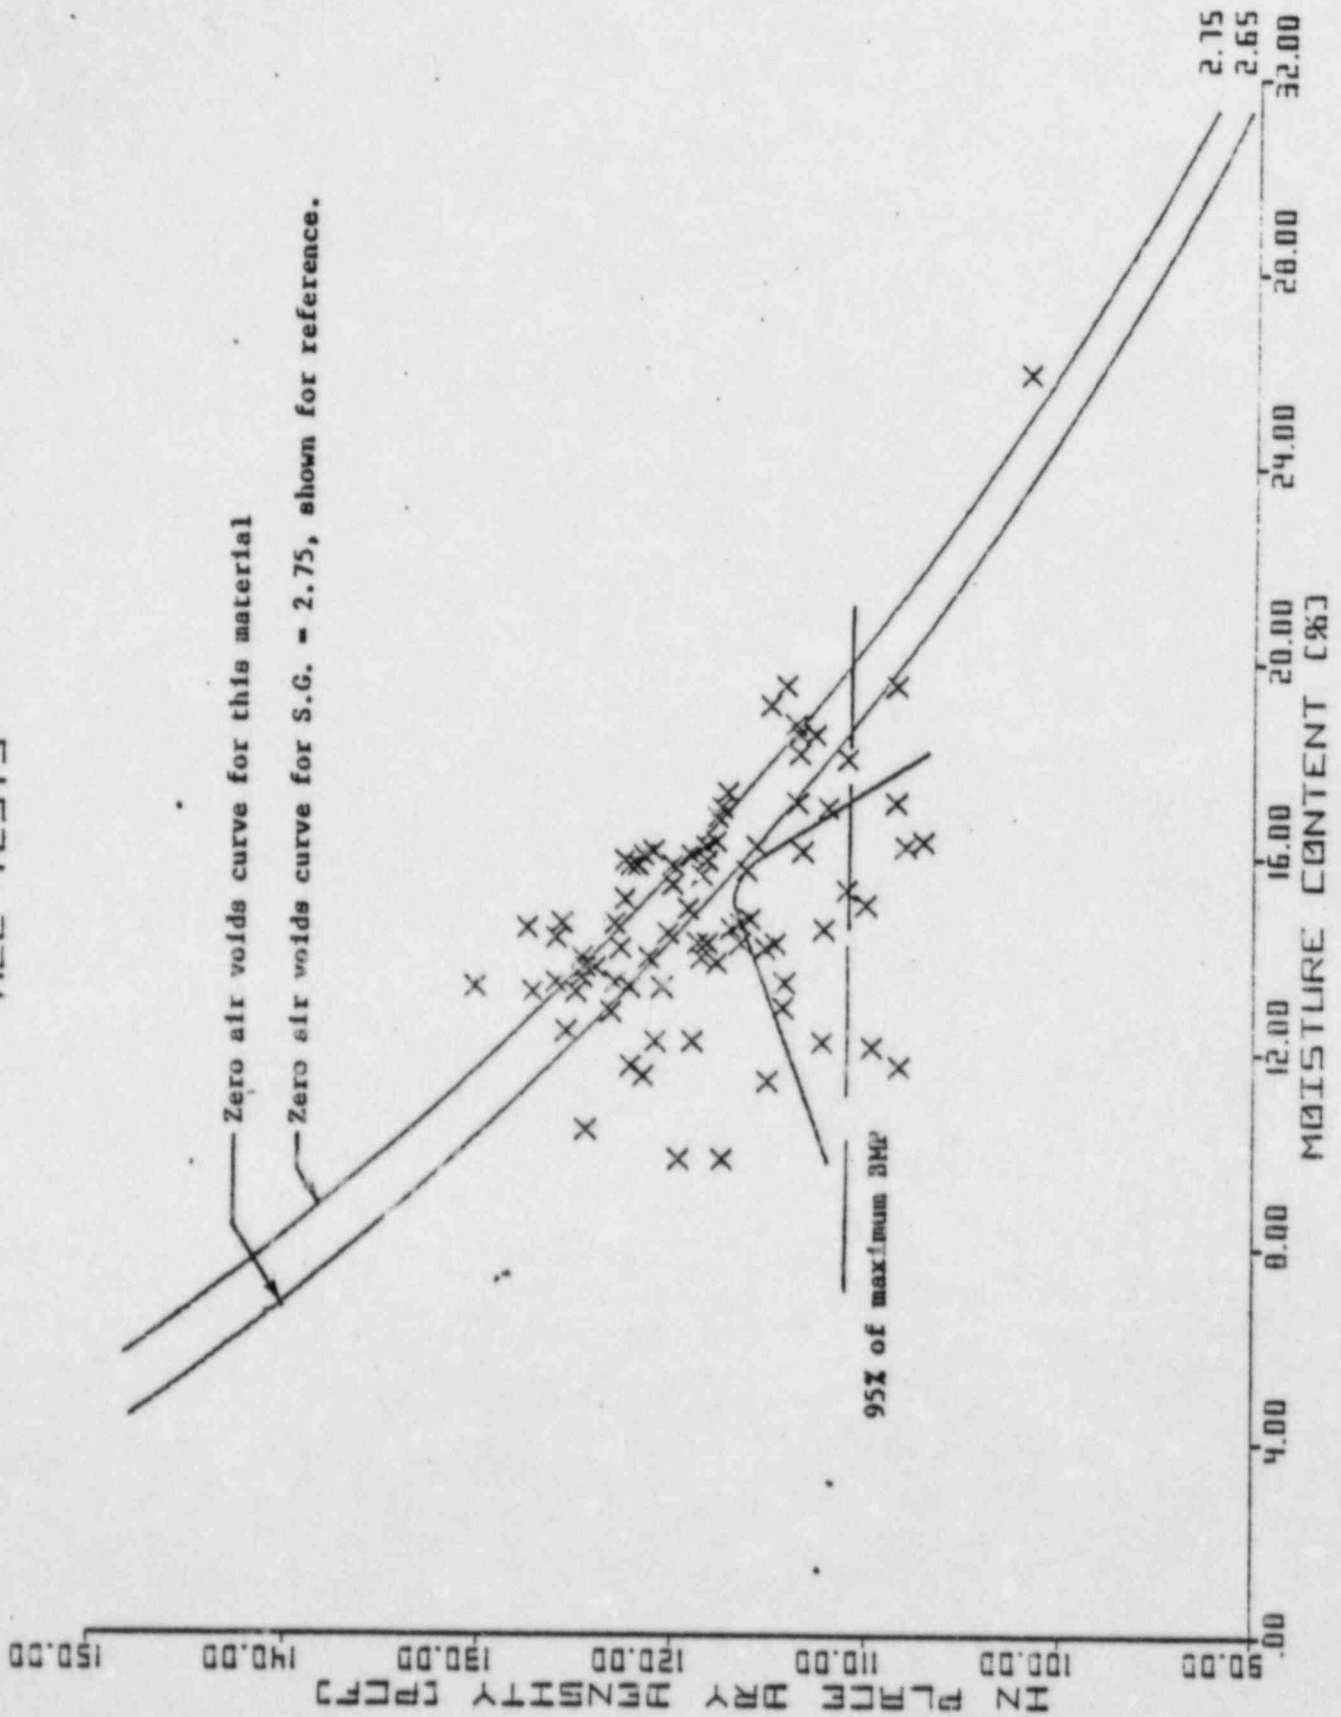
FIGURE 1

Soils cannot be more than 100 percent saturated; therefore, all field density test data points, when plotted as dry density versus moisture content, must be below the zero air voids curve as defined by the specific gravity of the material. Specifications do not require examination of the zero air voids curve, but it is considered common practice relative to compaction plots. There are numerous cases in the U. S. Testing Company data where points plot above the zero air voids curve. Figure 1 attached shows a typical laboratory compaction test curve with field test results plotted on it. Many of the field test results are to determine percent compaction plot above the zero air voids curve. Provided the specific gravity is correct this is not possible so that all such points must represent erroneous data.

# MOISTURE-DENSITY FOR BMP 278

SPECIFIC GRAVITY = 2.65  
ALL TESTS

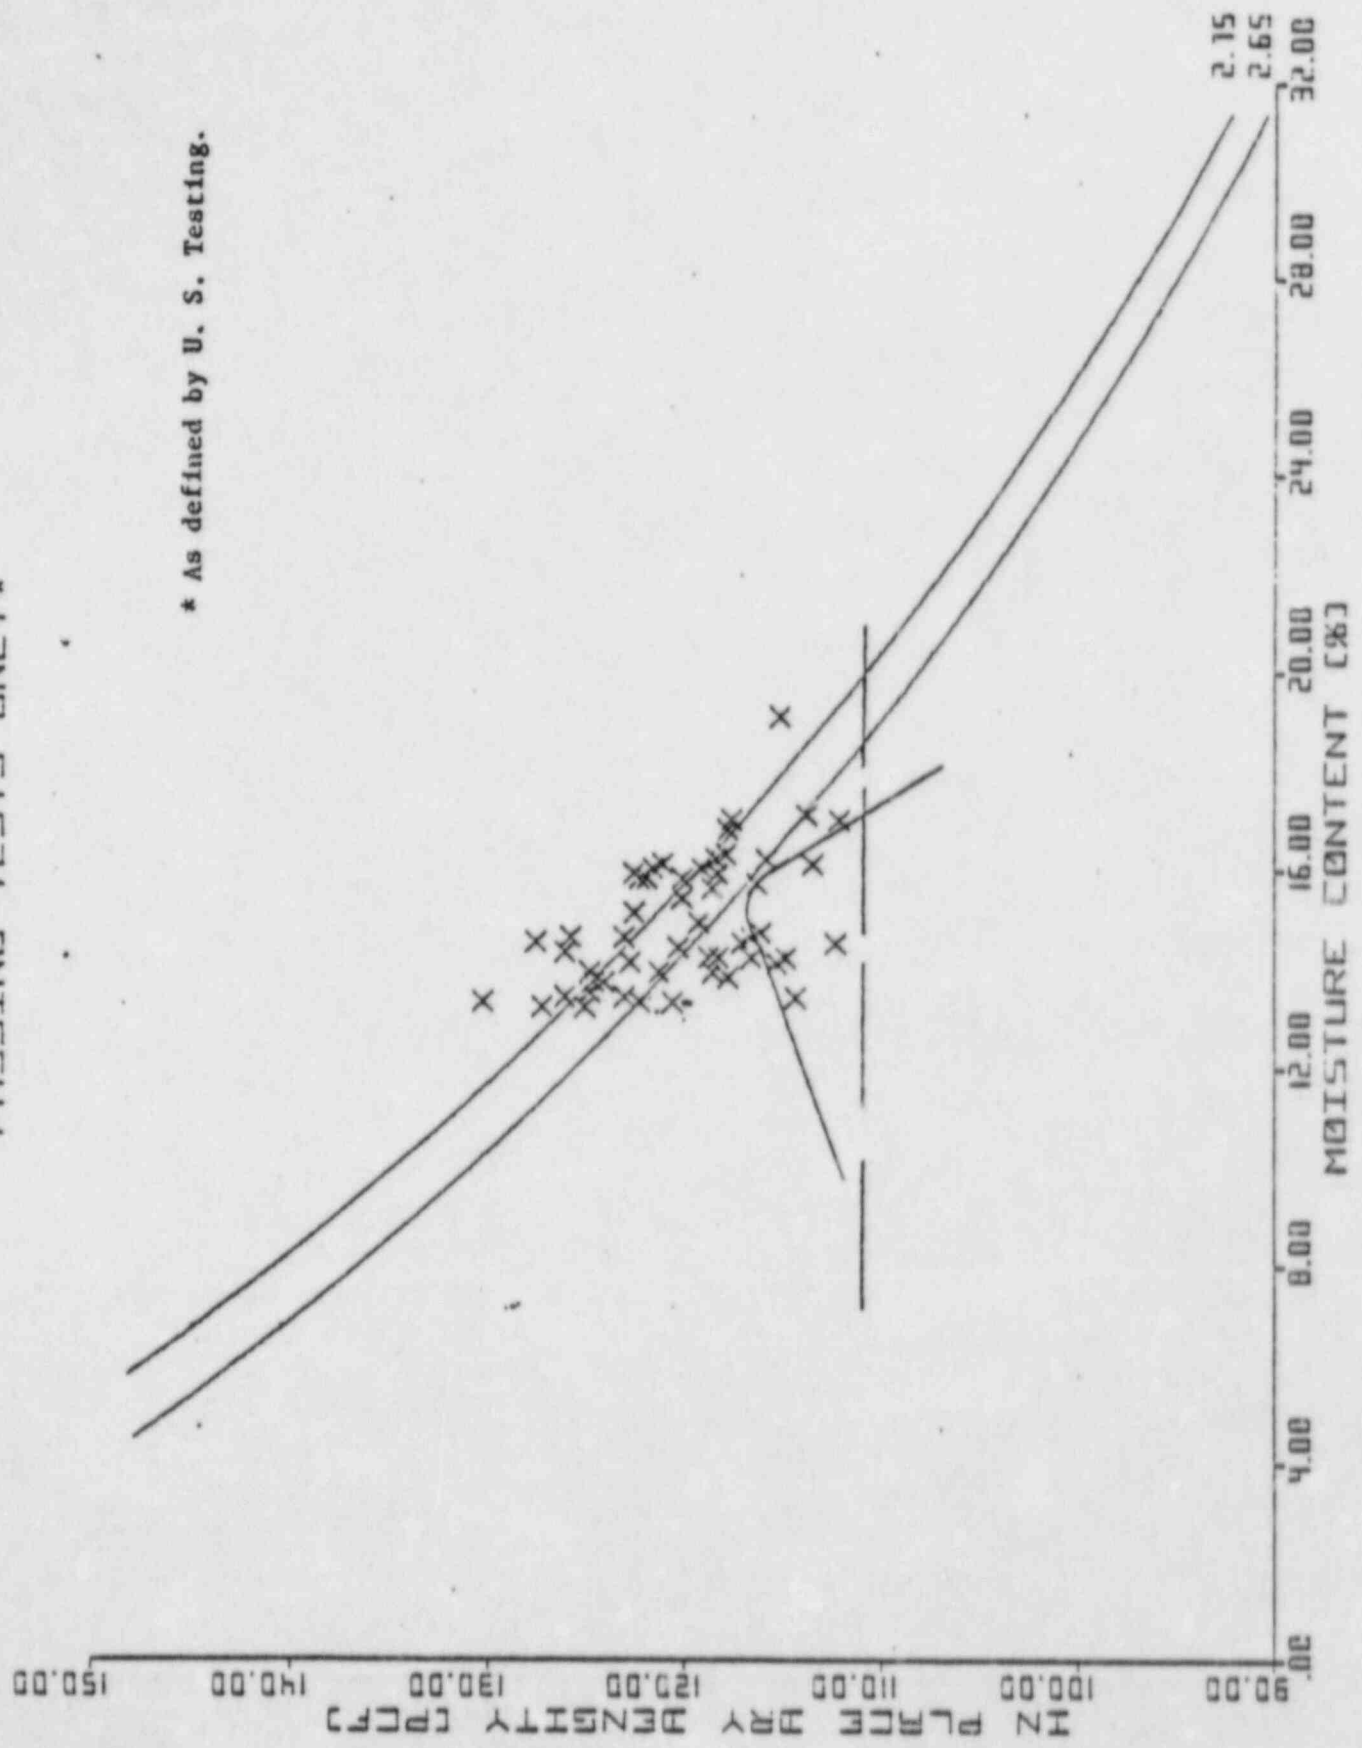
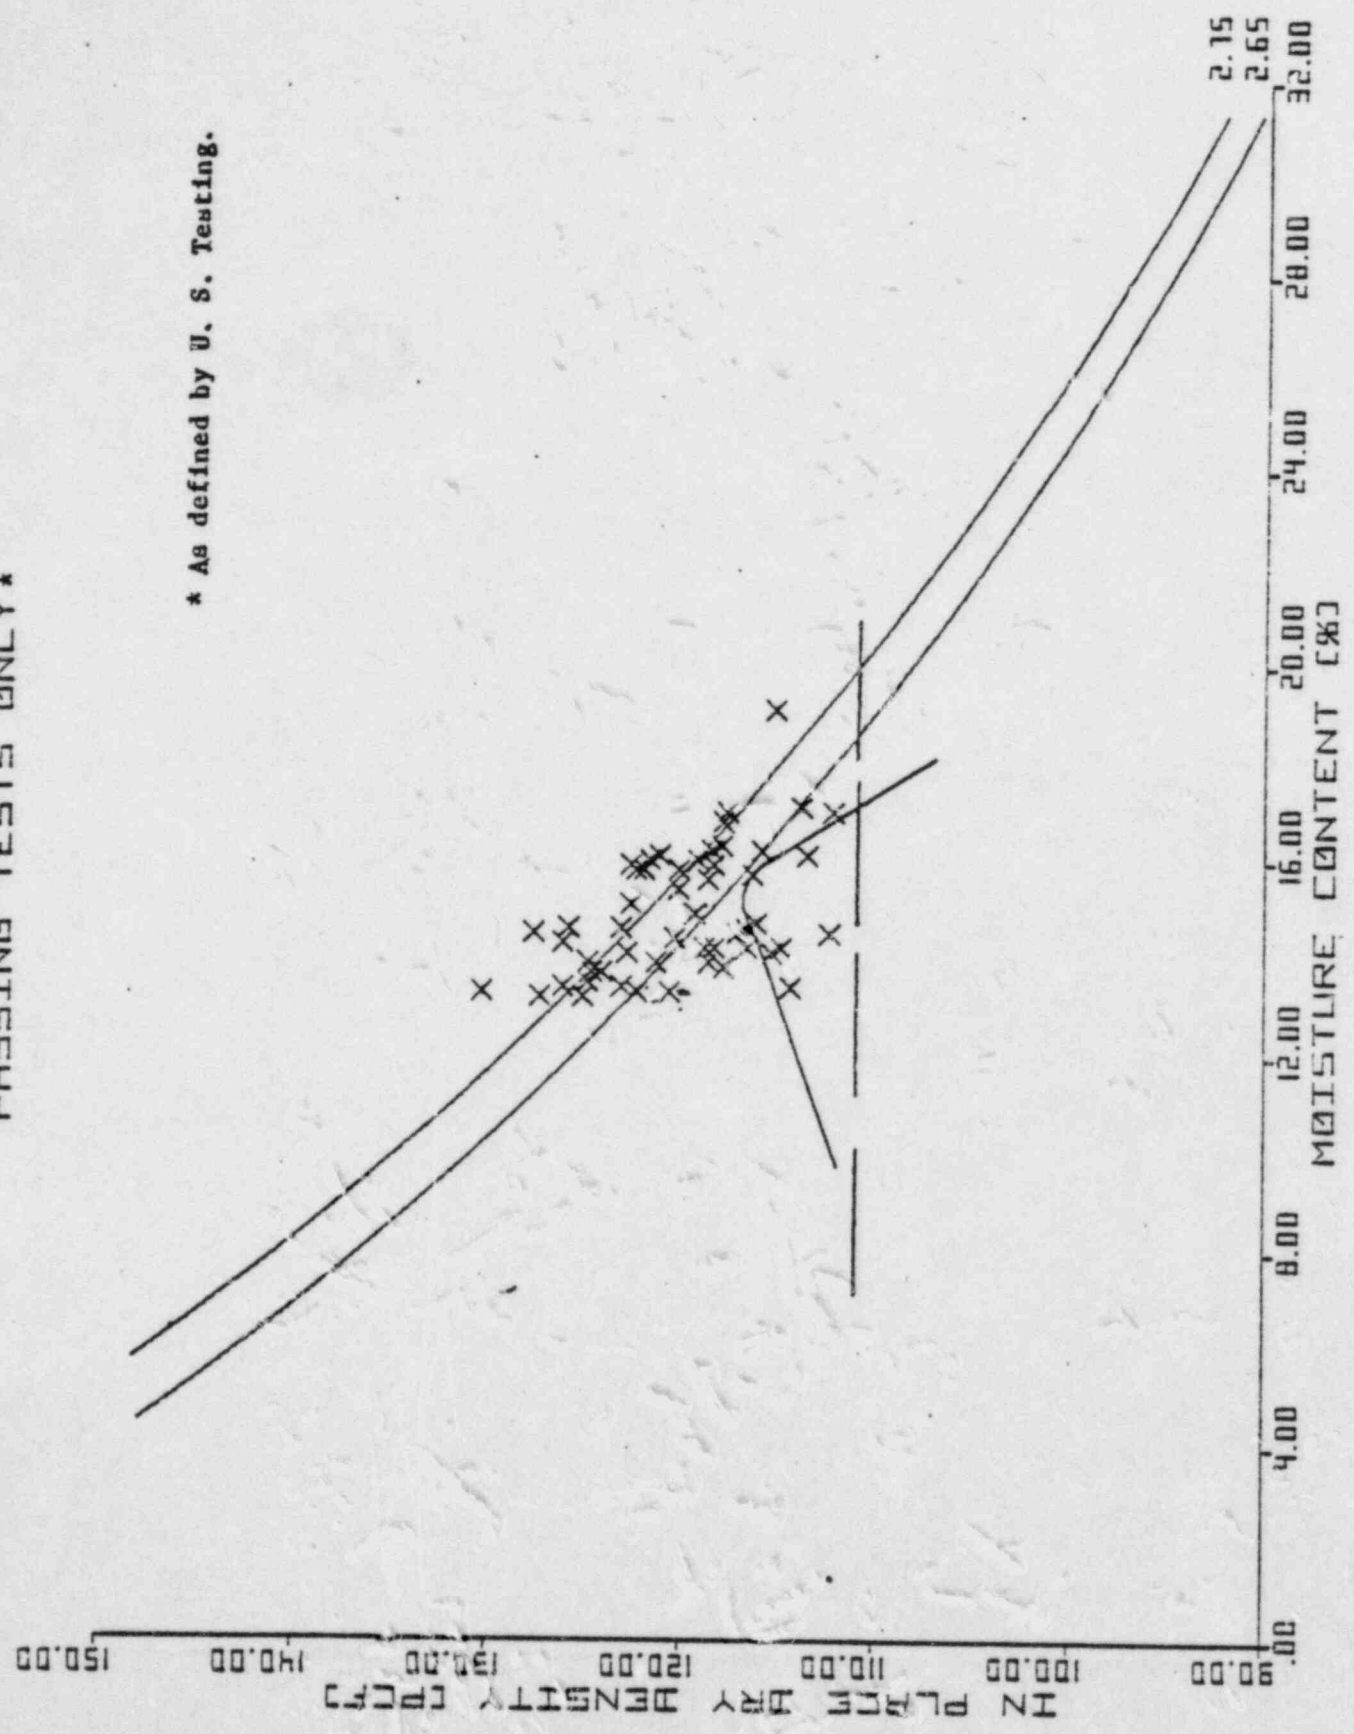
FIGURE 2

MOISTURE-DENSITY FOR BMP 278  
 SPECIFIC GRAVITY = 2.65  
 PASSING TESTS ONLY\*

Figure 2 and 5 -- there are approximately four tests that are shown to the right of the ~~water~~<sup>optimum</sup> moisture content plus 2% line which should be failing tests but are shown as passing tests.

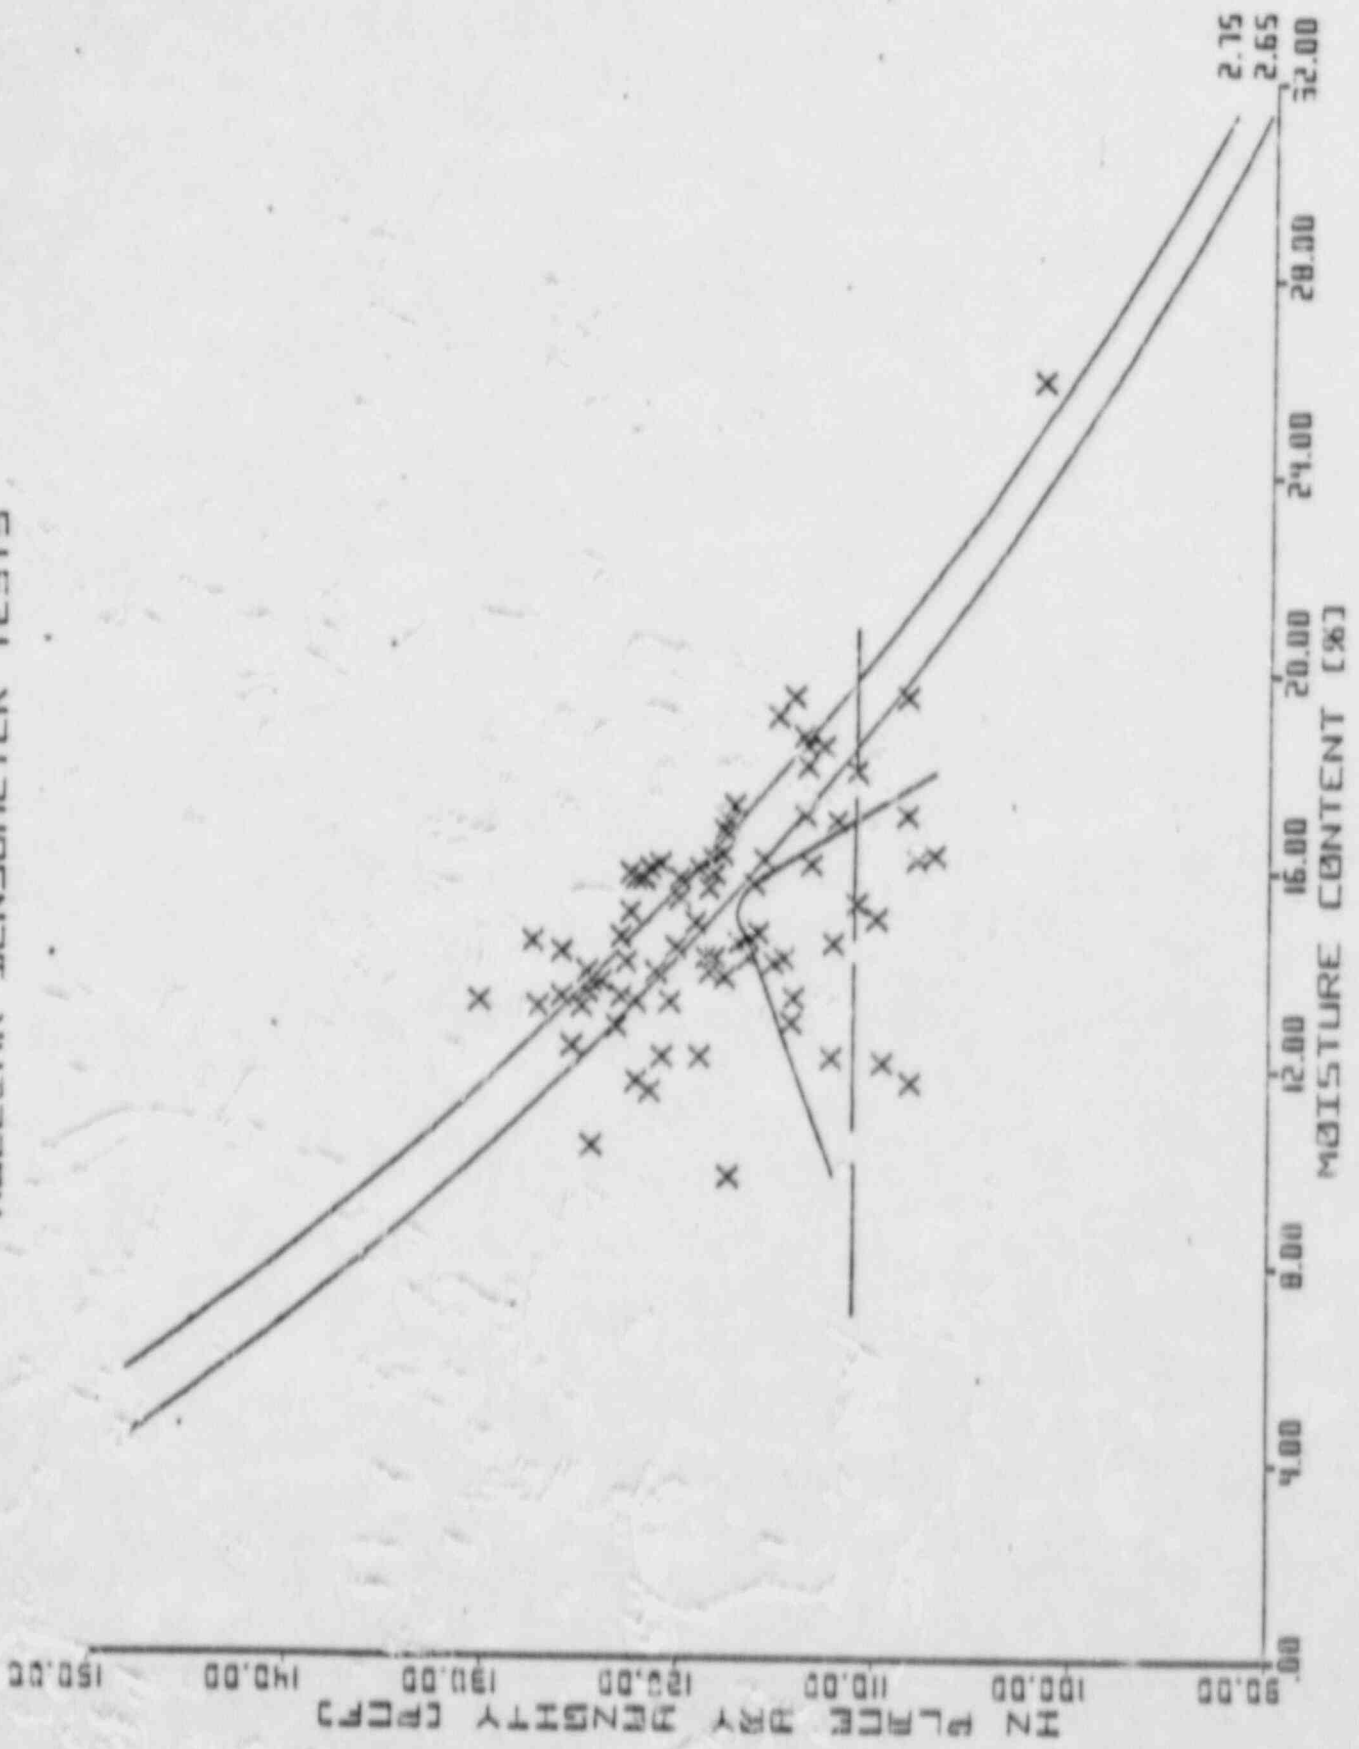
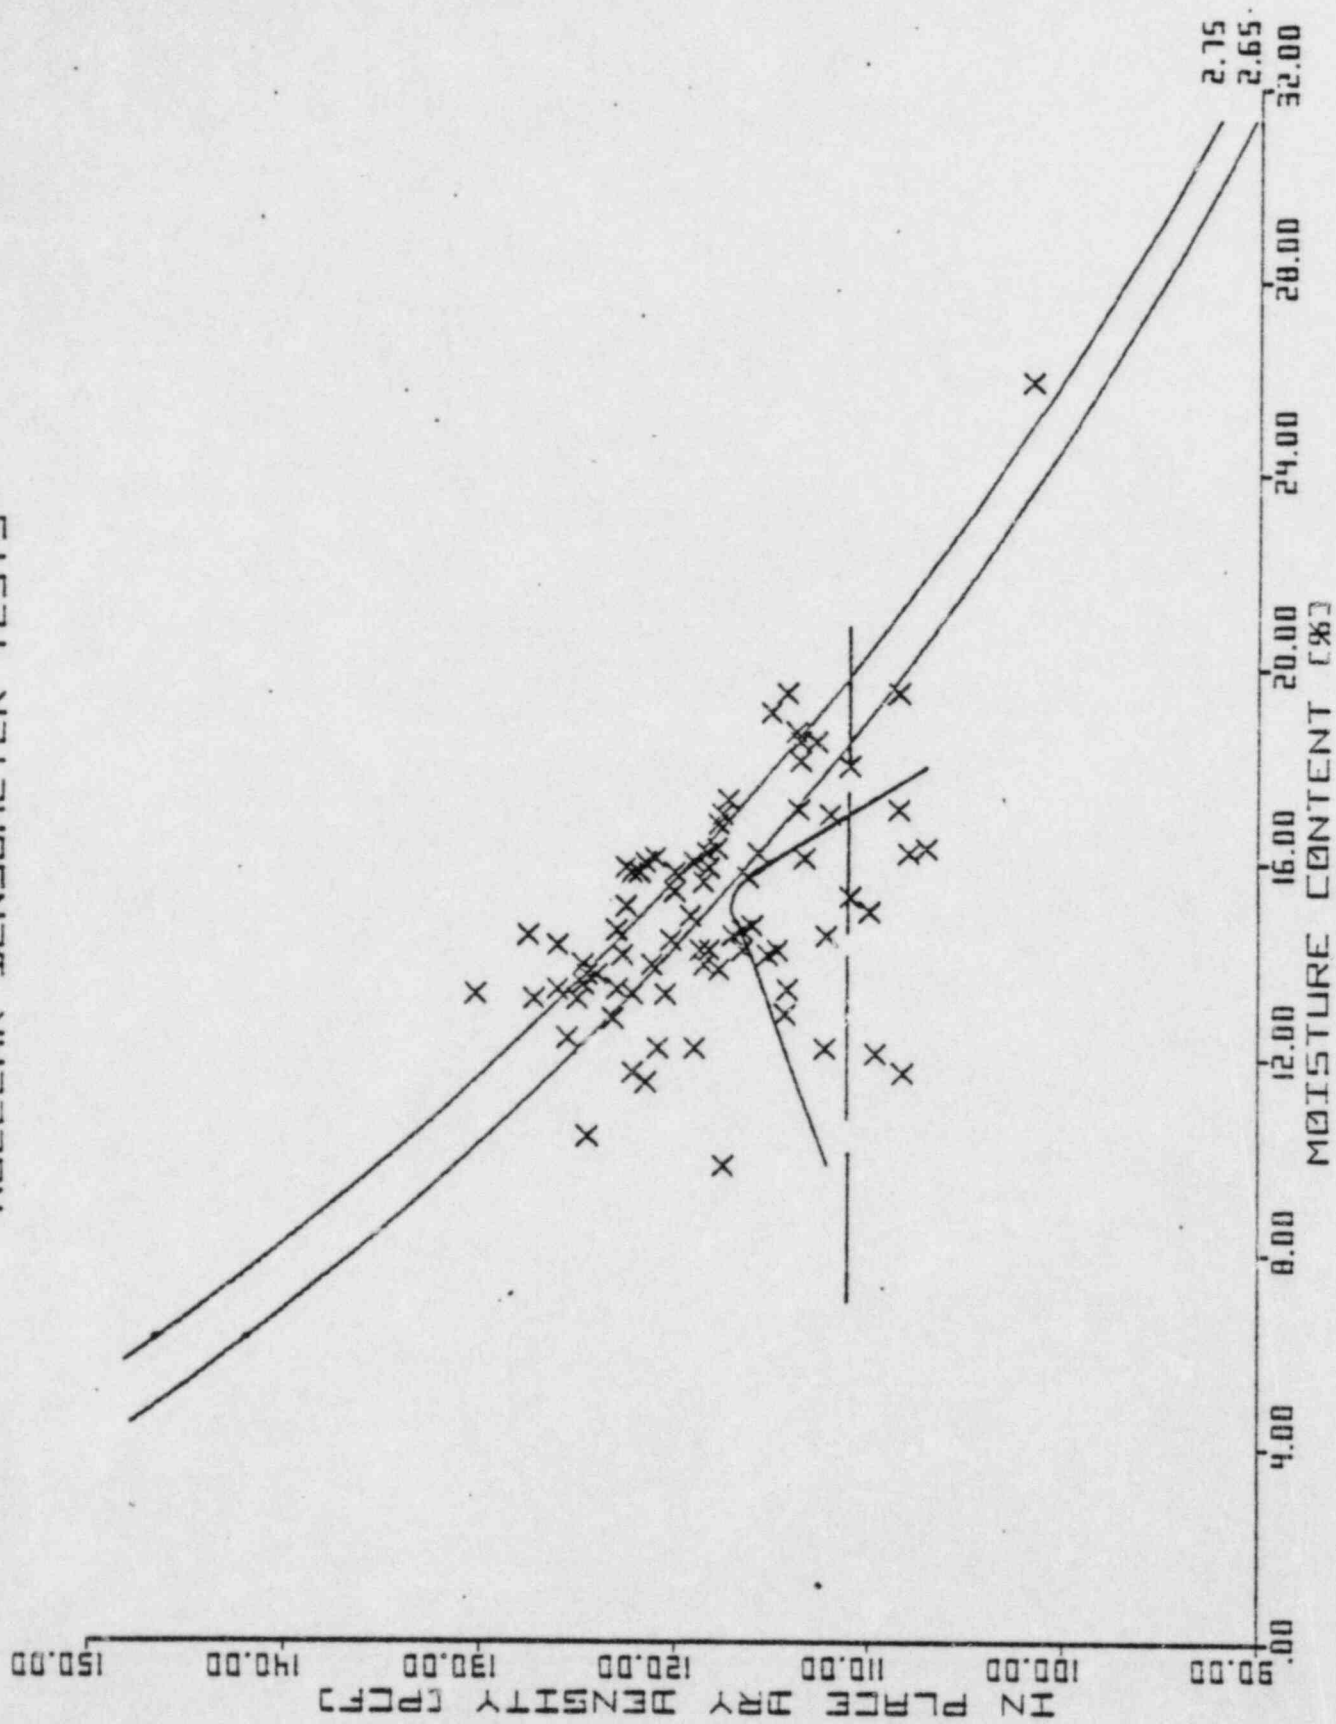
FIGURE 3

MOISTURE-DENSITY FOR BMP 278  
 SPECIFIC GRAVITY = 2.65  
 NUCLEAR DENSOMETER TESTS

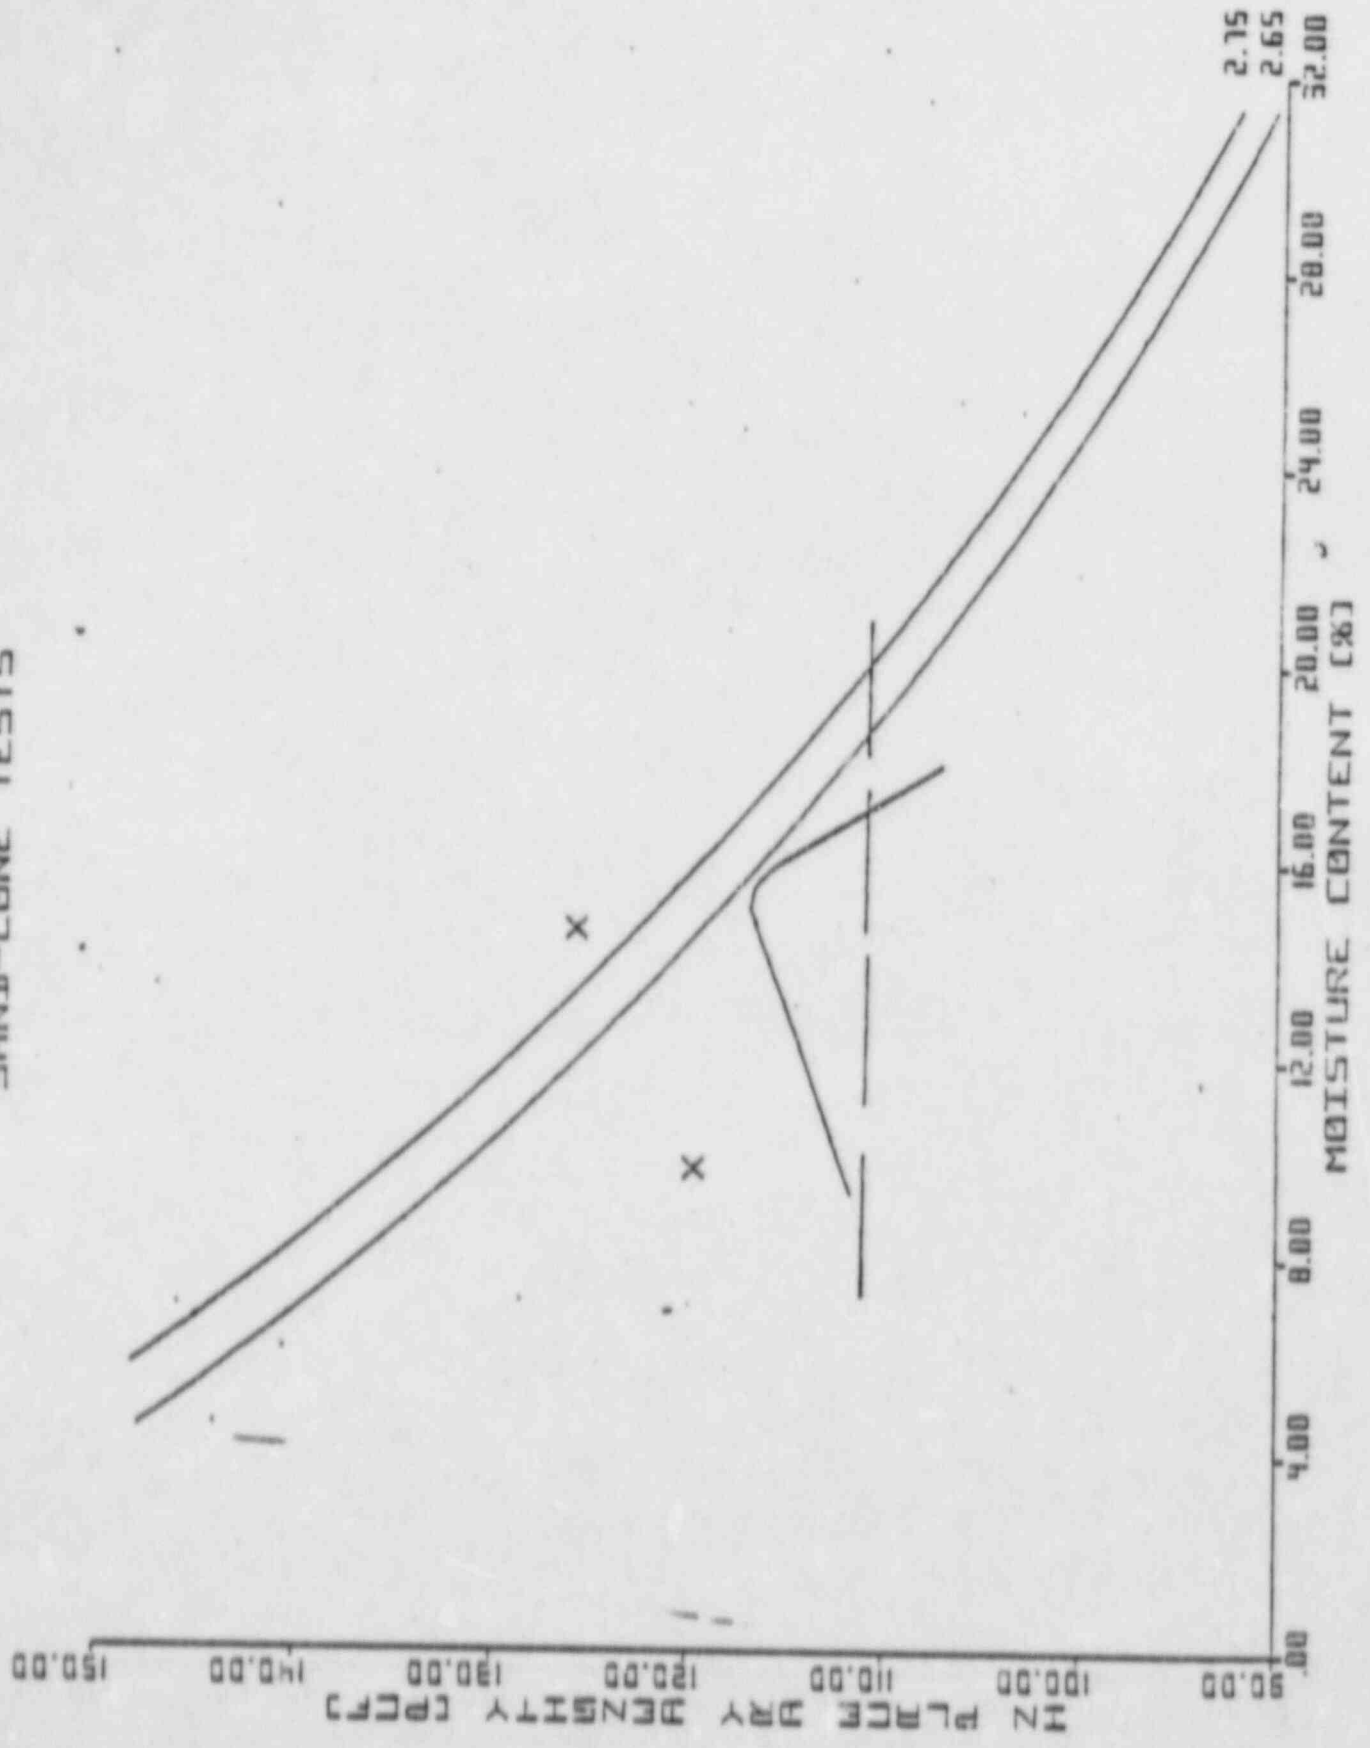
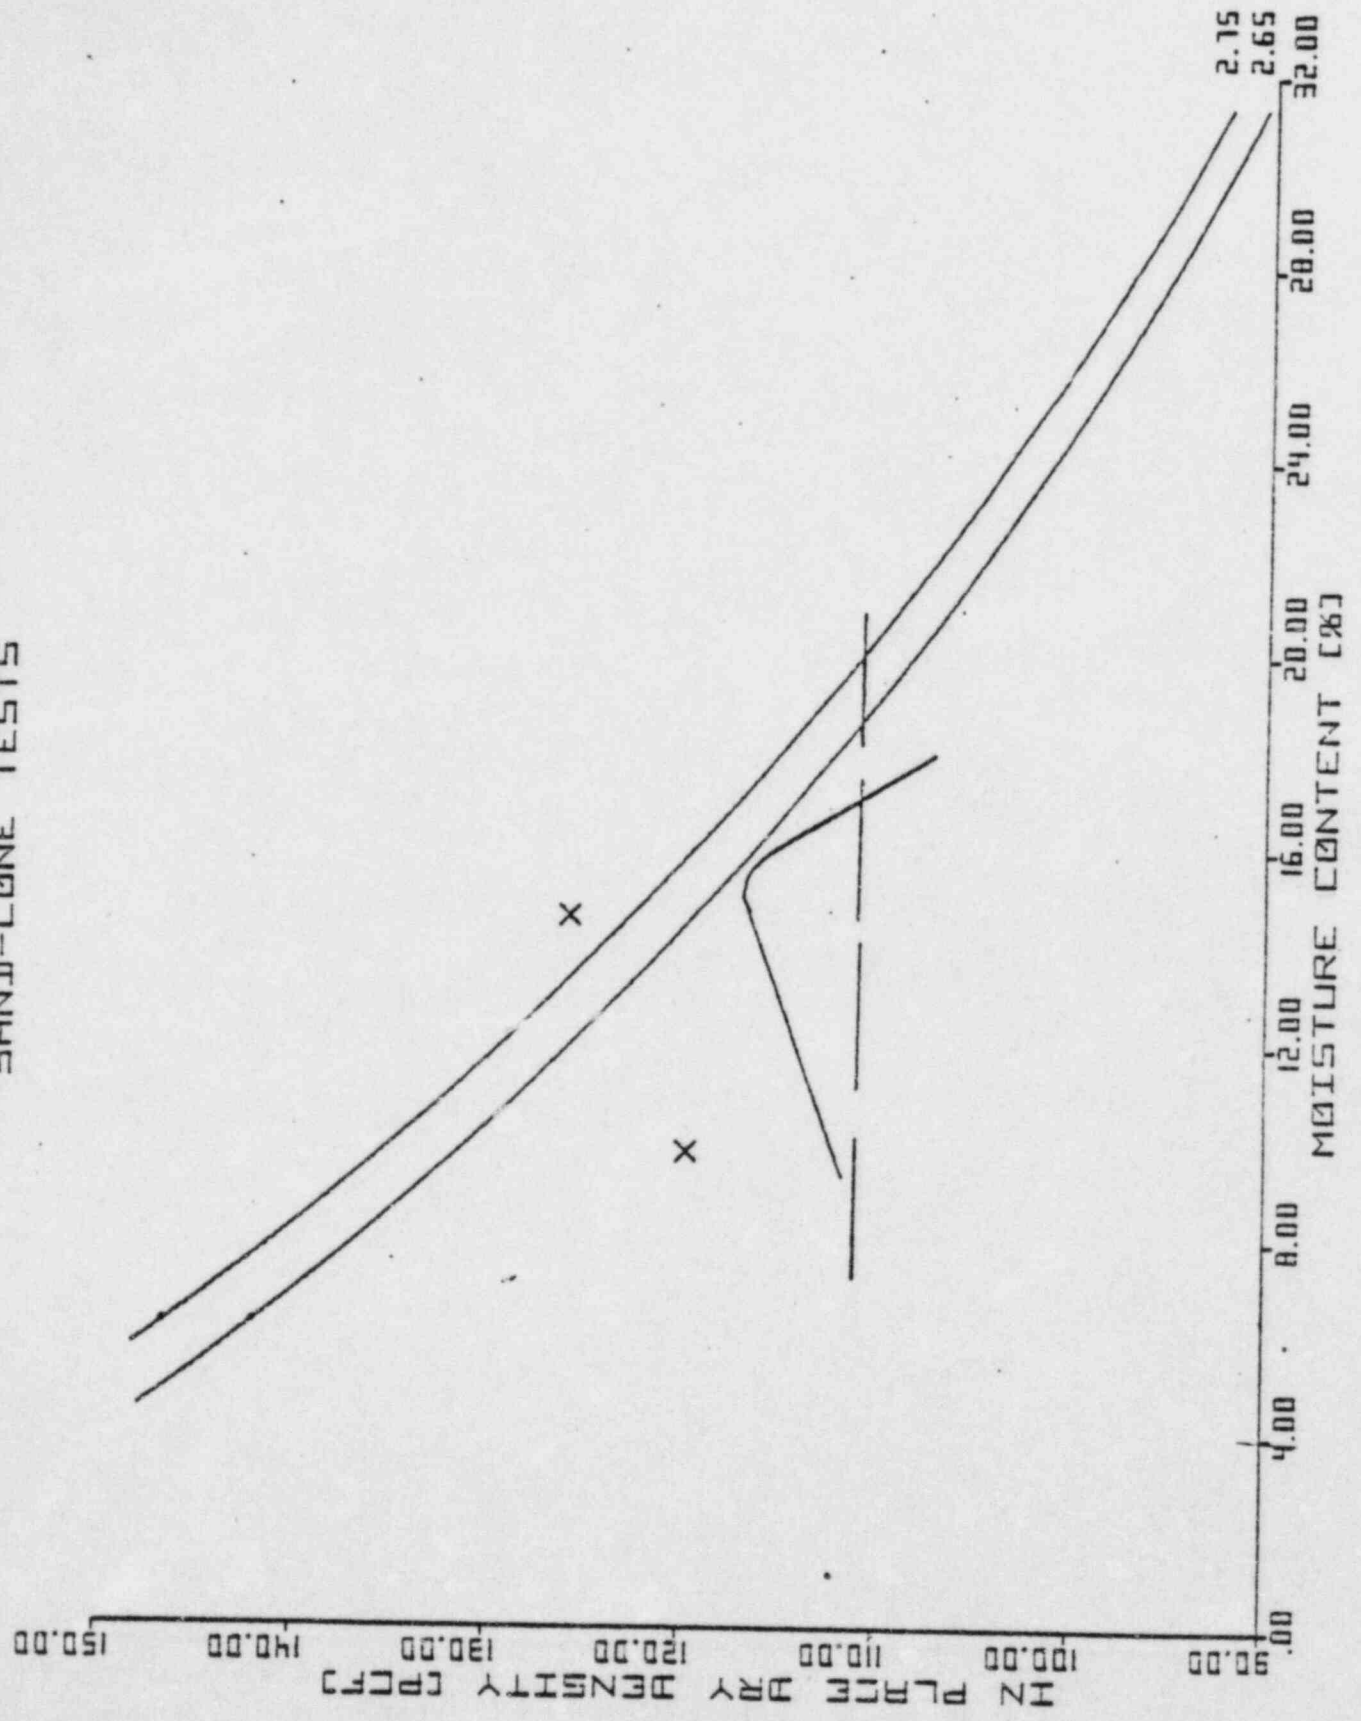
FIGURE 4

MOISTURE-DENSITY FOR BMP 278  
 SPECIFIC GRAVITY = 2.65  
 SAND-CONE TESTS
