MIDLAND UNITS 1 & 2  
JOB NO. 7220

REVIEW OF U.S. TESTING  
FIELD AND LABORATORY CONSTRUCTION  
TEST DATA ON SOILS USED AS FILL

BECHTEL ASSOCIATES PROFESSIONAL CORPORATION  
July 1979

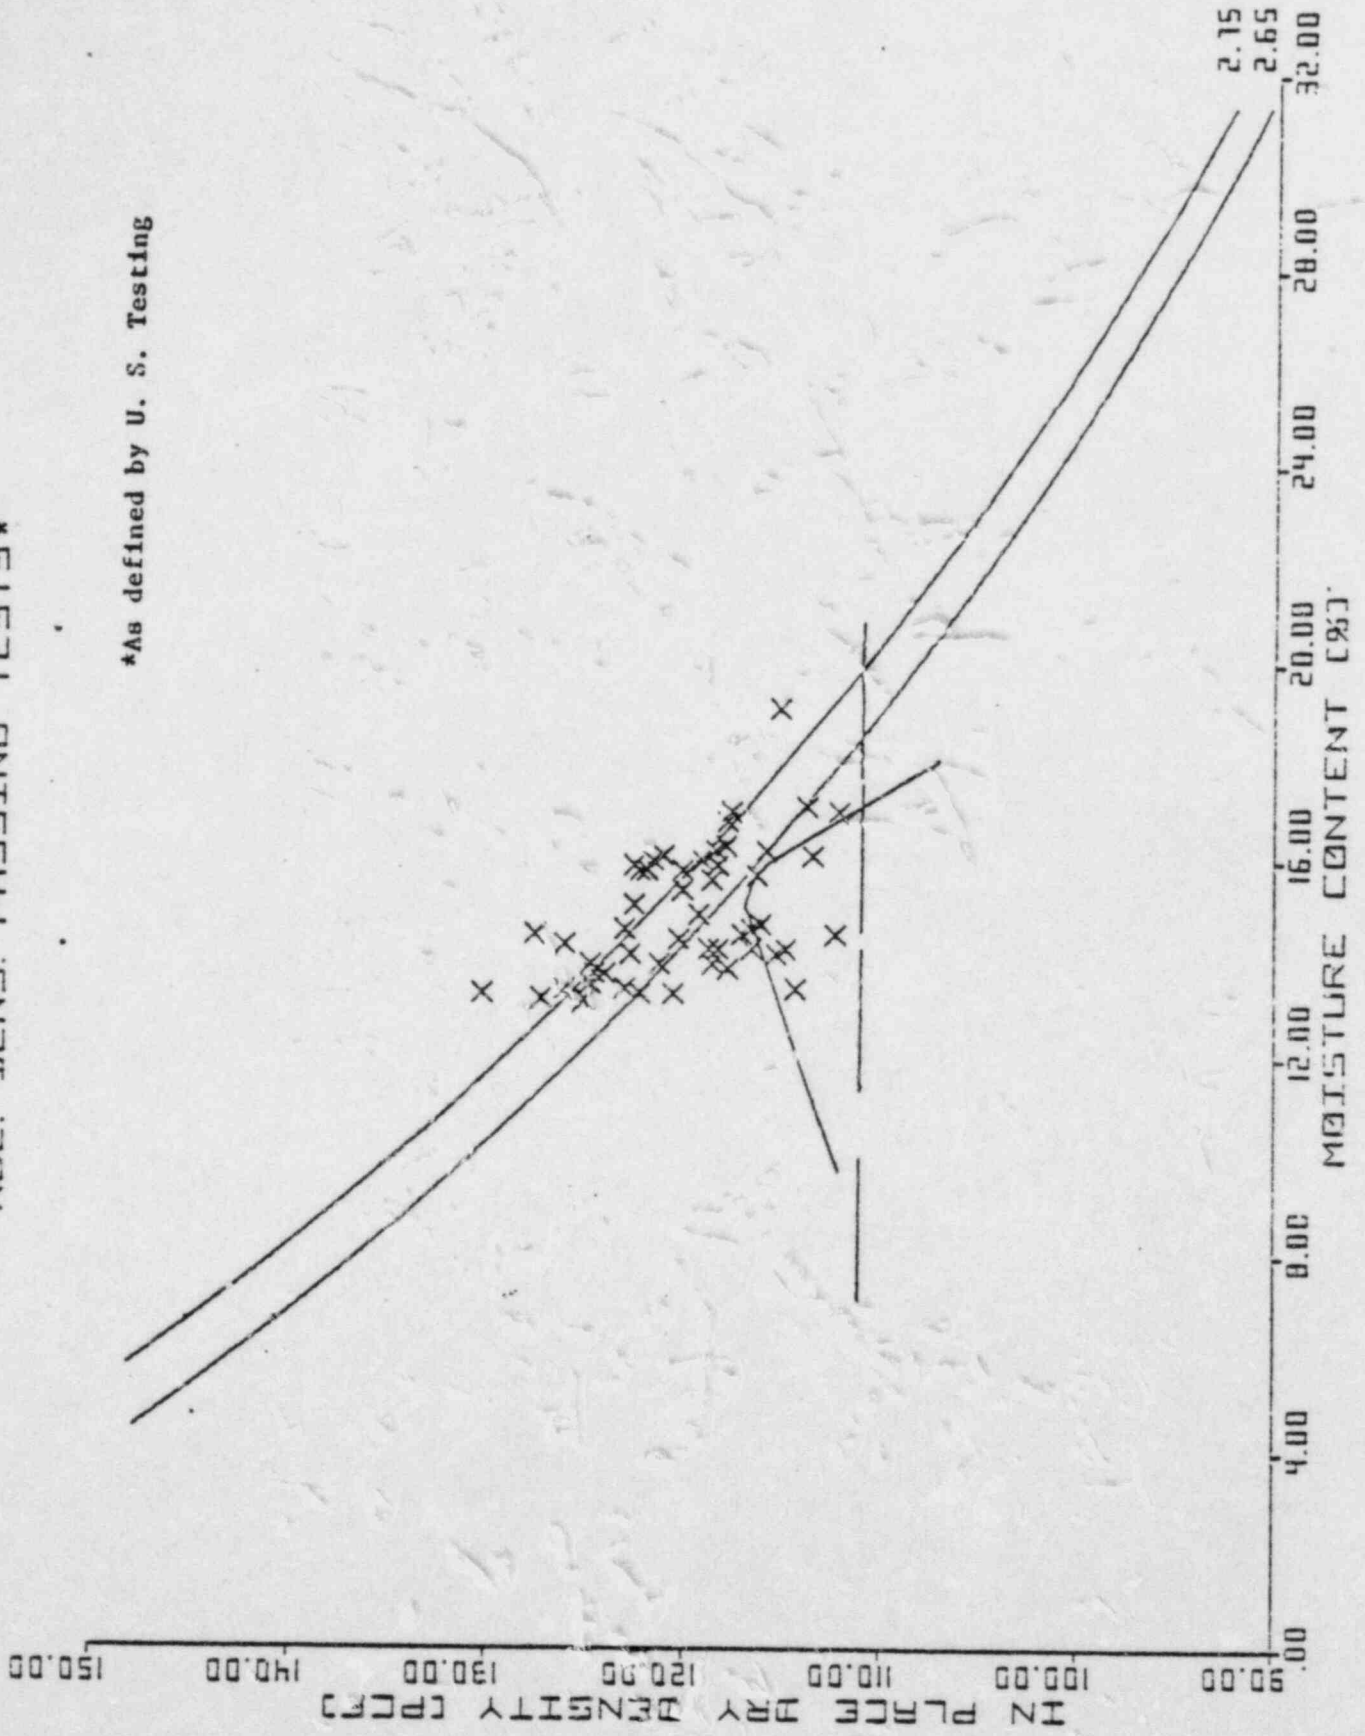
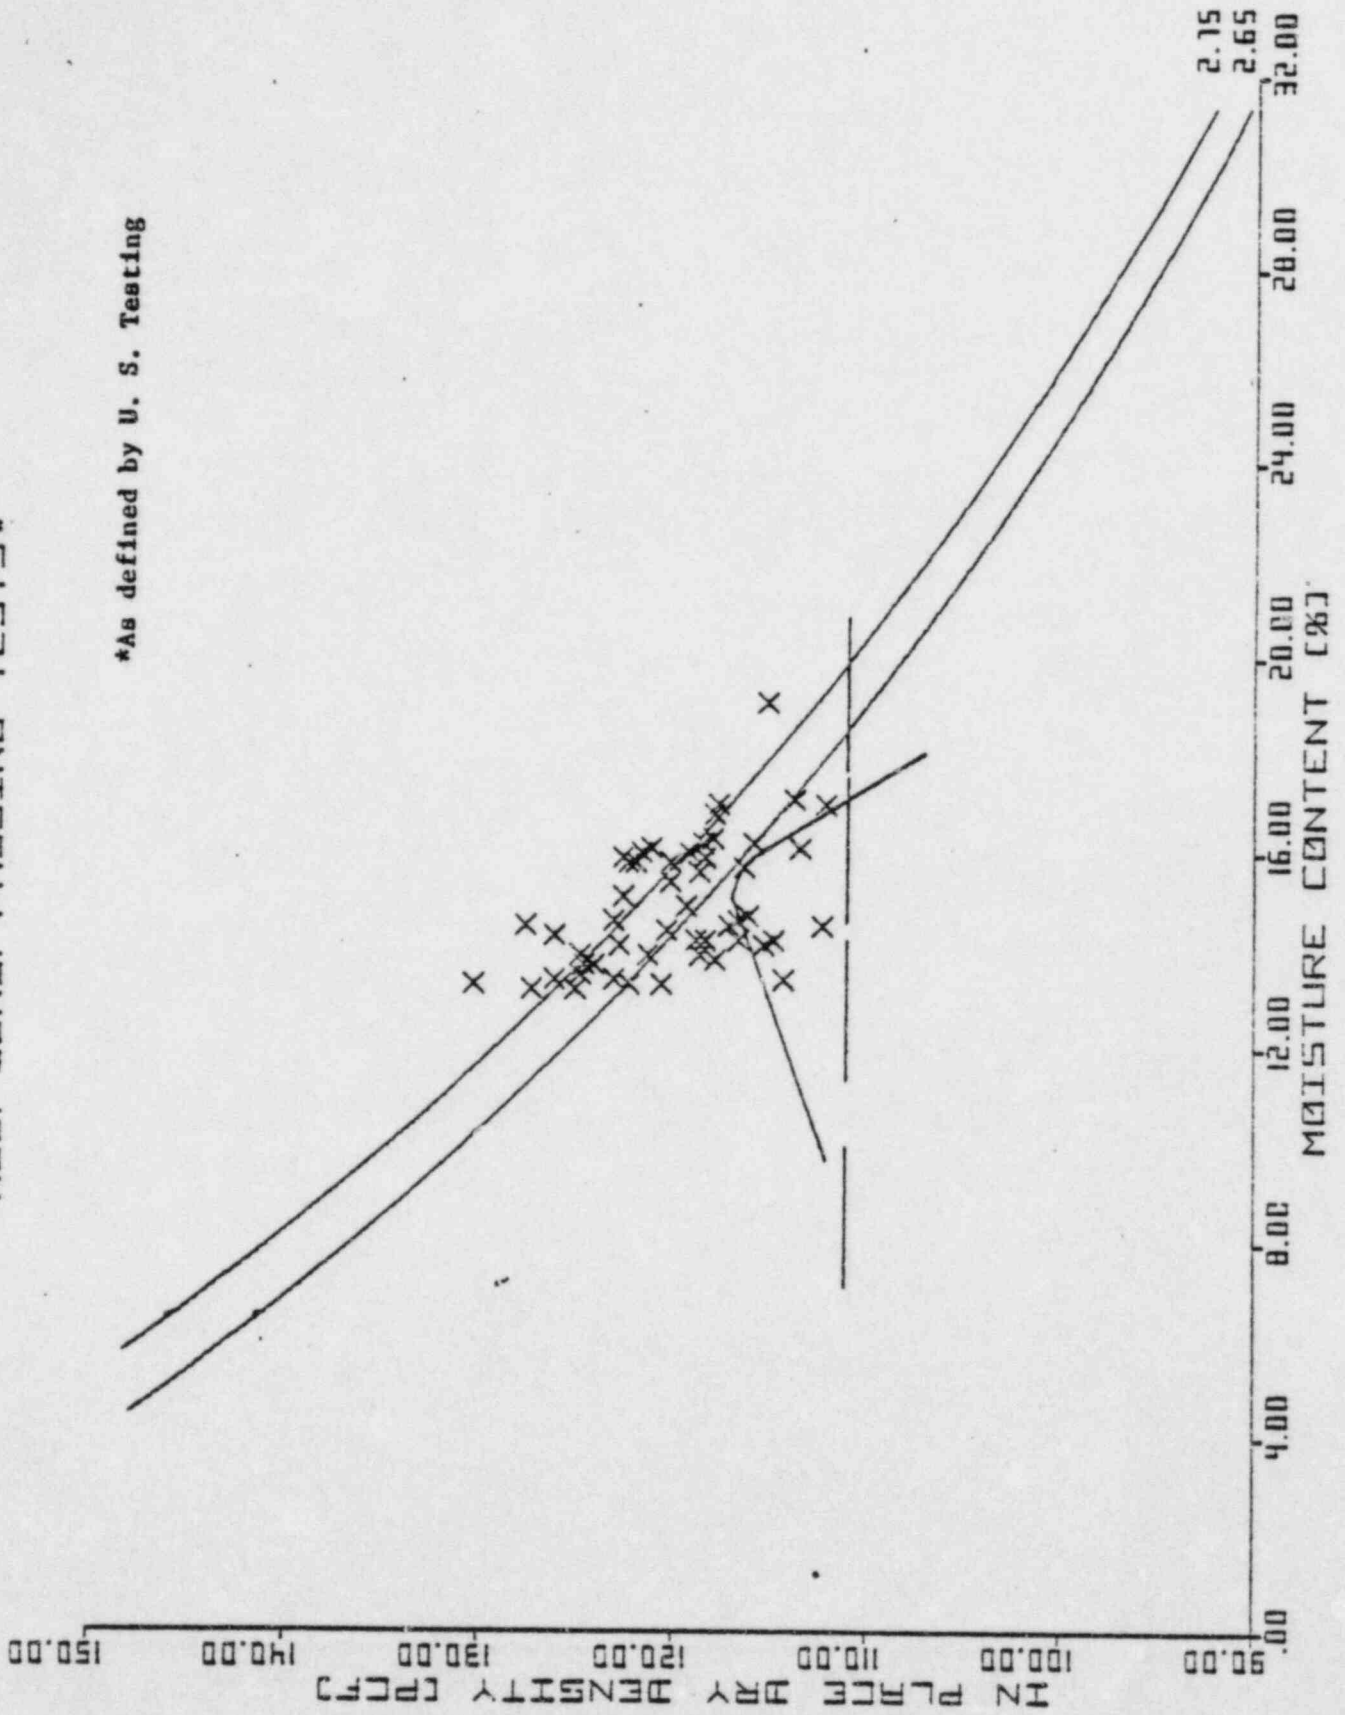
FIGURE 5

MOISTURE DENSITY FOR BMP 278  
 SPECIFIC GRAVITY = 2.65  
 NUC. DENS. PASSING TESTS\*

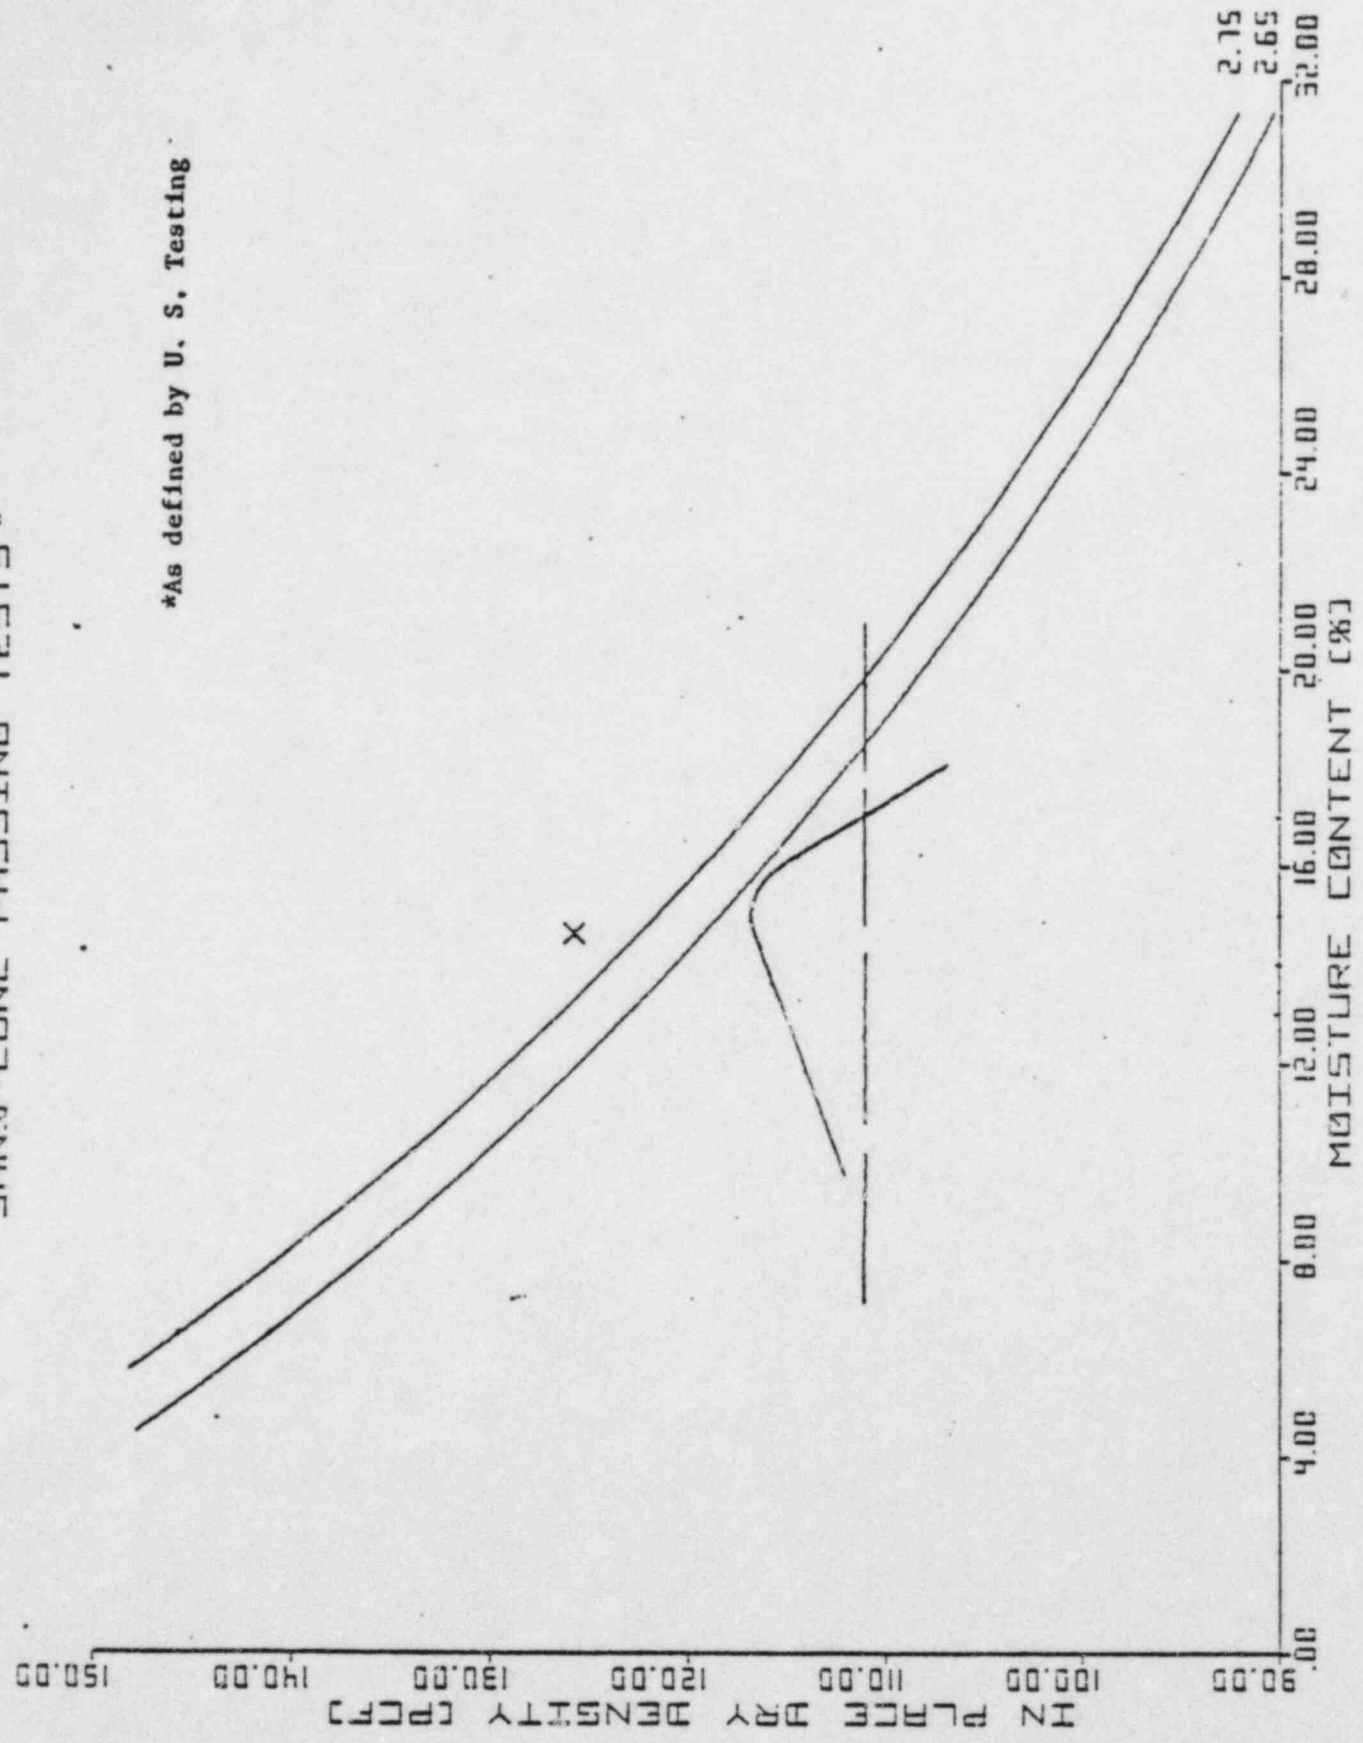
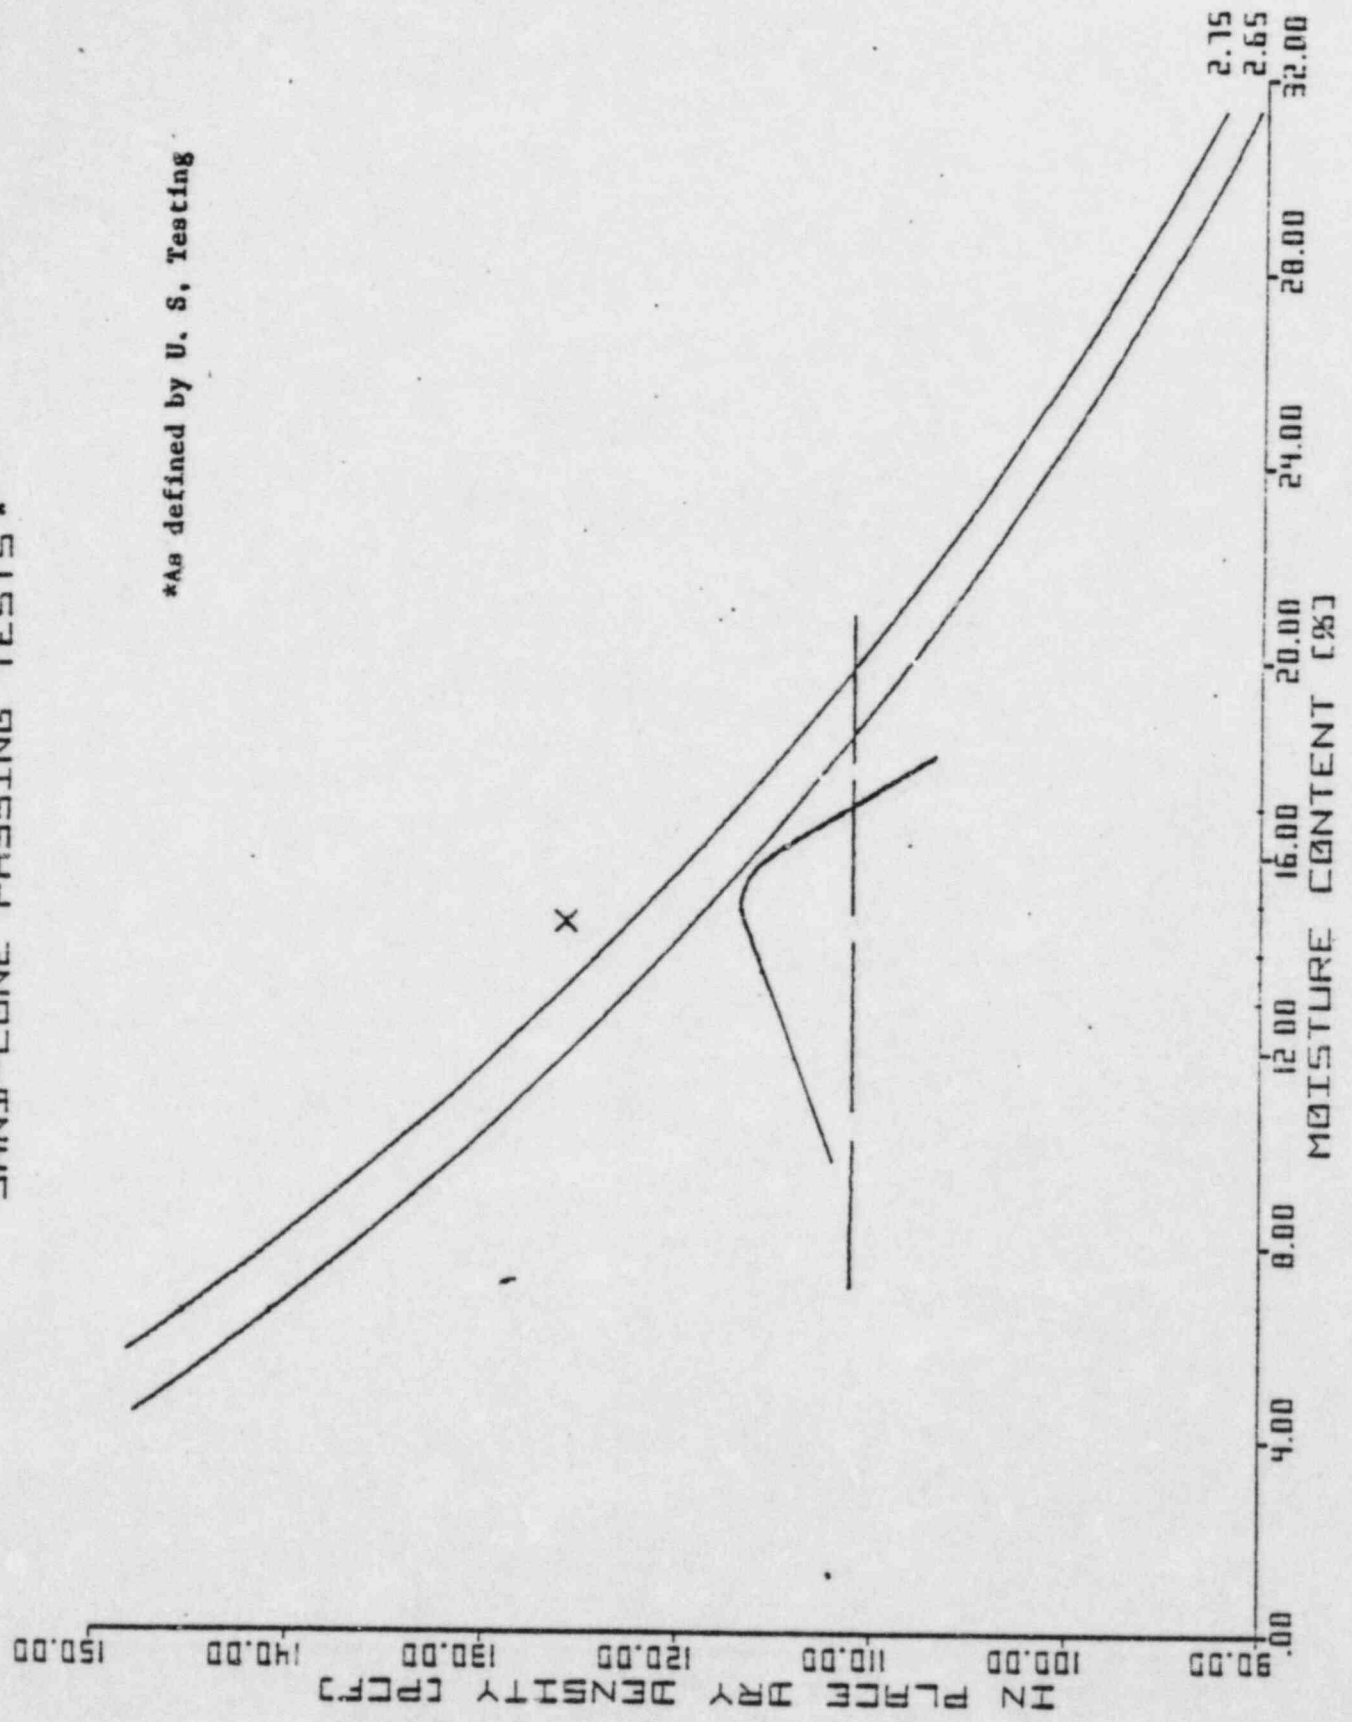
FIGURE 6

MOISTURE-DENSITY FOR BMP 278  
 SPECIFIC GRAVITY = 2.65  
 SAND-CONE PASSING TESTS \*

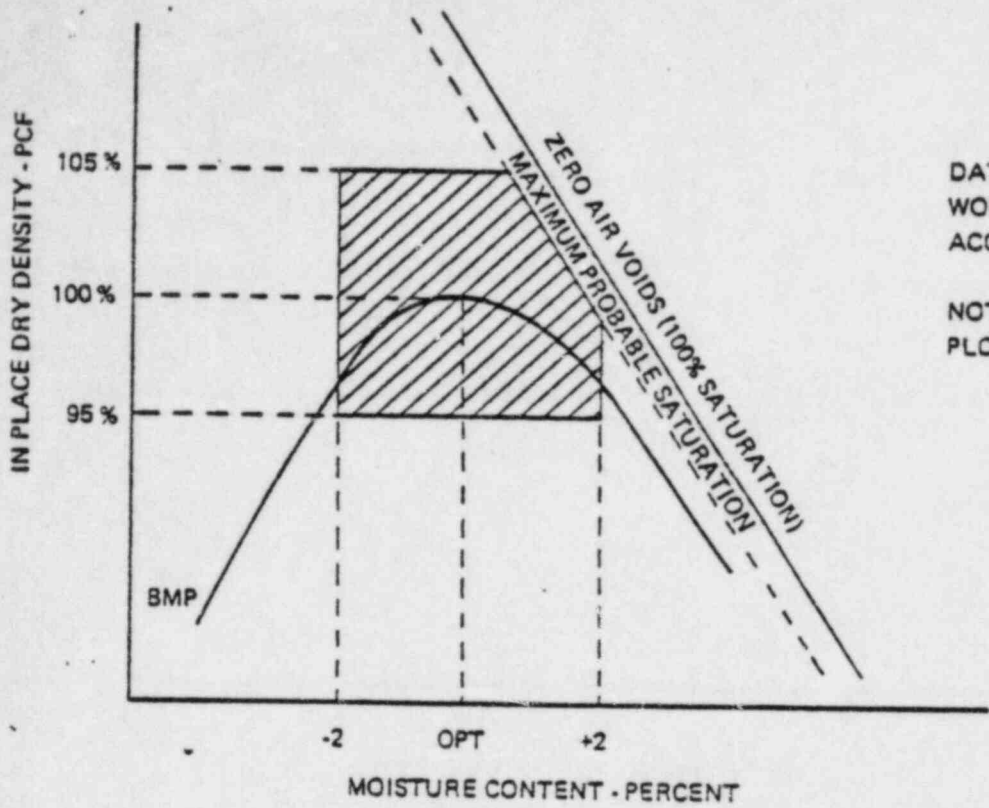
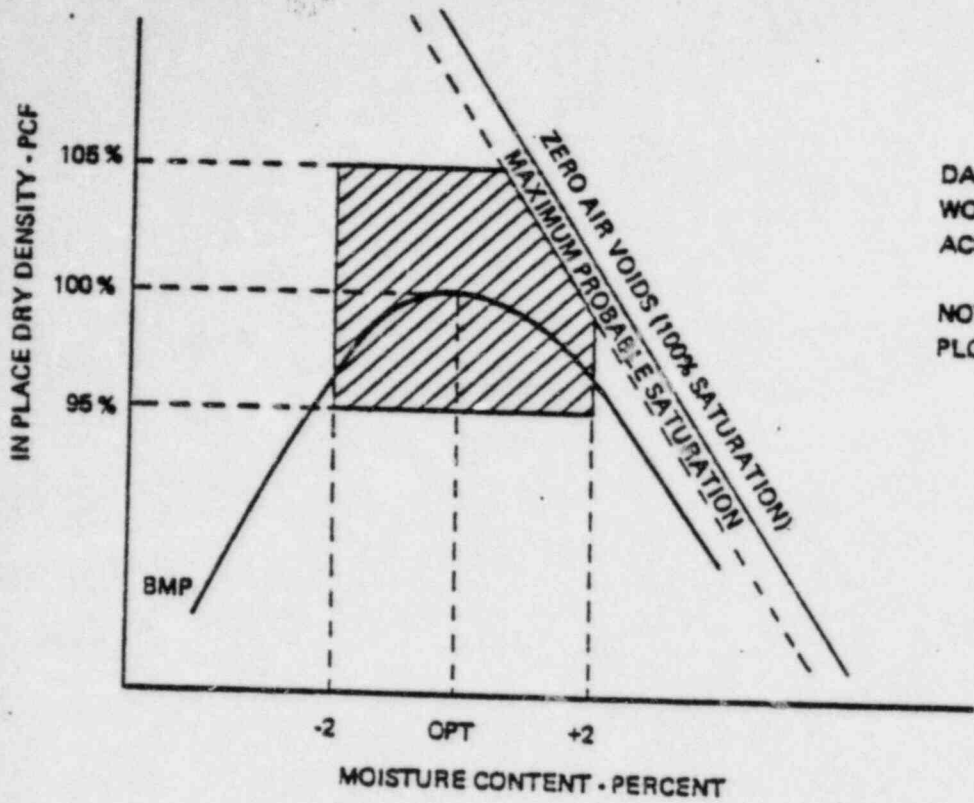
FIGURE 7-A-

For a field test result to be valid as well as "Passing" it must fall within a well defined area on the plot containing the laboratory compaction curve. This area or window of acceptability is shown for a hypothetical compaction curve on Figure 7a that would meet requirements of Specification 7220-C-210. It is defined by horizontal lines at 95 percent and 105 percent of specified density, vertical lines through  $\pm 2$  percent of optimum moisture content, and a line parallel to the zero voids line indicating saturation about half way between the compaction curve and 100 percent saturation (zero air voids curve). The practical upper limit of 105 percent of specified density is not defined in the specifications. It was arbitrarily chosen as numbers greater than this give increasingly invalid comparisons between field test results and the specified laboratory compaction test curve. Therefore, if all data points fall within the defined window there would be no reason to assume that they are wrong. However, when many data points fall outside the designated area there is something wrong with the information and then all data points become suspect. A review of all data indicates that about 25 percent of the cohesive soil test results fall within this area.

DATA POINTS THAT PLOT IN SHADED AREA WOULD BE GENERALLY ACCEPTABLE ACCORDING TO SPECIFICATIONS

NOTE: ABOUT 25% OF ALL FIELD DATA PLOTS IN THE SHADED AREA

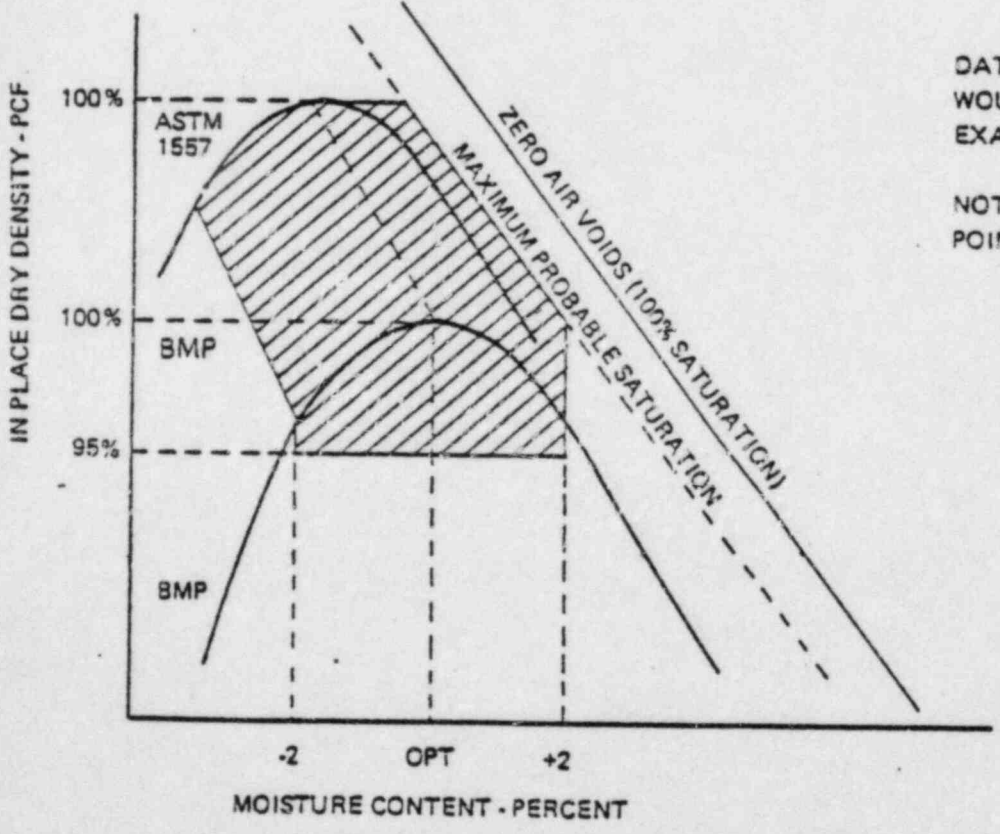
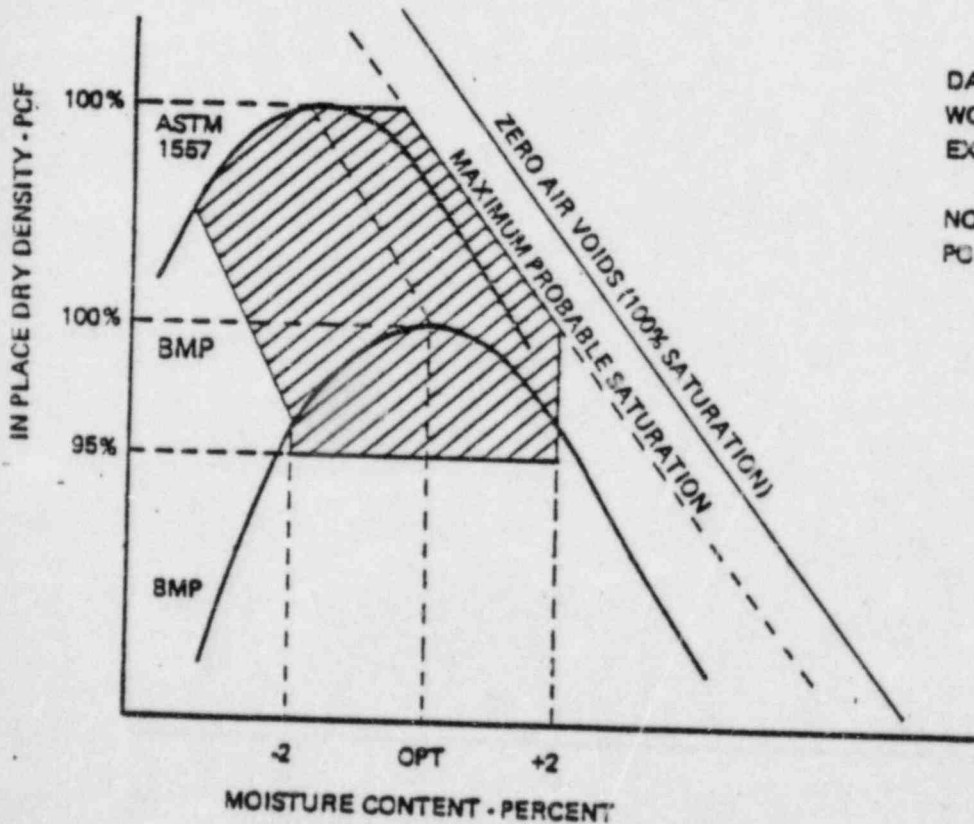
DATA POINTS THAT PLOT IN SHADED AREA WOULD BE ACCEPTABLE REGARDLESS OF EXACT SPECIFICATION WORDING

NOTE: ABOUT 40% OF ALL FIELD DATA POINTS PLOT IN THE SHADED AREA

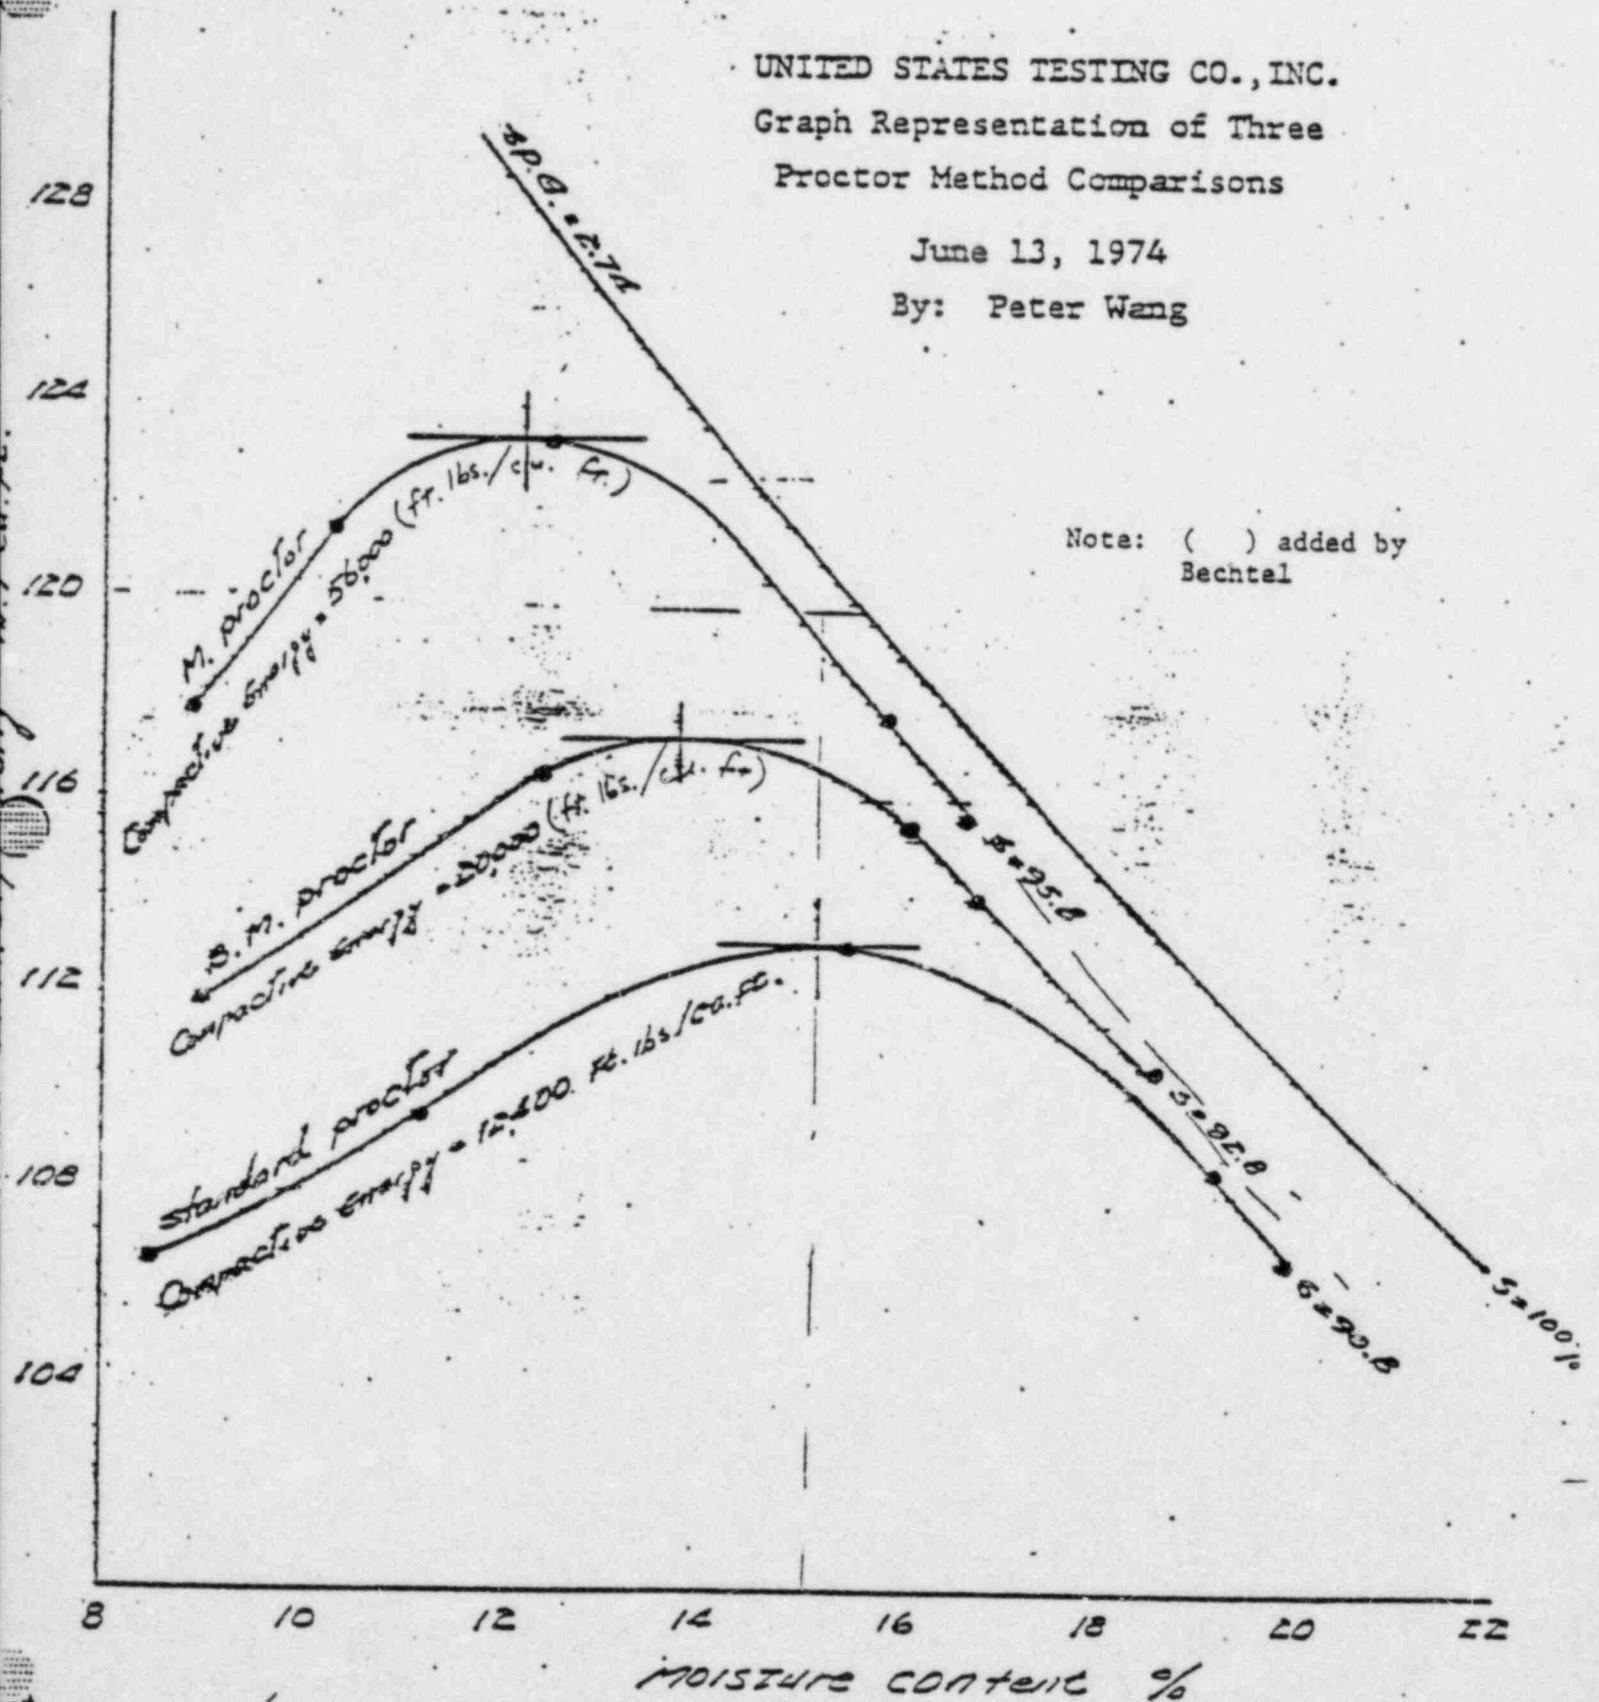
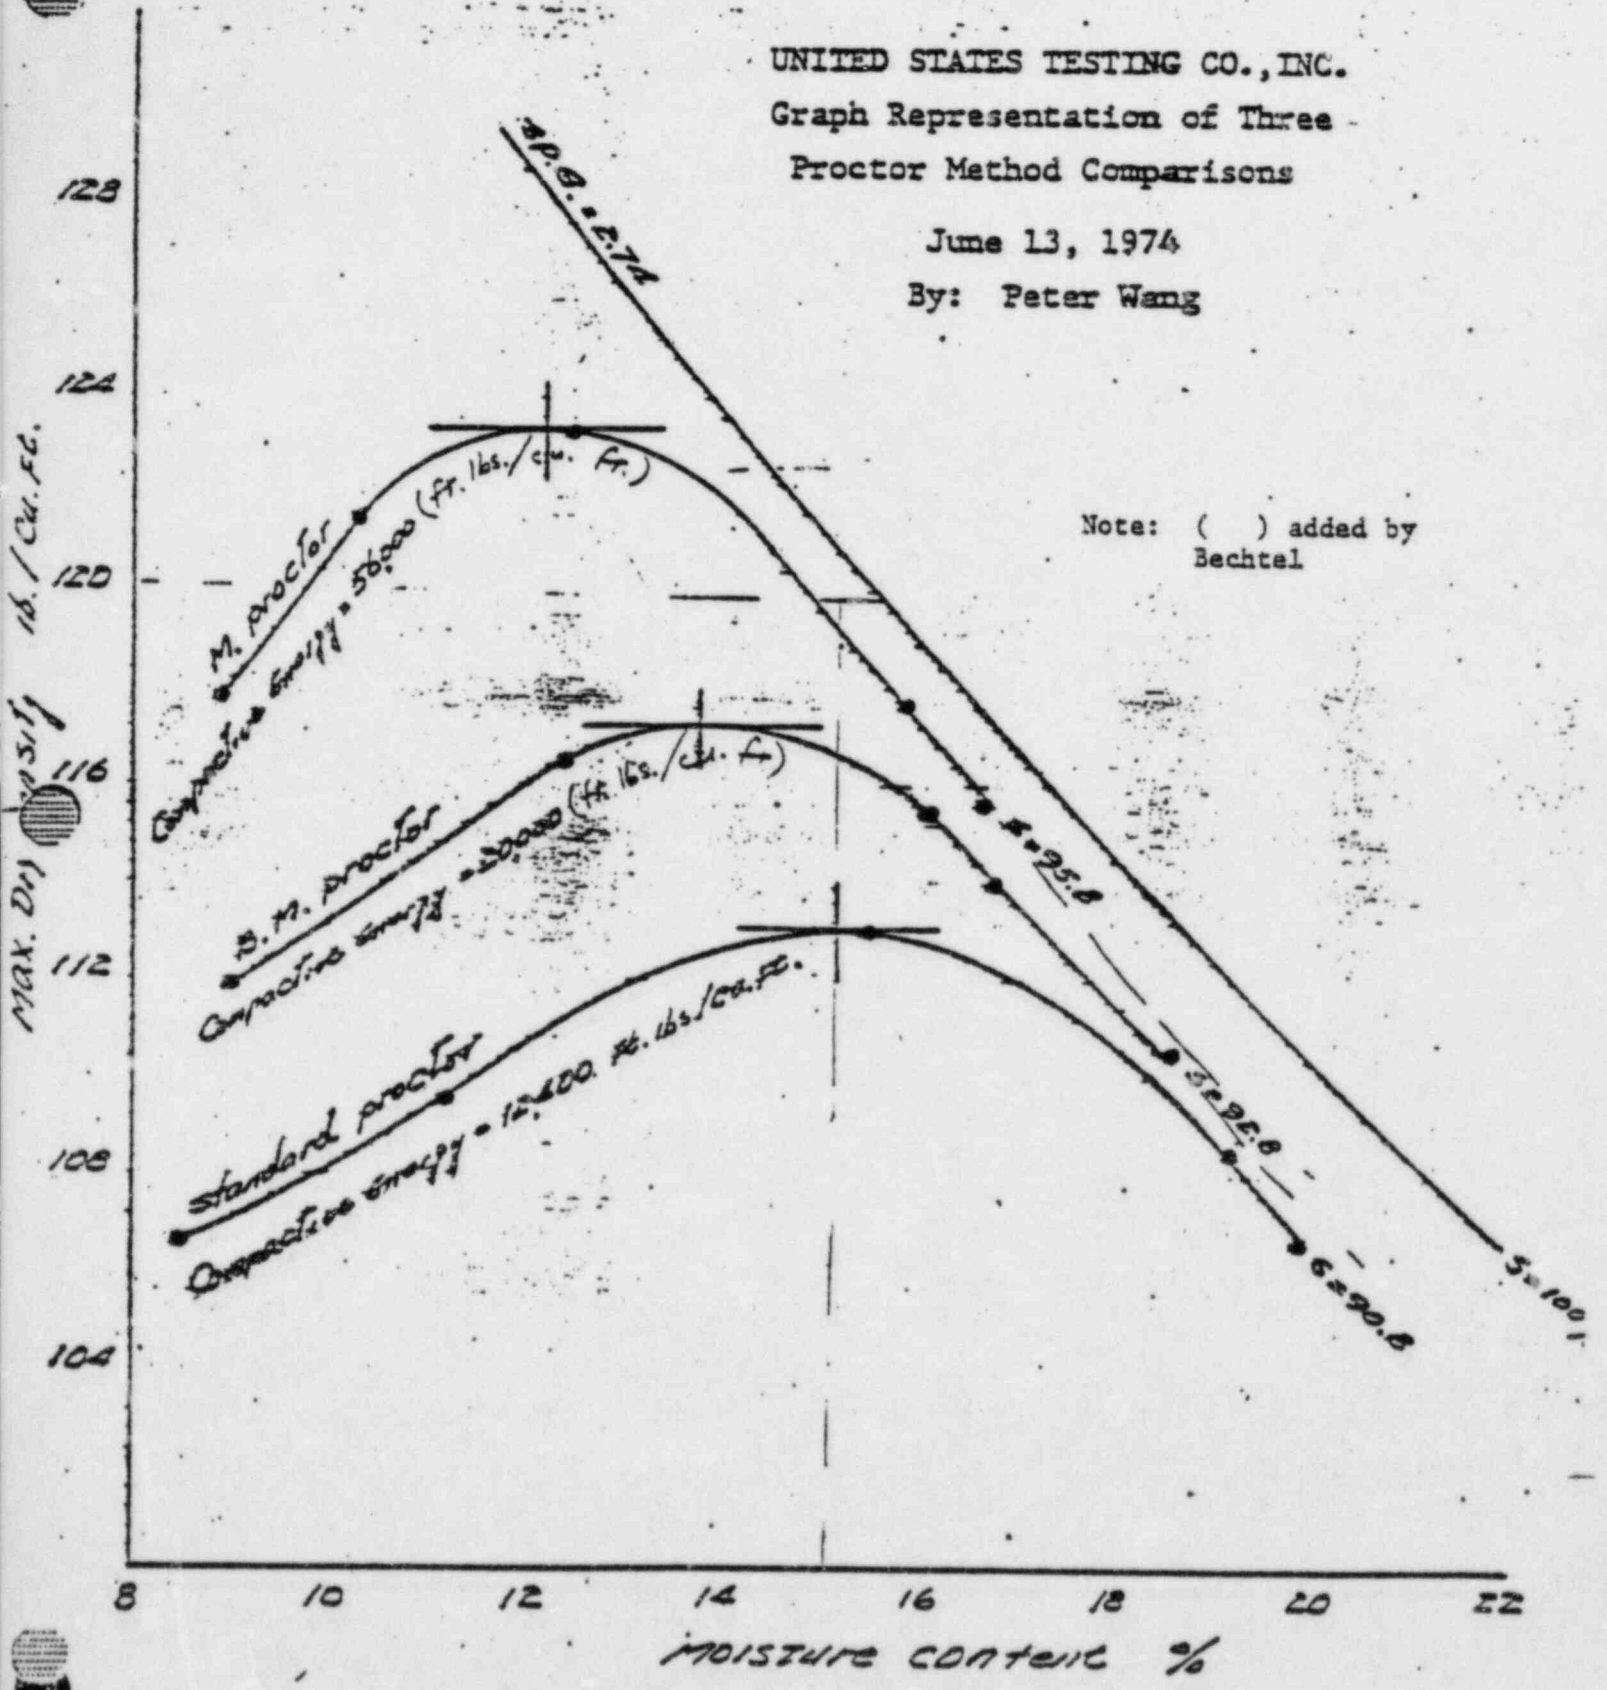
FIGURE 8

UNITED STATES TESTING CO., INC.  
Graph Representation of Three  
Proctor Method Comparisons
