MIDLAND UNITS 1 & 2  
JOB NO. 7220

REVIEW OF U.S. TESTING  
FIELD AND LABORATORY CONSTRUCTION  
TEST DATA ON SOILS USED AS FILL

BECHTEL ASSOCIATES PROFESSIONAL CORPORATION  
July 1979

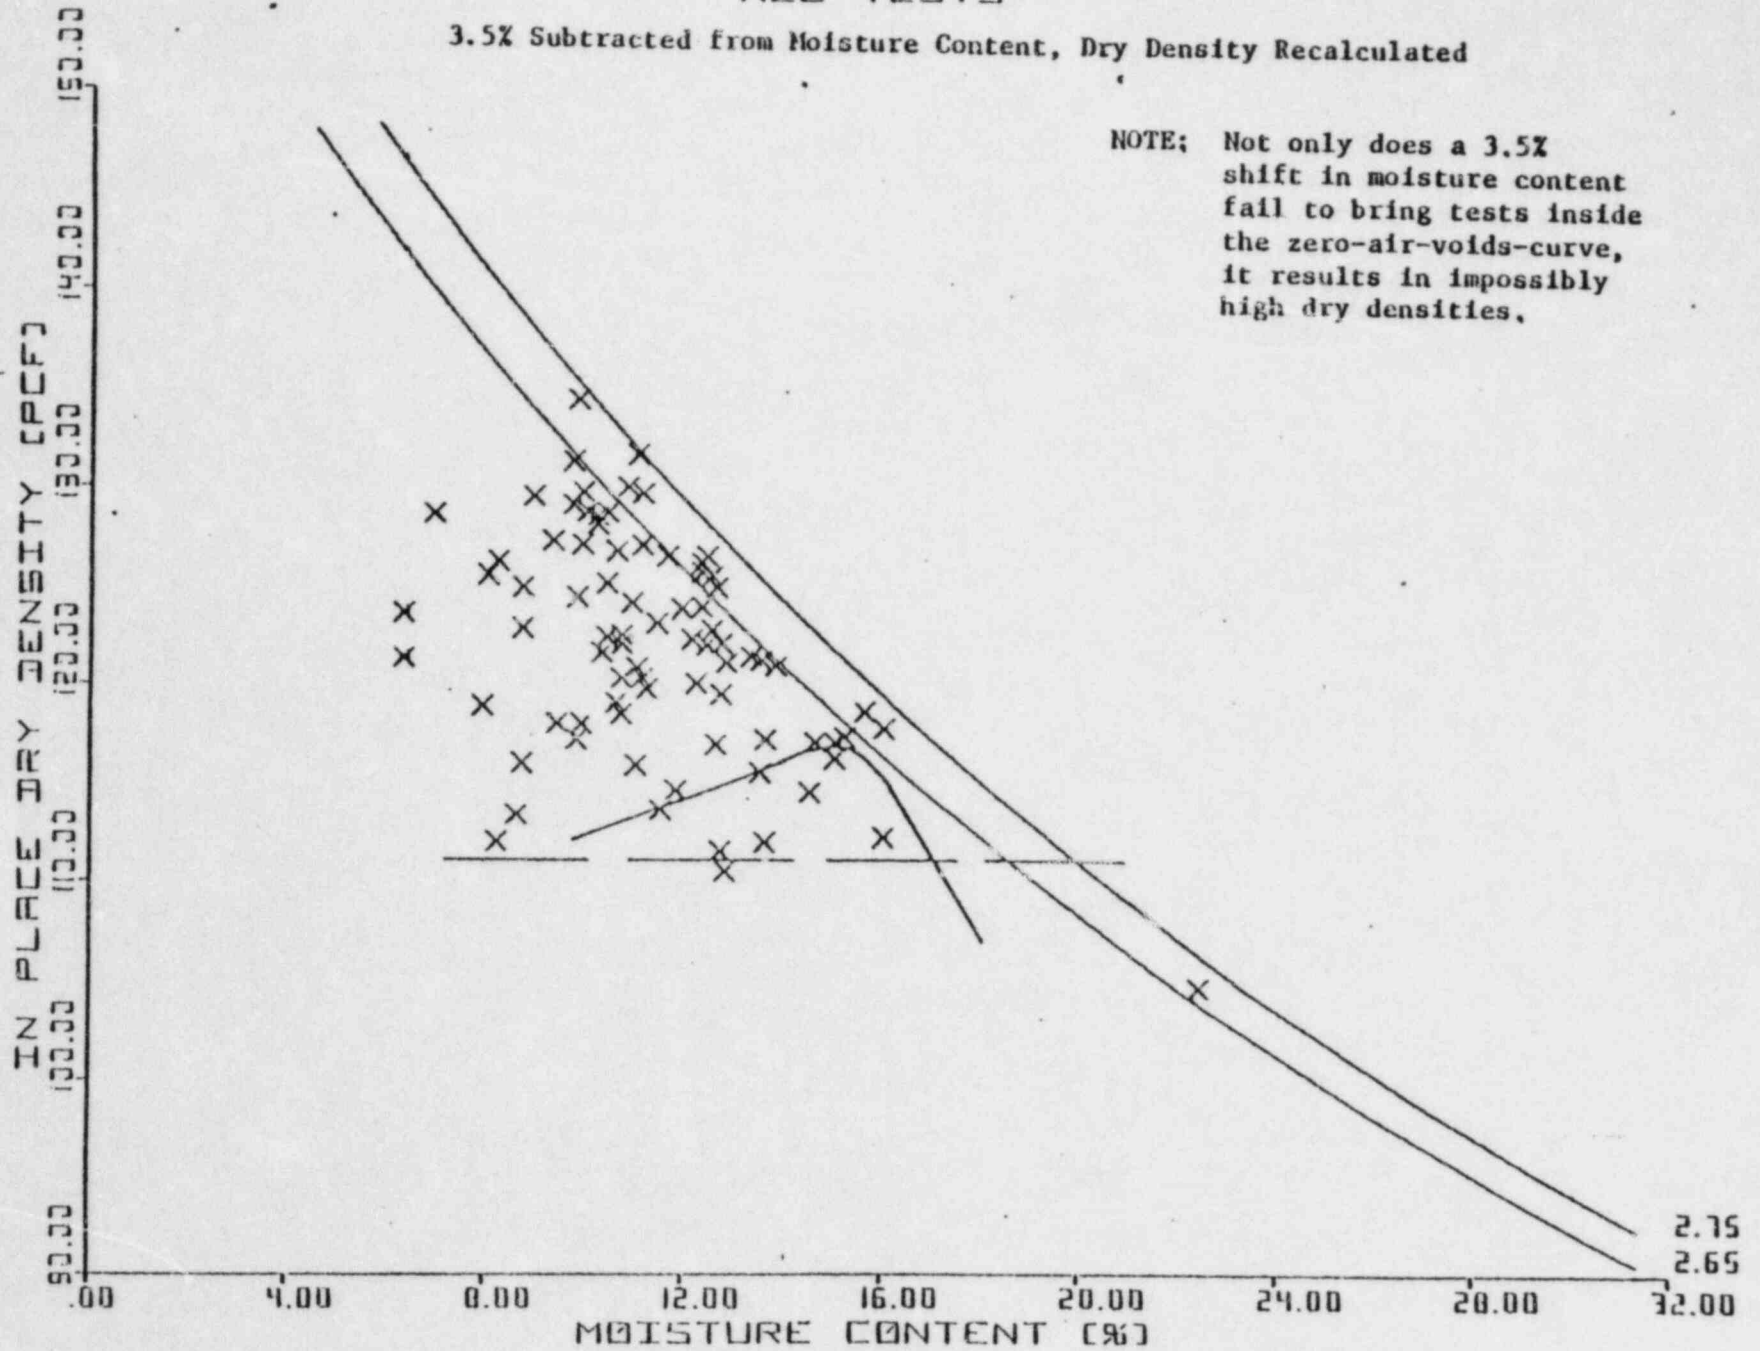
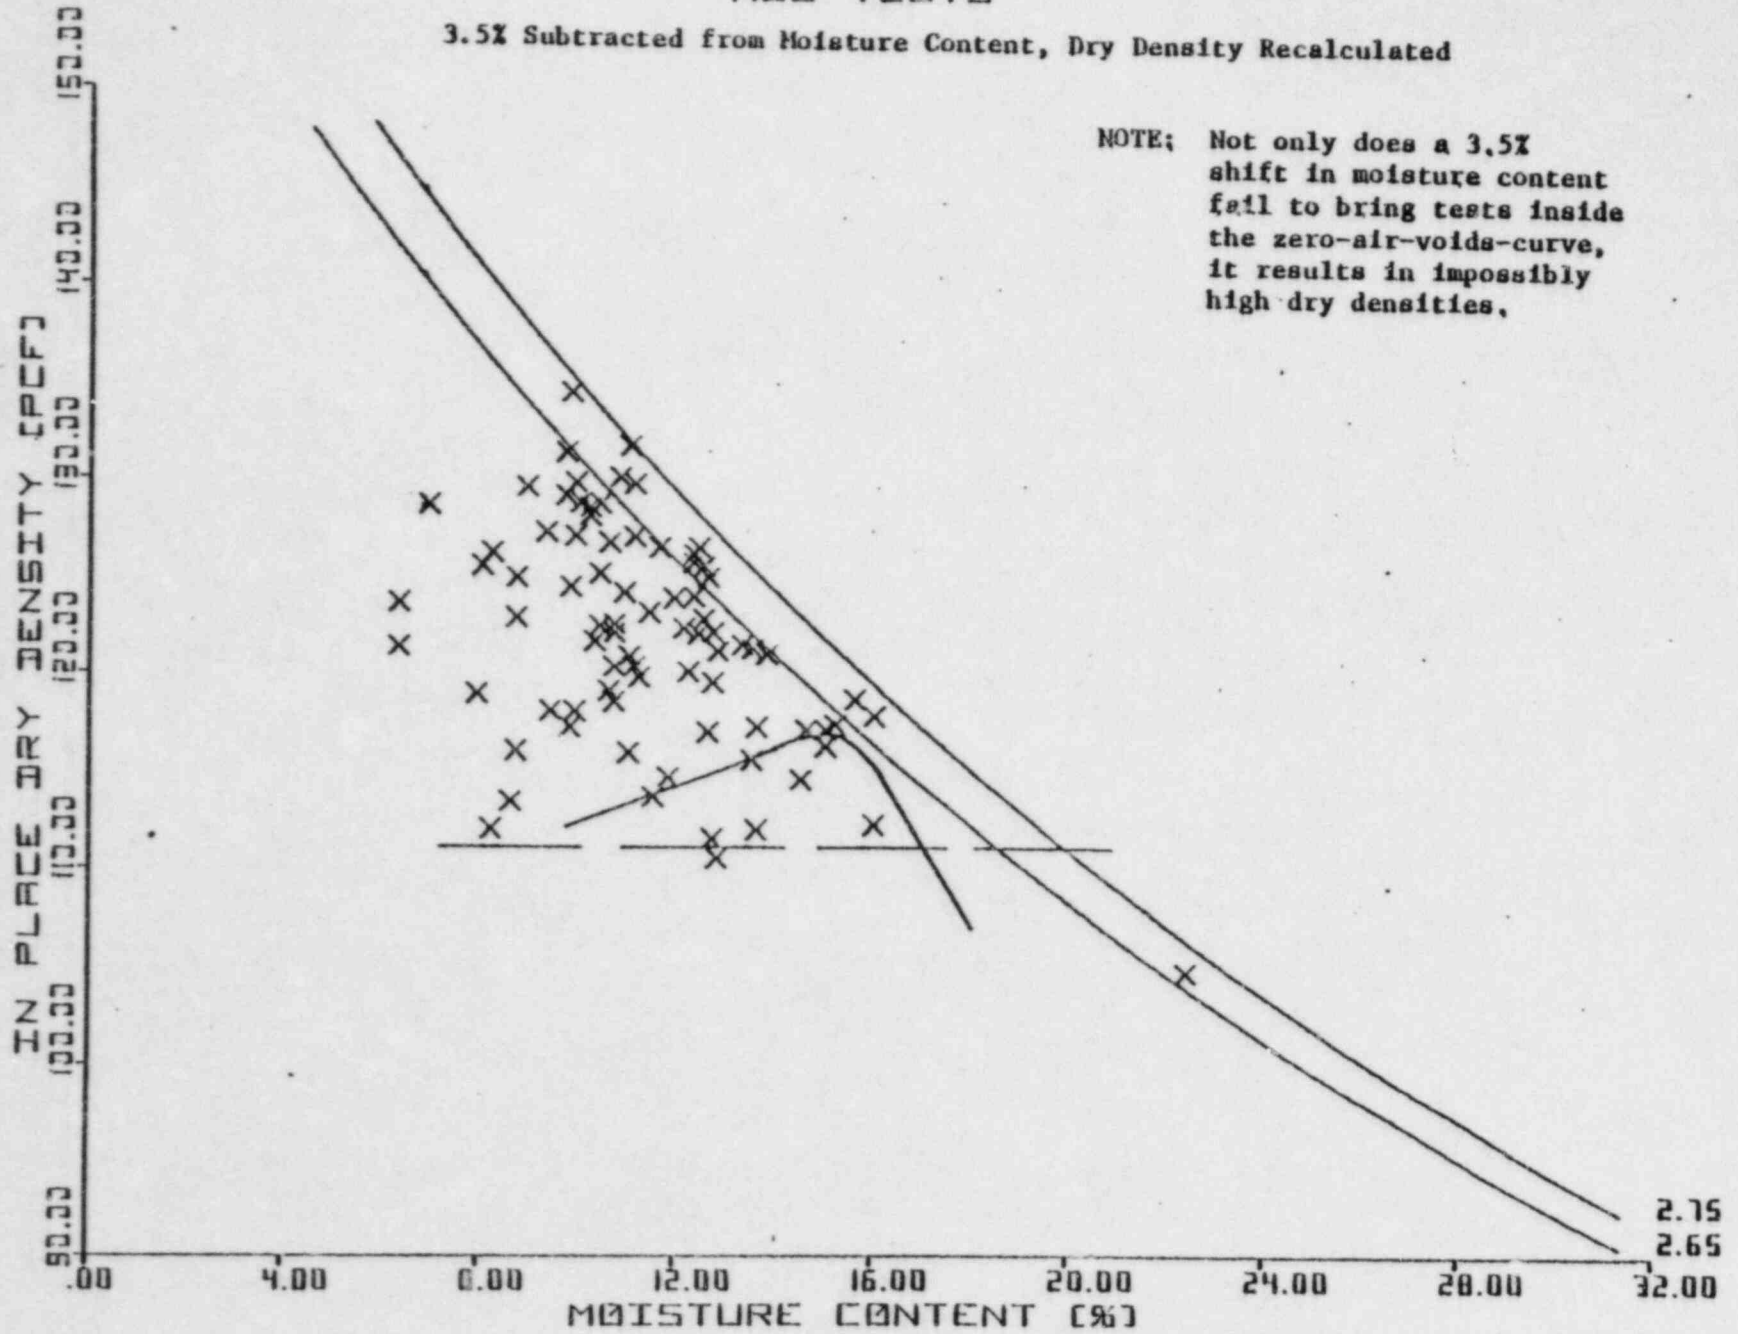
FIGURE 9

In a letter from U. S. Testing to Bechtel (dated May 30, 1974), the average deviation of the nuclear device from oven-dry moistures was +.12% for a set of 30 tests. However, the standard error of estimate is 1.8% for the data with the range of differences being from - 3.2% to +3.9%. Thus, accuracy of the nuclear device is questionable, and could translate into errors of about  $\pm 4$  pcf in the dry density calculation. (It should be noted that errors in the moisture content tend to shift the position of test results on a moisture density plot approximately parallel to the zero air voids curve, assuming the in-place wet density is correct, and thus do not explain the large number of points which plot outside the zero air voids. Compare Figures 1 and 9).

3.5% Subtracted from Moisture Content, Dry Density Recalculated

NOTE: Not only does a 3.5% shift in moisture content fail to bring tests inside the zero-air-voids-curve, the zero-air-voids-curve, it results in impossibly high dry densities.

Figure 9 has subtracted 3.5% from the moisture content and recalculated dry density. Couldn't the nuclear densometer also be giving incorrect wet densities?

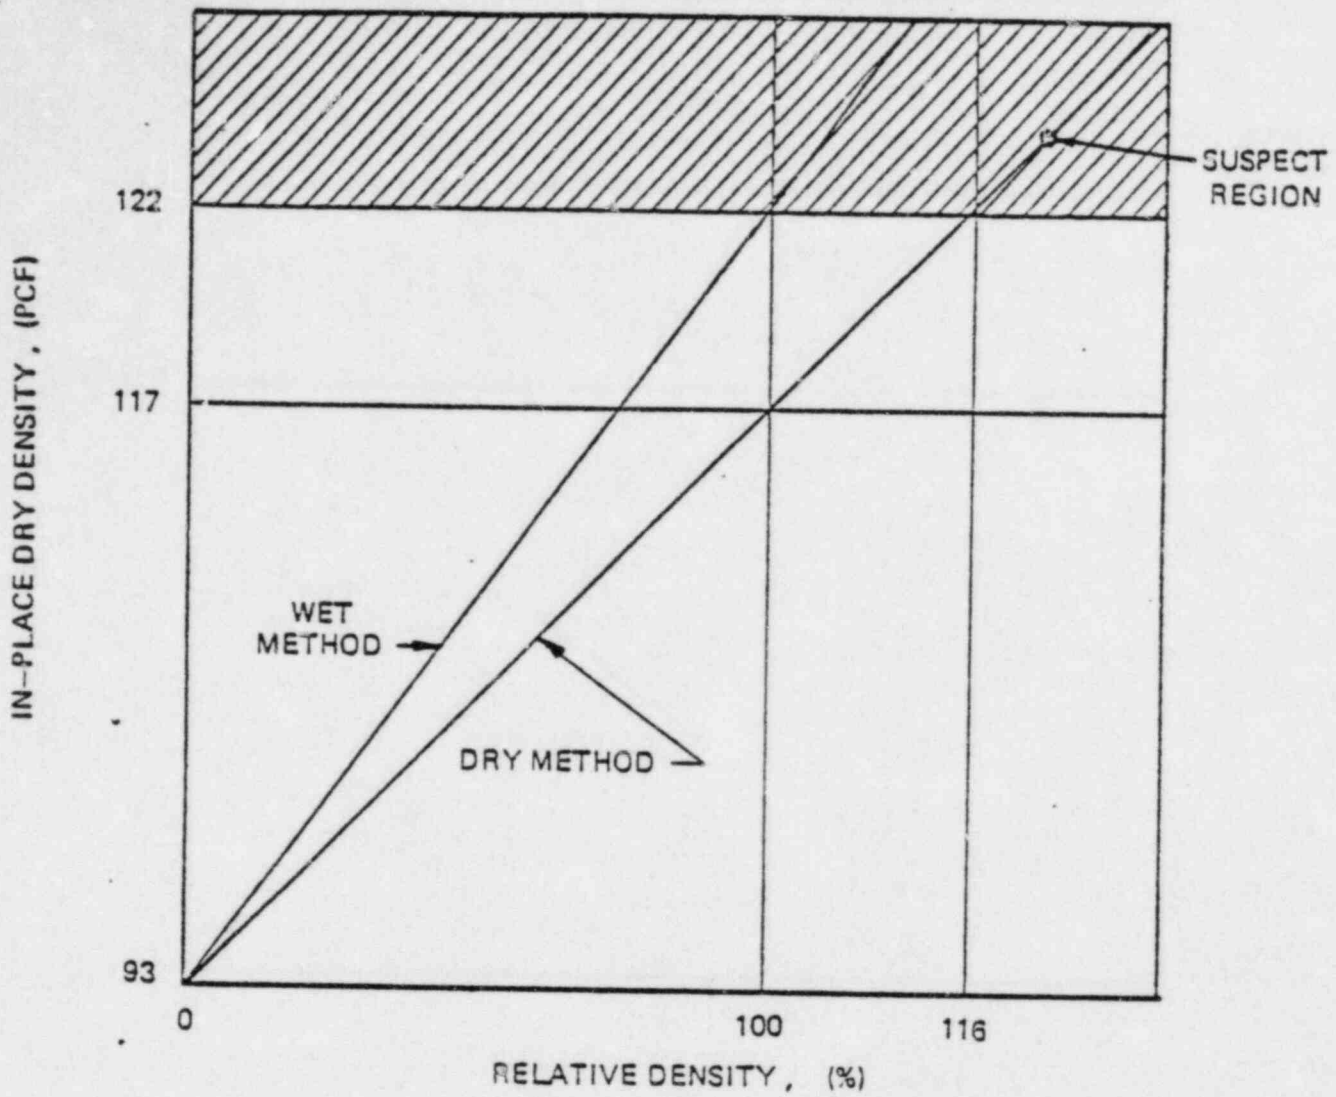
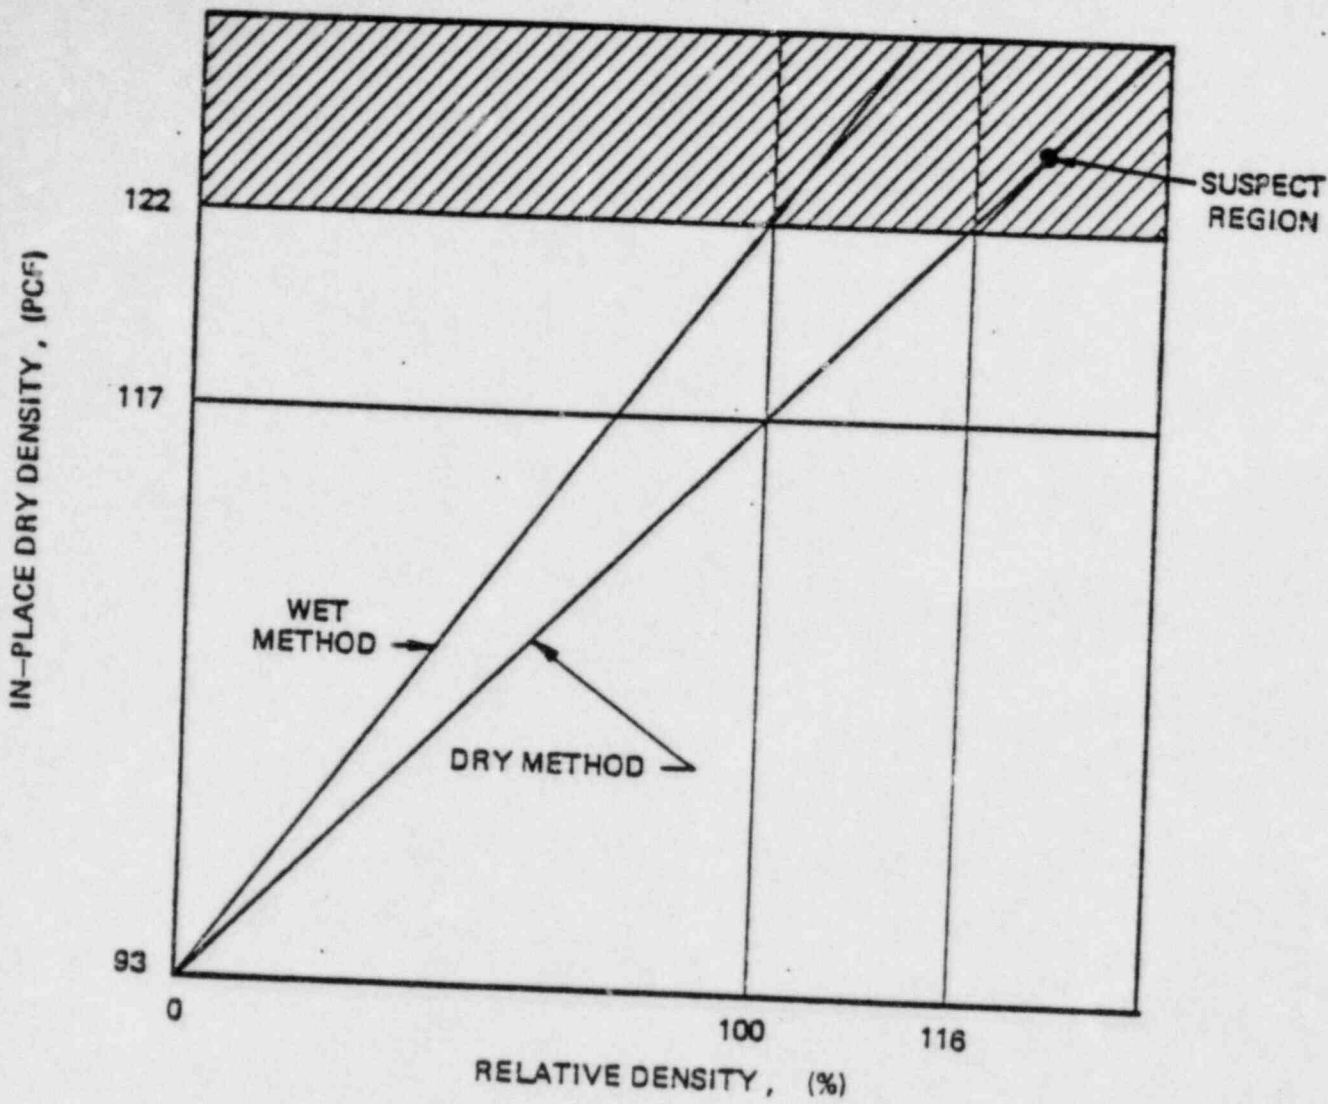
NOTE: VALUES FOR DRY DENSITY ARE TYPICAL OF A RANDOM FILL SAND. ANY TESTS SHOWING MORE THAN 117% RELATIVE DENSITY WOULD BE SUSPECT IN THIS EXAMPLE. STRUCTURAL SANDS TEND TO SHOW ONLY 2 OR 3 PCF INCREASE IN MAXIMUM DENSITY AND THUS RESULTS AT MUCH LOWER RELATIVE DENSITY WOULD BE SUSPECT, SAY 105 - 110 PERCENT

FIGURE 10  
CHANGE IN RELATIVE DENSITY SCALE FROM DRY TO WET METHODS  
OF OBTAINING MAXIMUM DENSITY, BASED ON RECENT LAB RESULTS
