CONSUMERS POWER COMPANY
MIDLAND UNITS 1 AND 2
MASTER LIST OF COMMITMENTS TO NRC ON 10 CFR 50.54(f) RESPONSES
STATUS SORT: PARTS I AND 2

Bechtel Power Corporation
October 8, 1980

MASTER LIST OF COMMITMENTS TO NRC ON 10 CFR 50.54(f) RESPONSES

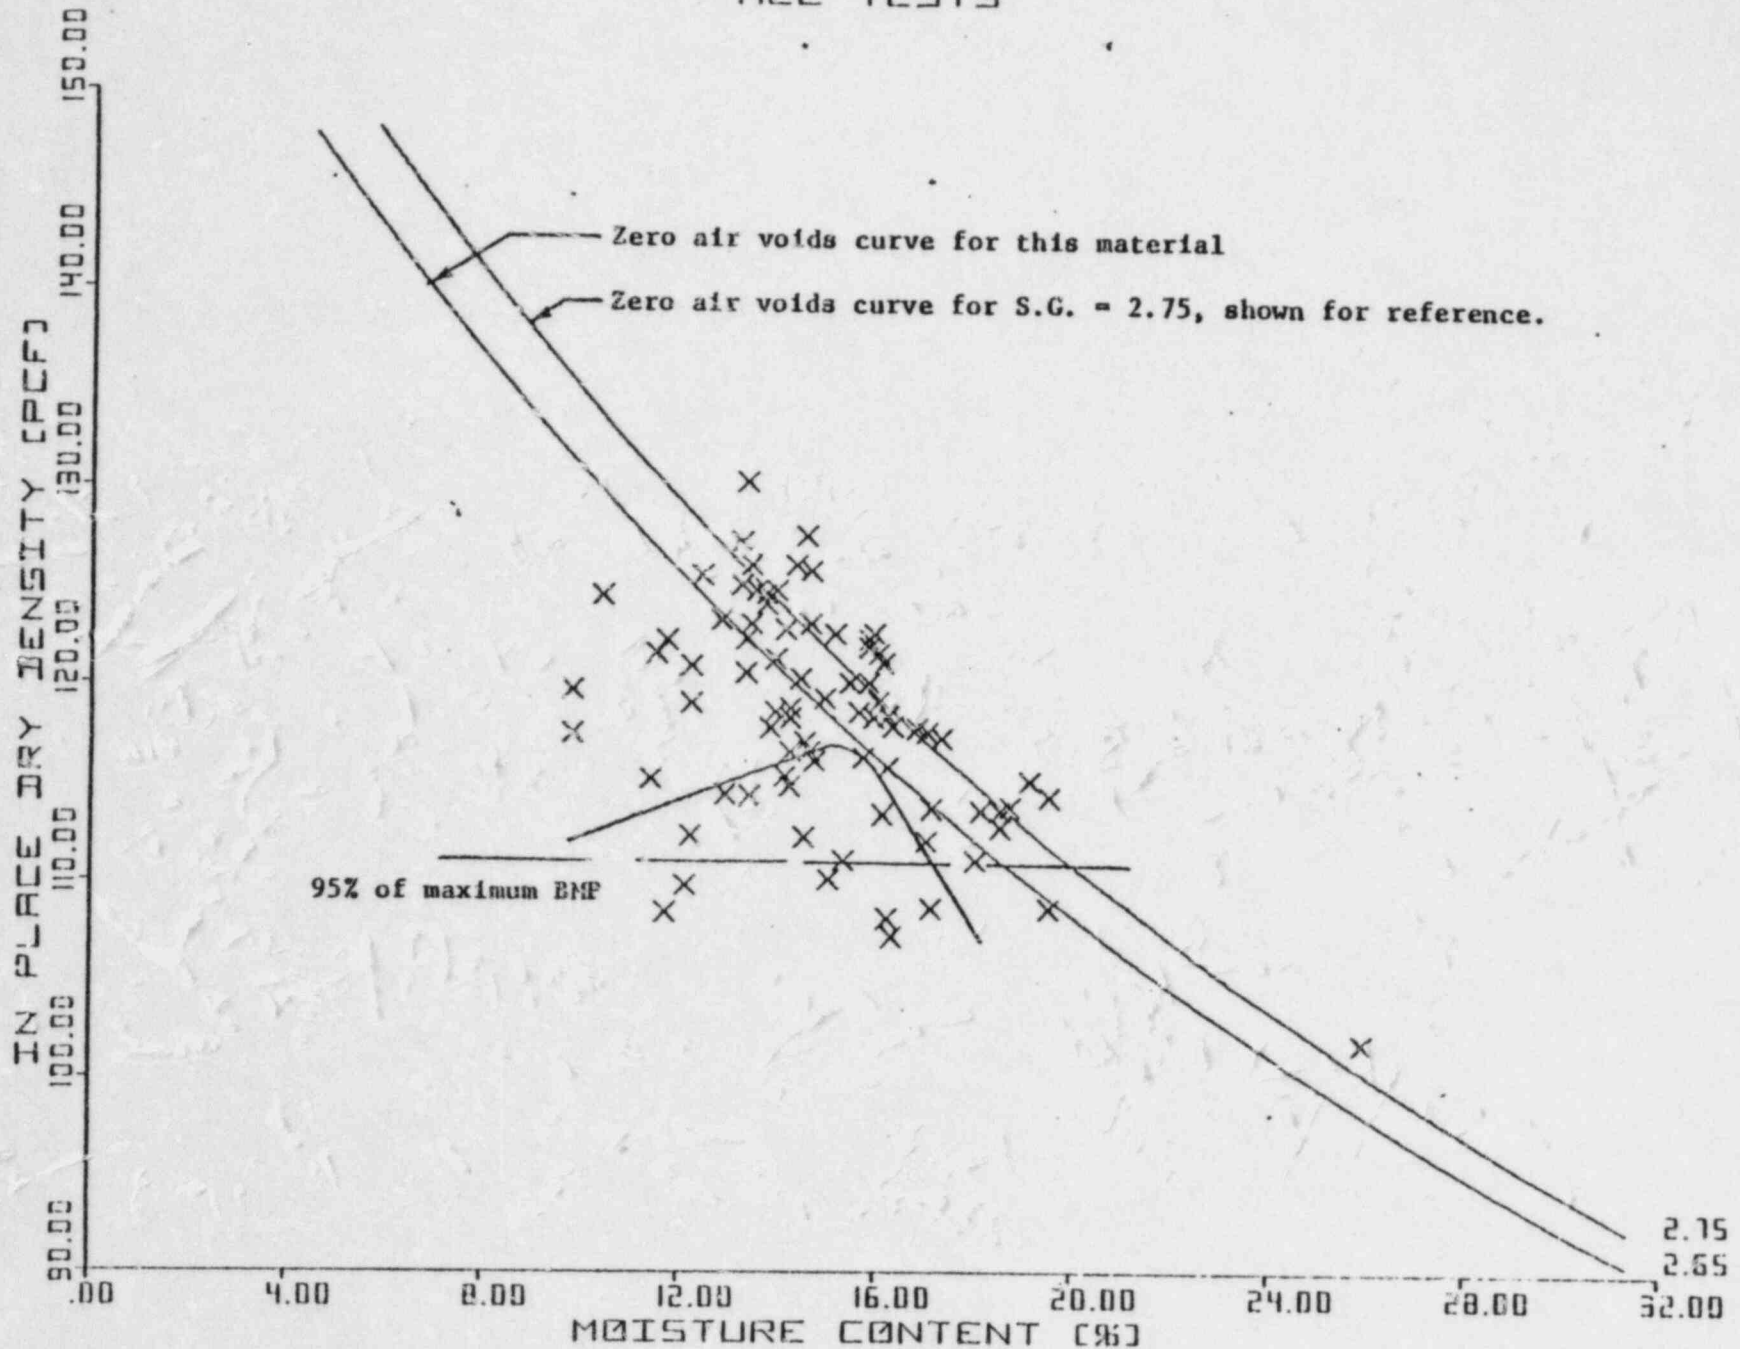
FIGURE 1

MOISTURE-DENSITY FOR BMP 278

SPECIFIC GRAVITY = 2.65
ALL TESTS

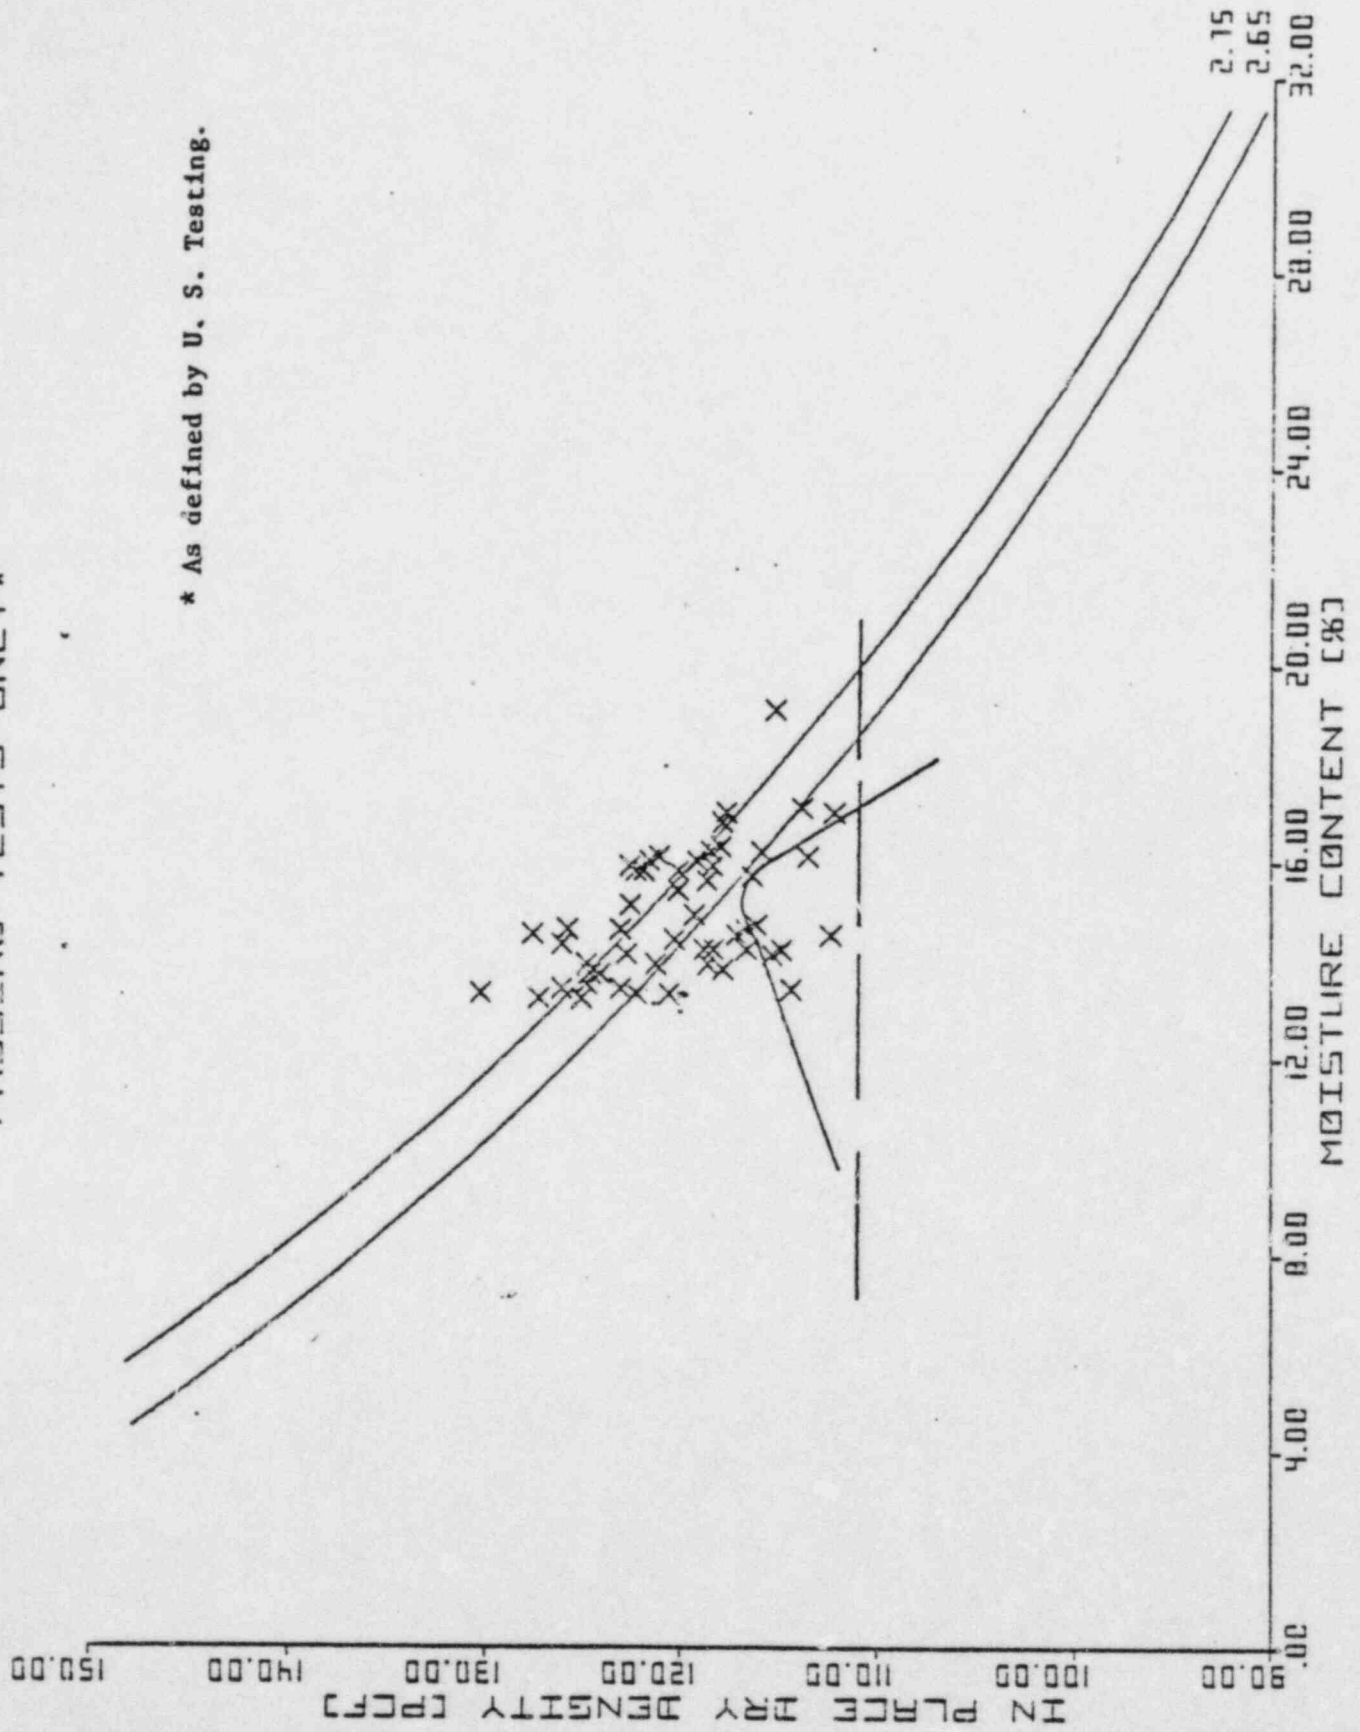
FIGURE 2

MOISTURE-DENSITY FOR BMP 278
 SPECIFIC GRAVITY = 2.65
 PASSING TESTS ONLY*

* As defined by U. S. Testing.

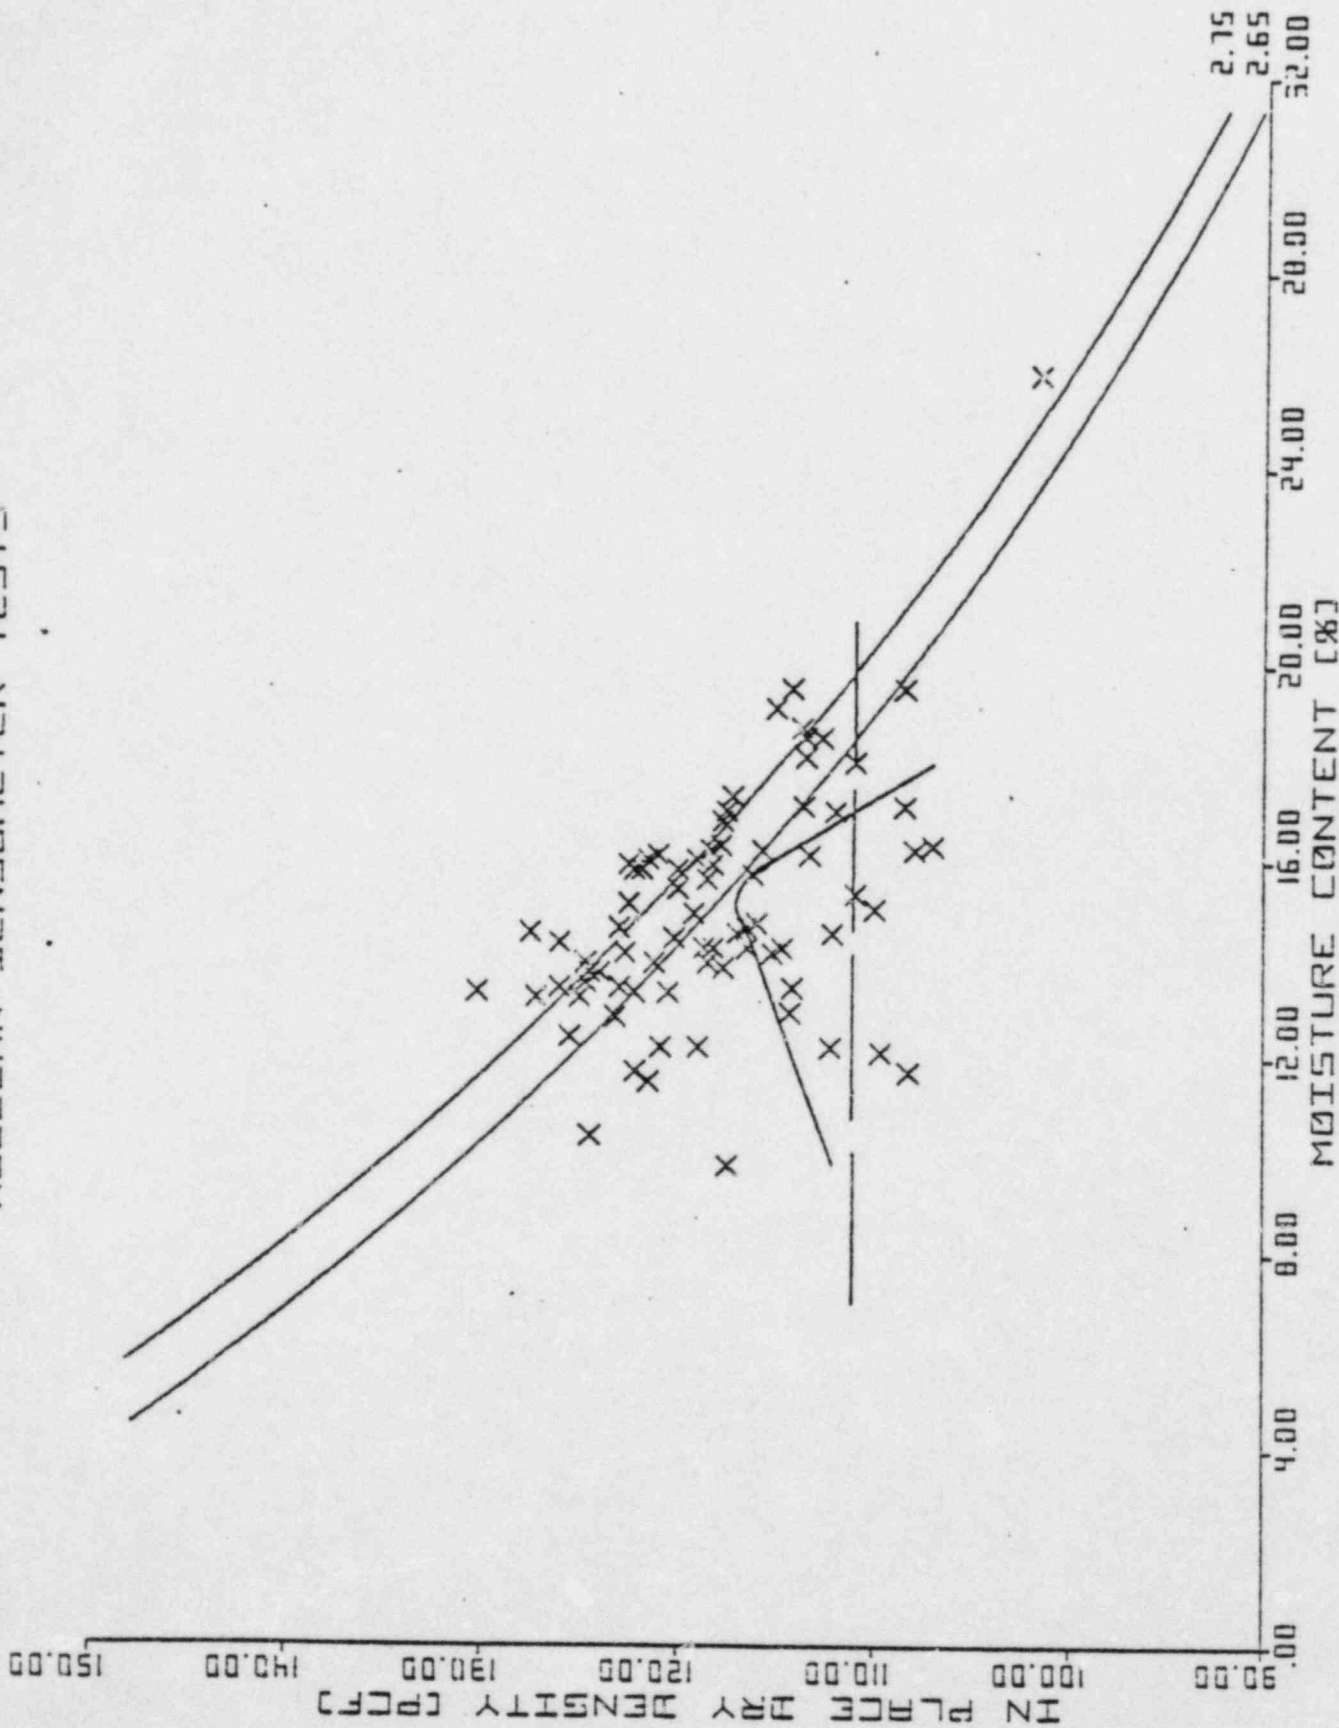
FIGURE 3

MOISTURE-DENSITY FOR BMP 278

SPECIFIC GRAVITY = 2.65
NUCLEAR DENSOMETER TESTS

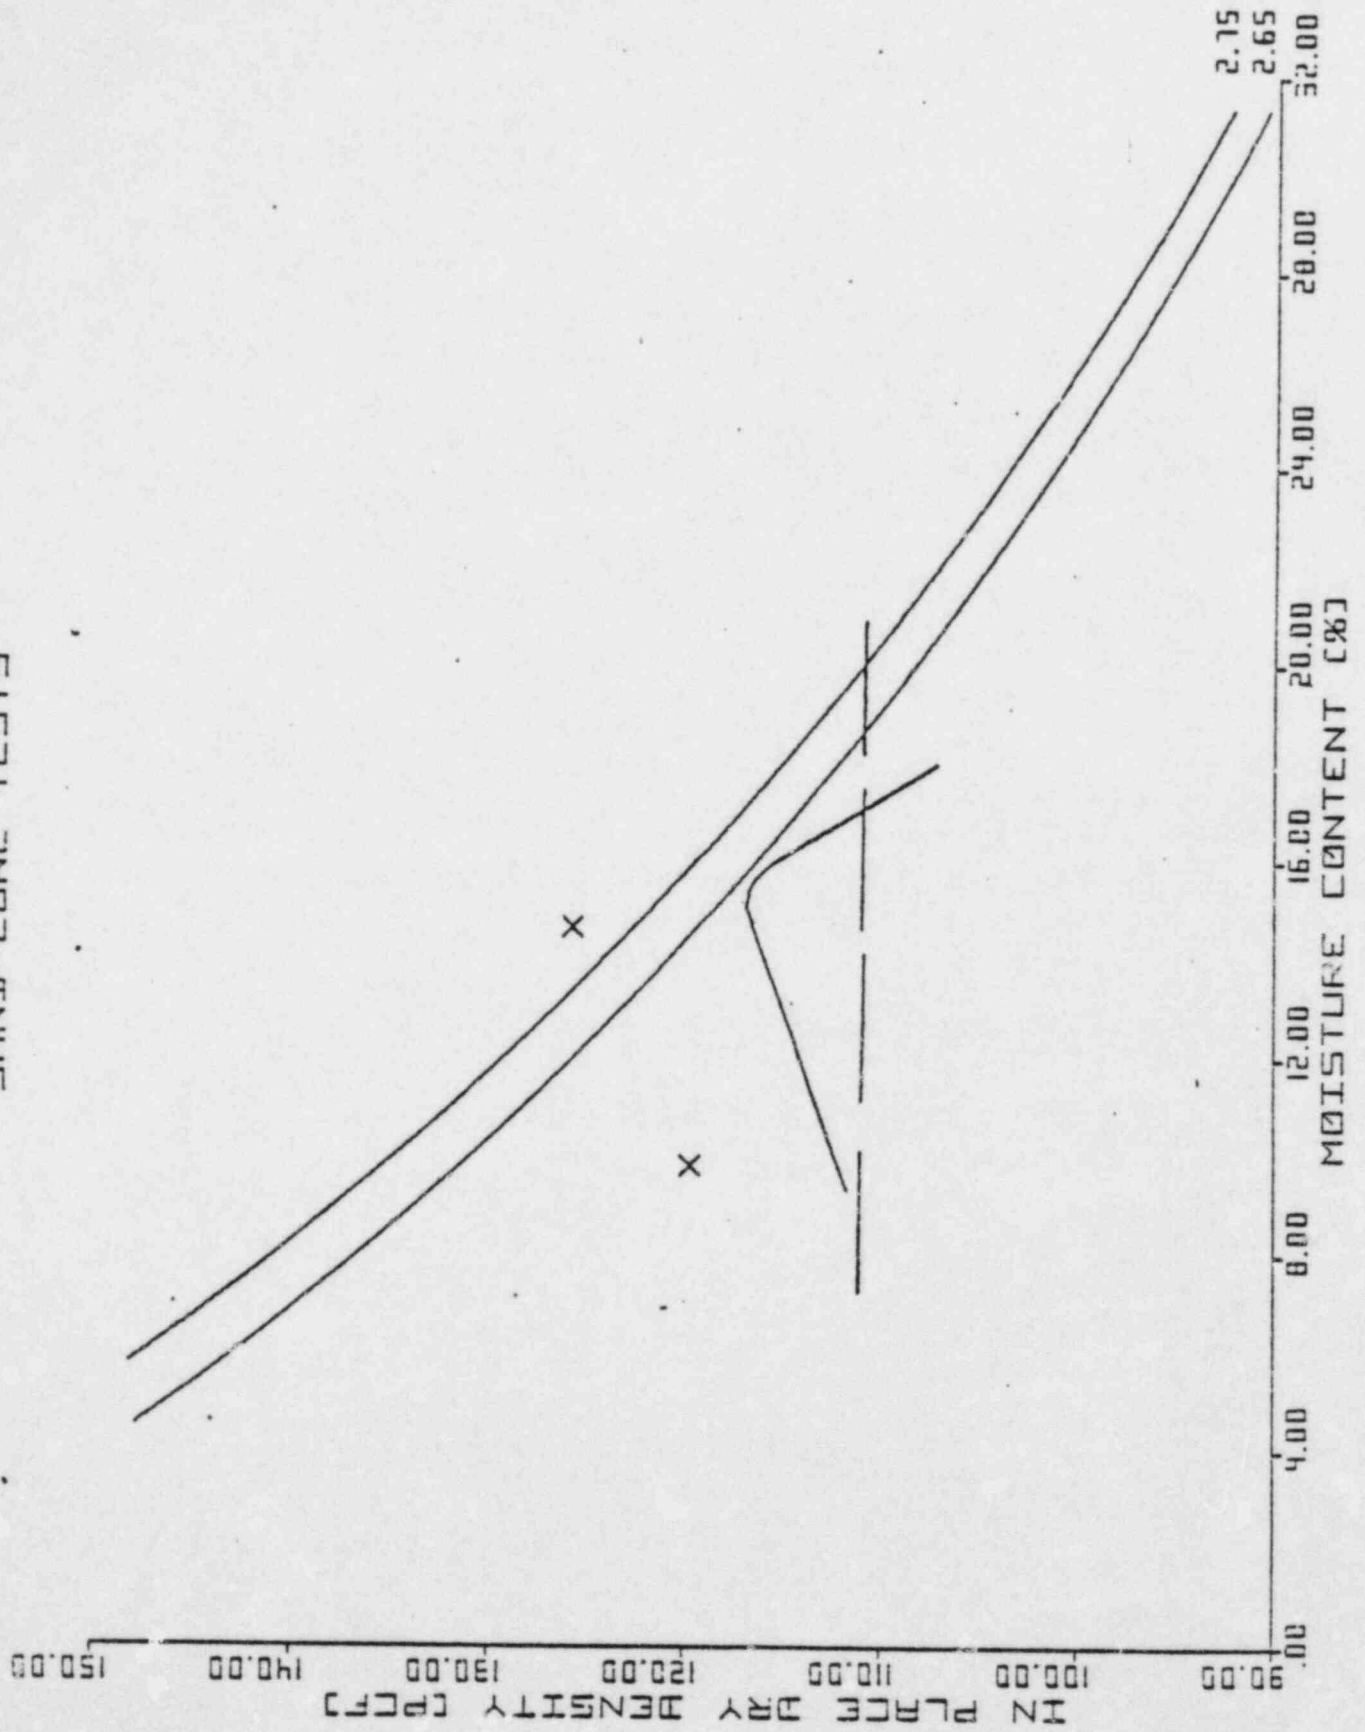
FIGURE 4

MOISTURE-DENSITY FOR BMP 276
 SPECIFIC GRAVITY = 2.65
 SAND-CONE TESTS

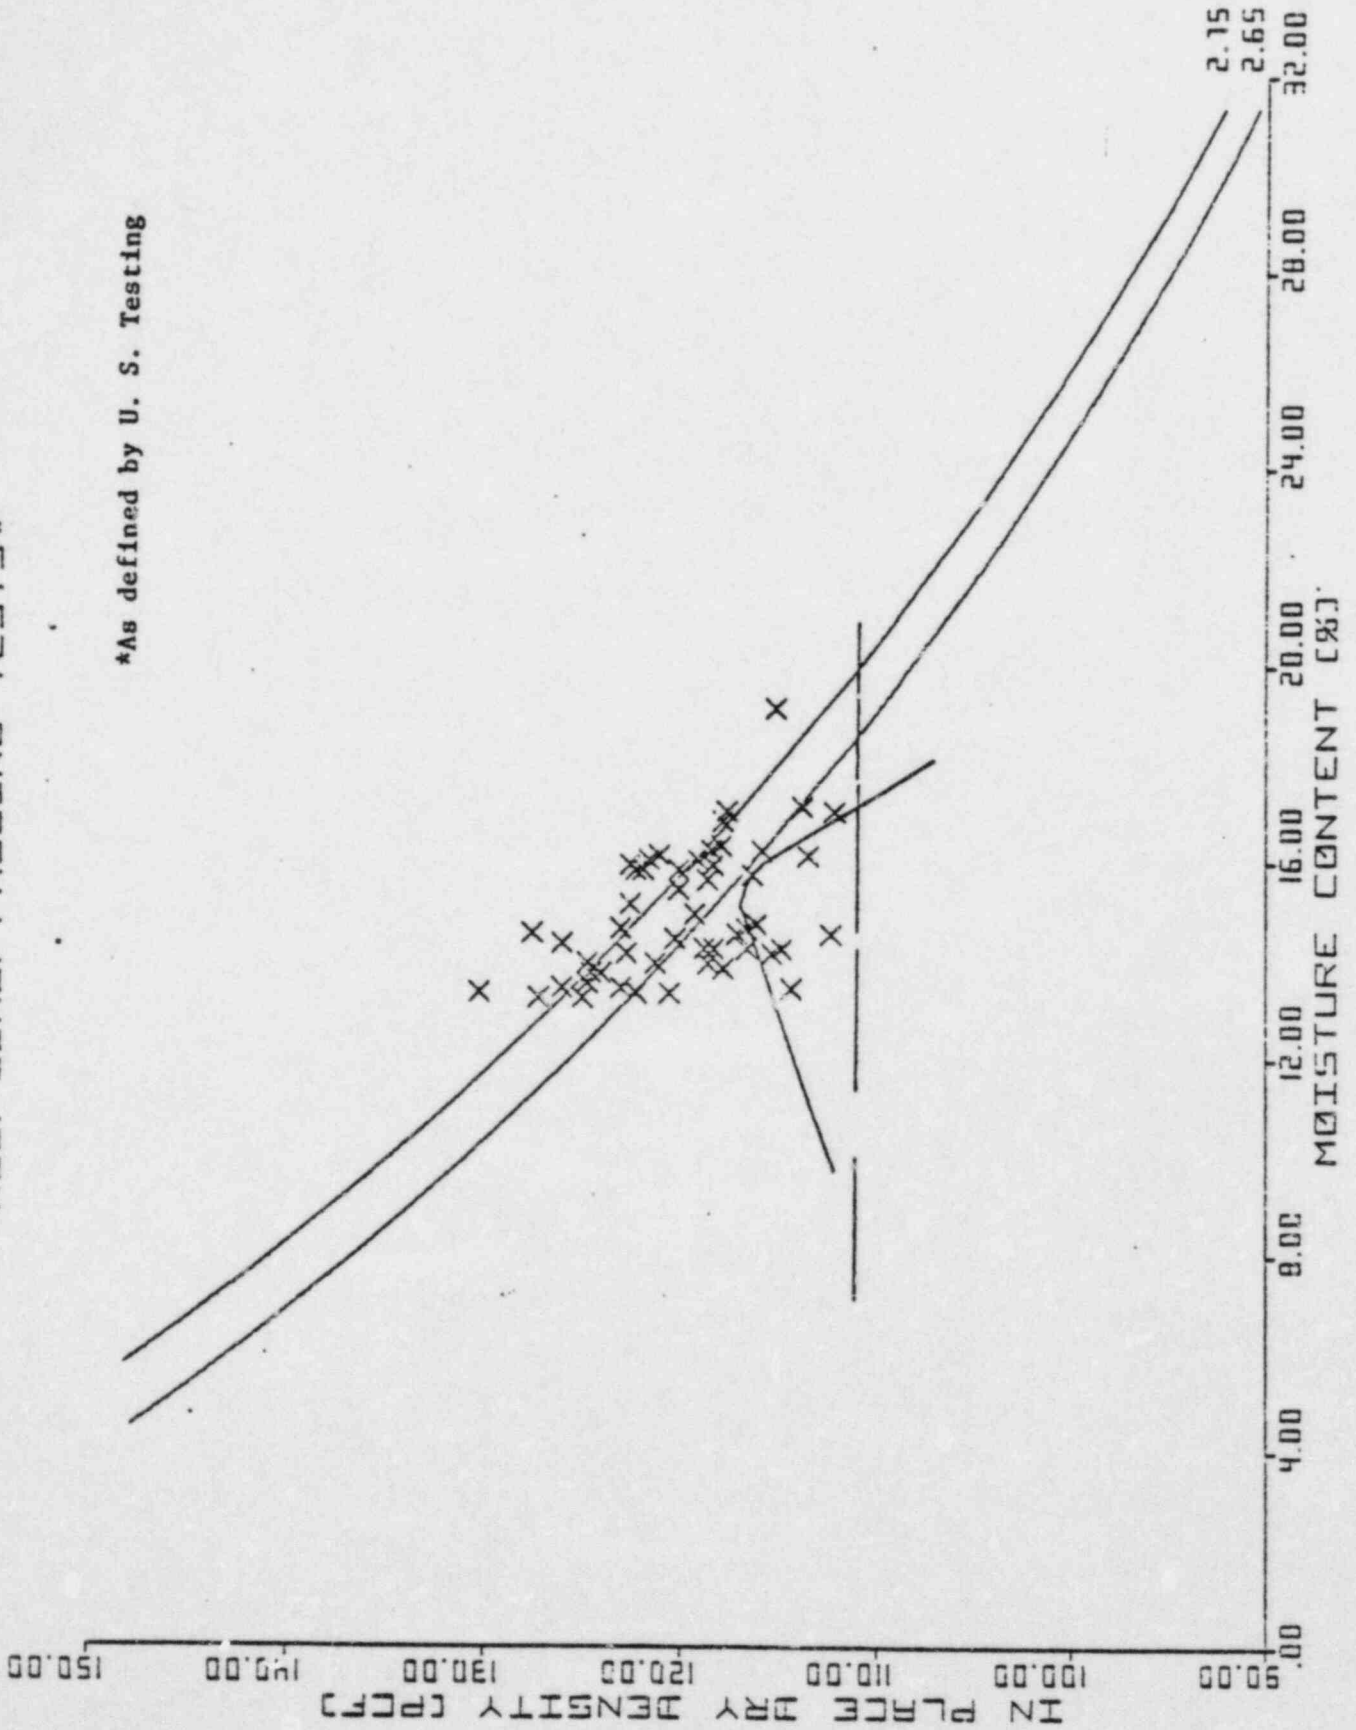
FIGURE 5

MOISTURE DENSITY FOR BMP 278
 SPECIFIC GRAVITY = 2.65
 NUC. DENS. PASSING TESTS*

*As defined by U. S. Testing

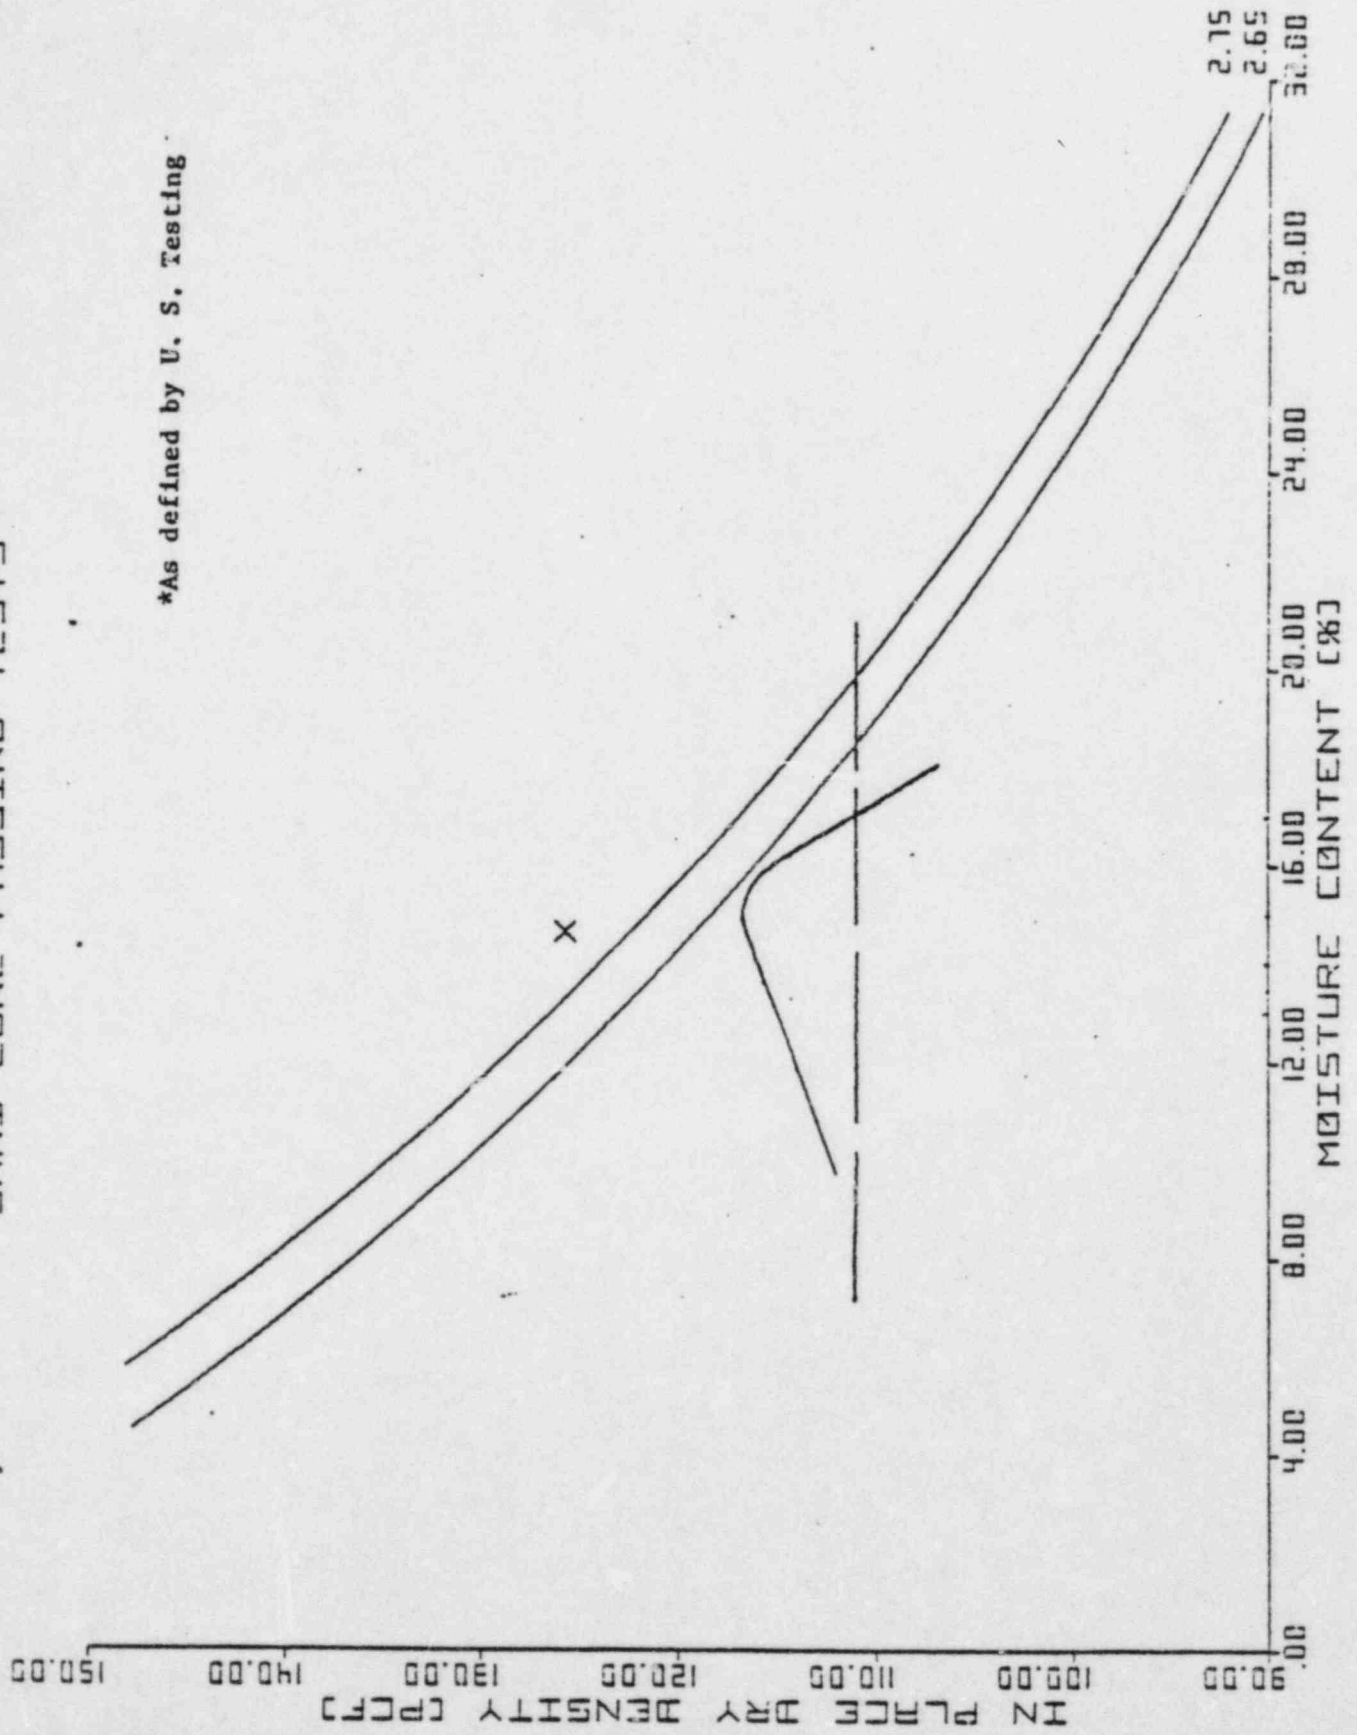
FIGURE 6

MOISTURE-DENSITY FOR BMP 278
 SPECIFIC GRAVITY = 2.65
 SAND-CONE PASSING TESTS *

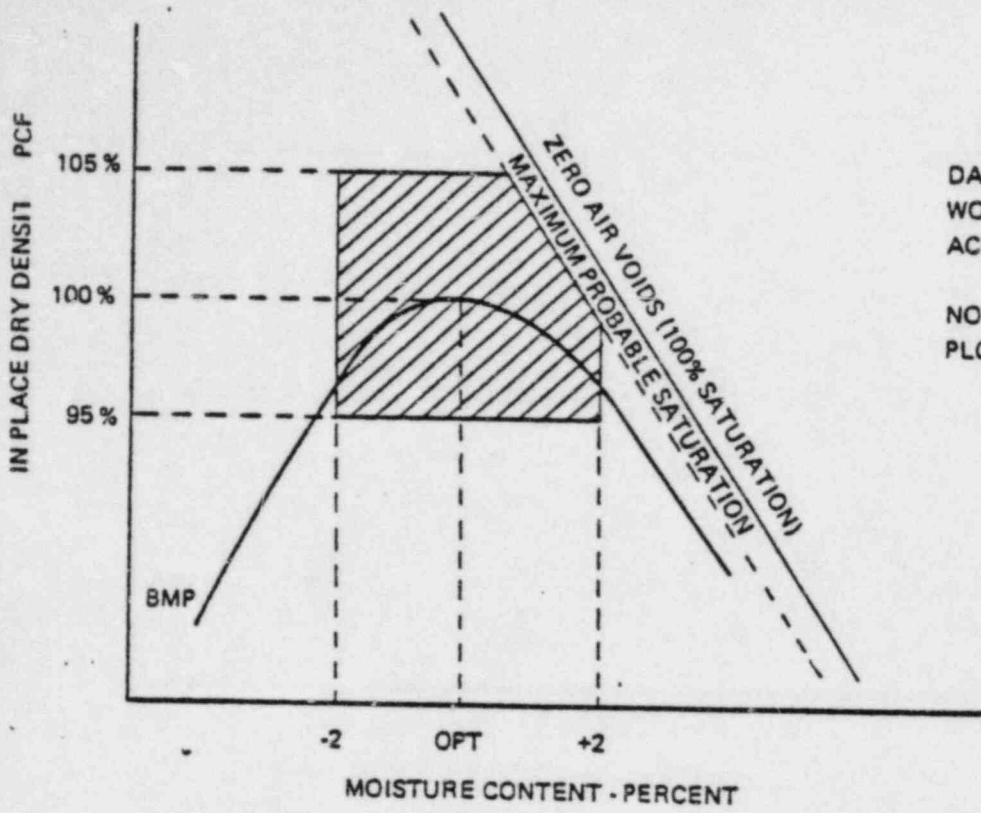
FIGURE 7-A-

DATA POINTS THAT PLOT IN SHADED AREA WOULD BE GENERALLY ACCEPTABLE ACCORDING TO SPECIFICATIONS

NOTE: ABOUT 25% OF ALL FIELD DATA PLOTS IN THE SHADED AREA

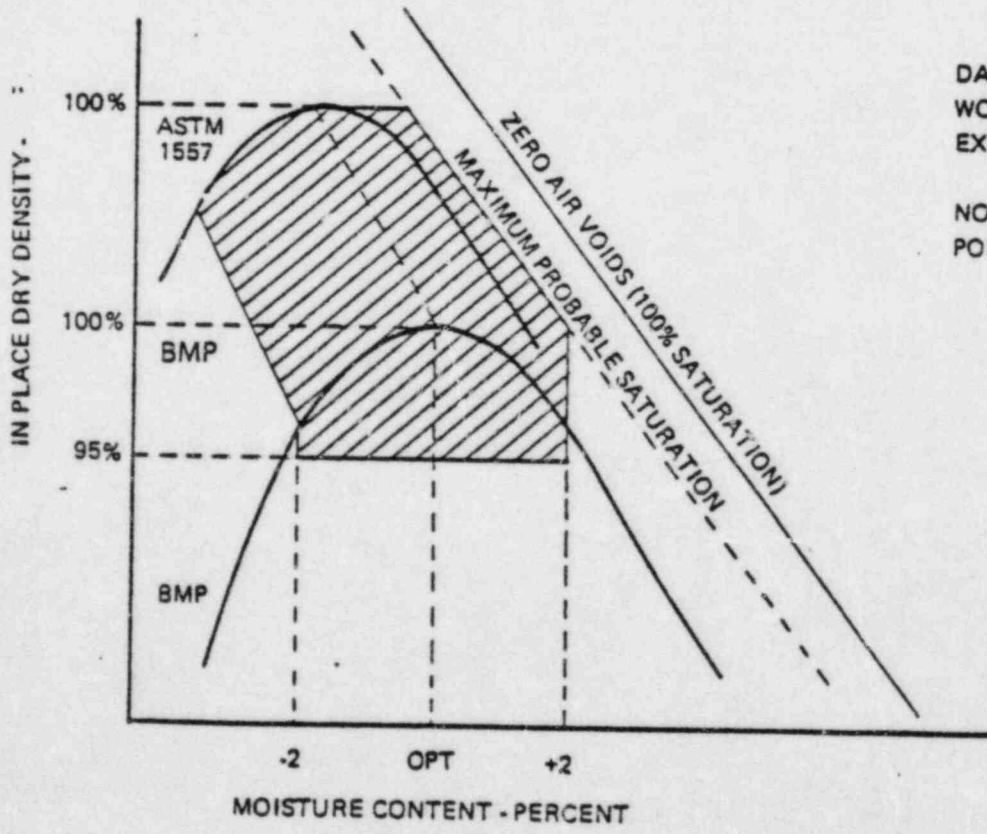
DATA POINTS THAT PLOT IN SHADED AREA WOULD BE ACCEPTABLE REGARDLESS OF EXACT SPECIFICATION WORDING

NOTE: ABOUT 40% OF ALL FIELD DATA POINTS PLOT IN THE SHADED AREA

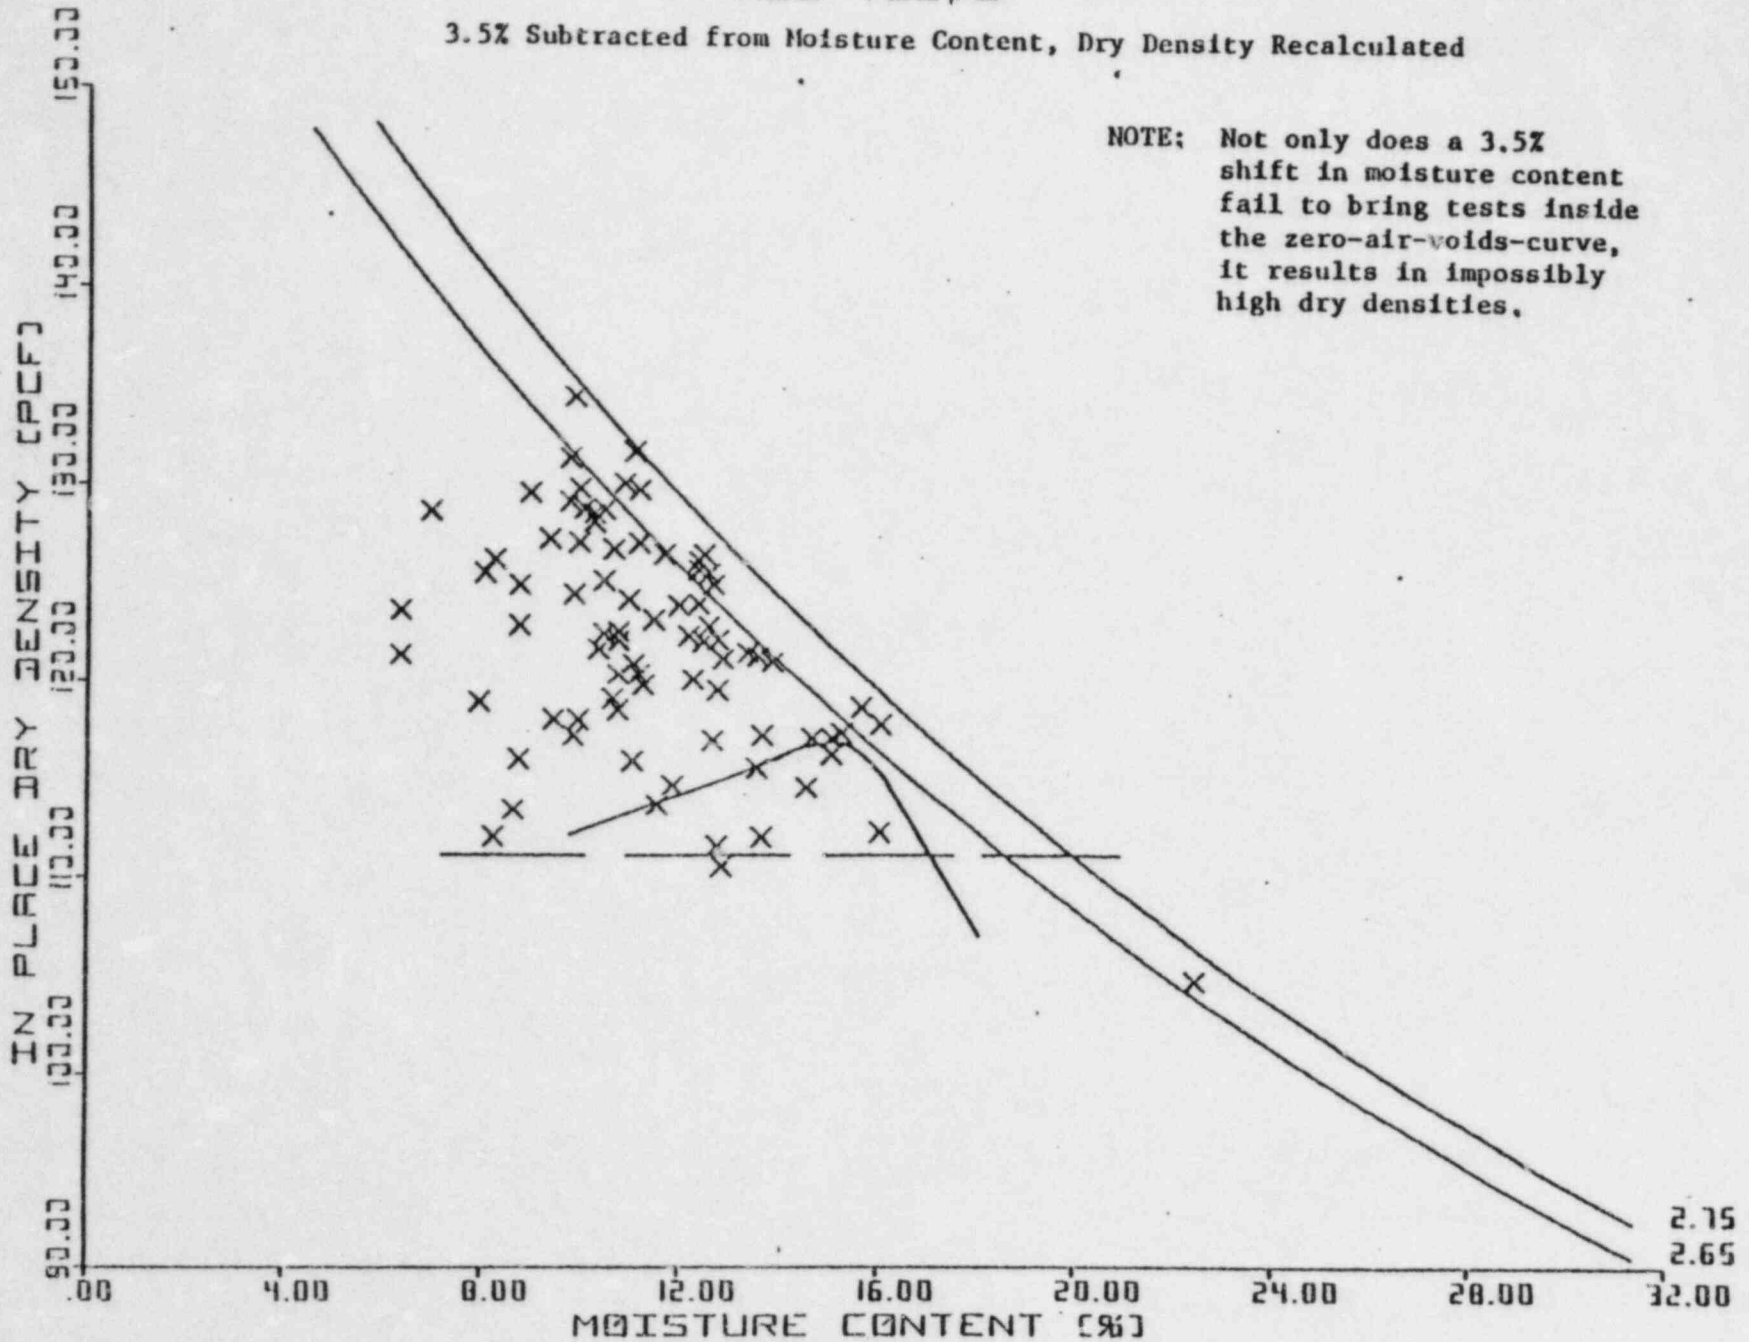
FIGURE 9

MOISTURE-DENSITY FOR BMP 278

3.5% Subtracted from Moisture Content, Dry Density Recalculated

NOTE: Not only does a 3.5% shift in moisture content fail to bring tests inside the zero-air-voids-curve, it results in impossibly high dry densities.

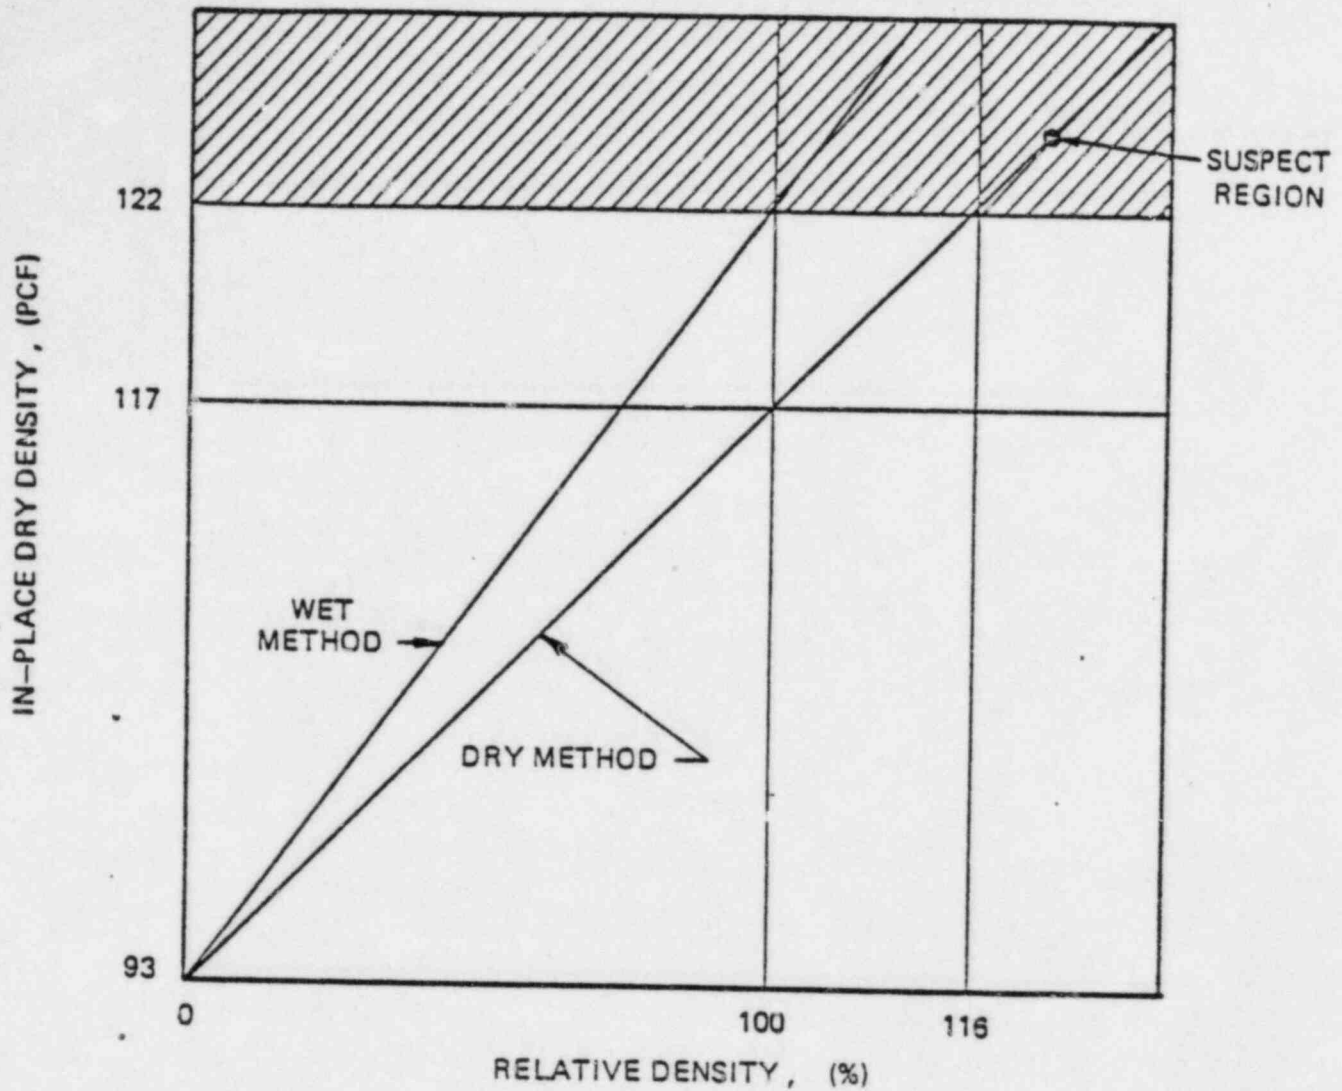
FIGURE 10
 CHANGE IN RELATIVE DENSITY SCALE FROM DRY TO WET METHODS
 OF OBTAINING MAXIMUM DENSITY, BASED ON RECENT LAB RESULTS

NOTE: VALUES FOR DRY DENSITY ARE TYPICAL OF A RANDOM FILL SAND. ANY TESTS SHOWING MORE THAN 117% RELATIVE DENSITY WOULD BE SUSPECT IN THIS EXAMPLE. STRUCTURAL SANDS TEND TO SHOW ONLY 2 OR 3 PCF INCREASE IN MAXIMUM DENSITY AND THUS RESULTS AT MUCH LOWER RELATIVE DENSITY WOULD BE SUSPECT, SAY 105 - 110 PERCENT
