BECHTEL INVESTIGATION  
INTO CAUSES  
OF DIESEL GENERATOR  
BUILDING SETTLEMENT

Consumers Power Company  
Midland Plant Units 1 and 2

SUBJECT: MCAR 24 (issued 9/7/78)  
 Settlement of the Diesel Generator Foundations and Building  
 INTERIM REPORT 4  
 DATE: February 16, 1979  
 PROJECT: Consumers Power Company  
 Midland Plant Units 1 & 2  
 Bechtel Job 7220

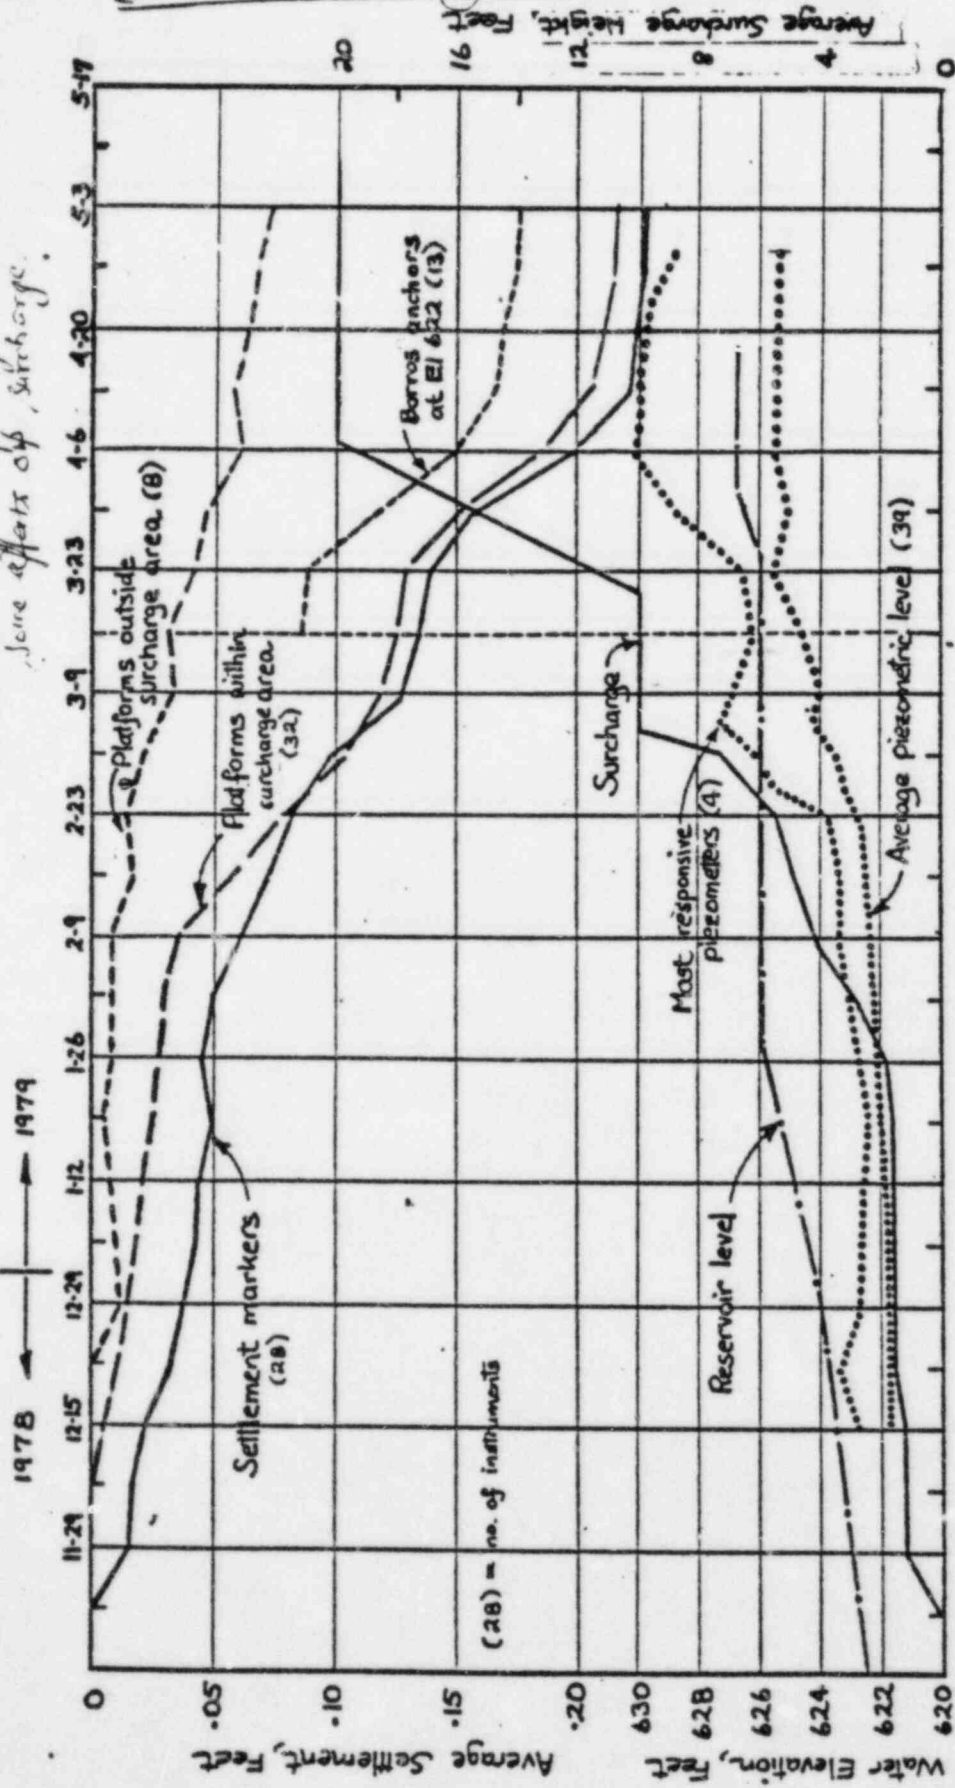
DIESEL GENERATOR BLDG : AVG SETTLEMENT, SURCHARGE & WATER LEVEL VS TIME

Almost all piez : 625 (+)

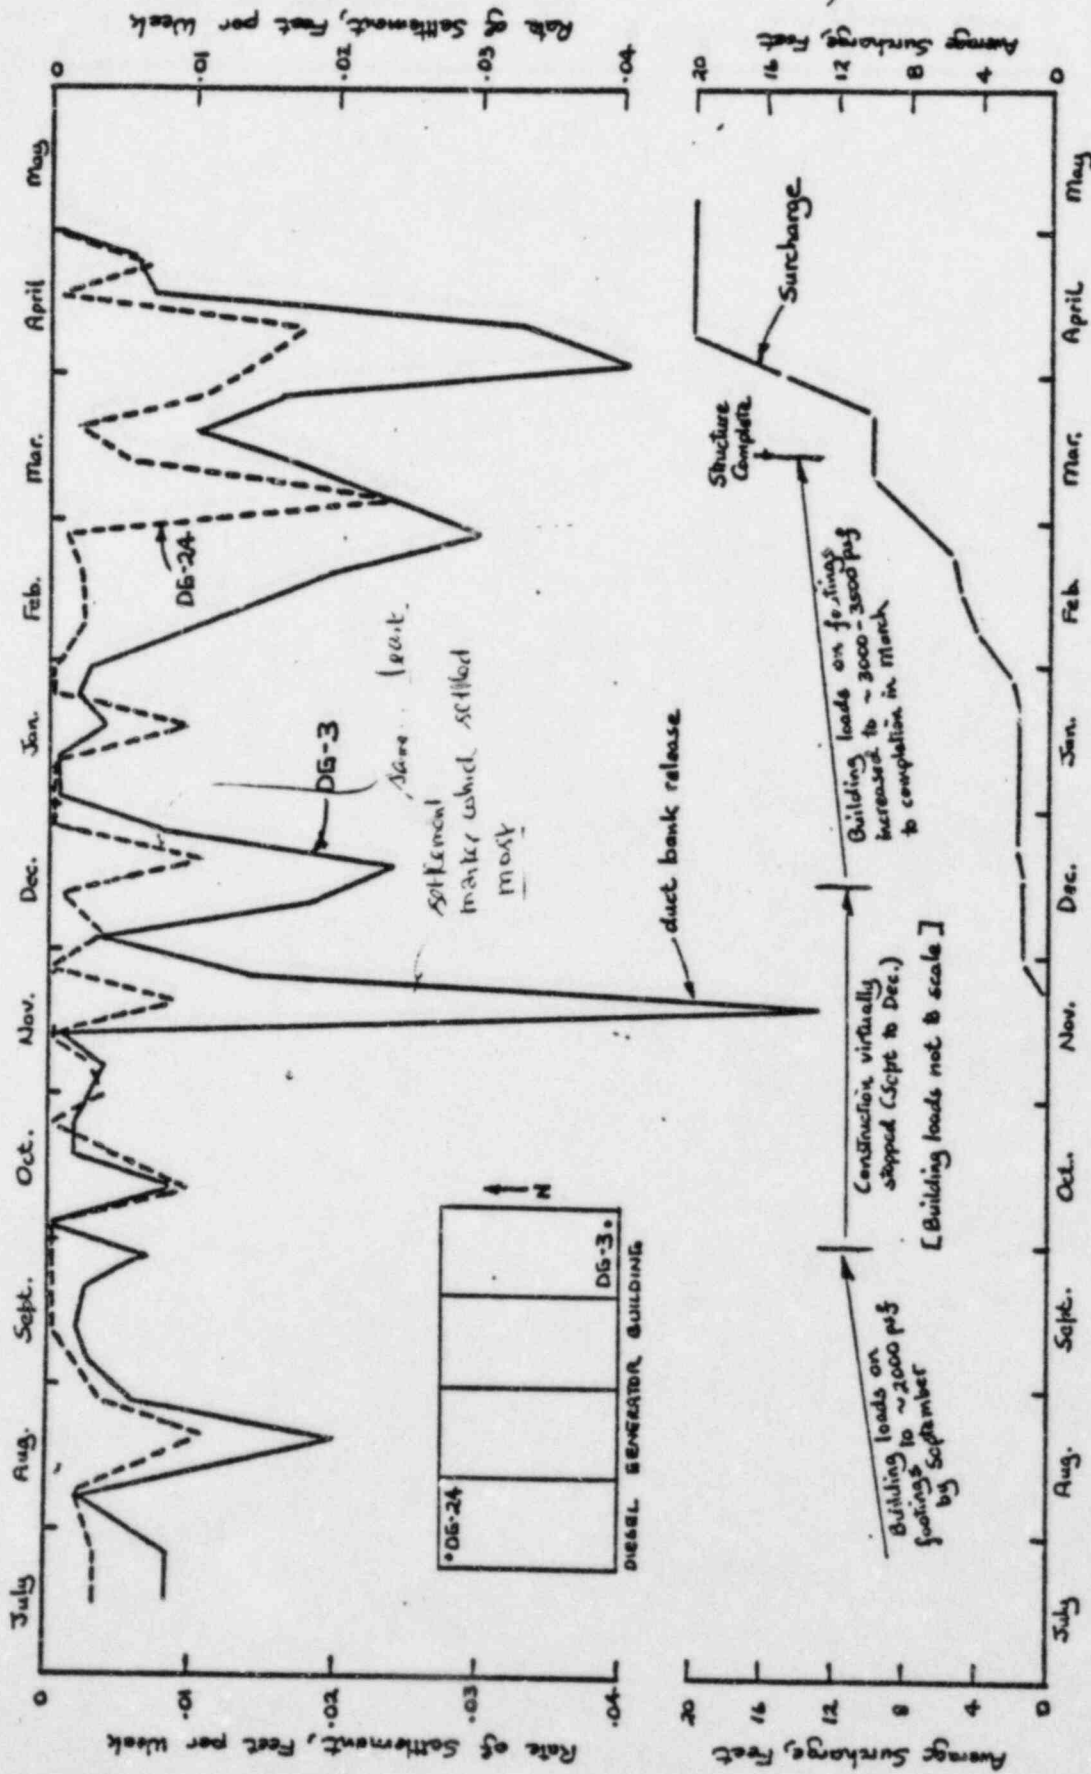
DIESEL GENERATOR BUILDING: SETTLEMENT MARKERS — SETTLEMENT RATE VERSUS TIME

Settlement, since completion of soft of surcharge.

Survey accuracy  $\pm 1/8"$

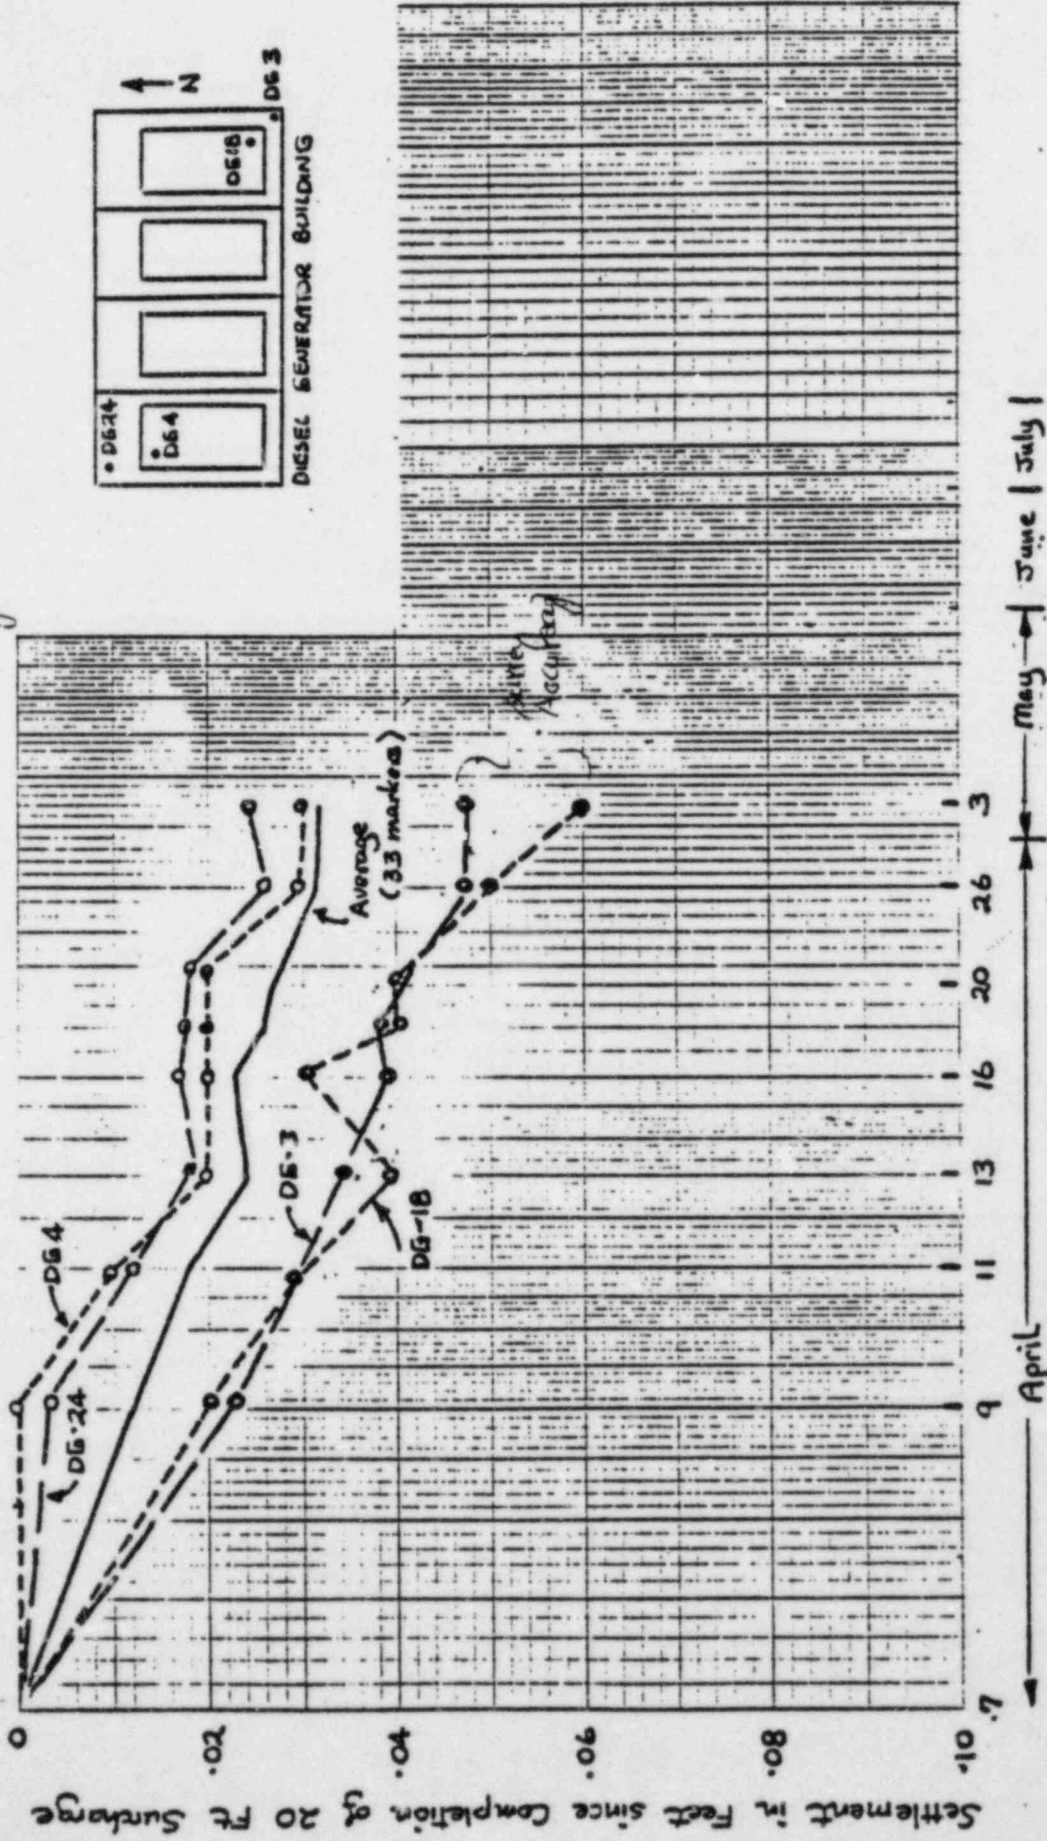
DIESEL GENERATOR BUILDING : SETTLEMENT VERSUS LOG TIME

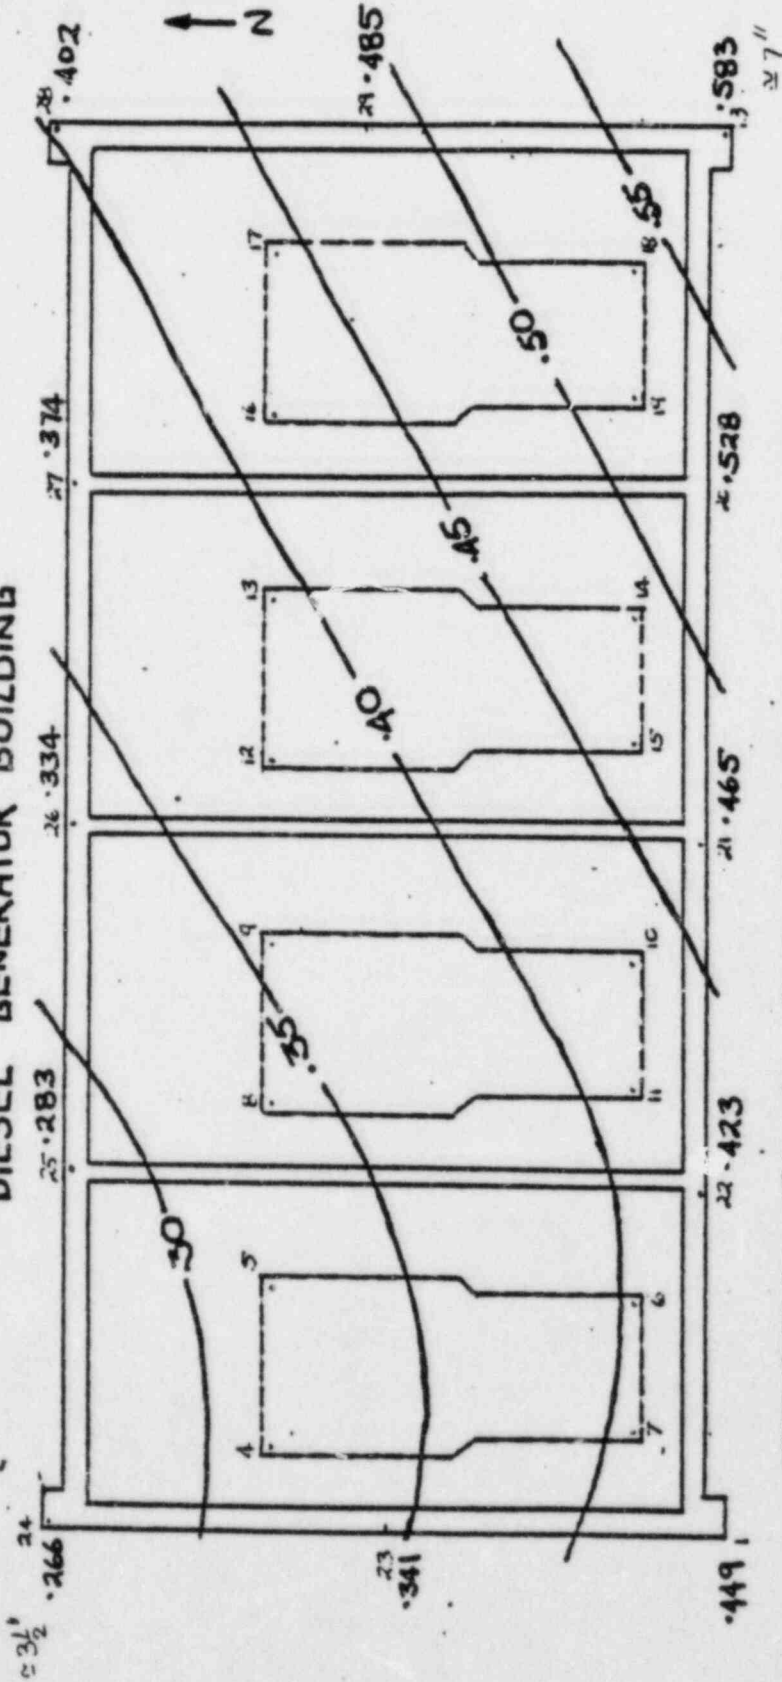
**SETTLEMENT MARKERS: TOTAL SETTLEMENT OF WALLS TO 5-3-79**  
 Readings in Feet; Total Surcharge of 20 ft (2200 psf)

Total settlement on building walls only

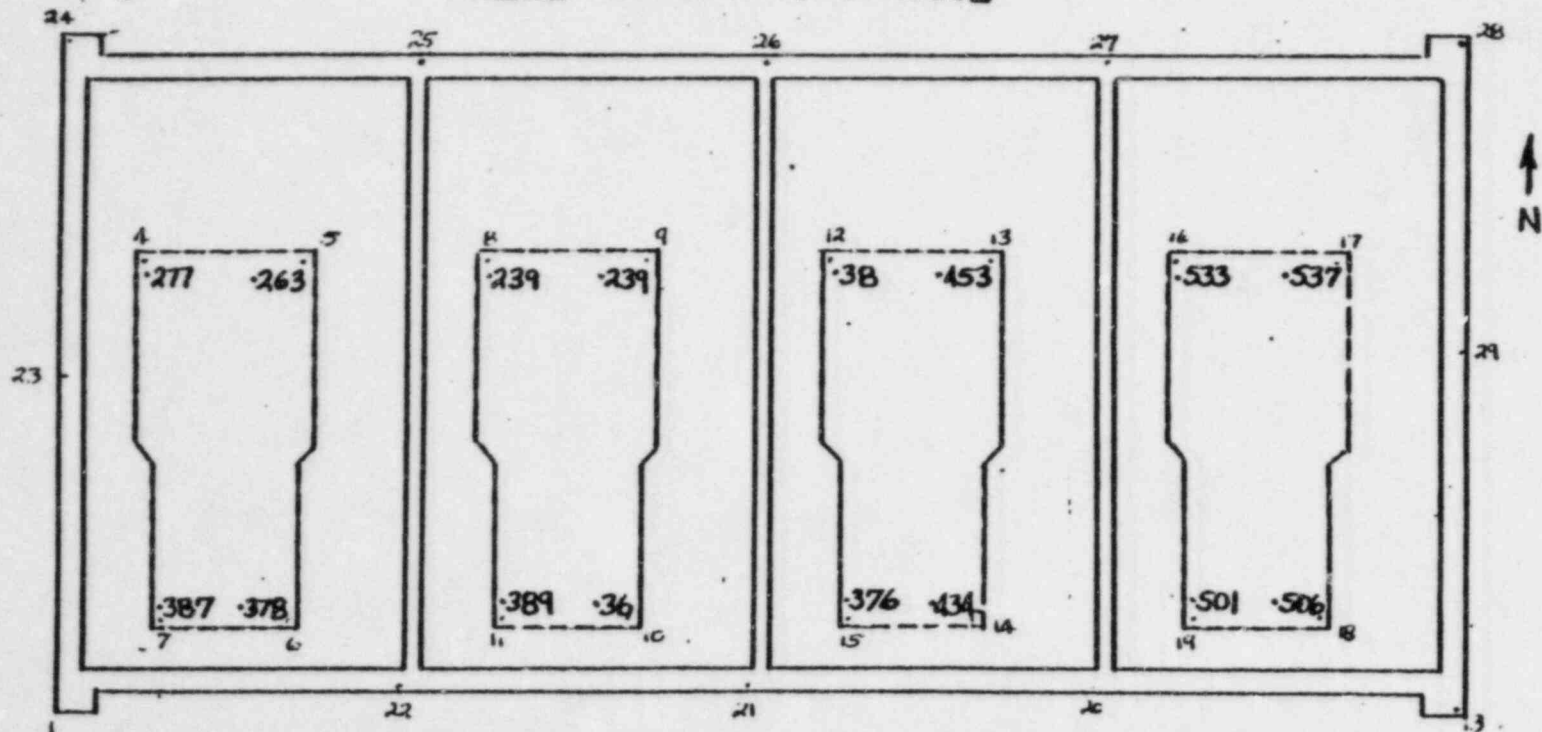
SETTLEMENT MARKERS: TOTAL SETTLEMENT OF PEDESTALS to 5-3-79  
 Readings in Feet; Total Surcharge of 20 FE (2200 psf)

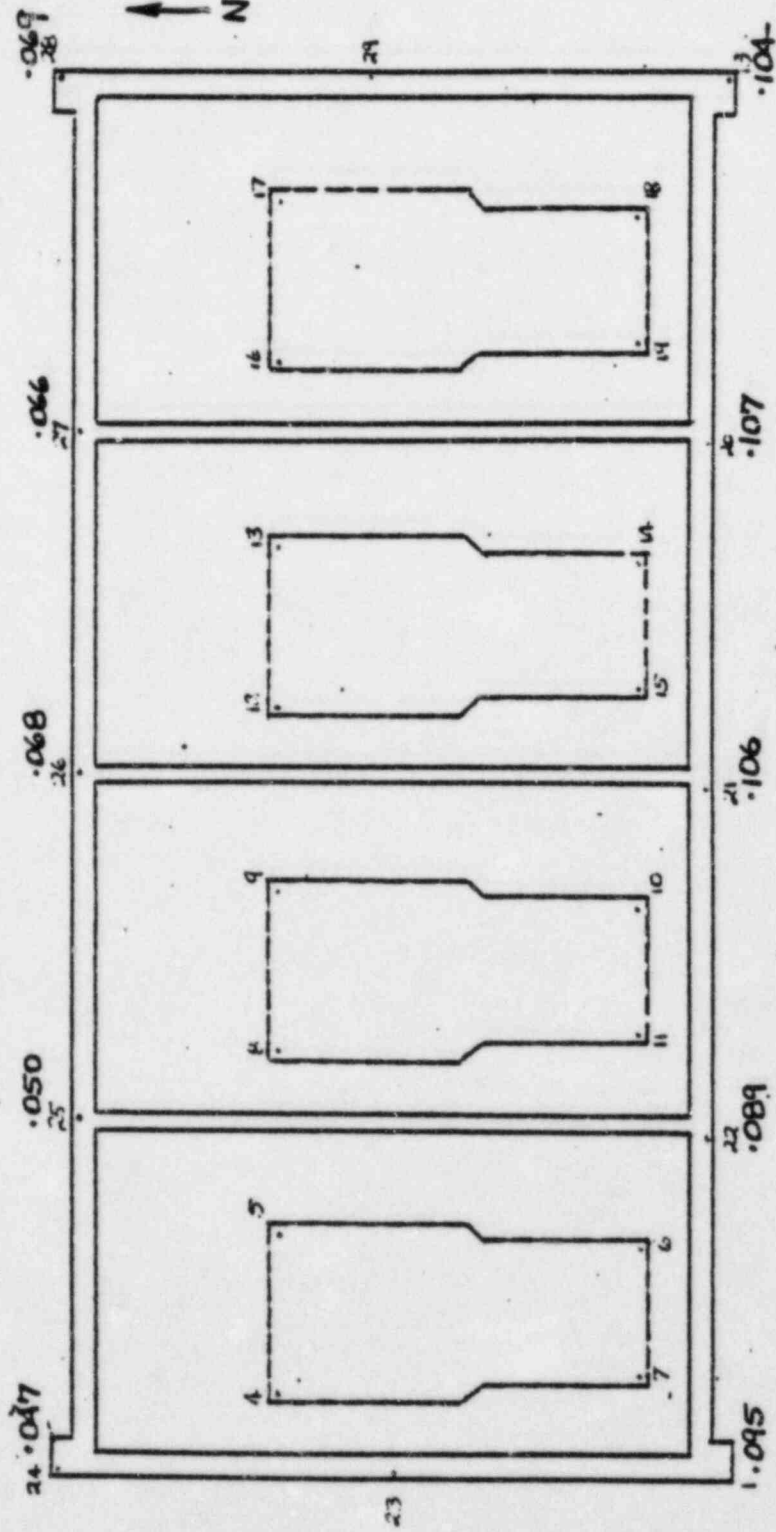
SETTLEMENT MARKERS: SETTLEMENT OF WALLS FROM 3-15-79 to 4-13-79  
 Readings in Feet ; 10 Ft Surcharge Added

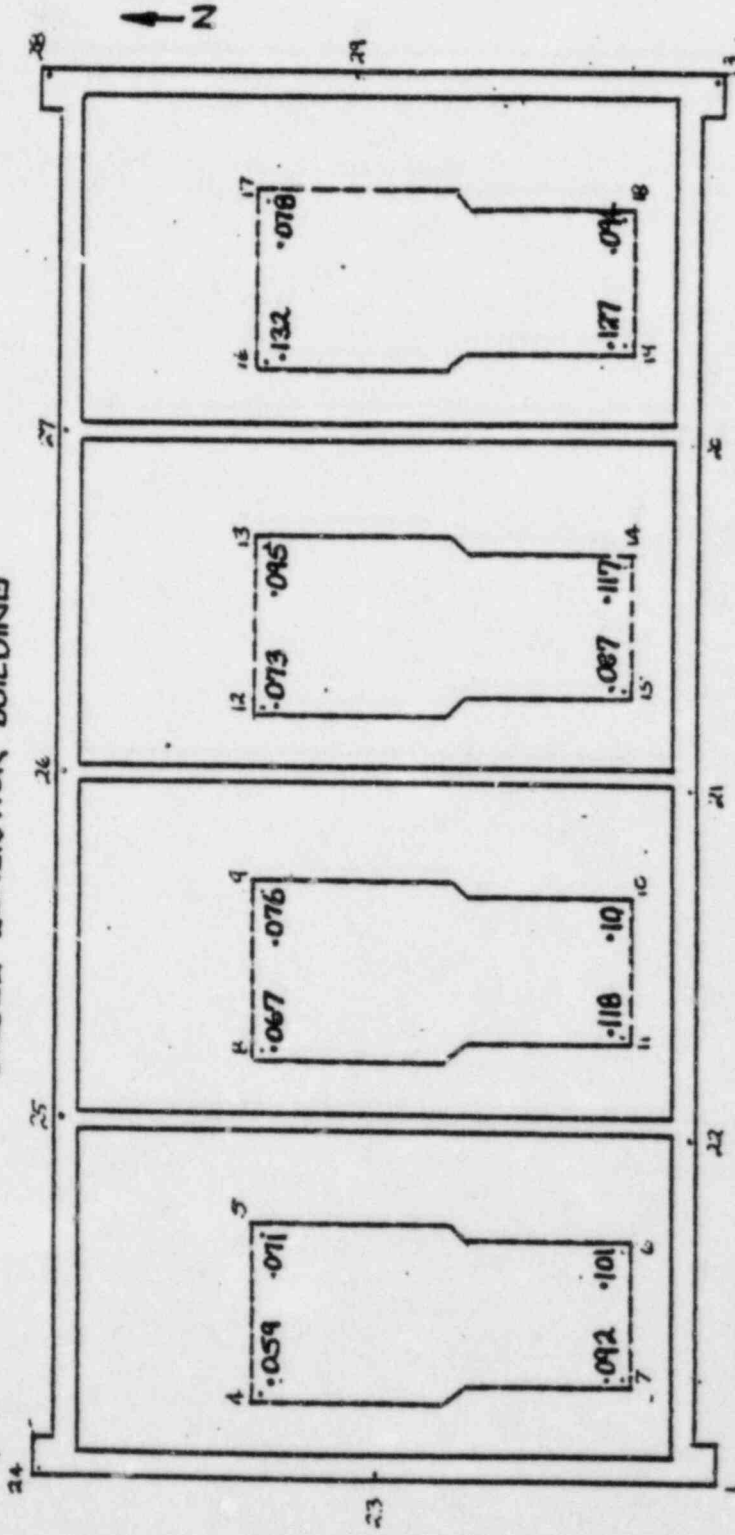
SETTLEMENT MARKERS : SETTLEMENT OF PEDESTALS FROM 3-15-79 to 4-13-79  
Readings in Feet; 10 FE of Surcharge Added

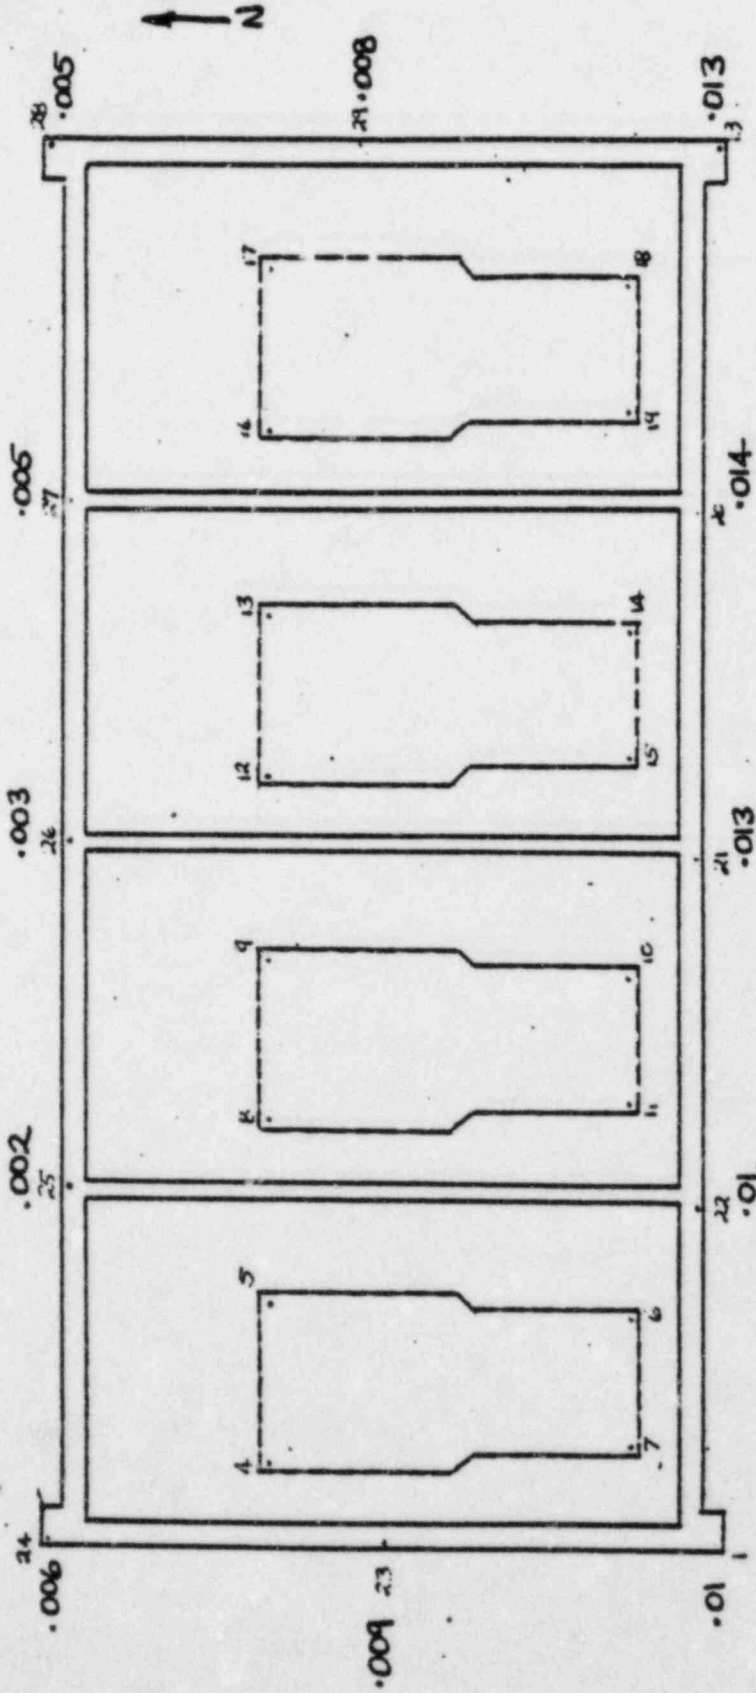
SETTLEMENT MARKERS: SETTLEMENT OF WALLS FROM 4-13-79 to 5-3-79  
 Readings in Feet; 0 Ft of Surcharge Added

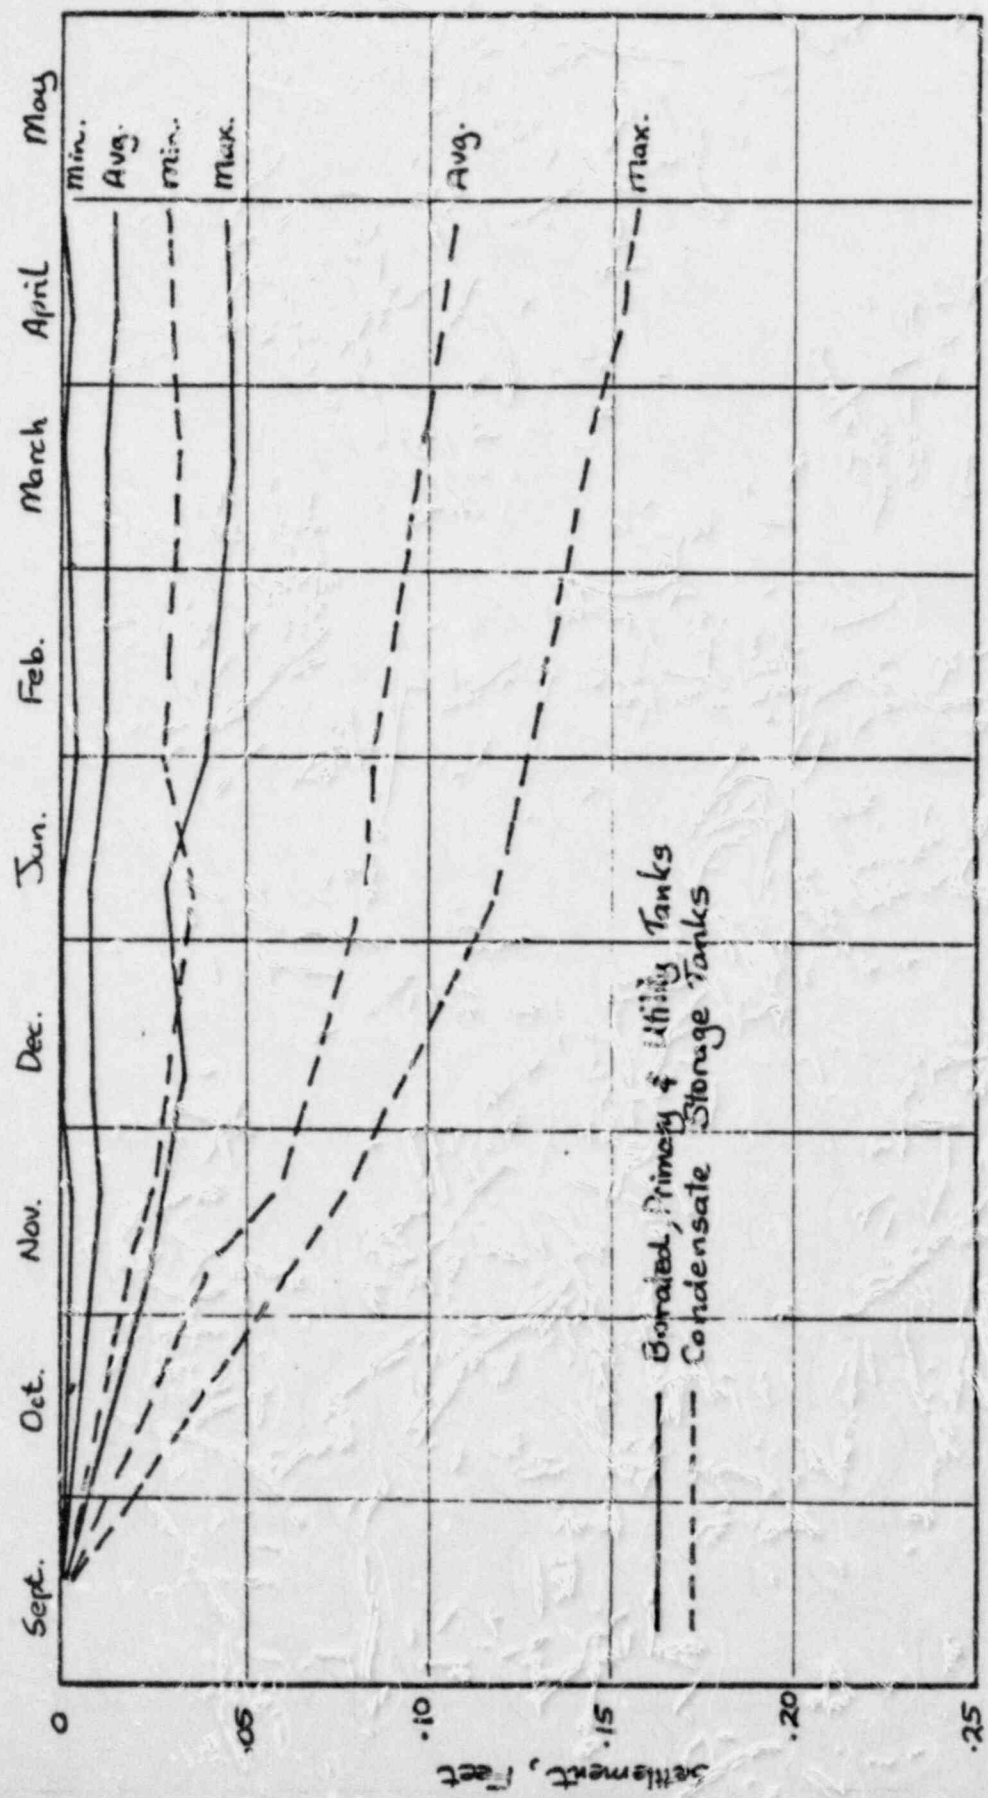
STORAGE TANKS : SETTLEMENT MARKERS ON TANK RINGWALLS

Boreated water placed first

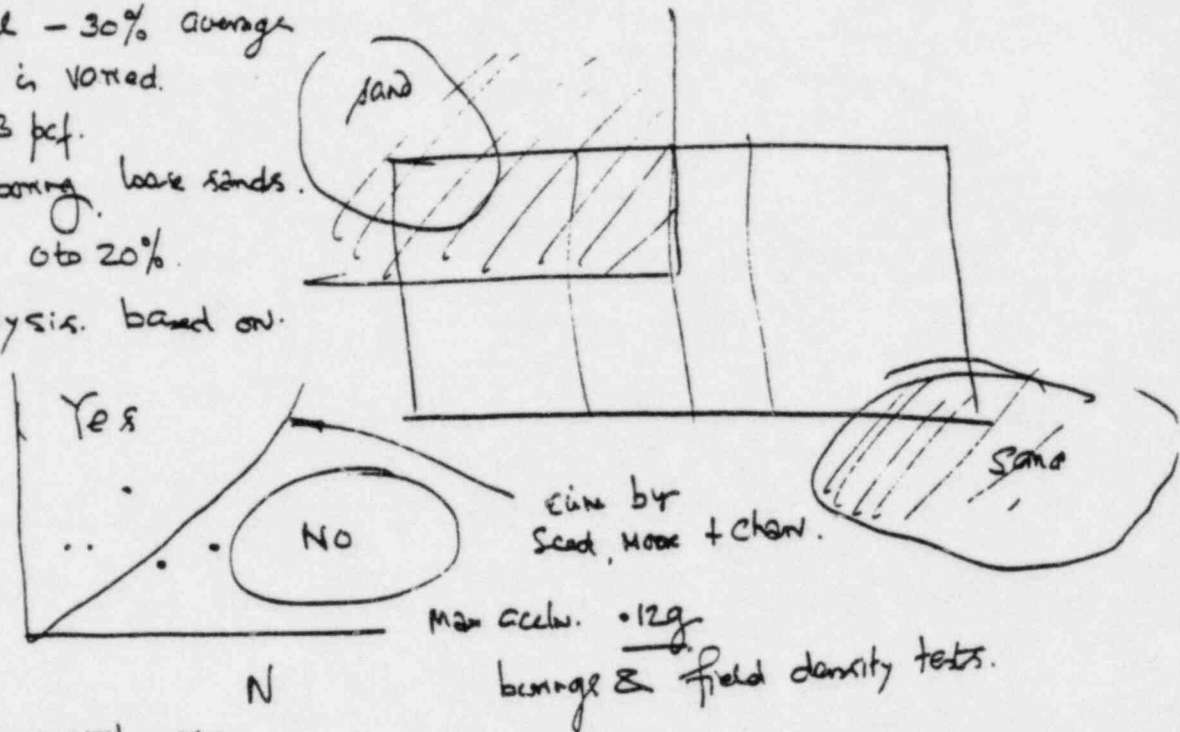
Sand material - 30% average  
 Distr. of sand is varied.  
 93pcf to 133 pcf.  
 615 to 625 boring loose sands.  
 passing 200 - 0 to 20%.  
 Liquif. Analysis based on:  
 STP.

NW is the worst one.  
 blow count normalized to exist Local  
 N = 10 or less. 15 points to the left. NW -

Summary. Good possibility of Liquifaction at .12g.

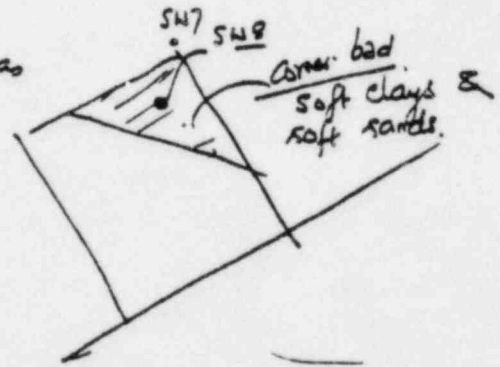
There are cracks in the building.

Settlement marks shown up as major.

Need more investigation of the cracking pattern.  
Review construction records.

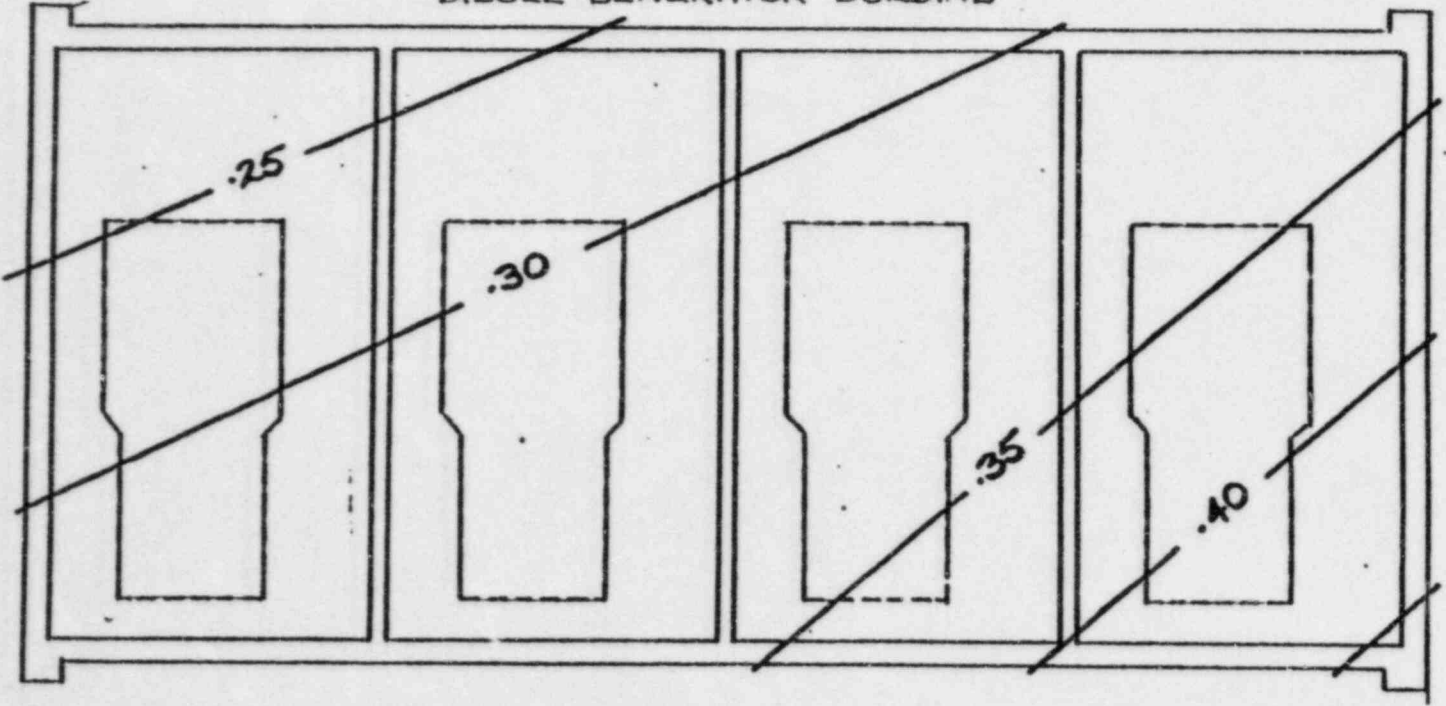
SETTLEMENT MARKERS : TOTAL SETTLEMENT OF BUILDING WALLS to 3-16-79  
Readings in Feet ; Total Surcharge of 1100 psf (10 Feet)

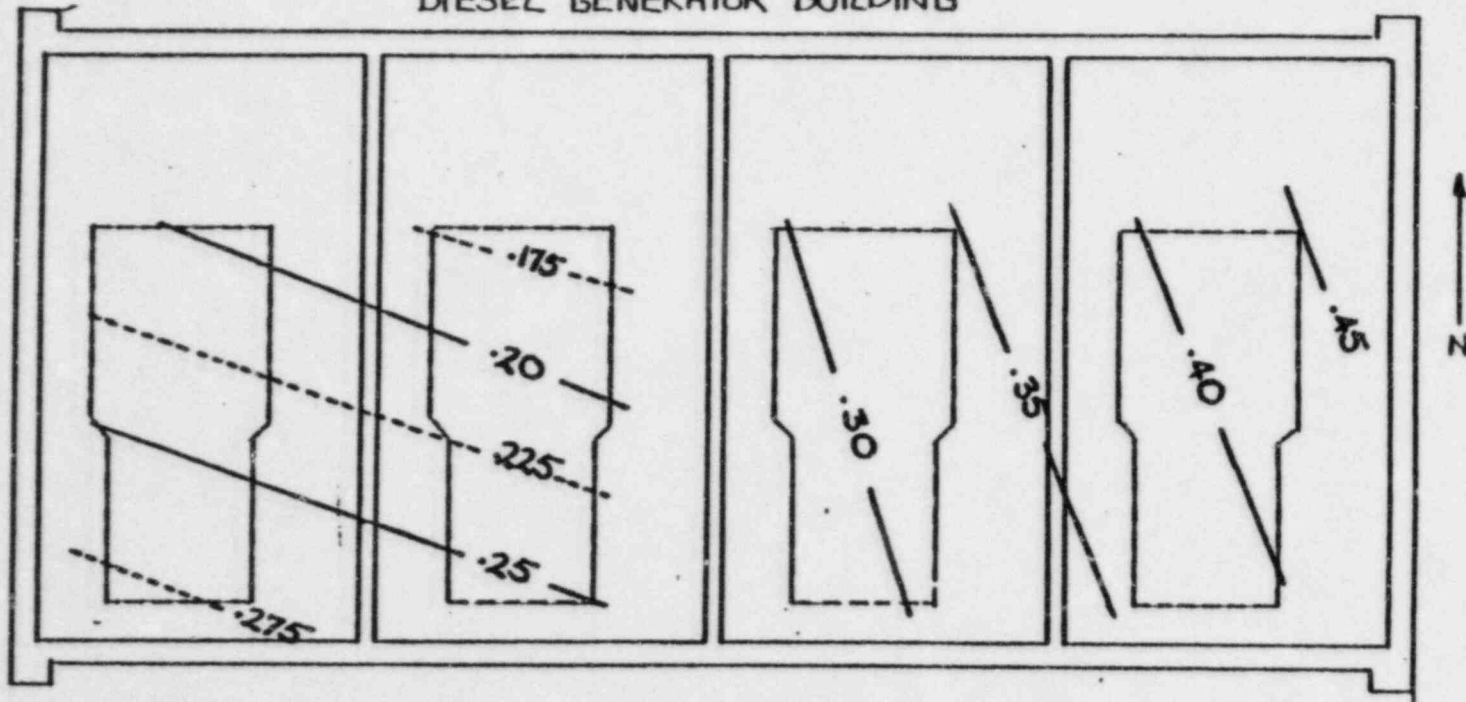
SETTLEMENT MARKERS: TOTAL SETTLEMENT OF PEDESTALS to 3-16-79  
Readings in Feet; Total Surcharge of 1100 psf (10 Feet)

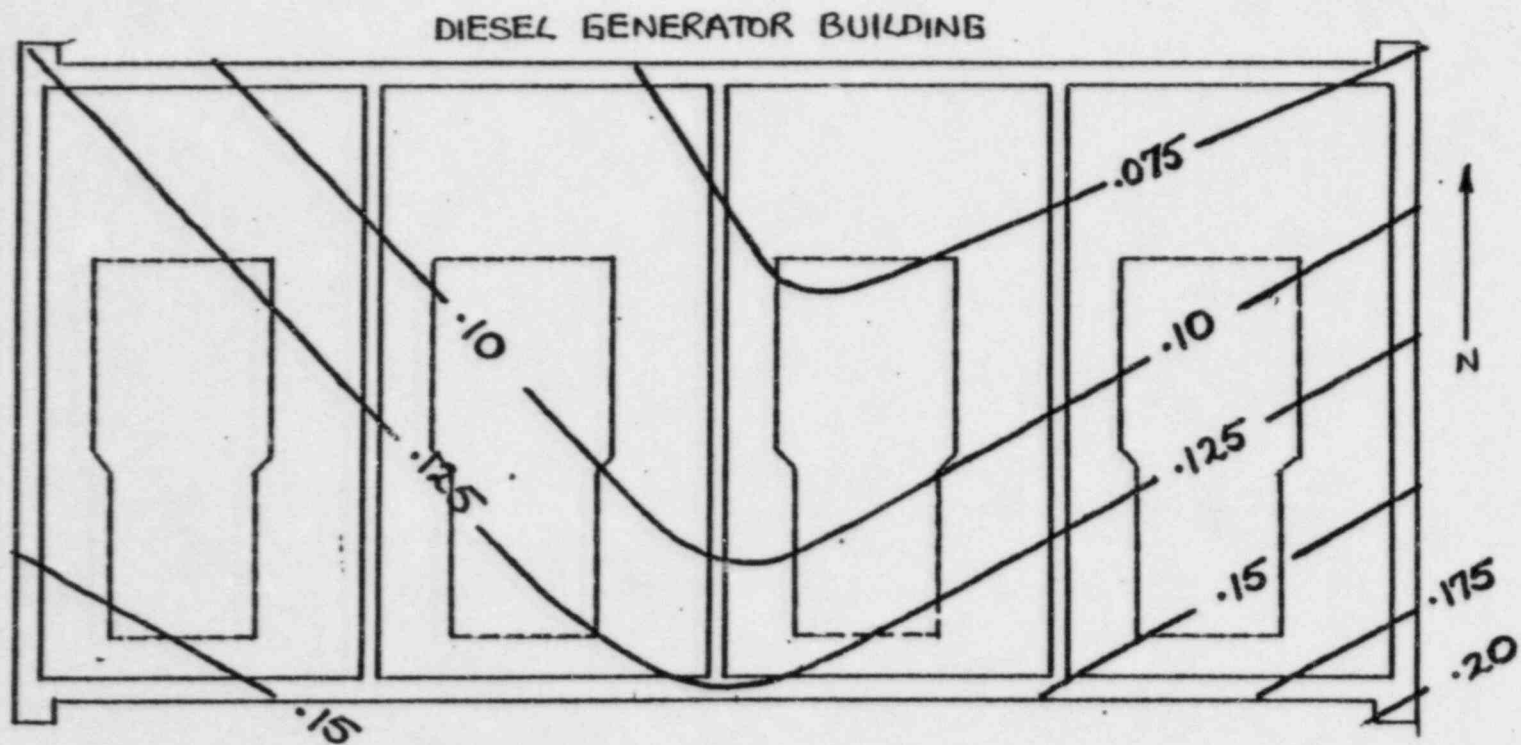
SETTLEMENT MARKERS: TOTAL SETTLEMENT OF BUILDING WALLS to 9-15-78  
 Readings in Feet; No Surcharge; Electrical Ducts Attached

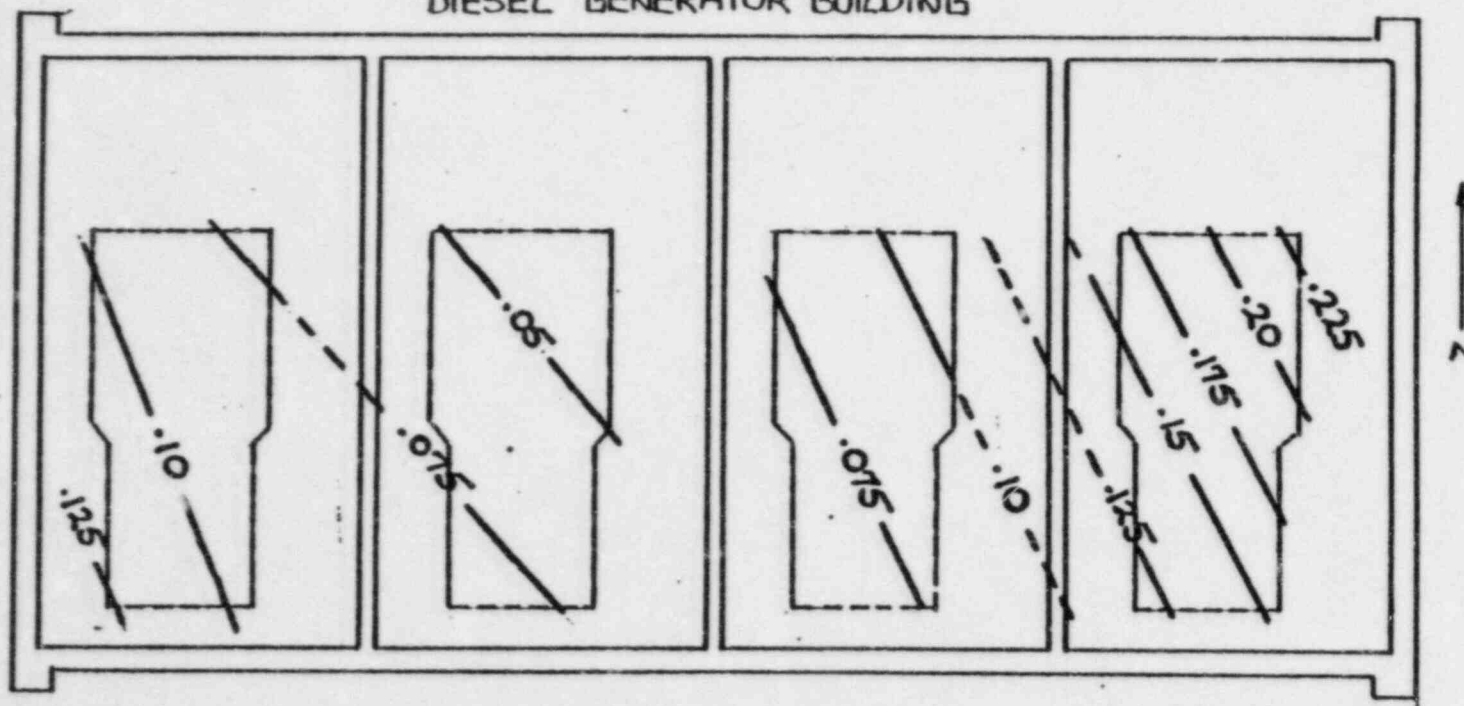
SETTLEMENT MARKERS: TOTAL SETTLEMENT OF PEDESTALS to 9-15-'78  
Readings in Feet ; No Surcharge ; Electrical Dies Attached.

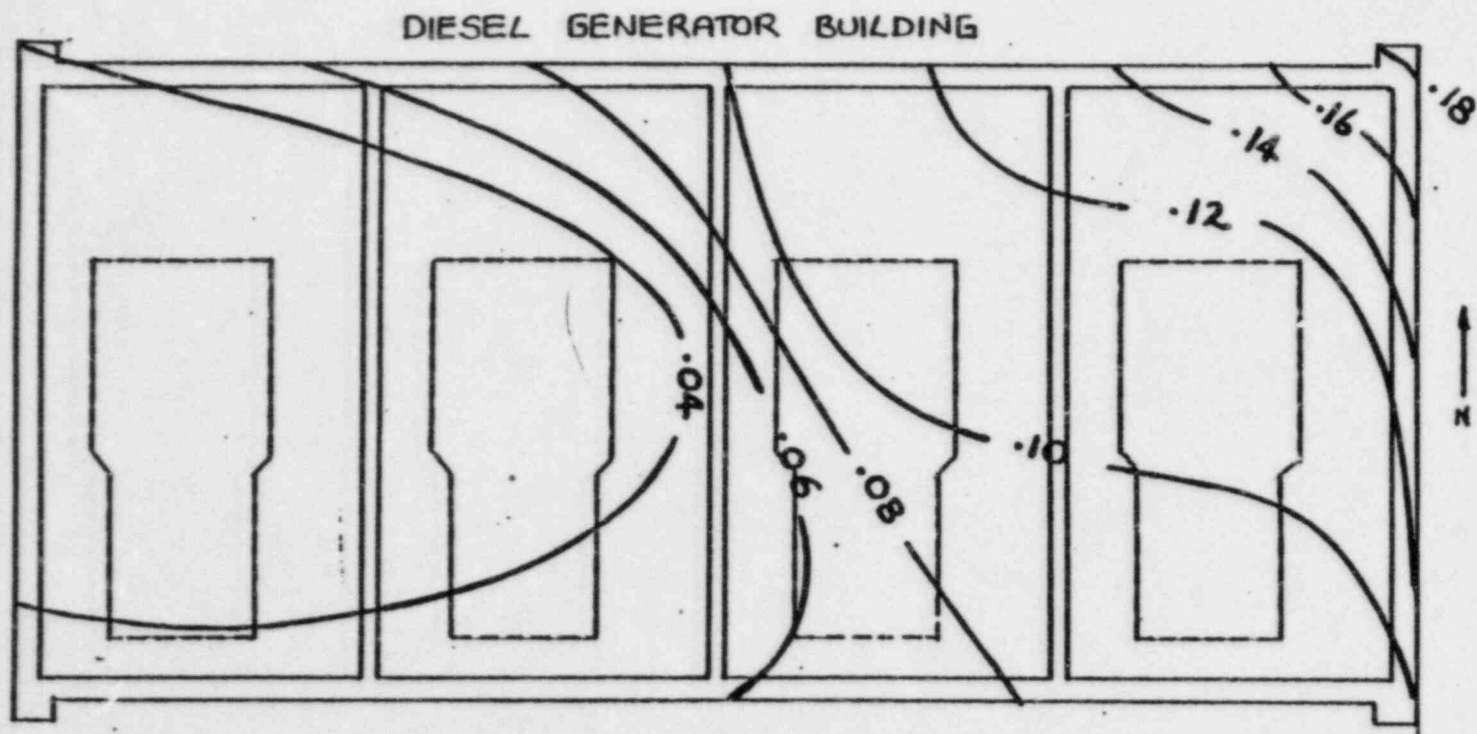
SETTLEMENT MARKERS : DIFFERENTIAL SETTLEMENT, 9-15-78 to 12-8-78  
 Readings in Feet ; Electrical Ducts Isolated in Period  
 BUILDING WALLS & PEDESTALS

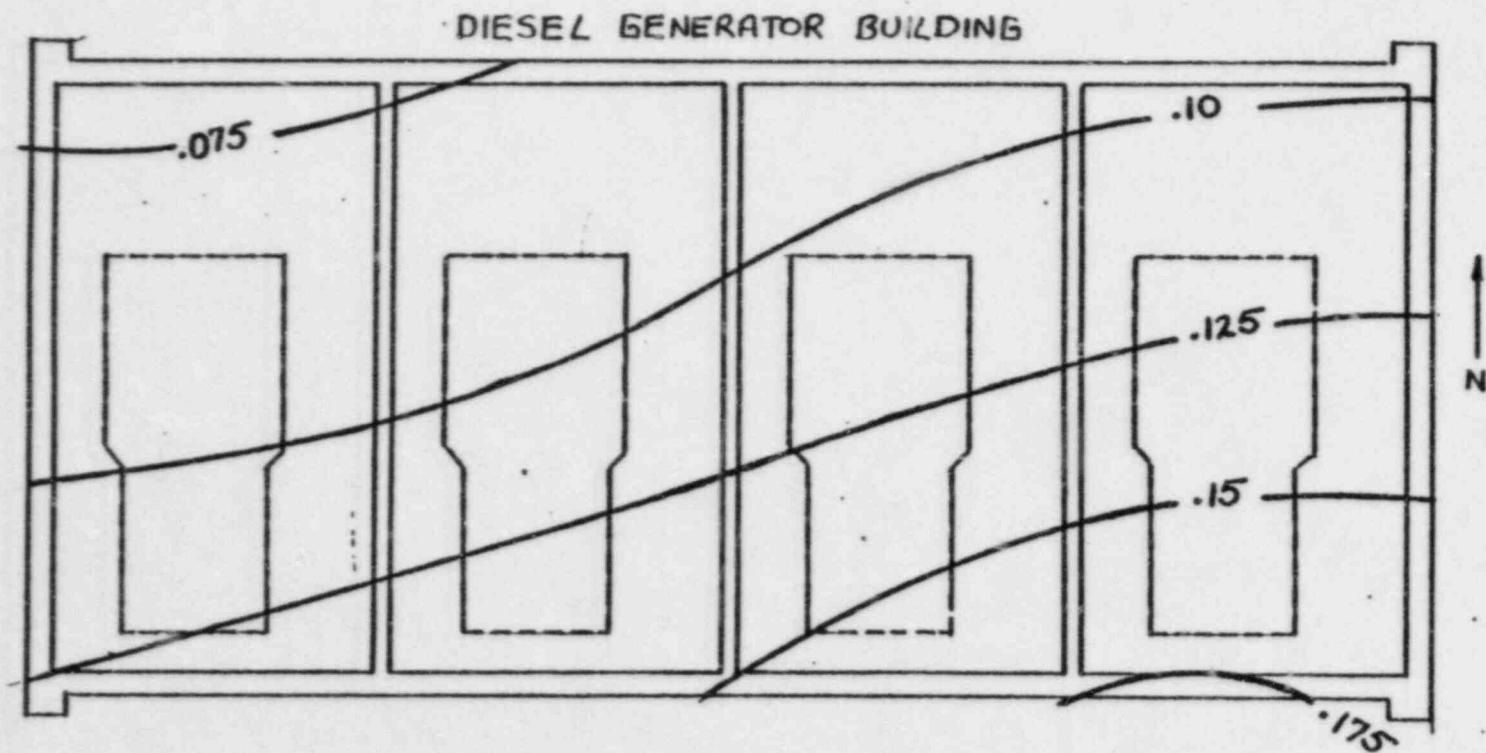
SETTLEMENT MARKERS : DIFFERENTIAL SETTLEMENT, 12-8-78 to 3-16-79  
 Readings in Feet ; 950 psf Surcharge added in Period  
 BUILDING WALLS & PEDESTALS
