BECHTEL INVESTIGATION  
INTO CAUSES  
OF DIESEL GENERATOR  
BUILDING SETTLEMENT

Consumers Power Company  
Midland Plant Units 1 and 2

SUBJECT: MCAR 24 (issued 9/7/78)  
 Settlement of the Diesel Generator Foundations and Building  
 INTERIM REPORT 4  
 DATE: February 16, 1979  
 PROJECT: Consumers Power Company  
 Midland Plant Units 1 & 2  
 Bechtel Job 7220

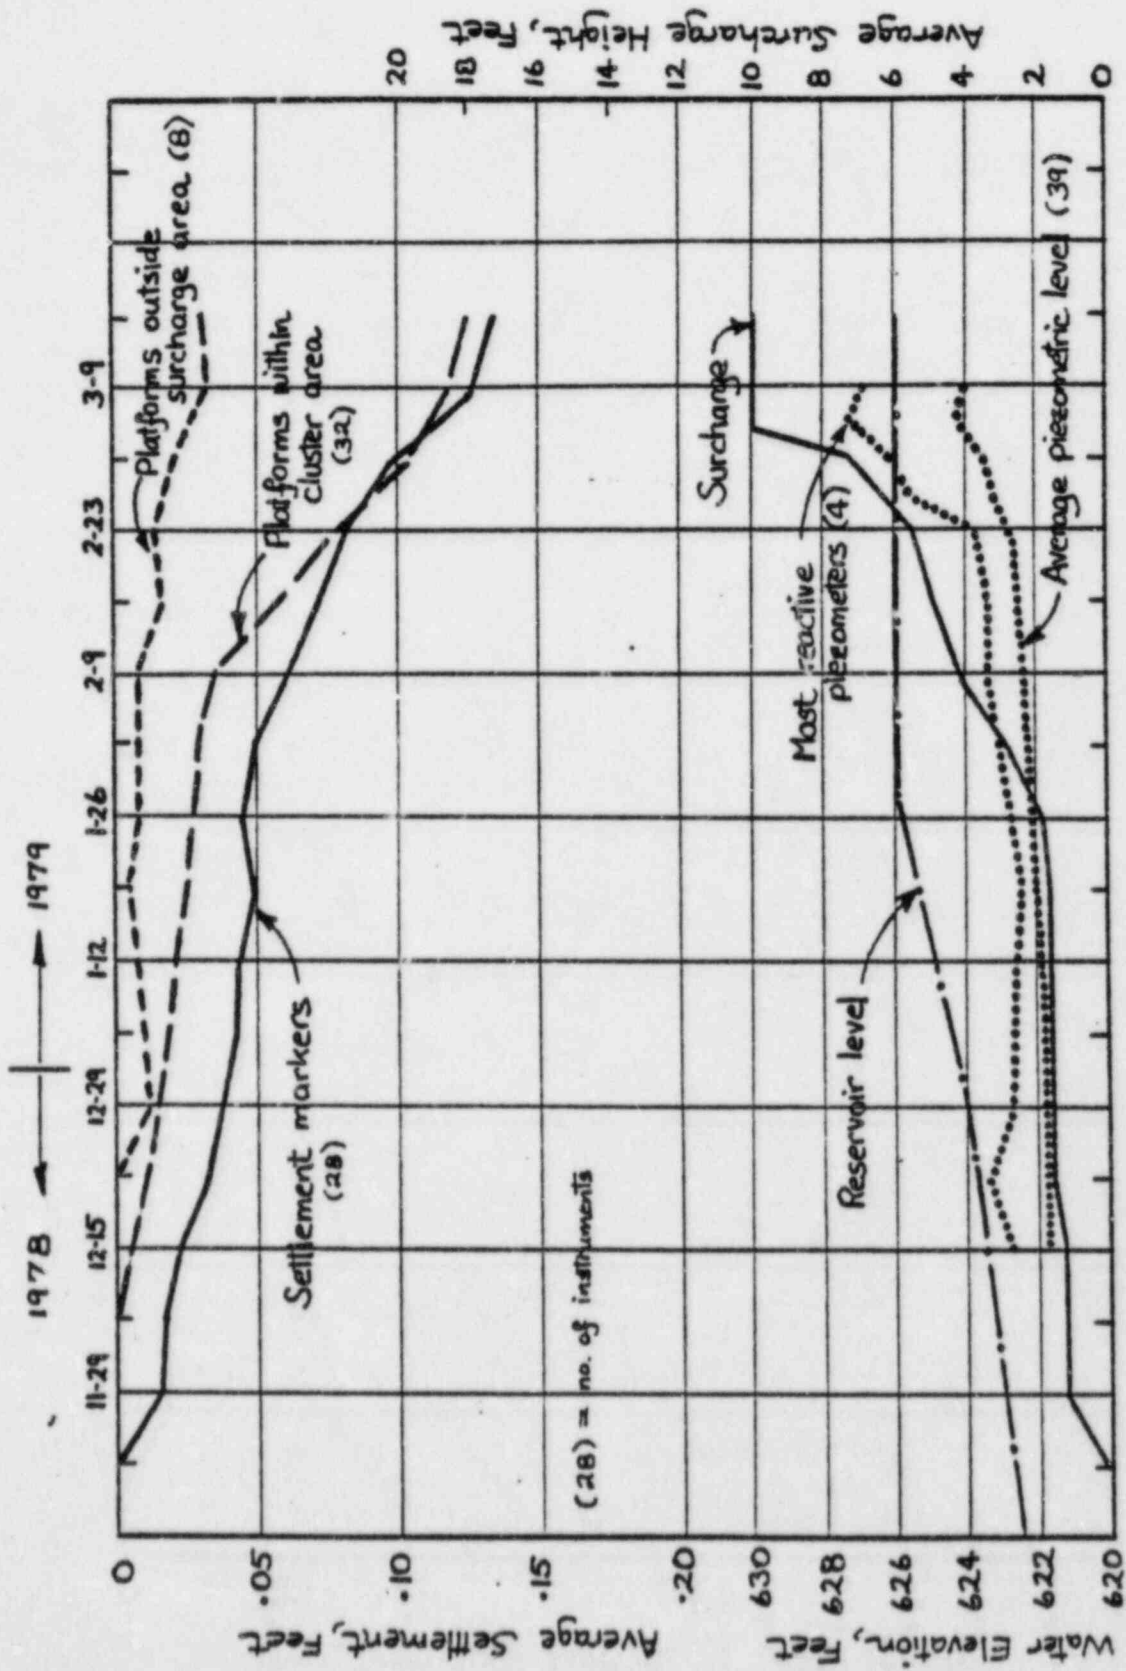
DIESEL GENERATOR BLDG : AVG SETTLEMENT, SURCHARGE & WATER LEVEL VS TIME

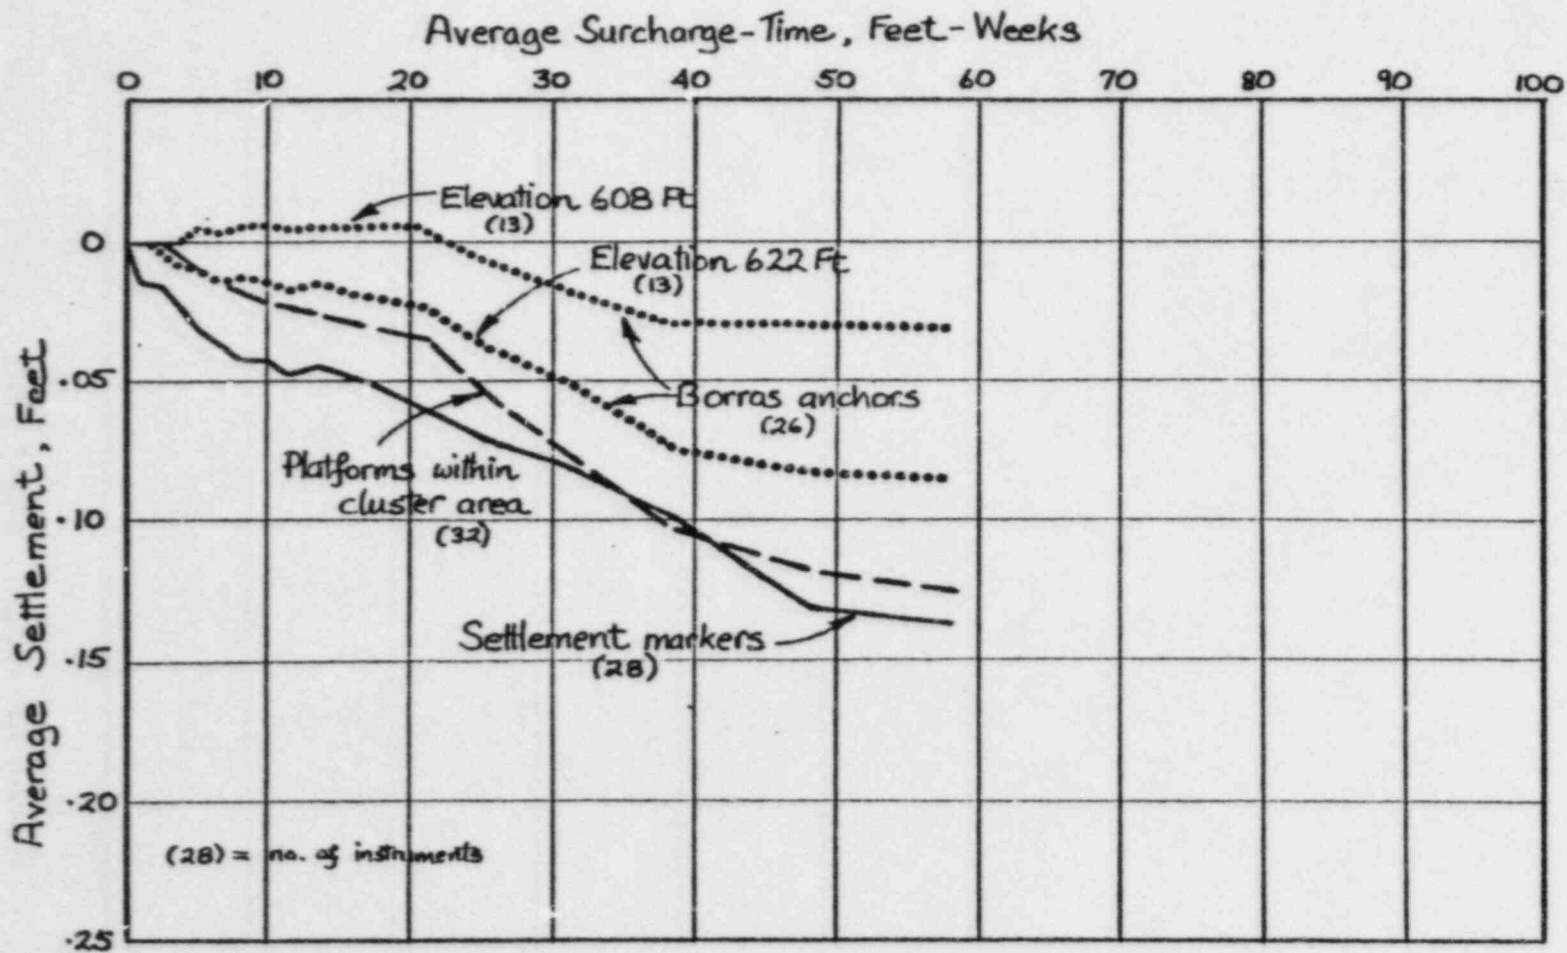
DIESEL GENERATOR BUILDING: AVERAGE SETTLEMENT VS. SURCHARGE-TIME
