UNITED STATES TESTING COMPANY'S
Response to the Bechtel Report

"Review of U. S. Testing Field
and Laboratory Construction
Test Data on Soils Uses as Fill"

Midland Units 1 & 2
Job No. 7220

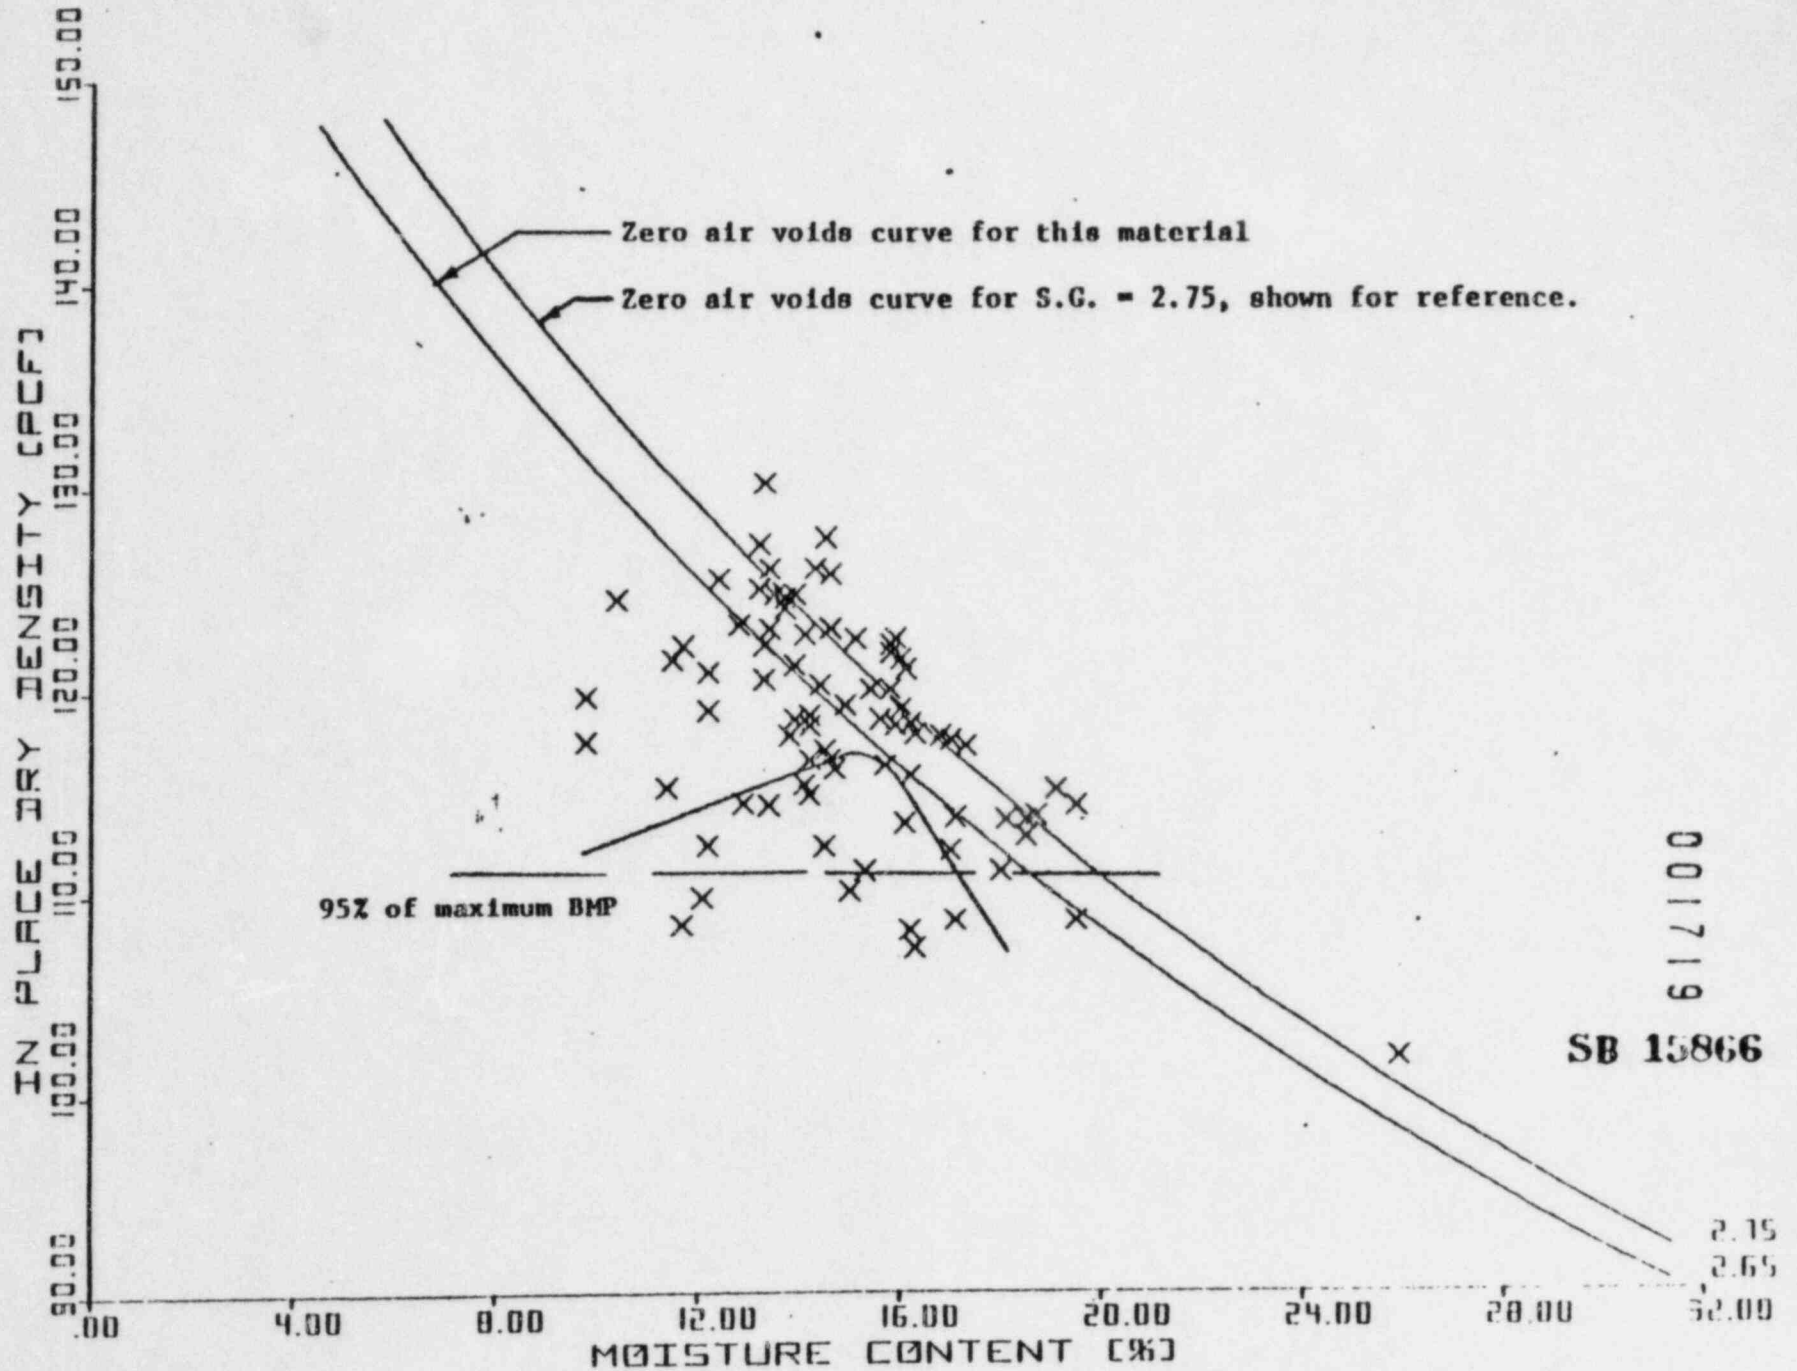
FIGURE 1

Soils cannot be more than 100 percent saturated; therefore, all field density test data points, when plotted as dry density versus moisture content, must be below the zero air voids curve as defined by the specific gravity of the material. Specifications do not require examination of the zero air voids curve, but it is considered common practice relative to compaction plots. There are numerous cases in the U. S. Testing Company data where points plot above the zero air voids curve. Figure 1 attached shows a typical laboratory compaction test curve with field test results plotted on it. Many of the field test results are to determine percent compaction plot above the zero air voids curve. Provided the specific gravity is correct this is not possible so that all such points must represent erroneous data.

In a letter from U. S. Testing to Bechtel (dated May 30, 1974), the average deviation of the nuclear device from oven-dry moistures was +.12% for a set of 30 tests. However, the standard error of estimate is 1.8% for the data with the range of differences being from - 3.2% to +3.9%. Thus, accuracy of the nuclear device is questionable, and could translate into errors of about ± 4 pcf in the dry density calculation. (It should be noted that errors in the moisture content tend to shift the position of test results on a moisture density plot approximately parallel to the zero air voids curve, assuming the in-place wet density is correct, and thus do not explain the large number of points which plot outside the zero air voids. Compare Figures 1 and 9).

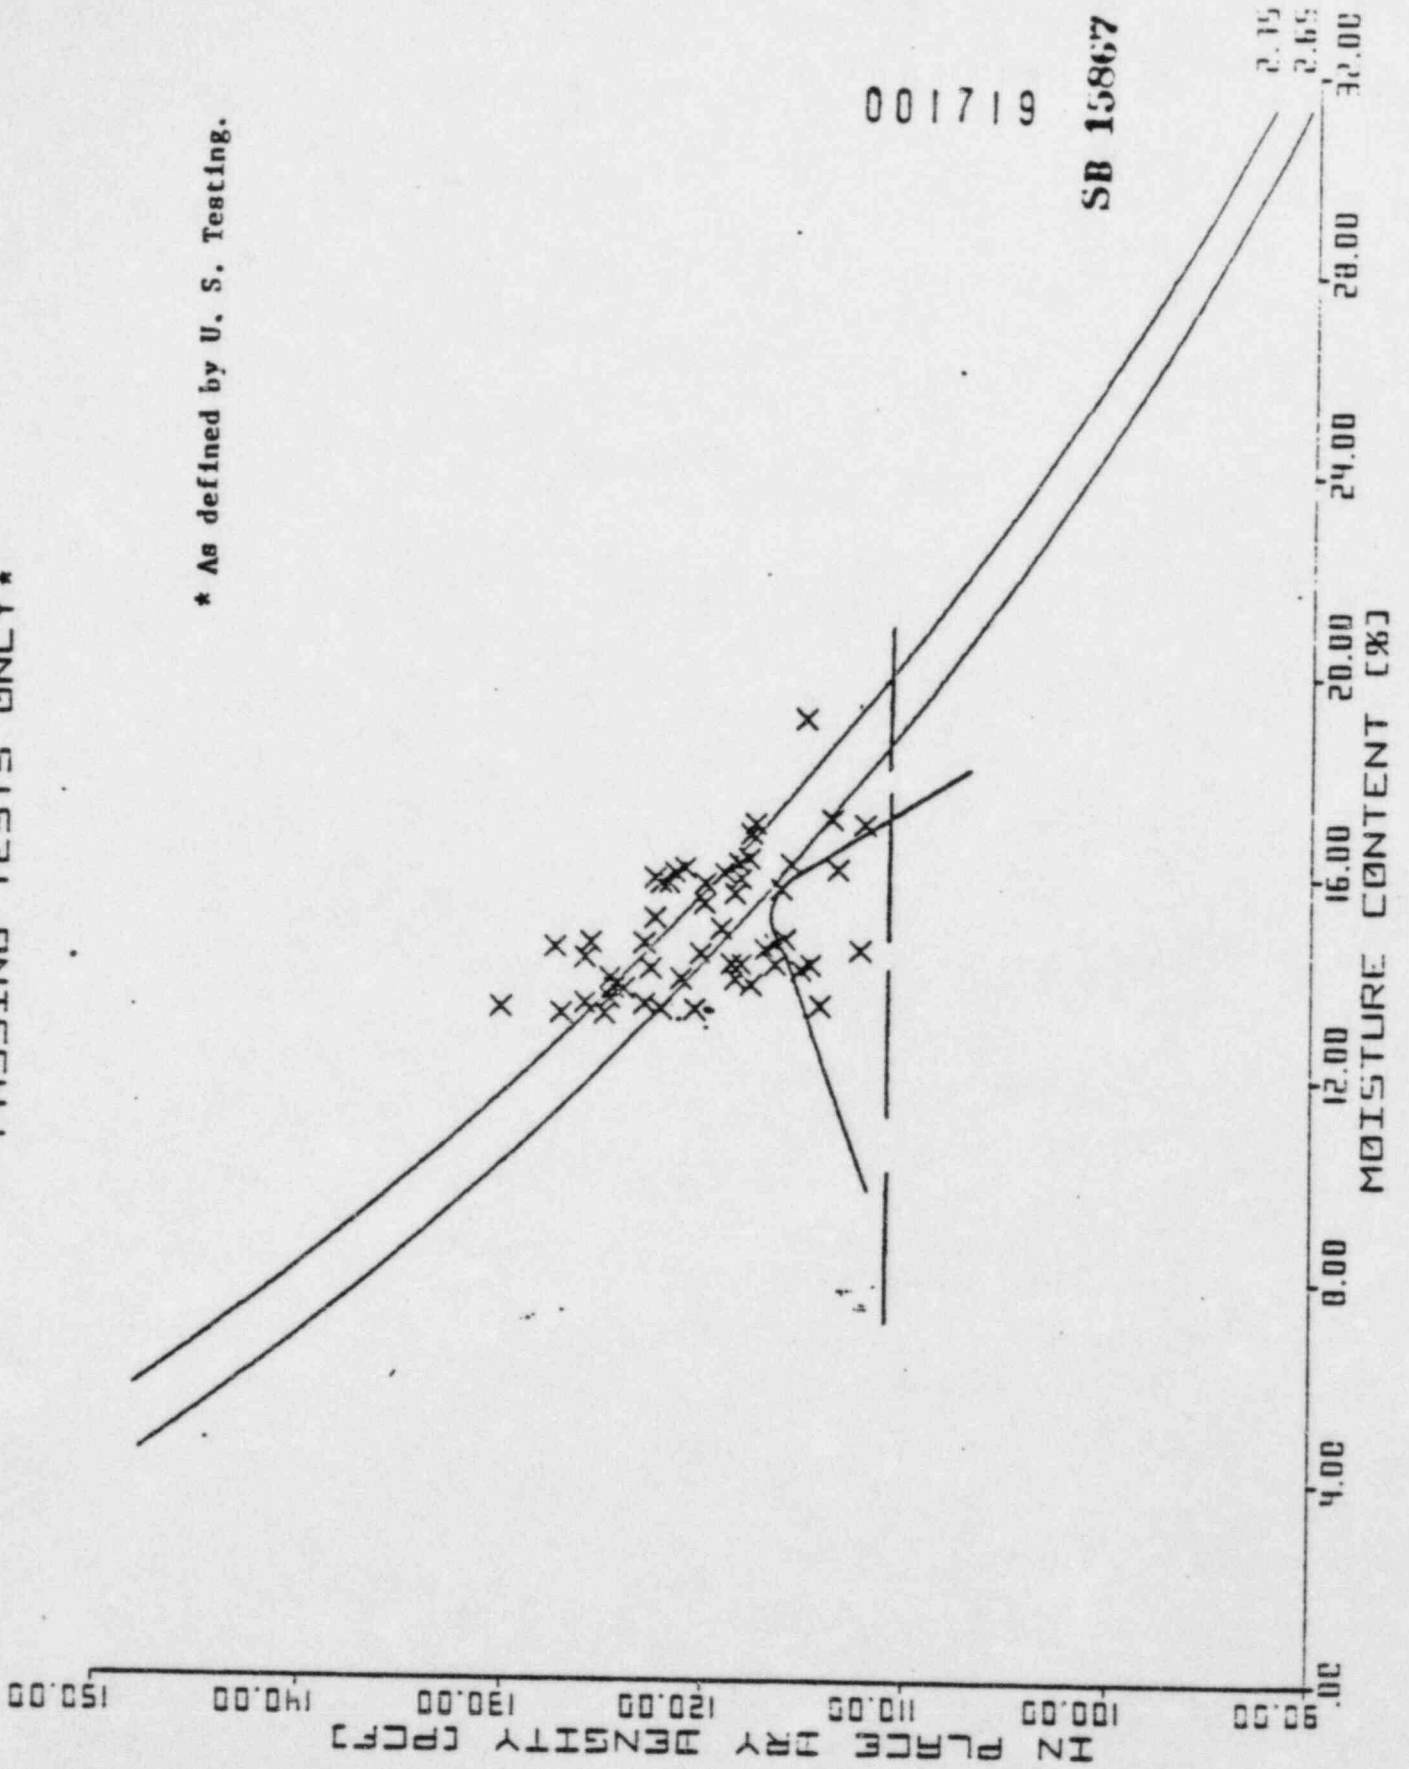
FIGURE 2

MOISTURE-DENSITY FOR BMP 278
 SPECIFIC GRAVITY = 2.65
 PASSING TESTS ONLY*

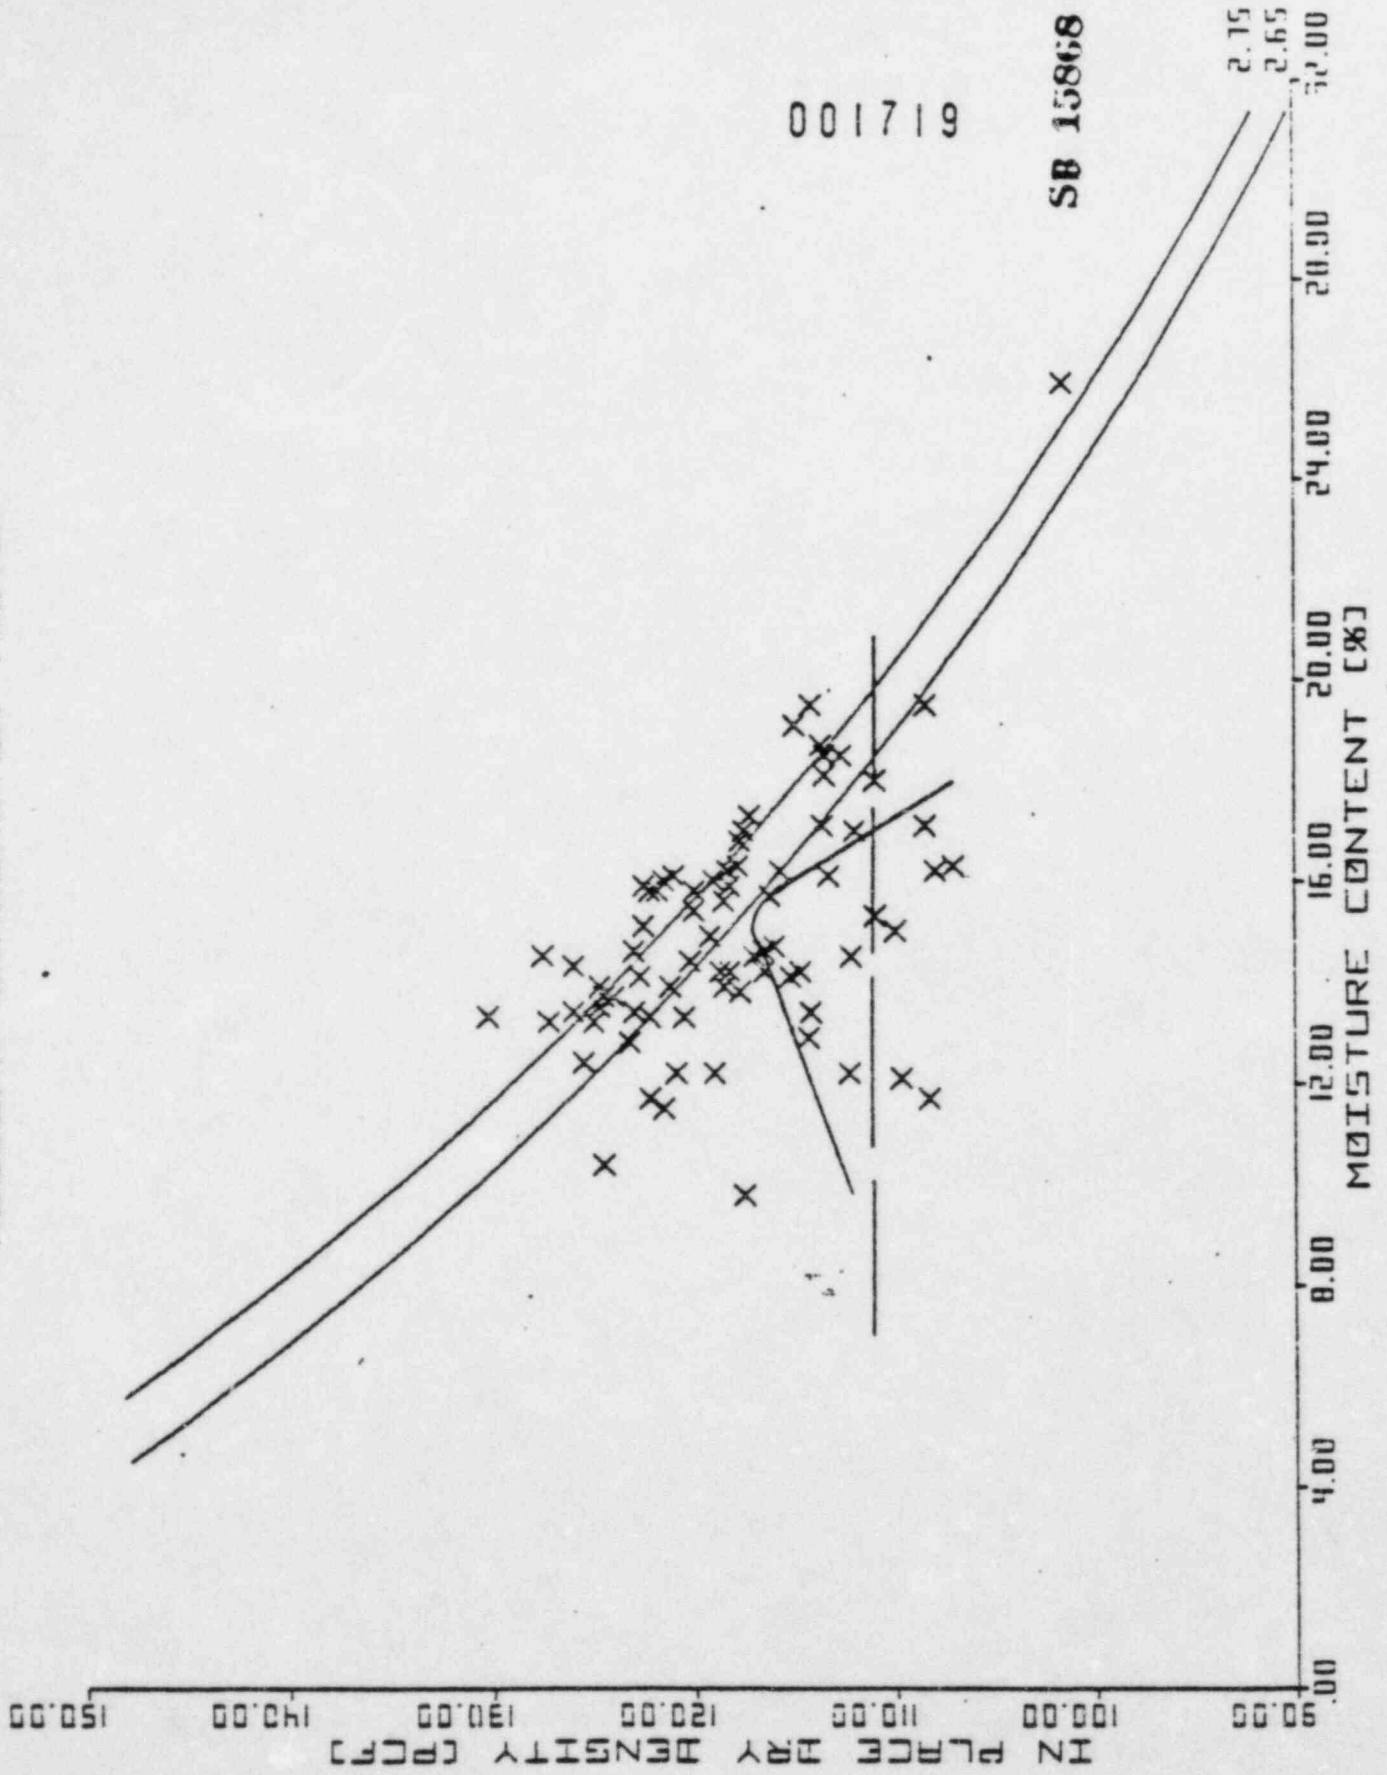
FIGURE 3

However, it is clear that a large number of the nuclear density tests are wrong. This can be explained by considering the wet unit weight may have been wrong or both the moisture content and unit weight may have been wrong. A reliable correlation with properly conducted sand cone tests should have revealed this, but it was not apparently done.

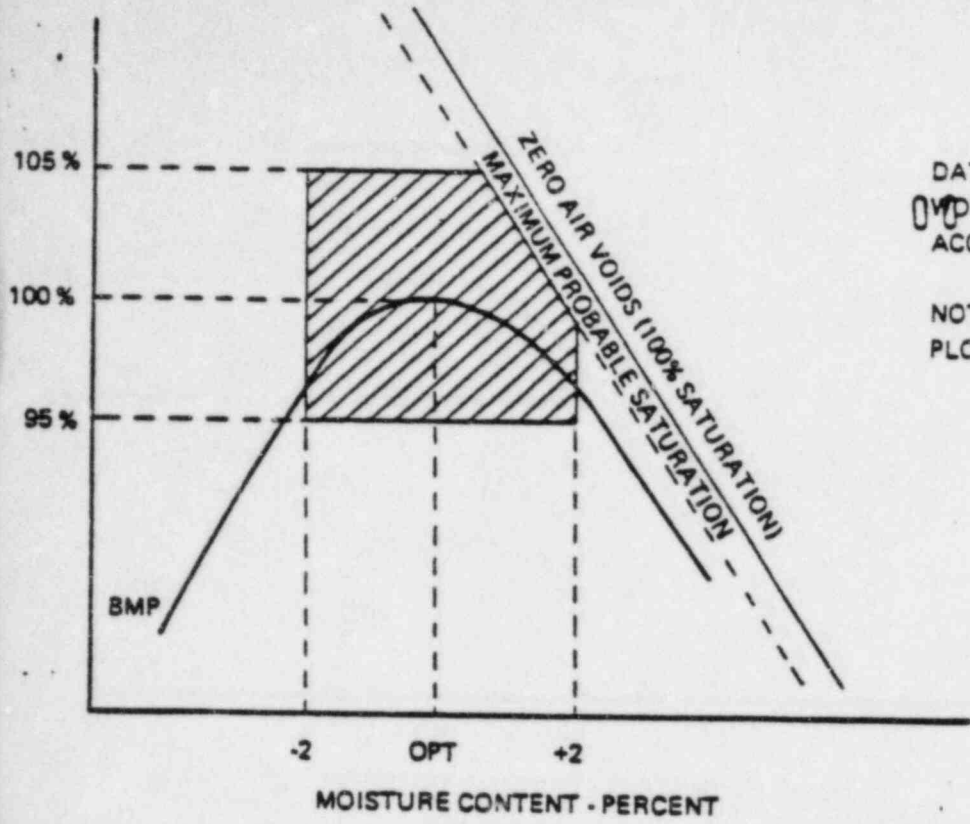
MOISTURE CONTENT - PERCENT
 FIGURE 7-A-

For a field test result to be valid as well as "Passing" it must fall within a well defined area on the plot containing the laboratory compaction curve. This area or window of acceptability is shown for a hypothetical compaction curve on Figure 7a that would meet requirements of Specification 7220-C-210. It is defined by horizontal lines at 95 percent and 105 percent of specified density, vertical lines through ± 2 percent of optimum moisture content, and a line parallel to the zero voids line indicating saturation about half way between the compaction curve and 100 percent saturation (zero air voids curve). The practical upper limit of 105 percent of specified density is not defined in the specifications. It was arbitrarily chosen as numbers greater than this give increasingly invalid comparisons between field test results and the specified laboratory compaction test curve. Therefore, if all data points fall within the defined window there would be no reason to assume that they are wrong. However, when many data points fall outside the designated area there is something wrong with the information and then all data points become suspect. A review of all data indicates that about 25 percent of the cohesive soil test results fall within this area.

DATA POINTS THAT PLOT IN SHADED AREA
 WOULD BE GENERALLY ACCEPTABLE
 ACCORDING TO SPECIFICATIONS

NOTE: ABOUT 25% OF ALL FIELD DATA
 PLOTS IN THE SHADED AREA

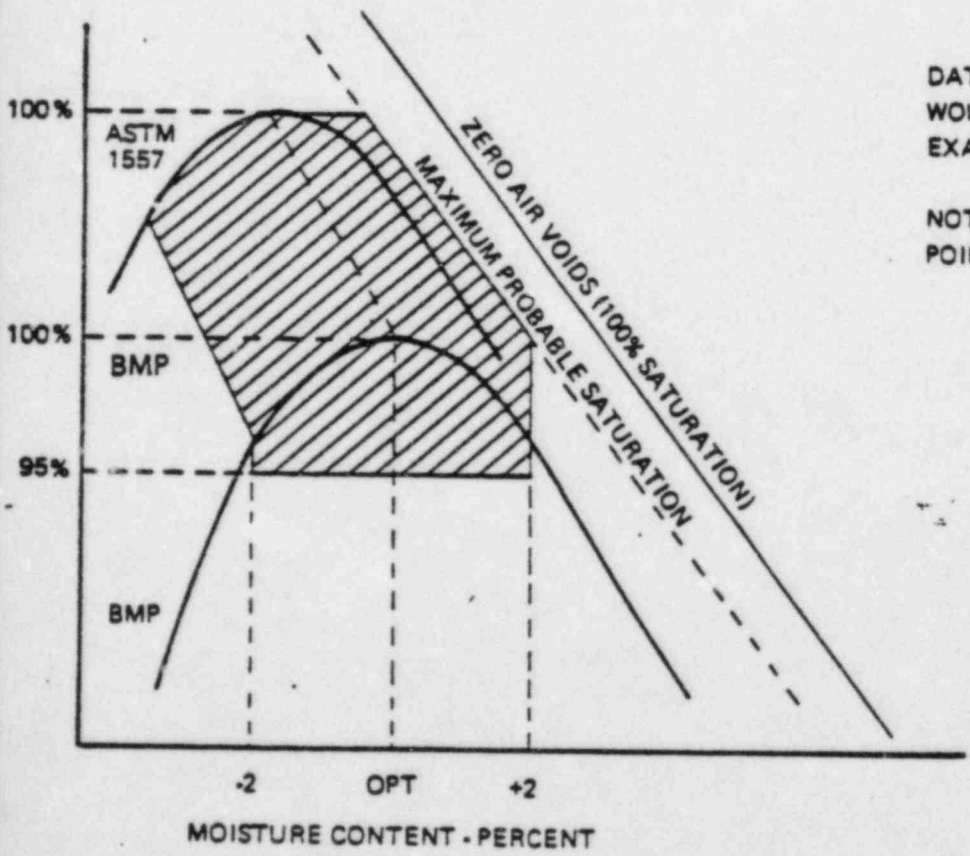
MOISTURE CONTENT - PERCENT
 FIGURE 7-B-

DATA POINTS THAT PLOT IN SHADED AREA
 WOULD BE ACCEPTABLE REGARDLESS OF
 EXACT SPECIFICATION WORDING

NOTE: ABOUT 40% OF ALL FIELD DATA
 POINTS PLOT IN THE SHADED AREA

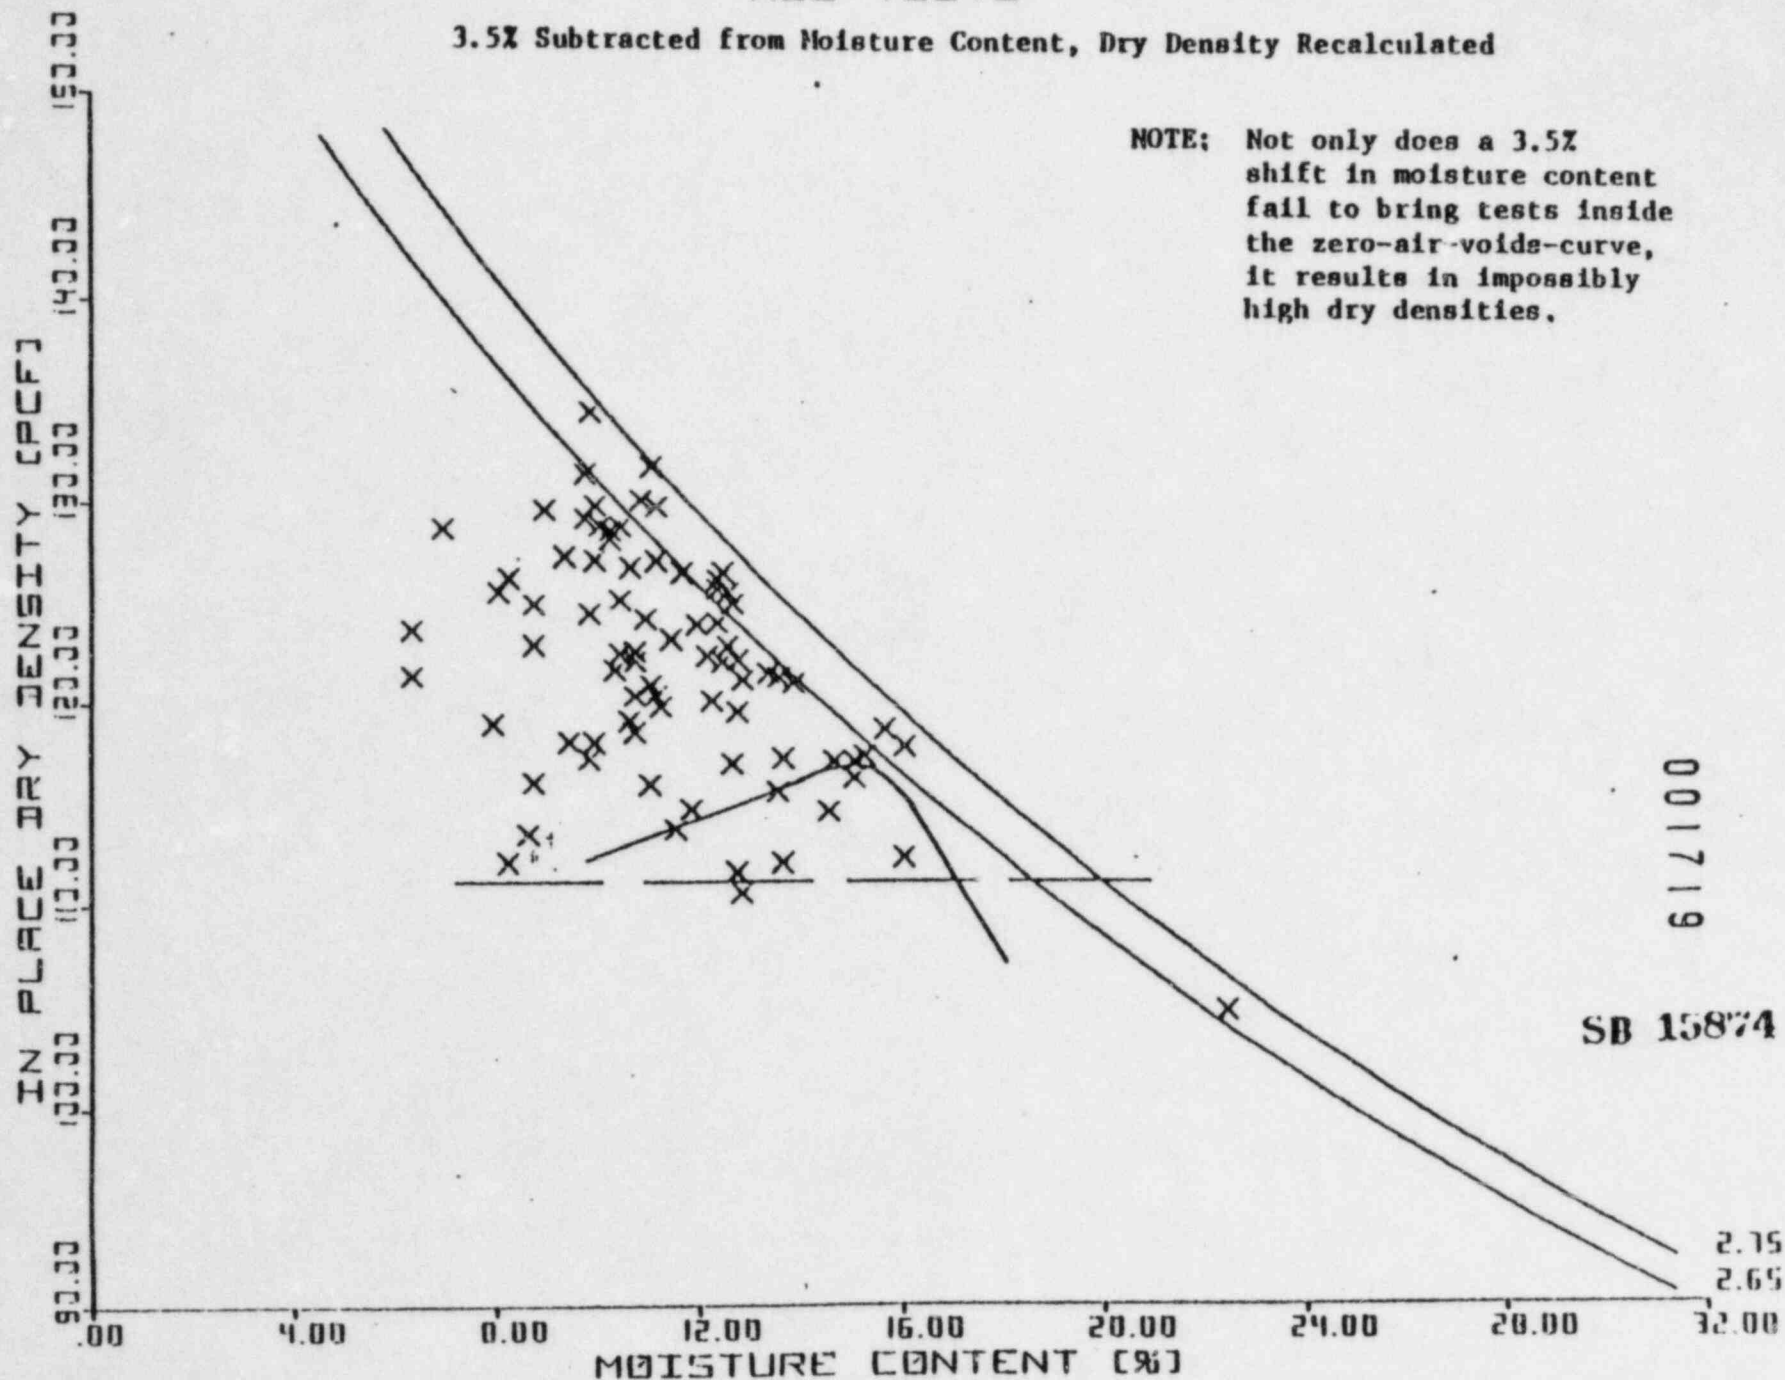
FIGURE 9

3.5% Subtracted from Moisture Content, Dry Density Recalculated

NOTE: Not only does a 3.5% shift in moisture content fail to bring tests inside the zero-air-voids-curve, it results in impossibly high dry densities.

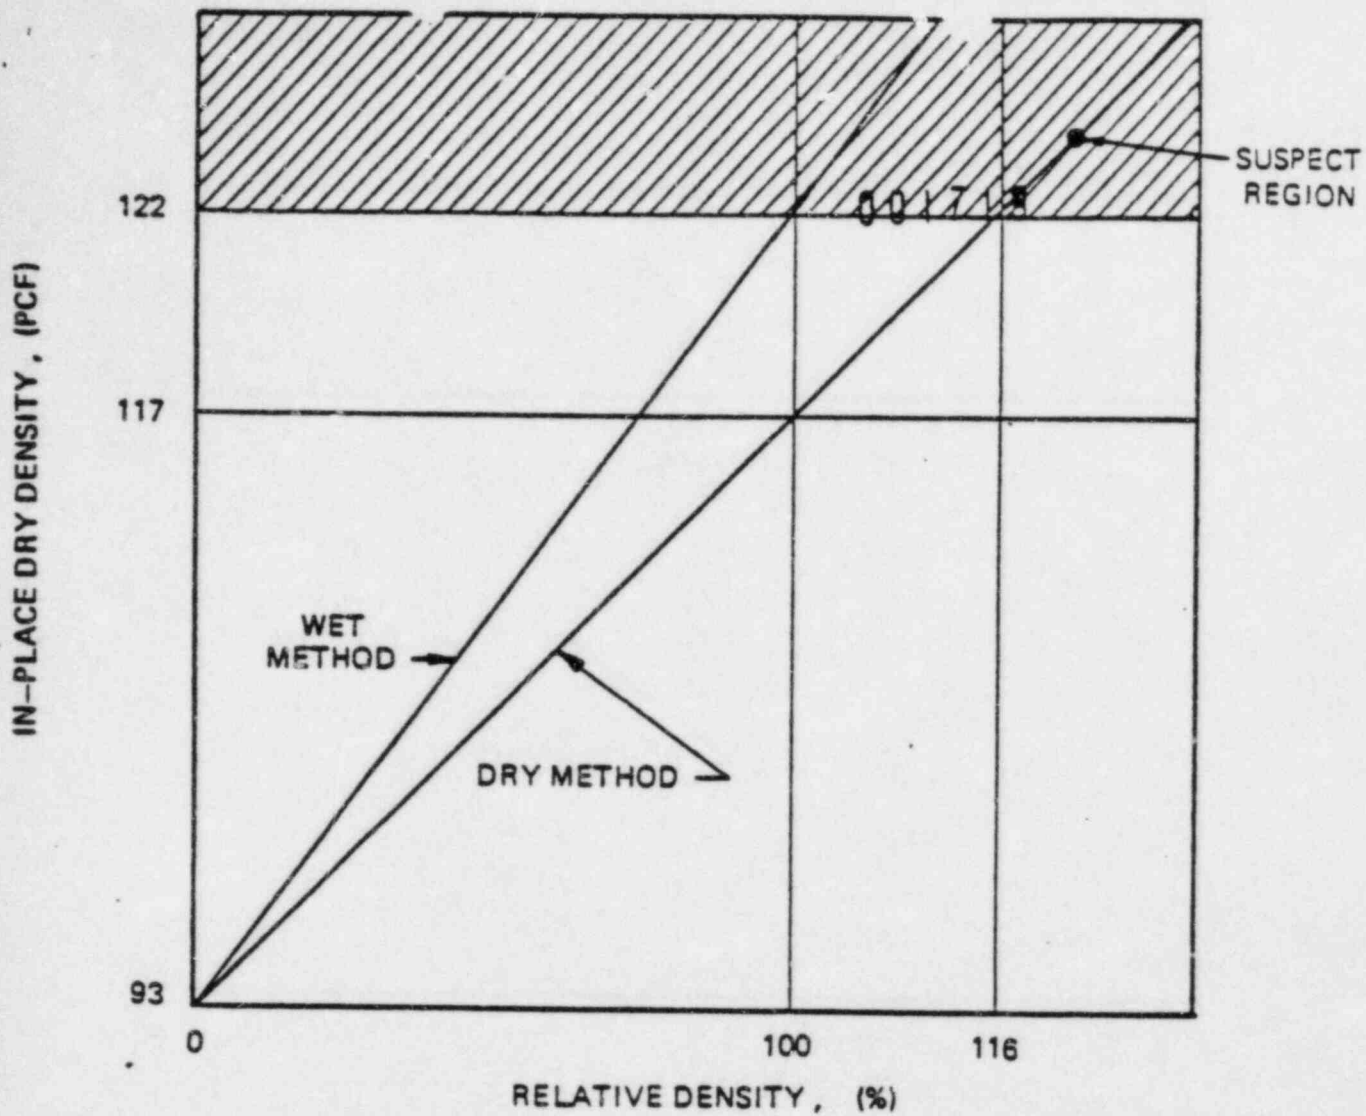
NOTE: VALUES FOR DRY DENSITY ARE TYPICAL OF A RANDOM FILL SAND. ANY TESTS SHOWING MORE THAN 117% RELATIVE DENSITY WOULD BE SUSPECT IN THIS EXAMPLE. STRUCTURAL SANDS TEND TO SHOW ONLY 2 OR 3 PCF INCREASE IN MAXIMUM DENSITY AND THUS RESULTS AT MUCH LOWER RELATIVE DENSITY WOULD BE SUSPECT, SAY 105 - 110 PERCENT
